## Home Inspection Report

PROPERTY INSPECTED:  
6227 Western Bluffs Boulevard  
Billings, MT 59106

Date of Inspection: 07/17/2024

Inspection No. 45957-1-1090

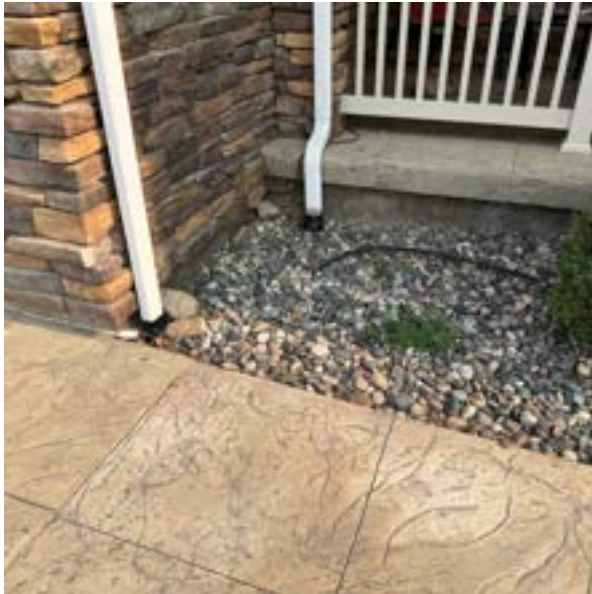
- Exterior East
- Exterior South

2.2.2 Regrade to slope away from structure to reduce foundation deterioration potential water entry and subsequent damage. Monitor landscape grading near foundation for signs of normal soil compaction and correct as required.

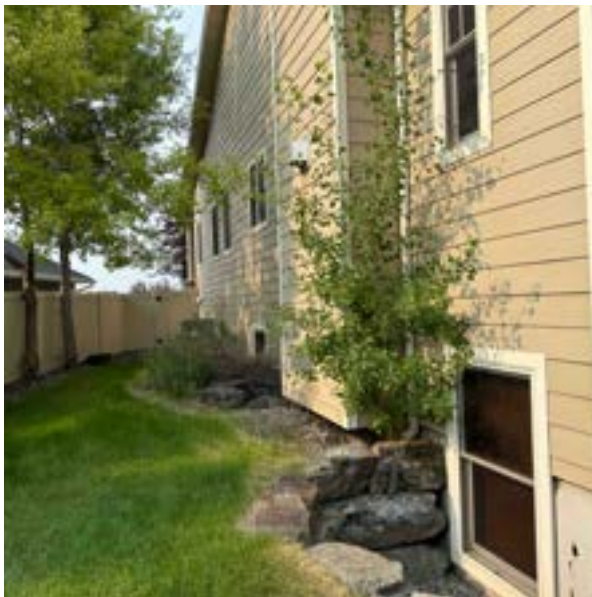
- Exterior East
- Exterior North

2.2.3 Trim and maintain trees, bushes and vines away from the structure to minimize damage/wear to structure and to discourage animal activity.

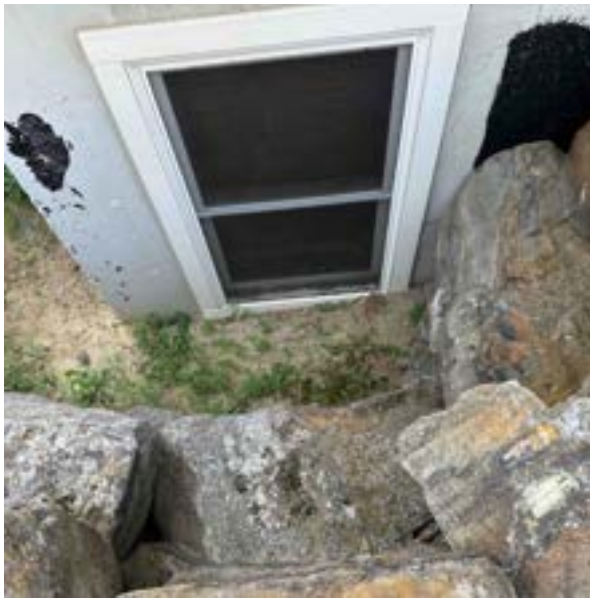
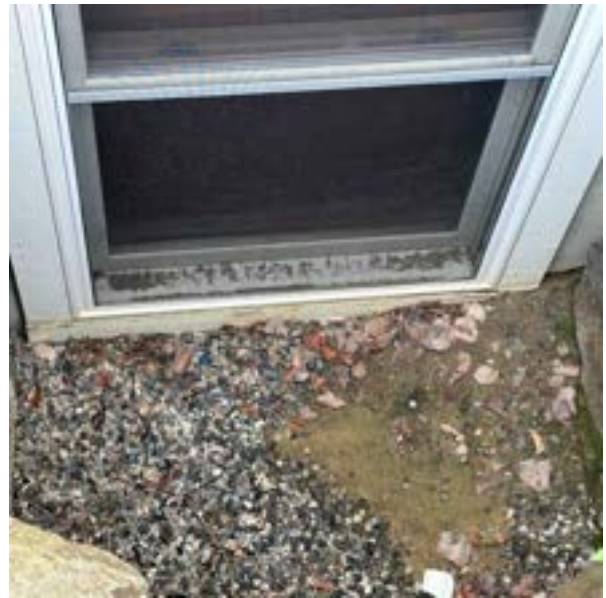
2.2.4 Provide clearance from landscaping to siding/wood contact to prevent deterioration and deter pest entry.  
**(Exterior North)**

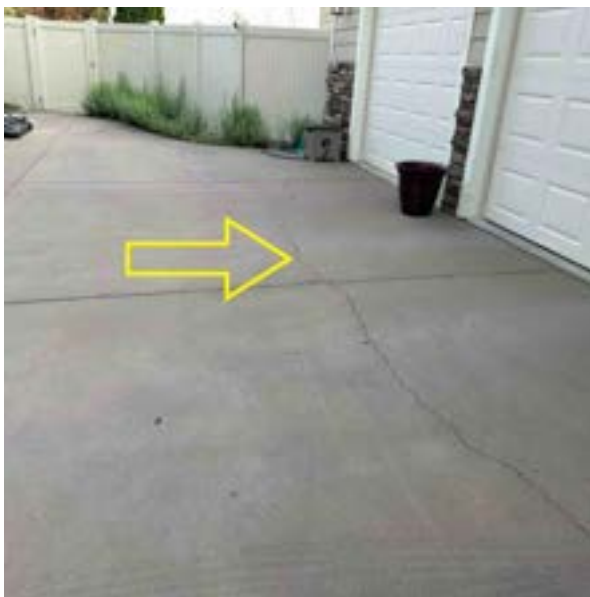
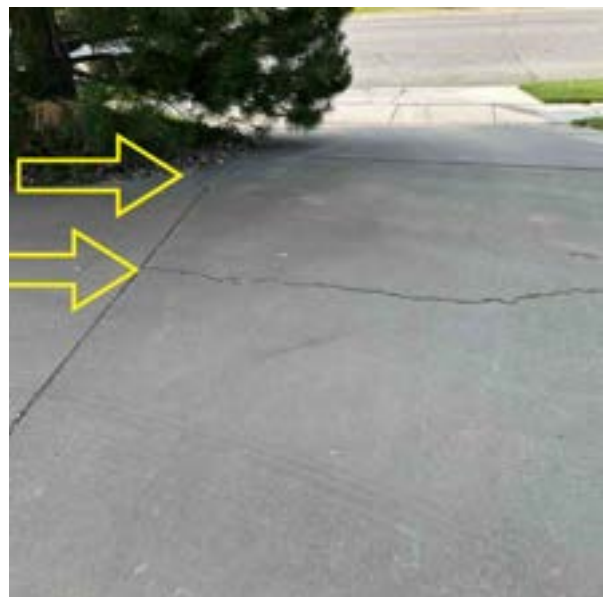
- Exterior North
- Exterior South
- Exterior West

2.4.2 Repair settled/cracked/uneven driveway/walkways/patio/porch to prevent further damage, moisture related damage, and trip hazards.

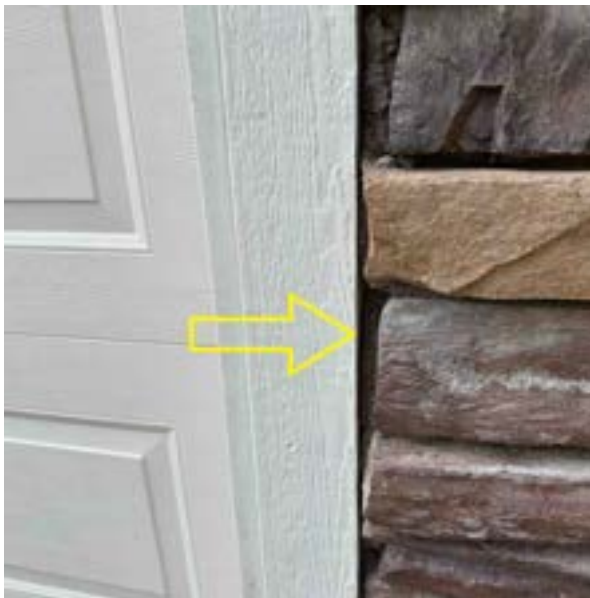
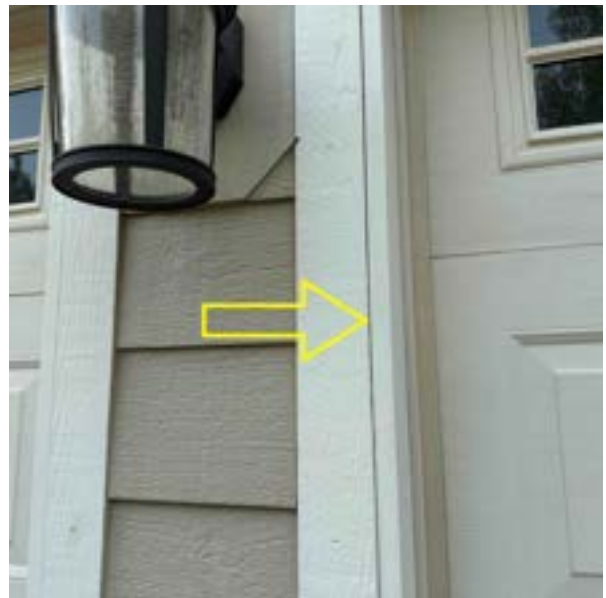
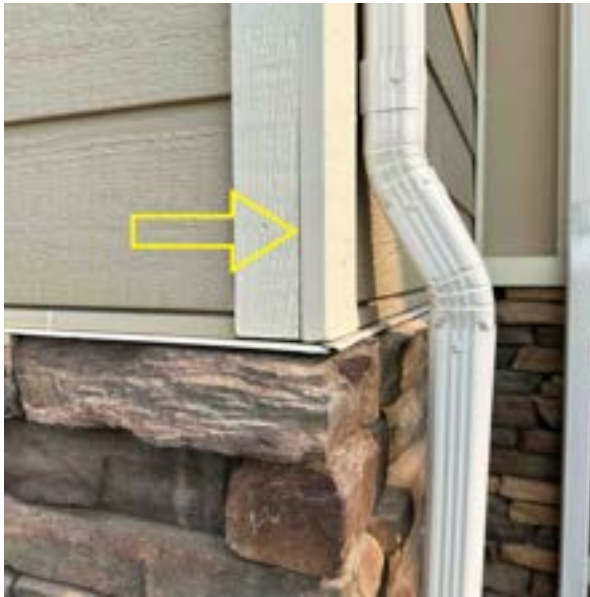
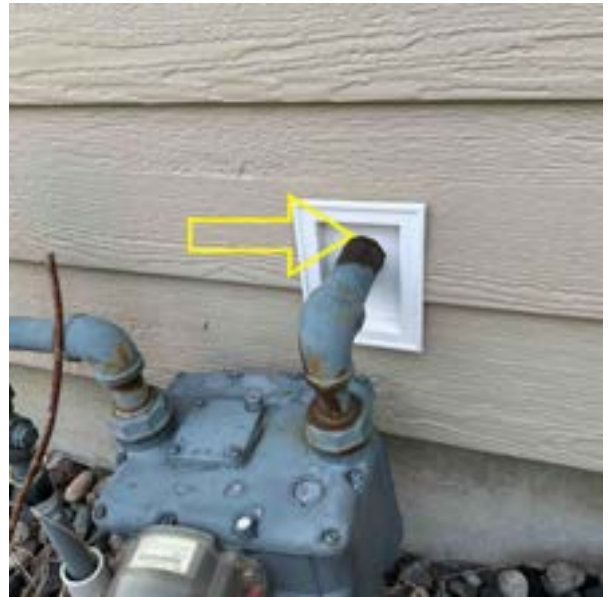
- Exterior East
- Exterior North
- Exterior South
- Exterior West

3.3.3 Ensure proper caulking and weather seal at all required locations and junctions such as windows, doors, dissimilar materials junctions, etc.

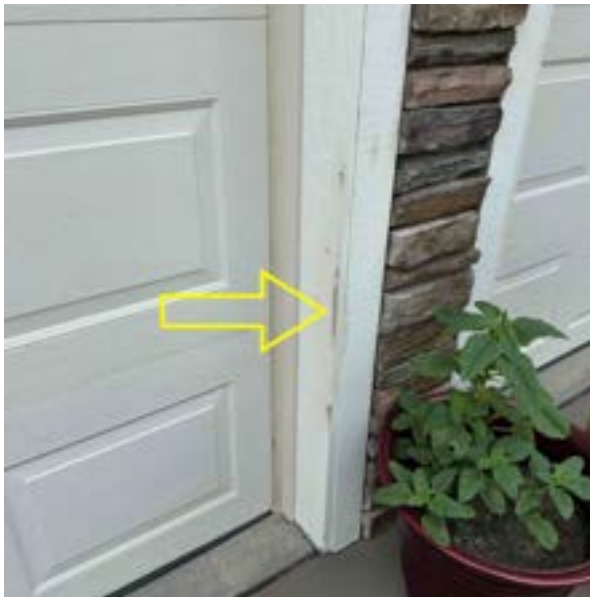
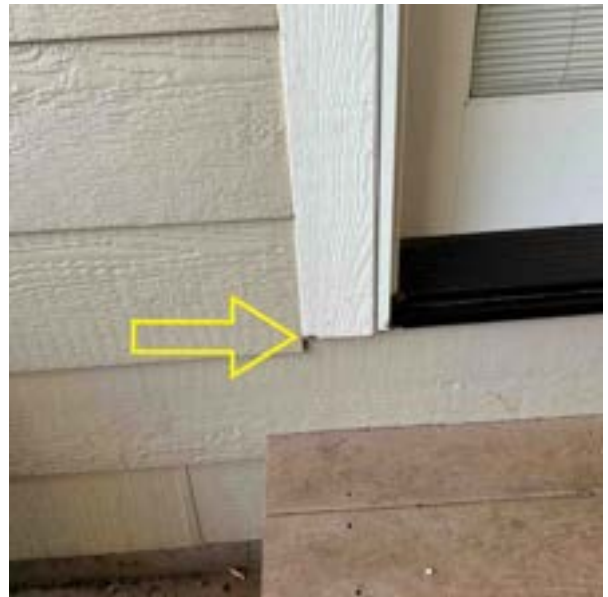
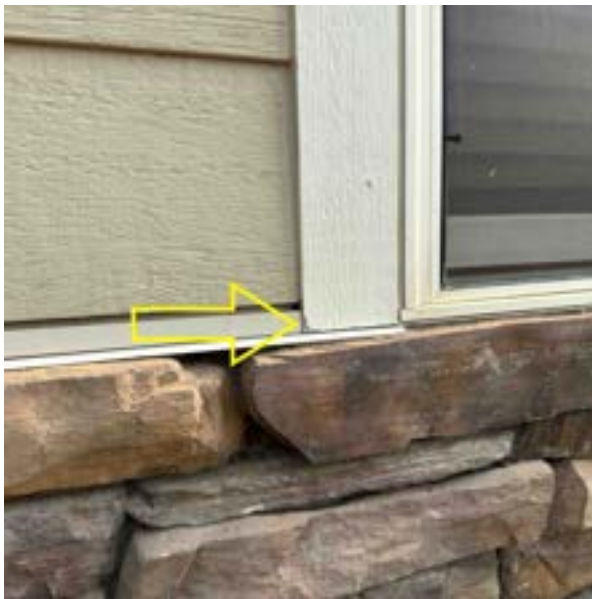
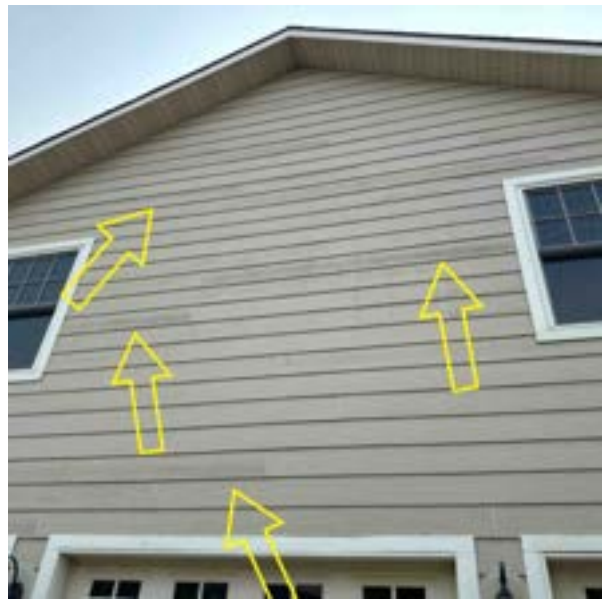
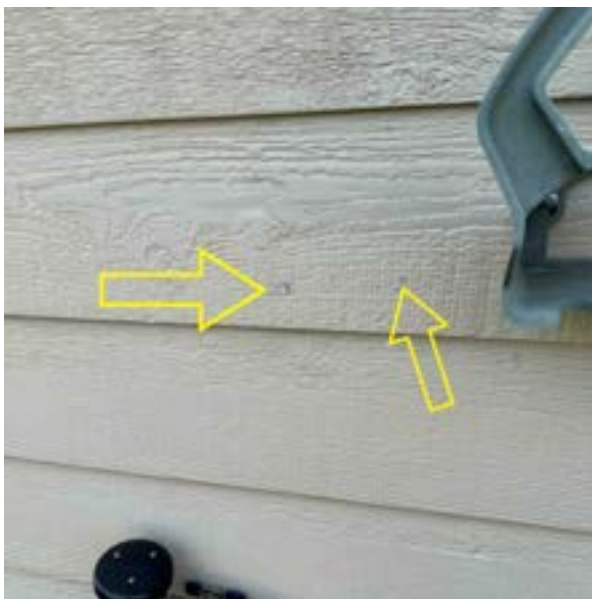
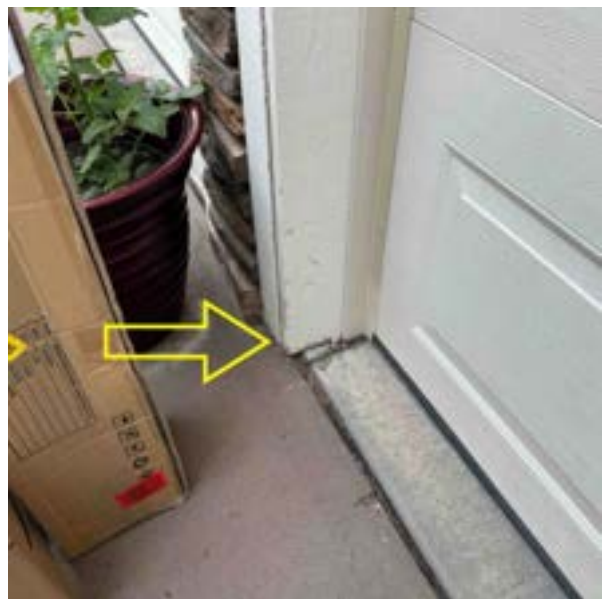
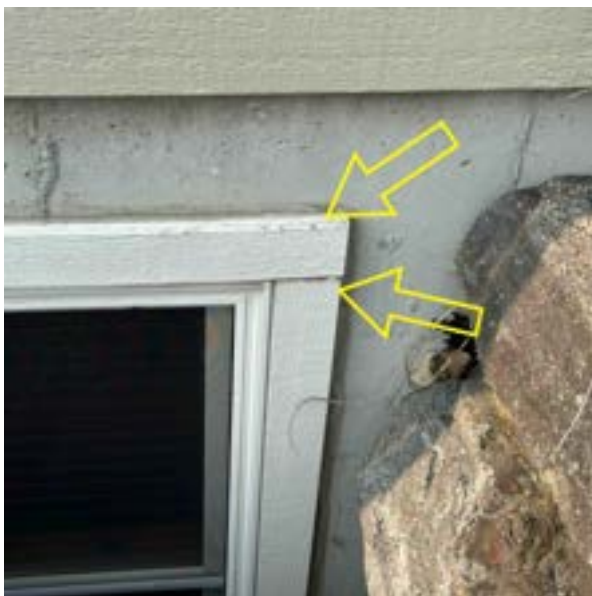
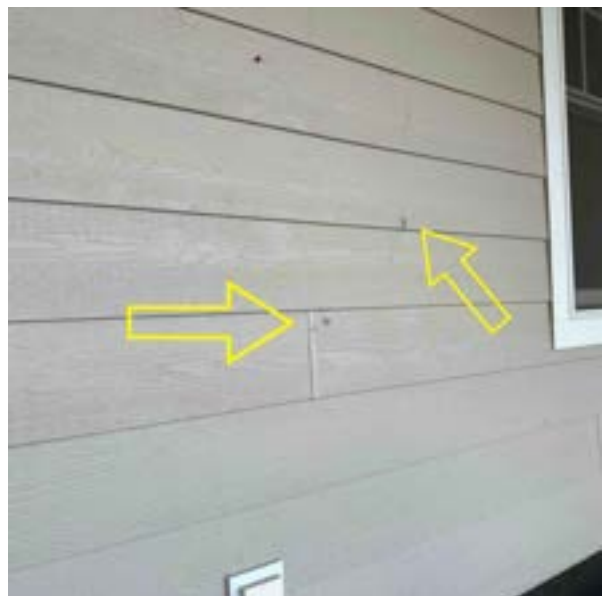
- Exterior East
- Exterior North
- Exterior South
- Exterior West

3.3.4 Clean, seal/paint/stain all exposed wood siding/trim to promote weathering protection.

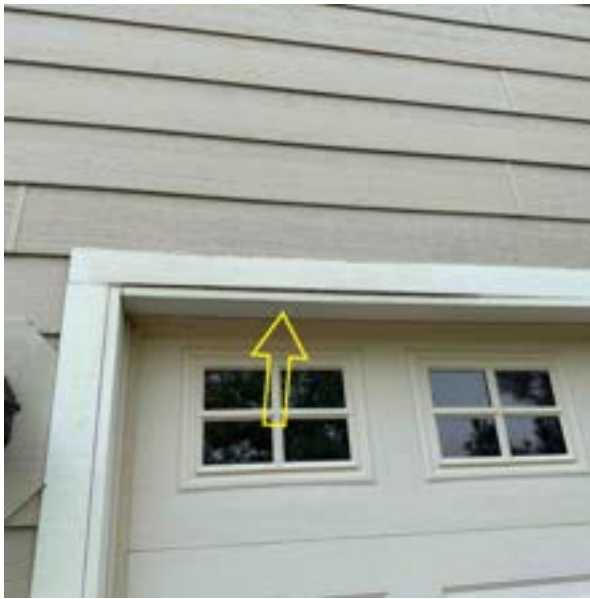
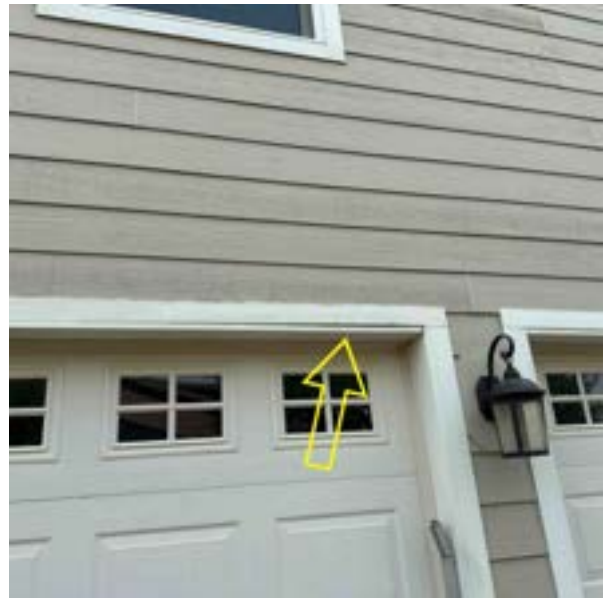
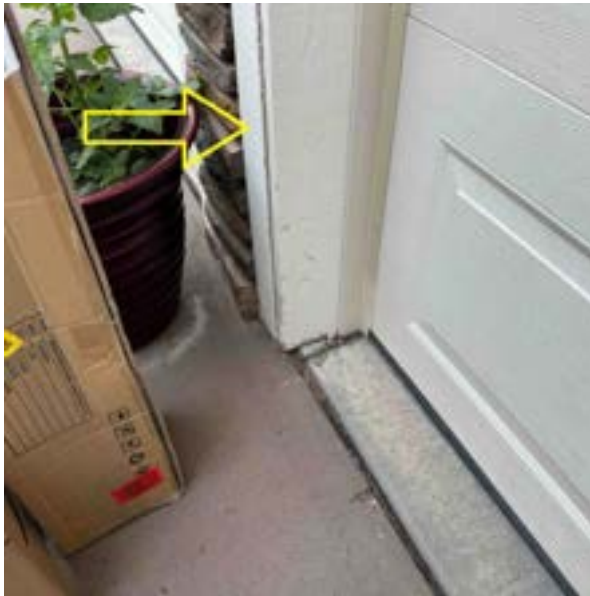
3.3.5 Secure loose siding to promote weathering protection and prevent further damage. **(Exterior West)**

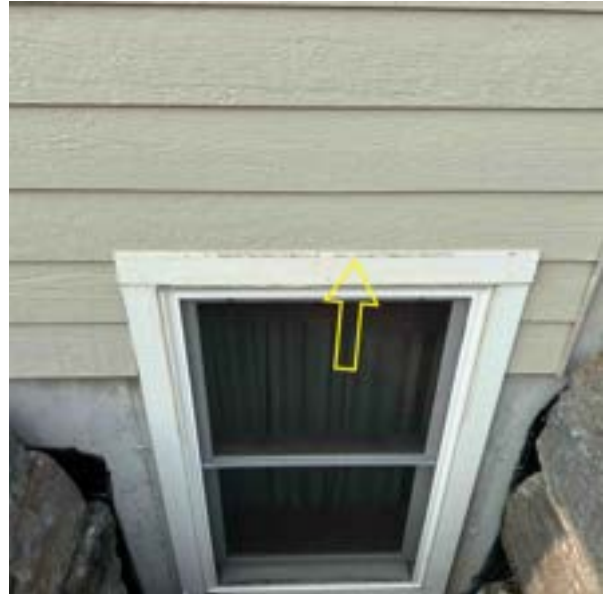
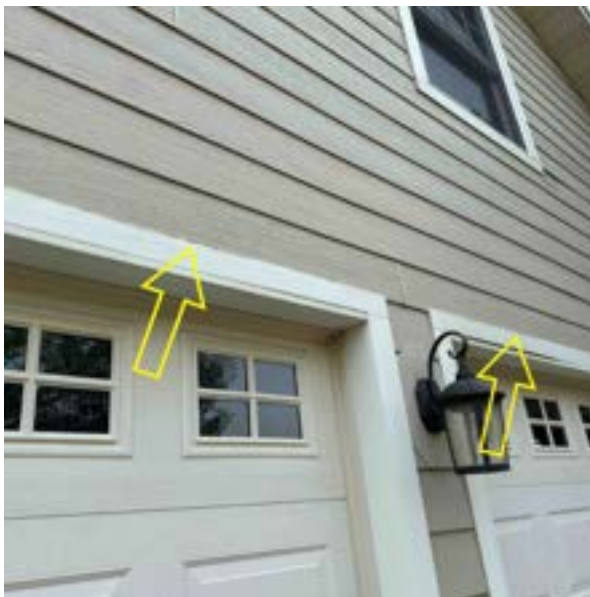
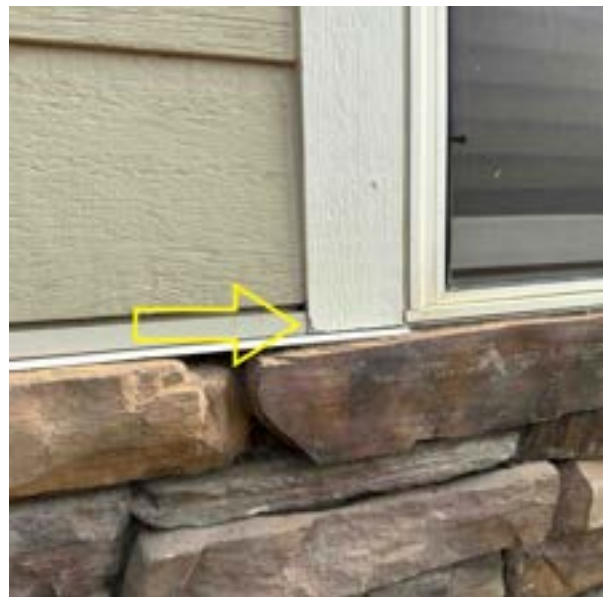
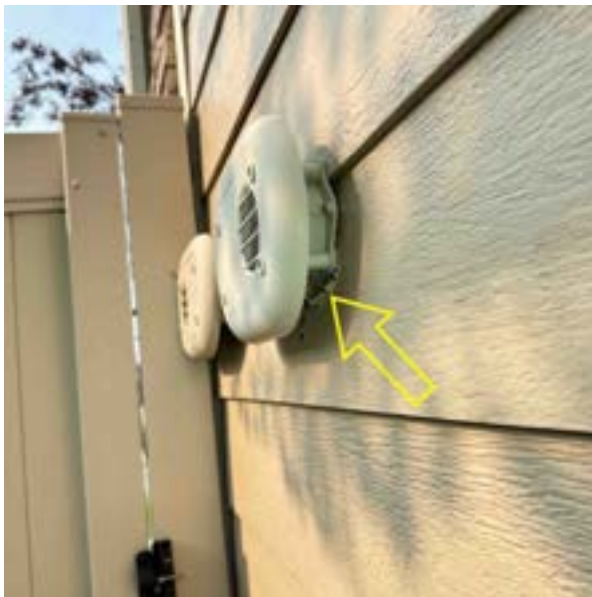
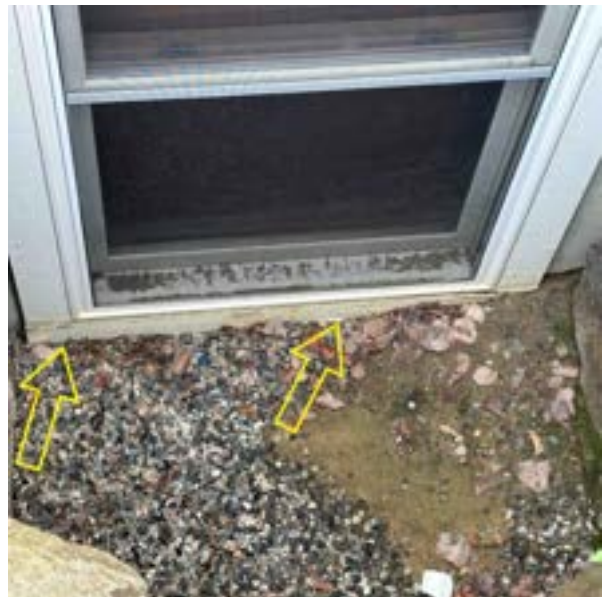
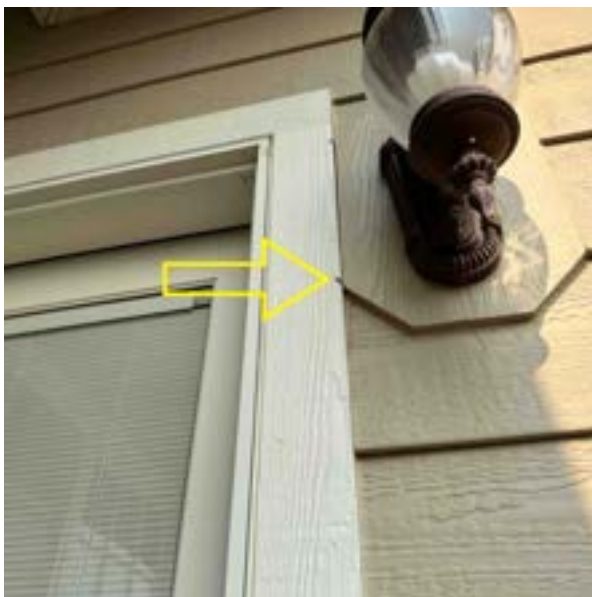
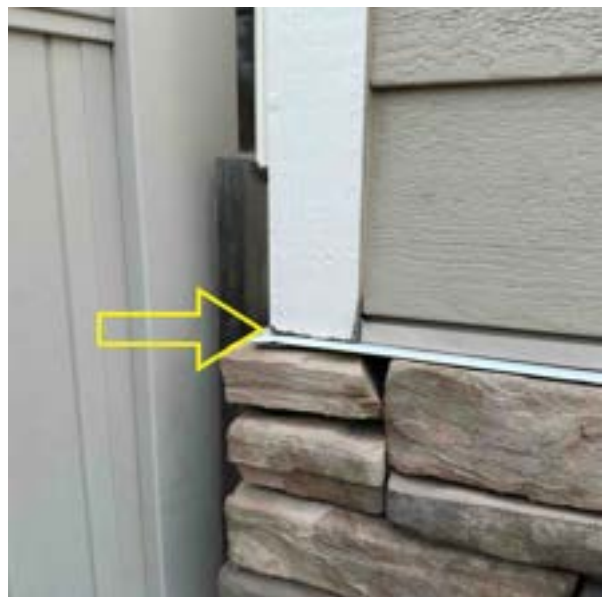
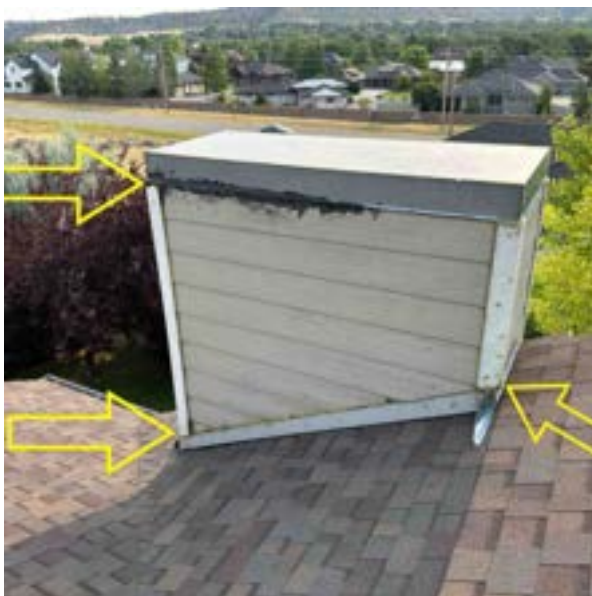
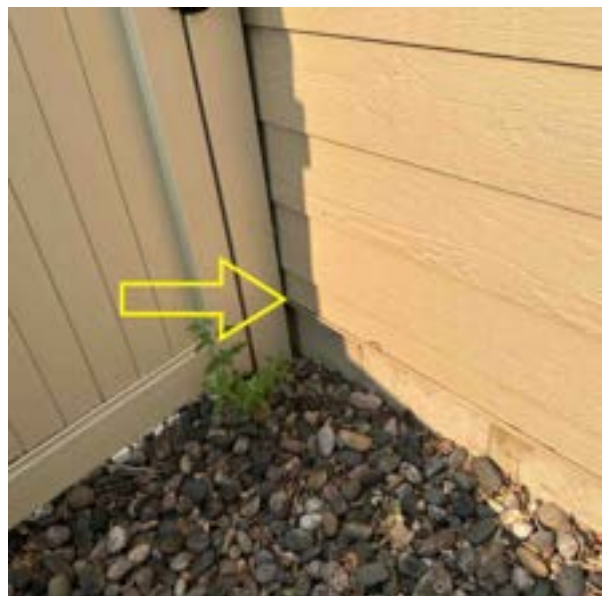
- Exterior East
- Exterior North
- Exterior South
- Exterior West

3.3.6 Repair/replace sections of siding/trim showing signs of deterioration to prevent further damage.

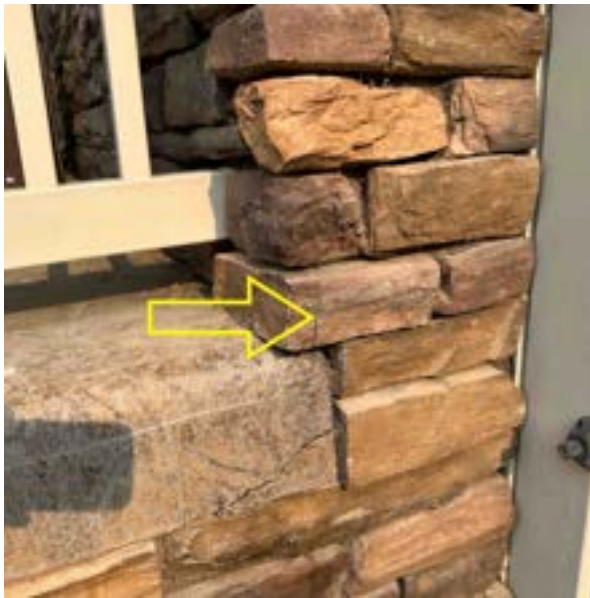
3.3.7 Repair damaged brick/stonework to prevent further damage and promote weathering protection.  
(Exterior South)

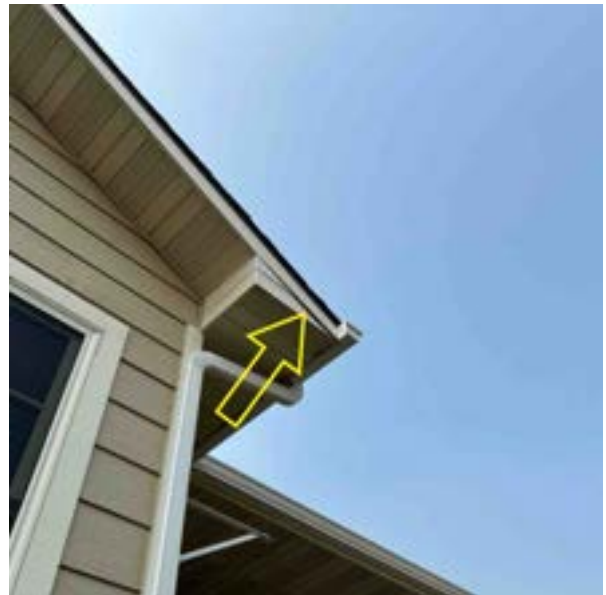
- Exterior East
- Exterior North

3.4.2 Secure loose soffit/fascia to prevent damage and deter pest entry.

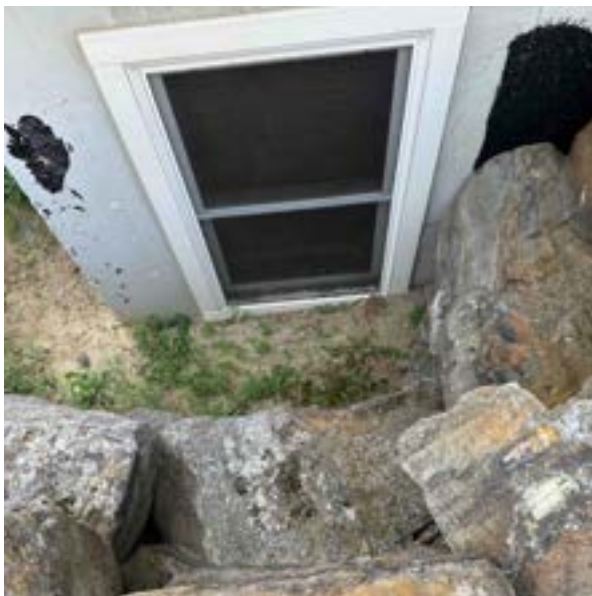
- Exterior East
- Exterior North
- Exterior West

3.7.3 Clean and maintain window wells to promote intended drainage away from structure. Recommended distance from bottom of rough open of window to soil to be between 8"-10".

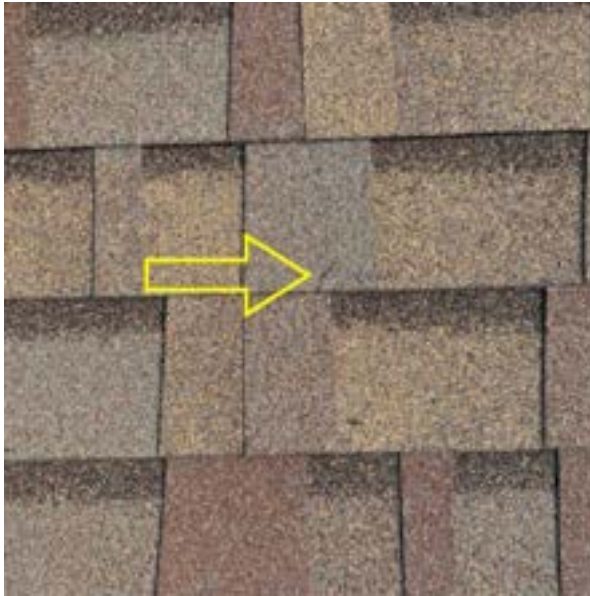
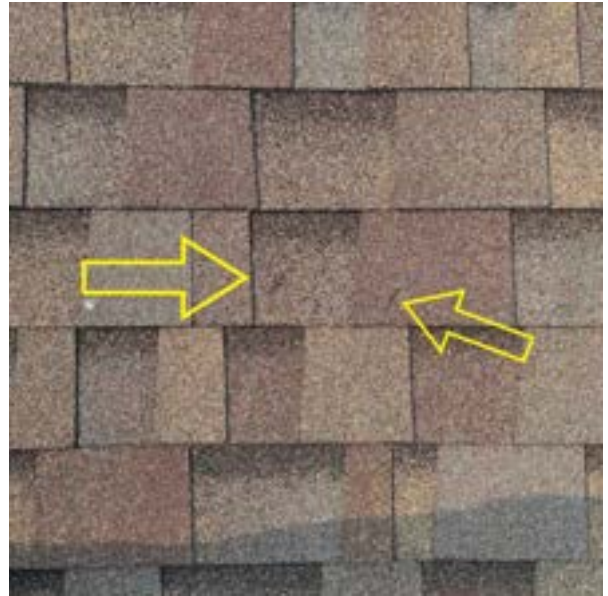
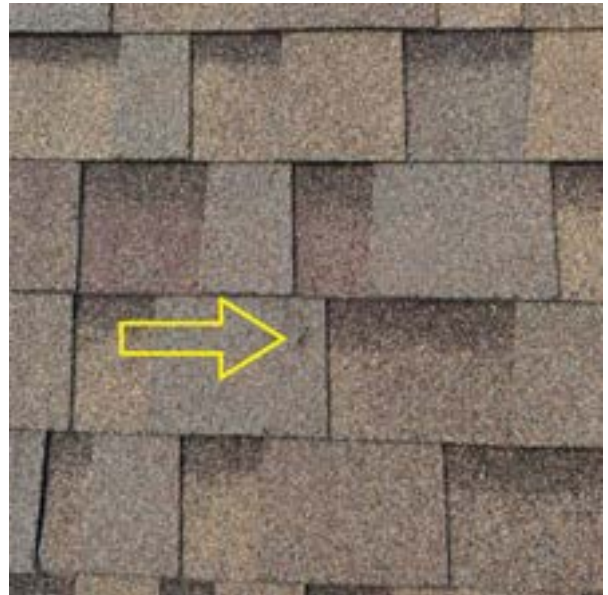
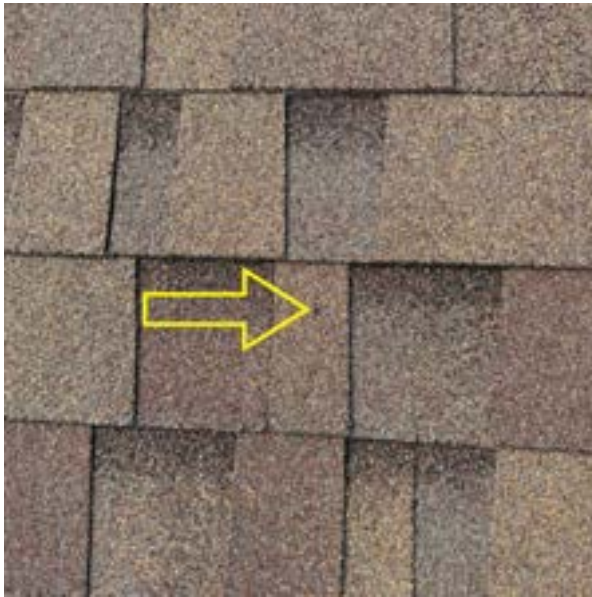
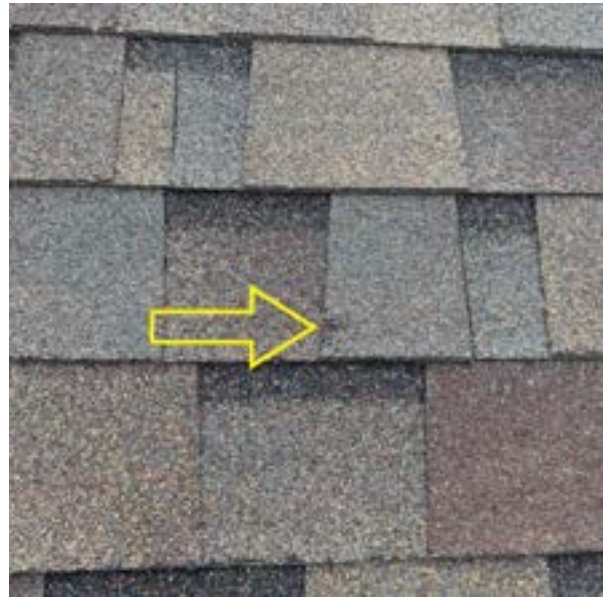
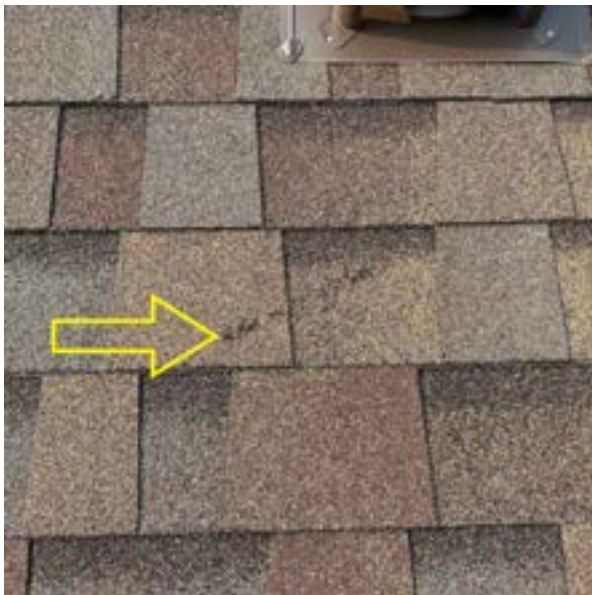
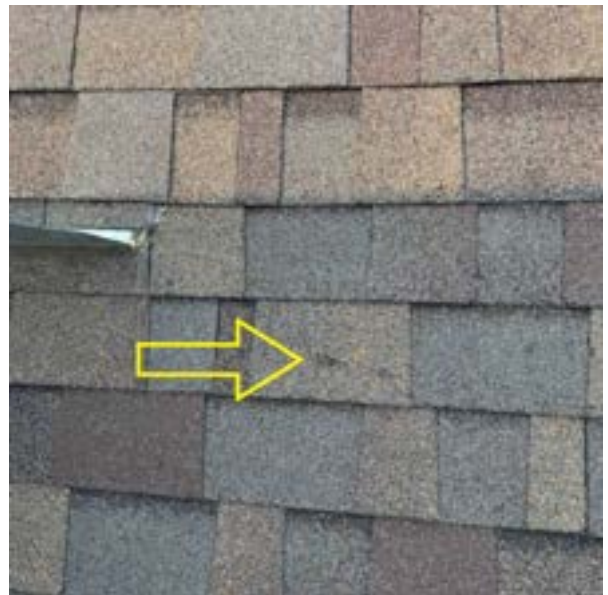
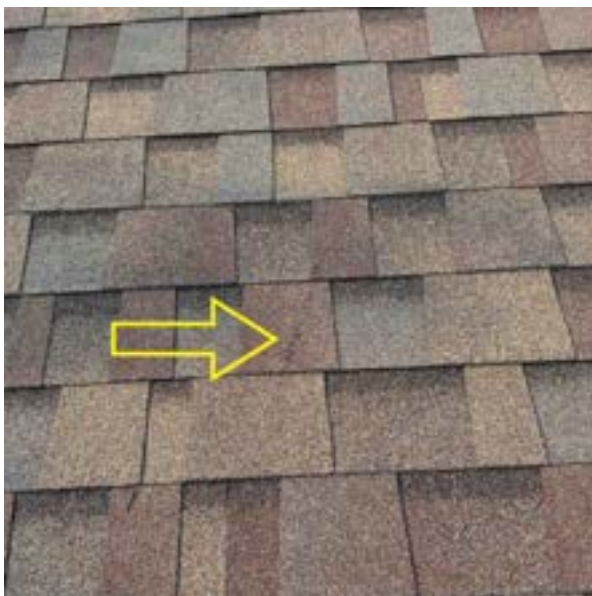
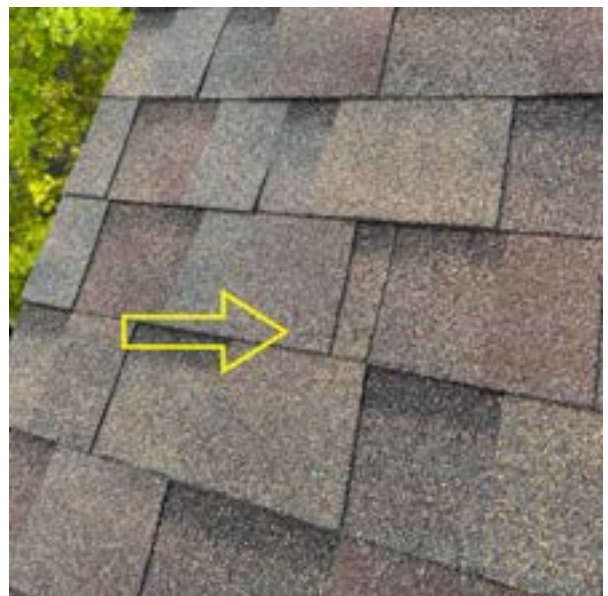
4.2.1 Consult a qualified roofer to evaluate scarred/damaged shingles and repair as recommended.

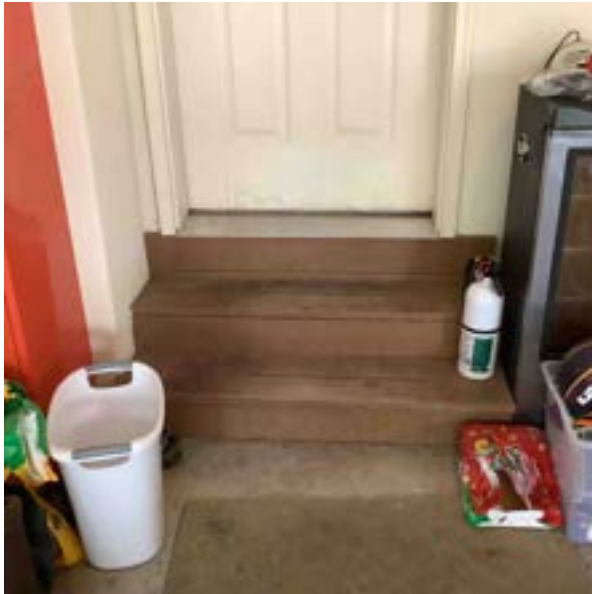
6.2.1 Install handrail at garage steps to promote safety. **(Garage)**

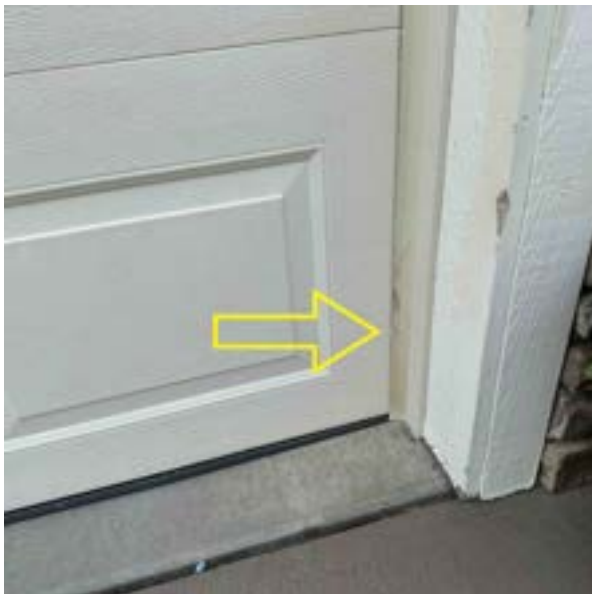
6.3.1 Replace damaged weather seal to promote weathering protection. **(Exterior West)**

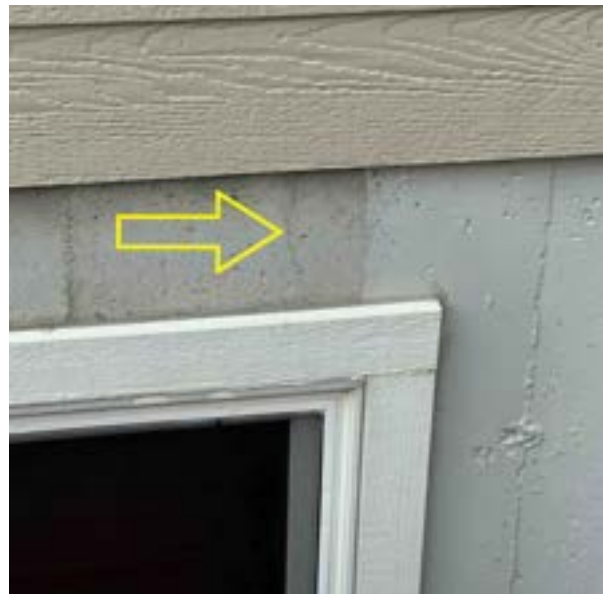
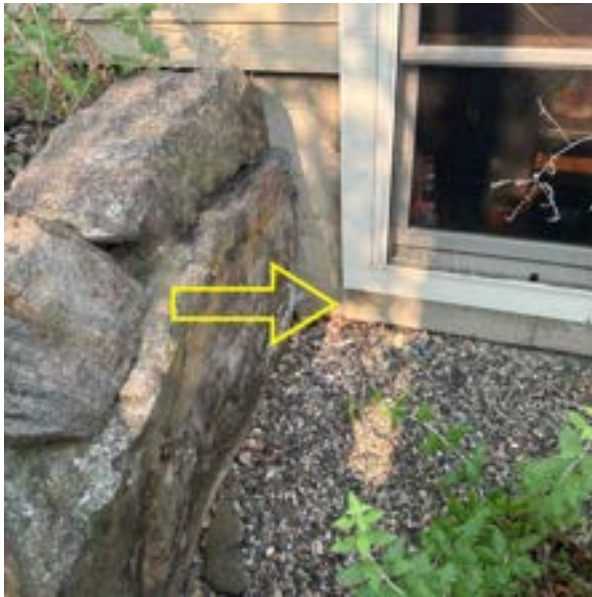
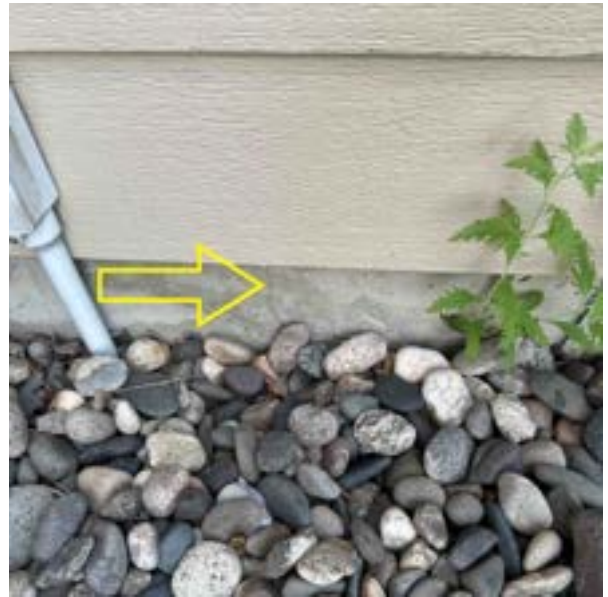
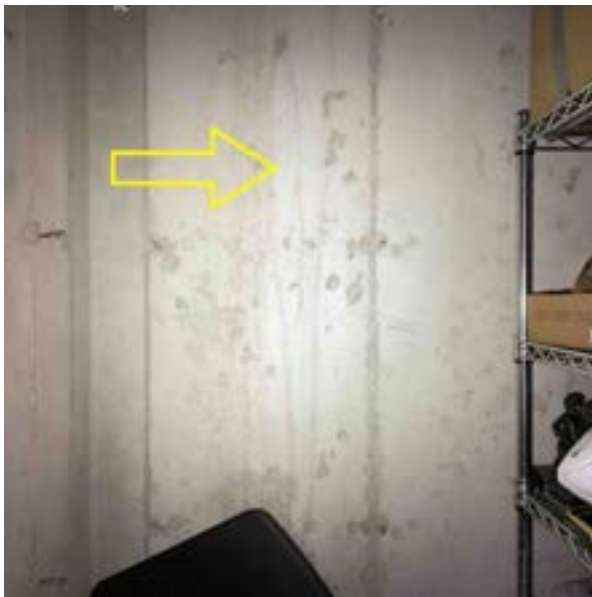
7.2.1 Consult a qualified contractor to evaluate foundation cracks and repair as recommended.

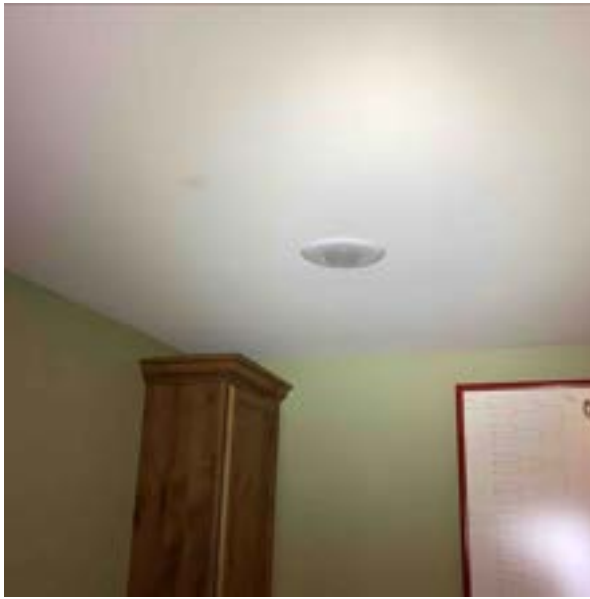
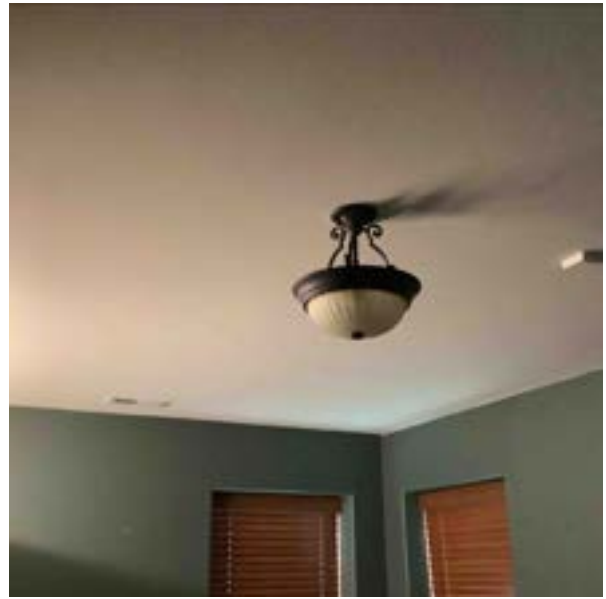
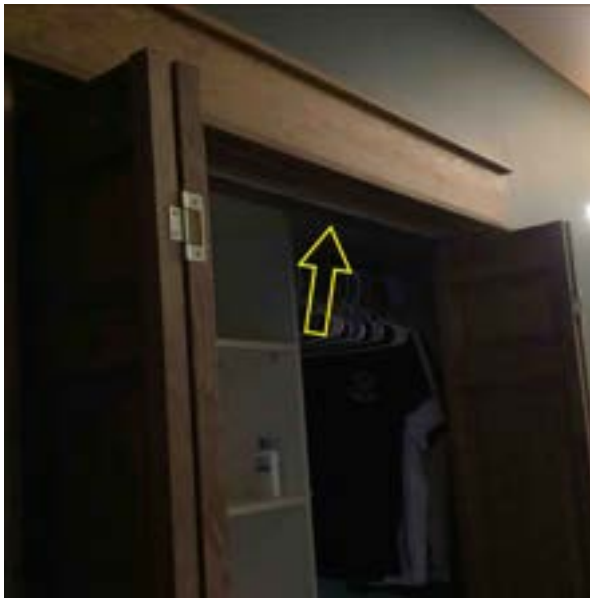
- Basement Living Room
- Basement Northwest Room

8.9.2 Determine cause of inoperable light fixture and repair as required. Replace bulb prior to further investigation.

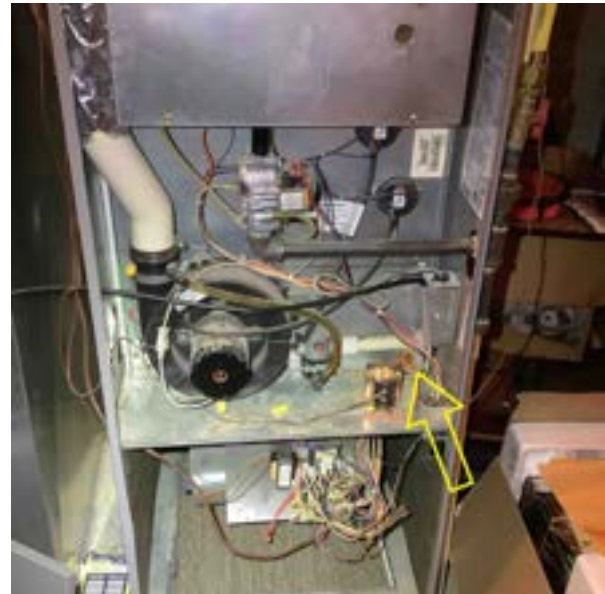
9.5.4 Further investigate to determine cause and extent of corrosion in furnace and repair as required to prevent further damages. Clean and service furnaces to promote system longevity. **(Utility Area)**

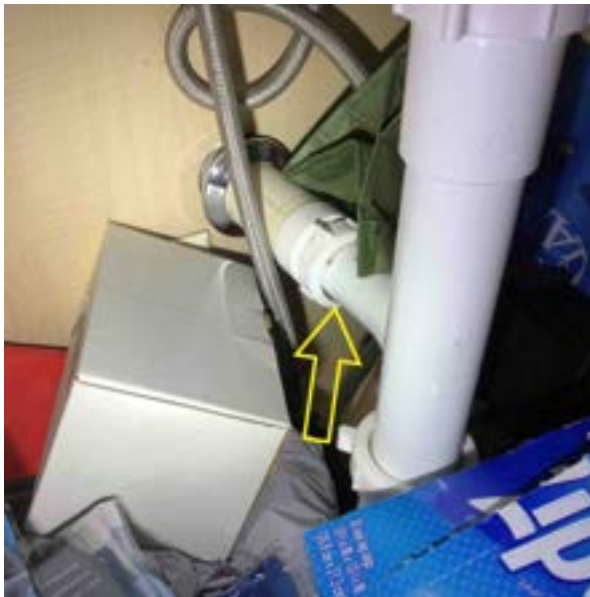
### 10.3.3 Repair leaking drain line to prevent secondary water damages. (Kitchen)

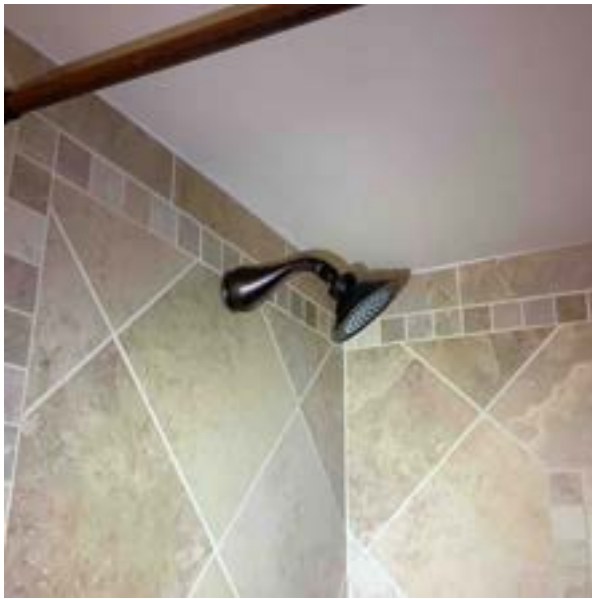
10.7.2 Secure shower head to reduce secondary water damages. **(Basement Bathroom)**

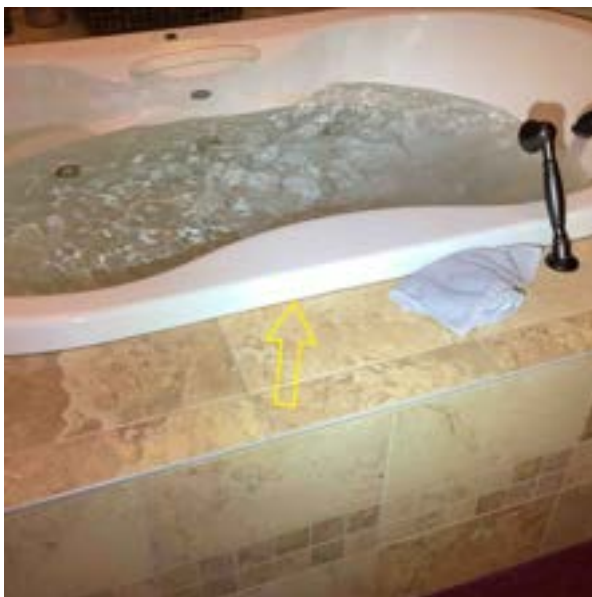
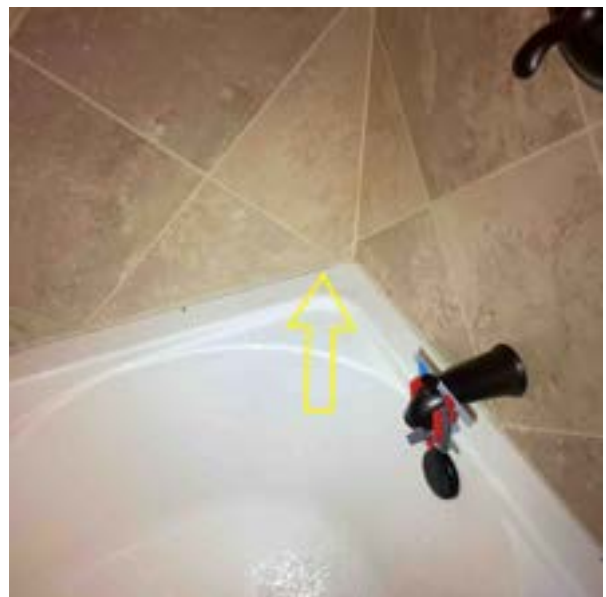
- 2nd Floor Bathroom
- Basement Bathroom
- Master Bathroom

10.10.4 Seal all cracks/gaps/joints in and around tubs and showers to reduce water penetration and subsequent deterioration.

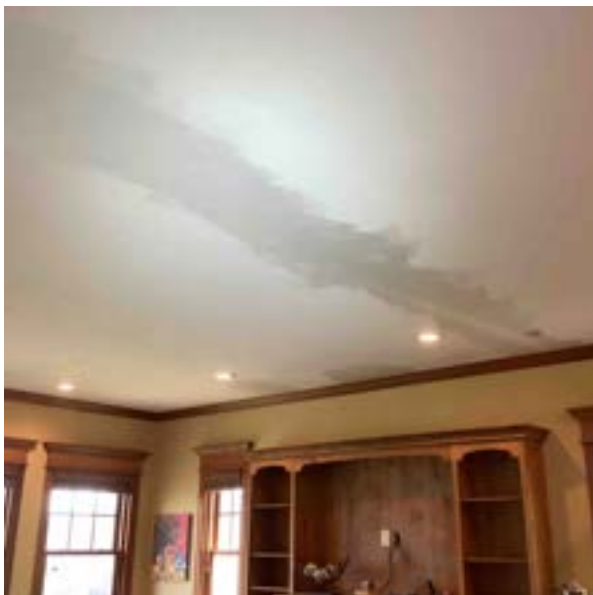
11.2.2 Confer with seller as to ceiling repairs and obtain receipts/work orders for warranty purposes. **(Living Room)**

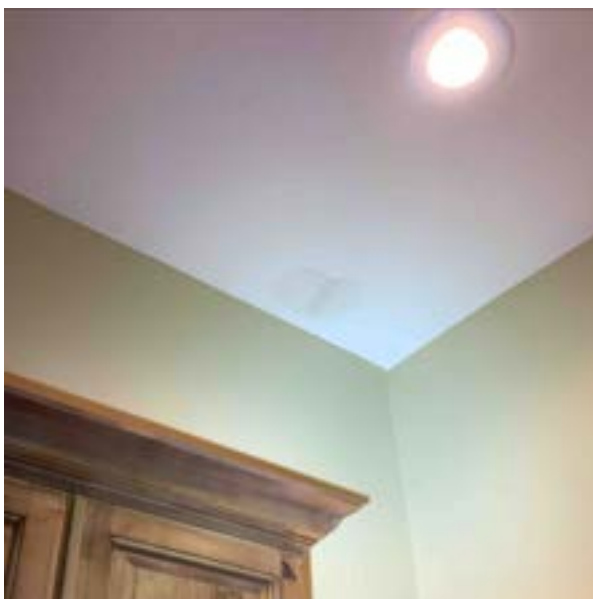
11.2.3 Further investigate cause and extent of staining/damage and correct as required. No moisture detected at time of inspection. **(Master Bathroom)**

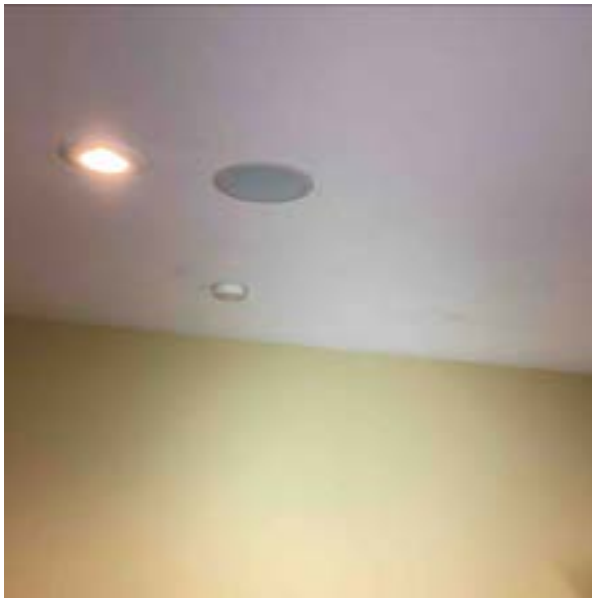
11.2.4 Further investigate cause and extent of staining/damage and correct as required. No moisture detected at time of inspection. **(2nd Floor Living Room)**

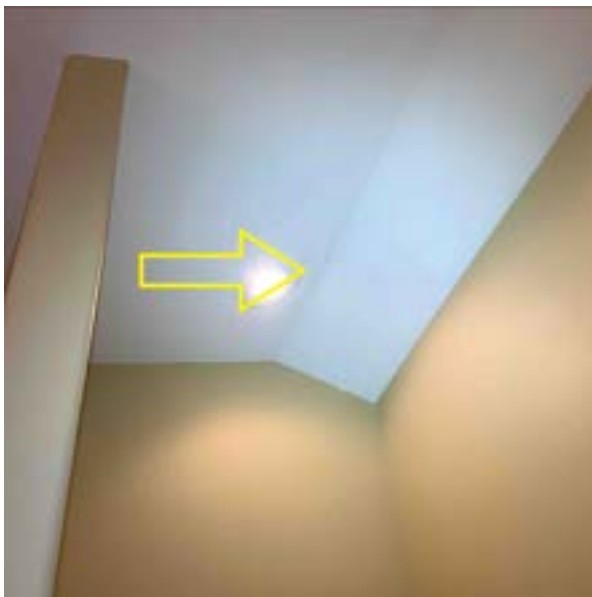
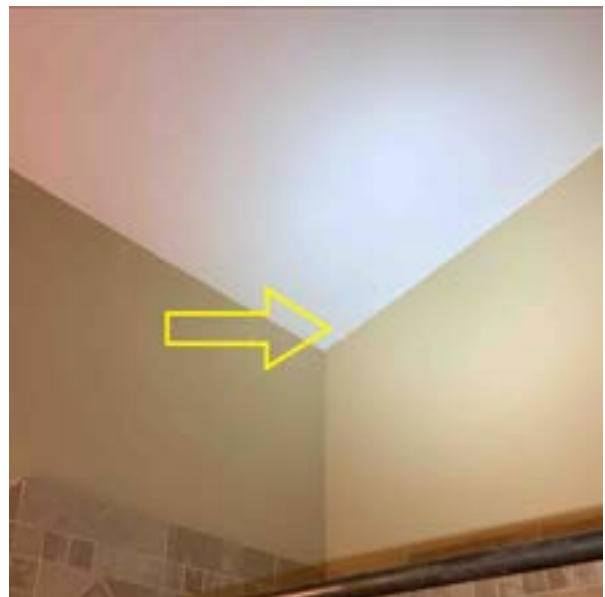
11.2.5 Further investigate cause and extent of staining/damage and correct as required. No moisture detected at time of inspection. **(2nd Floor Bathroom)**
