## Home Inspection Report

PROPERTY INSPECTED:  
6227 Western Bluffs Boulevard  
Billings, MT 59106

Date of Inspection: 07/17/2024

Inspection No. 45957-1-1090

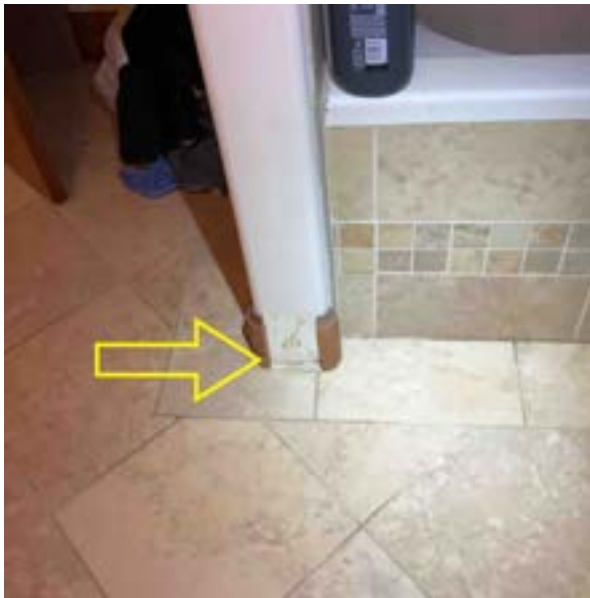
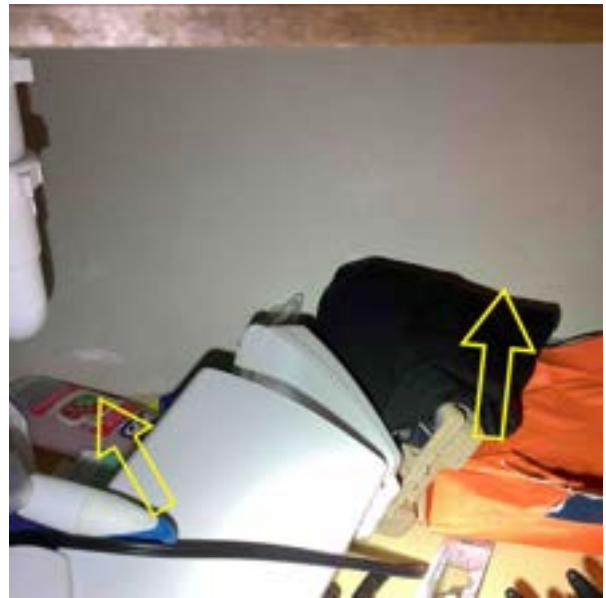
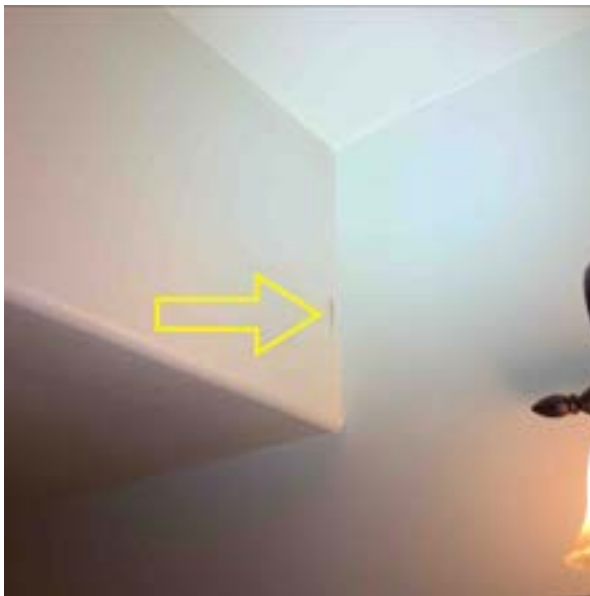
11.2.6 Further investigate cause and extent of staining/damage and correct as required. No moisture detected at time of inspection. **(Basement Bathroom)**

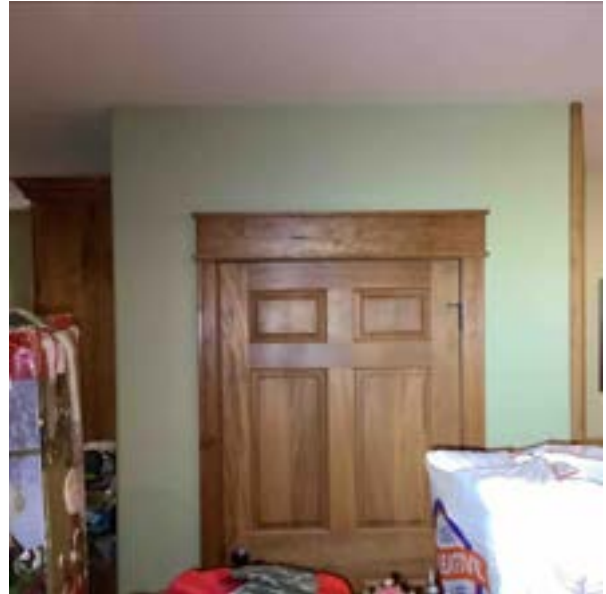
- 2nd Floor East Bedroom
- Basement Southwest Room
- Gym
- Understairs Storage

11.4.4 Adjust door to reduce binding and latch securely.

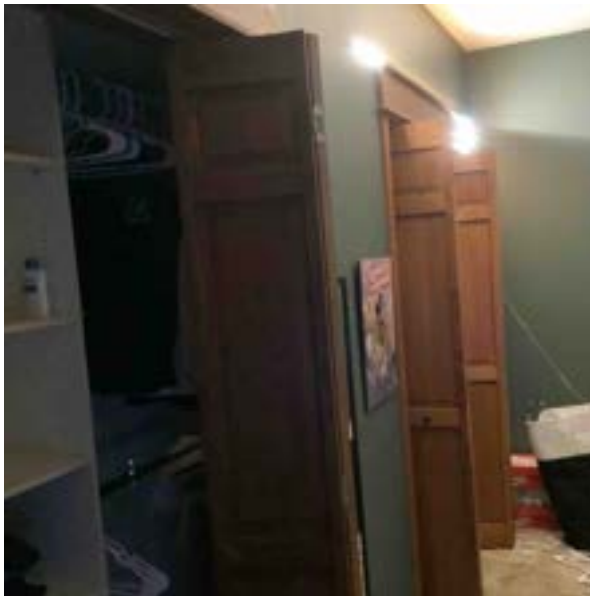
11.4.5 Adjust closet doors to reduce binding and prevent wear/damages. **(Basement Northwest Room)**

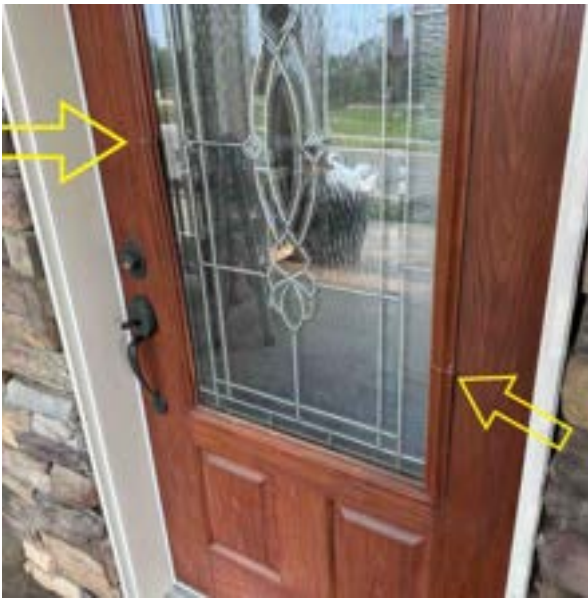
11.5.2 Replace damaged door trim to prevent further damages and safety hazards. **(Entry)**

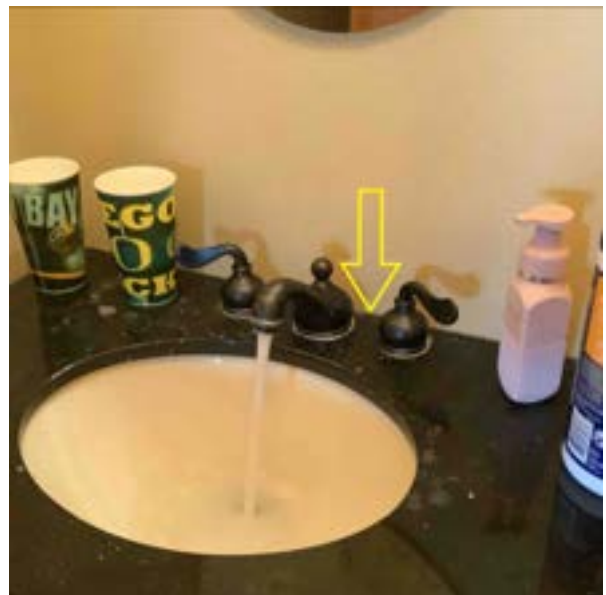
- 2nd Floor Bathroom
- Basement Kitchen
- Half Bathroom
- Laundry area
- Master Bathroom

11.7.4 Recaulk counters to prevent moisture intrusion and subsequent damages.

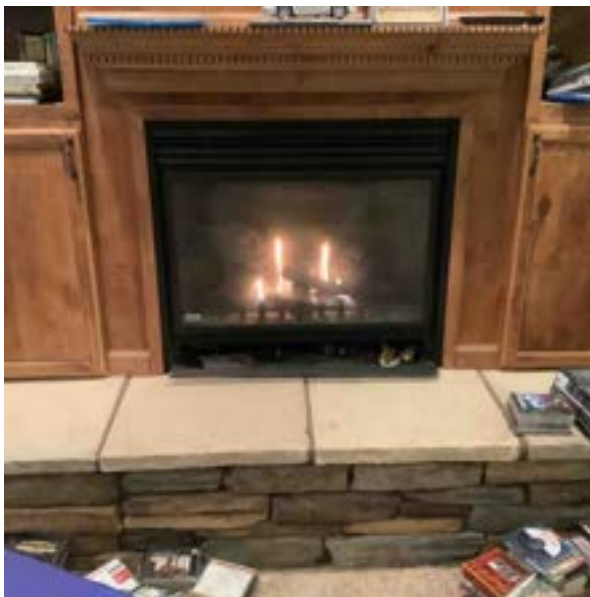
**(Basement Living Room)**

12.1.2 Further investigate cause of inoperable fireplace fan and repair as required to regain intended operation.
