Home Inspection Report

PROPERTY INSPECTED:
1920 Plateau Road
Billings, MT 59105

Date of Inspection: 10/02/2024

Inspection No. 45957-1-1153

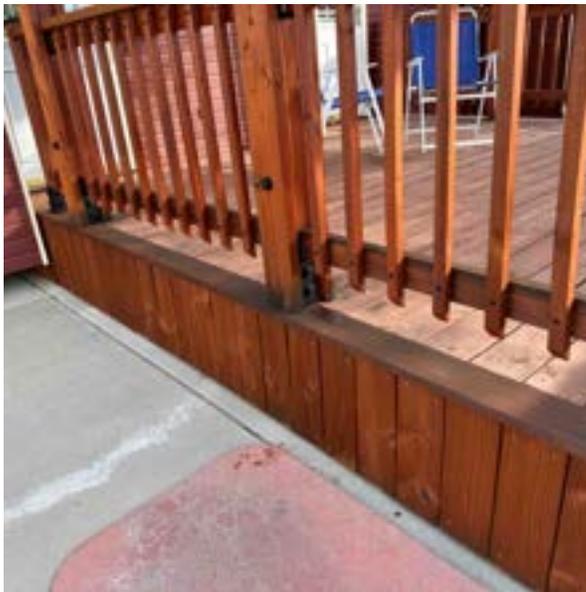
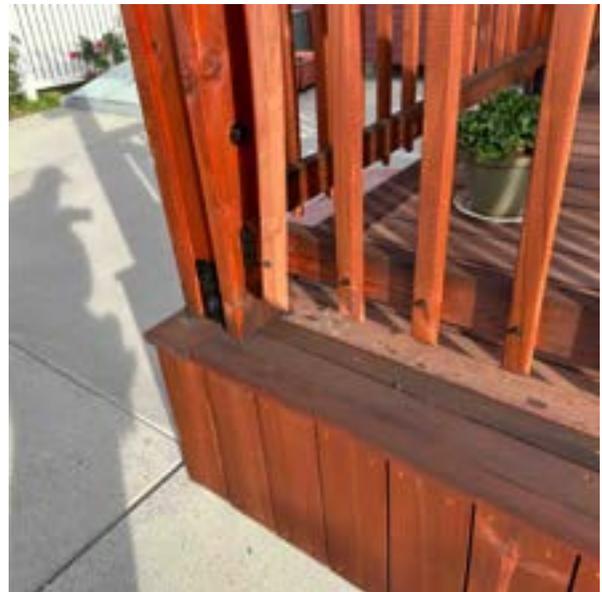
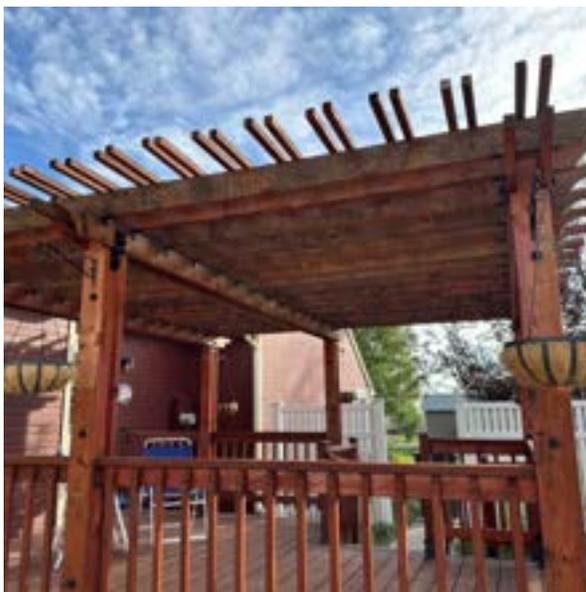
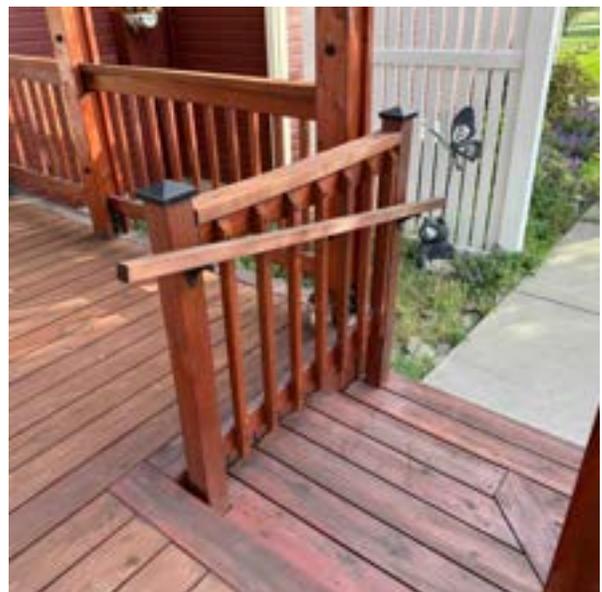
- missing weather seal
- damaged spindle
- loose railing
- cover movement

3.7.2 Consult a qualified contractor to evaluate decks and repair as recommended. A partial list of defects include:

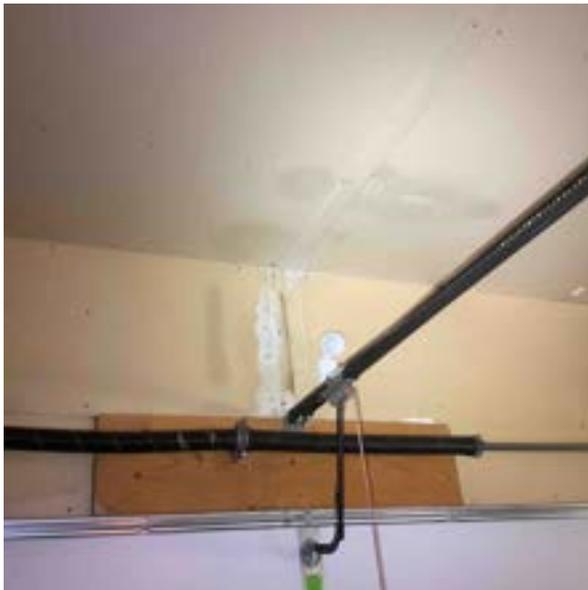
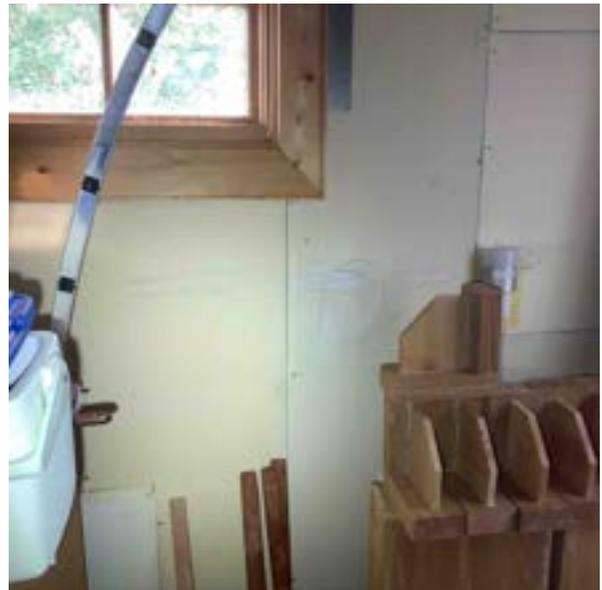
6.6.1 Stains

6.7.1 Stains

6.7.2 Further investigate cause and extent of staining/damages in wall/ceiling and repair as required to prevent further damages. **(Garage)**

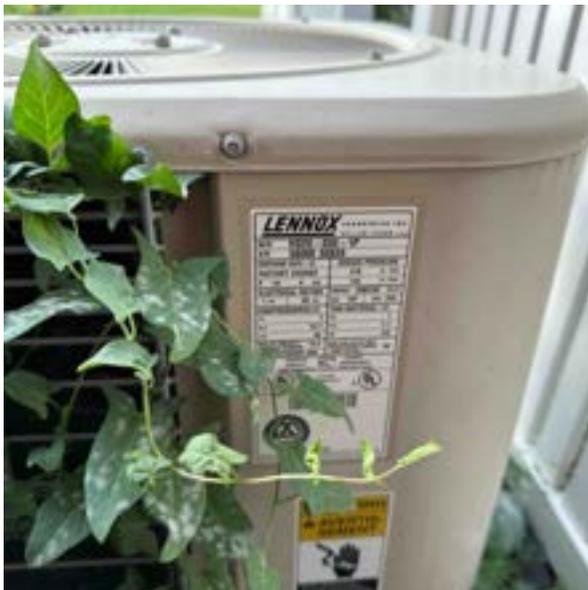
Data Plate: **(Exterior South)**

9.4.1 Exceeded Typical Life Expectancy - Budget to Replace

9.4.3 Typical life expectancy for an A/C unit is between 20-25 years.

9.4.4 Age: 24

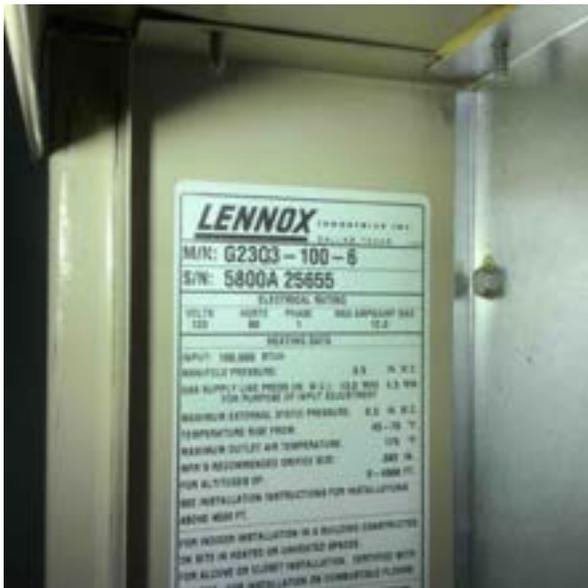
Data Plate: **(Basement)**

9.5.1 End of typical life expectancy. Budget to replace.

9.5.3 Typical life expectancy for a forced air furnace is between 20-25 years.

9.5.4 Age: 24

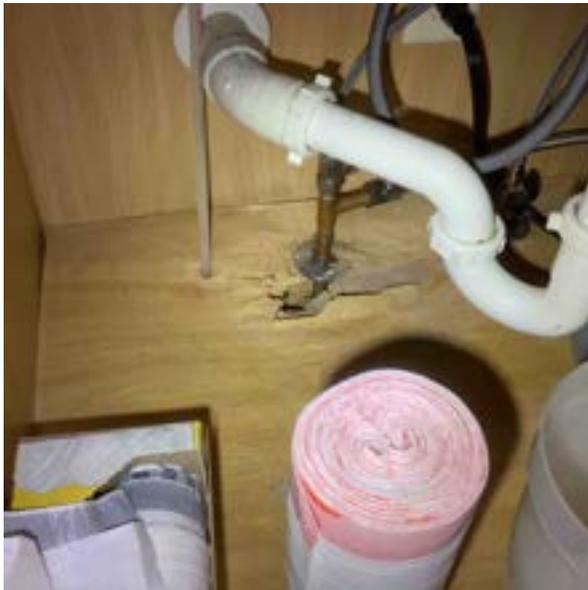
11.8.3 Previous water damages noted - No moisture detected at time of inspection.

11.8.5 Further investigate cause and extent of water damage in cabinets and repair as required to prevent further damages. **(Kitchen)**
