Inspection Report

3924 Granite Way
Wellington NV 89444

Clear Choice Home Inspection Services

Date: 4/22/2024	Time: 09:00 AM	Report ID: QUI392
Property: 3924 Granite Way Wellington NV 89444	Customer: Doris Quijada	Real Estate Professional: Thomas Vander Laan Coldwell Banker

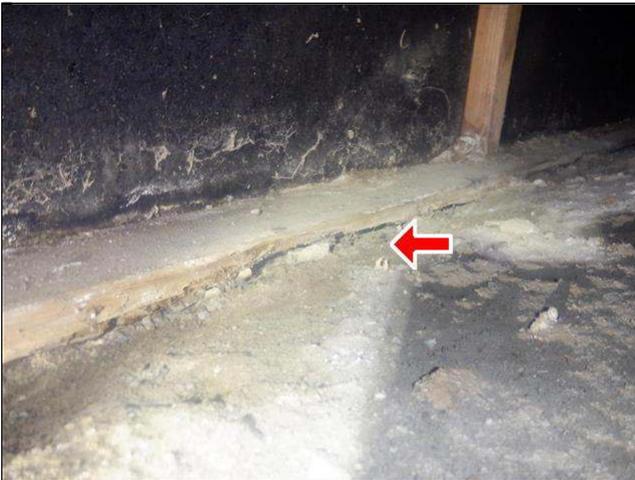
1.1 Item 4(Picture) deterioration from ground contact

(3) Siding/skirting framing sole-plate is in contact with the ground in areas under the home. This condition can rapidly deteriorate wood materials. There is deterioration noted on the bottom side of framing sole-plates, however does not warrant replacement. Recommend correct grade to eliminate ground contact.

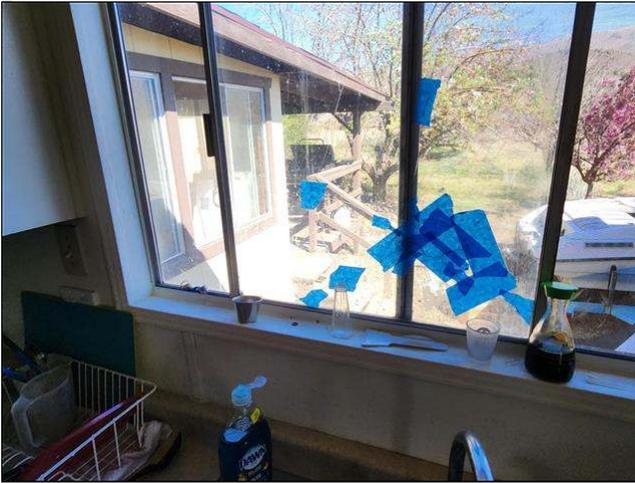
Cracked window panes noted at the kitchen sliding window, and back porch Southwest window.

1.4 Item 1(Picture) cracked window at kitchen

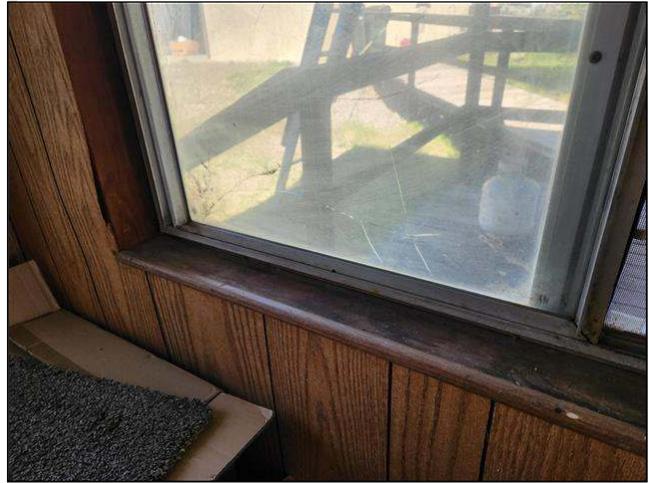
1.4 Item 2(Picture) cracked window at back porch

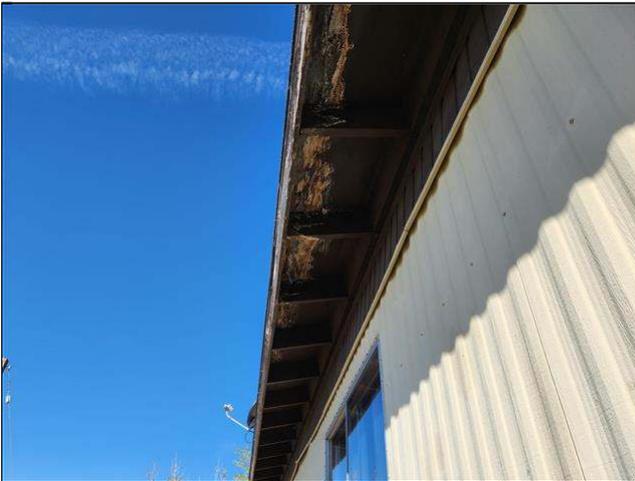
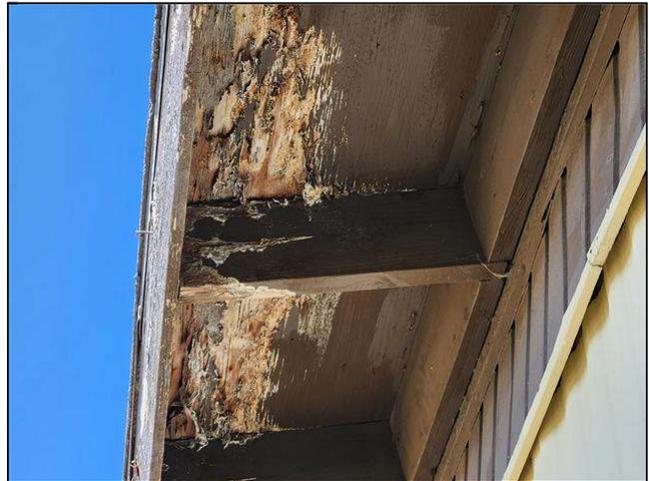
South facing eave shows extreme failure of paint, with slight deterioration of the plywood noted. Paint maintenance is recommended.

1.5 Item 1(Picture) south facing eaves

1.5 Item 2(Picture) paint failing under eave

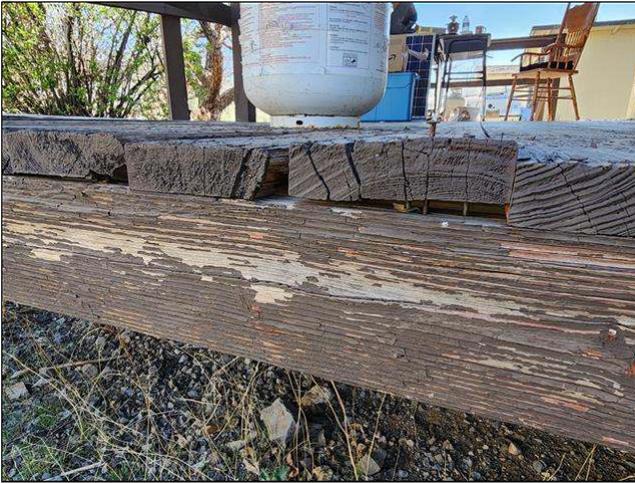
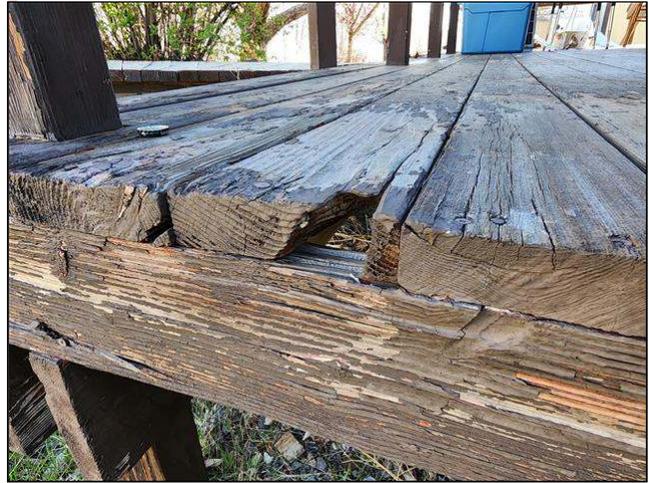
(1) Rear deck appears aged, however remains solid and serviceable. There are a few loose deck boards that should be secured.

1.6 Item 1(Picture) aged rear decking

1.6 Item 2(Picture) aged rear decking

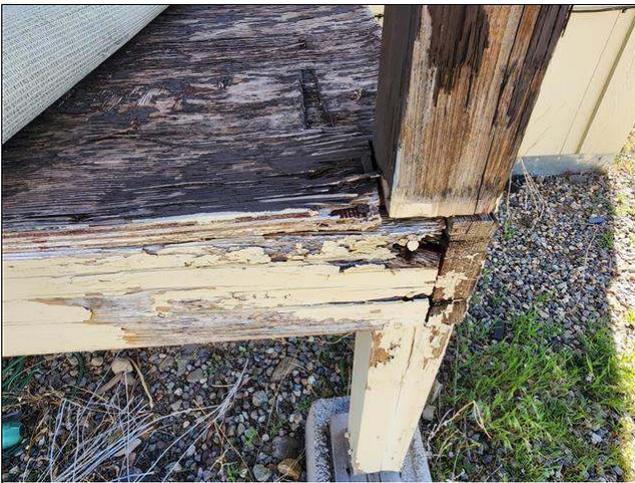
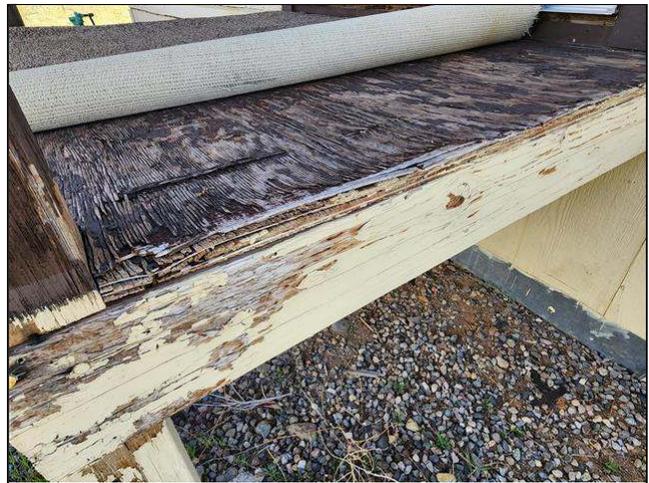
(2) Moisture damage noted at the West side porch outer floor joist and plywood decking.

1.6 Item 3(Picture) west side porch

1.6 Item 4(Picture) west side porch

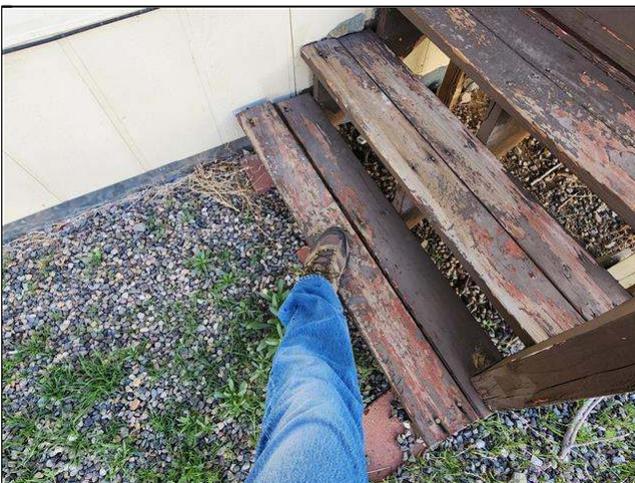
(3) Loose step treads noted at the West side porch, and should be secured to prevent possible trip hazard.

1.6 Item 5(Picture) loose step treads

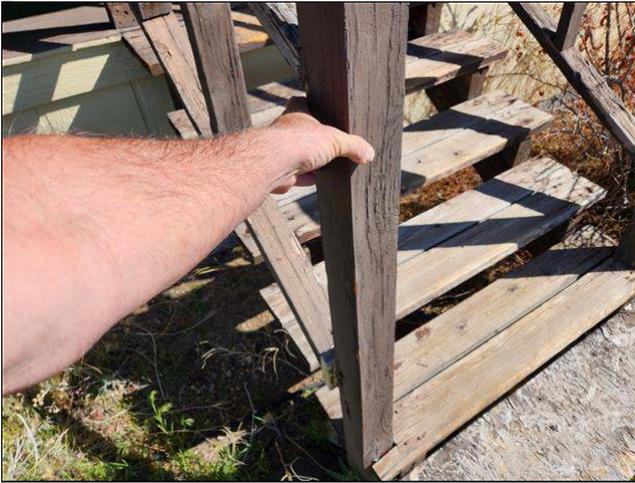
(4) Deck/porch railing are very loose at the Front, and left side of home, and should be secured... Lower step tread at main entry should be replaced with matching common lumber.

1.6 Item 6(Picture) loose railings at South side deck

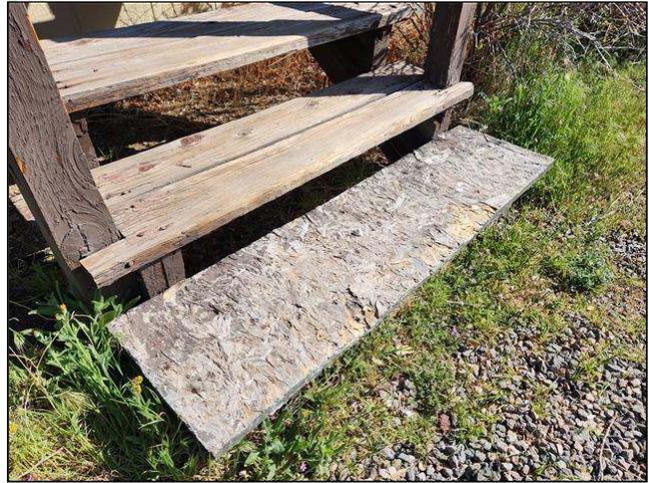
1.6 Item 7(Picture) replace lower step tread

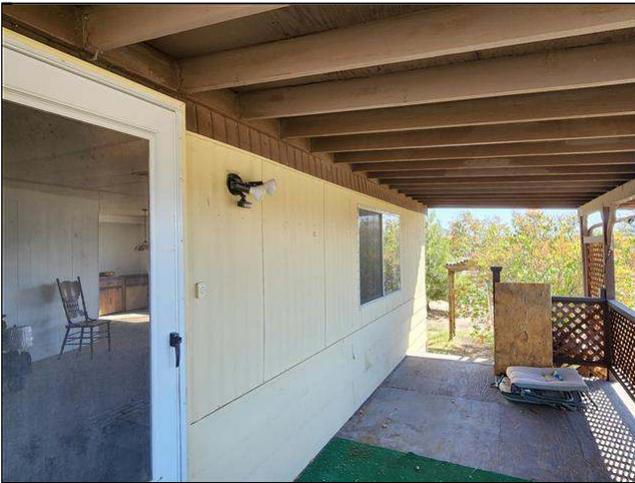
(5) NOTE: Generally, it is not allowed by local codes to "hang" a roof structure from the wall of a Manufactured Home. This causes additional load on the outer "cantilevered" subfloor area, which does not have direct vertical support to the ground. These type of additions should be constructed as "self-supported".

1.6 Item 8(Picture) not self-supported

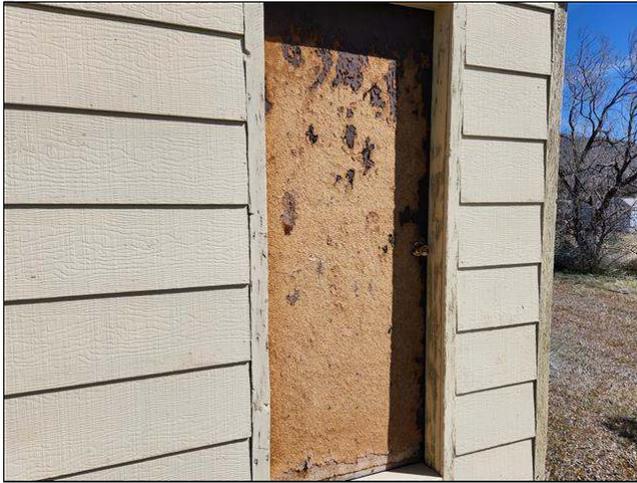
NOTE: Exterior wood entry door is damaged from moisture absorption at the storage shed... Roof covering has expired at the storage sheds.

1.9 Item 1(Picture) door damaged from moisture

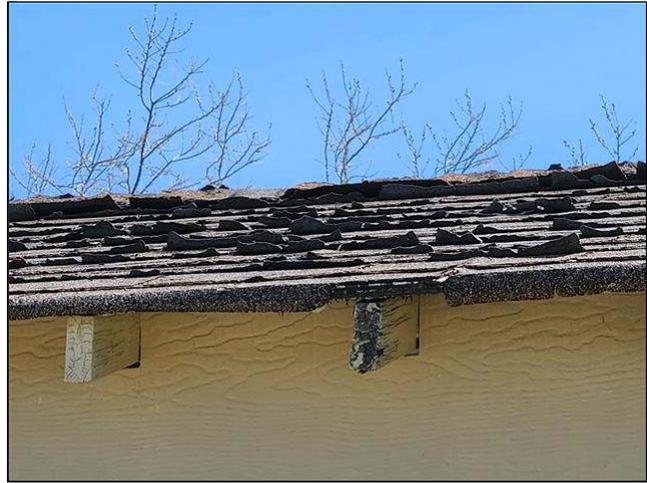
1.9 Item 2(Picture) roof covering at sheds

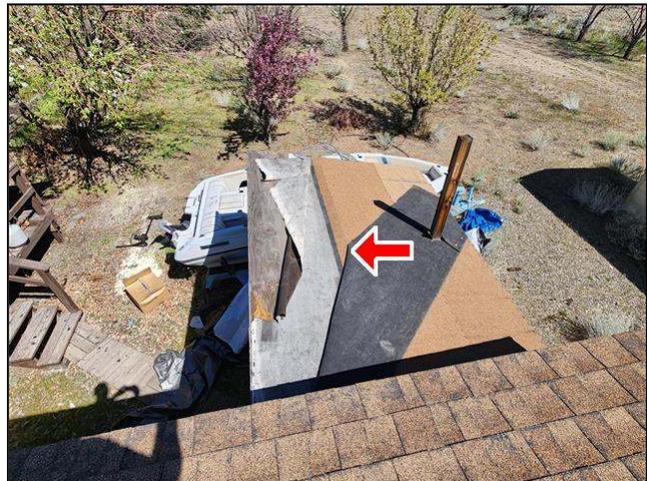
1.9 Item 4(Picture) roof covering damage at shed

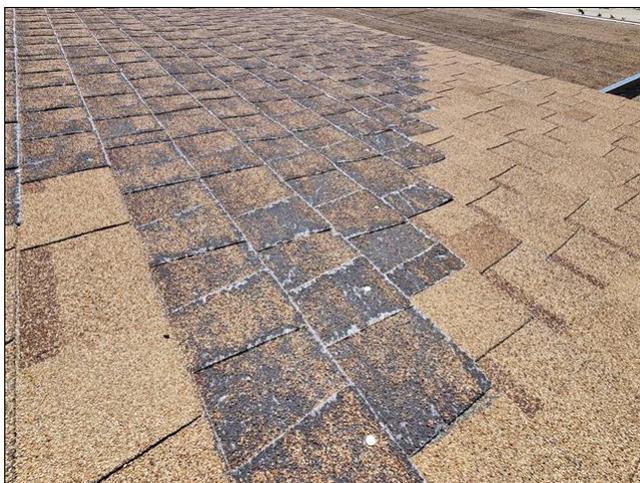
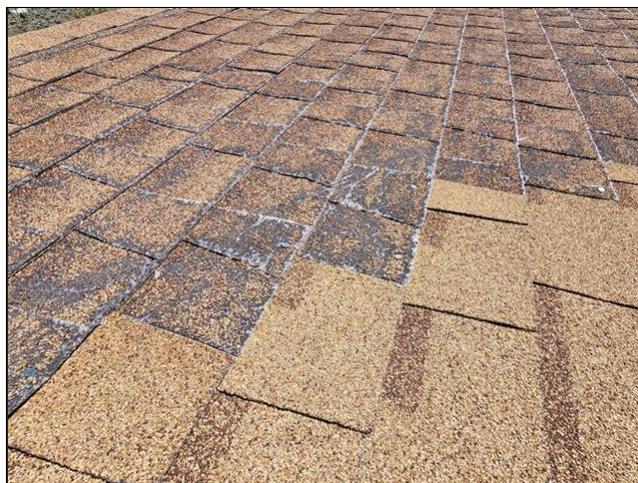
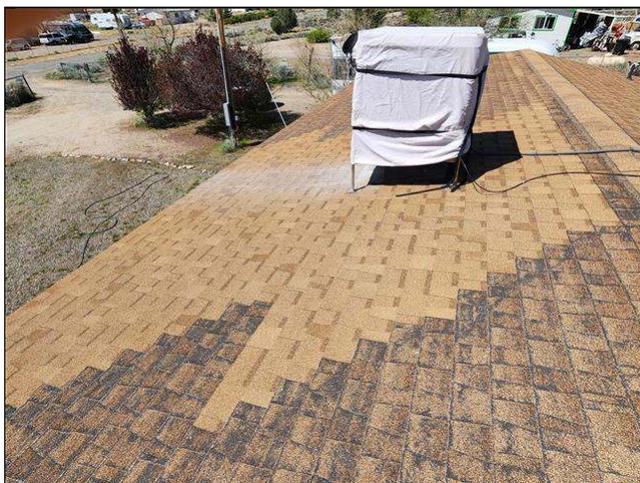
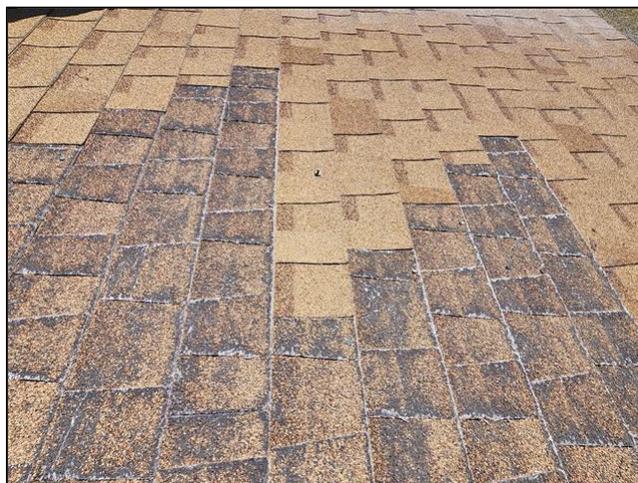
(2) The roof covering has been recently replaced around the evaporative cooler area, with adjacent shingles showing advanced wear.

2.1 Item 3(Picture) advanced wear adjacent to cooler area

2.1 Item 4(Picture) advanced wear adjacent to cooler area

2.1 Item 5(Picture) recently replaced around cooler

2.1 Item 6(Picture) worn south slope shingles

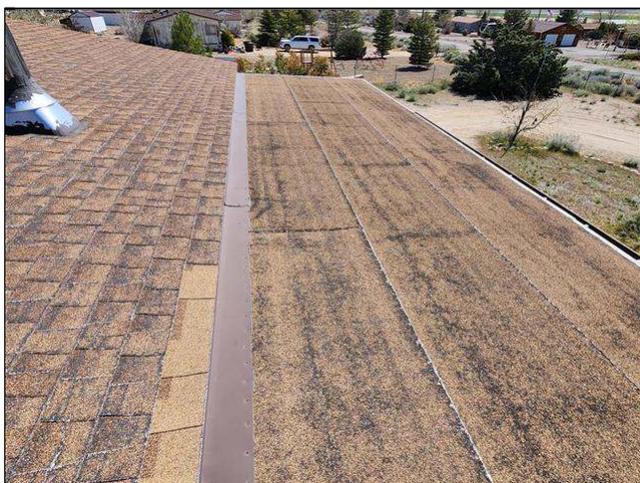
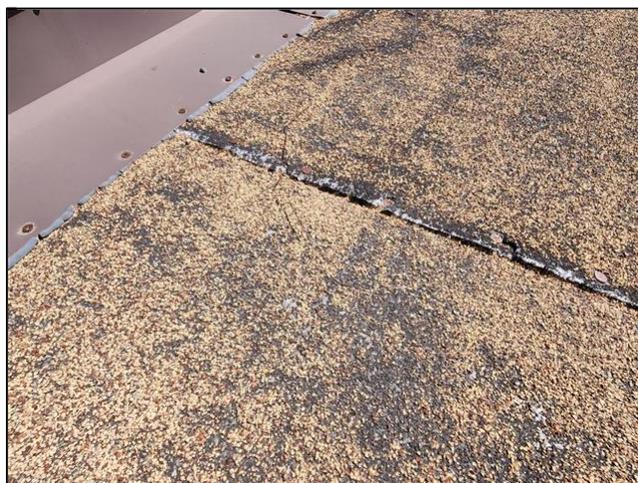
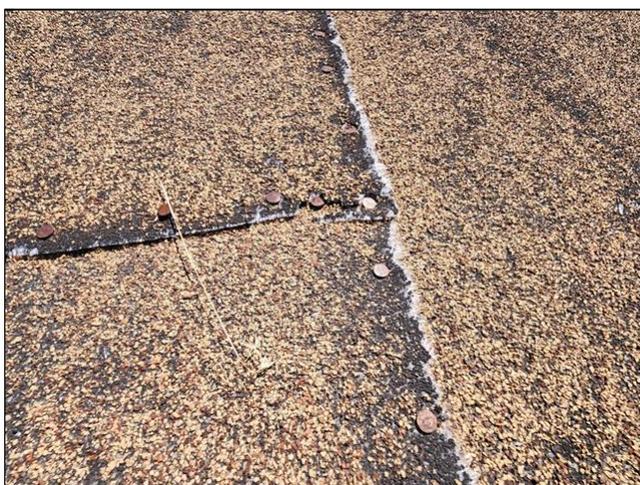
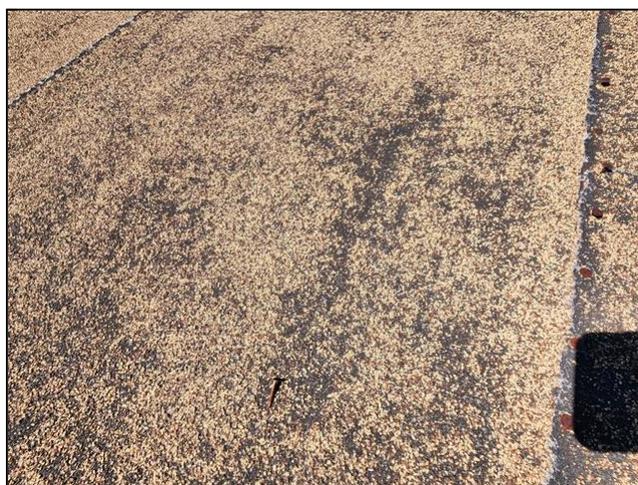
(4) Front Deck Cover... Uses "rolled asphalt" roofing, and appears worn/aged, with feathering of edges and loss of granules noted. There appears to be approximately 20% of life remaining.

2.1 Item 9(Picture) front porch cover

2.1 Item 10(Picture) worn edges on roofing

2.1 Item 11(Picture) worn edges on roofing

2.1 Item 12(Picture) loss of granules

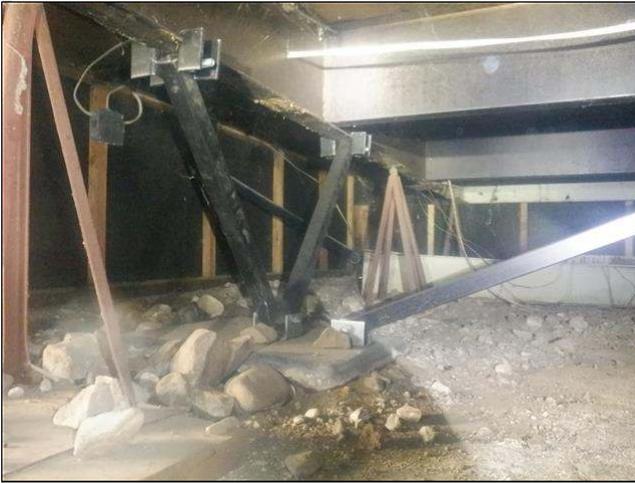
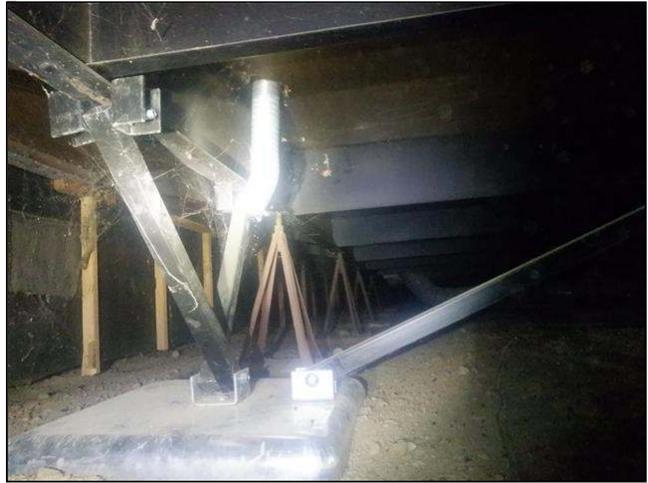
- 🏠 The Foundation consists of Steel Adjustable Jacks located approximately at 8' on center, with Latitude and Longitude Tie- Down tubes being installed at both North end corners of the home's outer frame rails. NOTE: These Tie-Downs are typically installed at opposite corners of the home's main frame. Recommend consulting a Manufactured Home Foundation Engineer to verify proper placement of these Tie-Downs.

3.2 Item 1(Picture) tie-down system

3.2 Item 2(Picture) tie-down system

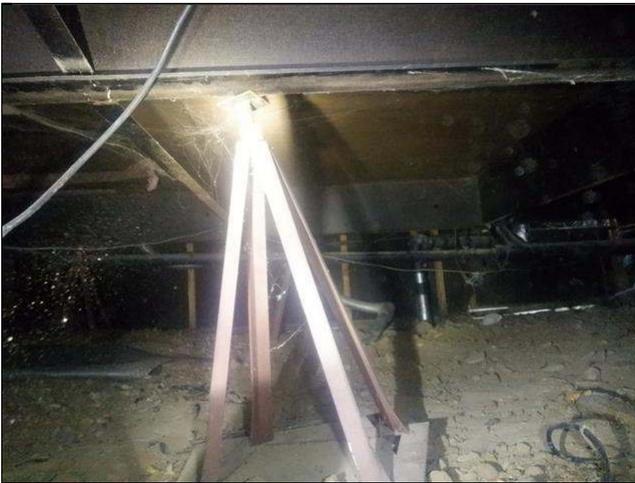
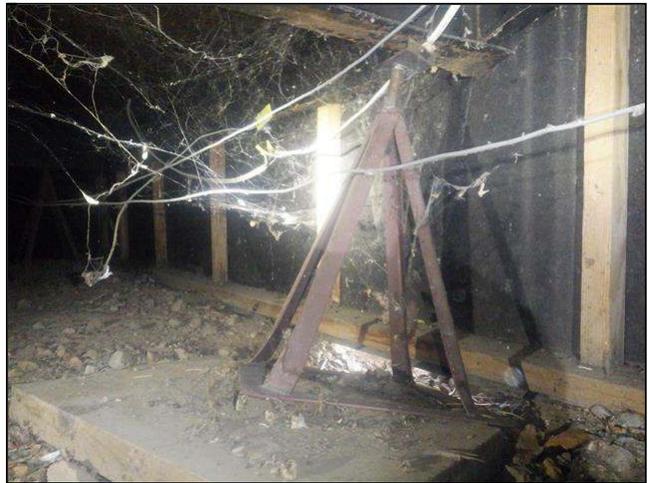
- 🏠 The home uses steel adjustable jacks to maintain a level and functioning interior. At least 4 jacks are loose (under the West end), not carrying any weight due to normal settlement. This settling is most likely the cause for interior drywall cracks, and doors that do not fit into jambs properly. The home does not appear to have been re-leveled since the initial set-up. Recommend re-leveling the home, or at least tighten loose jacks, by a licensed manufactured home contractor as needed.

3.4 Item 1(Picture) loose jack at west end

3.4 Item 2(Picture) loose jack at west end

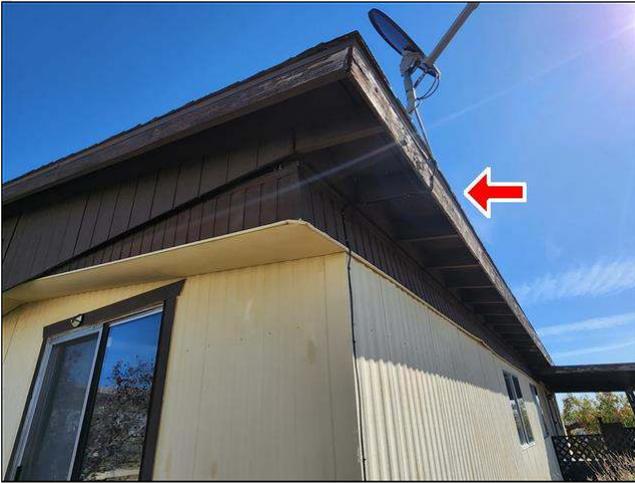
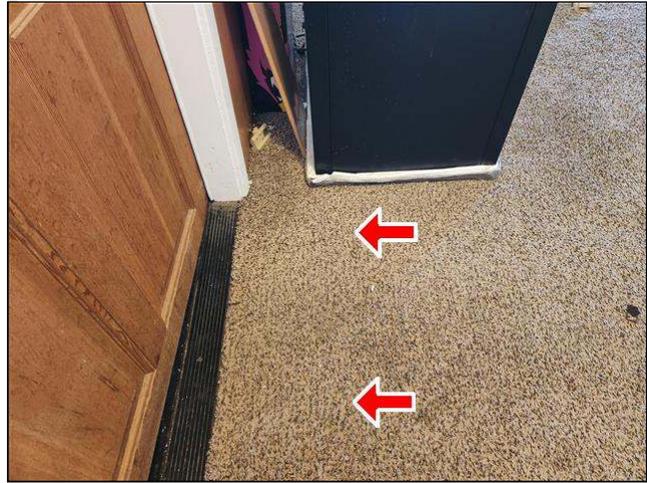
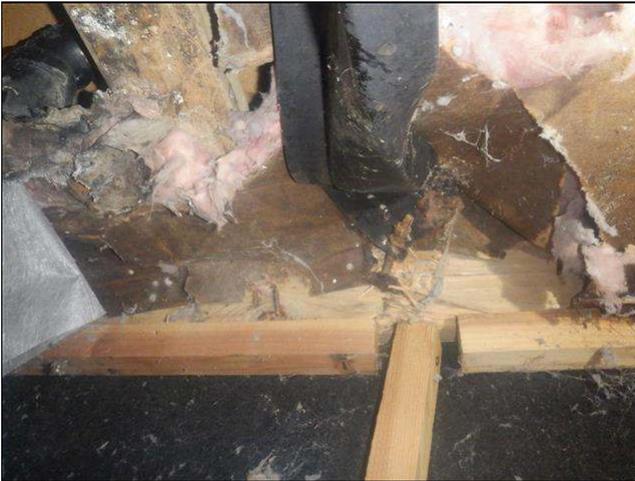
- 🏠 Metal support bracket at outer edge of home under kitchen/dining area has been damaged (possibly during transport), eliminating support for the exterior wall (which is also carrying additional load of the stick-built roof). There are no additional supports installed under the outer wall of home to carry this load, and has allowed the subfloor system to sag at the outer 2 feet.

3.5 Item 1(Picture) additional load of stick built roof

3.5 Item 2(Picture) subfloor slopes downhill

3.5 Item 3(Picture) damaged support bracket at outer floor joist

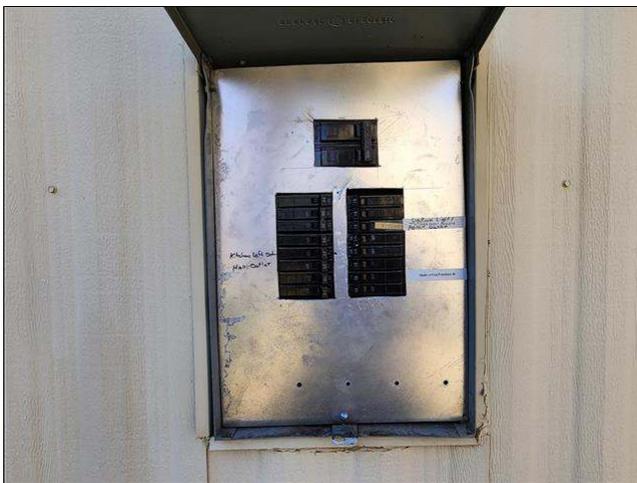
Some circuit labels are present, others are illegible/missing or confusing. I recommend correcting for safety reasons.

4.1 Item 1(Picture) north exterior panel

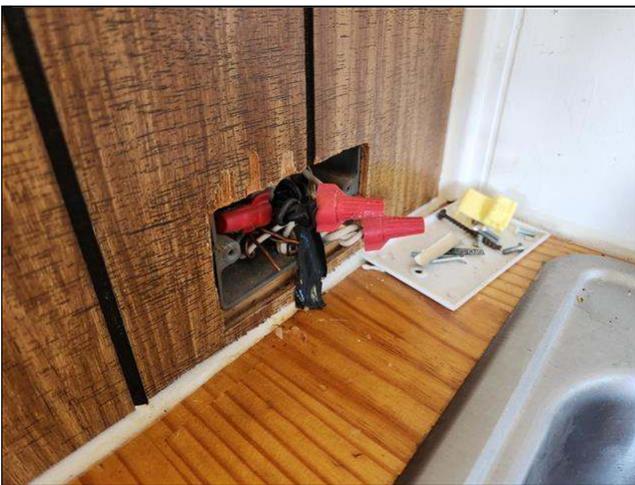
(1) Open electrical wire noted at the Bar Sink area. Recommend repair by a qualified person.

4.5 Item 1(Picture) electrical at bar sink

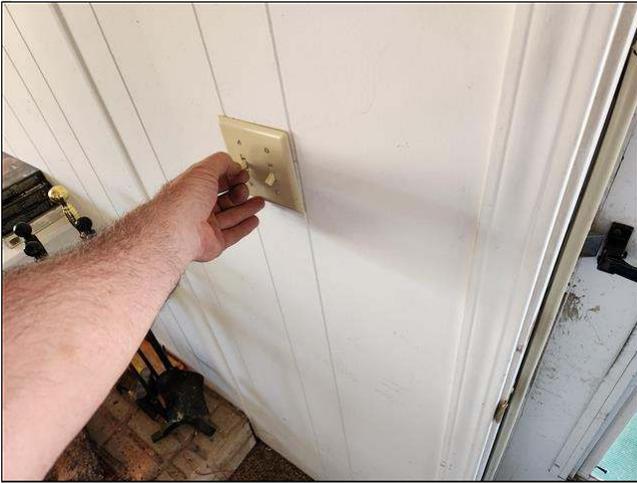
(2) Faulty/Non-operational Switch noted at the main entry. Recommend further evaluation/repair by a licensed Electrician.

4.5 Item 2(Picture) faulty light switch

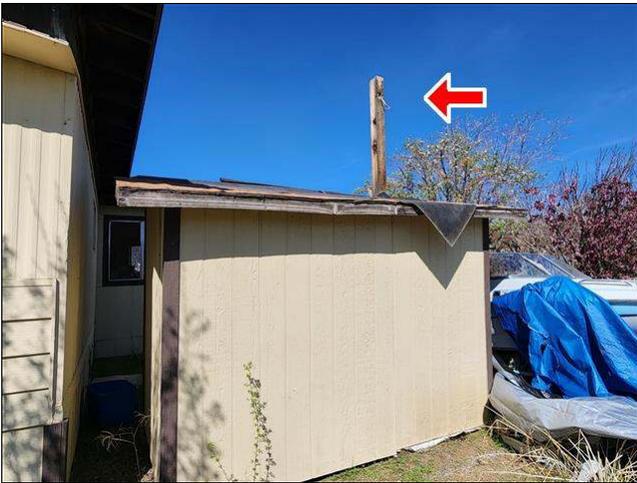
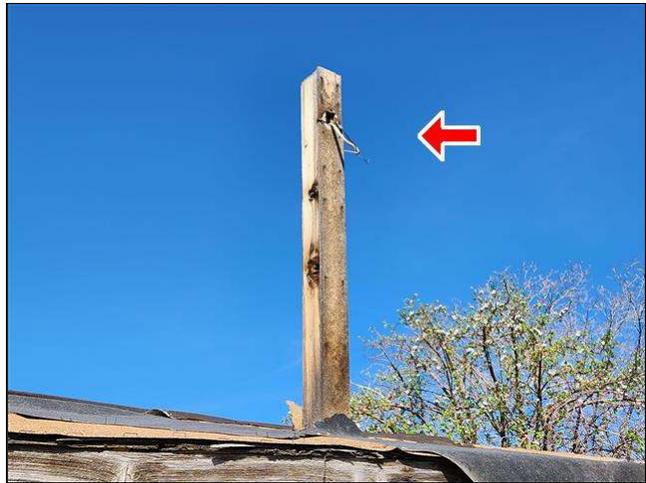
🏠 (3) Electrical wire exposed to weather and moisture was noted at the storage shed, and should be repaired to function as intended, or eliminated. **RE: 4.5(3)**—Please see *Exhibit: Seller Repair Itemization*

4.5 Item 3(Picture) open electrical at shed

4.5 Item 4(Picture) open electrical at shed

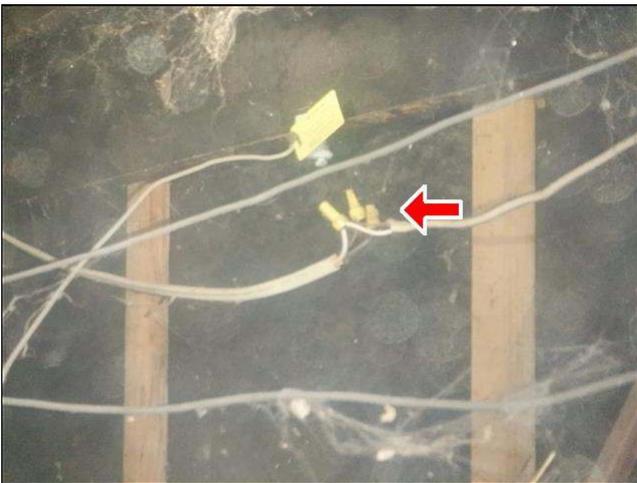
🏠 (4) Improper electrical wiring connection (open connection) noted in the crawlspace area under master bedroom/bathroom, and needs to be placed inside a covered metal box. Recommend repairs be completed by a Licensed Electrician. **RE: 4.5(4)**—Please see *Exhibit: Seller Repair Itemization*

4.5 Item 5(Picture) open wire connection

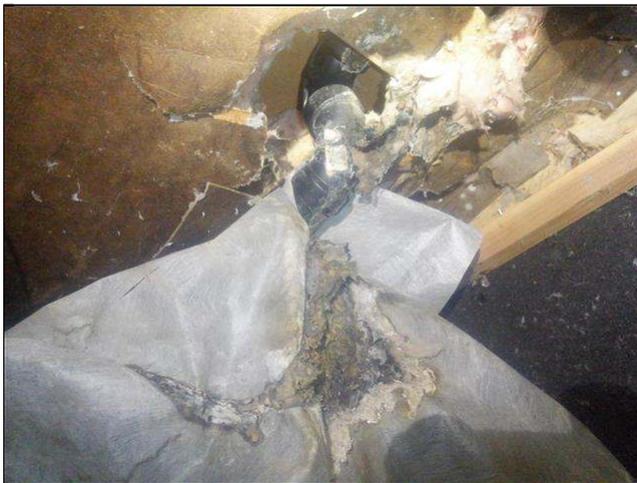
Sink drain is leaking in the crawlspace area under the kitchen. Recommend repair by a licensed plumbing contractor to prevent excessive moisture, which can lead to mold/fungus, in the crawlspace.

5.2 Item 1(Picture) kitchen sink drain leak

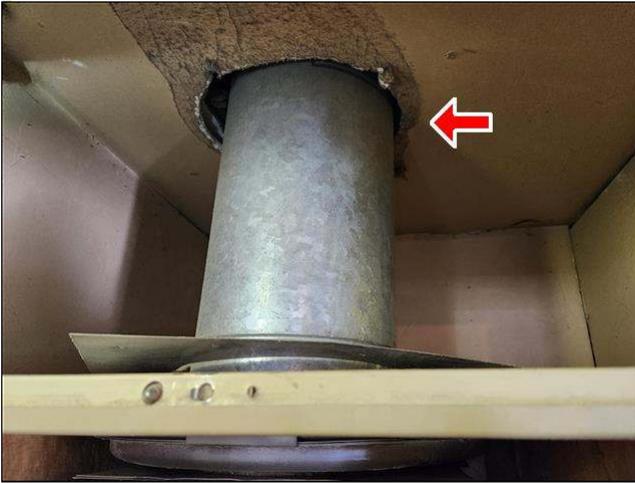
Recommend securing Fire-trim metal flashing to ceiling above the furnace.

5.7 Item 1(Picture) fire-trim ring above furnace

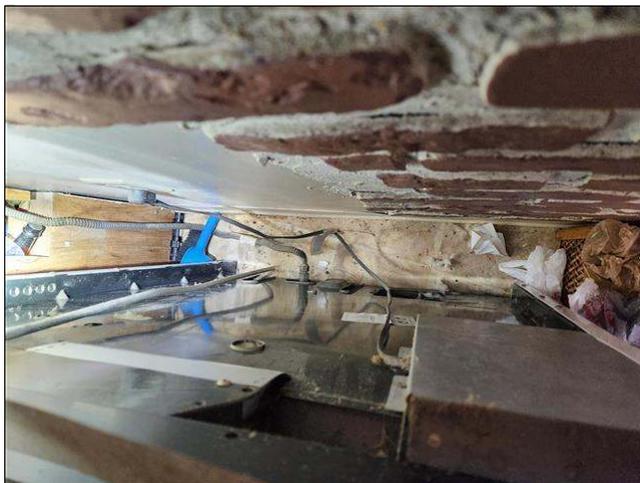
Note: This appliance does not have an anti-tip bracket installed. This is recommended by the MFG to prevent accidental tipping of the appliance, in the event of a child standing on the oven door.

6.2 Item 1(Picture) behind range

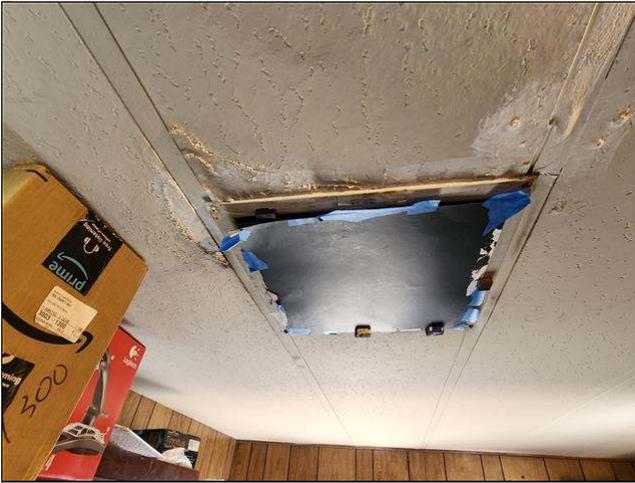
(1) Ceiling panel is damaged from moisture absorption at the master bedroom closet.

7.1 Item 1(Picture) master bedroom closet ceiling

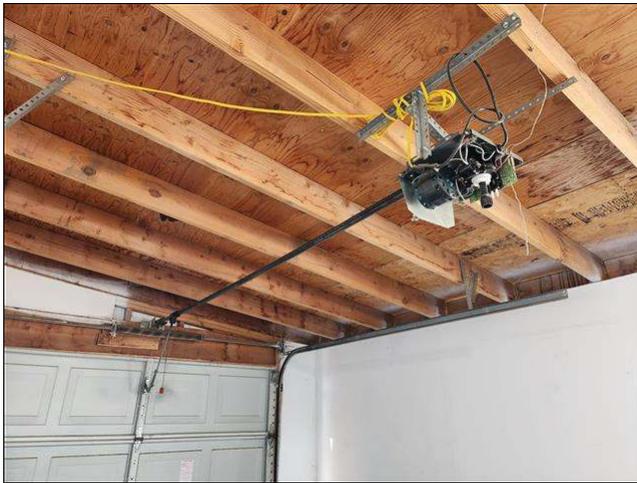
(2) Southwest Door... door operator was unresponsive to normal operating controls. Recommend further evaluation by a qualified person as needed.

8.9 Item 1(Picture) non-operational garage door

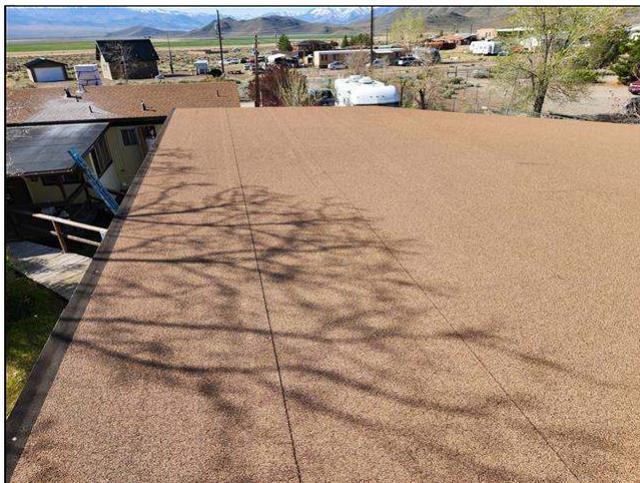
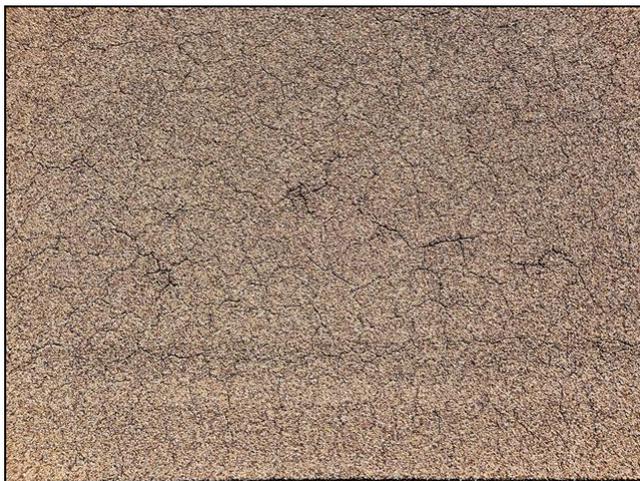
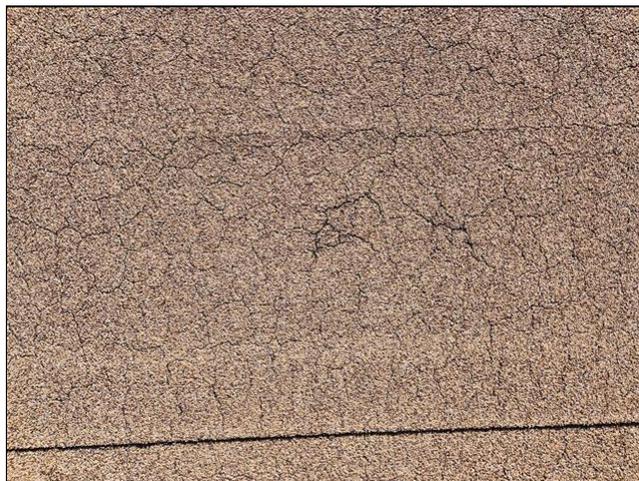
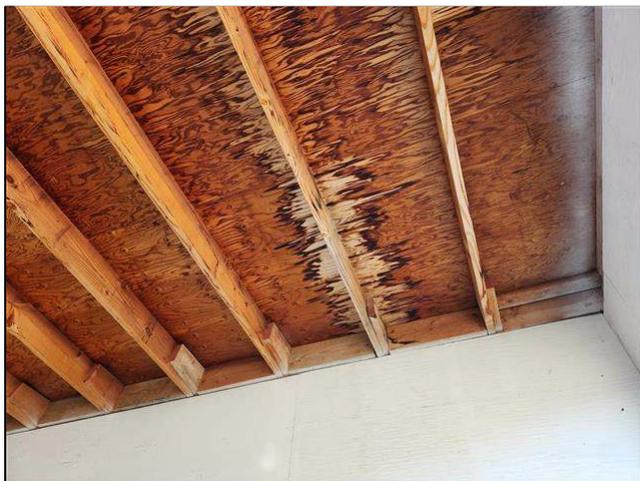
(1) The Garage roof covering does not appear to be original to the building, and is "rolled asphalt" roofing that appears to be near the end of it's useful life. Cracking/checking was noted throughout the roof area, however no signs of moisture intrusion noted. Recommend further evaluation of roof covering materials by a licensed Roofing Contractor for estimated remaining life of roof, as desired. NOTE: signs of past moisture intrusion noted at the interior roof sheathing plywood, however appear to be caused from past roof covering issues that no longer exist.

8.10 Item 1(Picture) view of roof

8.10 Item 3(Picture) age cracks in roofing

8.10 Item 4(Picture) age cracks in roofing

8.10 Item 5(Picture) appears from past roof covering issues

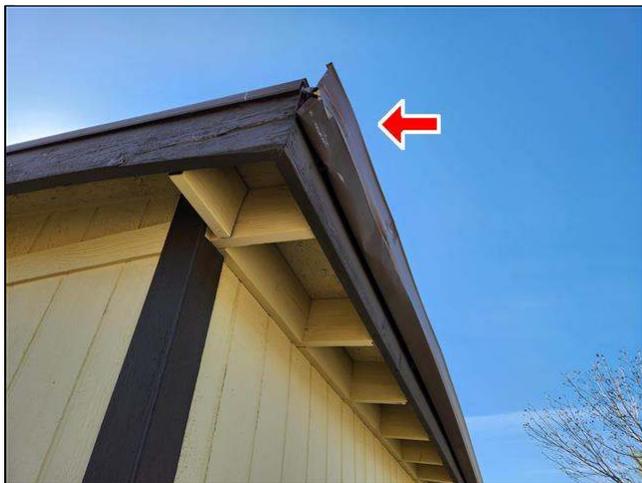
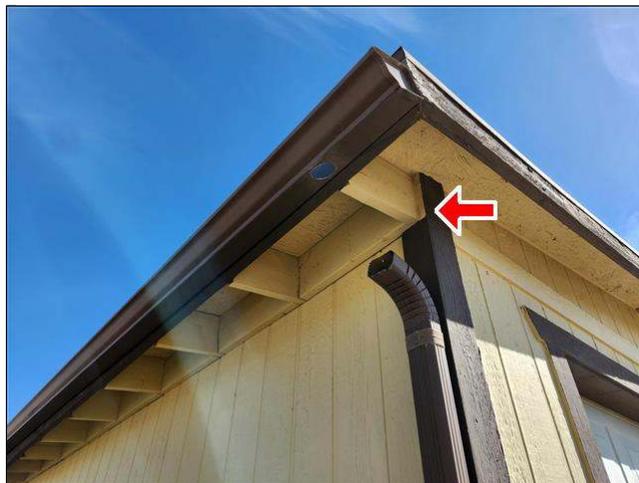
(2) NOTE: Roof gutter damage is noted at the West side of garage, with a disconnected downspout.

8.10 Item 6(Picture) damage to gutter

8.10 Item 7(Picture) disconnected downspout

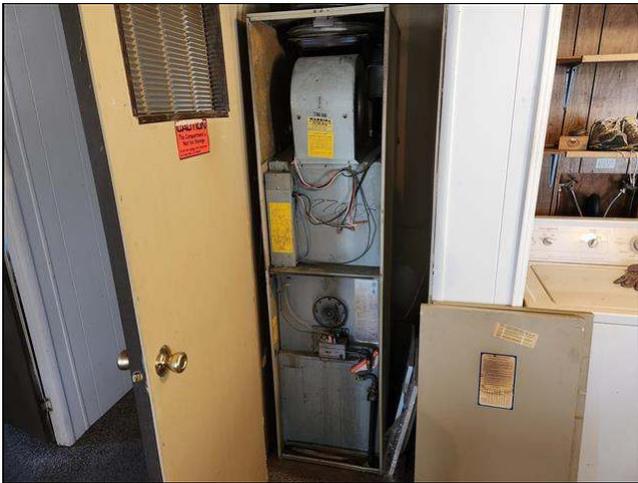
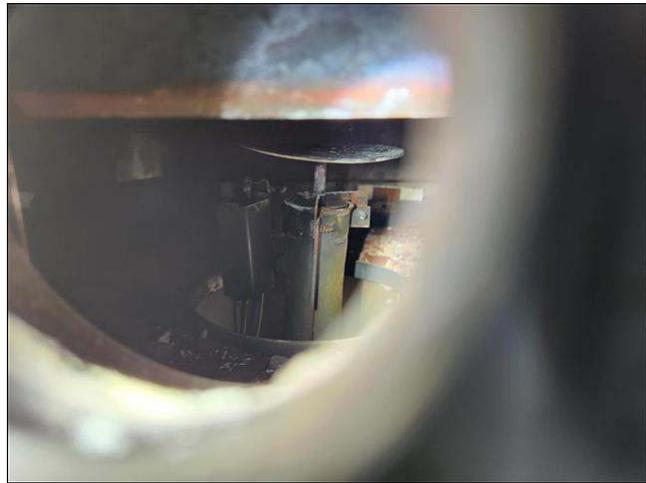
The heating equipment is original (47 years). The furnace is a vertical downdraft propane gas fired forced air unit, Rated at 100,000btu's, that Could Not be operated due to system being shut-down at time of inspection. The burner compartment appears operational. Manufactured in 1977 by Coleman Heating. Recommend further evaluation of heating system by a qualified person.

10.0 Item 1(Picture) forced air furnace

10.0 Item 2(Picture) furnace burner compartment
