Inspection Report

Property Address:
1370 Chichester Dr.
Gardnerville NV 88410

Clear Choice Home Inspection Services

Date: 7/17/2023	Time: 08:00 AM	Report ID: WAL137
Property: 1370 Chichester Dr. Gardnerville NV 88410	Customer:	Real Estate Professional: Thomas Vander Laan Coldwell Banker

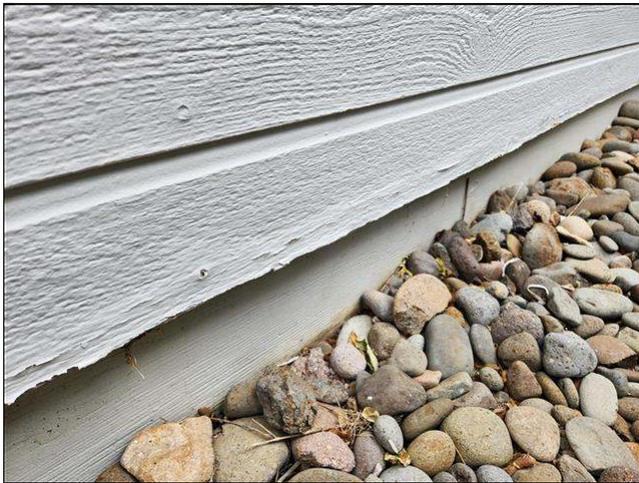
(1) Exterior wall cladding appears original to the home, and is T-111 and Horizontal lap style compressed board that appears in average condition for the age home. Normal aging and wear was noted, with slight deterioration at the lower edges, possibly from irrigation over-spray or roof run-off splashing on the ground. No problems were noted with the siding materials, and appears properly secured to wall framing.

1.1 Item 1(Picture) condition of lower siding boards

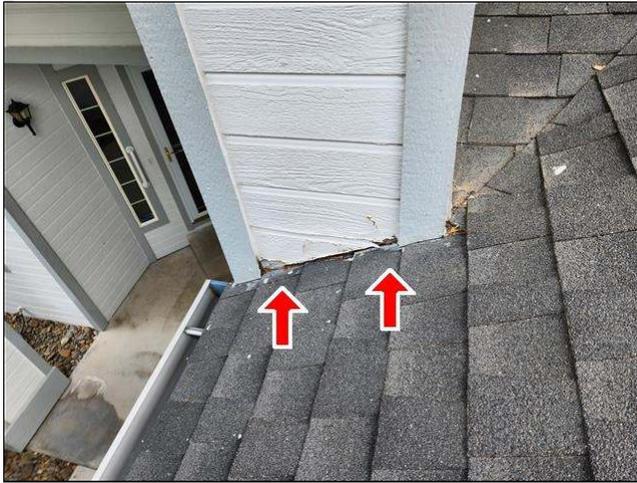
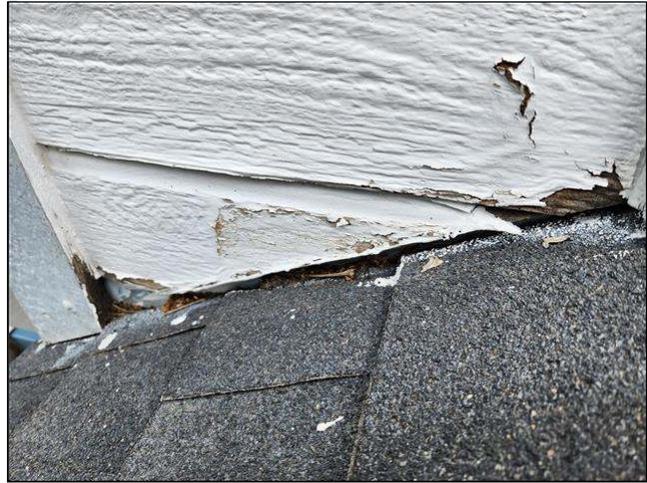
- 🏠 (2) Recommend maintaining generous paint coverage on the horizontal lap siding and corner trim boards at right side over main entry area. This area sees a generous amount of roof run-off moisture, and should be protected.

1.1 Item 2(Picture) generous amount of roof drainage at siding

1.1 Item 3(Picture) maintain generous paint in this area

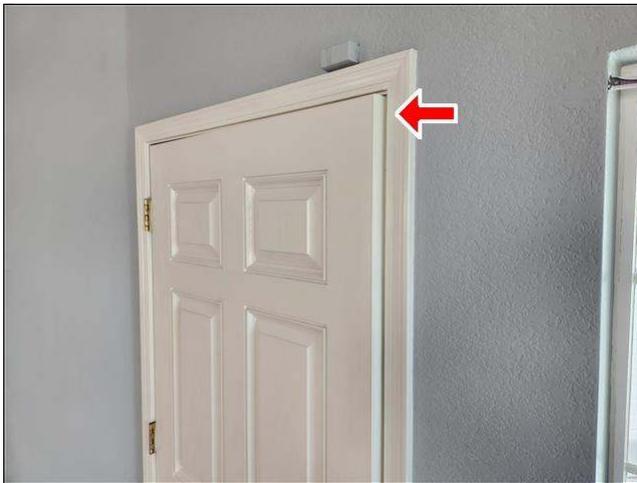
The front entry door sags at hinges, and rubs at top jamb area when closing. This is a maintenance issue and is for your information. A qualified person should repair as needed.

1.3 Item 1(Picture) main entry door drags

RE: 1.3—Please see *Exhibit: Seller Repair Itemization*

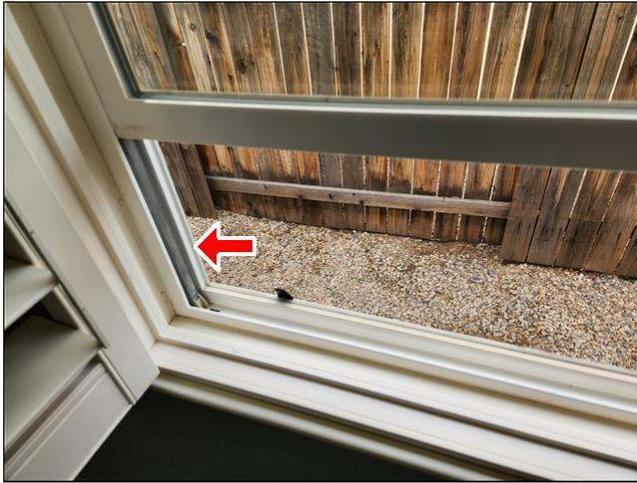
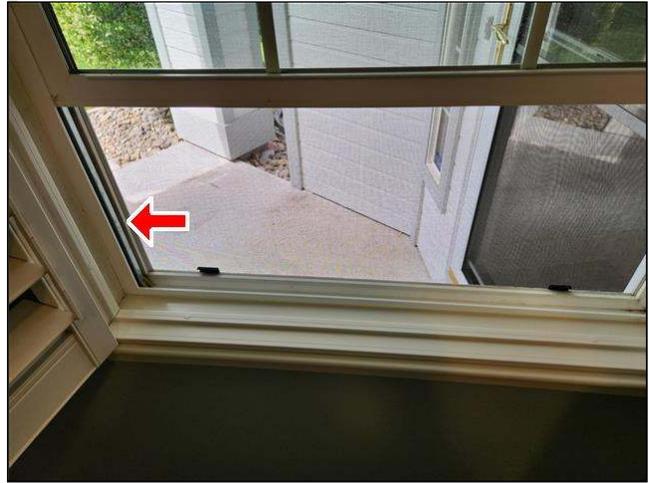
(2) Jamb spring(s) is weak or no longer works properly at the Family room West wall, and Office southwest window. A repair may be needed. A qualified contractor should inspect and repair as needed.

1.4 Item 1(Picture) family room west wall

1.4 Item 2(Picture) office window

RE: 1.4(2)—Please see *Exhibit: Seller Repair Itemization*

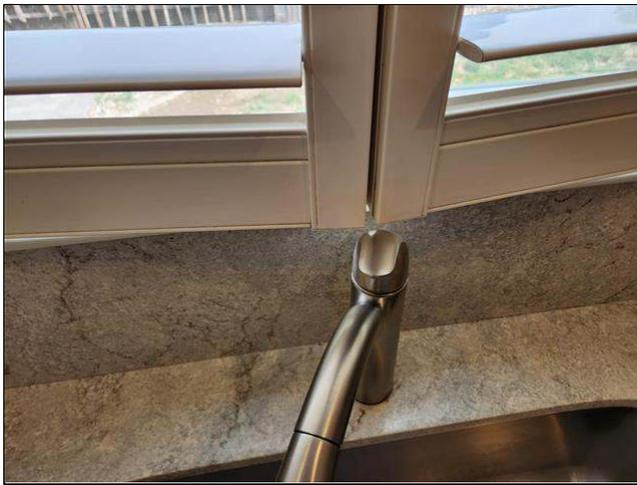
(3) NOTE: Kitchen window is not accessible from the interior due to window shades contacting the sink faucet.

1.4 Item 3(Picture) kitchen window shades/sink faucet

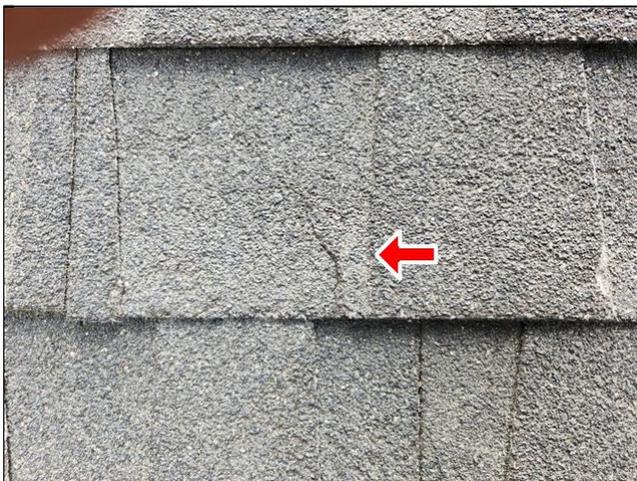
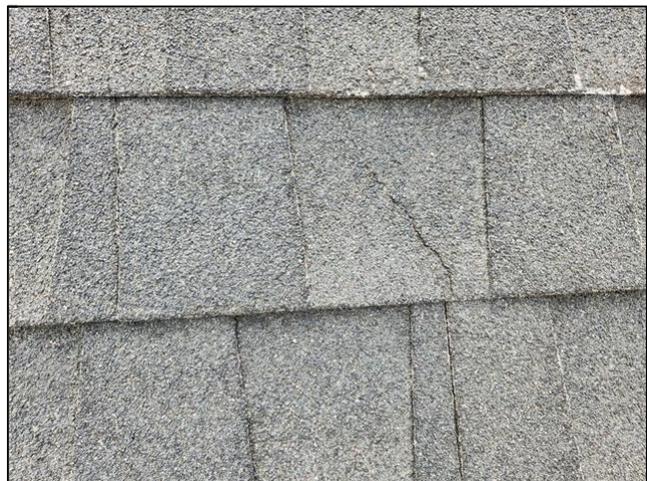
(1) The roof covering appears to be original (21 years) and is a 30 year architectural, asphalt/fiberglass Composition shingle with much of it's life remaining. Typical loss of granules noted from shingles, with a few "aged cracked" shingles noted. No major problems noted at time of inspection. Recommend further evaluation of roof covering materials by a licensed Roofing Contractor for estimated remaining life of roof, as desired.

2.1 Item 1(Picture) age cracked shingle

2.1 Item 2(Picture) aged cracked shingles

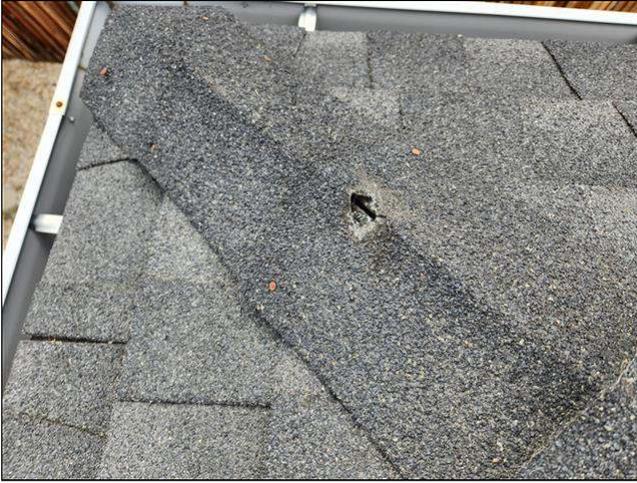
(2) NOTE: One damaged ridge cap shingle noted at the Northeast corner of garage roof, that should be replaced by a qualified person.

2.1 Item 3(Picture) damaged ridge cap shingle

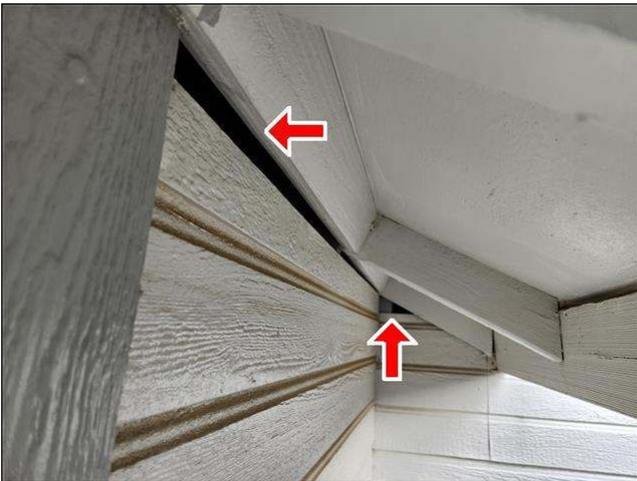
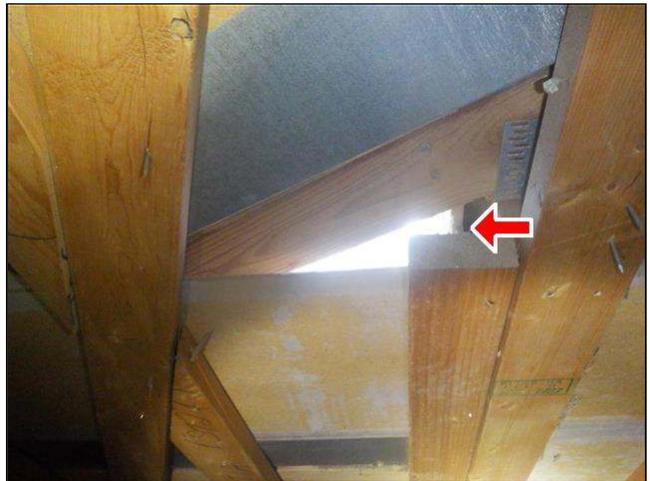
NOTE: Recommend blocking holes at South end of attic (adjacent to connection with garage), where birds/pests could gain access into the attic area.

3.9 Item 1(Picture) holes into attic area

3.9 Item 2(Picture) viewed from attic area

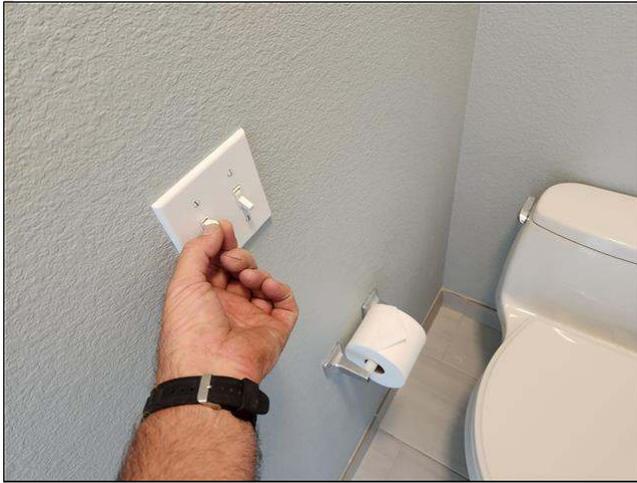
(1) Faulty light switch noted at the master bathroom water closet. Recommend further evaluation/repair by a licensed Electrician.

4.5 Item 1(Picture) switch at master bathroom

RE: 4.5(1)—Please see *Exhibit: Seller Repair Itemization*

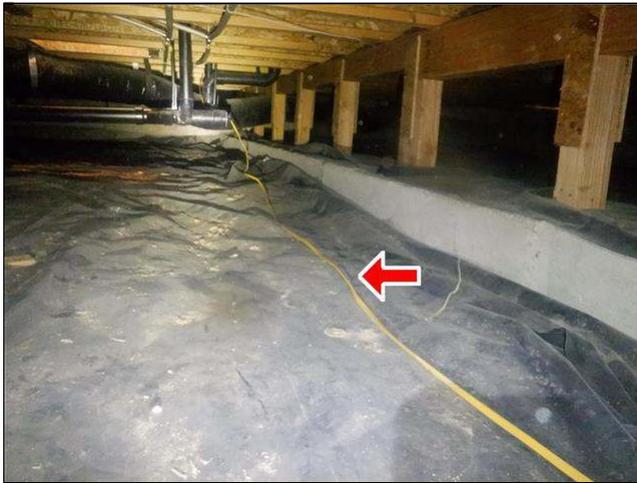
- 🏠 (2) The electrical wiring under bedroom hallway area in crawlspace was not secured to wood members properly, and was not installed in standard workmanlike practice. Recommend securing electrical wiring to floor joists at 4' on center, by a qualified person.

4.5 Item 2(Picture) wire not properly secured to floor

RE: 4.5(2)—Please see *Exhibit: Seller Repair Itemization*

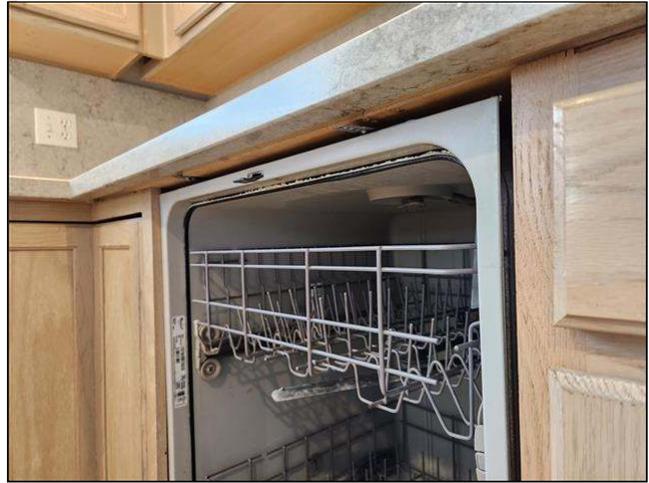
6.1 Item 2(Picture) dishwasher not properly secured

- 🏠 (2) The dishwasher is loose and needs securing to underside of countertop (using a proper length screw). I recommend repair as necessary. **RE: 6.1(2)—Please see *Exhibit: Seller Repair Itemization***

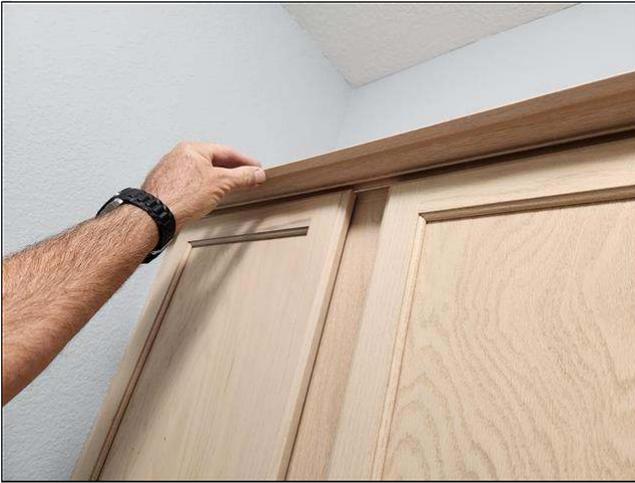
(1) Recommend repositioning and securing crown moulding at laundry room upper cabinet.

7.4 Item 1(Picture) crown moulding at laundry

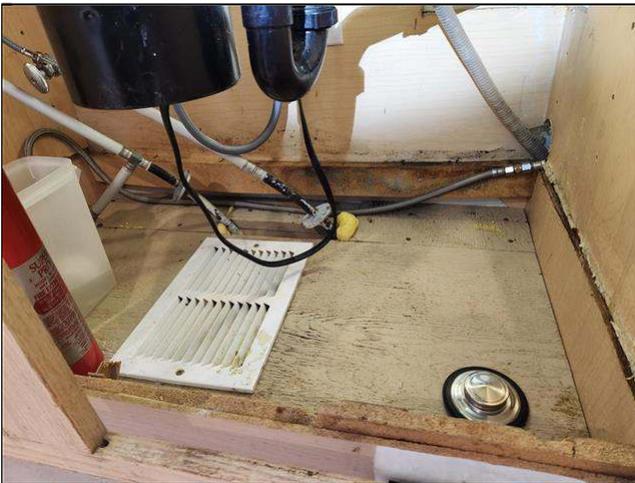
- 🏠 (2) Lower cabinet shelving is missing under sink at bottom shelf (appears was damaged from a previous leak) at Kitchen. New/solid exterior siding type of materials have been used to cover the subfloor (which I am unable to verify condition of). This repair is functional, however replacing the lower shelf inside the cabinet would be beneficial. Recommend replace missing cabinet shelving with new material as needed.

7.4 Item 2(Picture) missing lower cabinet shelf

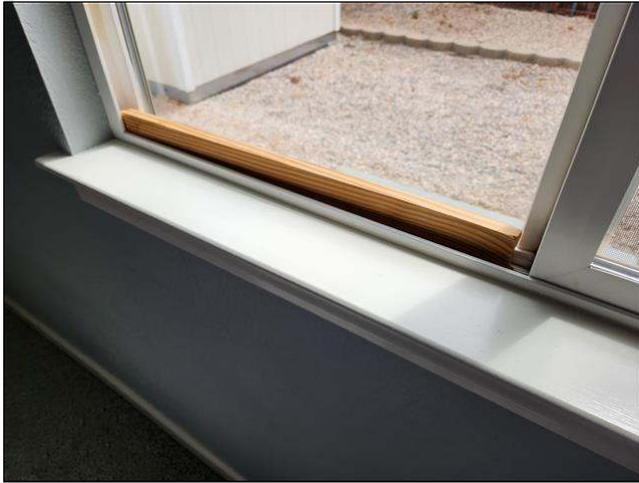
7.5 Item 1(Picture) SE guest bedroom window

RE: 7.5—Please see *Exhibit: Seller Repair Itemization*

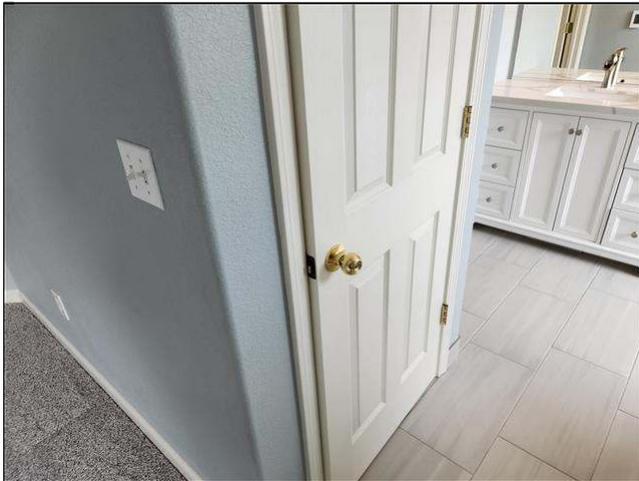
The Privacy door needs strike and latch adjustment to latch properly at the Master Bathroom. This is a maintenance issue and is for your information. A qualified person should repair as needed.

7.6 Item 1(Picture) door at master bathroom

RE: 7.6—Please see *Exhibit: Seller Repair Itemization*

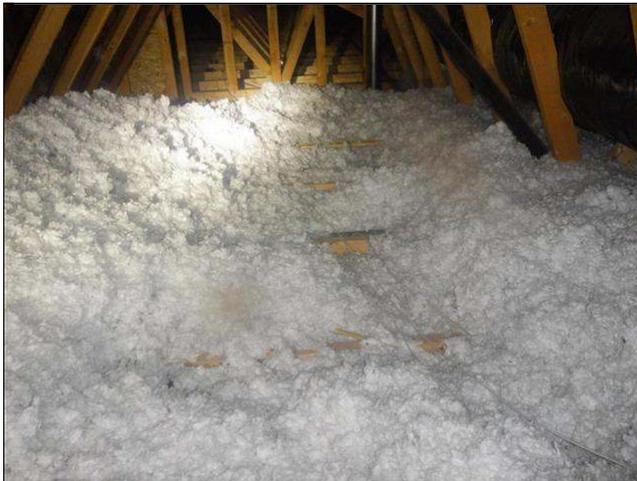
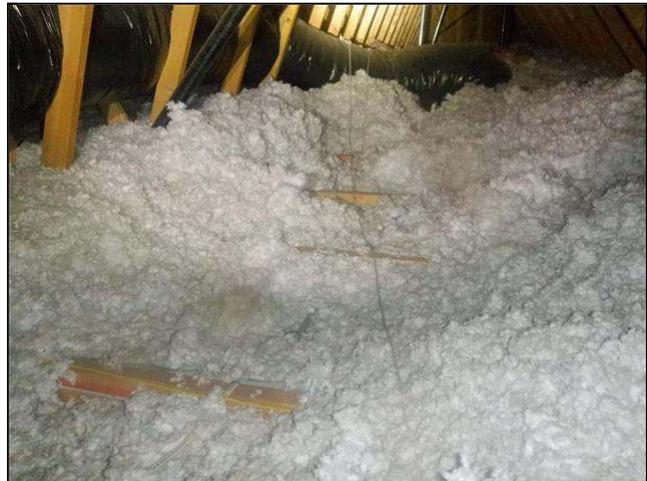
(2) Attic/ceiling Insulation has been compressed in some areas, appears due to repairs/installations/inspections, which decreased the R-Value rating of the insulation. Recommend raking insulation even and fluffing insulation, for improved performance and efficiency.

9.0 Item 1(Picture) compressed attic insulation

9.0 Item 2(Picture) compressed attic insulation

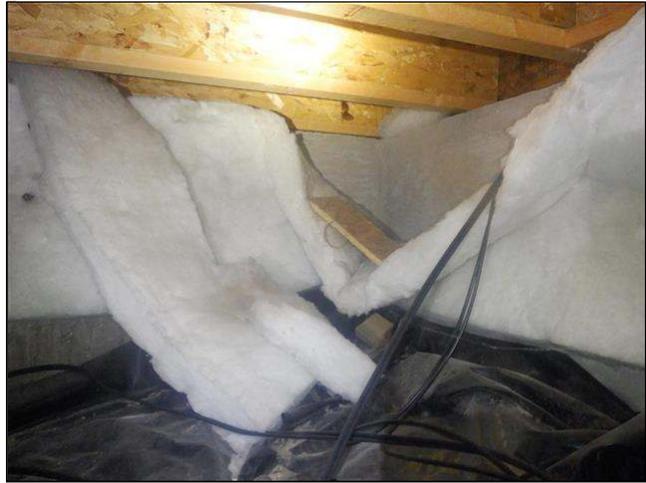
The crawlspace area is insulated on the inner wall of perimeter of the foundation using R13 fiberglass Batts, with a couple areas of loosened/fallen insulation, no problems noted.

9.1 Item 2(Picture) fallen crawlspace insulation

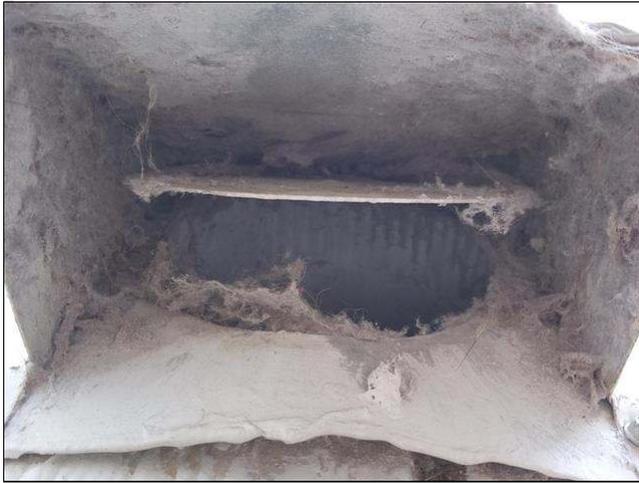
(2) The dryer vent piping has a damaged/bent/clogged vent hood outside, not allowing the vent to close when not in use. This condition could allow pest/rodent intrusion. I recommend repair as needed.

9.4 Item 3(Picture) dryer vent hood

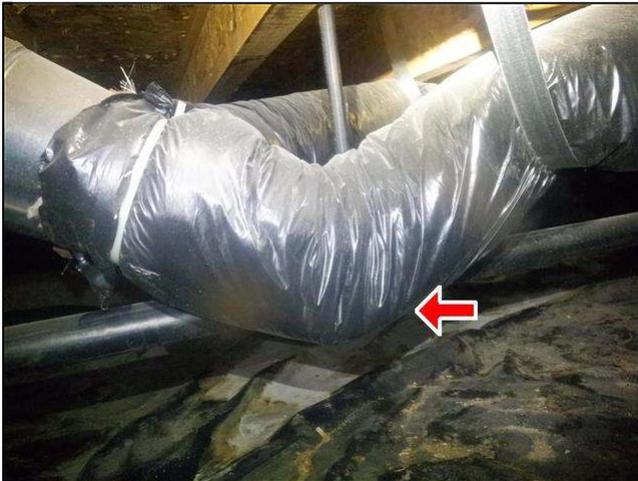
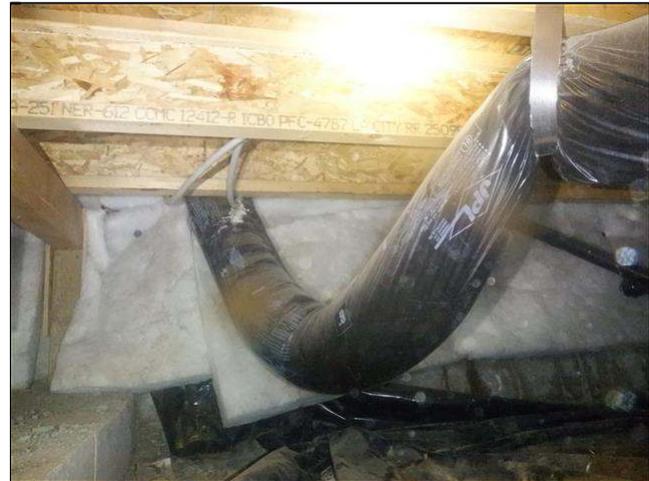
(2) NOTE: Heating ducts under kitchen and master bathroom areas are full of water. I am unable to determine how long this water has been present, or if fungus/mold growth is present inside these ducts. Recommend further evaluation, including testing for possible Mold growth, by a qualified person.

10.3 Item 1(Picture) master bathroom heating duct

10.3 Item 2(Picture) kitchen heating duct

RE: 10.3(2)—Please see *Exhibit: Seller Repair Itemization*

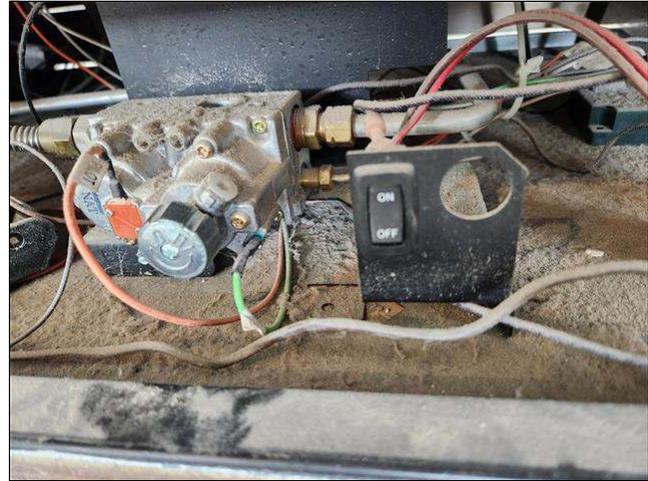
11.0 Item 2(Picture) excessive dust under fireplace

(2) Recommend cleaning gas valve compartment under fireplace, due to excessive dust noted.
