Inspection Report

Property Address:
1844 Alpine St.
Carson City NV 89703

Clear Choice Home Inspection Services

Date: 6/14/2024	Time: 09:00 AM	Report ID: DAS184
Property: 1844 Alpine St. Carson City NV 89703	Customer: Barrett Dasenbrock	Real Estate Professional: Thomas Vander Laan Coldwell Banker

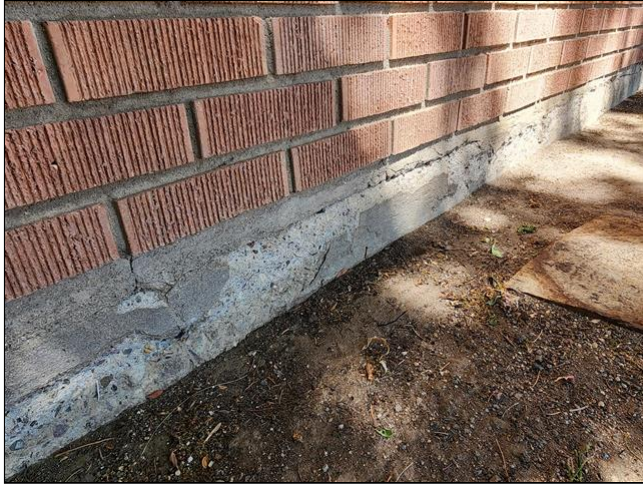
(1) Some Spalling damage of the concrete surfaces was noted at the exterior of foundation at various locations around the building. Spalling is the result of moisture freezing within the cracks of concrete surfaces that causes pieces of the concrete to break loose when freezing water expands as it turns into ice. NOTE: This condition does not appear structural, but rather cosmetic.

3.2 Item 1(Picture) spalling damage at foundation

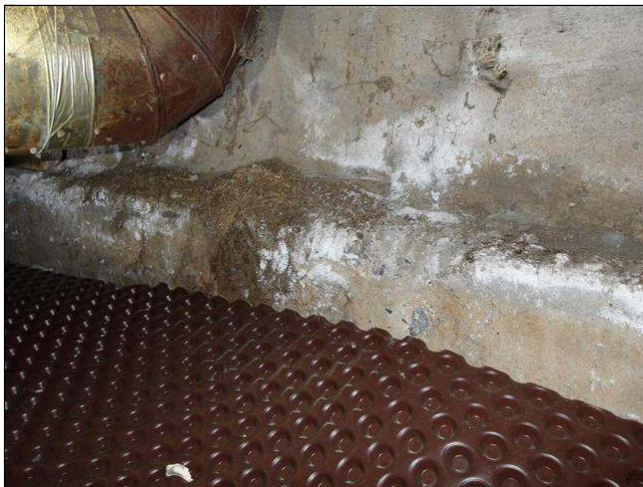
(2) Crawlspace area was dry at time of inspection. There are signs of past moisture intrusion noted at the along the West side foundation (possibly from downhill grading in the back yard, and lack of roof drainage gutters). There is a sump pump system installed to control the moisture, and appears adequate.

3.2 Item 2(Picture) signs of excessive exterior moisture

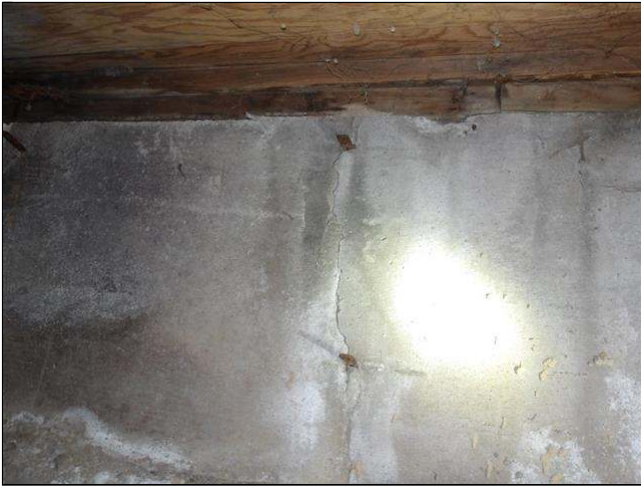
(3) There is one vertical crack noted in the foundation stemwall at the Southwest corner area. All cracks are 3/16" or smaller, and do not appear to be recent movement. These are typically caused from tree roots, or expansive soils (clay) under the footing. Recommend seal any cracks noted in the foundation stemwall, to prevent moisture intrusion and deterioration.

3.2 Item 3(Picture) small vertical foundation crack

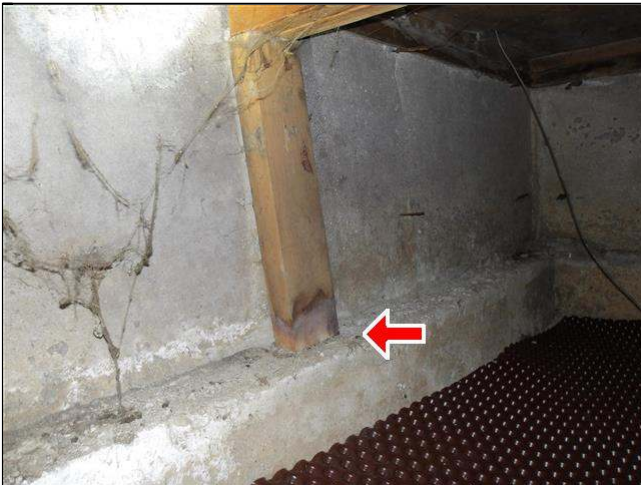
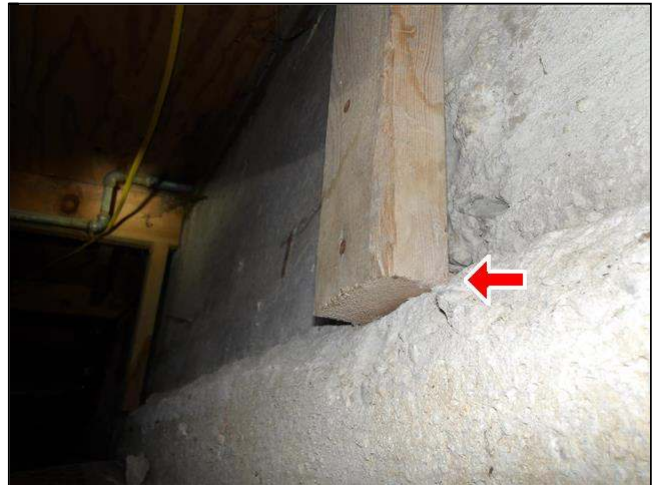
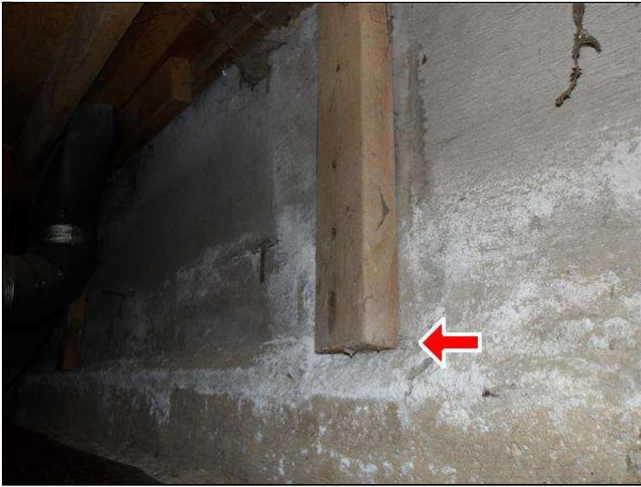
NOTE: A few Subfloor girder beam support posts along the West side foundation, are resting on a deteriorating concrete ledge. Although these posts appear unsupported, they are also nailed into the foundation stemwall and show no signs of sagging.

3.4 Item 2(Picture) losing ledge support

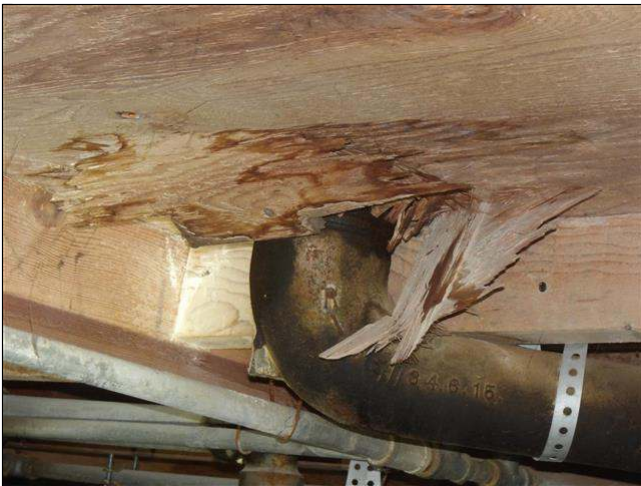
NOTE: Slight deterioration of subfloor plywood was noted under the hall bathroom toilet. There are moisture stains on the plywood from what appears to be PAST toilet leaking. This is 1-1/4" plywood subfloor materials, which appear to remain solid and serviceable.

3.6 Item 1(Picture) subfloor plywood under hall bathroom toilet

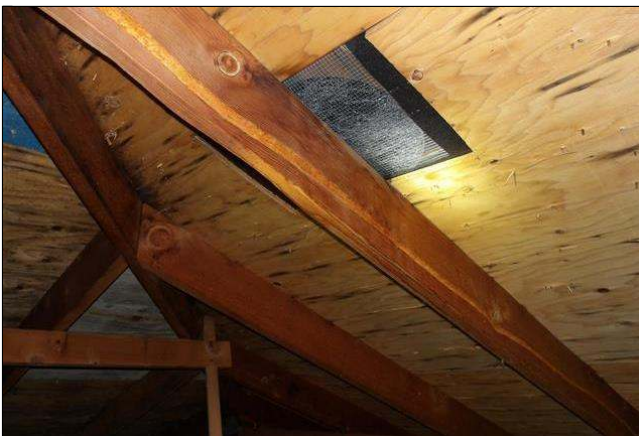
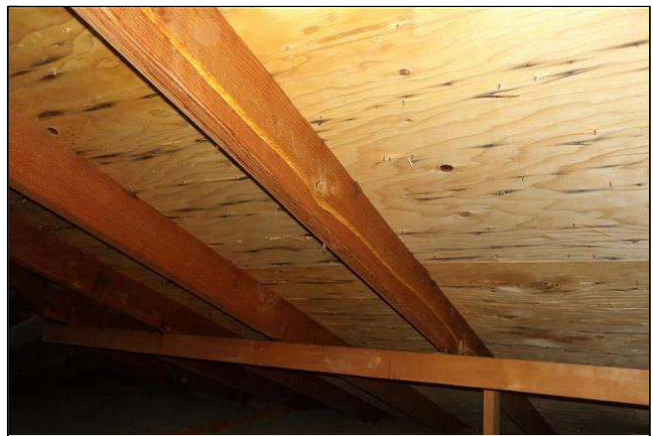
Cracked roof rafter noted at the South slope of roof, and needs to be repaired or replaced by a qualified person.

3.9 Item 1(Picture) cracked roof rafter

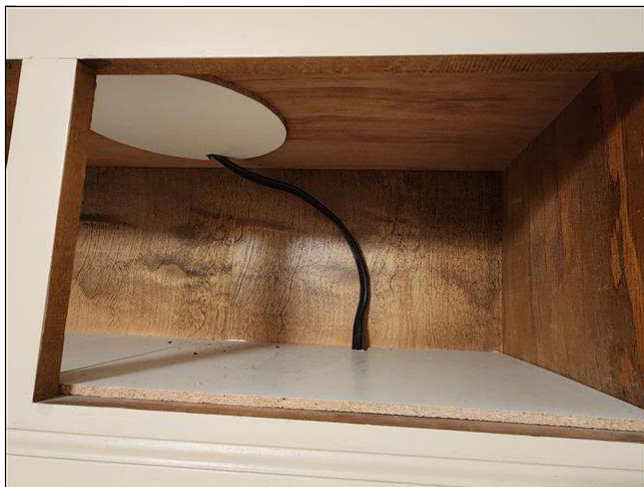
Exposed electrical wire noted in the following locations: Inside upper range hood cabinet. Electrical wiring below 7 feet high, or inside cabinets, should be covered for protection of wiring damage, and also for personal protection. Recommend repairs by a qualified person.

4.5 Item 1(Picture) exposed wire inside cabinet

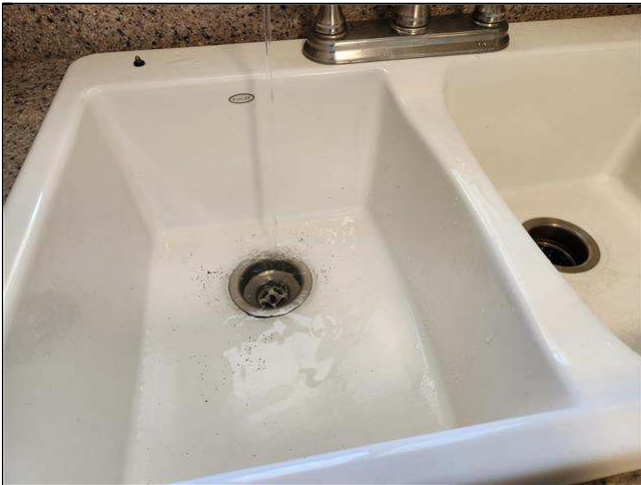
Maintenance Item... The sink drains slowly at the kitchen (left side). A qualified person should repair or correct as needed.

5.3 Item 1(Picture) slow drain at kitchen sink

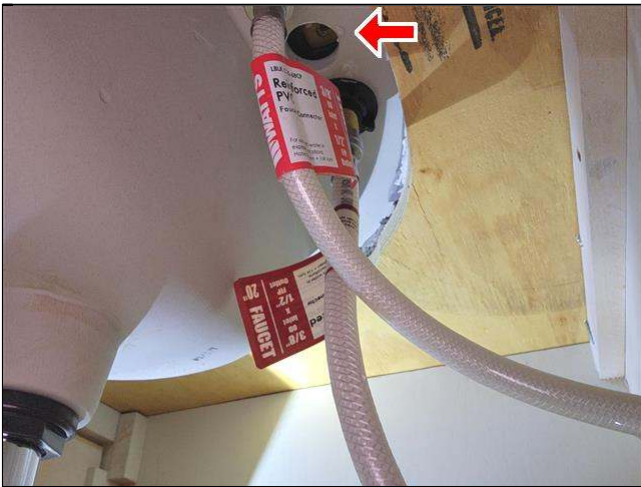
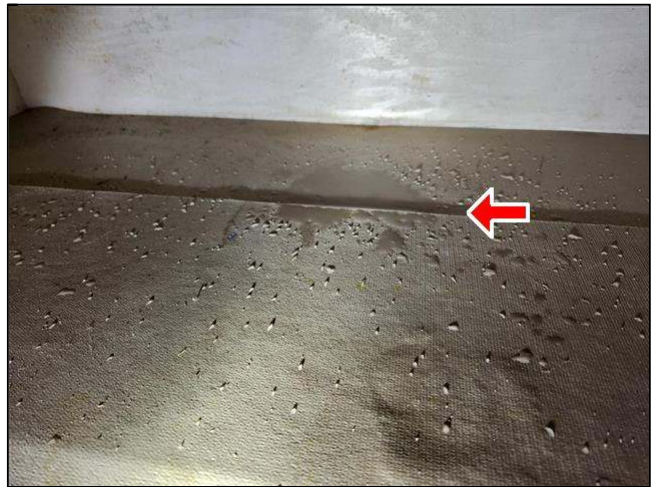
Master Bathroom sink faucet leaks at base, and should be repaired or replaced by a qualified person.

5.5 Item 1(Picture) faucet leaks under base

5.5 Item 2(Picture) moisture from leak

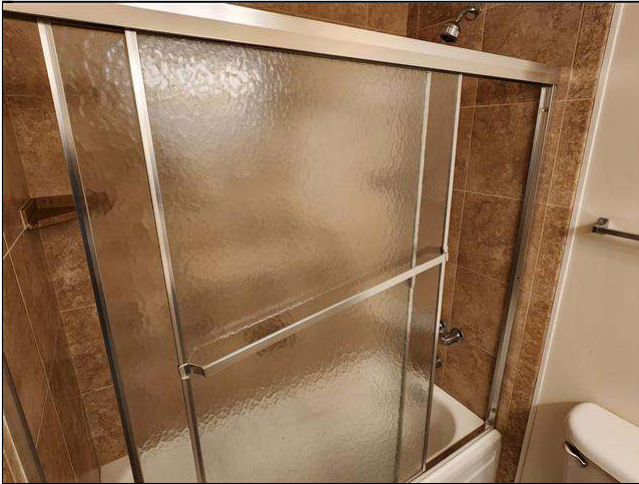
Hall bathroom shower enclosure door needs repairs to function as intended. Appears loose at the upper rollers.

5.7 Item 1(Picture) hall bathroom shower door

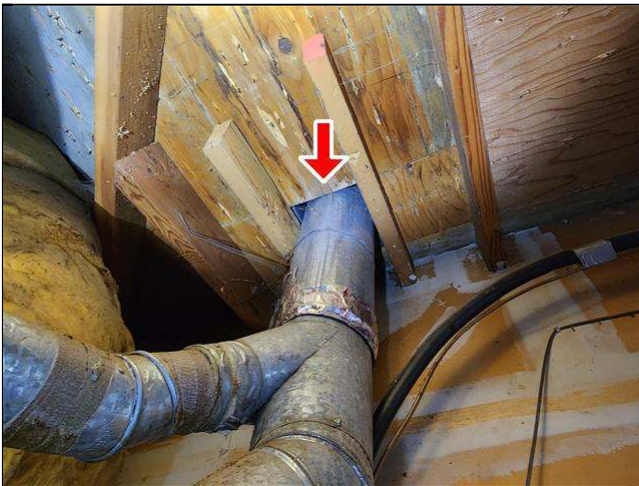
Water heater/furnace flue pipe does not maintain the required 1" clearance to combustibles materials. Flue pipe is resting against the roof sheathing plywood, and needs repair to maintain the proper clearance.

5.8 Item 1(Picture) improper clearance at flue pipe

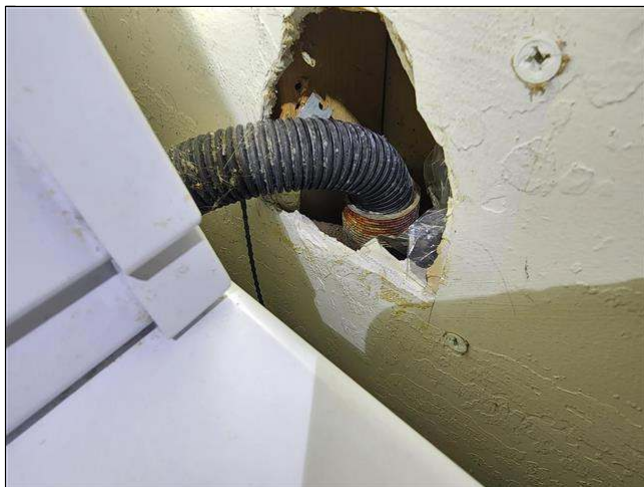
(1) The Drywall adjacent to the washing machine in the Laundry closet reveals damage from past plumbing repairs? While this damage is cosmetic, it should be repaired to eliminate possible rodent access into laundry closet area. A qualified person should repair or replace as needed.

7.2 Item 1(Picture) hole at laundry closet wall

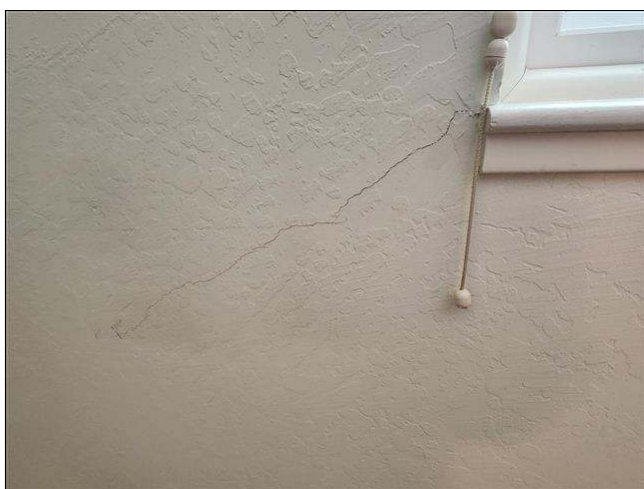
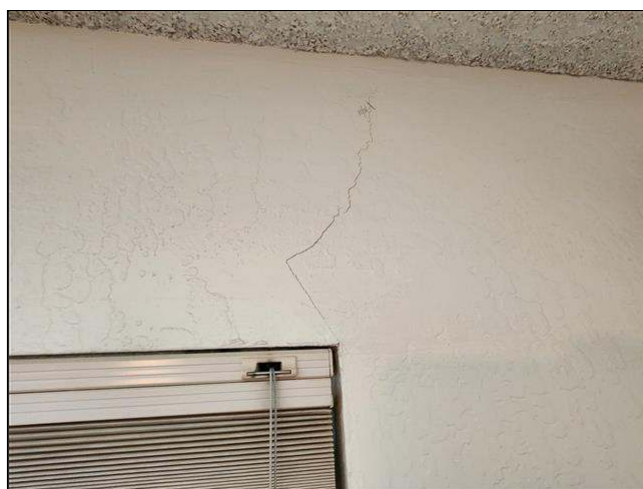
(2) The sheetrock on the wall has settlement cracks at the Master bedroom (adjacent to the window). This damage is considered cosmetic. A qualified person should repair or replace as needed.

7.2 Item 2(Picture) settlement crack at master bedroom

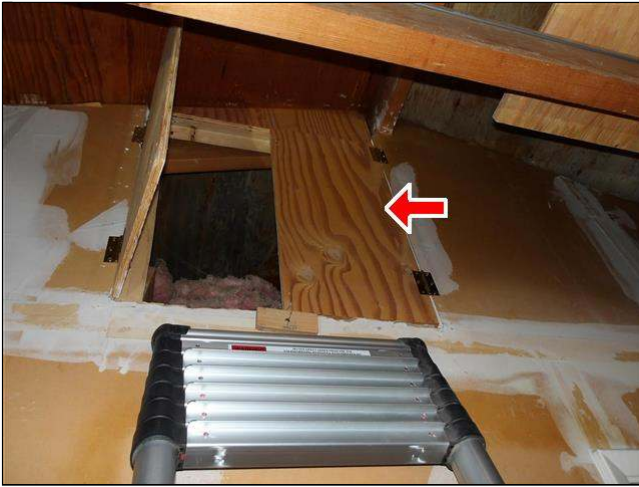
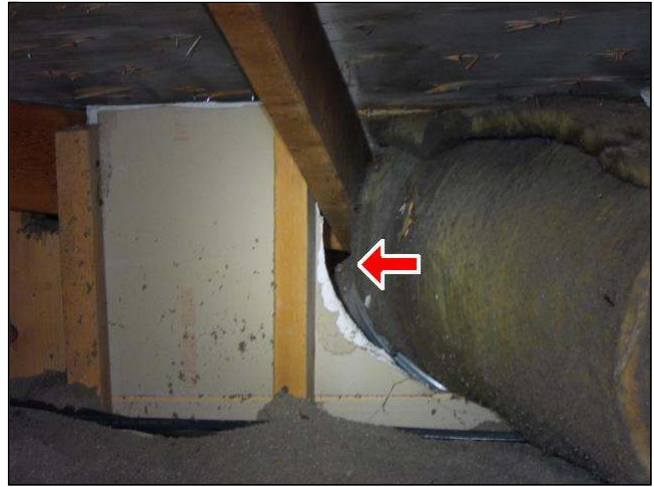
Fire-separation wall between the garage and the house is compromised at the attic access, and around the return air duct. This wall is required to be fully drywalled and taped to prevent rapid spread of a possible garage fire, into the home's attic area. Recommend repair by a qualified person.

8.3 Item 1(Picture) compromises fire-separation wall integrity

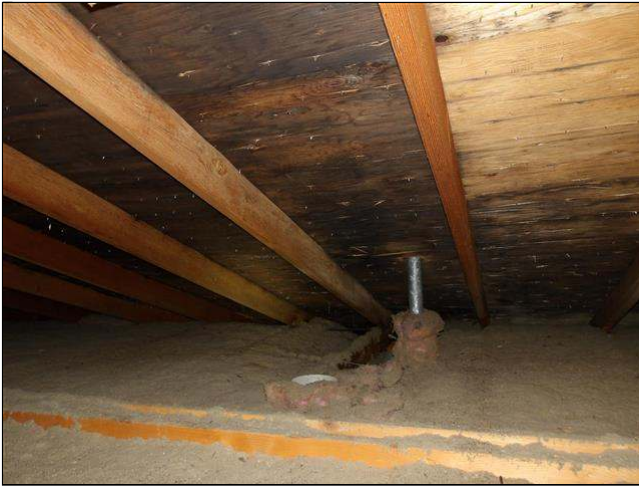
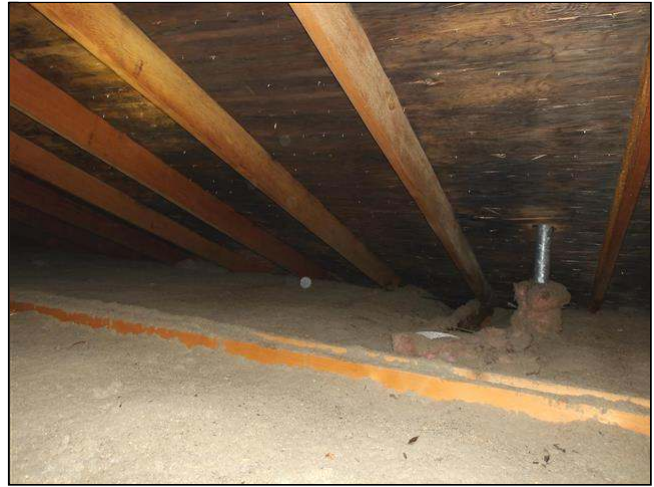
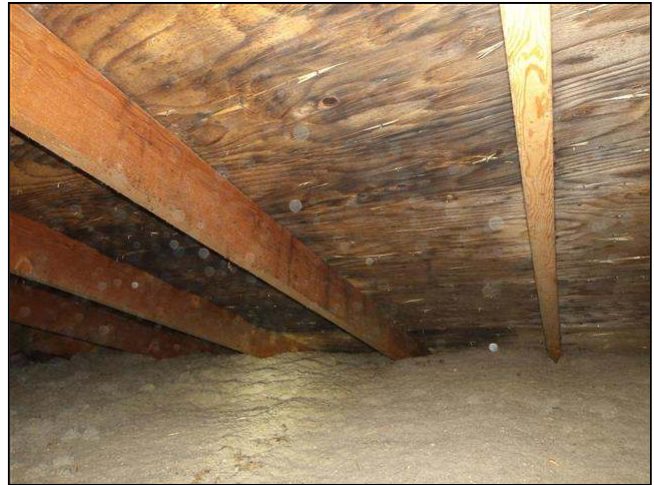
The attic shows signs of poor ventilation, with blackened plywood from moist air noted. Additional roof vents have been installed (appears at last roof covering replacement), and now appears adequate. Blackened plywood remains, however appears to remain solid.

9.3 Item 1(Picture) blackened roof sheathing plywood

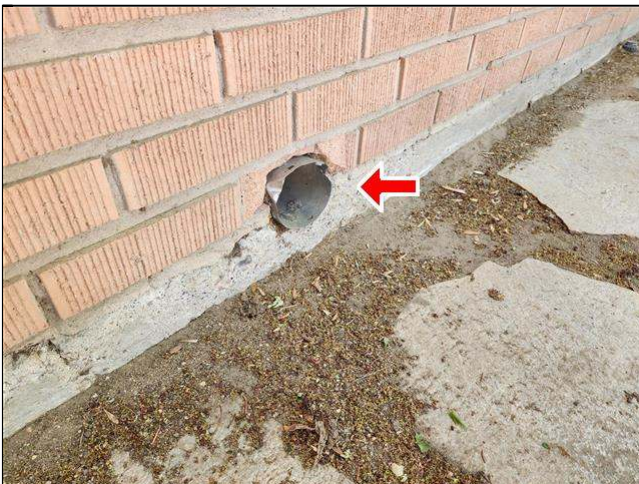
(2) The dryer vent piping has a damaged/bent/clogged vent hood outside, not allowing the vent to close when not in use. This condition could allow pest/rodent intrusion. I recommend repair as needed.

9.4 Item 1(Picture) dryer vent hood missing

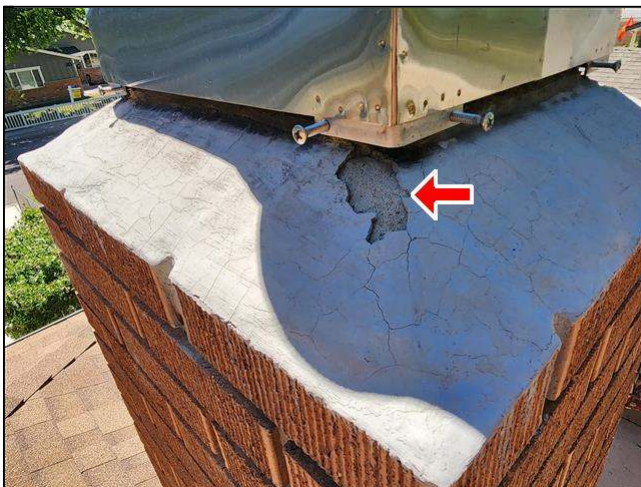
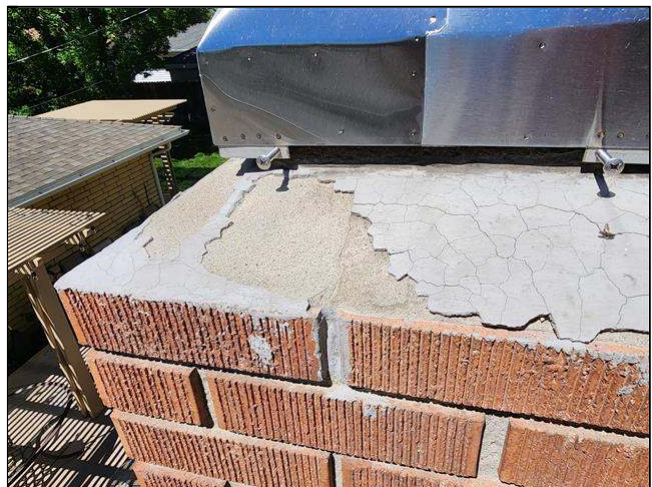
Chimney is brick and appears to be in good overall condition, with proper base flashings installed, and recent concrete chimney cap resurfacing. NOTE: touch-up is needed at a few locations at the chimney cap.

11.1 Item 3(Picture) touch-up needed
