Inspection Report

Property Address:
994 Mica Dr.
Carson City NV 89705

Clear Choice Home Inspection Services

Date: 9/8/2023	Time: 08:30 AM	Report ID: HAY994
Property: 994 Mica Dr. Carson City NV 89705	Customer: Debra Hays-Vaughn	Real Estate Professional: Thomas Vander Laan Coldwell Banker

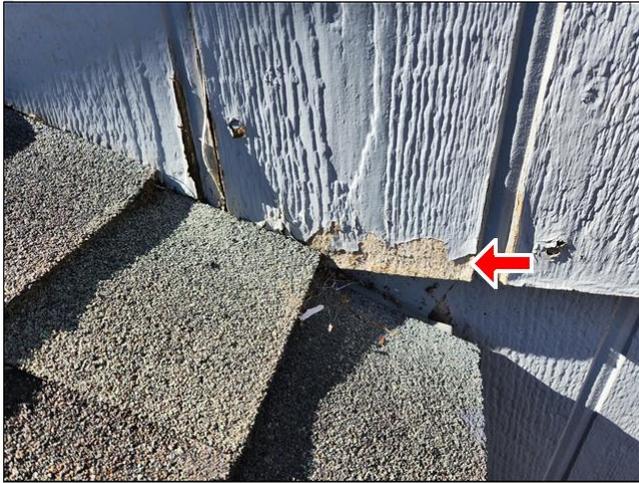
Lower edges of wall siding are showing some wear in various locations around the building. Recommend securing loosened overlapping seams, caulking and painting for weather protection.

1.1 Item 1(Picture) paint siding at roof gable areas

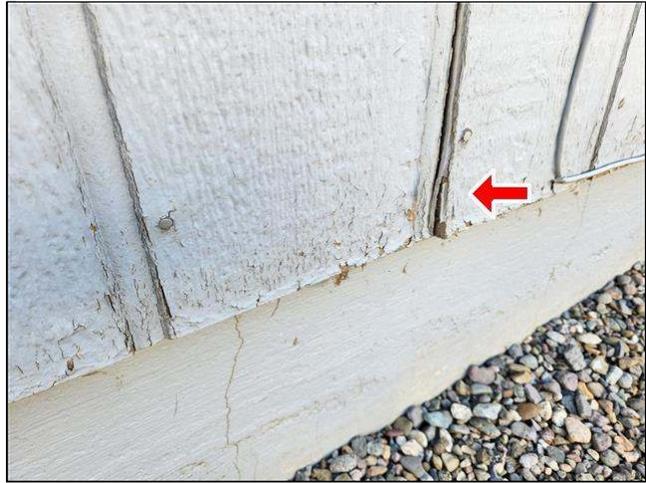
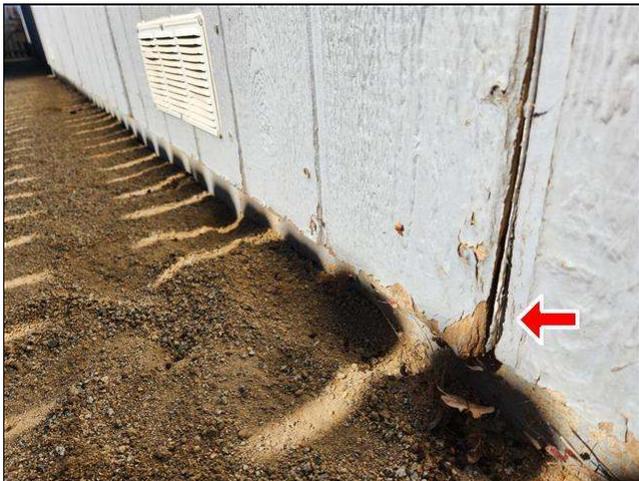
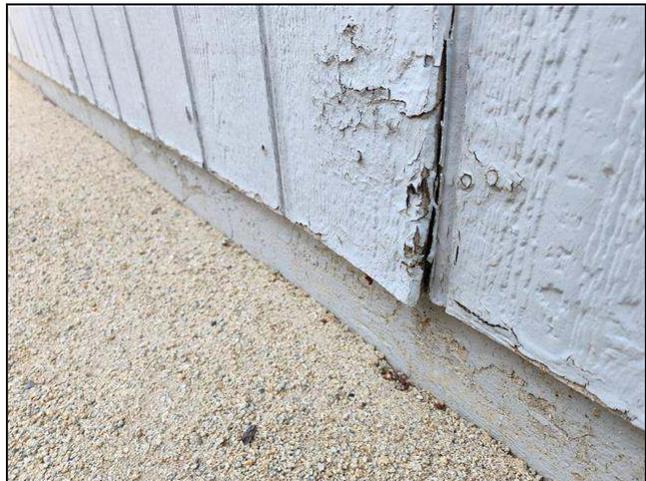
1.1 Item 2(Picture) loosened siding seam

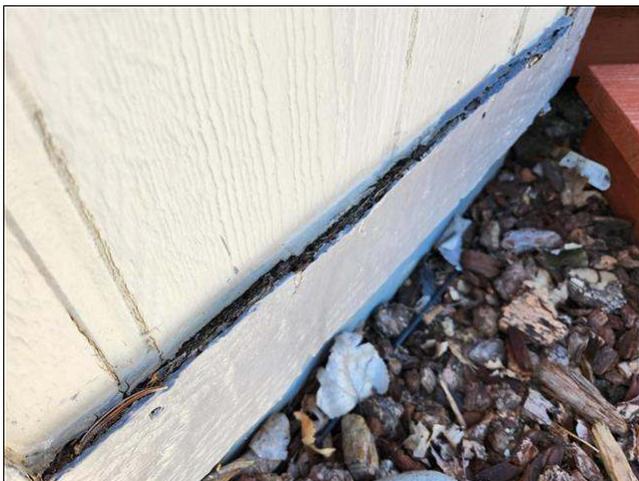
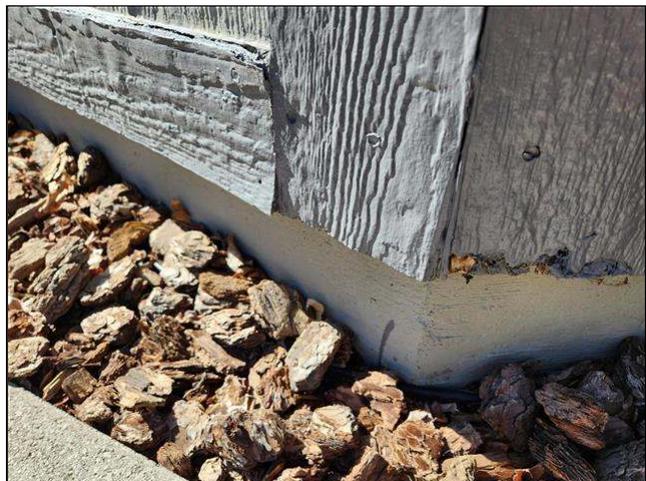
Lower siding trim at bay windows in kitchen nook area are damaged from moisture absorption, and appears will need replacement. Recommend further evaluation and repair by a qualified person.

1.2 Item 1(Picture) deteriorated siding trim at rear of home

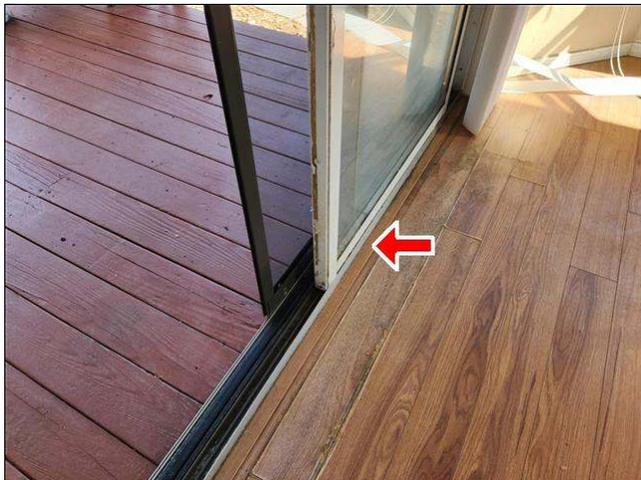
Sliding Glass door at rear patio drags against threshold and difficult to operate, and appears that the rollers may have deteriorated allowing door to settle on track. Recommend further evaluation and repair by a qualified person as needed.

1.3 Item 1(Picture) rear patio sliding glass door

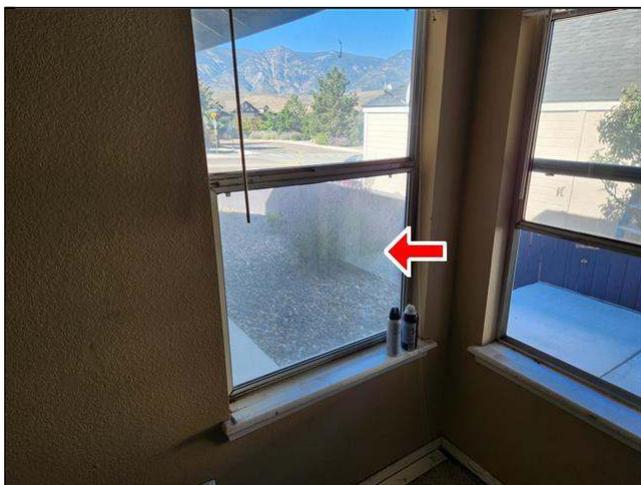
Single hung window is stuck closed at the West corner bedroom, and should be repaired by a qualified person.

1.4 Item 1(Picture) west corner bedroom window

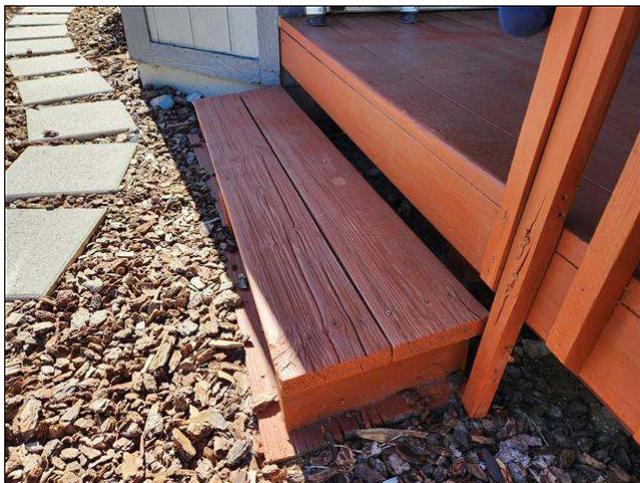
Rear deck steps are NOT secure, and should be secured to prevent possible trip hazard.

1.6 Item 1(Picture) loose rear deck steps

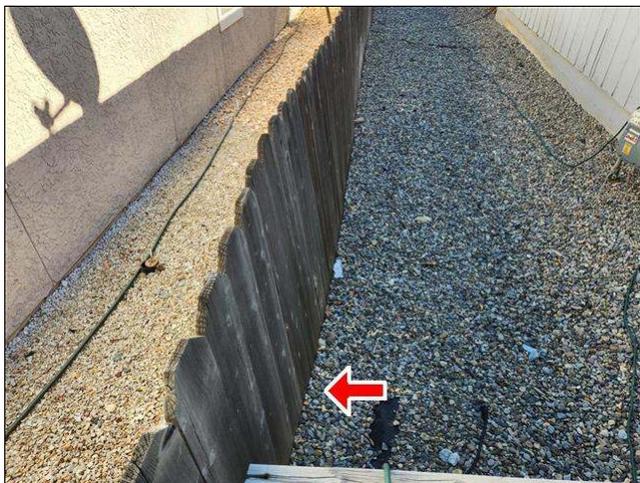
NOTE: left side facing property line fence is leaning outwards, appears from excessive fill/gravel against the fence boards.

1.8 Item 1(Picture) gravel pushing fence over

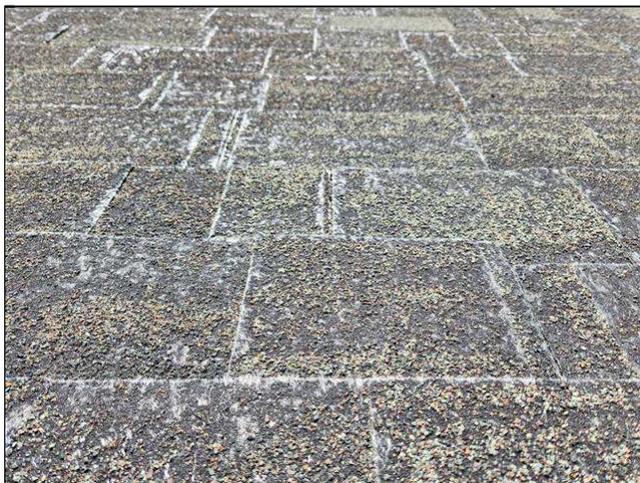
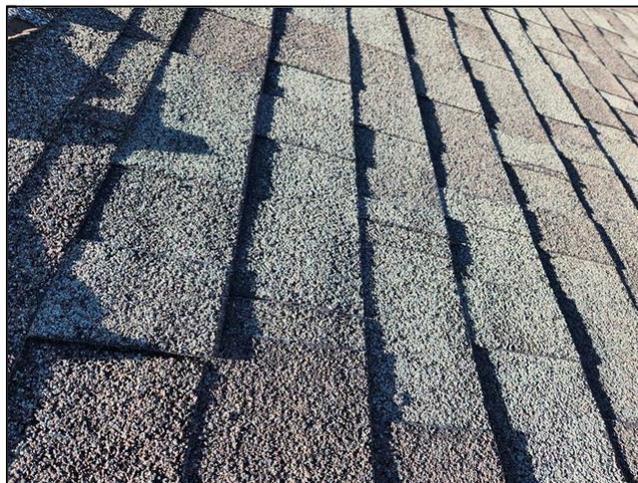
(1) The roof covering appears to be original (30 years) and is a 30 year architectural, asphalt/fiberglass Composition shingle that appears to be at the end of its useful life. Several areas of wind damaged shingles noted, with advanced granule loss noted at the South slope of roof. Recommend further evaluation of roof covering materials by a licensed Roofing Contractor.

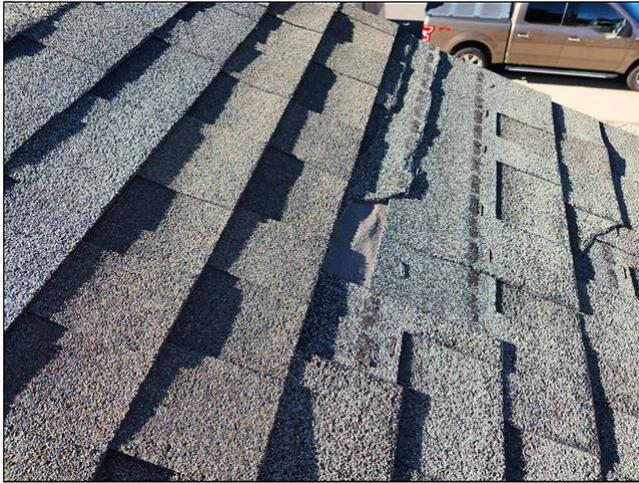
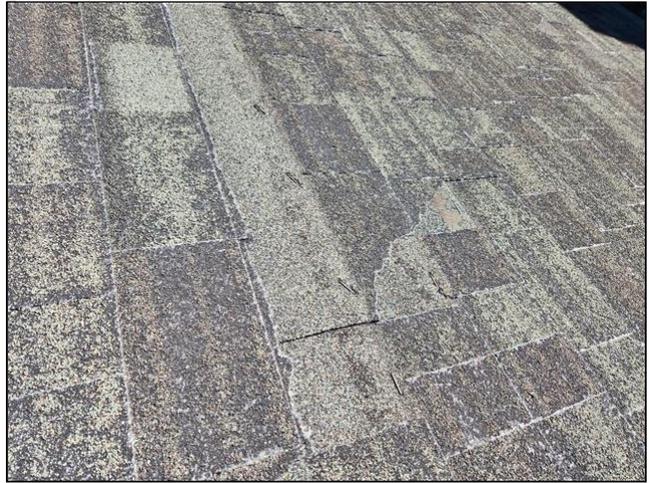
2.1 Item 3(Picture) wind damaged shingles

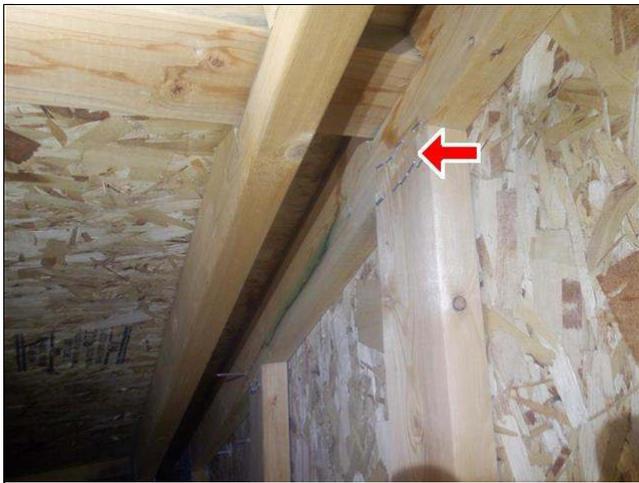
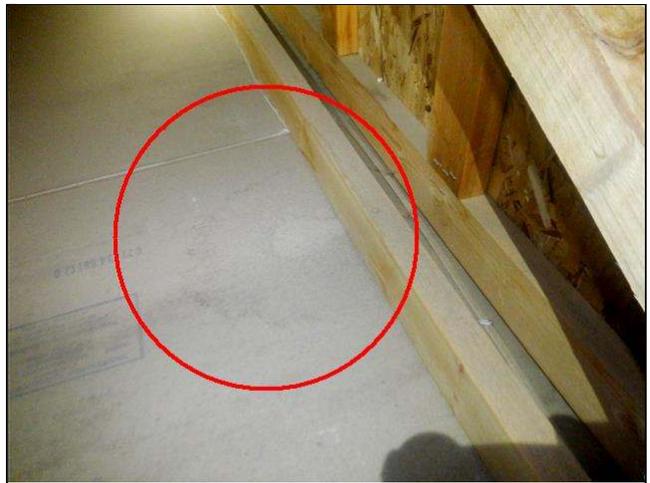
(2) Signs of moisture intrusion noted at the NW end of garage roof structure area.

2.1 Item 5(Picture) signs of moisture intrusion

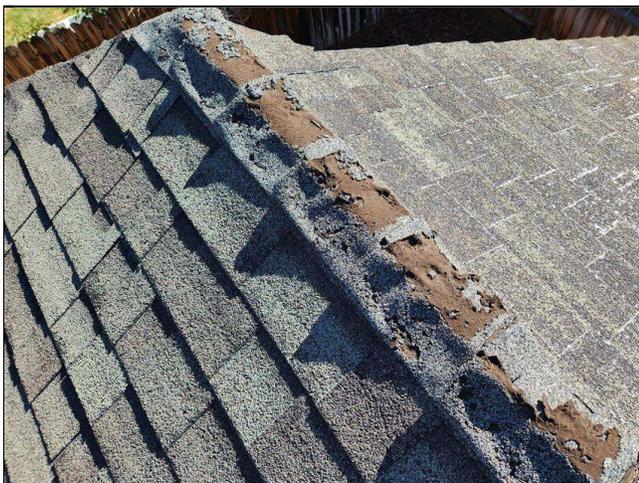
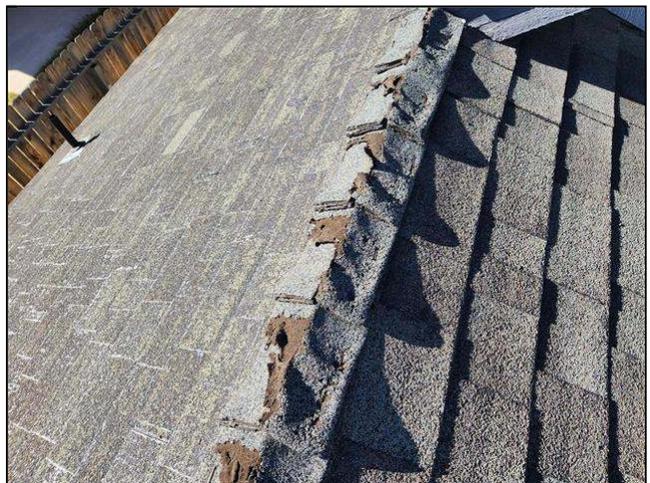
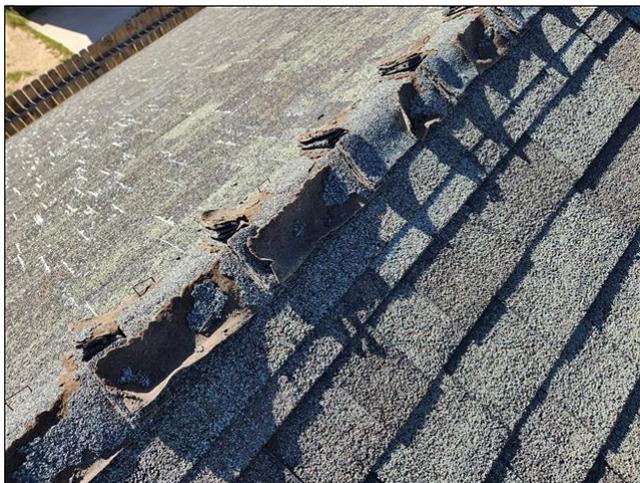
(3) Ridge cap shingles are worn/aged (missing over garage area), with loss of granules and exposed fiberglass base material noted. Recommend further evaluation by a qualified Roofing Contractor.

2.1 Item 7(Picture) deteriorated ridge cap shingles

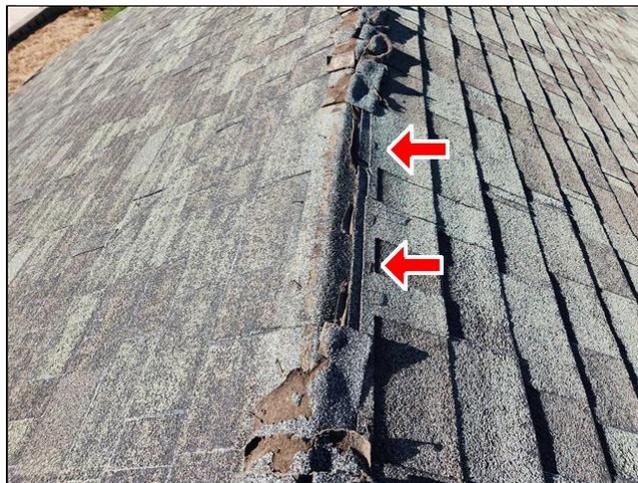
2.1 Item 10(Picture) missing over garage area

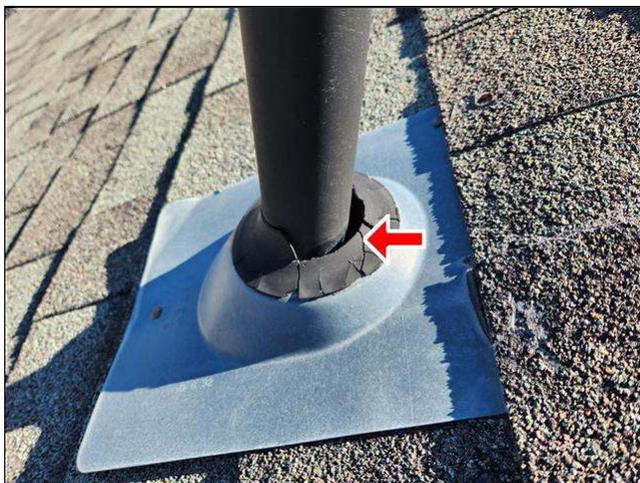
There are a few plumbing vent pipe roof penetrations with failing/deteriorated rubber boots. Recommend replacement of boot seals to prevent moisture intrusion to roof framing areas.

2.3 Item 1(Picture) failing rubber boots

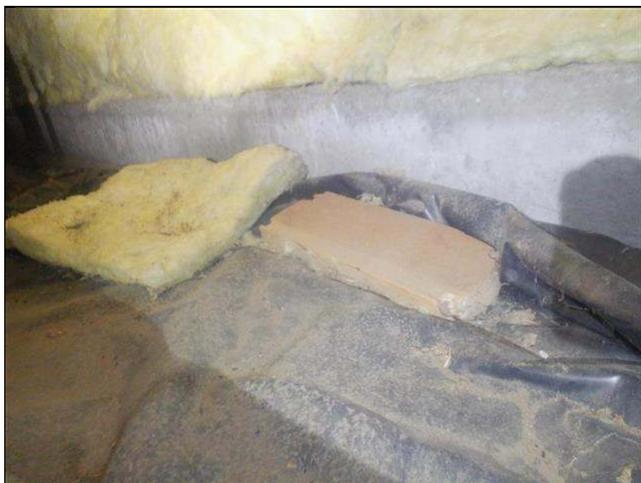
(3) Small areas of Construction debris (and/or trash) should be removed from the crawlspace area. Trash/Debris noted at various locations.

3.2 Item 1(Picture) construction debris

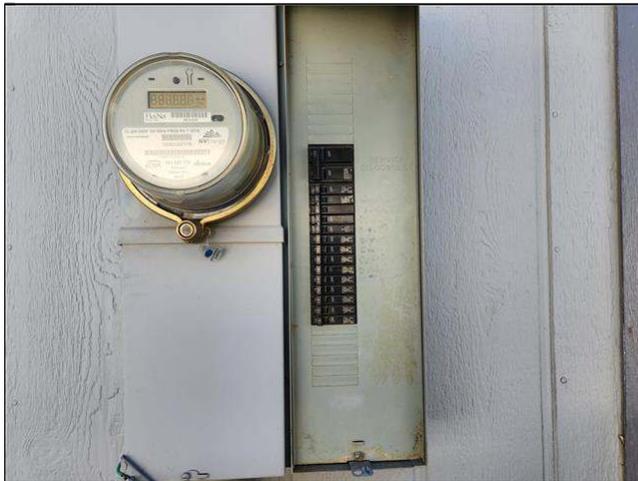
Circuit identification labels are faded and/or illegible. Recommend identifying and labeling circuits, to ensure proper circuit disconnection when needed.

4.1 Item 1(Picture) faded labels at main panel

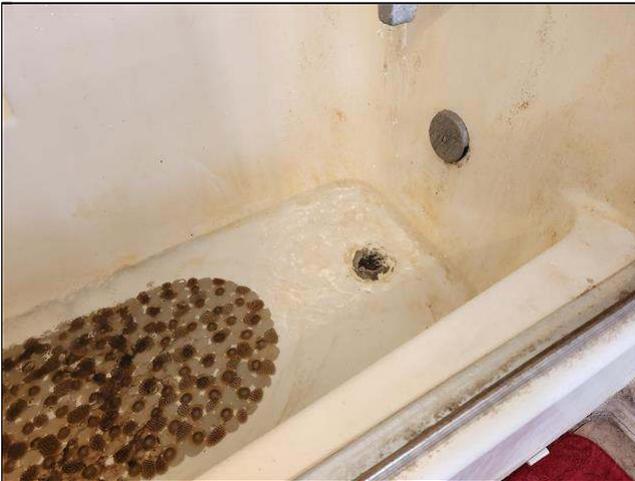
The tub drains slowly at the master bath (also both sinks drain slow at bathrooms). A qualified person should repair or correct as needed.

5.3 Item 1(Picture) slow drain at master bathtub

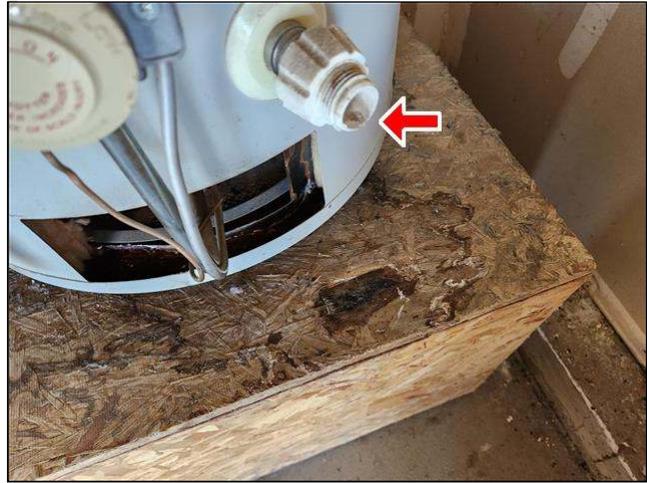
(1) Temperature and Pressure Relief valve is piped to the exterior of the house, or within 6 inches of the floor (for safety). Water Heater is NOT properly strapped with approved strapping material, and is setting on a pedestal minimum of 18" above the garage floor. Drip leg is installed in the gas line, water and fuel shut-off valves are present. Water heater operated as intended with no abnormal noises or leaks noted. No problems noted at time of inspection... Manufactured in 1993 by Bradford-White (30 years old). **NOTE: Signs of slow leaking noted at the water heater drain valve, and should be repaired.**

5.4 Item 2(Picture) slow leak at drain valve

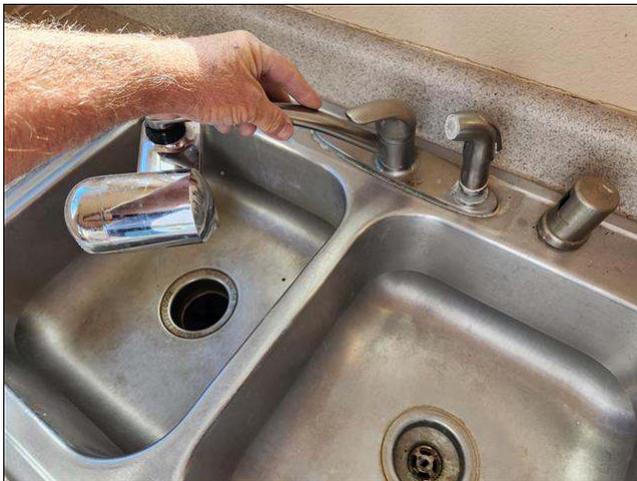
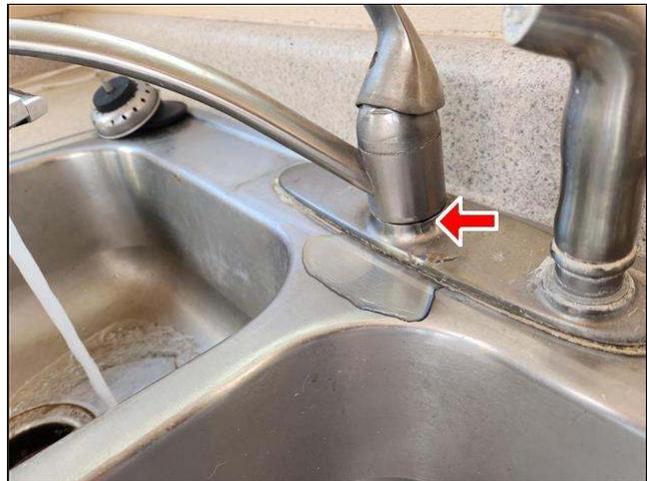
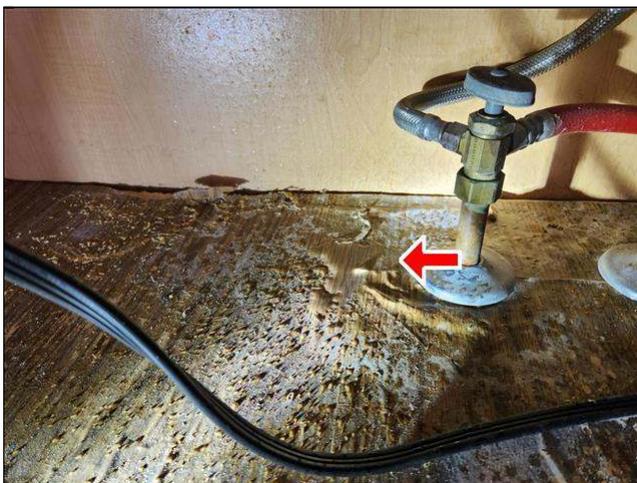
Kitchen sink faucet is loosely mounted, and leaks at the base. Moisture was noted to be dripping into the lower cabinet at time of inspection. Recommend repair or replace by a qualified person.

5.5 Item 1(Picture) loose kitchen sink faucet

5.5 Item 2(Picture) faucet leaks at base

5.5 Item 3(Picture) leaking into lower cabinet

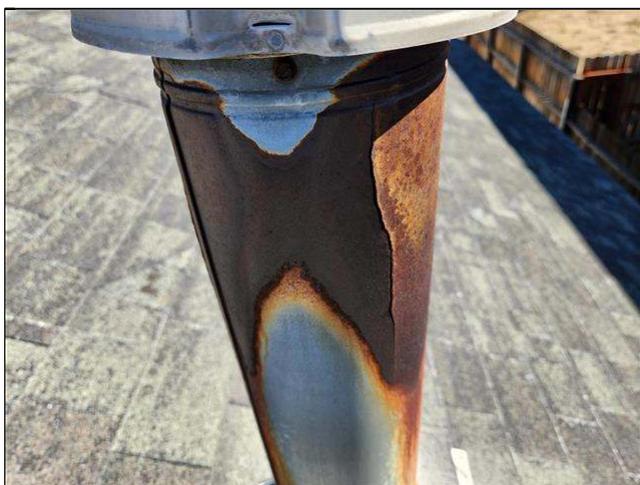
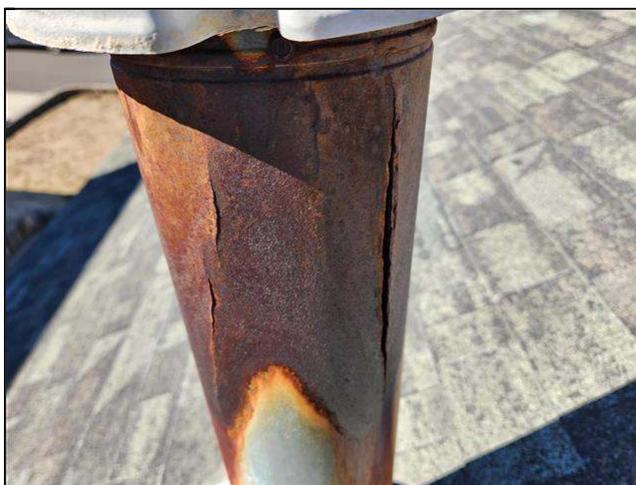
Furnace flue pipe is badly rusted, with a few larger sized cracks noted, and appears will need replacement. Recommend repair by a qualified person.

5.8 Item 1(Picture) furnace flue pipe

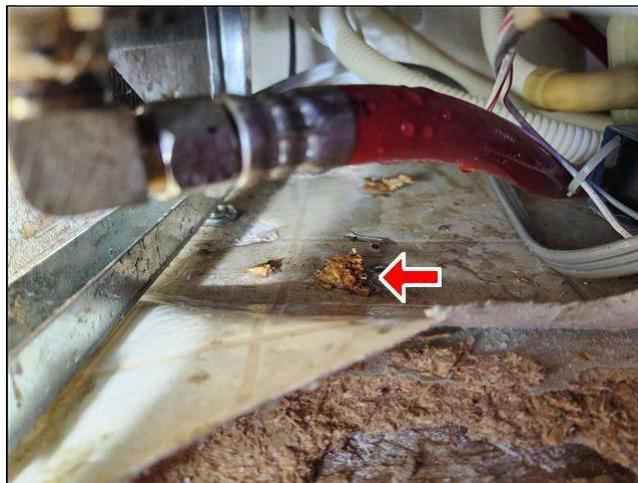
6.1 Item 2(Picture) pooled moisture under dishwasher

(2) Pooled moisture noted under the dishwasher pump/motor assembly during normal operation. Recommend further evaluation and repair by a qualified appliance technician.

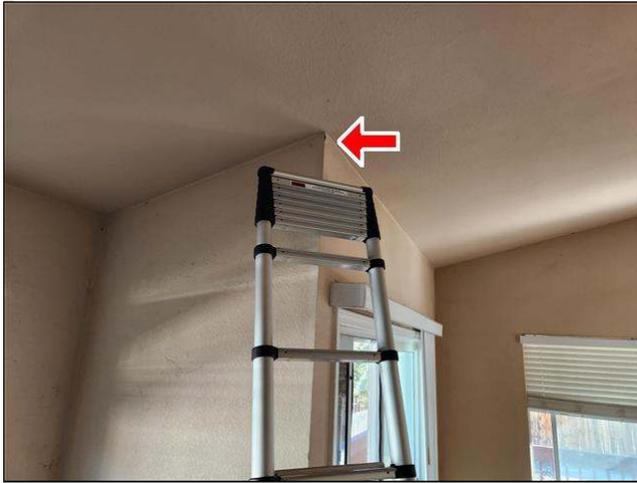
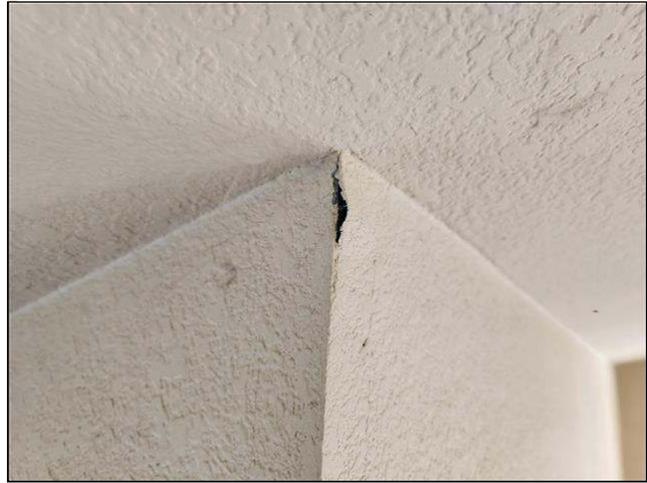
Bulging drywall paper corner noted above the dining room sliding glass door. This appears to be caused from normal settlement of the framing, And is considered to be a cosmetic item.

7.2 Item 1(Picture) bulging drywall corner

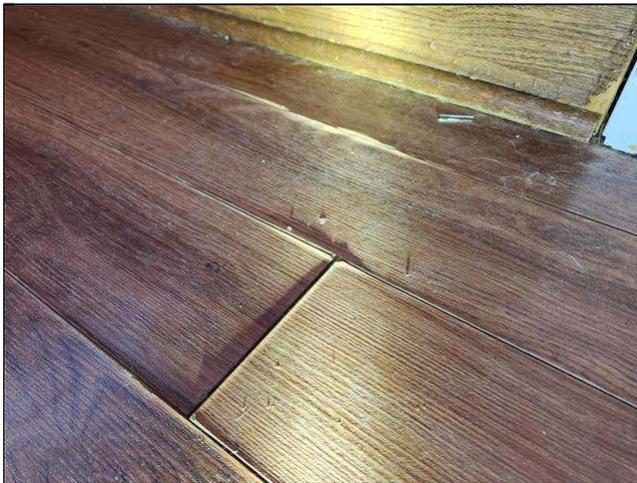
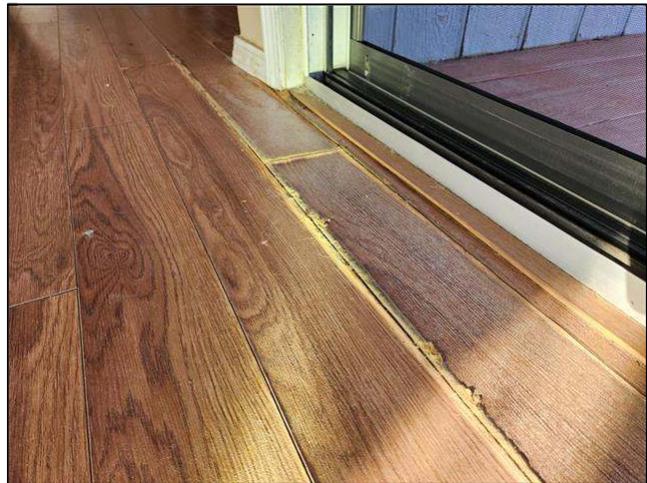
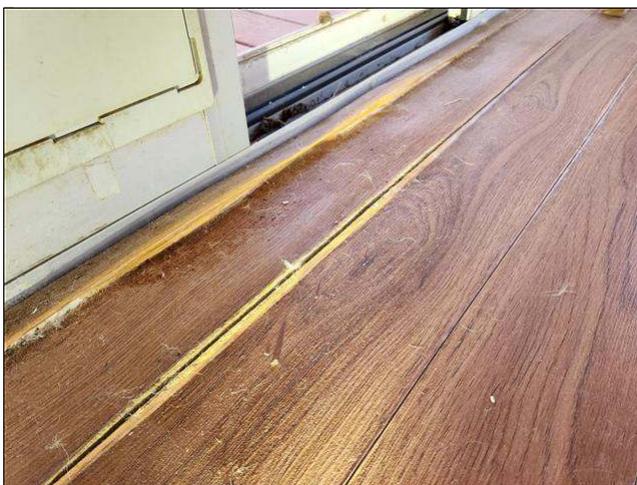
(1) Laminated flooring appears aged/worn, with several swollen boards noted from moisture absorption.

7.3 Item 1(Picture) swollen laminated flooring

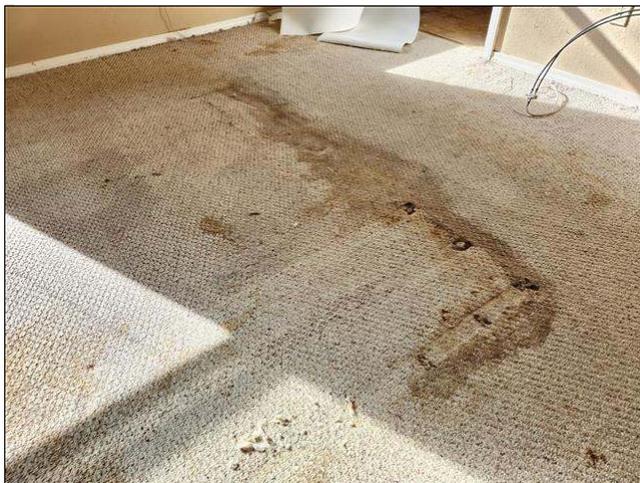
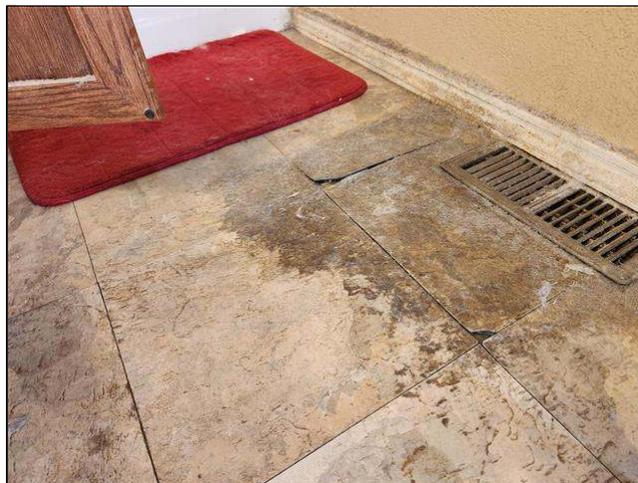
(2) Several carpeted and linoleum flooring areas are badly stained, and appears will need replacement or possibly professional cleaning.

7.3 Item 4(Picture) stained carpet

7.3 Item 5(Picture) linoleum flooring

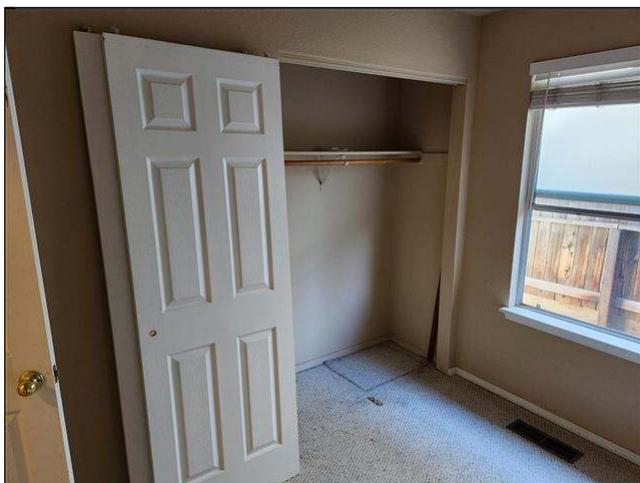
NOTE: Closet doors are present, however are not installed at the East guest bedroom closet.

7.5 Item 1(Picture) east guest bedroom closet doors

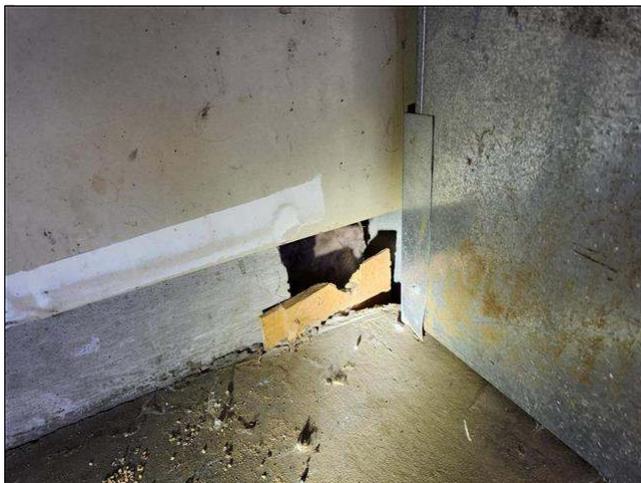
(2) Hole noted between the garage and crawlspace area adjacent to the furnace, and should be blocked.

8.3 Item 1(Picture) hole through to crawlspace

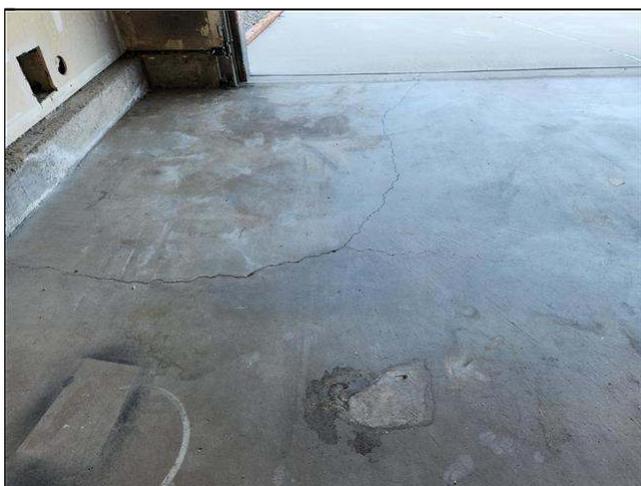
The Garage floors are poured concrete in serviceable condition, with normal settlement cracks.

8.4 Item 1(Picture) normal settlement cracks

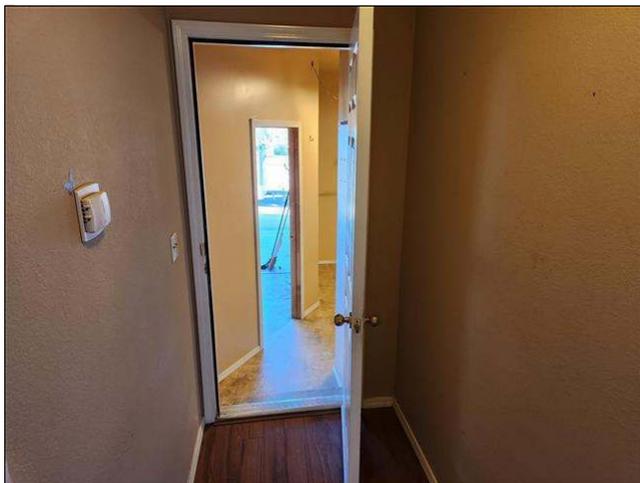
Occupant door from Garage to Interior of house, does not completely self-close on it's own momentum. Recommend repair/adjust door to close completely to prevent accidental carbon monoxide or fire intrusion into home.

8.7 Item 1(Picture) garage occupant door

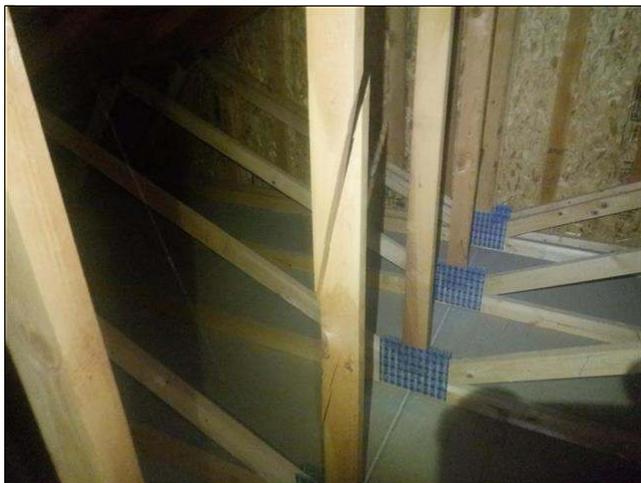
(2) Broken roof truss support noted in the attic area over the Garage, and should be repaired by a qualified person.

8.9 Item 3(Picture) broken truss support over garage
