Inspection Report

Property Address:
3791 Zeolite Cir.
Wellington NV 89444

Clear Choice Home Inspection Services

Date: 7/18/2023	Time: 08:00 AM	Report ID: QUA379
Property: 3791 Zeolite Cir. Wellington NV 89444	Customer:	Real Estate Professional: Thomas Vander Laan Coldwell Banker

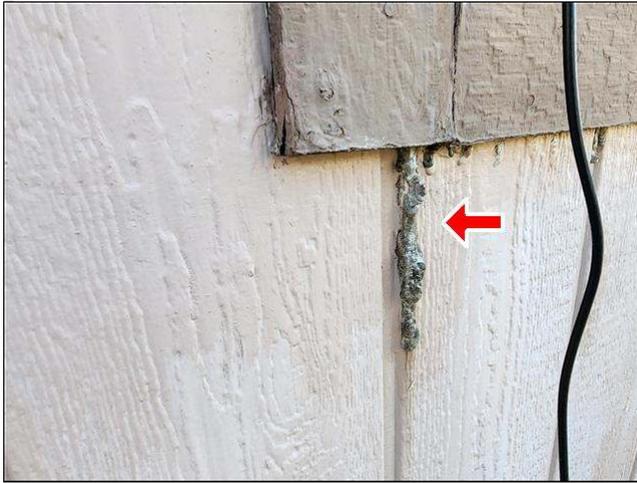
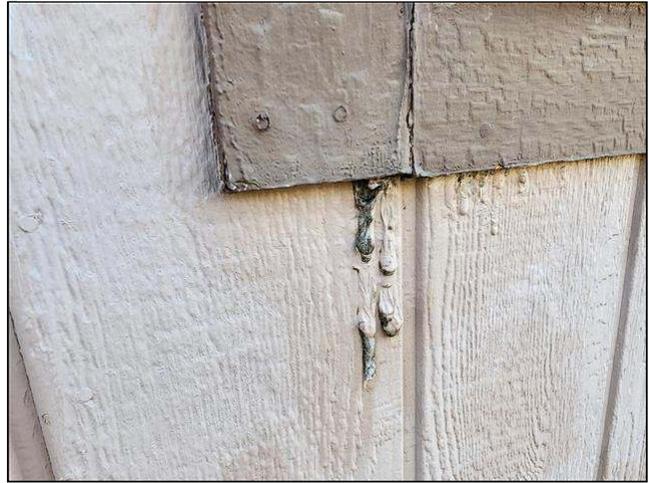
NOTE: It appears the caulking/sealant used at the South side window trim has gotten hot enough to melt and run down the siding.

1.2 Item 1(Picture) south wall caulking/sealant

1.2 Item 2(Picture) south wall caulking/sealant

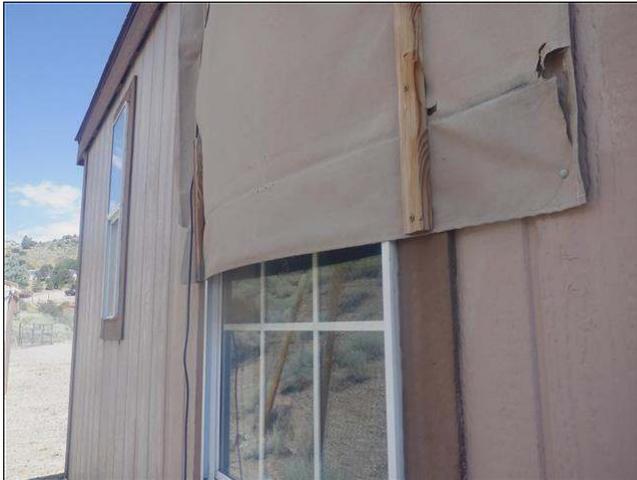
(2) NOTE: Master bedroom single hung window is broken-out at the top glass section, and should be replaced by a qualified person.

1.4 Item 1(Picture) broken-out window at master bedroom

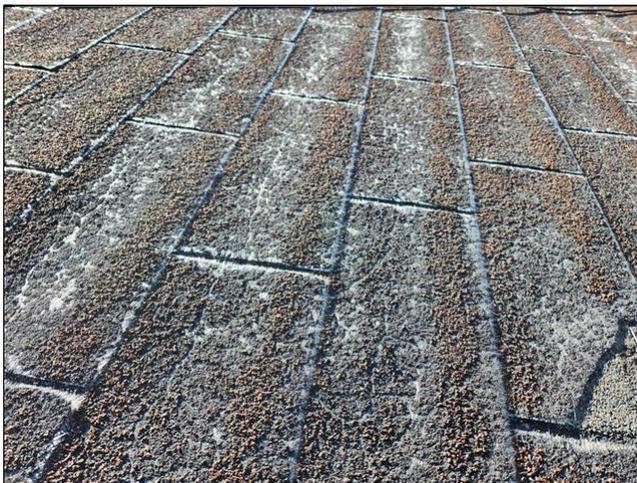
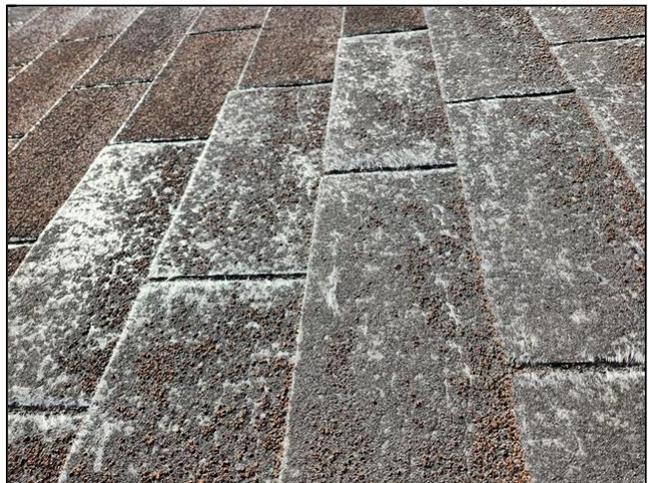
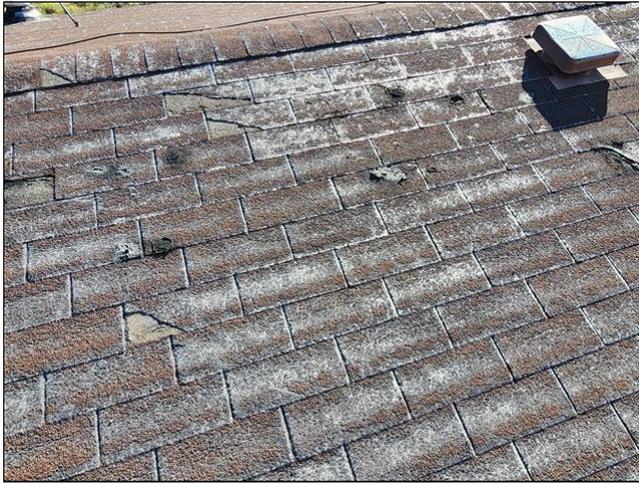
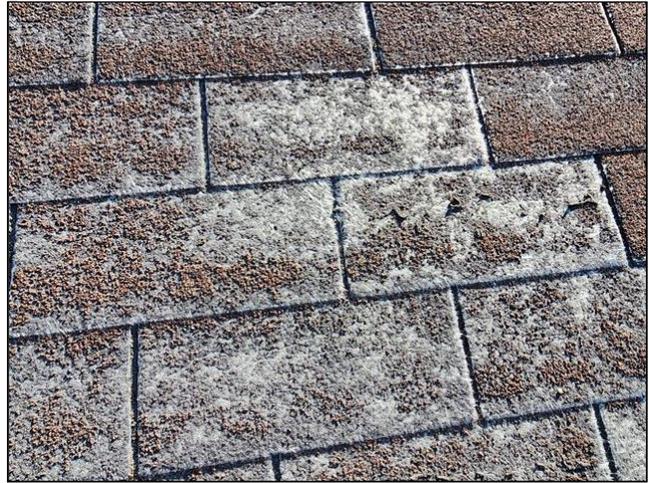
The roof covering appears to be original (29 years) and is a 20 year asphalt/fiberglass Composition shingle that appears to be past its useful life. Advanced granule loss noted at the shingles. Recommend further evaluation of roof covering materials by a licensed Roofing Contractor.

2.1 Item 1(Picture) condition of roofing

2.1 Item 2(Picture) condition of roofing

2.1 Item 3(Picture) condition of roofing

2.1 Item 4(Picture) condition of roofing

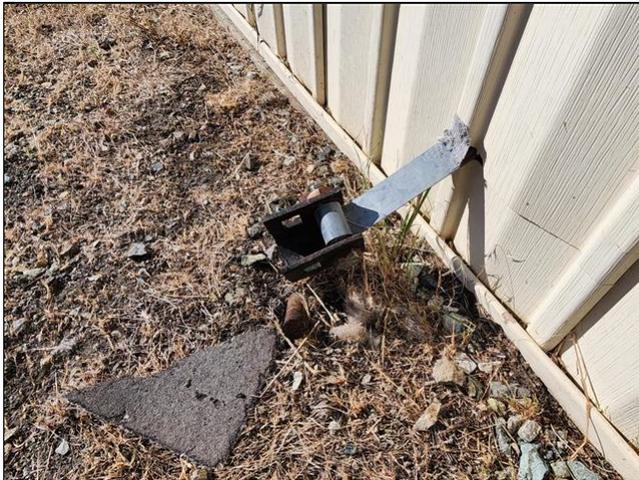
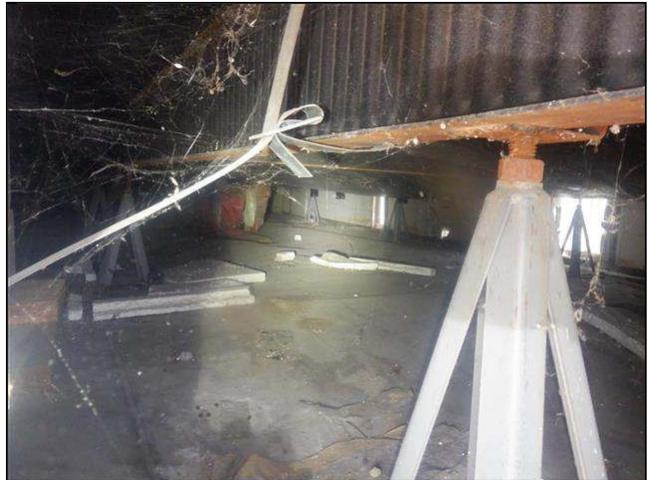
3.2 Item 1(Picture)

(2) The Foundation consists of Steel Adjustable Jacks located approximately at 8' on center, with Tie Down Straps being installed at every 16' along the length of outer frame rails.

3.2 Item 2(Picture) support jacks and straps

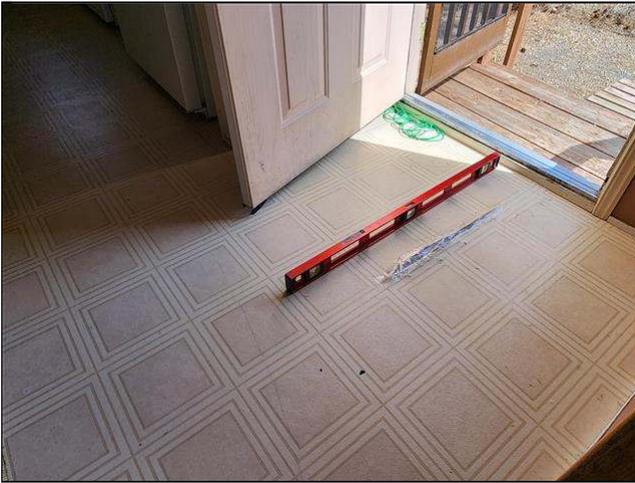
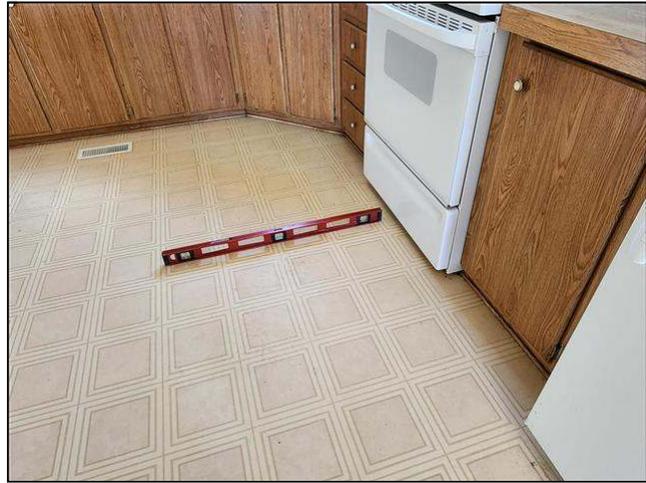
NOTE: Subfloor slopes downward at the outer 3 foot edge at kitchen and main entry areas. This home is "set" only at the Main frame area, with the outer cantilever subfloor without adequate supports, and has allowed settlement.

3.6 Item 1(Picture) slopes downward at exterior wall

3.6 Item 2(Picture) slopes downward towards exterior wall

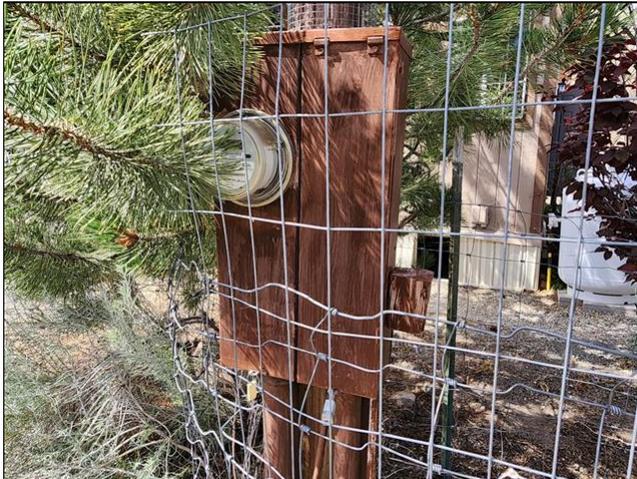
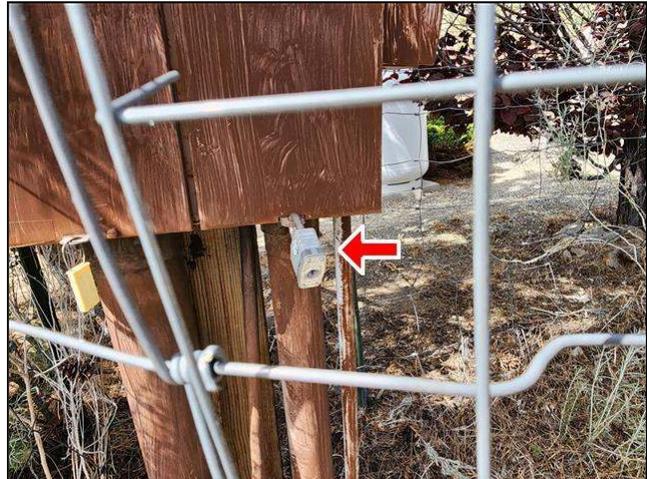
Underground service conductors, not visible due to being locked at time of inspection, with no key available.

4.0 Item 1(Picture) could not access main panel

4.0 Item 2(Picture) panel cover locked

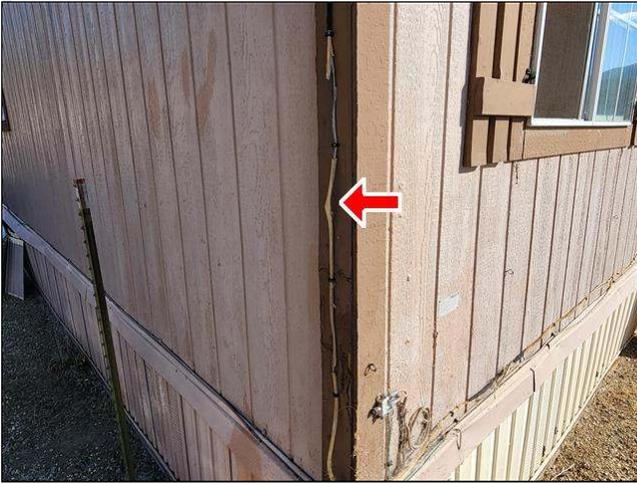
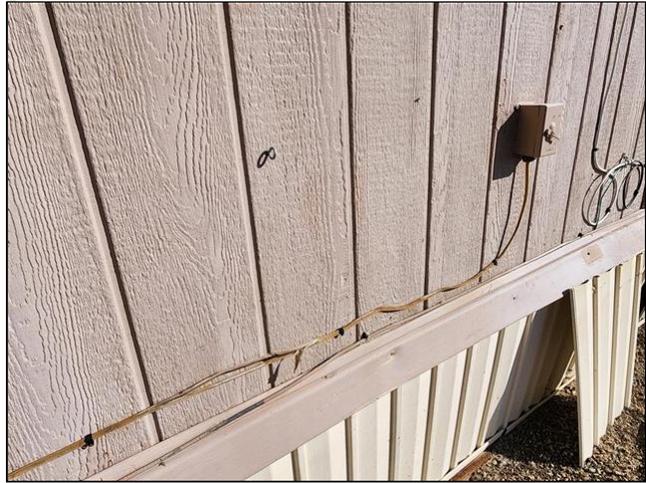
- 🏠 (1) Exposed electrical wire noted in the following locations: East end of homes exterior. Electrical wiring below 7 feet high, or inside cabinets, should be covered for protection of wiring damage, and also for personal protection. Recommend repairs by a qualified person.

4.5 Item 1(Picture) exposed wire at east corner

4.5 Item 2(Picture) exposed wire at east end

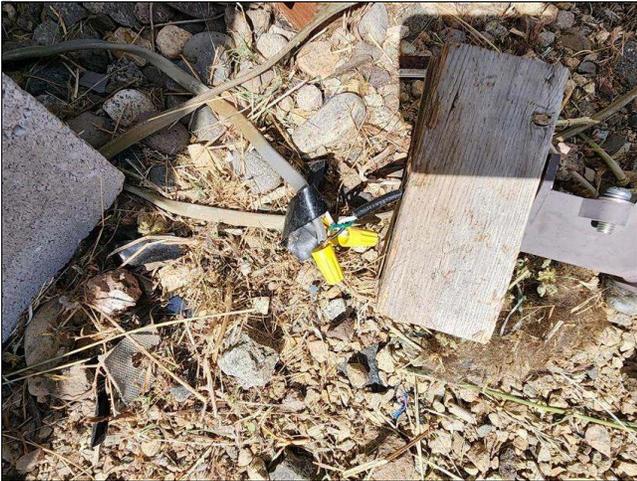
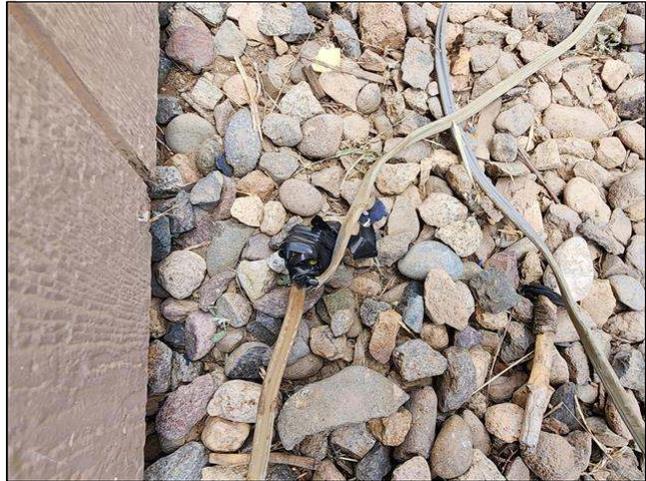
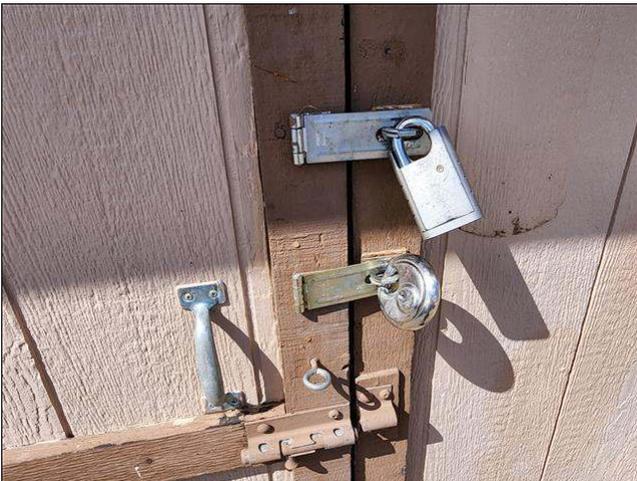
(3) Storage Shed... electrical receptacle at the left side is non-operational... Right side exterior electrical wire has 2 open wire connections, that need to be re-made inside covered metal boxes... I was unable to access the interior of the storage shed due to multiple locks installed.

4.5 Item 3(Picture) storage shed electrical

4.5 Item 4(Picture) storage shed electrical

4.5 Item 5(Picture) could not access interior

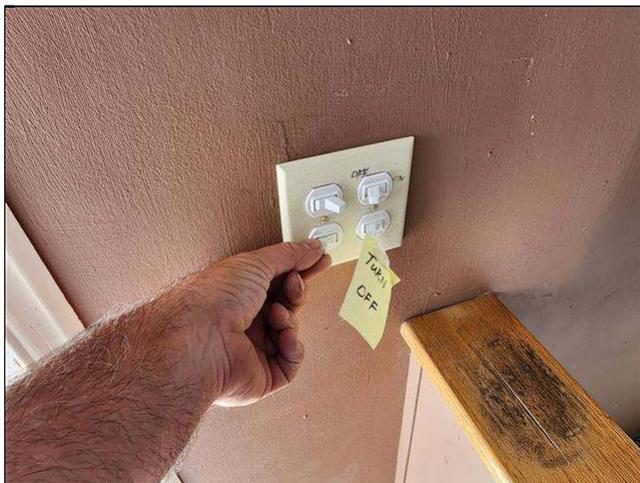
- 🏠 (1) I was unable to verify the operation of light switches/fixtures at the following locations: Laundry room ceiling lighting, Kitchen ceiling switch & fixture, Lower left switch at main entry. Recommend current owner to verify proper operation of this/these item(s).

4.6 Item 1(Picture) switch at main entry

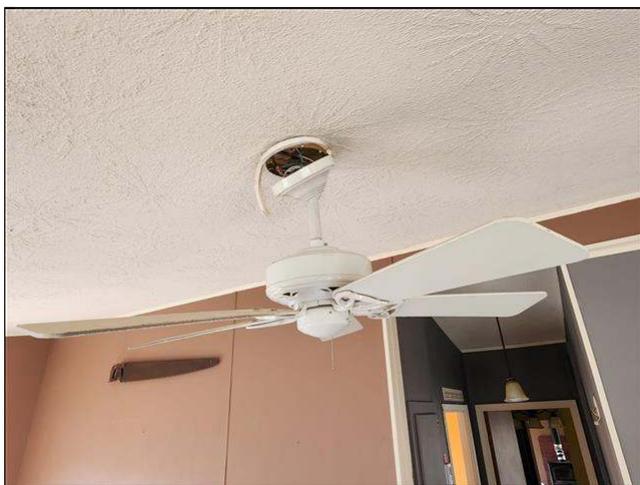
- 🏠 (2) NOTE: Ceiling fan located in the living room is NOT properly secured to the ceiling framing, and is hanging loosely. Recommend repair by a qualified person.

4.6 Item 2(Picture) living room ceiling fan

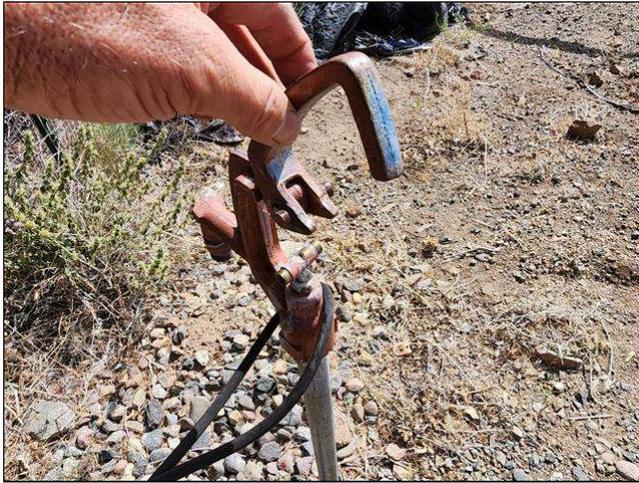
NOTE: Both exterior yard hydrants were non-operational at time of inspection. Hydrant at driveway is broken at handle/valve, Hydrant at East side of home appears Serviceable, however did not function at time of inspection.

5.1 Item 1(Picture) broken yard hydrant

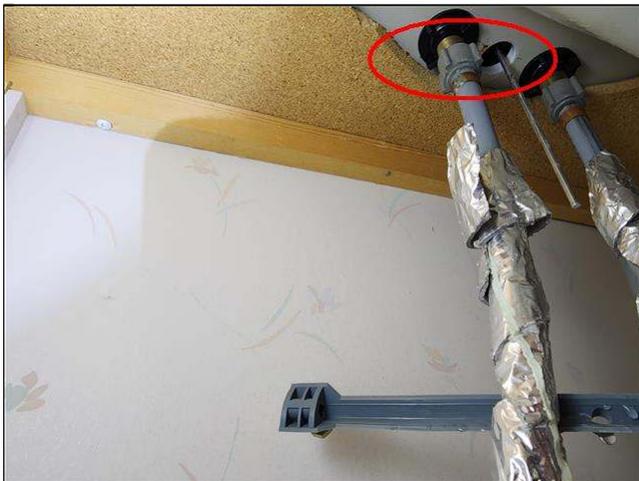
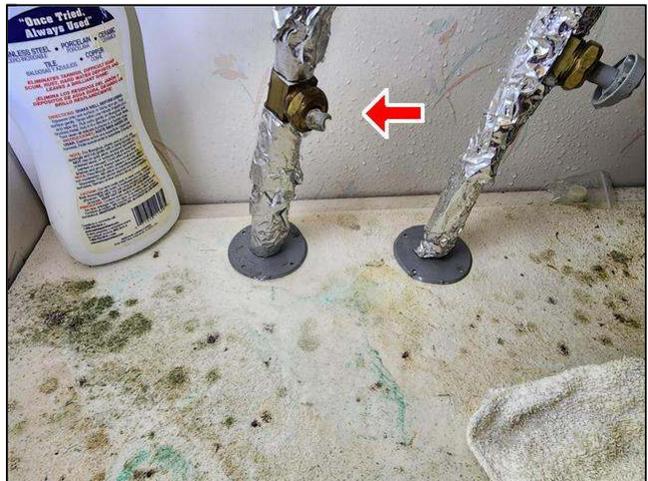
(1) NOTE: HOT water supply is leaking at the supply pipe connection or at the sink faucet in the guest bathroom. The water shut-off valve at this location is broken as well, preventing operation of the whole house HOT water system.

5.2 Item 1(Picture) leaking hot water supply at guest bathroom sink

5.2 Item 2(Picture) broken HOT water shut-off valve

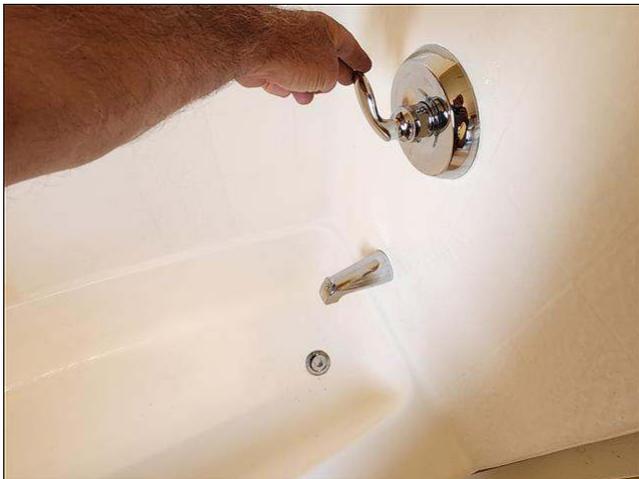
(2) NOTE: There is NO water supply to the master bathroom shower. Recommend further evaluation by a qualified person as needed.

5.2 Item 3(Picture) no water supply at master shower

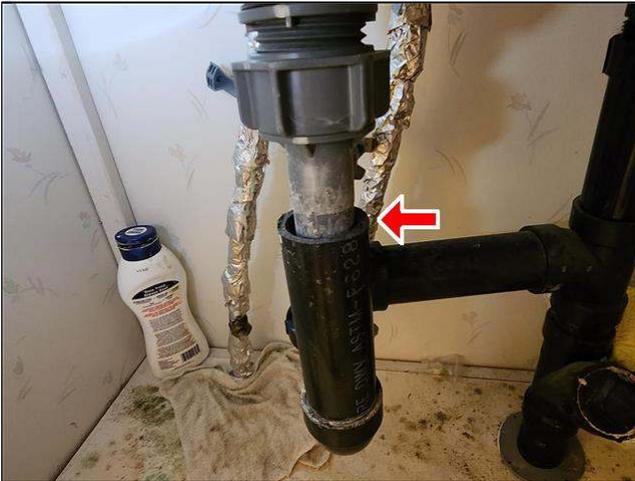
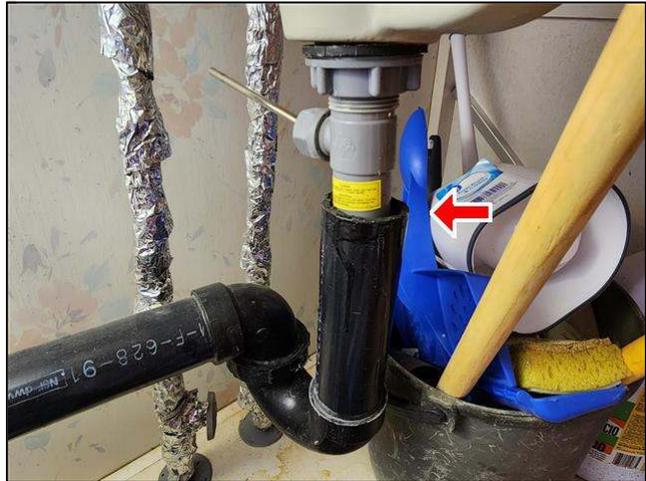
(1) Incorrect sink drain connection noted at the Master & Guest Bathroom sinks, missing a connecting nut and seal. Recommend repair by a qualified person.

5.3 Item 1(Picture) missing nut and seal

5.3 Item 2(Picture) missing nut and seal at master

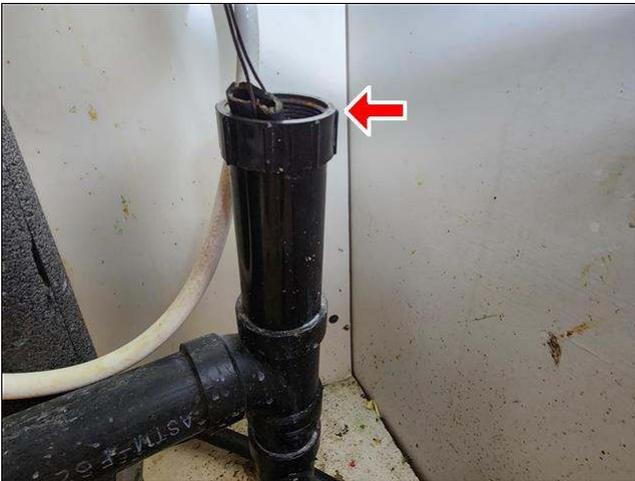
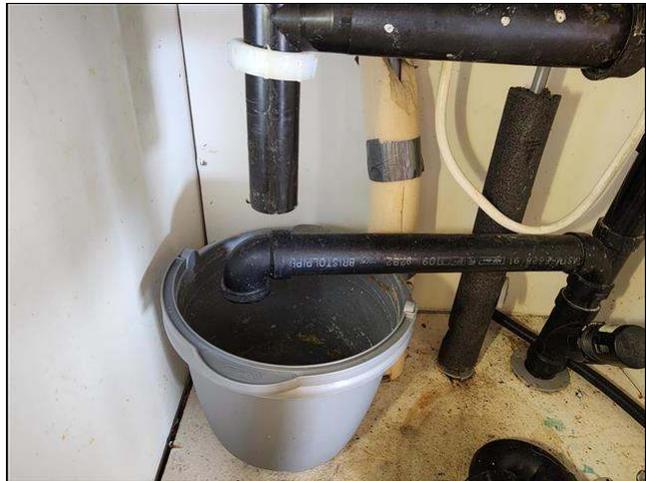
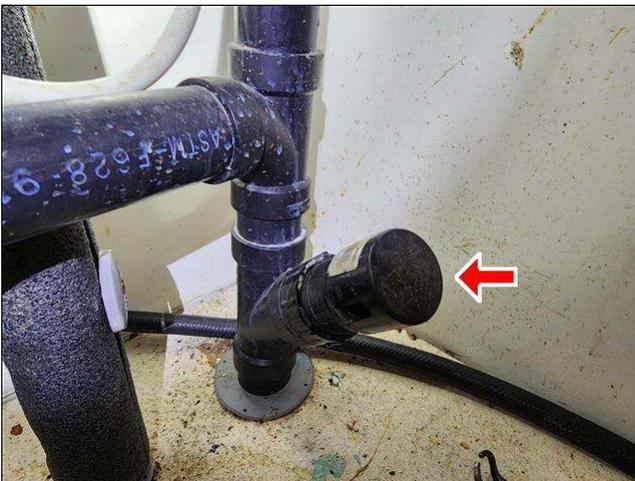
(2) Kitchen Sink... Air Admittance Valve is installed below the sink drain pipe, and needs to be installed at the uppermost vent pipe area. Sink drain P trap was disconnected and removed at time of inspection, preventing operation of sink fixture. Sink drain vent pipe is currently "open", and will allow septic gases to escape into the home.

5.3 Item 3(Picture) sink drain vent pipe open

5.3 Item 4(Picture) sink drain trap removed

5.3 Item 5(Picture) Air Admittance Valve in wrong location

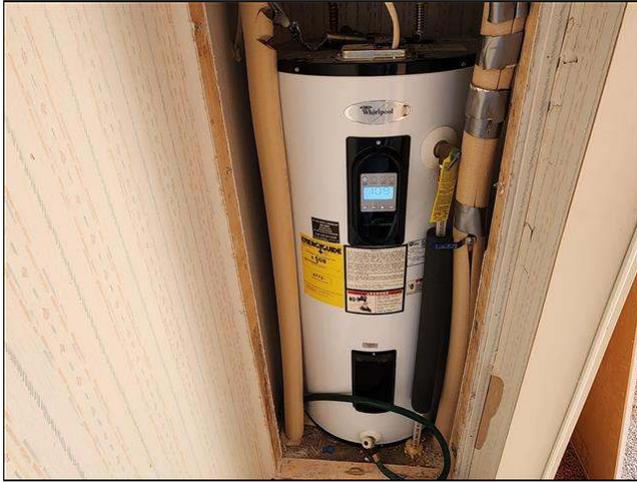
(1) Water heater is located in the guest bedroom closet, and is NOT strapped to current local codes. Temperature and Pressure Relief Valve is piped to the exterior of the home, or within 6 inches of the floor (for safety reasons). Water shut-off valve is present. Water heater operated as intended with no abnormal noises or leaks noted. Manufactured in 2010 by Whirlpool.

5.4 Item 1(Picture) electric water heater

(3) The water heater is setting on the common house subfloor, and does not have a drip pan installed for subfloor protection against a water heater failure. Installation of a drip pan was not required at time of water heater installation, however the addition of a drip pan would be a good idea.

(4) NOTE: Water heater electrical circuit breaker was shut-off upon arrival to home. This appears to be from HOT supply leaks in the guest bathroom. System was turned in to verify proper operation of the water heater, with no problems noted, however could not be left on due to bathroom fixture leaks.

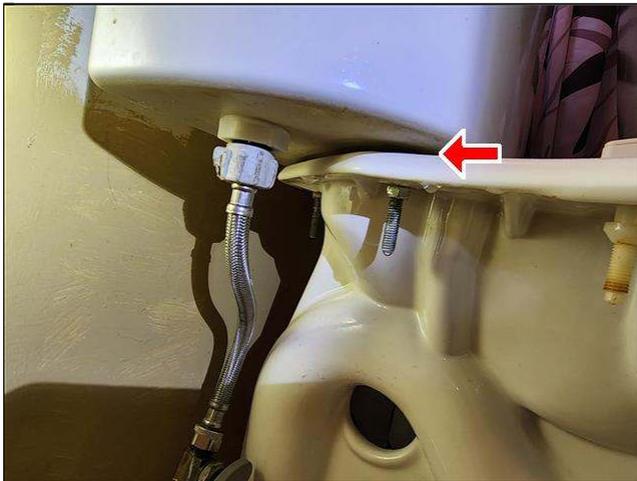
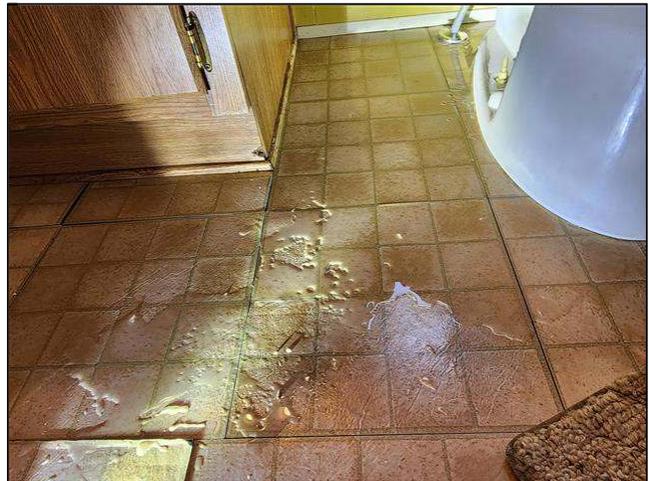
Tank to Bowl seal is defective at the Guest Bathroom toilet, leaking badly when flushed. Recommend repair by a qualified person.

5.5 Item 1(Picture) leaking tank to bowl seal

5.5 Item 2(Picture) water from leaking toilet

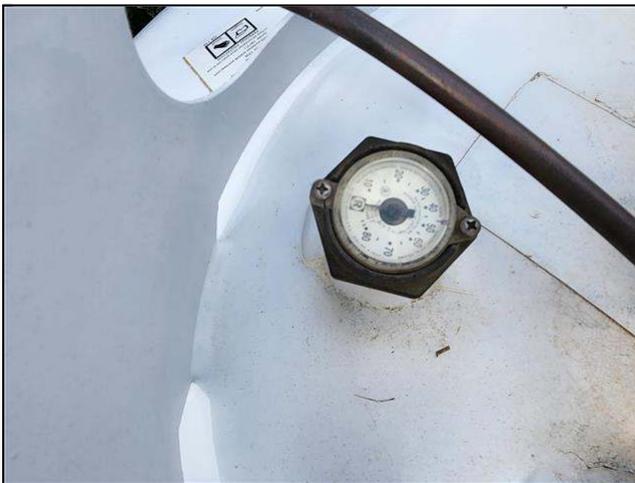
NOTE: Fuel tank was Empty at time of inspection. Gas furnace was not checked for proper operation.

5.10 Item 1(Picture) propane storage tank empty

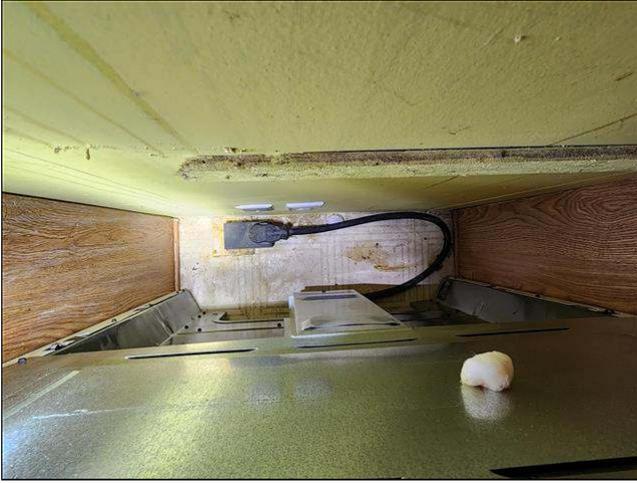
Note: This appliance does not have an anti-tip bracket installed. This is recommended by the MFG to prevent accidental tipping of the appliance, in the event of a child standing on the oven door.

6.2 Item 1(Picture) behind range

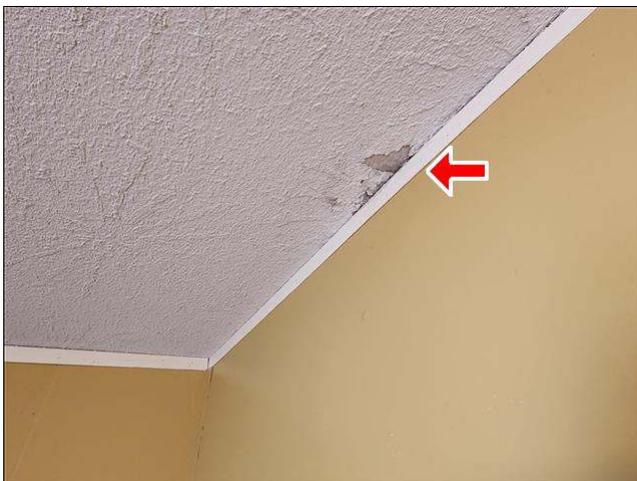
Ceiling drywall finish is damaged from moisture absorption at guest bathroom. This appears to be caused from active roof leaks. Recommend repair ceiling finish by a qualified person.

7.1 Item 1(Picture) guest bathroom ceiling

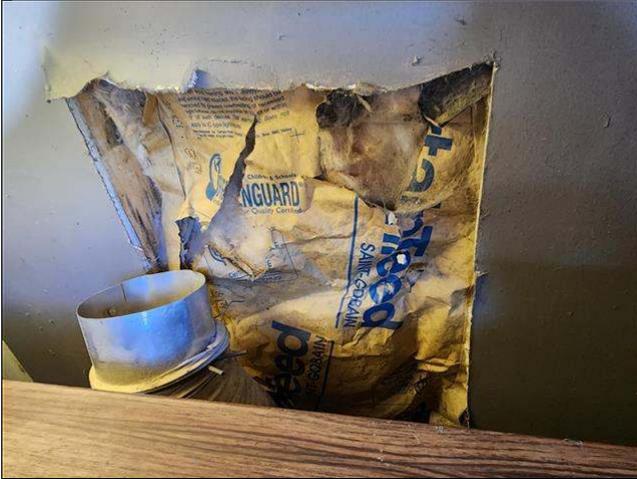
Interior wall needs repair in laundry room behind the dryer.

7.2 Item 1(Picture) hole at laundry room wall

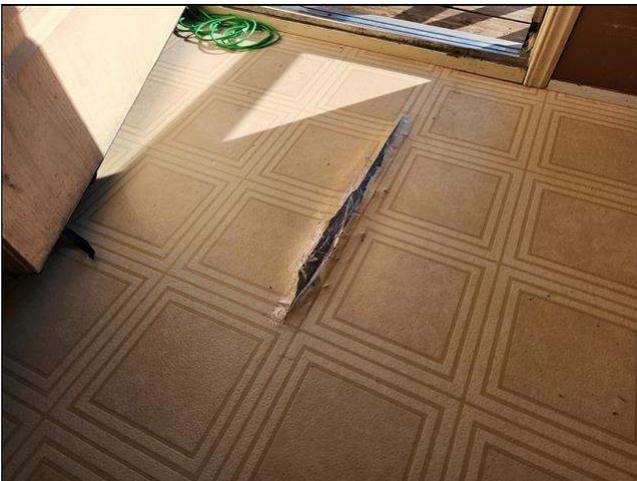
Linoleum flooring is damaged (split) at the main entry area.

7.3 Item 1(Picture) flooring at main entry

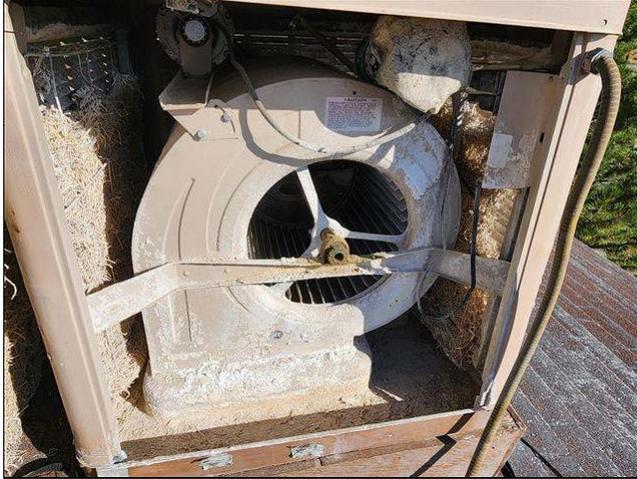
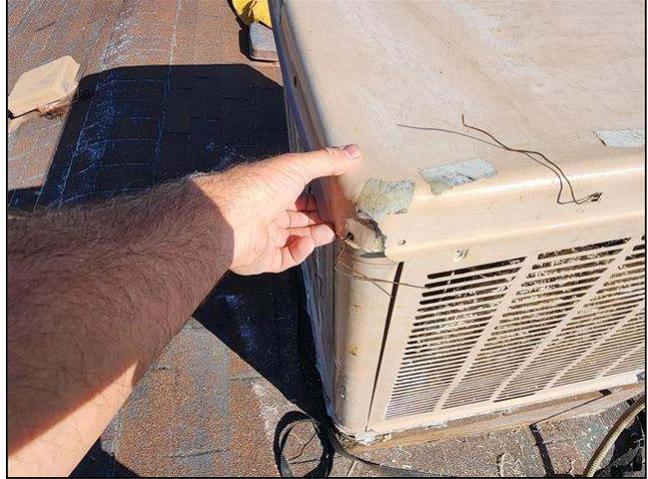
The home uses an Evaporative Cooler located in the Living room (roof mounted). Cooler has been winterized, and could not be checked for proper operation. Water pan appeared serviceable, pads and drive belt need replacing. Could not determine if water pump functions properly. Systems electrical switch thermostat control and blower motor functions as intended. NOTE: Cooler top is missing fasteners, and is loosely set in place.

9.5 Item 1(Picture) winterized cooler

9.5 Item 2(Picture) missing fasteners at cooler top

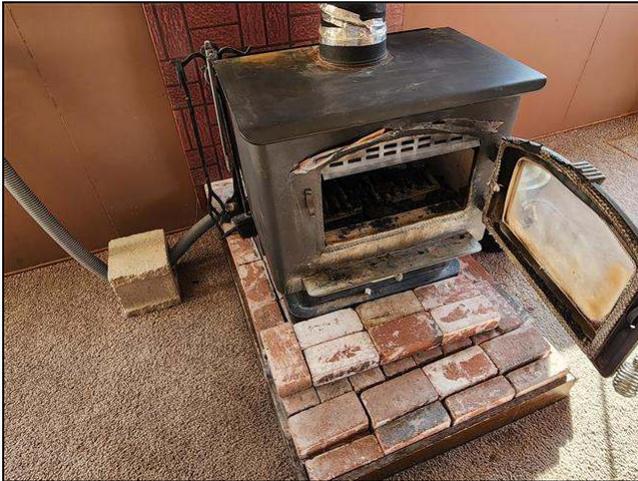
(1) Woodstove appears operational, with stovepipe fastened securely. Clearances to combustibles appears inadequate at the sides. Door seals and damper controls appear serviceable.

10.3 Item 1(Picture) living room woodstove

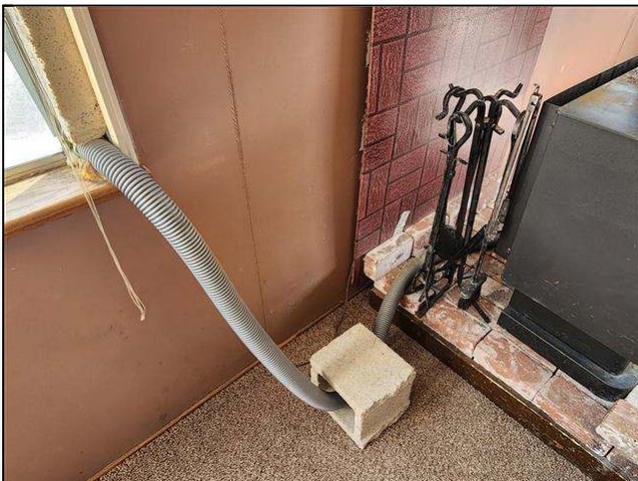
(2) Combustion air for woodstove is currently being fed through the window opening. This vent pipe size is insufficient, and should have a 4 inch duct drawing air from the exterior, typically from the crawlspace area.

10.3 Item 2(Picture) insufficient combustion air supply

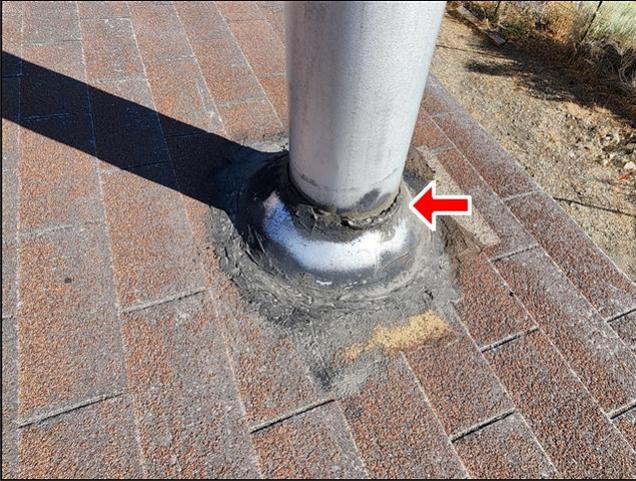
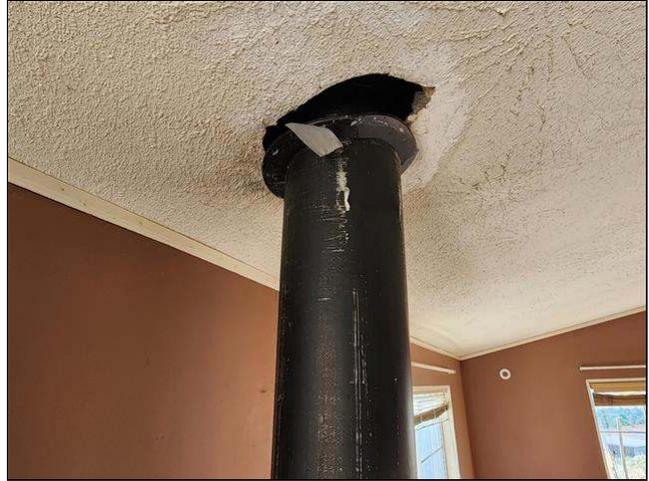
- 🏠 (3) Double wall pipe is used penetrating through the ceiling and roof structure, and should be "triple wall" pipe. Note: Recommend consulting a licensed fireplace contractor for a more thorough examination of the woodstove, pipe systems and code compliance, as needed.

10.3 Item 3(Picture) double wall pipe

10.3 Item 4(Picture) double wall pipe
