Inspection Report

Property Address:
25 Panavista Cir.
Yerington NV 89447

Clear Choice Home Inspection Services

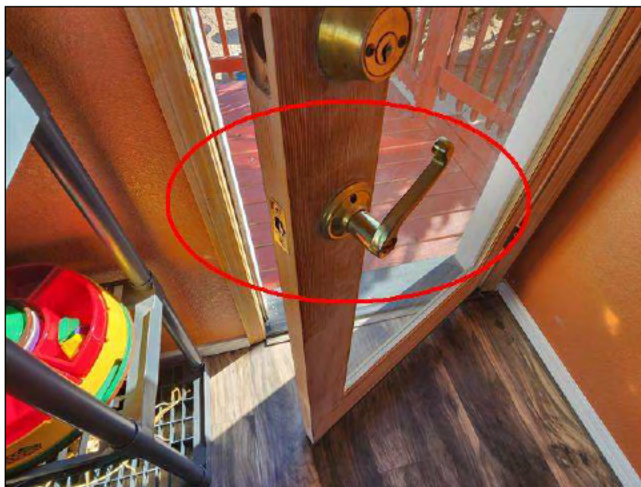
- 🏠 (1) Dining room rear entry door knob does not function as intended, and appears needs service or replacement.

1.3 Item 1(Picture) dining room exit door knob

(1) Dining room rear entry door knob does not function as intended, and appears needs service or replacement.
-

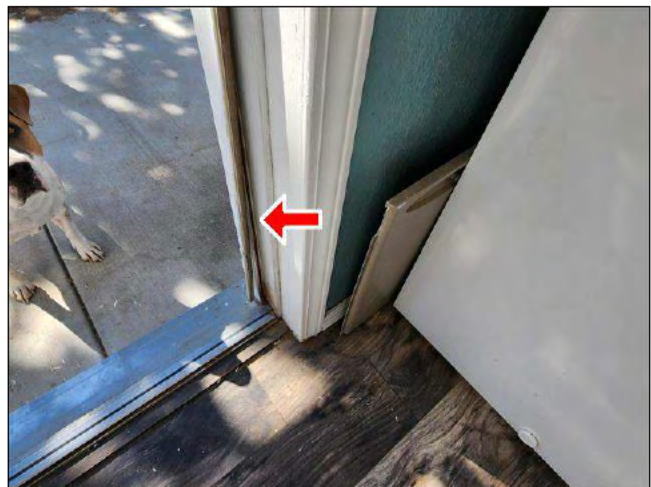
1.3 Item 2(Picture) weather stripping at laundry door

- 🏠 (2) Recommend repositioning and security door weather stripping at rear laundry room exterior door.

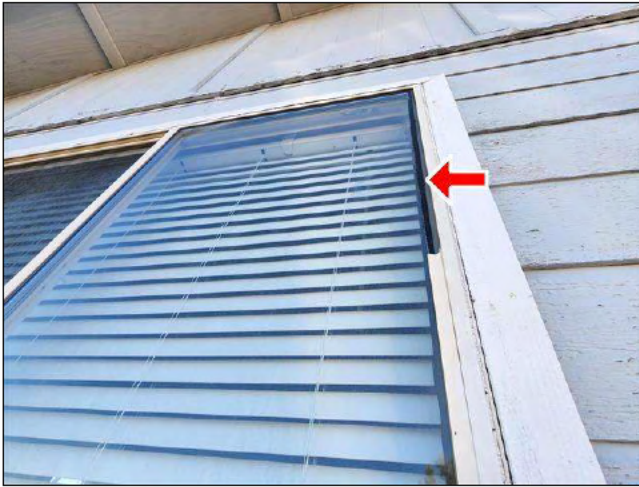
- (1) Windows are vinyl framed, thermal insulated sliding and single hung windows, all accessible windows operate and secure.
- (2) Exterior dust seals are missing at 2 West side windows.

1.4 Item 1(Picture) missing exterior dust seals

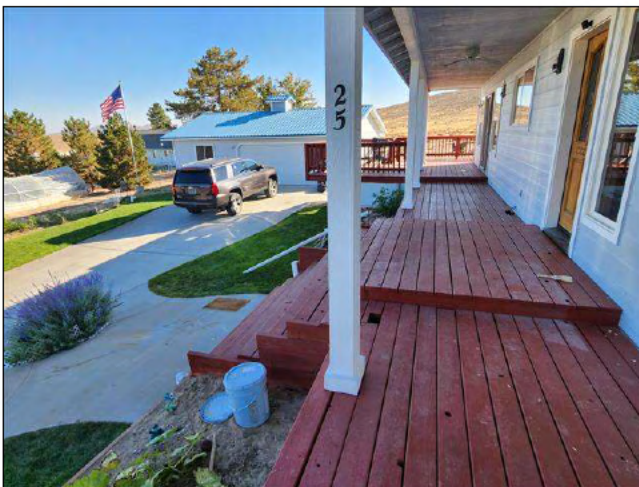
Handrails and stair railings are missing at the front deck and steps.

1.6 Item 1(Picture) missing handrails at steps

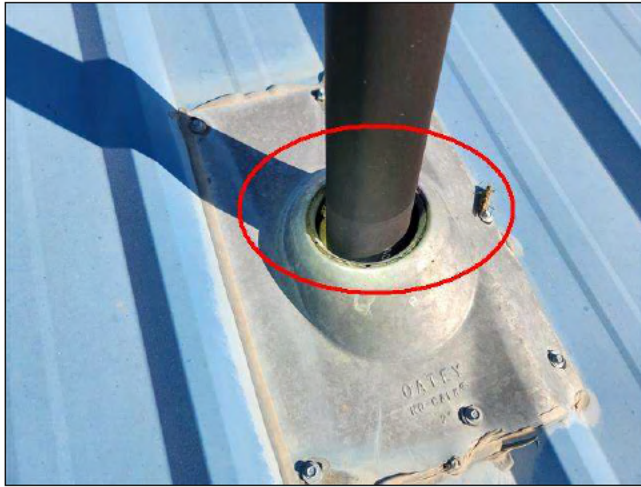
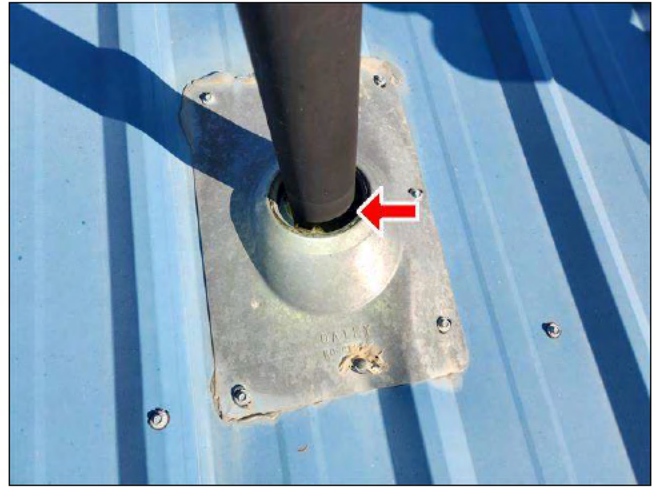
ALL plumbing vent pipe roof penetrations have failing/deteriorated rubber boots. Recommend replacement of boot seals to prevent moisture intrusion to roof framing areas.

2.3 Item 1(Picture) plumbing vent pipe seals

2.3--Seller serviced rubber boots of plumbing vent pipes on roof. See provided "Repair Log" under Documents.

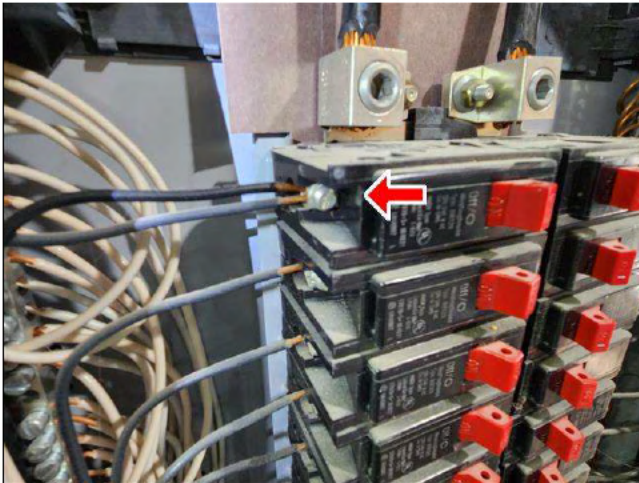
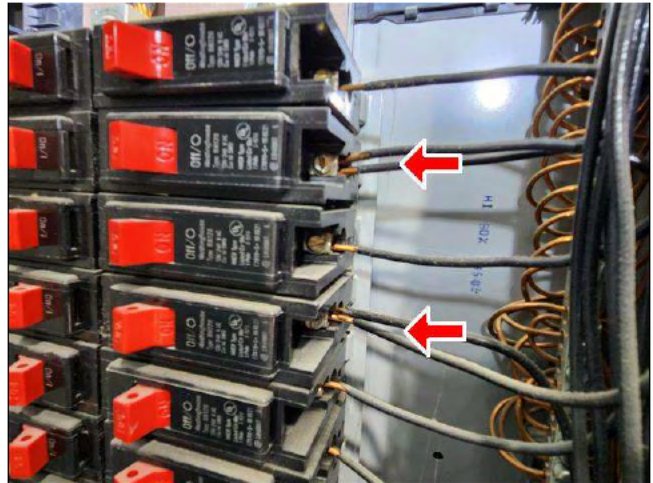
(2) Note: There are 5 "double tap" circuit breakers noted inside the Laundry room panel. Each conductor should be wired and connected to separate circuit breakers. Recommend repair by a licensed electrician.

4.4 Item 3(Picture) double tap circuit breaker

4.4 Item 4(Picture) double tap circuit breakers

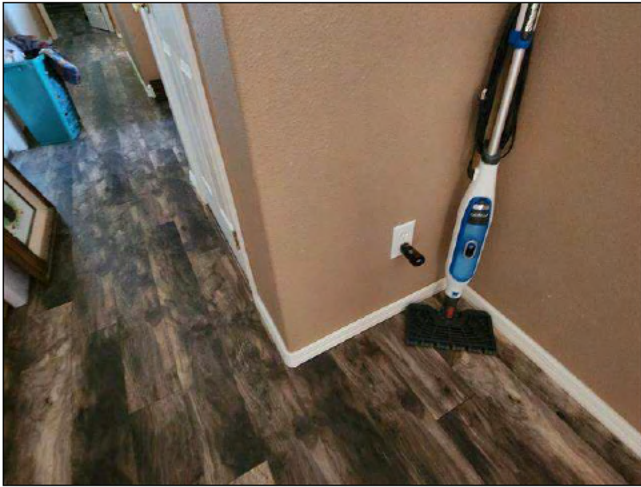
(1) Non-operational receptacle noted at the kitchen hallway. Recommend further evaluation/repair by a qualified person.

4.5 Item 1(Picture) non-operational outlet

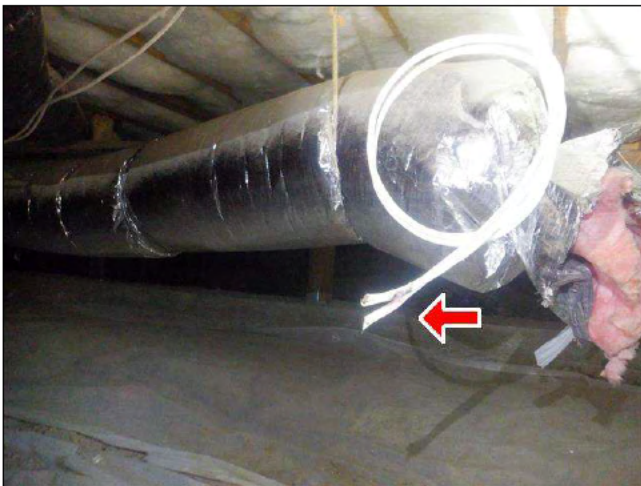
(2) Loose wire end needs placing inside a box with a cover-plate in the crawlspace area adjacent to the entry. A qualified licensed electrician should perform repairs that involve wiring.

4.5 Item 2(Picture) loose end wires in crawlspace

4.5(2)--Seller serviced with wire nut to secure loose wires. See provided "Repair Log" under Documents.

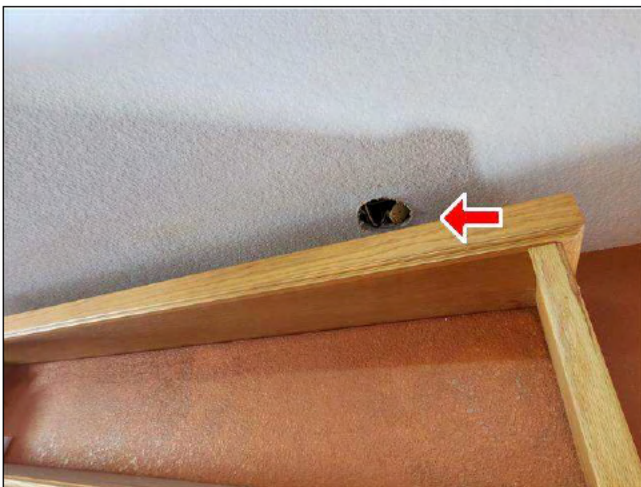
(3) Recommend installing electrical box cover plate at the open electrical ceiling box in hallway/dining area.

4.5 Item 3(Picture) recommend install cover plate

4.5(3)--Seller serviced by replacing fire alarm. See provided "Repair Log" under Documents.

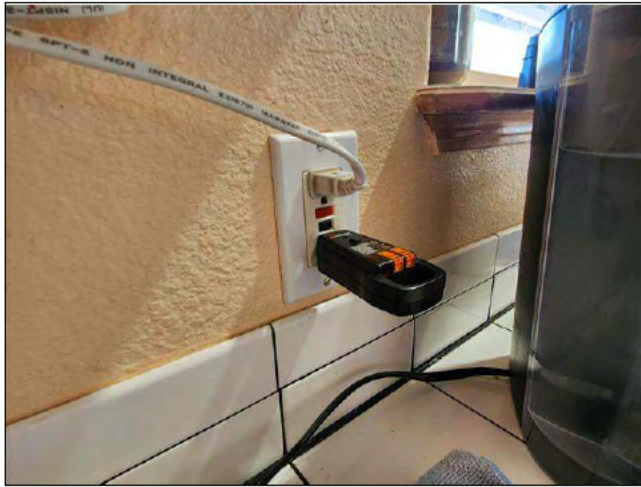
GFCI (Ground Fault Circuit Interrupter) outlet at kitchen left side of sink, did not trip when tested (defective). Further inspection/repair is needed by a qualified licensed electrician.

4.7 Item 1(Picture) faulty GFCI at kitchen

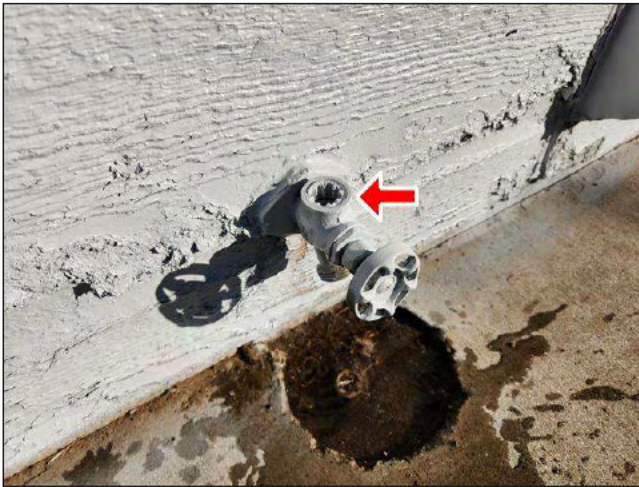
(1) South exterior hose bib is missing the top vent cap, and discharges water from the top when in use.

5.0 Item 1(Picture) south exterior hose bib

5.0 EXTERIOR WATER VALVES, AND HOSE BIBS 5.0(1)--Seller serviced south exterior hose bib. See provided "Repair Log" under Documents.

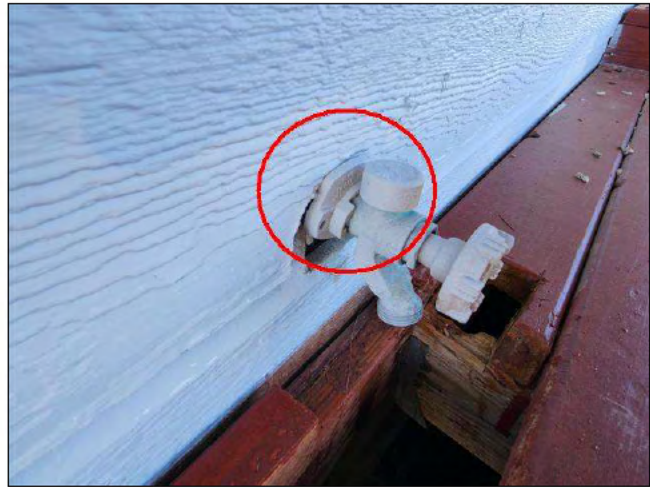
5.0 Item 2(Picture) secure north hose bib flange

(2) Recommend securing North hose bib flange to wall, to prevent possible twisting and breakage of plumbing pipes/connectors.

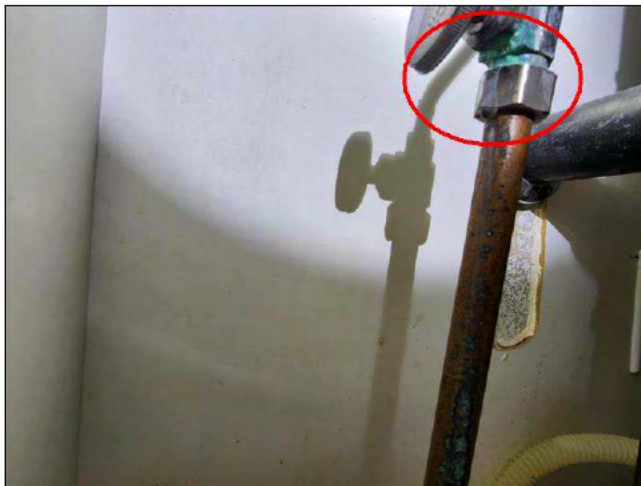
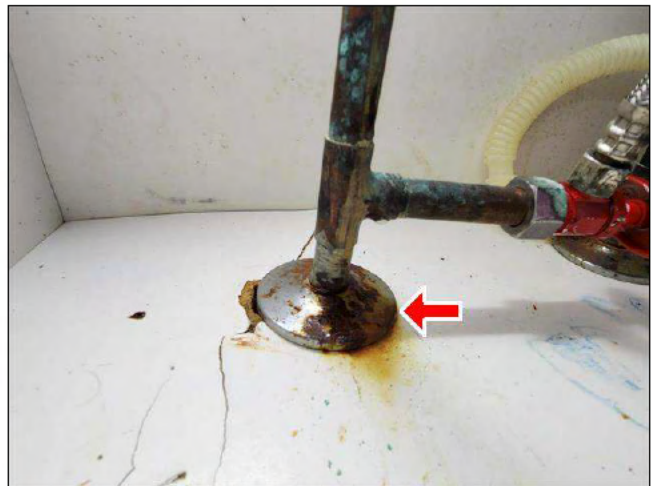
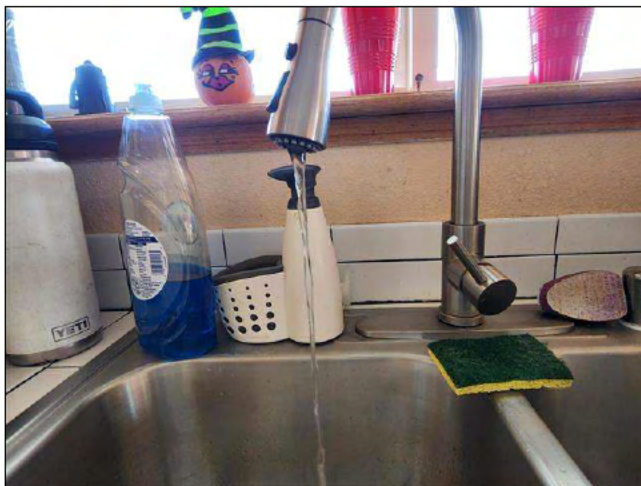
🏠 (2) Hot water supply shut-off valve for kitchen sink is leaking, and should be replaced. NOTE: water supply (volume) through the hot side of faucet is very low.

5.1 Item 3(Picture) hot water supply shut-off valve

5.1 Item 4(Picture) moisture from leak

5.1 Item 5(Picture) low volume at hot side

5.1(2)--Seller serviced leak on kitchen sink hot water. See provided "Repair Log" under Documents.

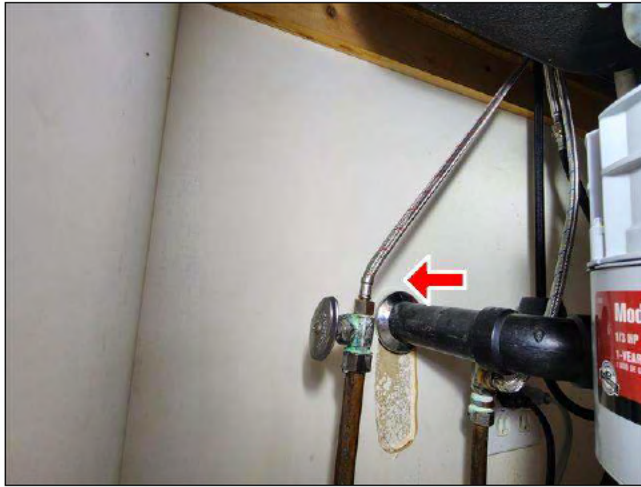
🏠 (3) Water supply hoses for kitchen sink are too short, and are pulling on coupler ends.

5.1 Item 6(Picture) supply hose too tight

5.1(3)--Seller serviced with extended hot water line. See provided "Repair Log" under Documents.

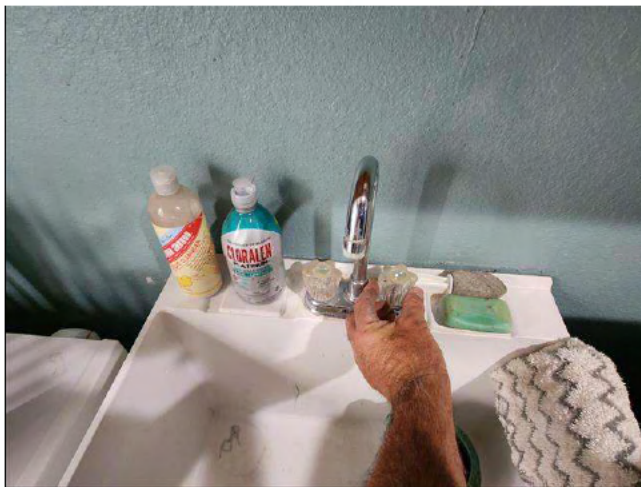
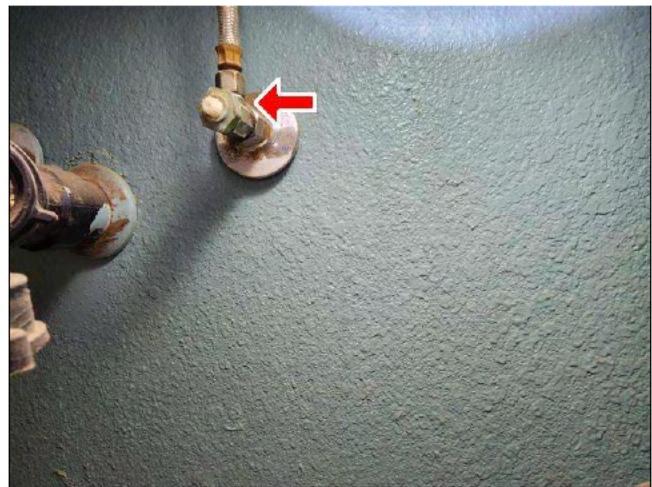
🏠 (4) There is NO Cold water supply at the Laundry room sink faucet, and NO handle noted at the shut-off valve.

5.1 Item 7(Picture) no cold water supply at laundry sink

5.1 Item 8(Picture) supply valve missing handle

5.1(4)--Seller serviced by installing handle at shut-off valve. See provided "Repair Log" under Documents.

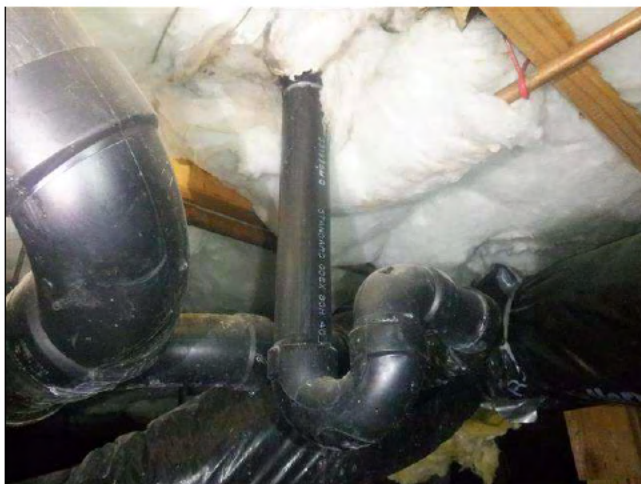
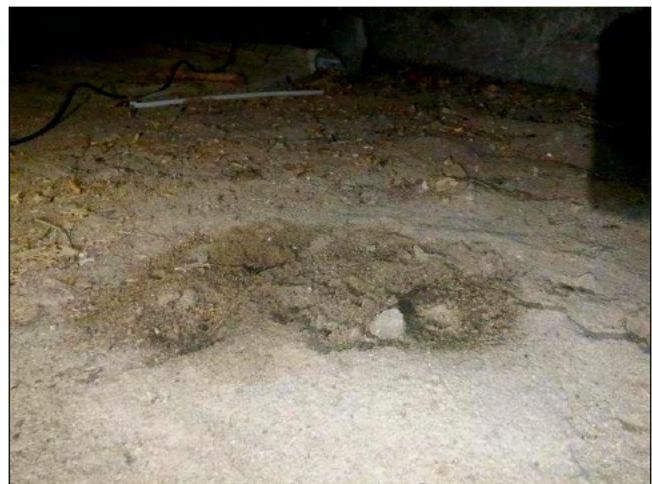
🏠 Shower drain is leaking in the crawlspace area under the Guest Bathroom. Recommend repair by a licensed plumbing contractor to prevent excessive moisture, which can lead to mold/fungus, in the crawlspace.

5.2 Item 1(Picture) guest bathroom shower drain

5.2 Item 2(Picture) moisture from leak

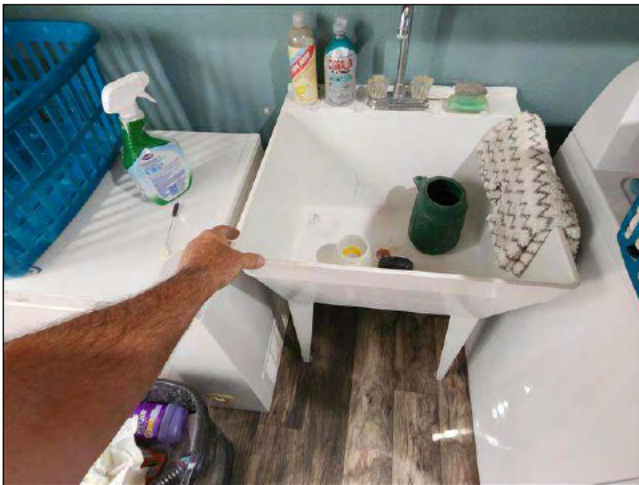
(1) The sink/faucet is loose and needs securing to wall at the Laundry room. The associated plumbing supply and drain lines for faucet are not leaking at time of inspection. A qualified person should repair as necessary.

5.4 Item 1(Picture) secure laundry sink

5.4(1)--Seller serviced by securing laundry room sink. See provided "Repair Log" under Documents.

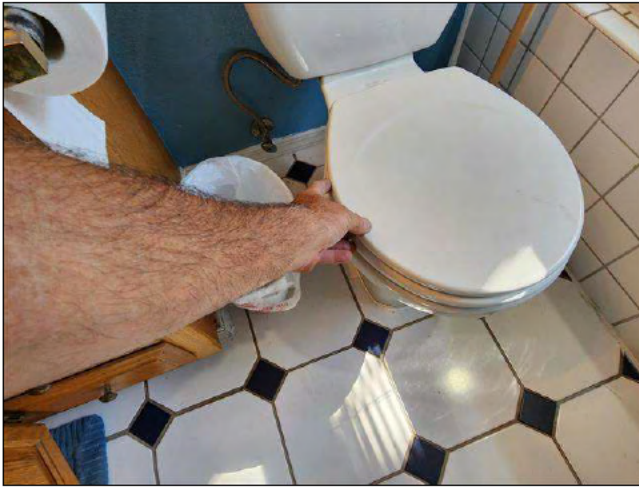
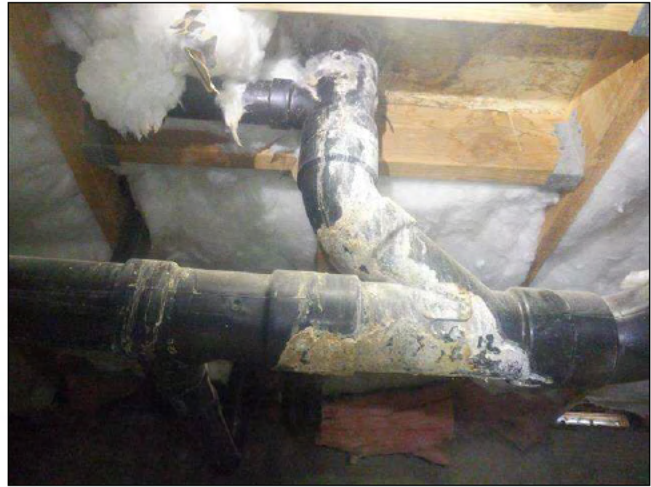
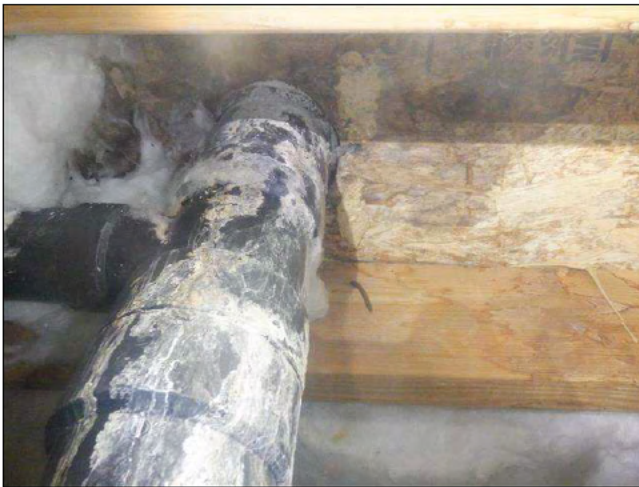
(2) The toilet is loose at floor at the Master Bathroom. Repairs may involve re-setting the toilet on a new wax seal. I recommend a qualified licensed plumber repair or correct as needed. Signs of leaking were noted in the crawlspace area. Subfloor plywood appears to remain solid and serviceable at this time.

5.4 Item 2(Picture) master bathroom toilet

5.4 Item 3(Picture) signs of leakage under toilet

5.4 Item 4(Picture) subfloor remains solid

5.4(2)--Seller serviced master bath wax ring. See provided "Repair Log" under Documents.

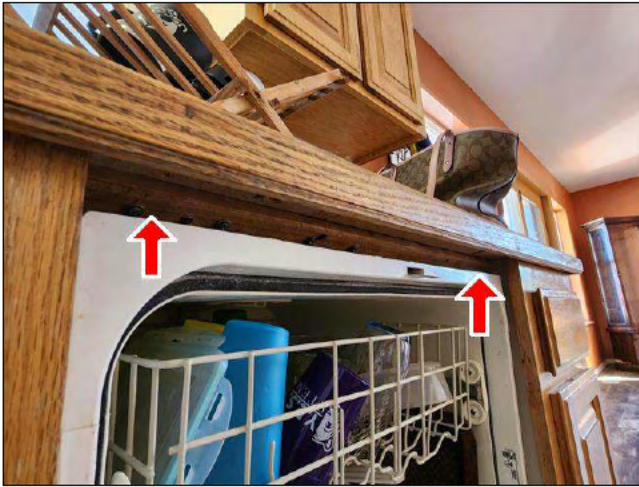
(2) The dishwasher is loose and needs securing to underside of countertop (using a proper length screw). I recommend repair as necessary.

6.1 Item 1(Picture) secure upper dishwasher mounts

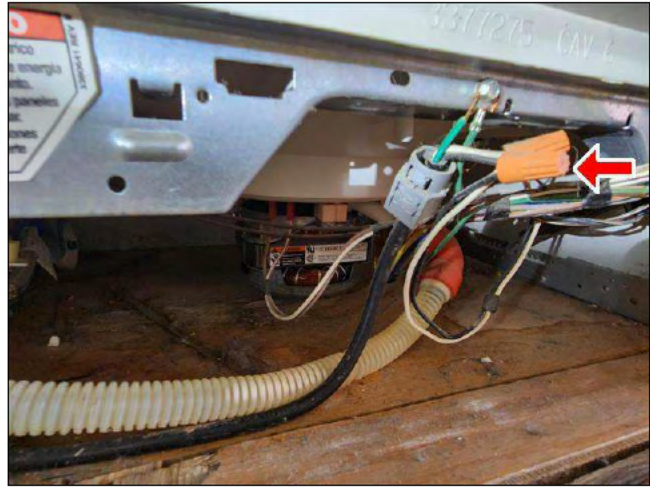
6.1 Item 2(Picture) open electrical connection under dishwasher

(3) Improper electrical wiring connection beneath dishwasher, and needs to be placed inside a covered metal box.

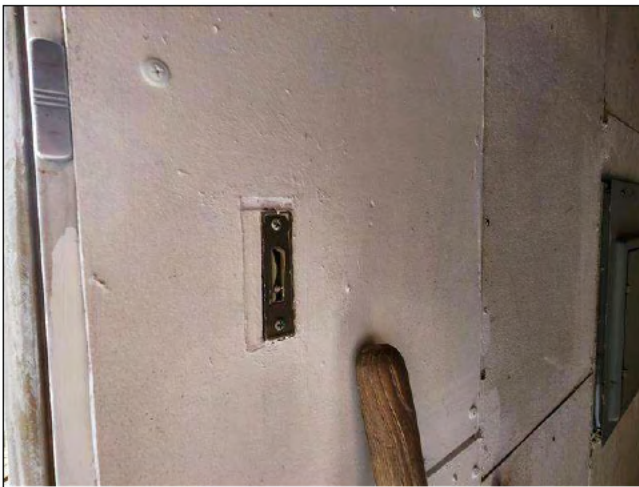
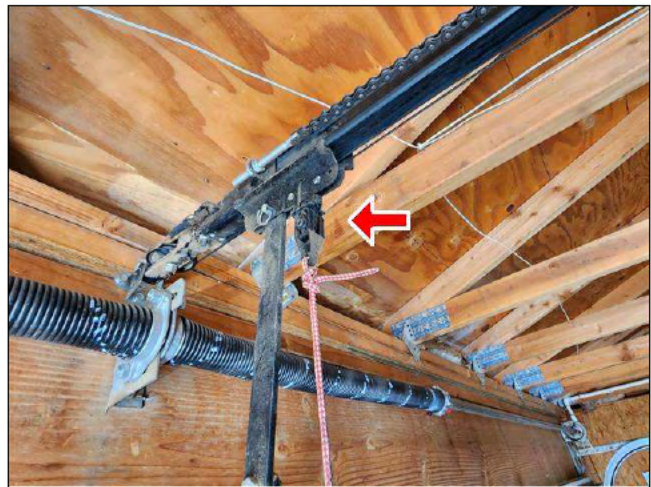
Door operator button is broken, door was disconnected from the operator at time of inspection. Recommend current owner to verify proper operation of this item.

8.9 Item 1(Picture) broken control button

8.9 Item 2(Picture) door disconnected from operator

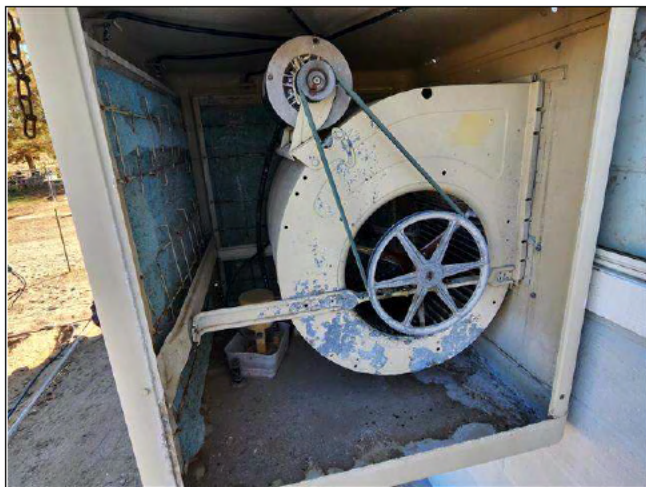
(1) The Garage uses an Evaporative Cooler located at the North wall. Cooler has been winterized, and could not be checked for proper operation. Water pan appeared serviceable, drive belt needs replacing. Could not determine if water pump functions properly.

8.14 Item 1(Picture) winterized cooler

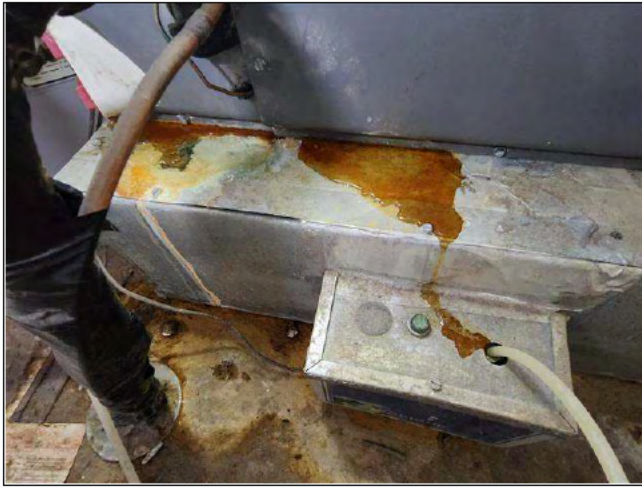
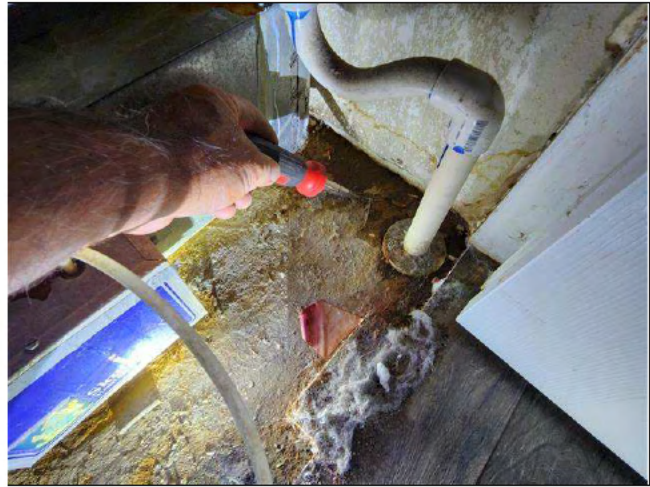
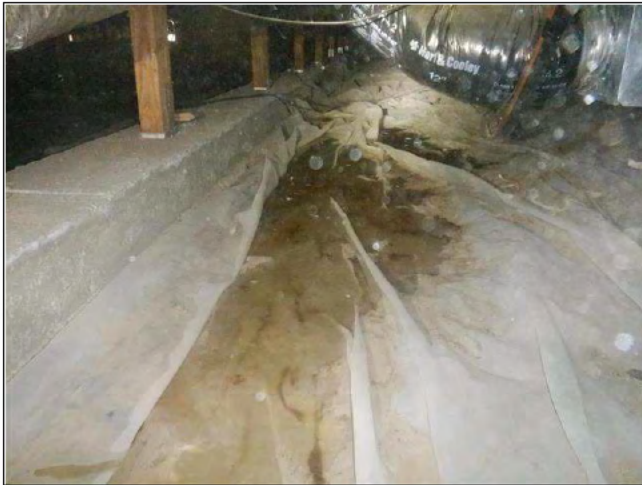
(2) NOTE: moisture noted leaking from the bottom of the furnace Evaporator unit during normal operation, with moisture stains noted at the subfloor (subfloor plywood remains solid and serviceable at this time). Large pool of moisture noted in the crawlspace area from this leak. Recommend further evaluation and repair by a qualified person.

10.0 Item 3(Picture) moisture from furnace

10.0 Item 4(Picture) subfloor remains solid

10.0 Item 5(Picture) pooled moisture in crawlspace

10.0(2)--Seller serviced furnace water leak. See provided "Repair Log" under Documents.
