Home Inspection Report

PROPERTY INSPECTED:
6249 Dawson Drive
Billings, MT 59105

Date of Inspection: 08/22/2024

Inspection No. 45957-1-1126

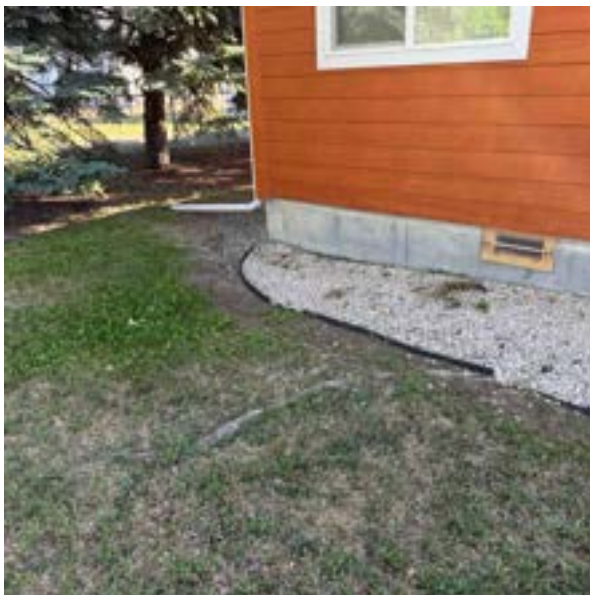
2.1.2 Regrade to slope away from structure to reduce foundation deterioration potential water entry and subsequent damage. Monitor landscape grading near foundation for signs of normal soil compaction and correct as required.

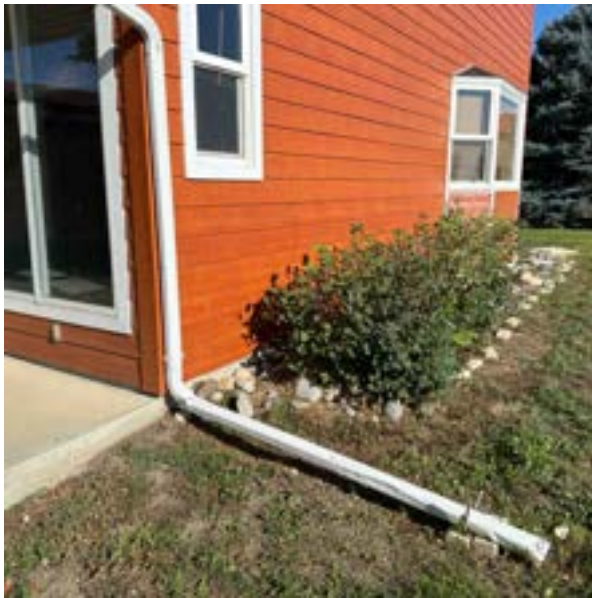
2.1.3 Trim and maintain trees, bushes and vines away from the structure to minimize damage/wear to structure and to discourage animal activity. **(Exterior East)**

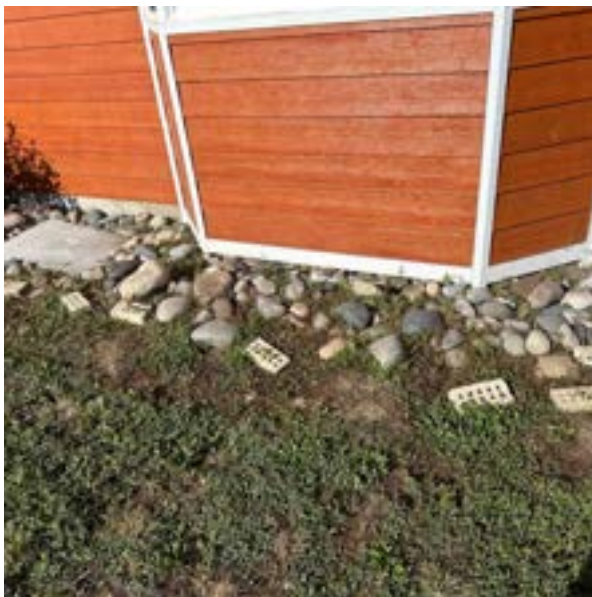
2.1.4 Provide clearance from landscaping to siding/wood contact to prevent deterioration and deter pest entry. **(Exterior East)**

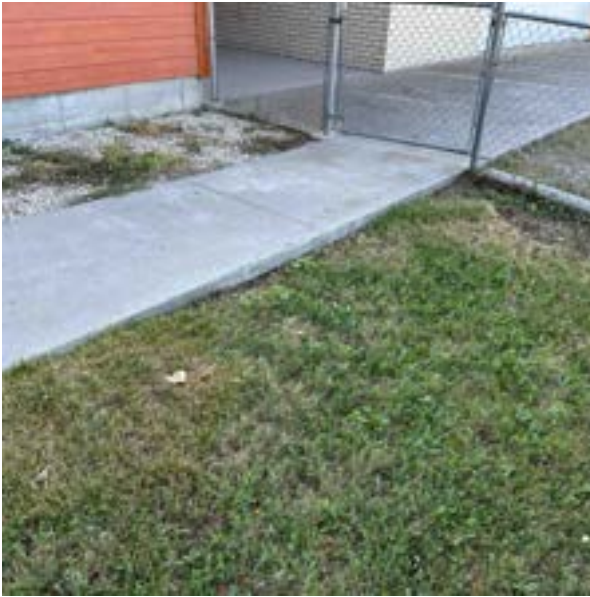
2.2.2 Backfill soil under concrete walkway/driveway to promote stability and prevent damage. **(Exterior West)**

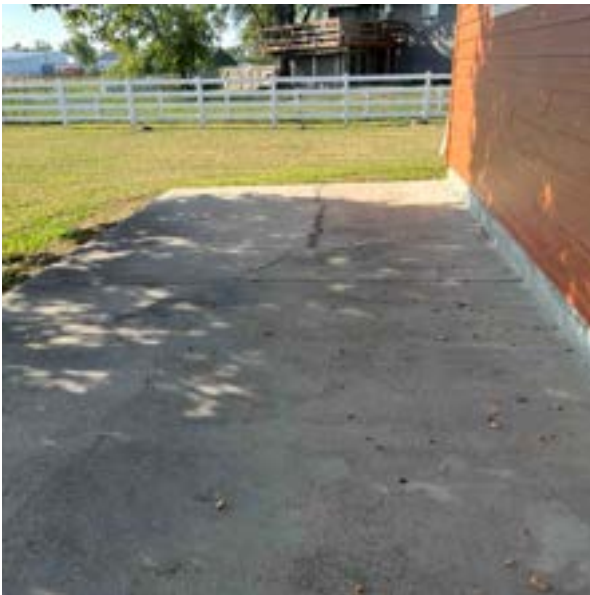
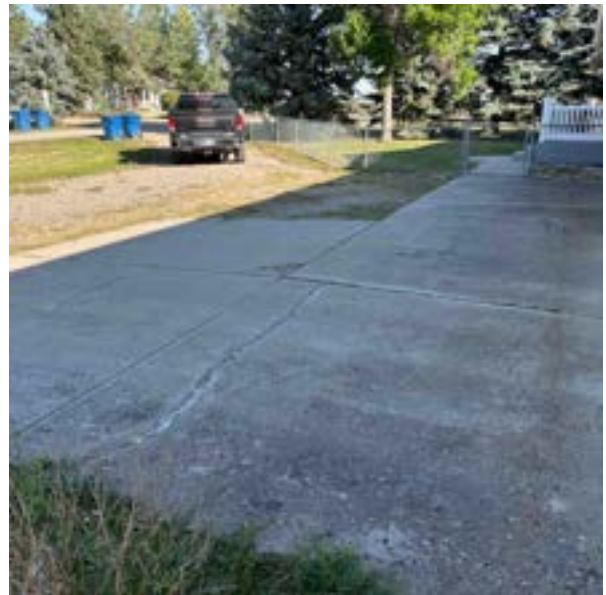
2.3.2 Repair settled/cracked/uneven driveway/walkways/patio to prevent further damage, moisture related damage, and trip hazards.

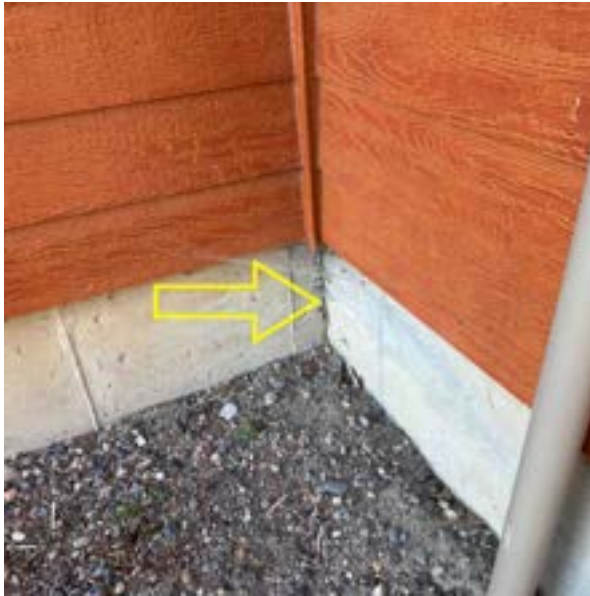
3.2.1 Fill and seal foundation cold joints to prevent moisture intrusion and subsequent damage. **(Exterior East)**

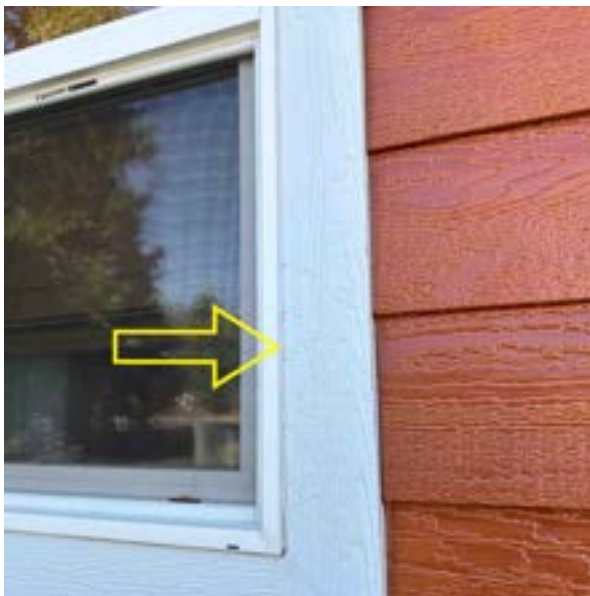
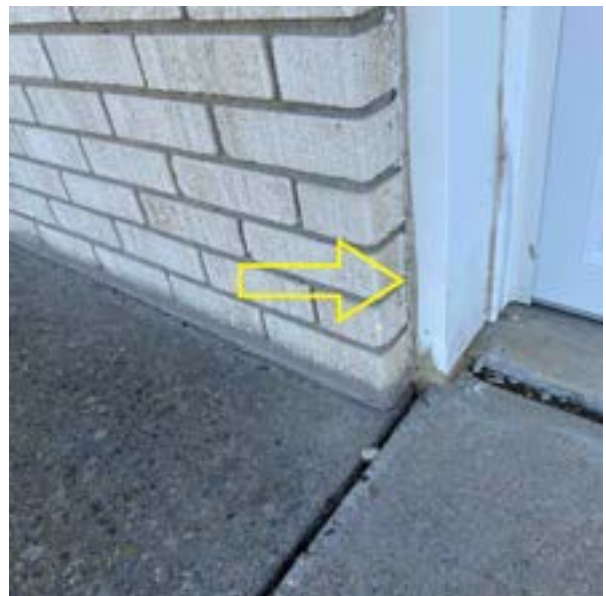
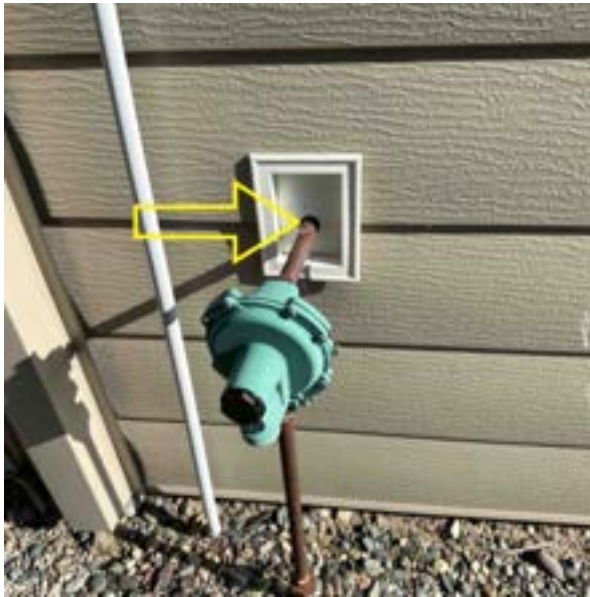
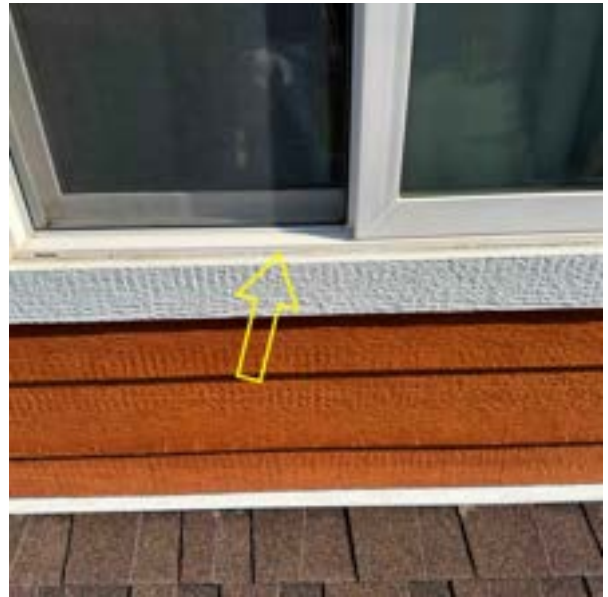
3.3.3 Ensure proper caulking and weather seal at all required locations and junctions such as windows, doors, dissimilar materials junctions, etc.

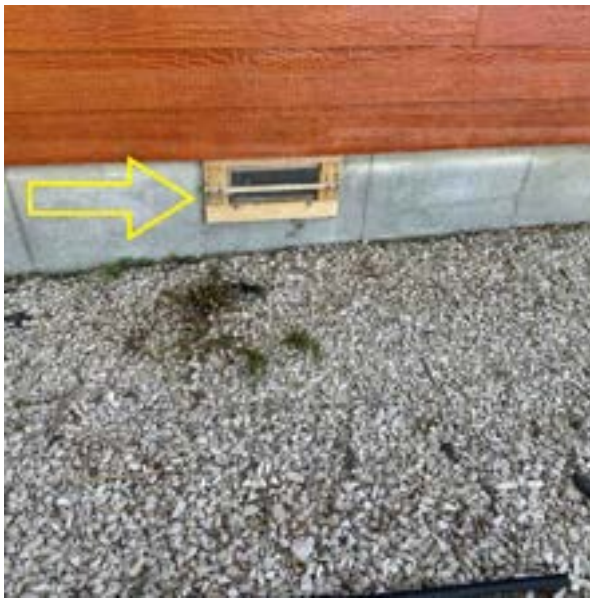
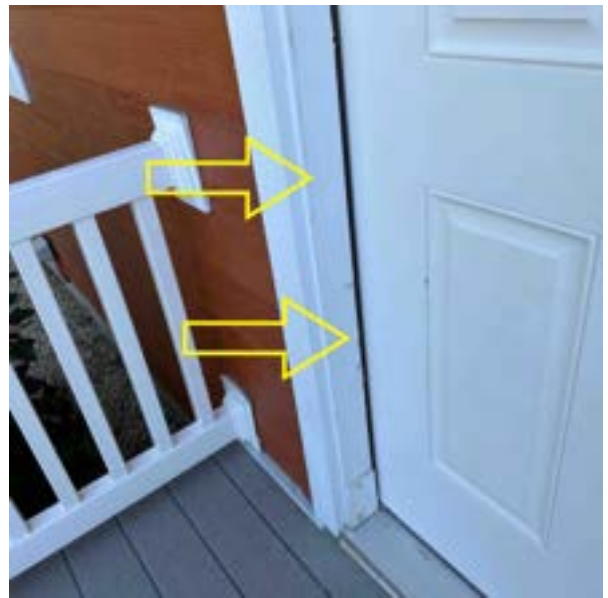
3.3.4 Clean, seal/paint/stain all exposed wood siding/trim to promote weathering protection.

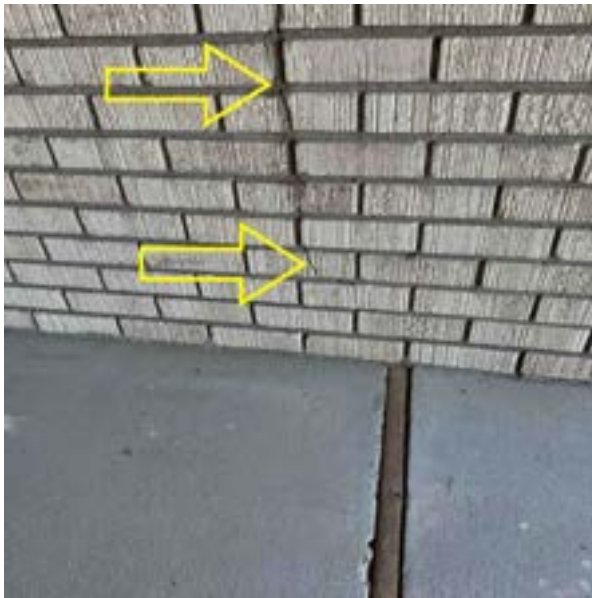
3.3.5 Repair/repoint damaged brickwork to prevent further damage and promote weathering protection.
(Exterior West)

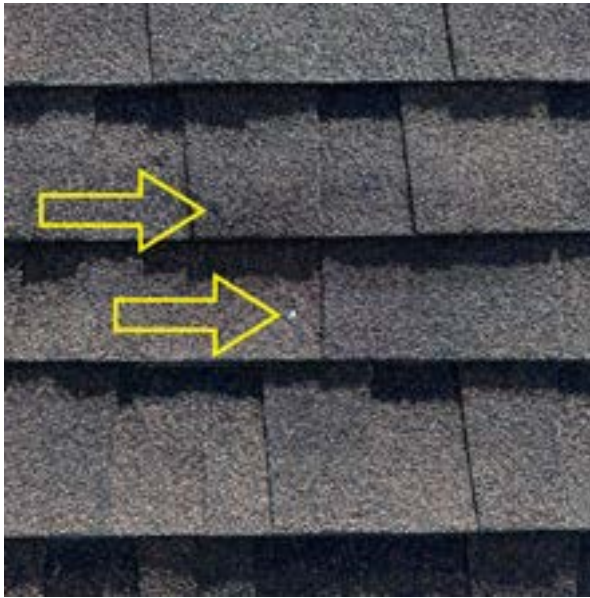
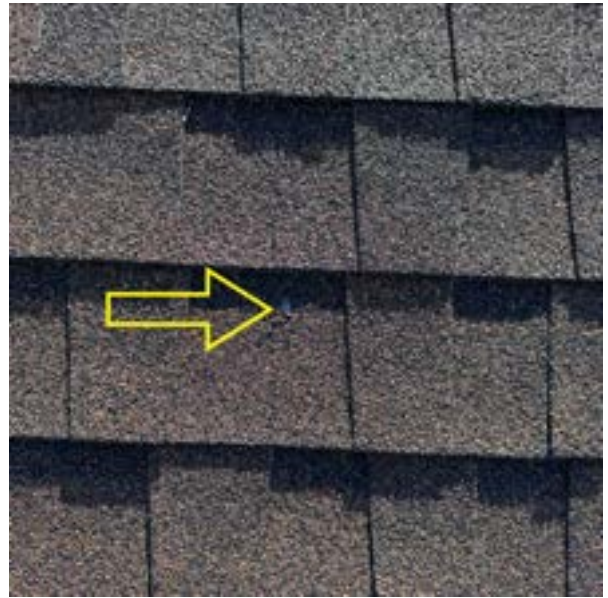
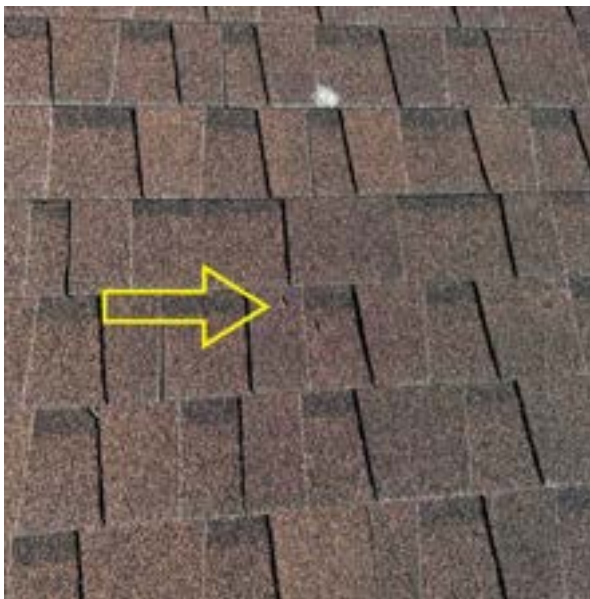
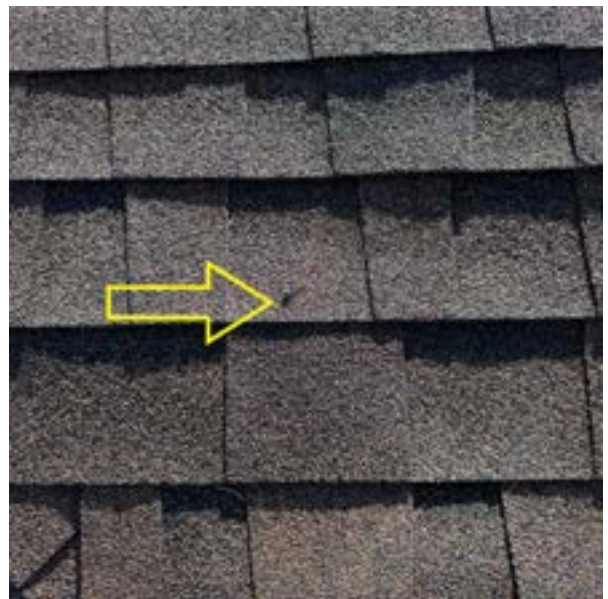
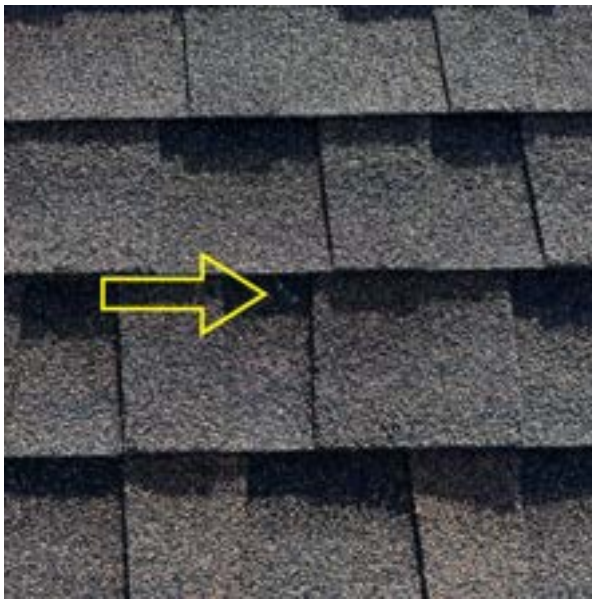
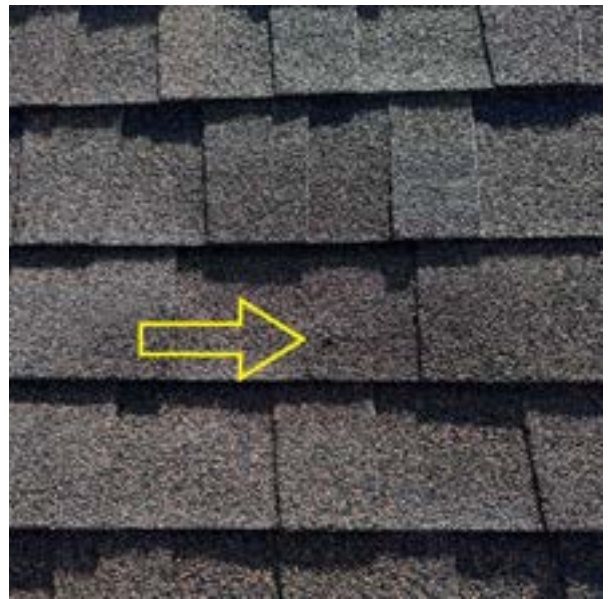
4.2.1 Consult a qualified roofer to evaluate scarring/damaged shingles and exposed nail heads and repair as recommended.

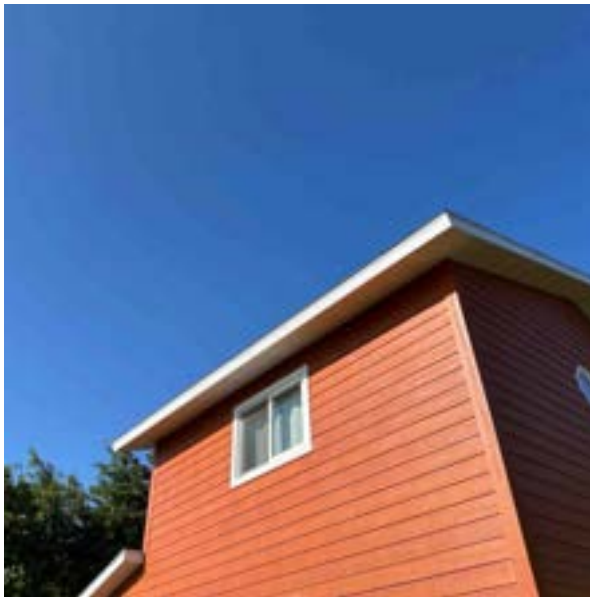
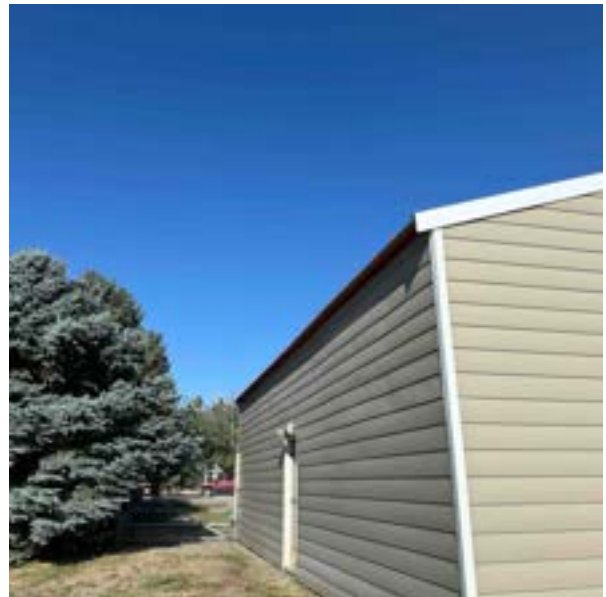
4.4.3 Provide means of dispersing water away from structure to reduce foundation deterioration, potential water entry and related damage.

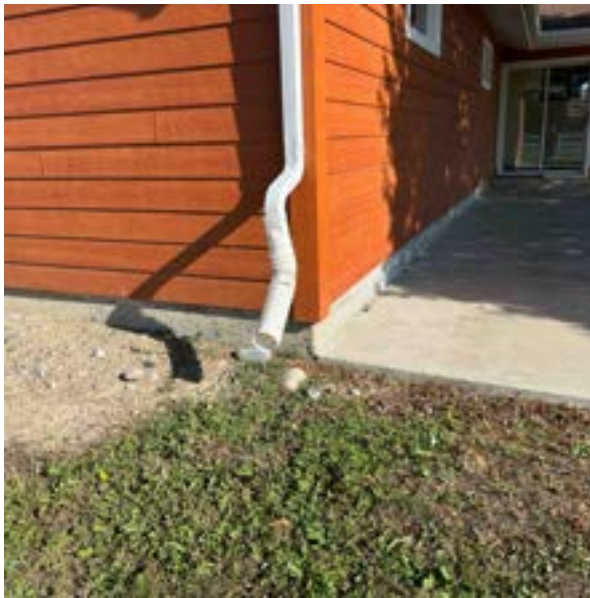
4.4.4 Extend all downspouts away from foundation to reduce wall deterioration, potential water entry and subsequent damage. **(Exterior South)**

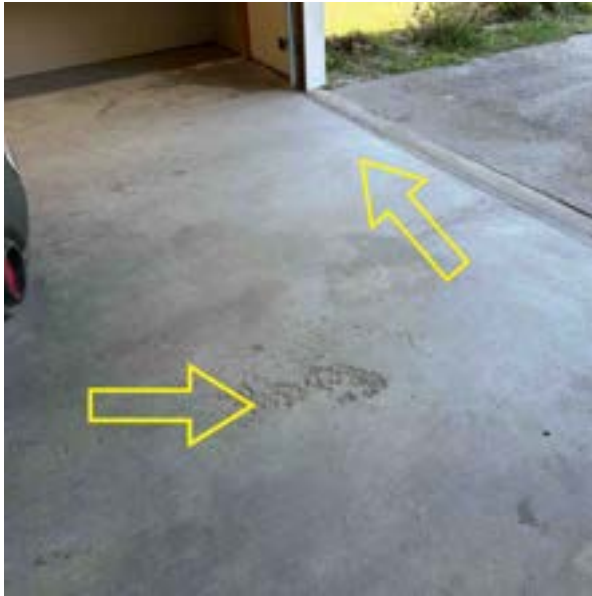
6.5.1 Fill/seal floor cracks/pitting to reduce further separation and potential trip hazards. **(Garage)**

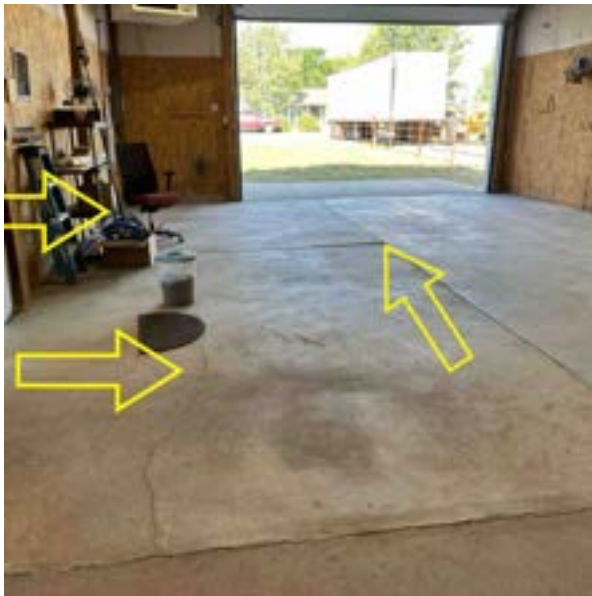
6.5.2 Consult qualified contractor to evaluate settled/improperly sloped/cracked concrete floor and repair as required to promote intended drainage and prevent secondary water damages. **(Shop)**

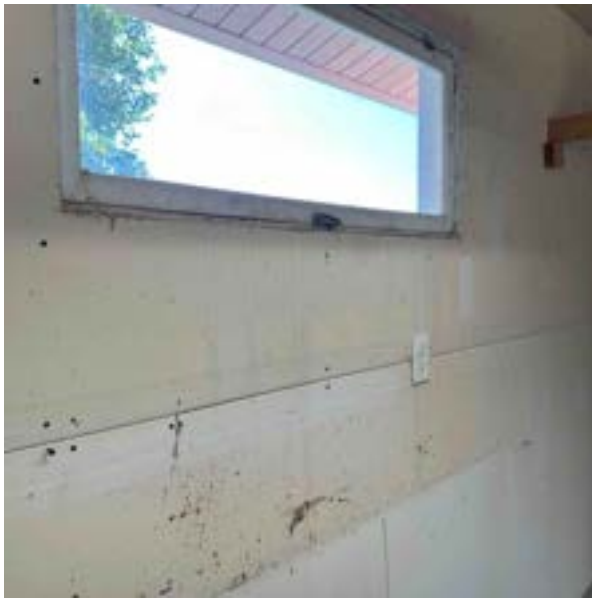
6.6.2 Further investigate cause and extent of water staining/damages and repair as required to prevent further damages. No moisture noted at time of inspection. **(Garage)**

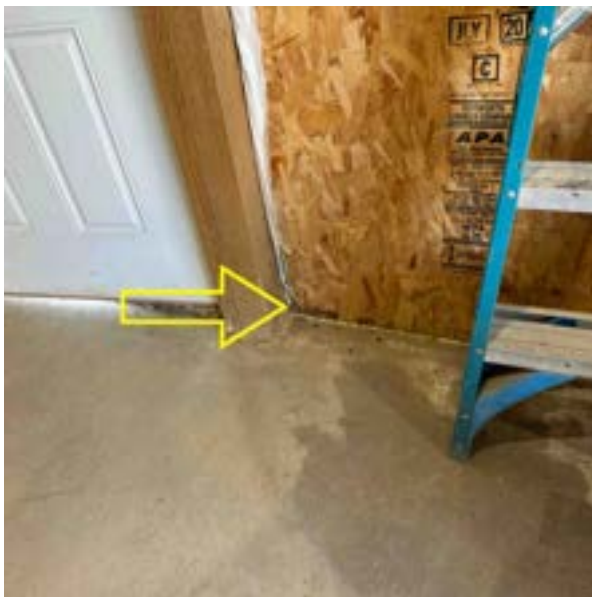
6.6.3 Further investigate cause and extent of wall staining and repair as required to prevent further damages. No moisture detected at time of inspection. **(Shop)**

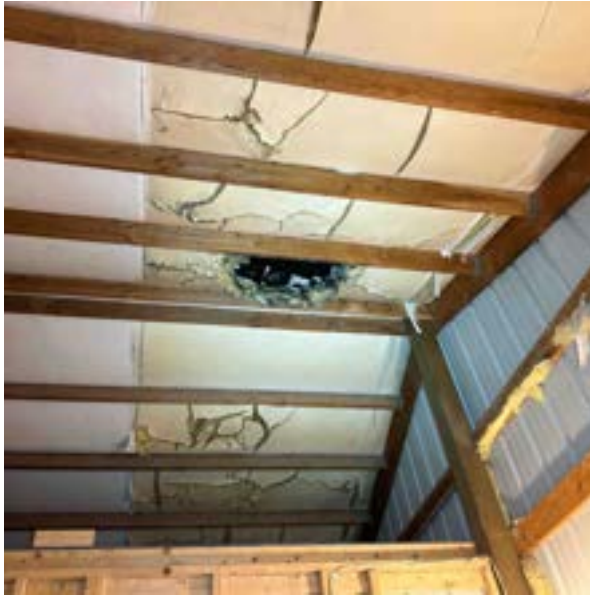
6.7.1 Further investigate cause and extent of staining/damages and repair as required to prevent further damages. **(Shop)**

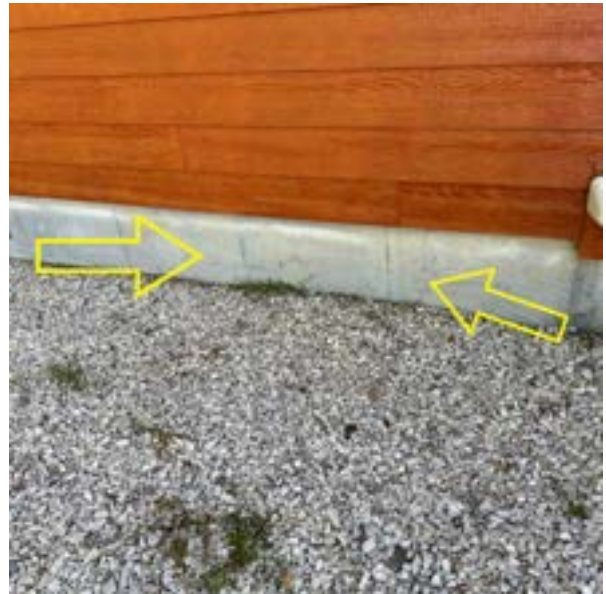
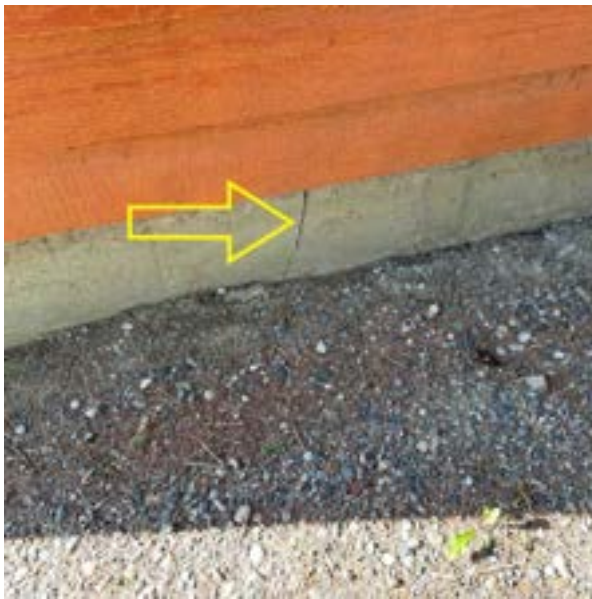
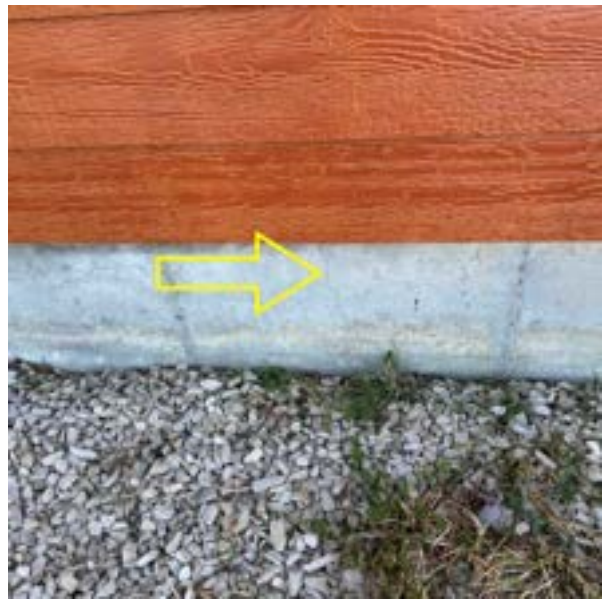
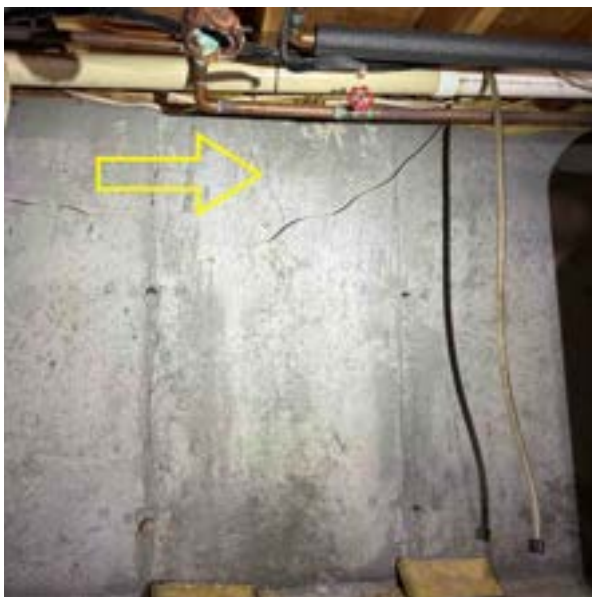
7.2.1 Consult a qualified contractor to evaluate foundation cracks and repair as recommended.

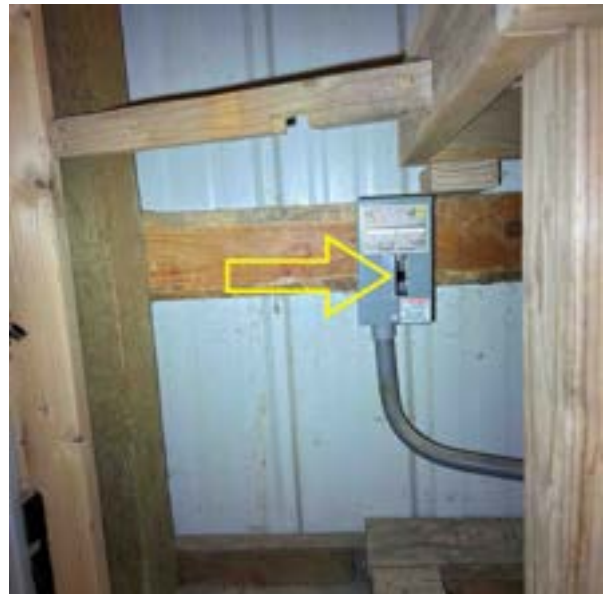
8.5.2 Provide filler pieces at knockout locations to reduce hazards associated with accessible wiring.

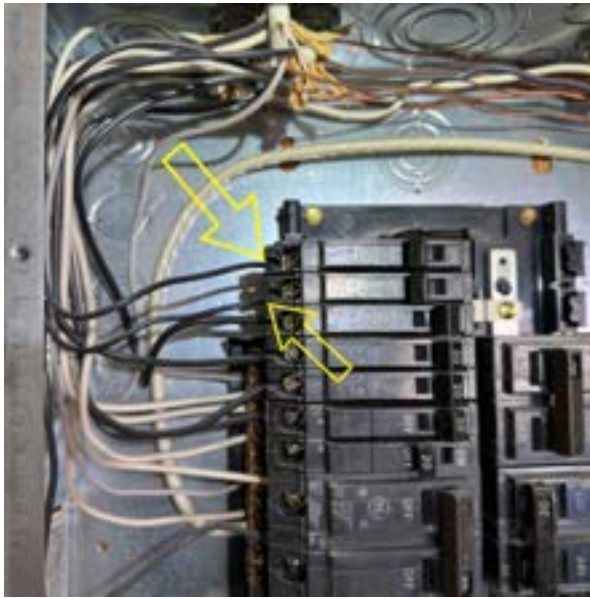
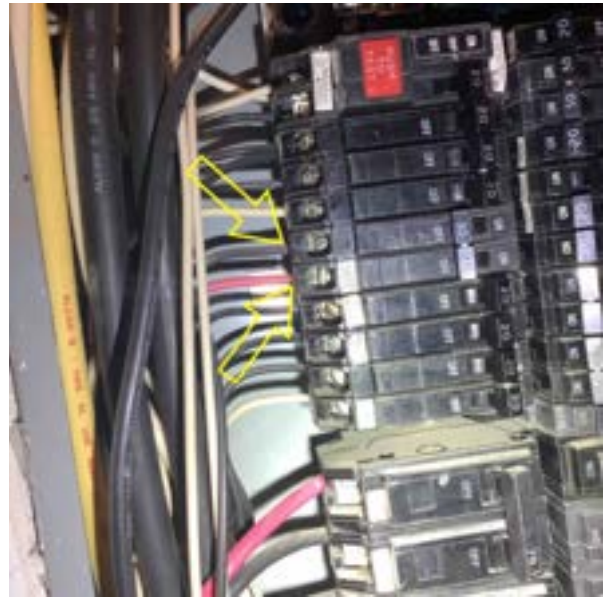
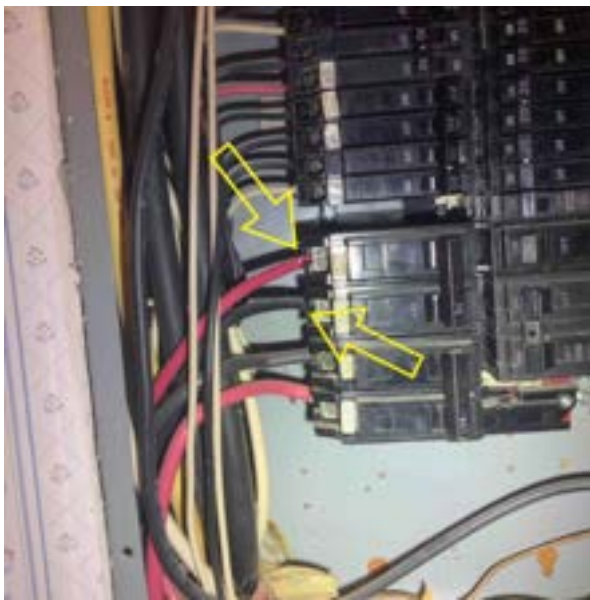
8.5.3 Consult a qualified electrician to correct undersized wiring in distribution panel to prevent electrical hazards.

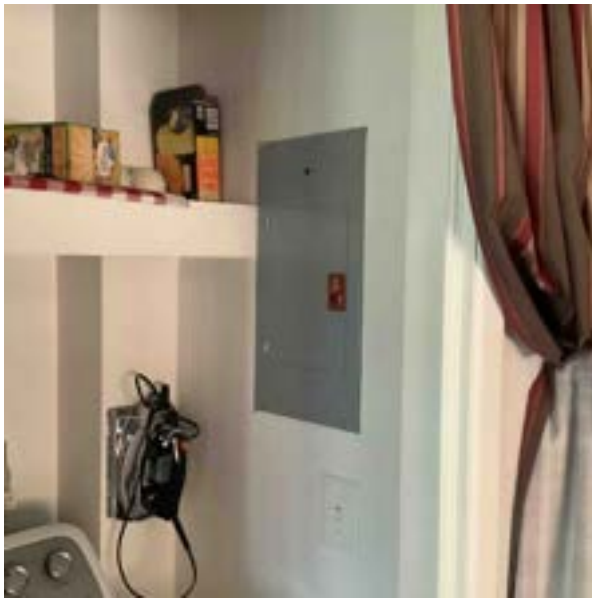
8.5.4 Further evaluate interior of electrical distribution panel when access is available. Shelving obstructing access at time of inspection. **(East Living Room)**

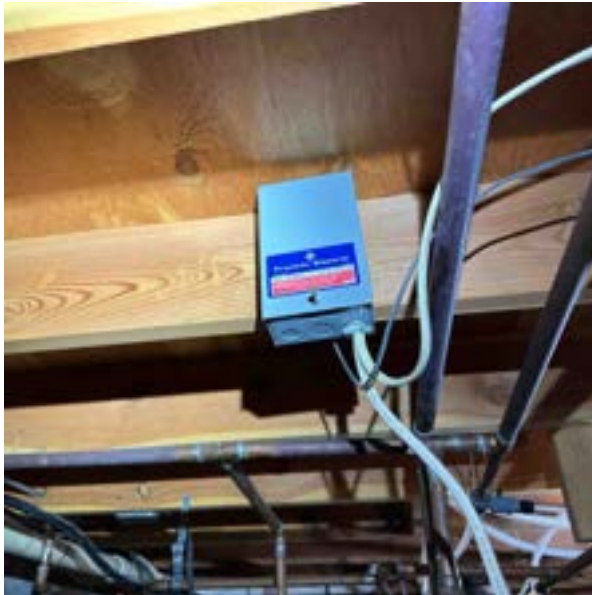
8.5.5 Secure loose disconnect panel to prevent electrical hazards. **(Crawlspace)**

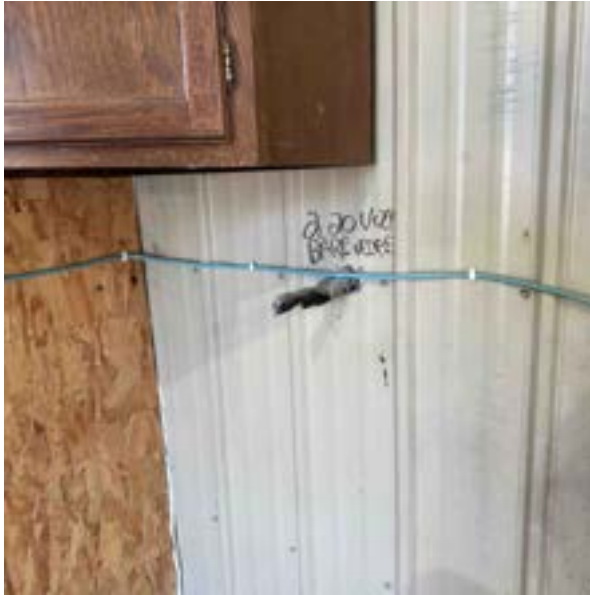
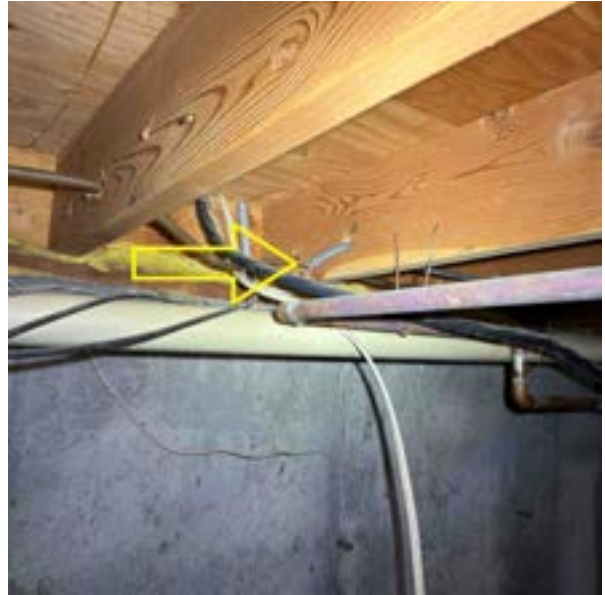
8.7.1 Provide junction box at exposed wiring to prevent electrical hazards.

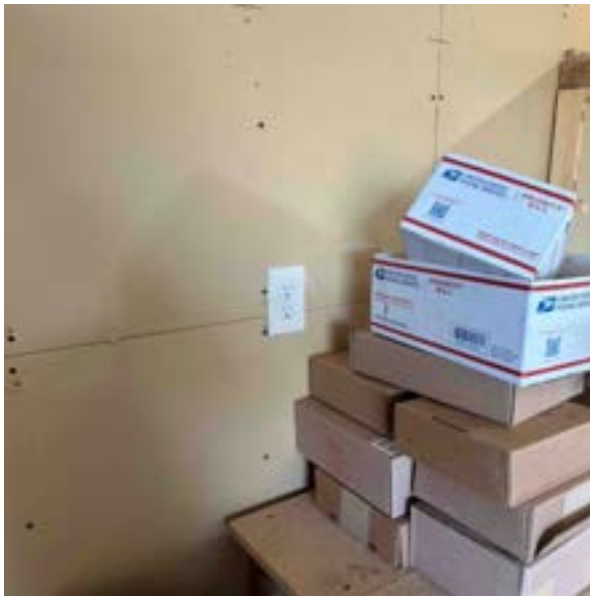
8.8.2 Secure loose receptacles to prevent stress wiring and electrical hazards. **(Garage)**

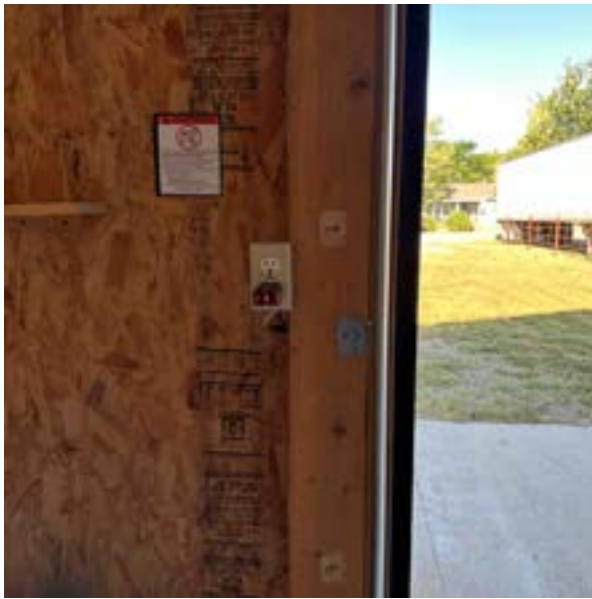
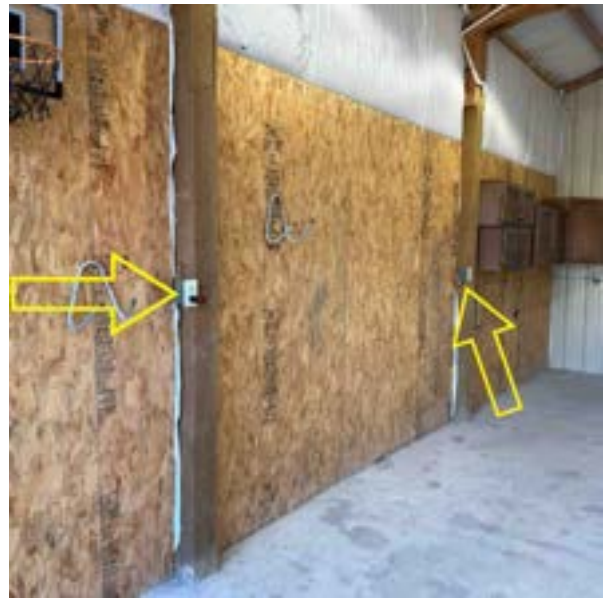
8.8.3 Repair hot/neutral reverse outlets to prevent electrical hazard. **(Shop)**

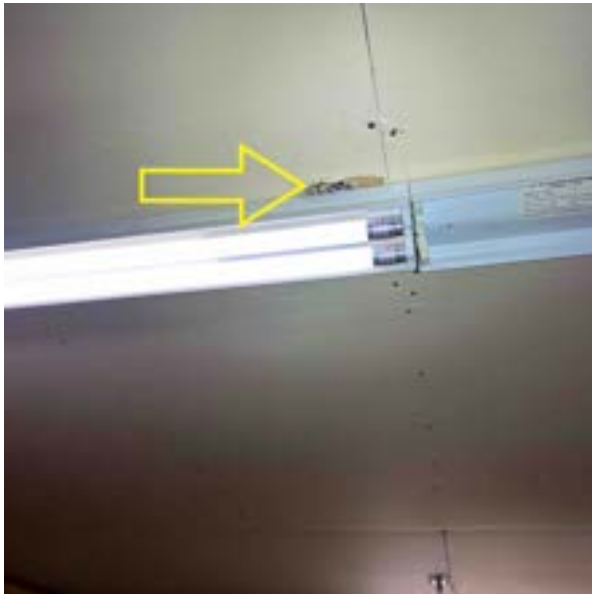
8.8.4 Replace missing switch plate/junction box cover to prevent electrical hazards. **(Garage)**

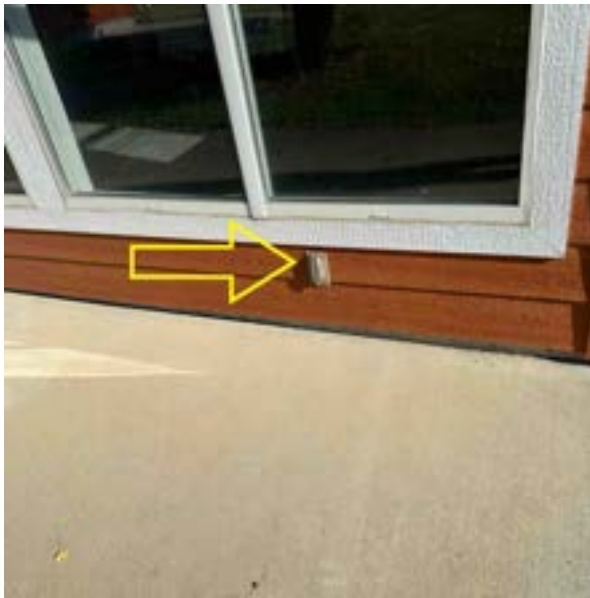
Replace damaged exterior outlet cover to prevent electrical hazards. **(Exterior East)**

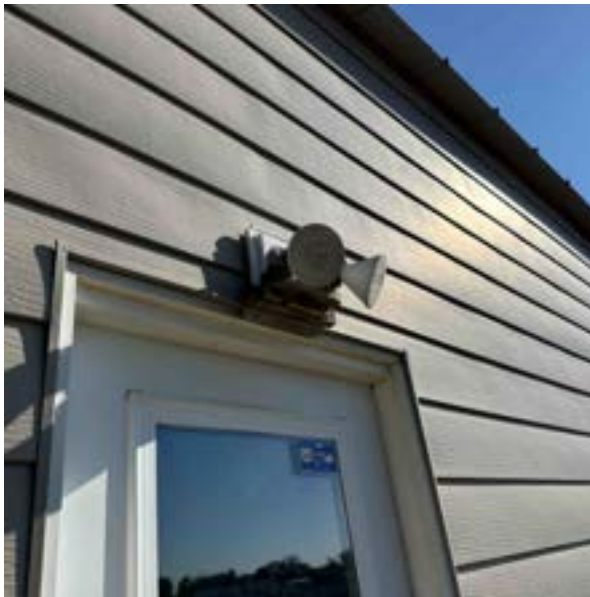
8.9.2 Replace damaged exterior light to prevent further damages and safety hazards. **(Shop)**

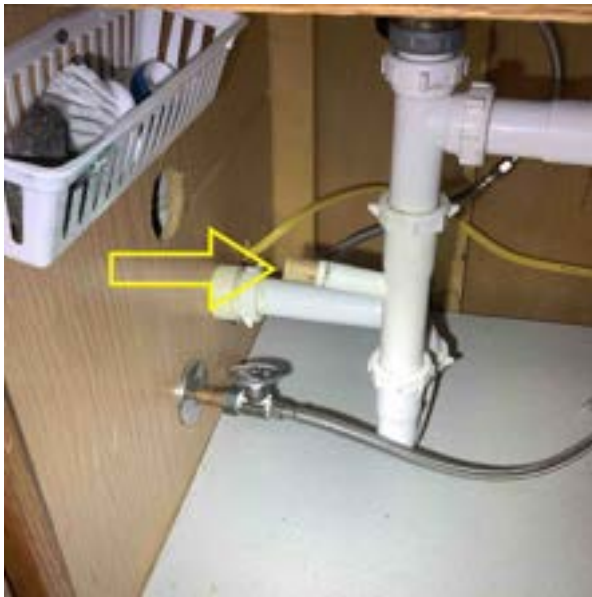
10.3.3 Properly seal plumbing drain under sink to prevent secondary water damages. **(Kitchen)**

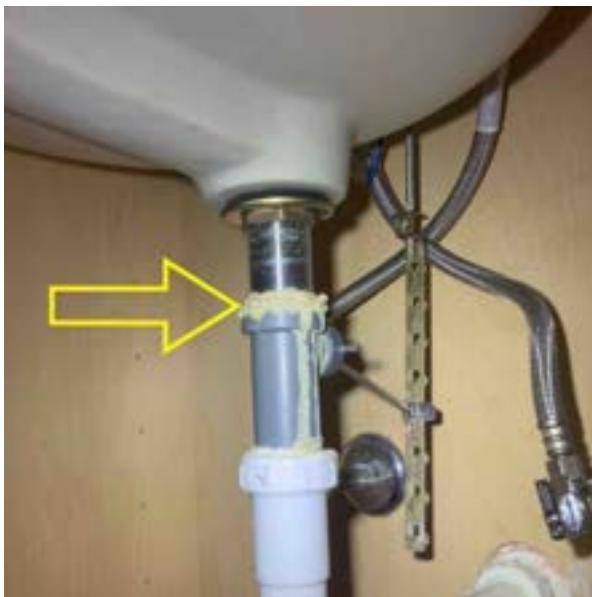
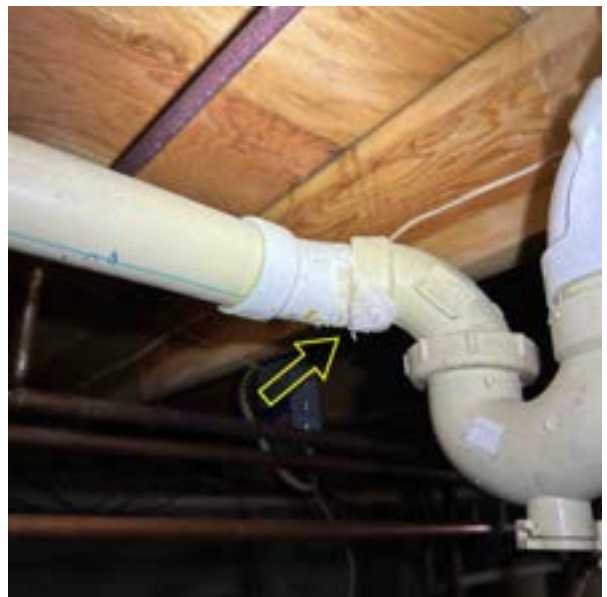
10.3.4 Repair drain line showing signs of leaking to prevent secondary water damages.

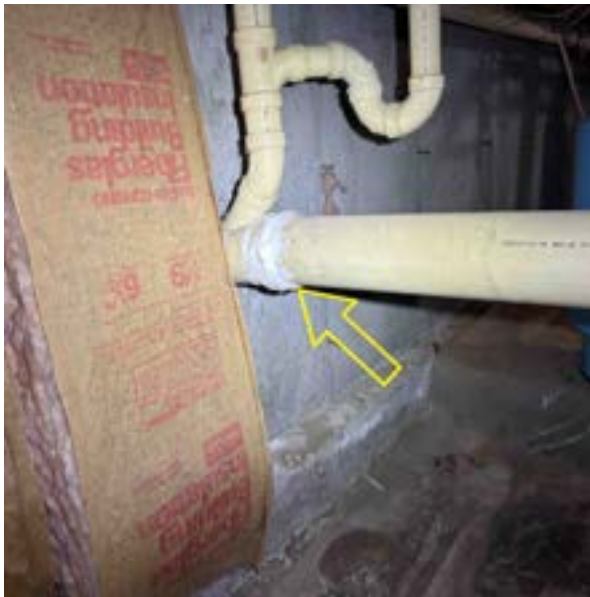
10.3.5 Properly seal plumbing drain to prevent secondary water damages. **(Crawlspace)**

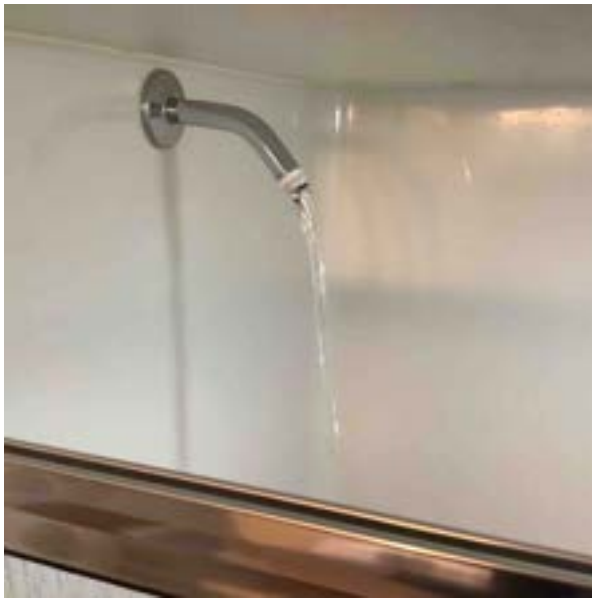
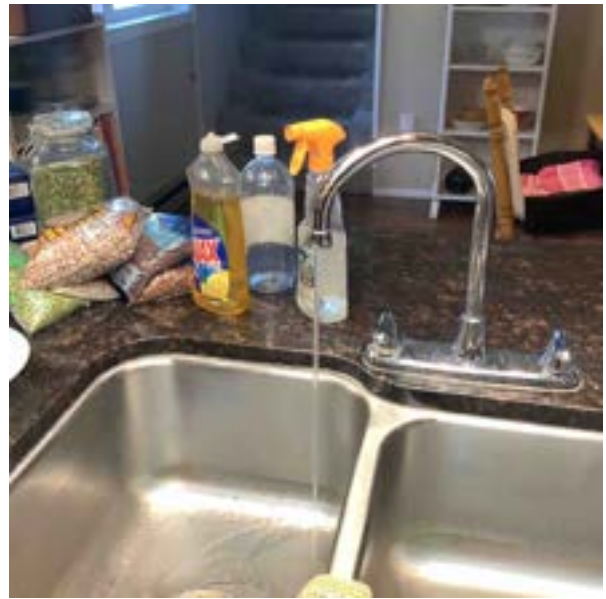
10.6.2 Further investigate causes of decreased water pressure and repair as required. **(Throughout)**

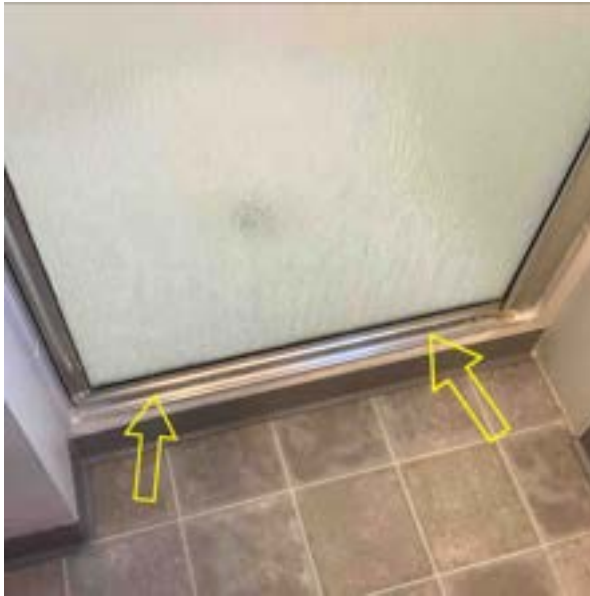
10.9.4 Reconfigure shower door trim/seal to direct water back to shower pan and prevent moisture intrusion and damage. **(2nd Floor Hallway Bathroom)**

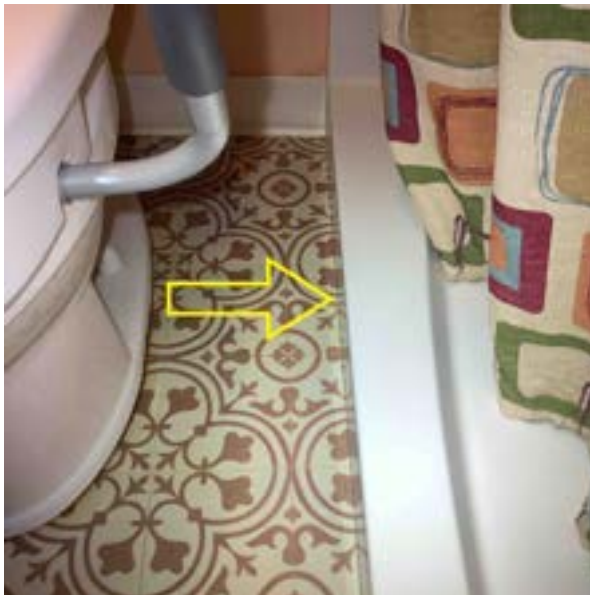
10.9.5 Seal all cracks/gaps/joints in and around tubs and showers to reduce water penetration and subsequent deterioration. **(1st Floor Hall Bathroom)**

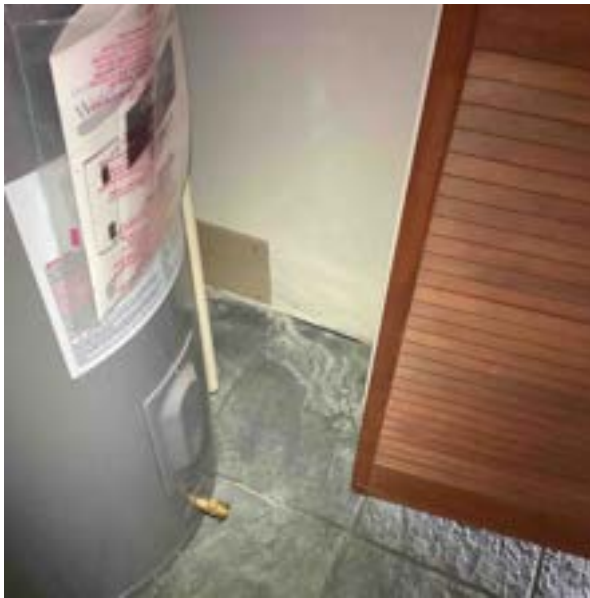
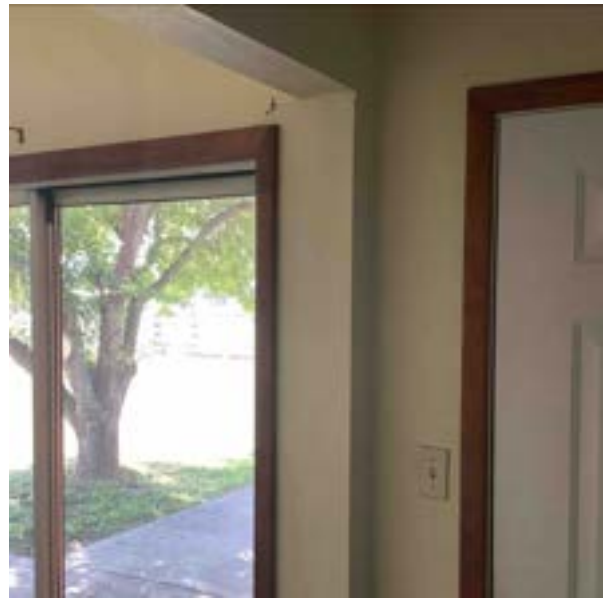
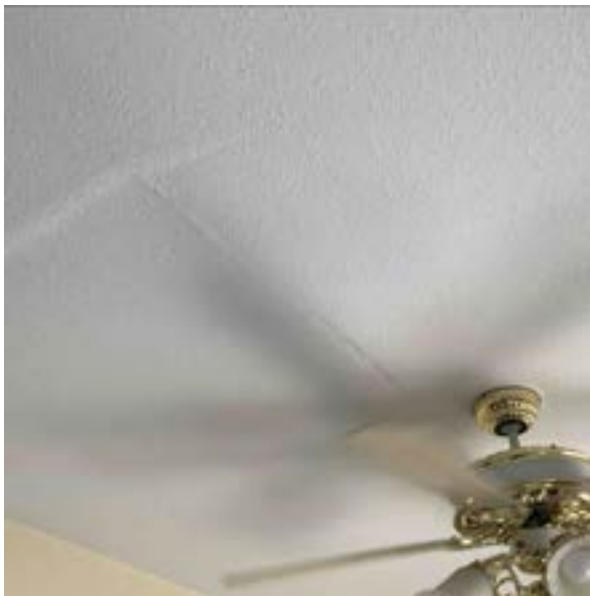
11.2.2 Further investigate cause and extent of staining/damage and correct as required. No moisture detected at time of inspection. **(Breezeway)**

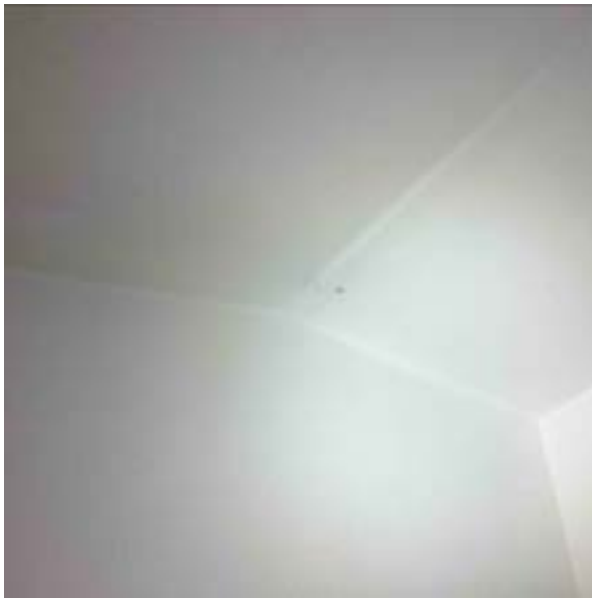
11.2.3 Further investigate cause and extent of staining/damage and correct as required. No moisture detected at time of inspection. **(2nd Floor West Room)**

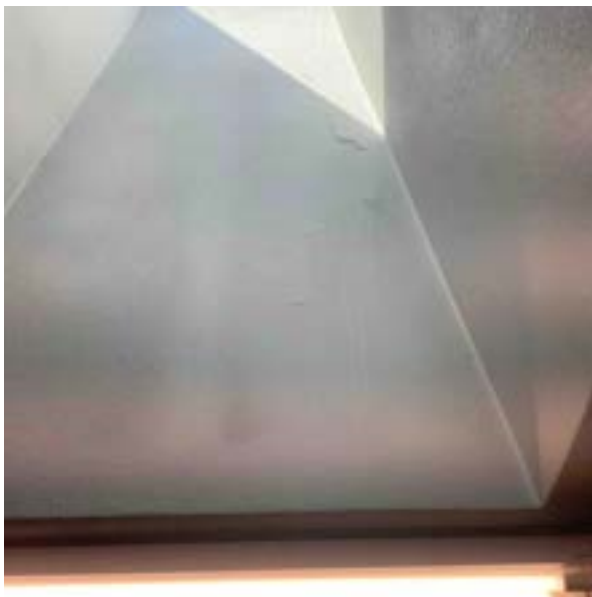
11.2.4 Further investigate cause and extent of staining/damage and correct as required. No moisture detected at time of inspection. **(Kitchen)**

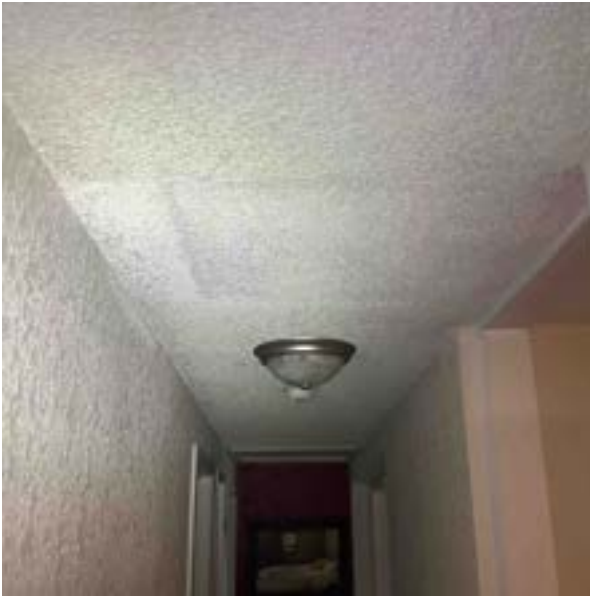
11.2.5 Further investigate cause and extent of staining/damage and correct as required. No moisture detected at time of inspection. **(Hallway)**
