Home Inspection Report

PROPERTY INSPECTED:
6249 Dawson Drive
Billings, MT 59105

Date of Inspection: 08/22/2024

Inspection No. 45957-1-1126

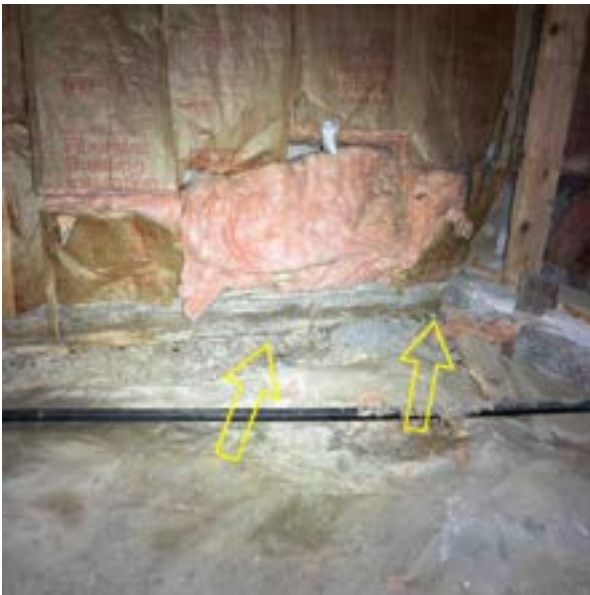
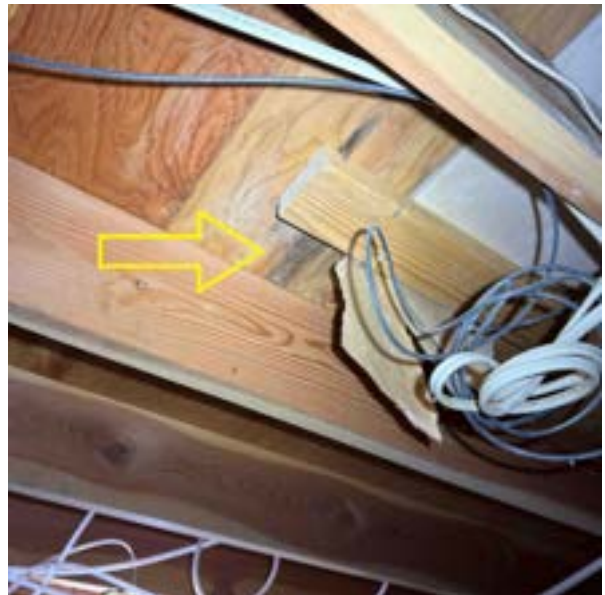
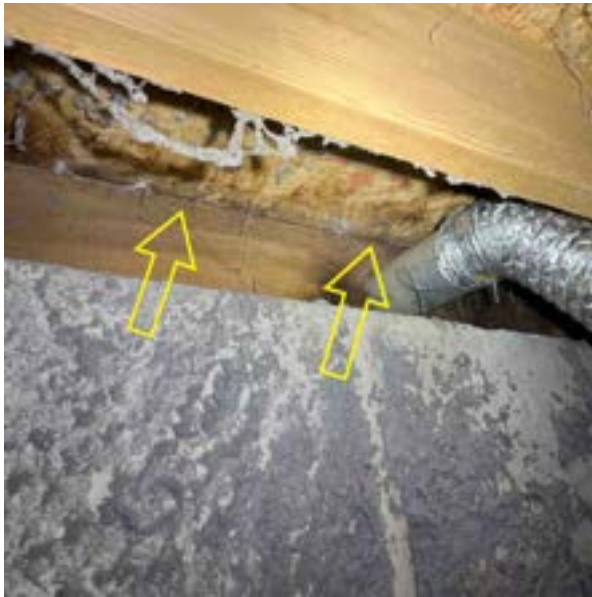
11.2.6 Further investigate cause of staining/damages and suspected mold growth and correct as required. **(Crawlspace)**

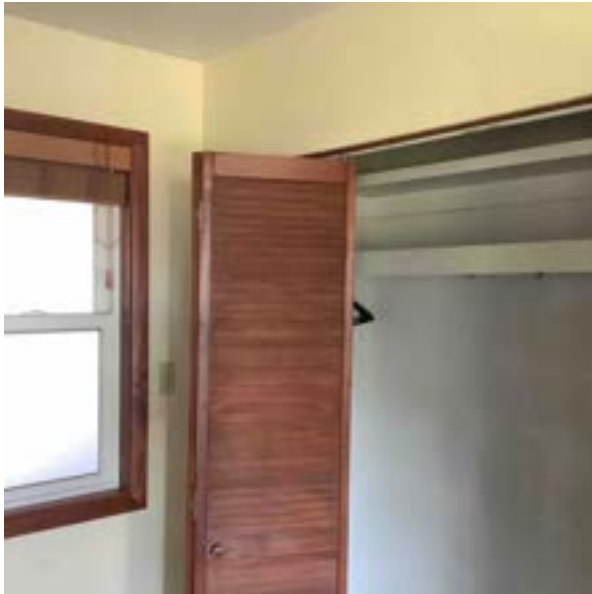
11.4.4 Adjust closet doors to reduce binding and prevent wear/damages. **(Breezeway)**

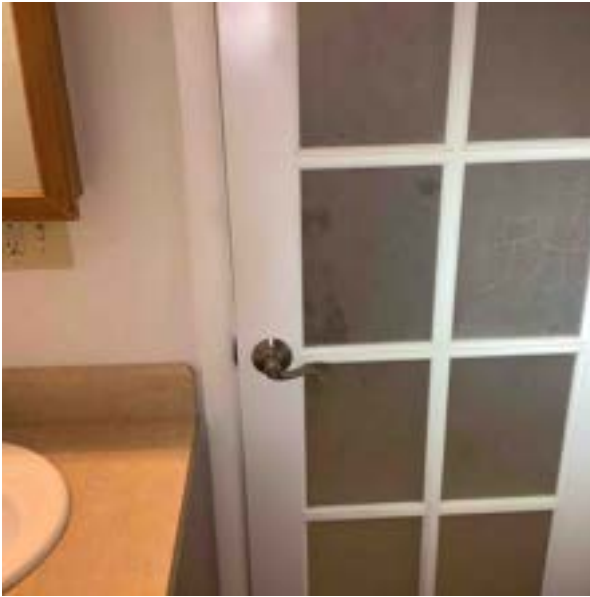
11.4.5 Adjust door to reduce binding and latch securely. **(2nd Floor Hallway Bathroom)**

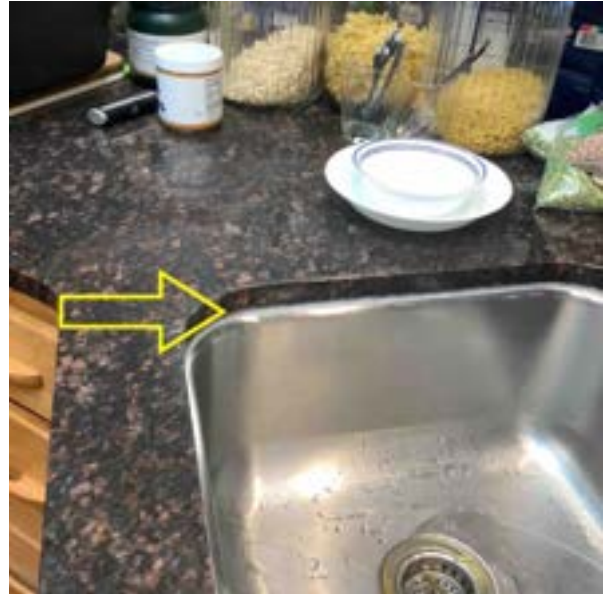
11.7.4 Recaulk counters to prevent moisture intrusion and subsequent damages.
