## Home Inspection Report

PROPERTY INSPECTED:  
**311 Stonegate Circle**  
**Billings, MT 59102**

Date of Inspection: 10/10/2024

Inspection No. 45957-1-1167

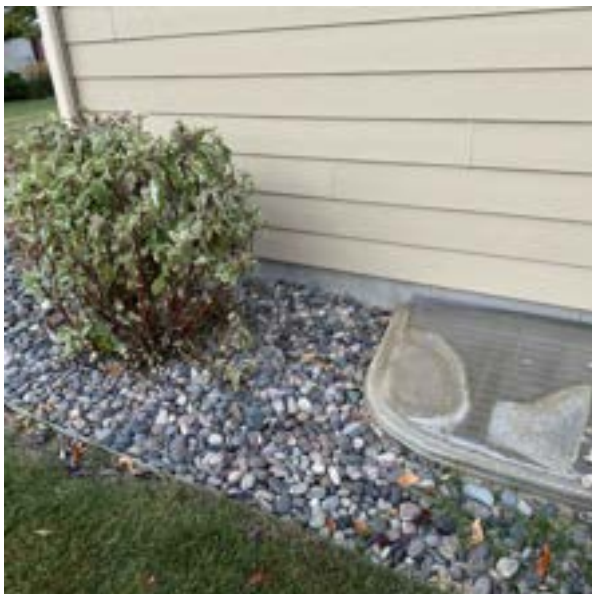
2.2.2 Regrade to slope away from structure to reduce foundation deterioration potential water entry and subsequent damage. Monitor landscape grading near foundation for signs of normal soil compaction and correct as required. **(Exterior East)**

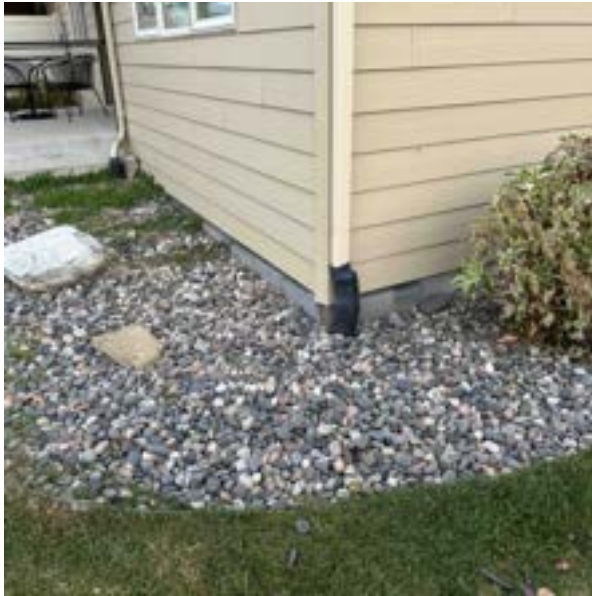
2.2.3 Consult seller as to drainage repair and obtain receipts/work orders for warranty purposes. **(Exterior South)**

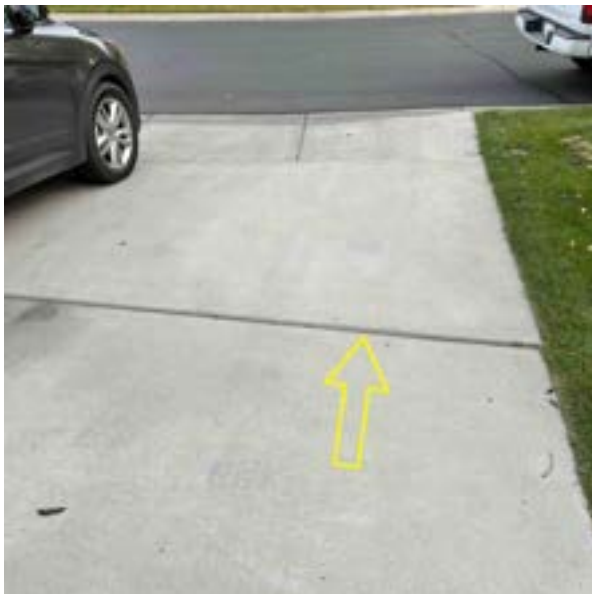
2.4.2 Repair uneven driveway to prevent further damage, moisture related damage, and trip hazards. **(Exterior North)**

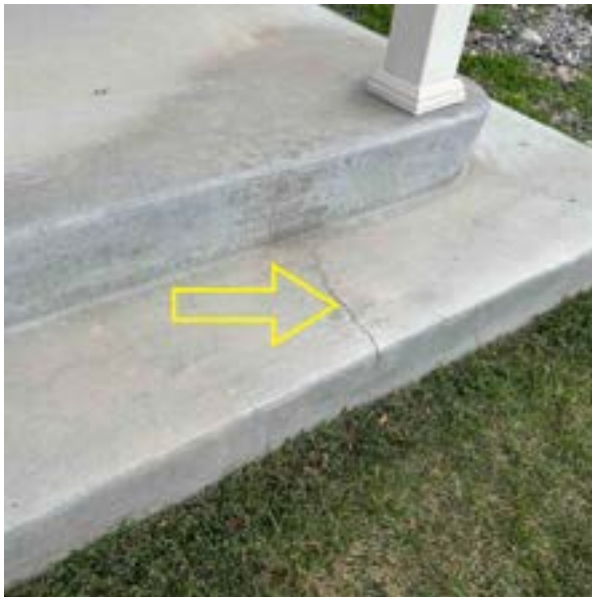
2.5.2 Seal crack in concrete patio to prevent further damage.

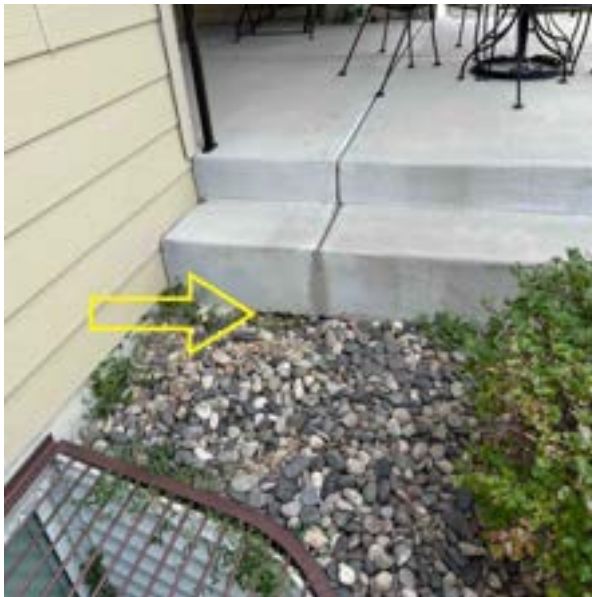
2.5.3 Backfill soil under concrete patio to prevent damage, promote stability, and deter pest entry. (**Exterior South**)

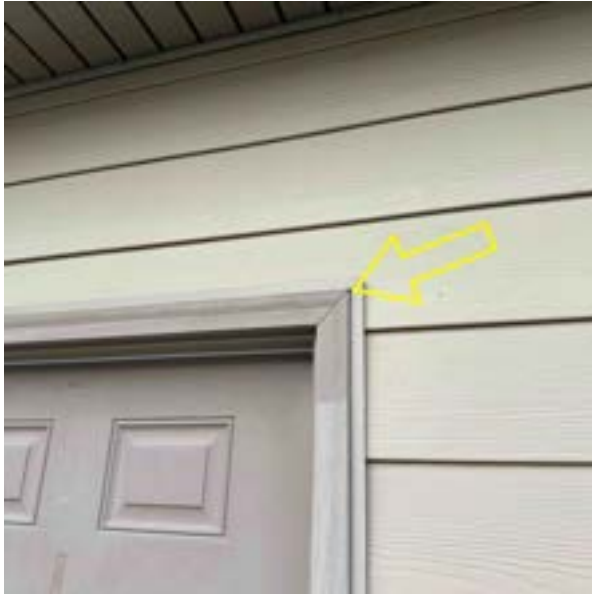
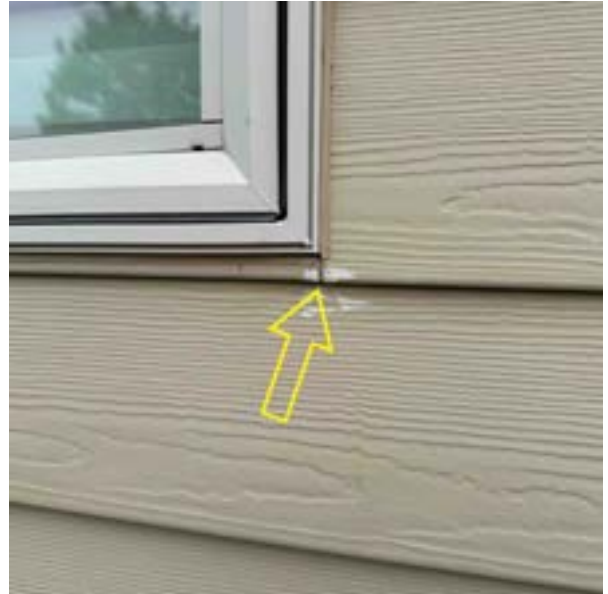
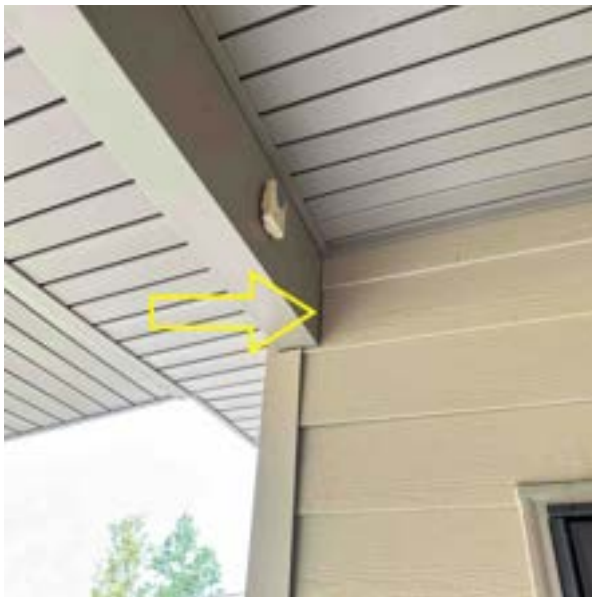
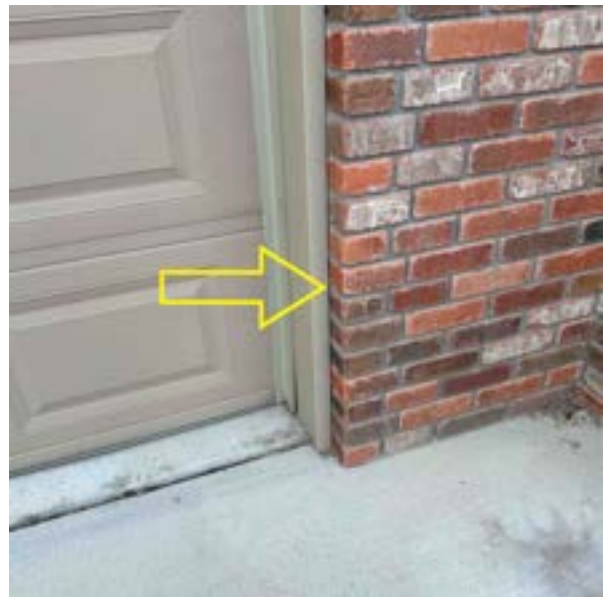
- Exterior East
- Exterior North
- Exterior South

3.3.2 Ensure proper caulking and weather seal at all required locations and junctions such as windows, doors, dissimilar materials junctions, etc.

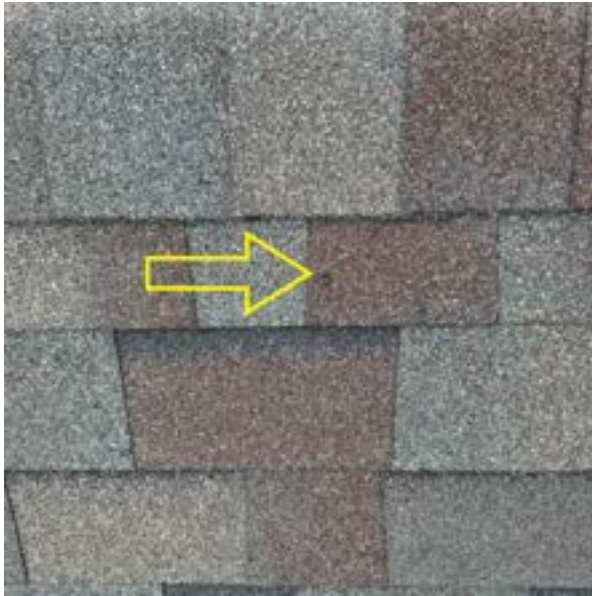
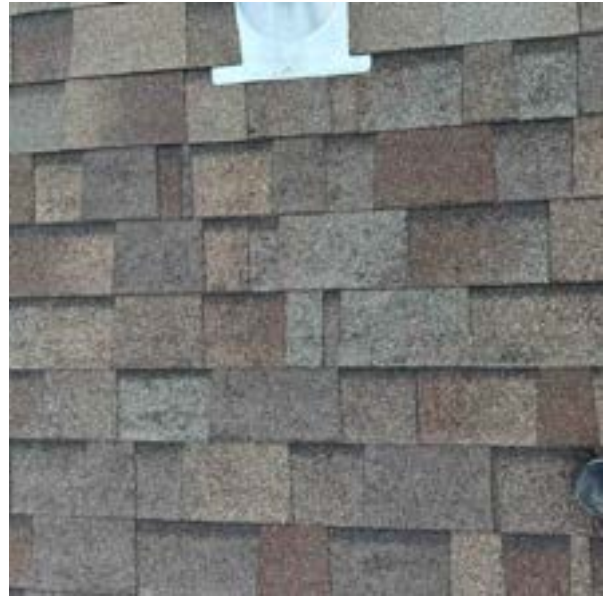
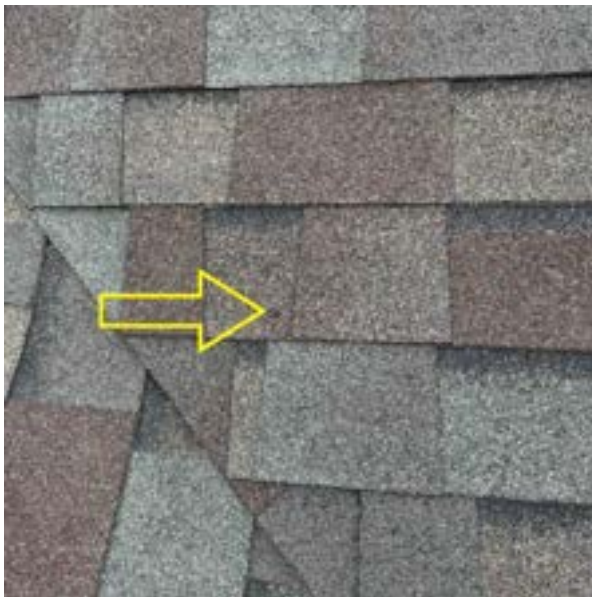
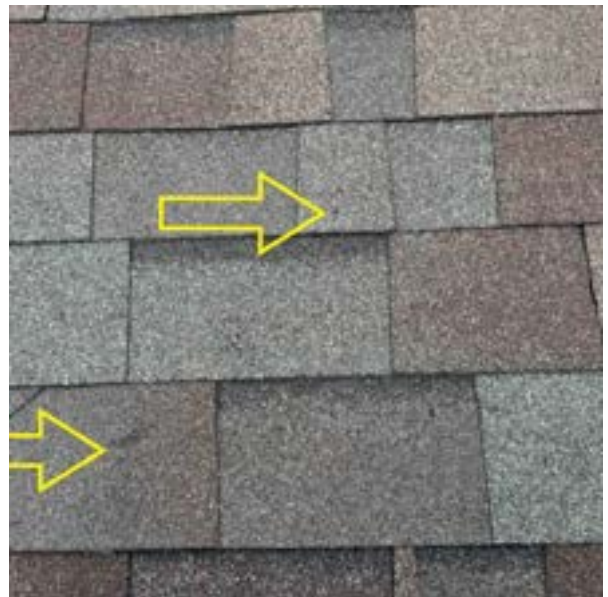
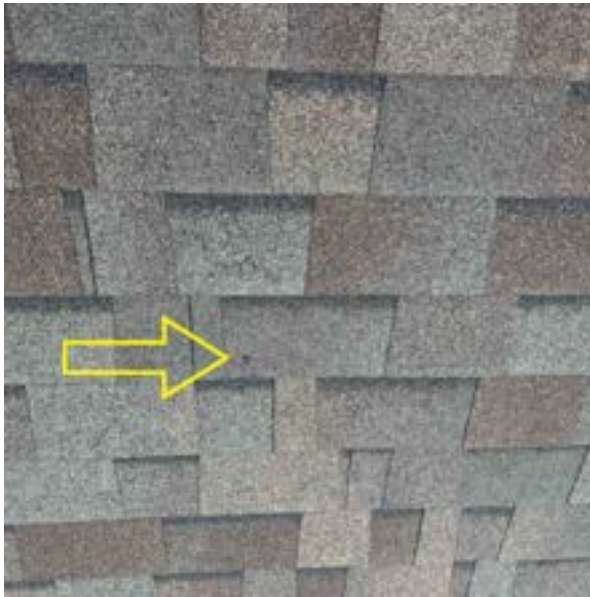
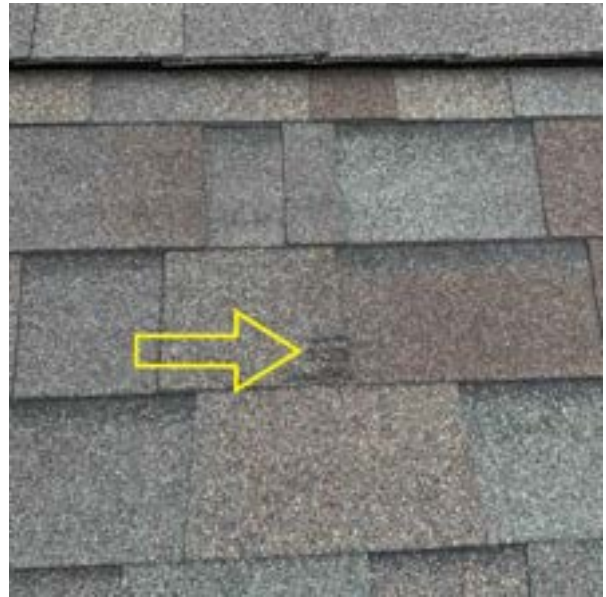
4.2.1 Consult a qualified roofer to evaluate scarred/damaged shingles and repair as recommended.

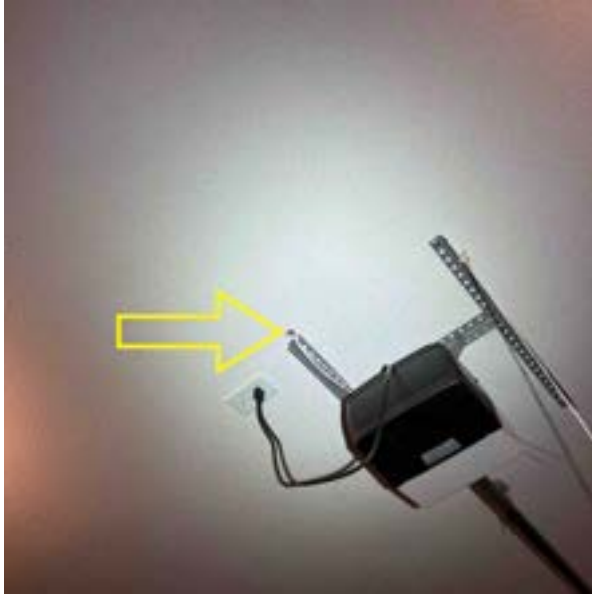
6.7.1 Seal all gaps, holes/ penetrations/entries in firewall to promote fire/gas barrier. **(Garage)**

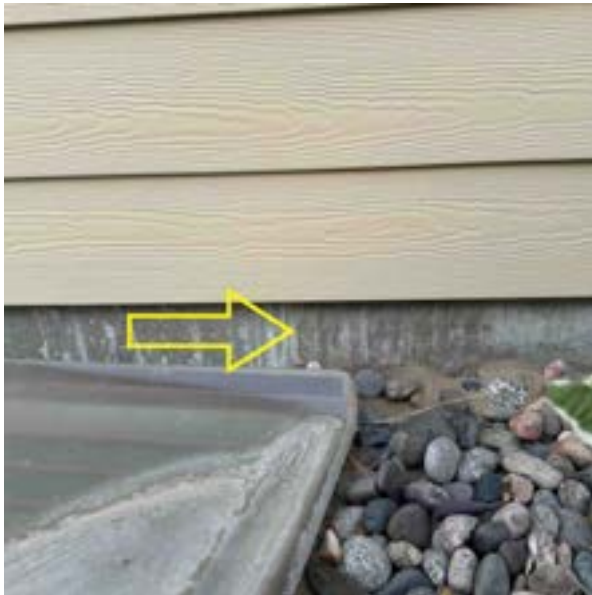
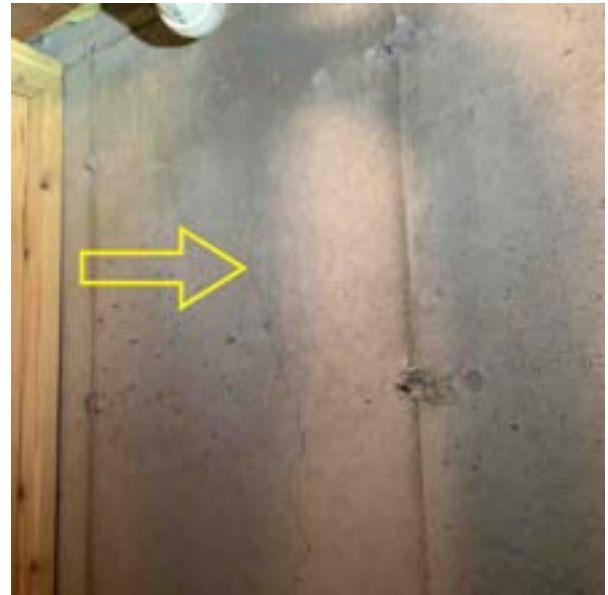
7.2.1 Consult a qualified contractor to evaluate foundation cracks and repair as recommended.

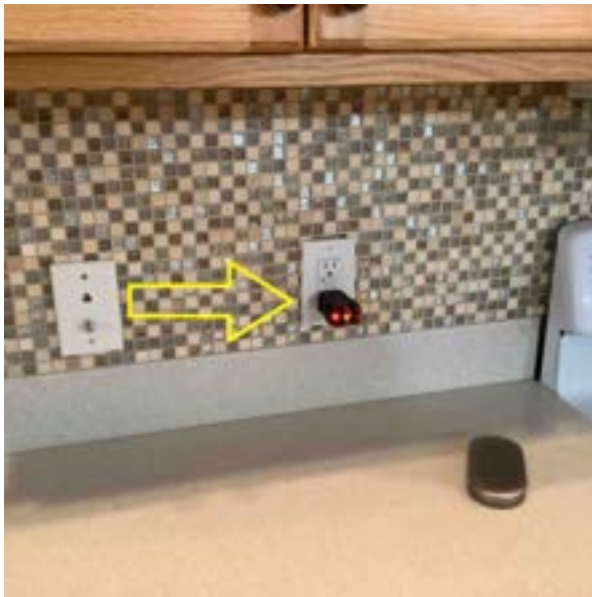
8.8.2 Reversed-polarity receptacles should be repaired to prevent electric shock injuries. **(Kitchen)**

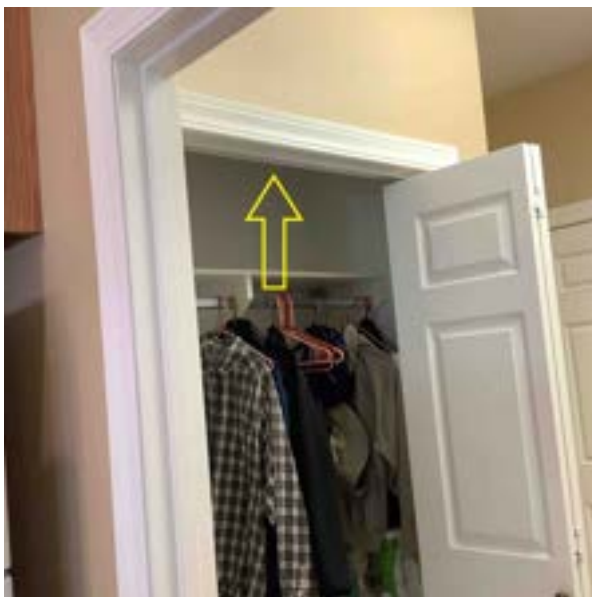
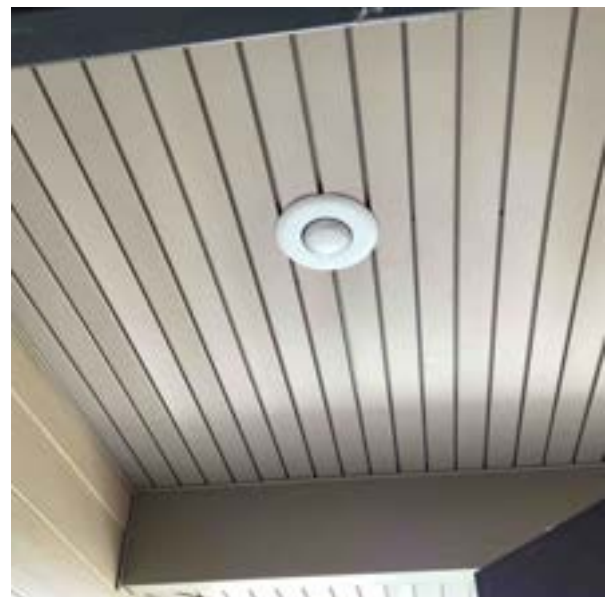
- Exterior North
- Laundry area

8.9.2 Determine cause of inoperable light fixture and repair as required. Replace bulb prior to further investigation.

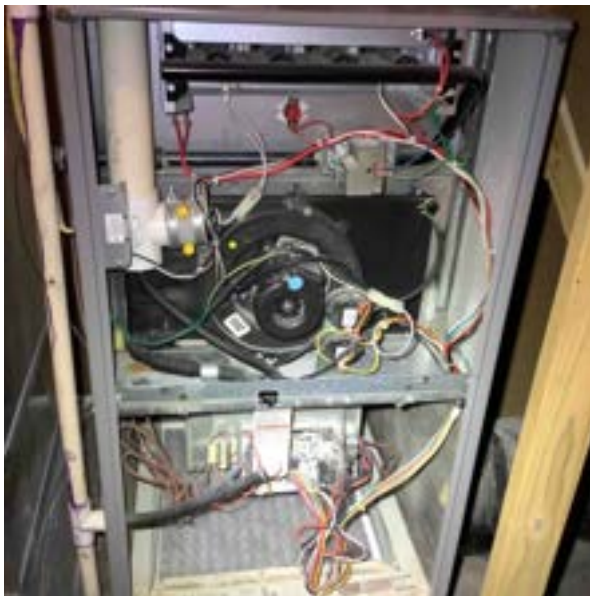
9.5.4 Clean and service furnace to promote system longevity. **(Utility Area)**

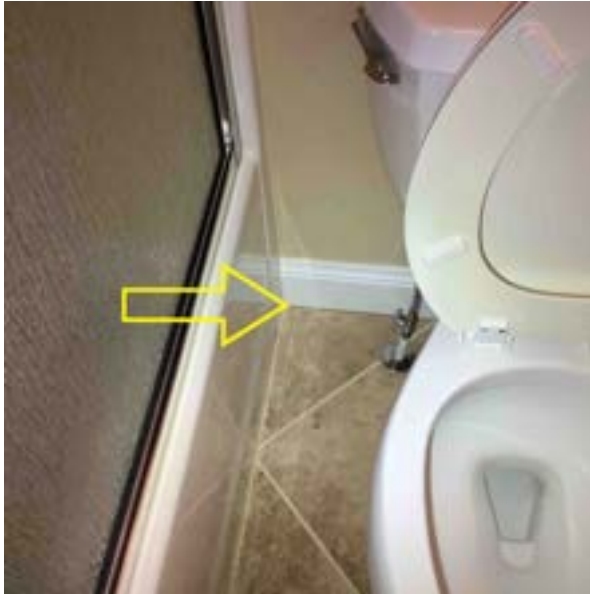
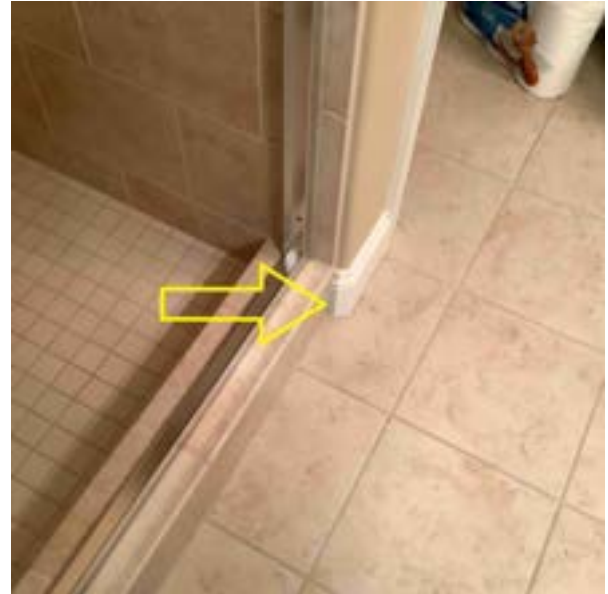
- 1st Floor Hall Bathroom
- Basement Bathroom
- Master Bathroom

10.10.3 Seal all cracks/gaps/joints in and around tubs and showers to reduce water penetration and subsequent deterioration.

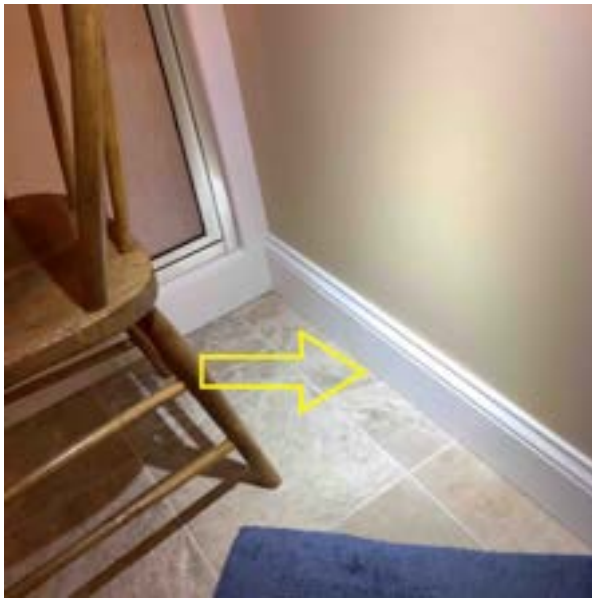
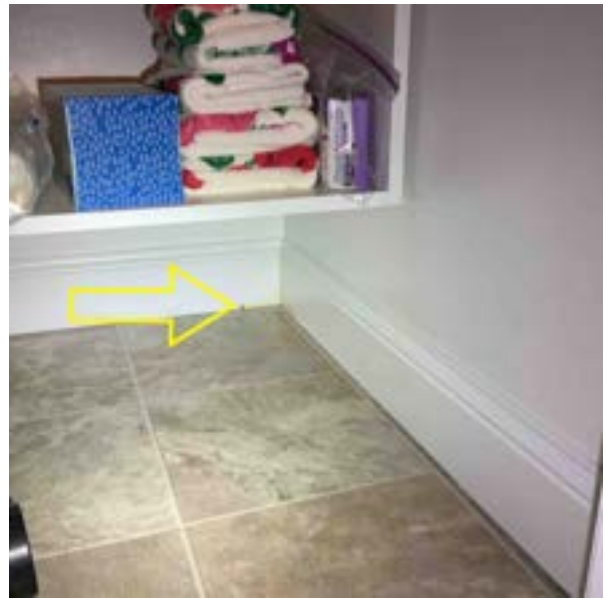
11.2.2 Further investigate cause and extent of staining/damage and correct as required. No moisture detected at time of inspection. **(Basement Bathroom)**

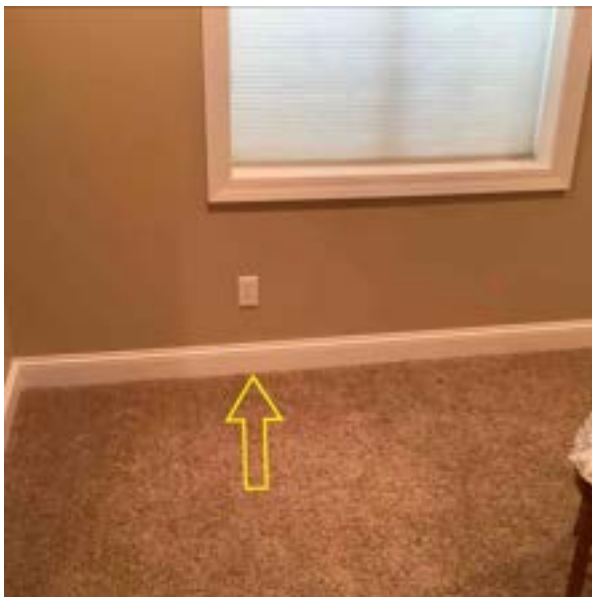
11.2.3 Further investigate cause and extent of staining/damage and correct as required. No moisture detected at time of inspection. **(Basement Living Room)**

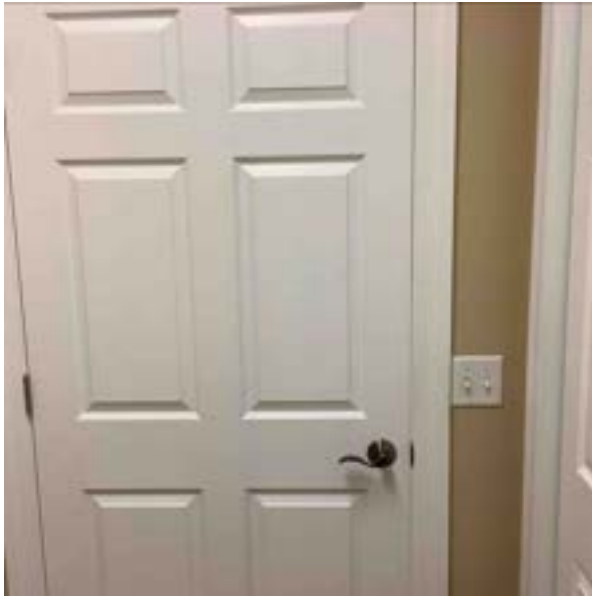
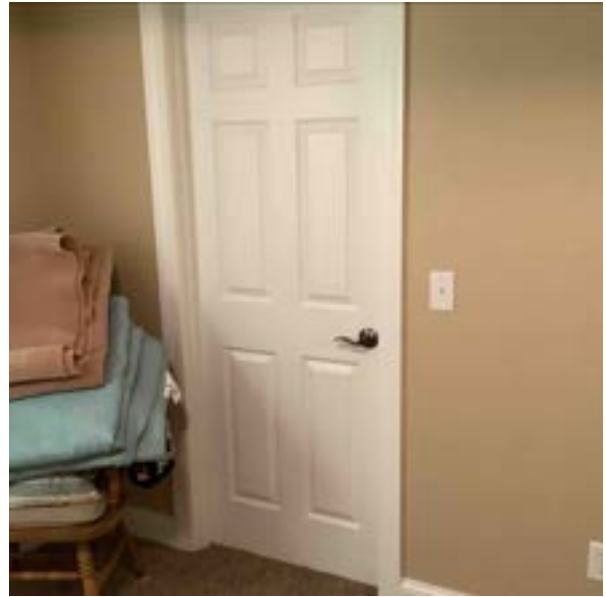
- Basement Northeast Room
- Laundry area
- Utility Area

11.4.4 Adjust door to reduce binding and latch securely.

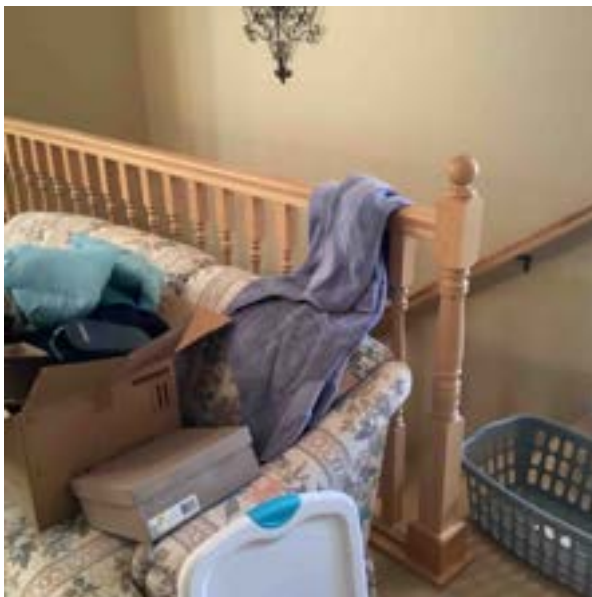
11.6.2 Caution is advised. Railing poses potential safety hazards due to design. Spindle span in greater than 4". **(Living Room)**
