# Inspection Report

**Property Address:**  
4018 Southpointe Dr  
Carson City NV 89701

**Clear Choice Home Inspection Services**

| <b>Date:</b> 8/4/2026 | <b>Time:</b> 09:00 AM | <b>Report ID:</b> PRO401 |

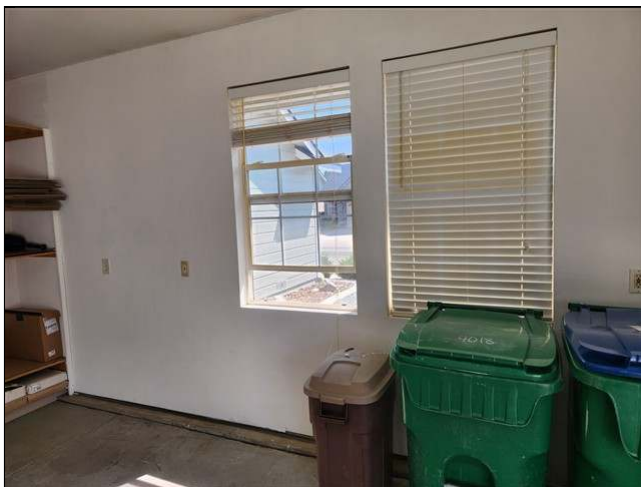
(2) NOTE: North window at garage East wall, and North window at 1st guest bedroom, are very stiff to operate, with signs of windows rubbing hard against the side jamb.

1.4 Item 1(Picture) North window at garage East wall

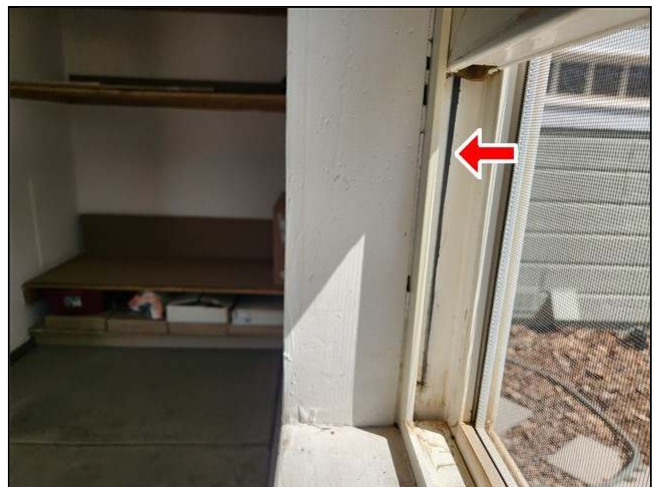
1.4 Item 2(Picture) rubbing side jamb

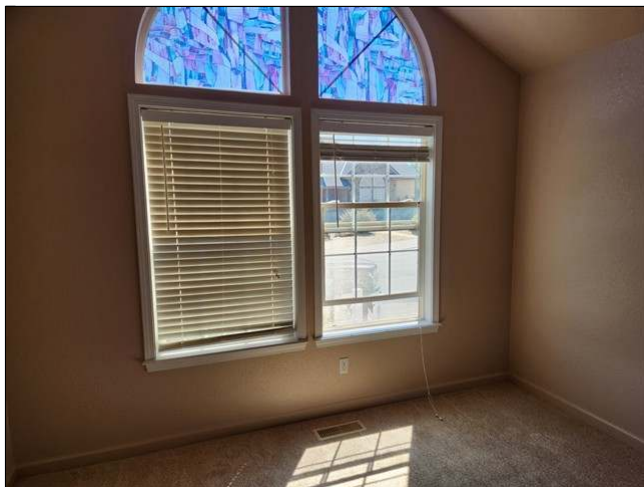
1.4 Item 3(Picture) North window at 1st guest bedroom

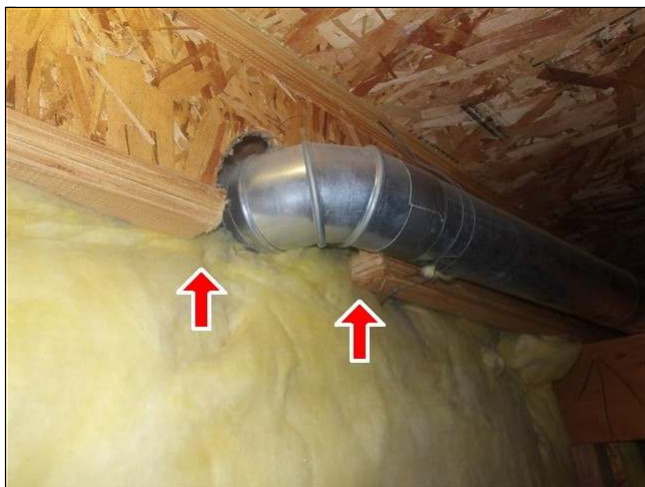
The floor joist bottom cord has been cut through under the laundry room for dryer vent ducting. Pre-manufactured or engineered floor joist should not be cut at the top or bottom cords. Recommend additional support, either headered off

3.6 Item 1(Picture) bottom cord has been cut through

from adjacent floor joists (preferred) or pier and post installed directly beneath the damaged area (with proper footings), as preferred by contractor.

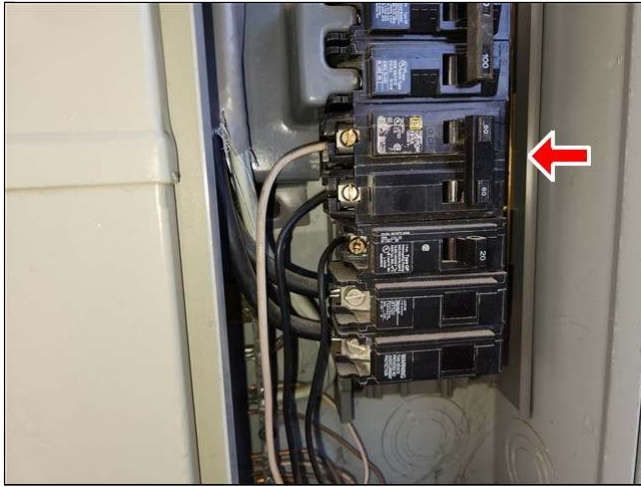
(2) Double Pole 60 amp circuit breaker has been installed in the main electrical panel, supplying current through 30 amp rated wire. This breaker does not afford overload protection for this wire and circuit. Recommend repair by a licensed electrician.

4.4 Item 1(Picture) 60 amp breaker, 30 amp wire

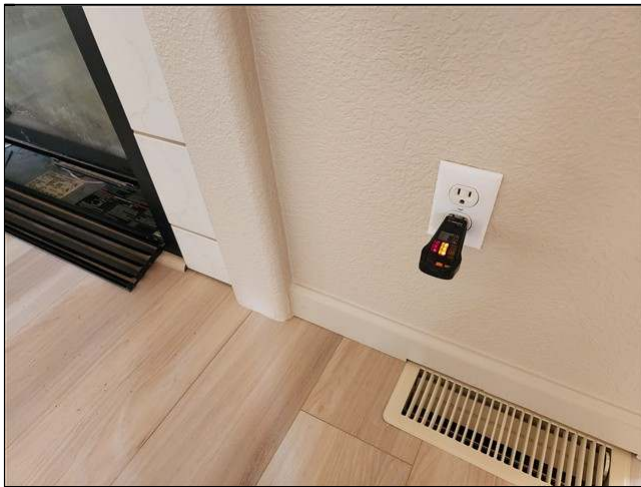
Hot/Neutral wires are crossed (reverse polarity) at the following location: Wall outlet at right side of living room fireplace. Recommend repair by a qualified person.

4.6 Item 1(Picture) Hot/Neutral wires are crossed (reverse polarity)

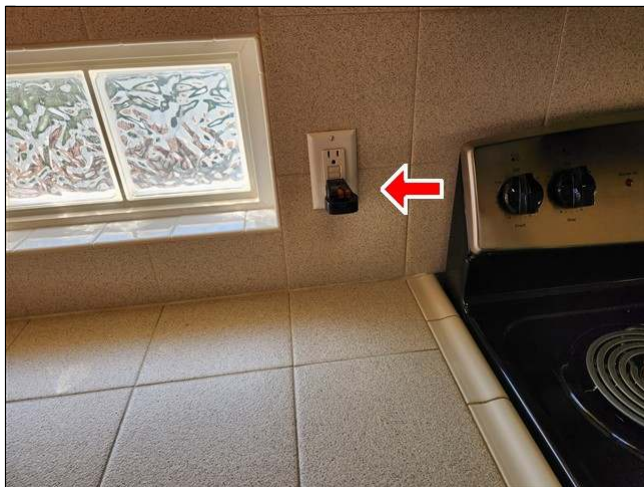
(2) GFCI (Ground Fault Circuit Interrupter) outlet at the kitchen, left side of range, did not trip when tested (defective). Further inspection/repair is needed by a qualified licensed electrician.

4.7 Item 1(Picture) defective GFCI at kitchen

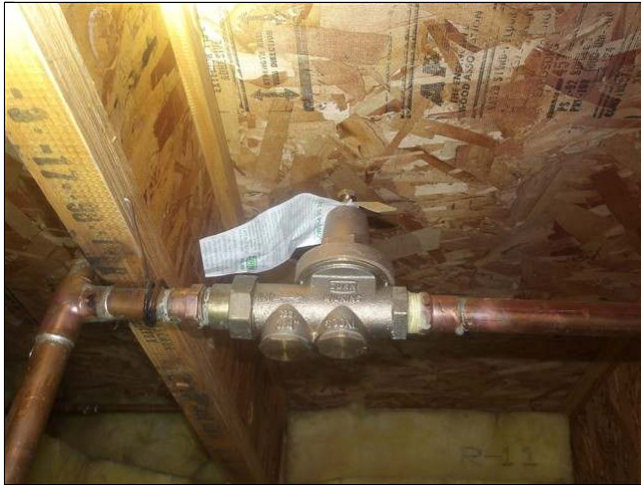
The water pressure was tested at the North hose bib, pressure was 135 psi at time of inspection. pressure was checked again at the rear garage hose bib, with 62 psi. It appears the North hose bib is located before the water pressure regulator, possibly for stronger psi for exterior irrigation. No problems noted... Pressure regulator noted at the Northeast corner of crawlspace area, for future water pressure adjustments, if necessary.

5.2 Item 1(Picture) pressure regulator in crawlspace

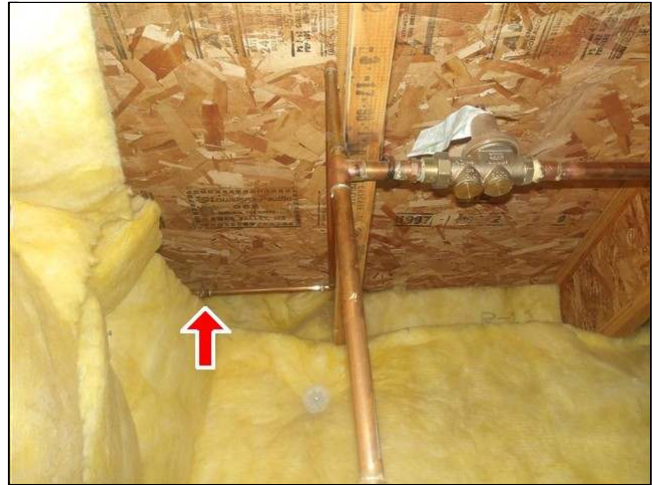
5.2 Item 2(Picture) north hose bib is before the pressure regulator

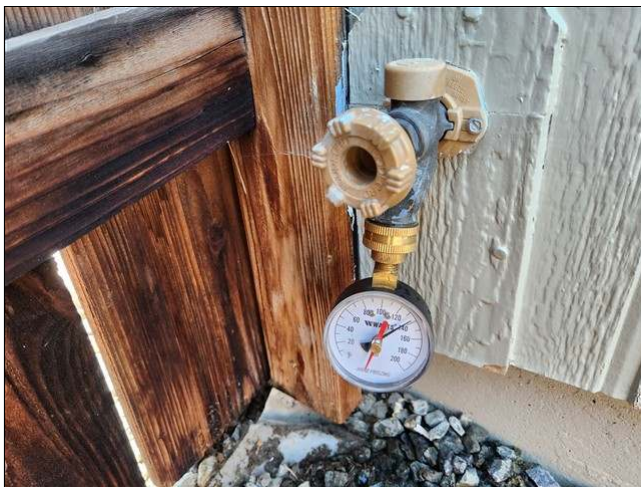
5.2 Item 3(Picture) water pressure at north hose bib

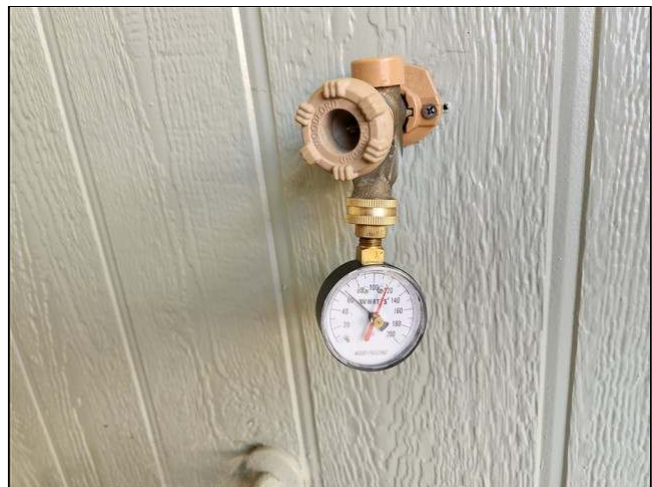
5.2 Item 4(Picture) water pressure at rear hose bib

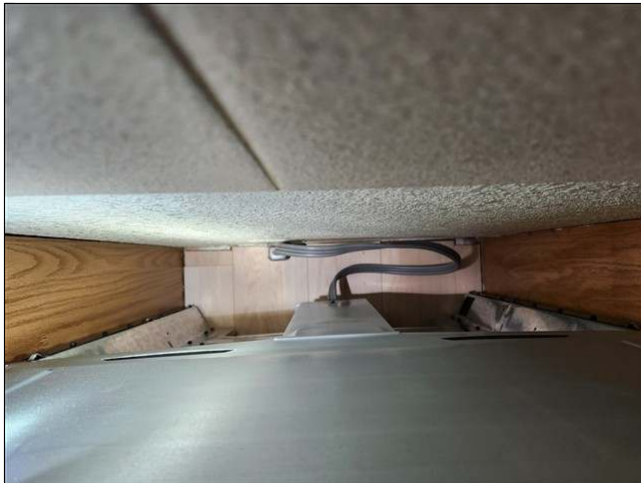
**Note: This appliance does not have an anti-tip bracket installed.** This is recommended by the MFG to prevent accidental tipping of the appliance, in the event of a child standing on the oven door.

6.2 Item 1(Picture) behind range

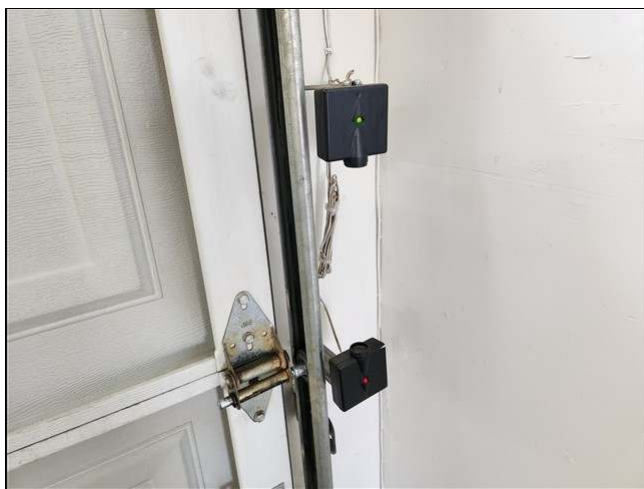
(2) The floor sensors for the garage door where installed facing each other on the front wall of the garage. The sensors need to be installed about six inches from the ground on both sides of the door, and are provided as a safety feature for the automatic opener. Recommend have the sensors properly installed for safety.

8.10 Item 1(Picture) garage door floor sensors

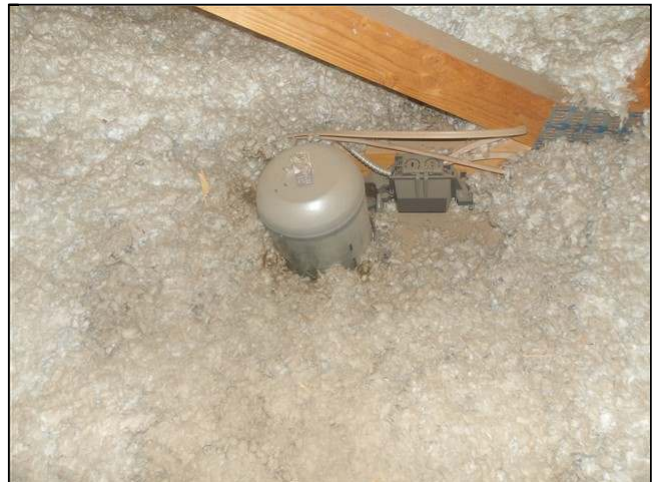
9.0 Item 4(Picture) contacting insulation

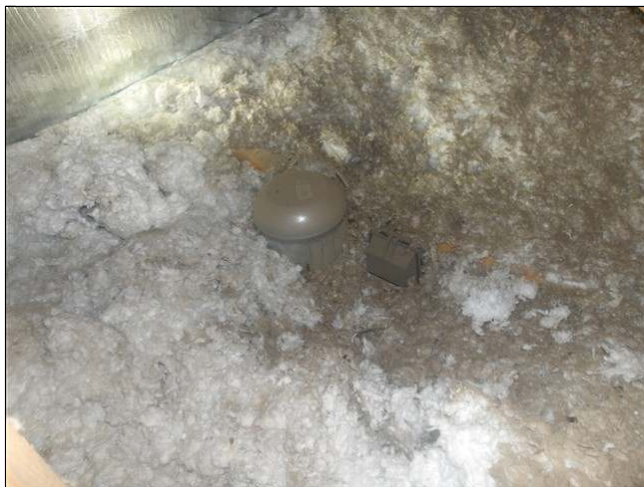
9.0 Item 5(Picture) contacting insulation

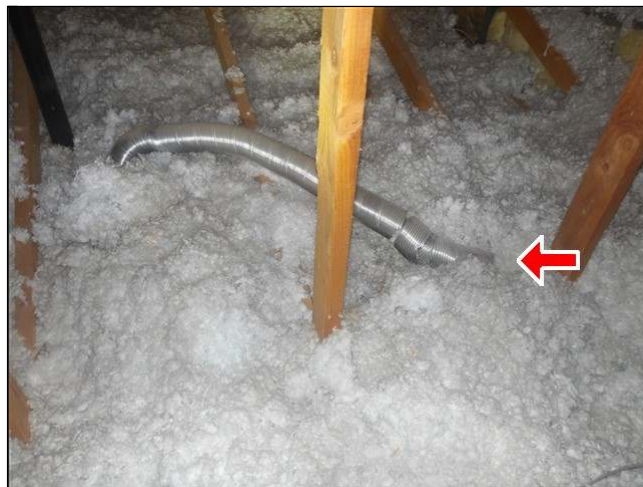
9.4 Item 2(Picture) does not vent to outside at the master bath

(2) The Exhaust fan does not vent to outside at the master bath. Vent pipes that terminate in attic space can sometimes cause moisture that can lead to mold or cause condensation. A qualified person should repair or replace as needed.
