Inspection Report

Property Address:
1926 Currant Ct.
Gardnerville NV 89410

Clear Choice Home Inspection Services

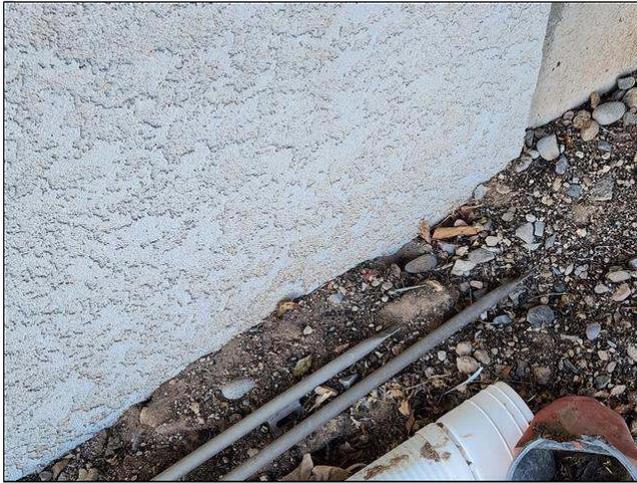
1.1 Item 1(Picture) ground contact at NW corner

Stucco Siding in contact with the ground at the Northwest corner of home (under deck). Although this is a masonry material, it uses plywood as a backing material, which could be damaged by wicking moisture from the ground. Recommend correct grade to eliminate ground contact.

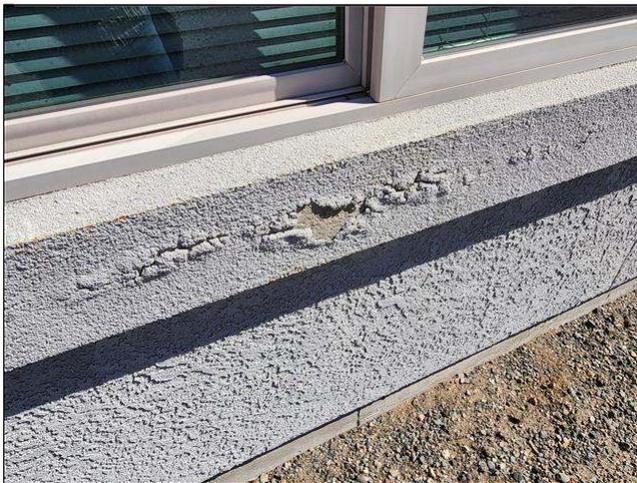
1.2 Item 1(Picture) south garage window trim

Stucco finish coat is failing at the South wall window of garage, and should be repaired for proper weather/moisture protection.

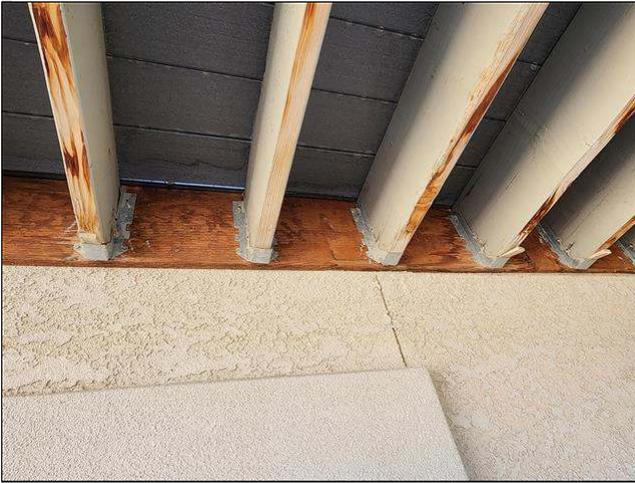
1.6 Item 1(Picture) NW deck joist brackets

Northwest deck framing joists are not properly secured, and requires additional fasteners through the brackets to prevent possible pulling away from the wall.

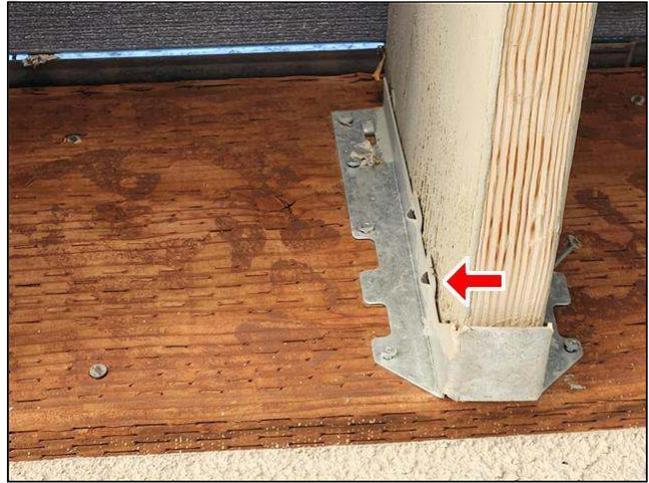
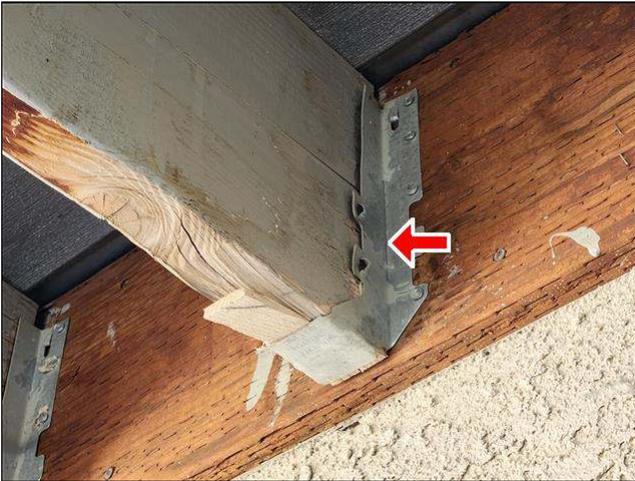
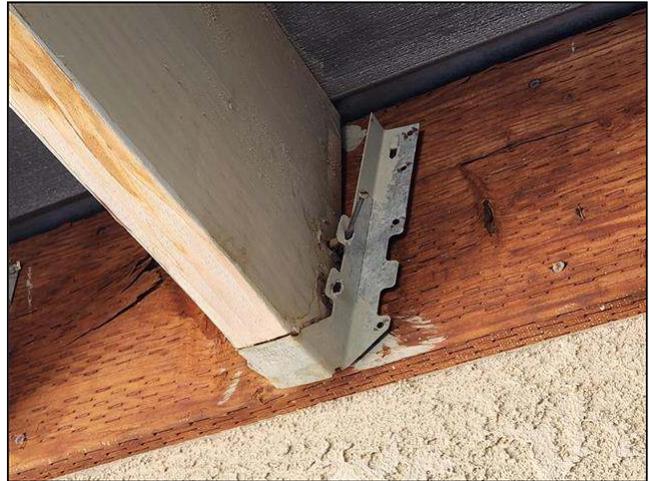
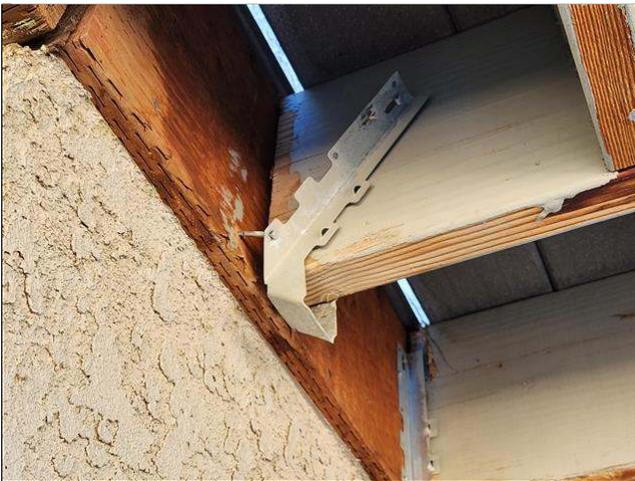
1.6 Item 2(Picture) missing fasteners

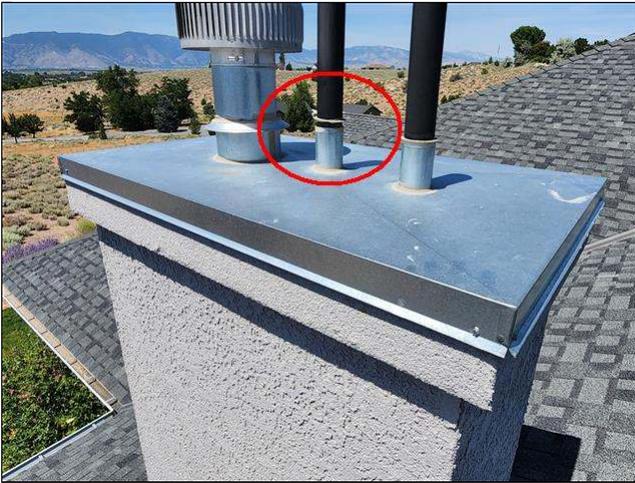
(2) NOTE: The plumbing vent pipe storm collar located at the chimney, should be repositioned and sealed against flashing to prevent moisture intrusion into attic framing areas.

2.3 Item 4(Picture) chimney vent pipe seals

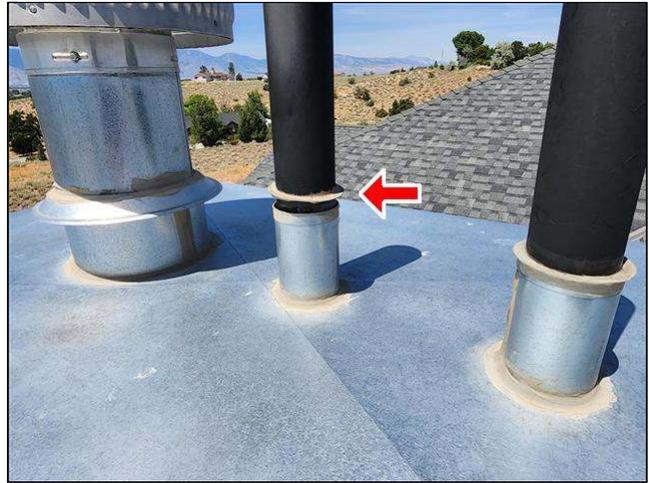
2.3 Item 5(Picture) reposition downward and seal

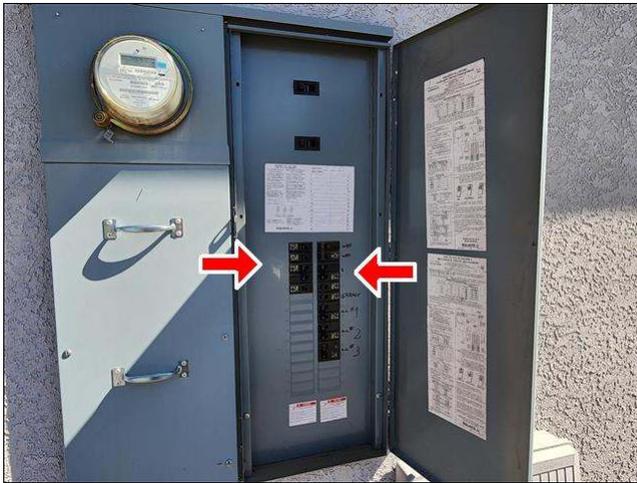
(2) Main Panel... Some circuit labels are present, others are illegible/missing or confusing. I recommend correcting for safety reasons.

4.1 Item 5(Picture) main panel missing labels

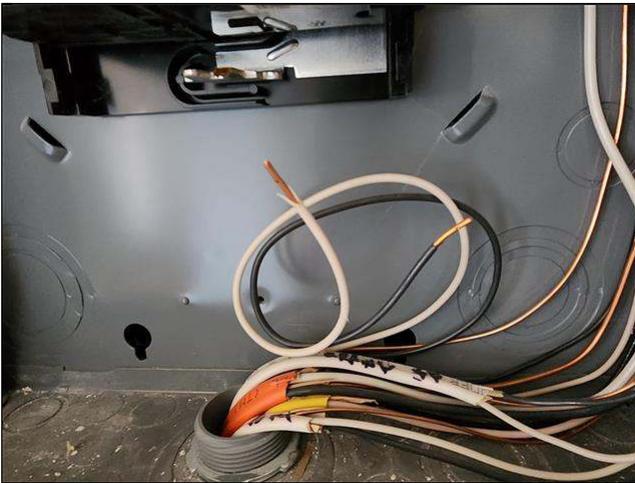
There are 4 Loose wire ends that need placing inside boxes with a cover-plate in the crawlspace area. Disconnected circuit wire inside hallway panel, appears was meant for 1 or 2 of the loose end wires, however I am unable to verify. Current local codes require loose end wires to be terminated inside a covered box. A qualified person should repair as needed.

4.5 Item 1(Picture) loose wires inside panel

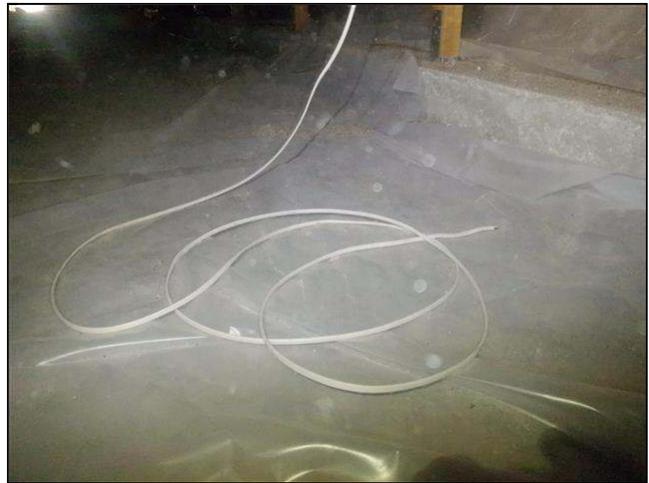
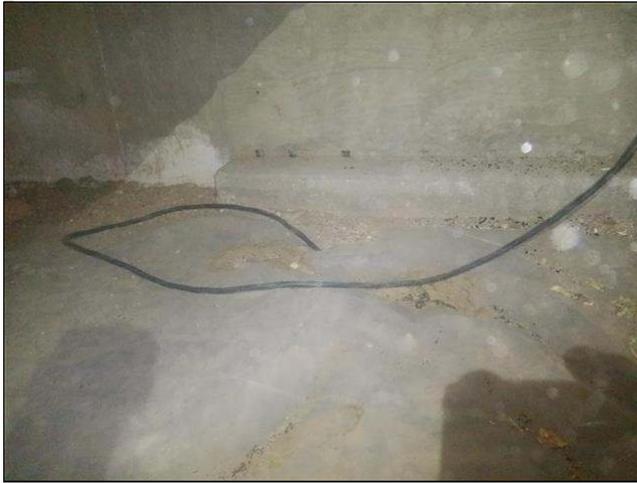
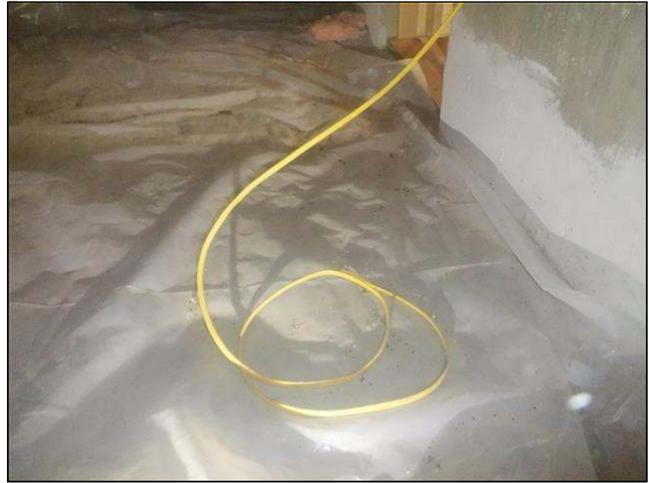
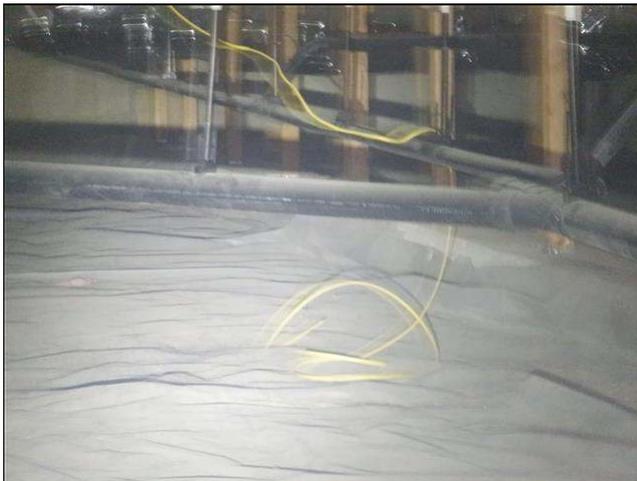
4.5 Item 2(Picture) loose wire in crawlspace

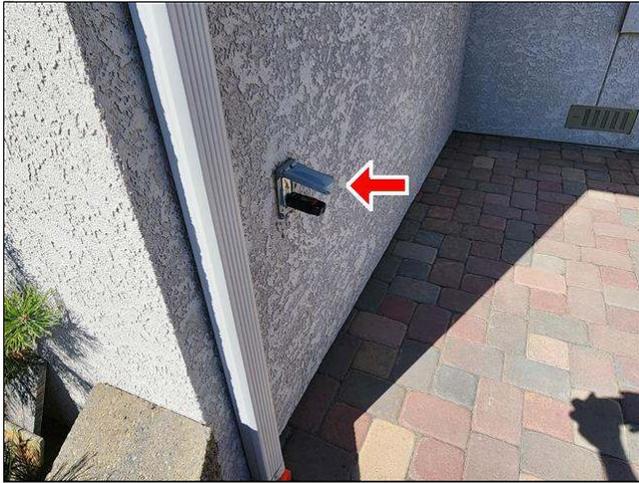
(1) GFCI (Ground Fault Circuit Interrupter) outlet at the East front exterior wall of home, did not reset properly when tested (defective). Further inspection/repair is needed by a qualified licensed electrician.

4.7 Item 1(Picture) faulty gfcı at east exterior

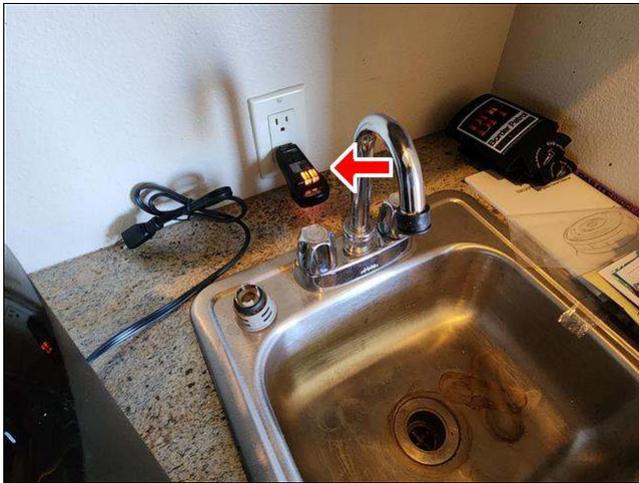
(2) There is NO GFCI protection at the Bar sink outlet. Recommend upgrading to GFCI outlets in areas within 6 feet of plumbing fixtures, by a qualified person. **RE: 4.7(2)**—Please see *Exhibit: Seller Repair Itemization*

4.7 Item 2(Picture) bar sink outlet not gfcı protected

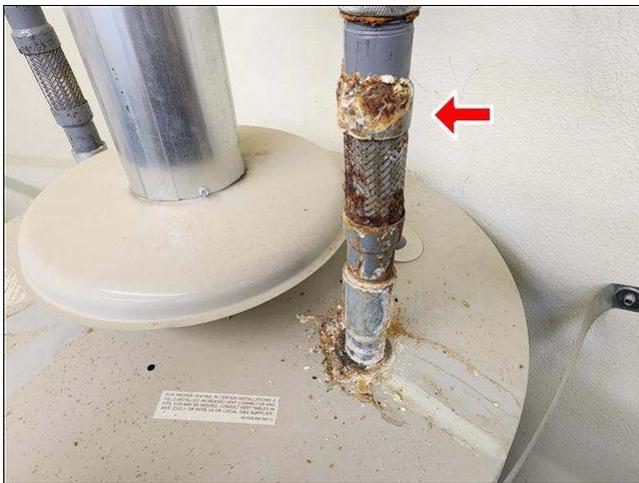
(2) Signs of past seeping and corrosion noted at the water heater supply pipe connection, however was not leaking at time of inspection.

5.2 Item 2(Picture) signs of past leaking

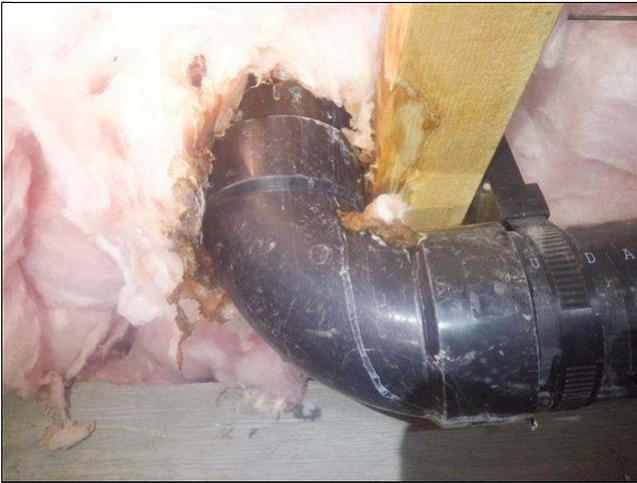
Toilet drain is leaking in the crawlspace area under the East Guest Bathroom (North bathroom). Recommend repair by a licensed plumbing contractor to prevent excessive moisture, which can lead to mold/fungus, in the crawlspace.

5.3 Item 1(Picture) guest bathroom toilet drain

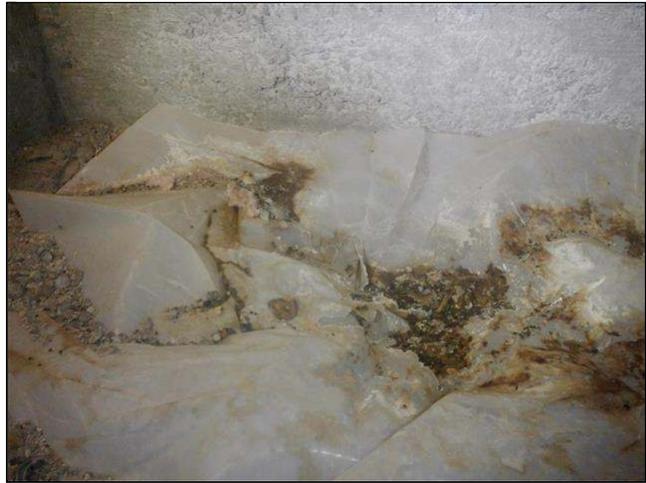
5.3 Item 2(Picture) moisture from leak

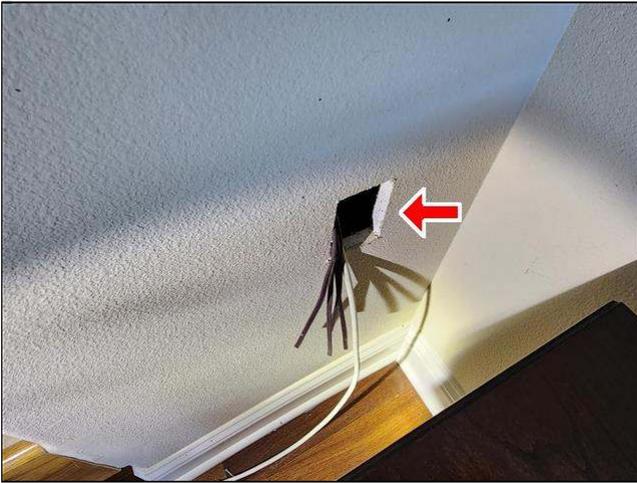
(2) NOTE: Recommend installing cover plate at right side of living room fireplace.

7.2 Item 1(Picture) open hole in wall

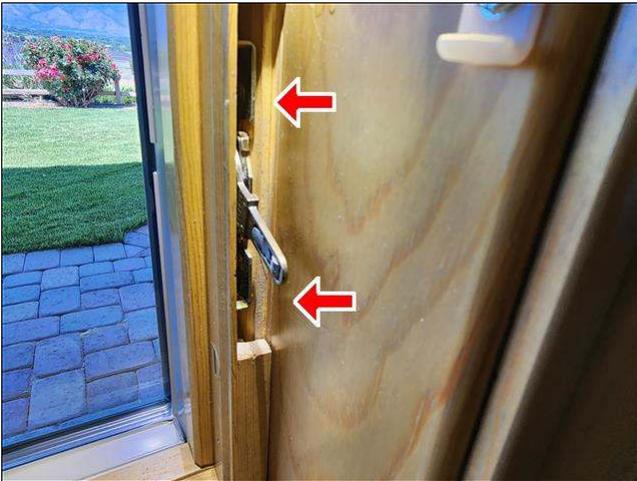
(1) NOTE: Interior casement windows at Living room and Kitchen Nook are missing finish trim on, and around the window latches.

7.5 Item 1(Picture) missing finish trim and handles

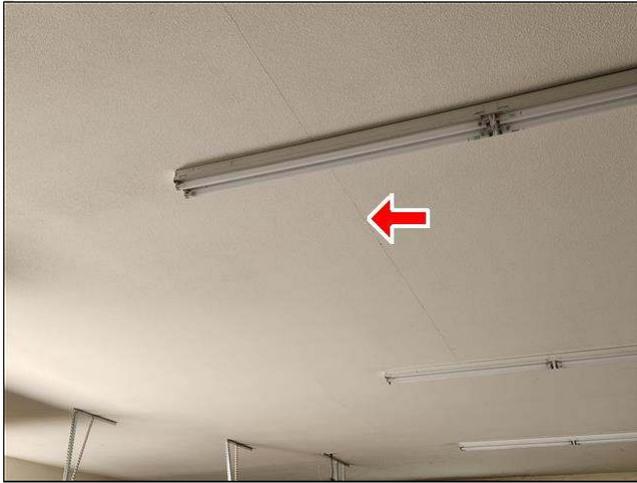
Ceilings finished with drywall, with typical settlement cracks, no problems noted.

8.3 Item 1(Picture) typical settlement crack
