# Inspection Report

**Property Address:**  
1459 Harvest Ave  
Gardnerville NV 89410

<b>Date:</b> 7/2/2024	<b>Time:</b> 08:00 AM	<b>Report ID:</b> CON145
<b>Property:</b> 1459 Harvest Ave Gardnerville NV 89410	<b>Customer:</b> Rosemarie Conner	<b>Real Estate Professional:</b> Thomas Vander Laan Coldwell Banker

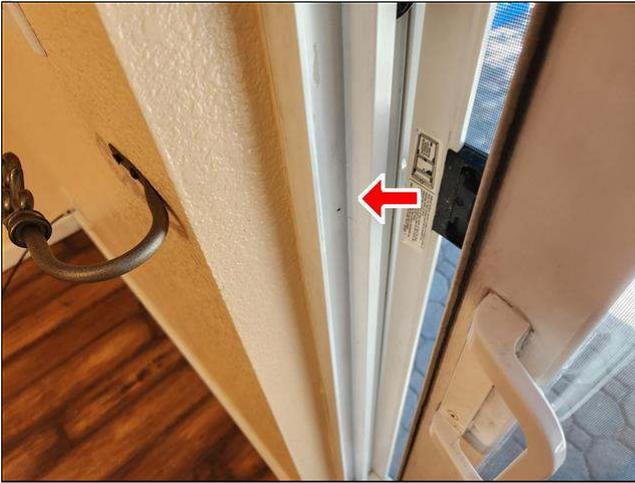
Latch is missing for the living room sliding glass door, which leaves the home unsecured.

1.3 Item 1(Picture) missing latch at living room slider door

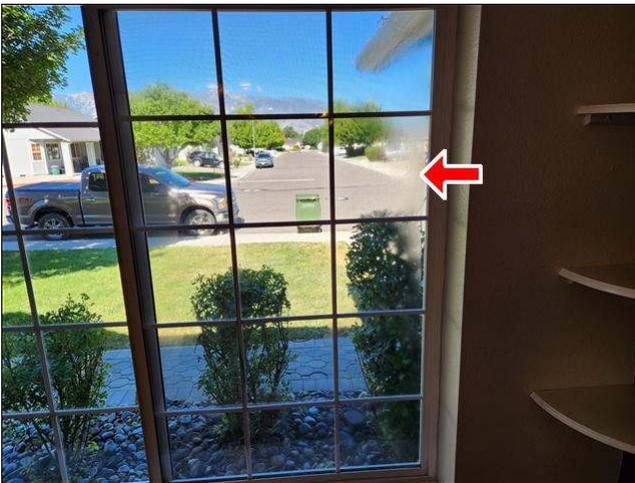
(2) Window is cloudy/condensation (lost seal) at the front dining room West window, South dining room window, Southwest guest bedroom, and guest bathroom window. This is a cosmetic issue for your information. In order to correct the cloudy appearance of glass, a replacement of glass pane or the unit will be necessary. A qualified person should repair or replace as needed.

1.4 Item 1(Picture) cloudy window at west dining room

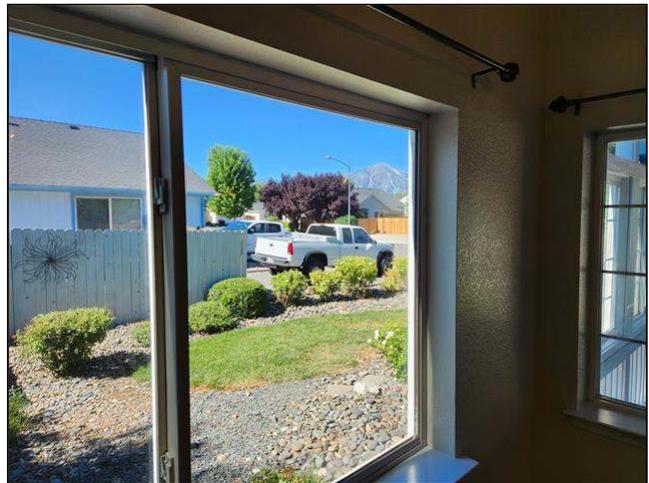
1.4 Item 2(Picture) condensation stains at south dining room

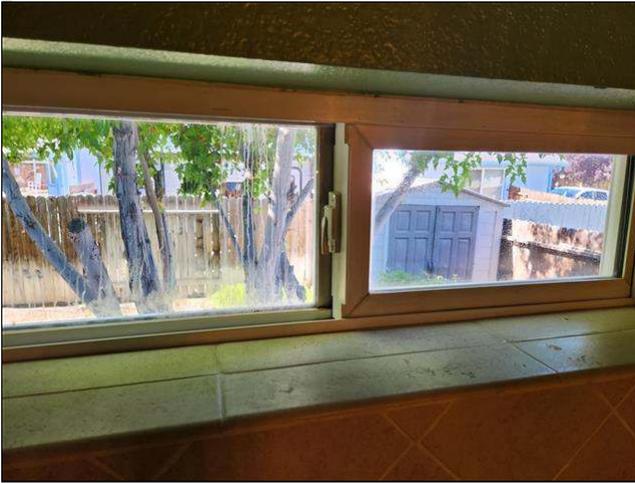
1.4 Item 3(Picture) guest bathroom window

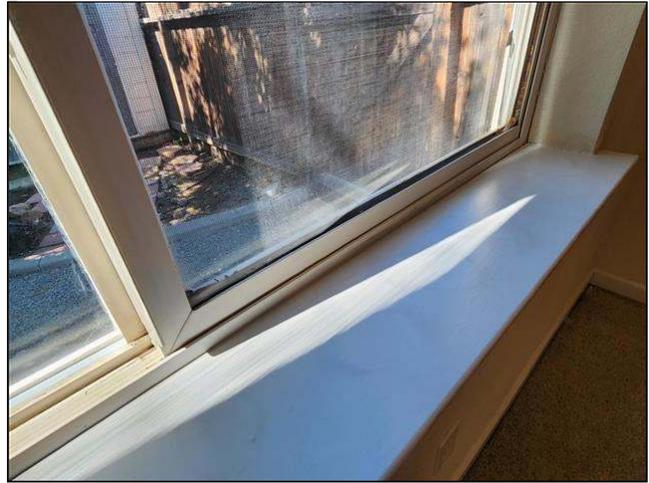
1.4 Item 4(Picture) southwest guest bedroom window

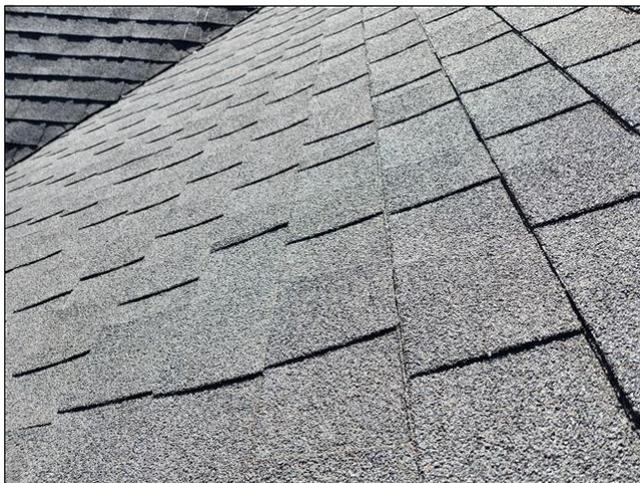
(1) The roof covering appears to be original (22 years) and is a 30 year architectural, asphalt/fiberglass Composition shingle with approximately 8 years of it's life remaining. Typical loss of granules noted from shingles, however is more advanced at the South and East slopes of roof. No problems noted at time of inspection. Recommend further evaluation of roof covering materials by a licensed Roofing Contractor for estimated remaining life of roof, as desired.

2.1 Item 1(Picture) condition of north slope shingles

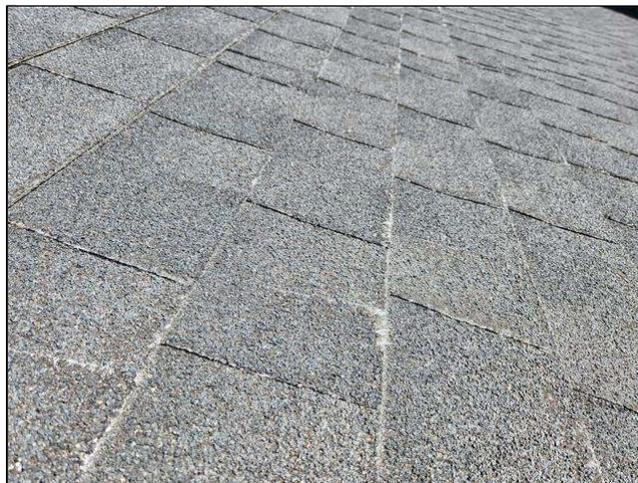
2.1 Item 2(Picture) condition of south and east shingles

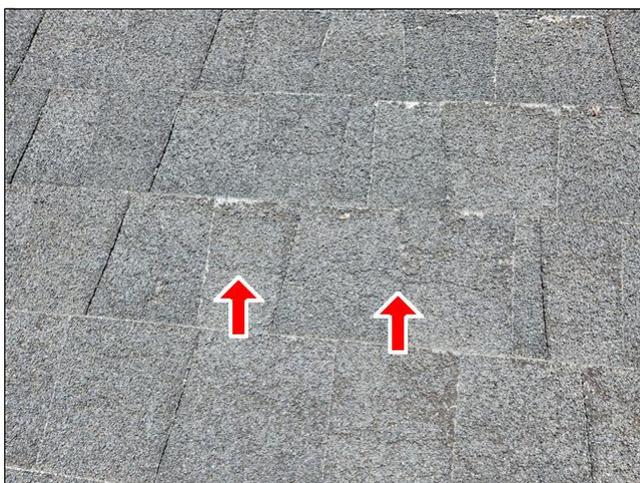
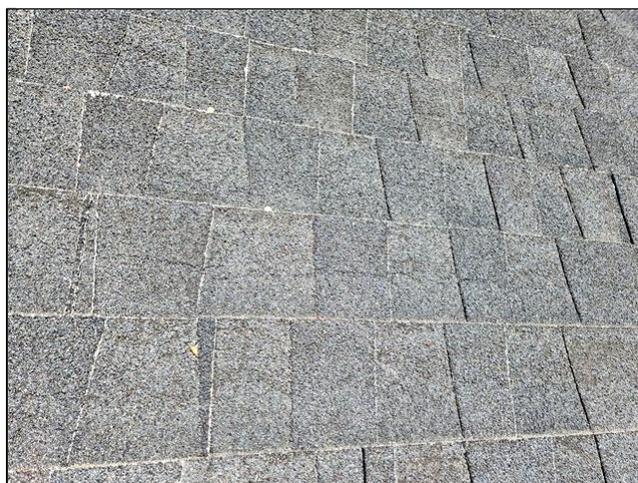
(2) NOTE: The asphalt composition shingle roof had visible widespread random cracking (mostly along the North and East slopes of roof). This condition is called "craze cracking". Craze-cracking is a natural response to long-term shrinkage of the shingle asphalt surface layer and is a common sign of aging. The severity of craze-cracking indicated normal wear.

2.1 Item 3(Picture) age cracking on shingles

2.1 Item 4(Picture) age cracking on shingles

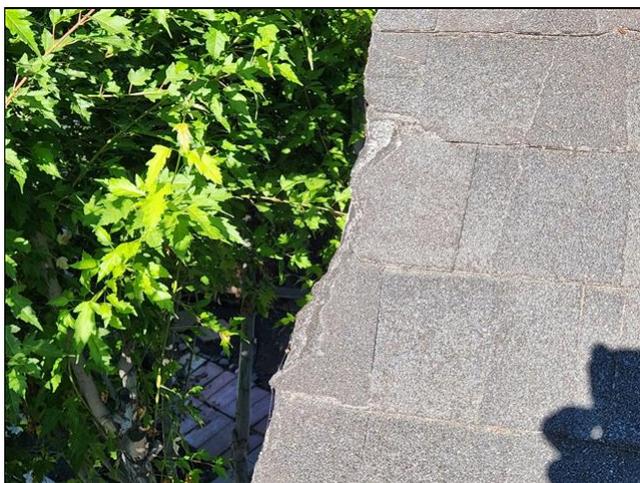
(3) NOTE: Small area of shingles damage noted at the Southeast corner of roof area, from past tree limbs.

2.1 Item 5(Picture) southeast corner roof edge

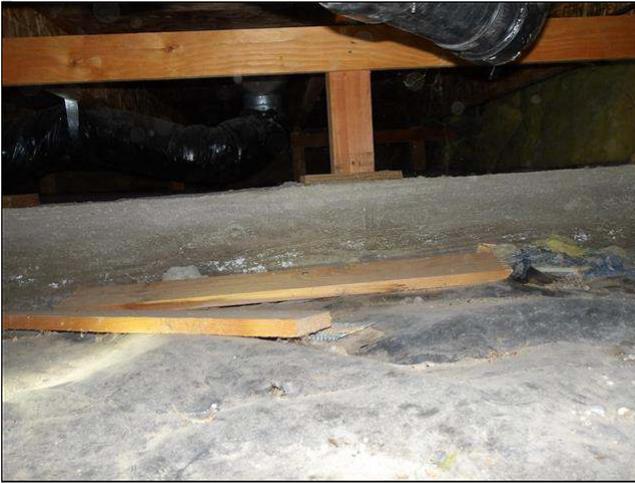
(2) Construction debris (and/or trash) should be removed from the crawlspace area. Trash/Debris noted at various locations.

3.2 Item 2(Picture) construction debris in crawlspace

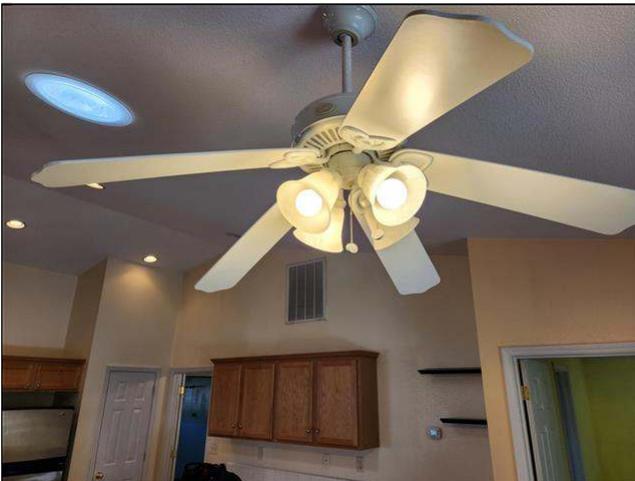
NOTE: Fan blades are VERY loose at the living room ceiling light/fan fixture, and should be secured to prevent possible damage.

4.6 Item 1(Picture) loose fan blades at living room

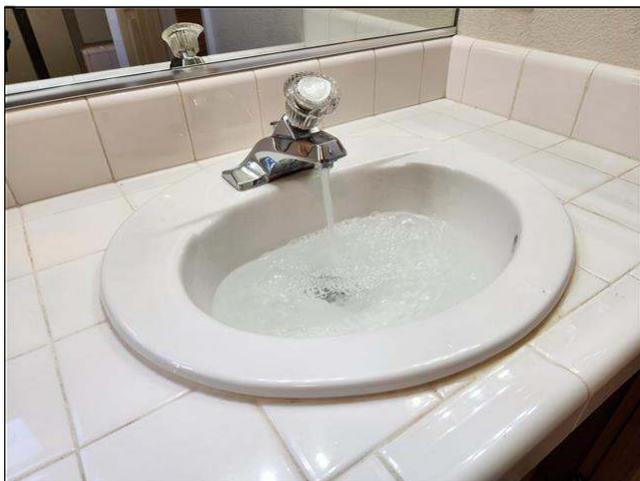
- 🏠 (1) Maintenance Item... The sinks drain slowly at the master bathroom. A qualified person should repair or correct as needed.

5.3 Item 1(Picture) slow draining sinks at master bath

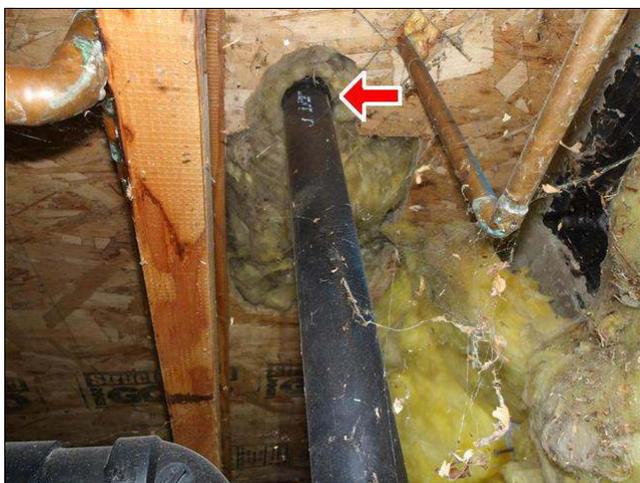
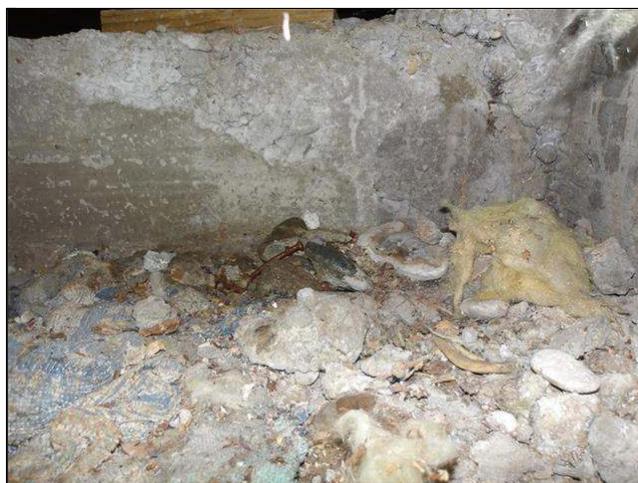
- 🏠 (2) Tub drain is leaking in the crawlspace area under the Guest Bathroom. Recommend repair by a licensed plumbing contractor to prevent excessive moisture, which can lead to mold/fungus, in the crawlspace.

5.3 Item 2(Picture) guest bath tub drain leaking

5.3 Item 3(Picture) moisture from leak

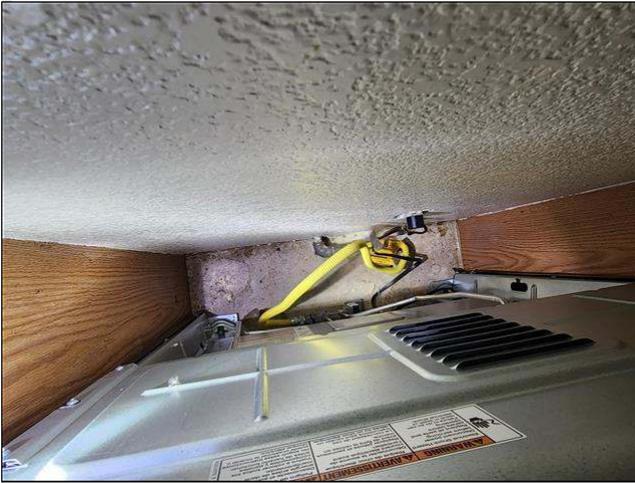
**Note: This appliance does not have an anti-tip bracket installed.** This is recommended by the MFG to prevent accidental tipping of the appliance, in the event of a child standing on the oven door.

6.2 Item 1(Picture) behind range

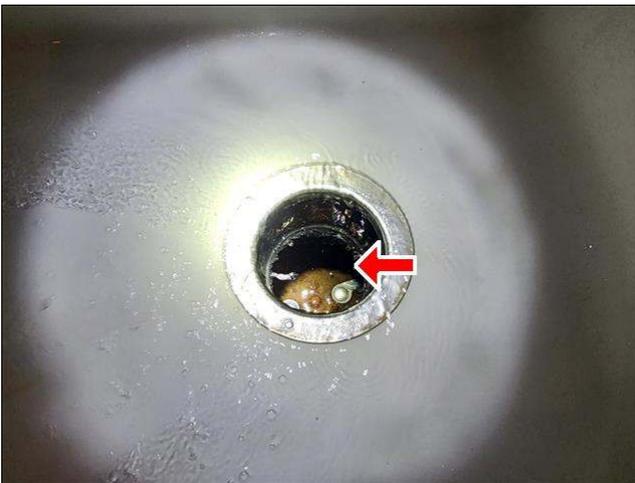
Disposer operated smoothly and quietly, appears clean and without cracks or signs of leaks. NOTE: Missing the rubber splash guard.

6.4 Item 1(Picture) missing rubber splash guard

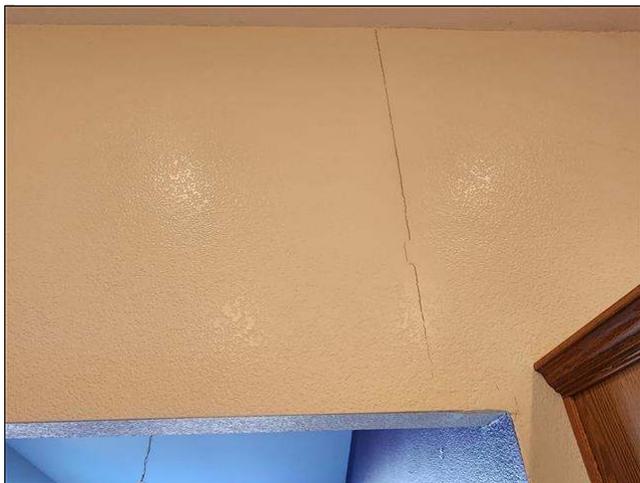
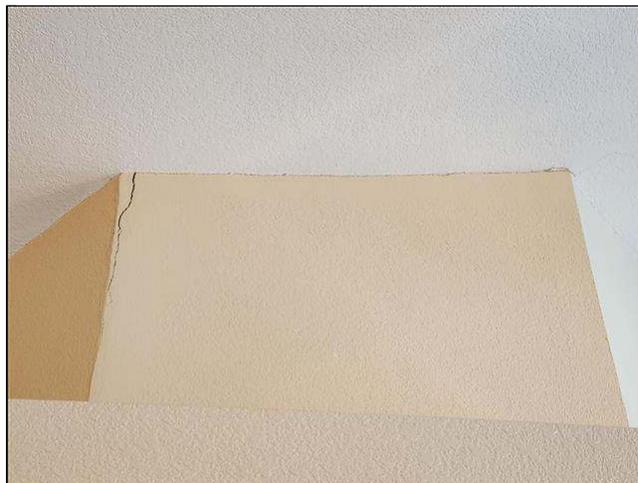
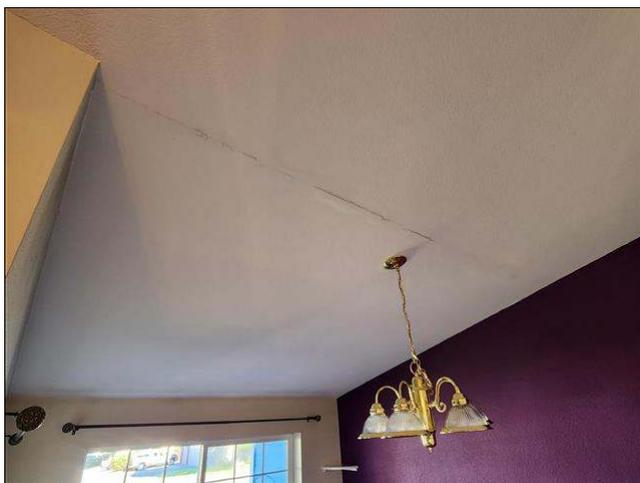
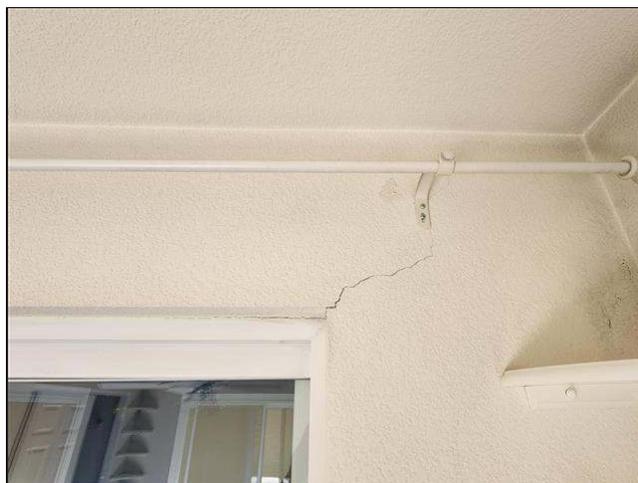
(1) Settling cracks noted to wall drywall and finish material at kitchen, dining room and Southeast bedroom. These cracks appear to be the result of normal settlement, and are considered to be cosmetic, as no foundation issues were noted.

7.2 Item 1(Picture) settlement crack at kitchen

7.2 Item 2(Picture) settlement crack at living/dining room

7.2 Item 3(Picture) settlement crack at dining room

7.2 Item 4(Picture) settlement crack at guest bedroom

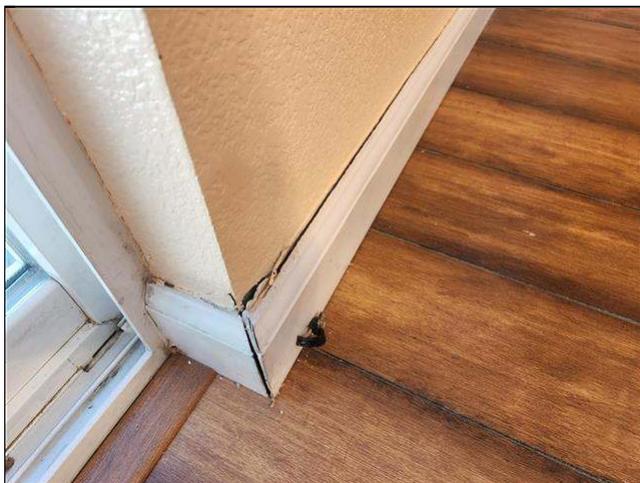
(2) Baseboard is loose and needs securing to wall at the living room, adjacent to the sliding glass door.

7.2 Item 5(Picture) loose baseboard at living room

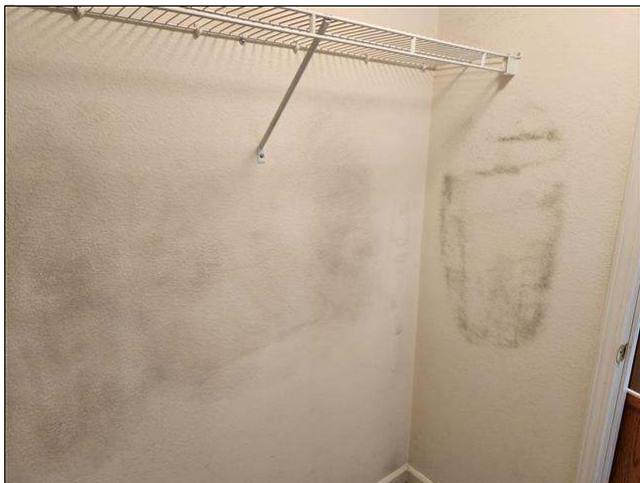
7.2 Item 6(Picture) master bedroom closet

(3) Interior walls need paint at various locations throughout the home.

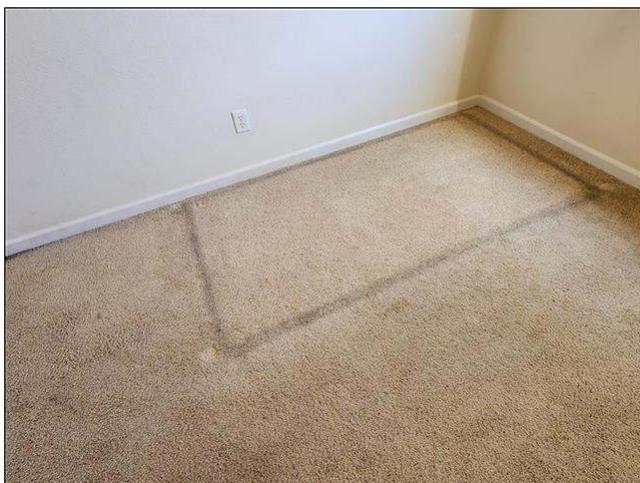
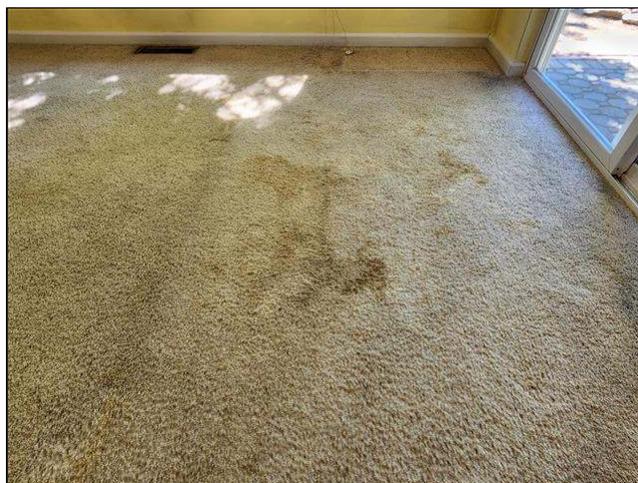
Carpet appears aged/worn and stained in areas, however is usable with professional cleaning... Small area of damage noted to edge of linoleum at garage occupant door from laundry room.

7.3 Item 1(Picture) stained carpet

7.3 Item 2(Picture) stained carpet

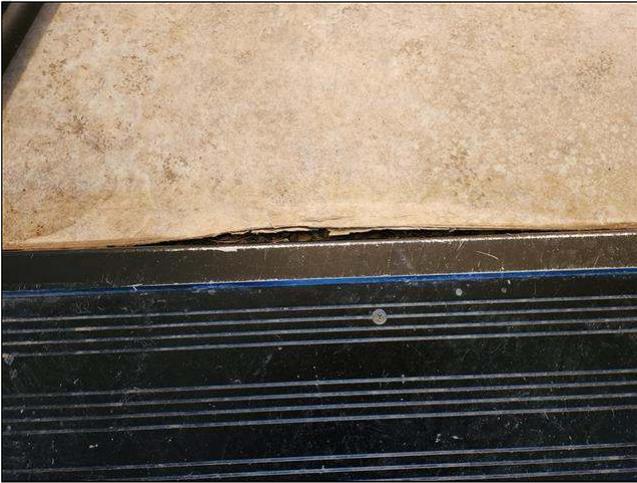
7.3 Item 3(Picture) linoleum flooring at garage occupant door

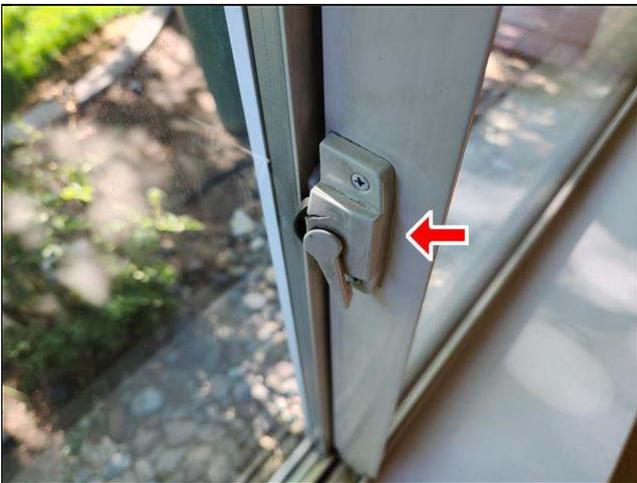
(1) Lower window lock/latch is broken at the master bedroom window (upper lock functions as intended).

7.5 Item 1(Picture) master bedroom window lock

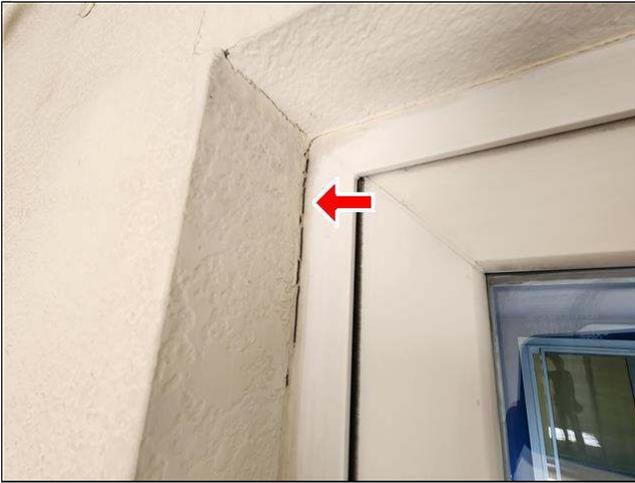
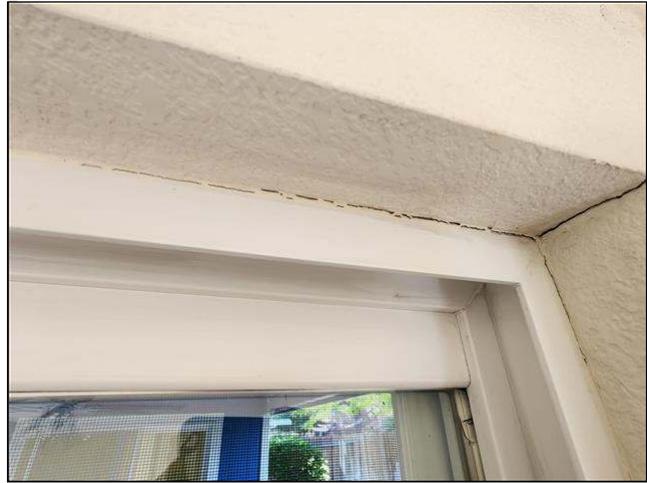
(2) Recommend caulking maintenance at interior window sills where settling has occurred, to prevent drafts and maintain the home's integrity and efficiency.

7.5 Item 2(Picture) caulking maintenance at interior window openings

7.5 Item 3(Picture) caulking maintenance at interior window openings

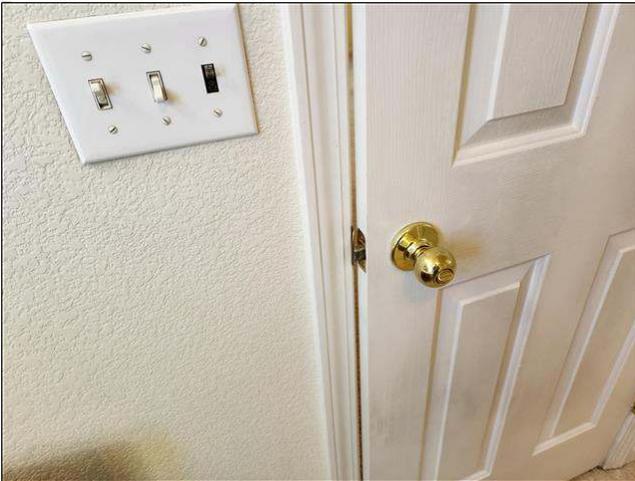
7.6 Item 1(Picture) master bathroom door

The Privacy door needs strike and latch adjustment to latch properly at the Master Bathroom. This is a maintenance issue and is for your information. A qualified person should repair as needed.

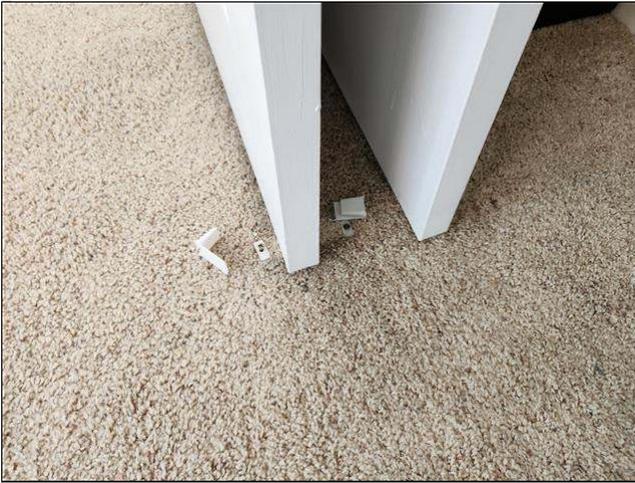
(2) The floor guides are missing/broken at the guest bedroom closet bi-pass doors. Recommend as to prevent track or roller slide damage.

7.7 Item 1(Picture) broken closet door floor guides

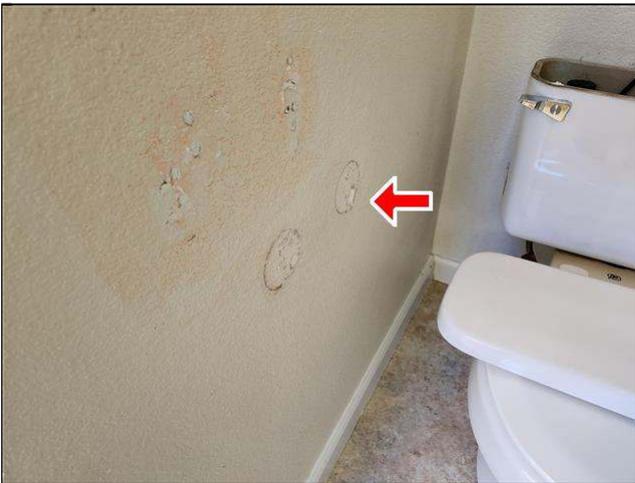
NOTE: Toilet paper holder is missing at the master bathroom.

7.8 Item 1(Picture) missing paper holder in master bath

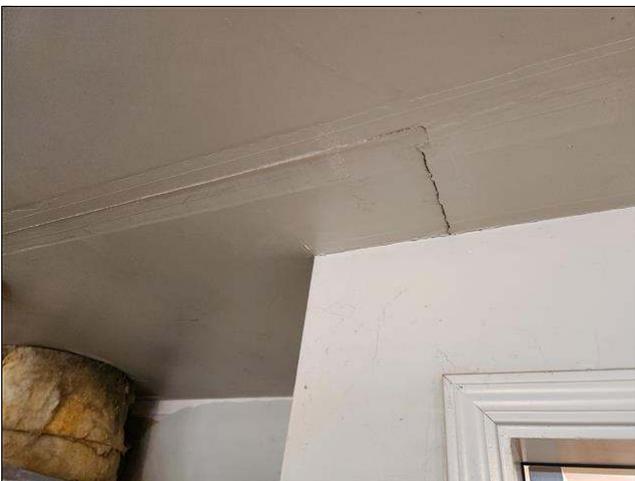
Ceilings finished with drywall, with a couple settlement cracks, no problems noted.

8.2 Item 1(Picture) settlement crack in garage

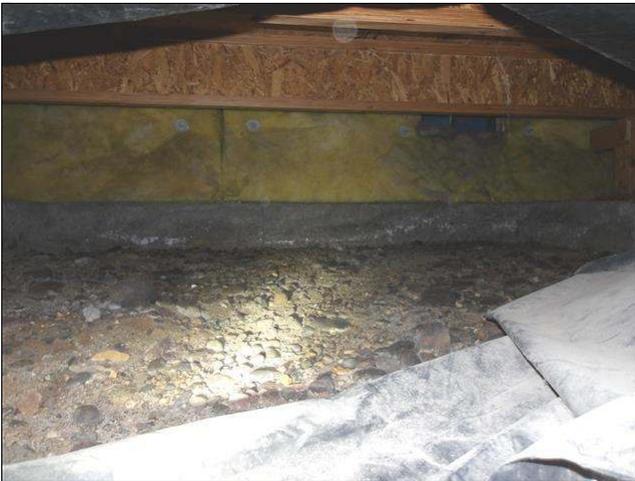
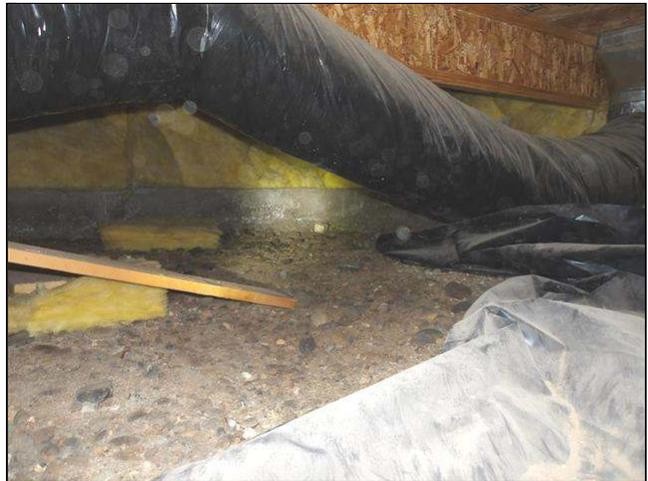
9.2 Item 1(Picture) under master bedroom

(2) The vapor barrier (plastic) on the crawlspace ground is out of position under Master bedroom and front Dining room areas, not fully covering the ground as intended. A vapor barrier provides added protection to the floor system from moisture or dampness that can enter from ground. A qualified person should repair as needed.

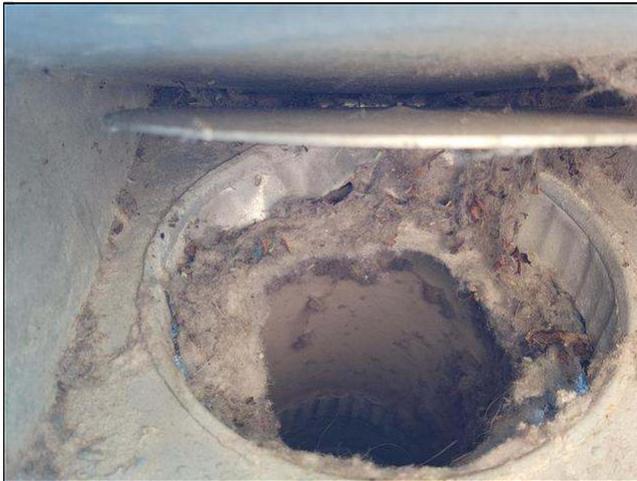
(2) The dryer vent piping has a damaged/bent/clogged vent hood outside, not allowing the vent to close when not in use. This condition could allow pest/rodent intrusion. I recommend repair as needed.

9.4 Item 3(Picture) dryer vent hood
