## **Title 5 Official Inspection Form**

Subsurface Sewage Disposal System Form - Not for Voluntary Assessments

6 Berkley Circle		*			
Property Address					
Mary Griffin					
Owner's Name		-			
Hingham		M.A.	02043	June 1, 2021	
City/Town		State	Zip Code	Date of Inspection

A.	General Information		
1.	Inspector:		
	Paul J Foisy		
	Name of Inspector		
	E.L. Margetts & Sons Inc		
	Company Name		
	Off 97 Ward Street		
	Company Address		
	Hingham	M.A. 02043	
	City/Town	State Zip Code	
	781-749-0559	SI4517	
	Telephone Number	License Number

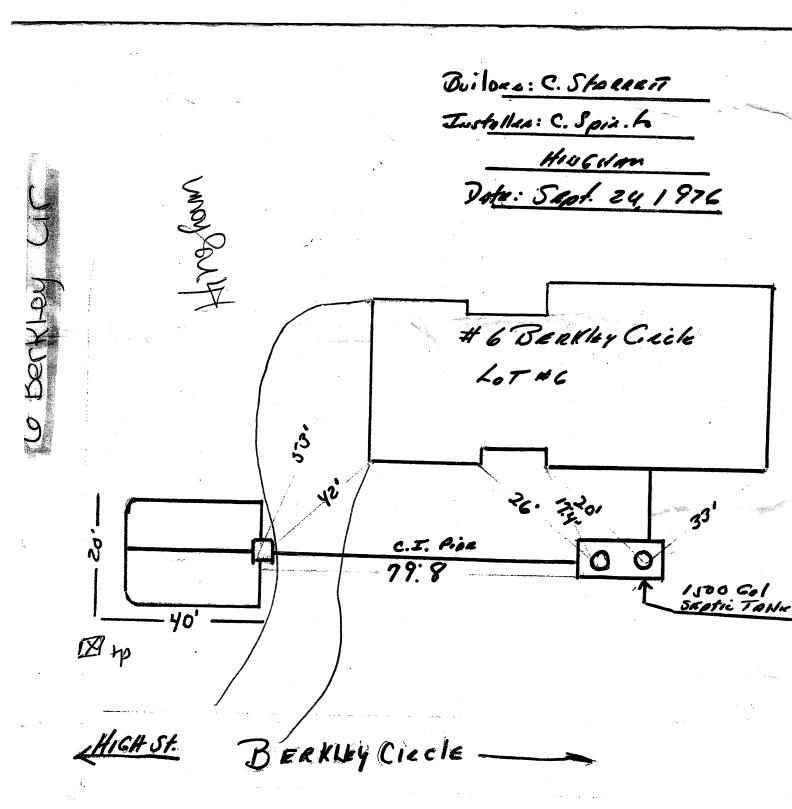
6 Berkley Circle Property Address			
Mary Griffin Dwner's Name			
Hingham	M.A.	02043	June 1, 2021
ity/Town	State	Zip Code	Date of Inspection
D. System Information (cont.)			
Sketch Of Sewage Disposal System: I at least two permanent reference land where public water supply enters the bases.	marks or benc	hmarks. Locate	e all wells within 100 feet. Loca
<ul><li>☐ hand-sketch in the area below</li><li>☐ drawing attached separately</li></ul>
