Inspection Report

304 Kathy Ave.
Yerington NV 89447

Date: 2/21/2023	Time: 08:15 AM	Report ID: CRE304
Property: 304 Kathy Ave. Yerington NV 89447	Customer:	Real Estate Professional: Thomas Vander Laan Coldwell Banker

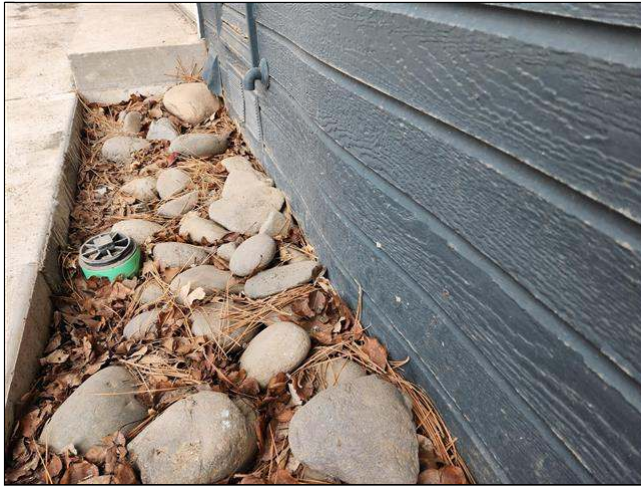
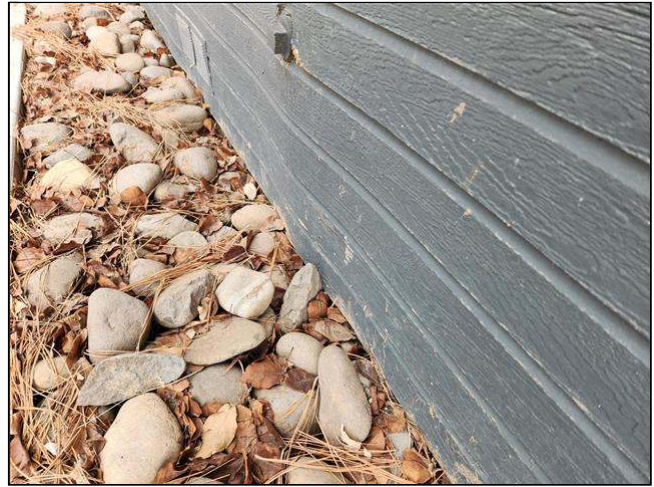
(1) Wall siding shows "bowed" areas across the North side of home, and appears was caused from past moisture absorption, most likely from roof run-off moisture splashing off the concrete. Gutters would be beneficial in this location.

1.1 Item 1(Picture) bowed siding at north side

1.1 Item 2(Picture) bowed siding at north side

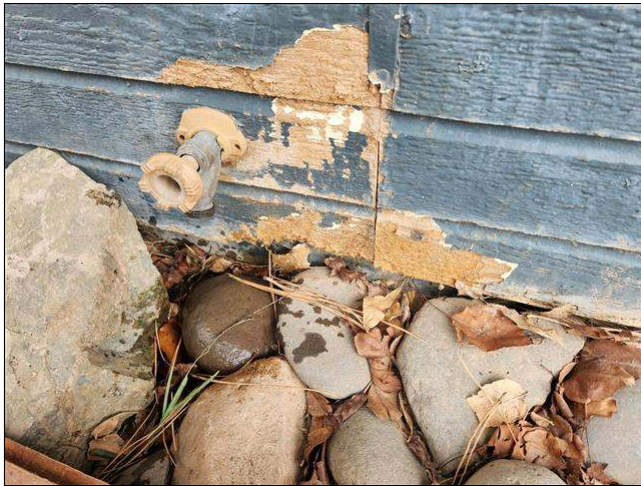
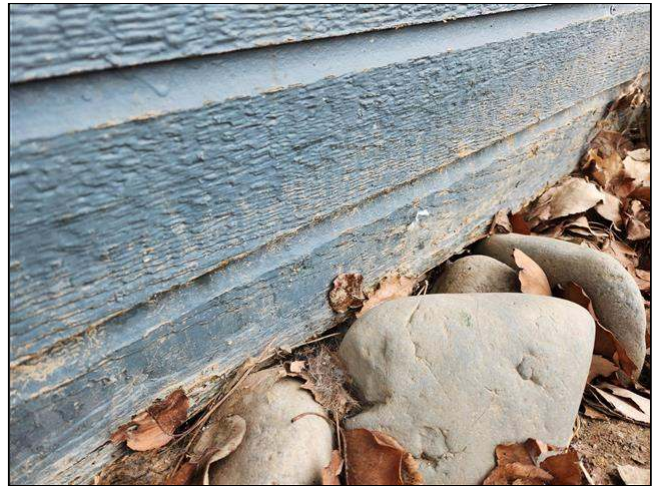
(2) NOTE: There are a few areas of lower wall siding damage noted along the North side of home. Recommend further evaluation by a qualified person as needed.

1.1 Item 3(Picture) damaged wall siding at north side

1.1 Item 4(Picture) damaged lower edge at north side

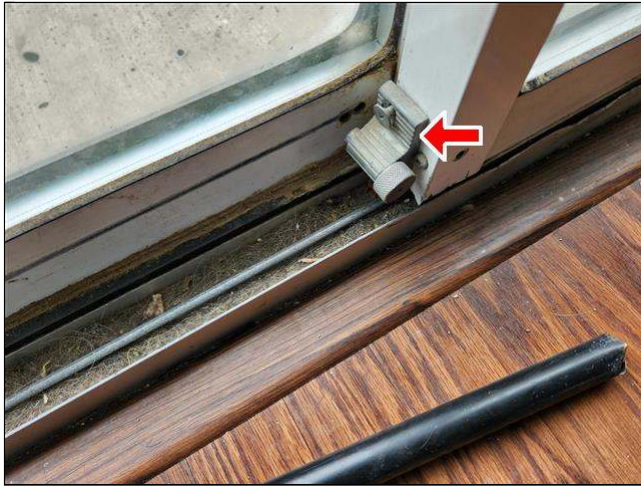
(2) Living room and Master bedroom sliding glass doors have NO lock installed at handles. Living room door has an operable lower security lock, however the master bedroom door security lock is broken.

1.3 Item 1(Picture) broken lock at master sliding glass door

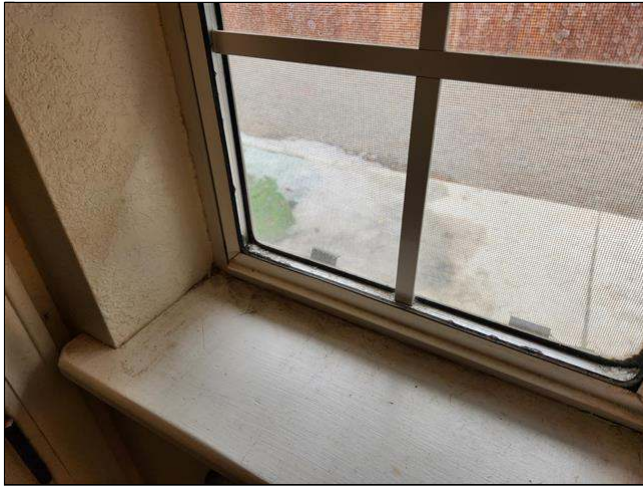
(2) Inside window pane is broken out at the master bathroom, and should be replaced.

1.4 Item 3(Picture) missing/broken window pane at master bathroom

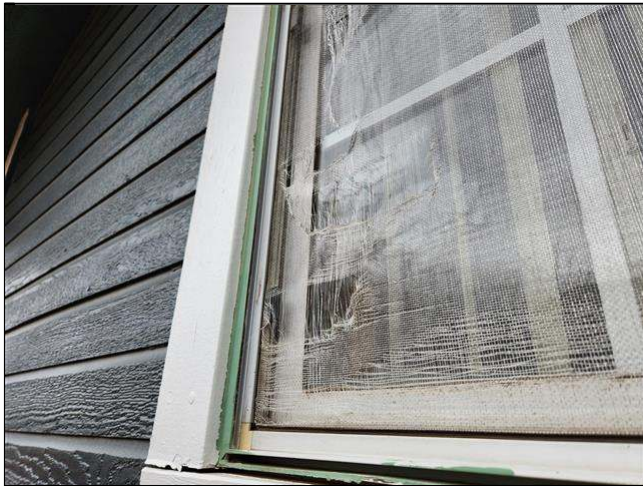
(3) Window screens at various locations are damaged/missing and no longer functions properly. Recommend repair as needed.

1.4 Item 4(Picture) damaged window screens

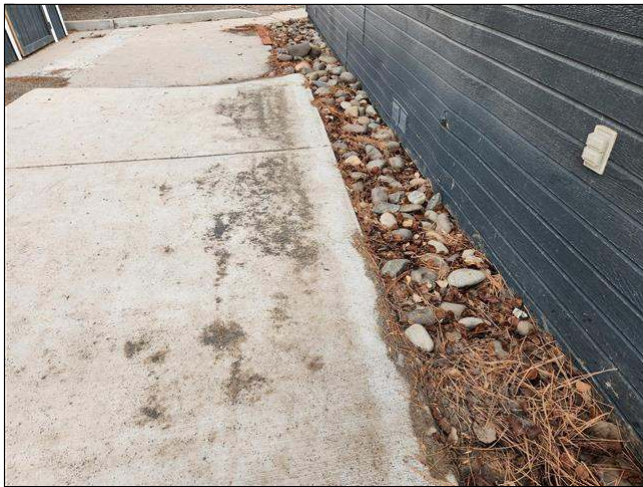
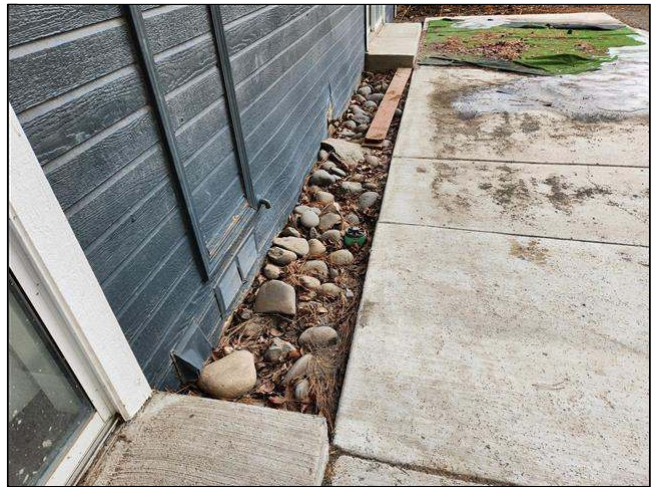
Grading at North side of home does not slope away from the foundation, and appears is catching roof run-off moisture and trapping the moisture against the home's foundation. Recommend correct slope to prevent excessive moisture against foundation.

1.7 Item 1(Picture) north foundation grading

1.7 Item 2(Picture) north foundation grading

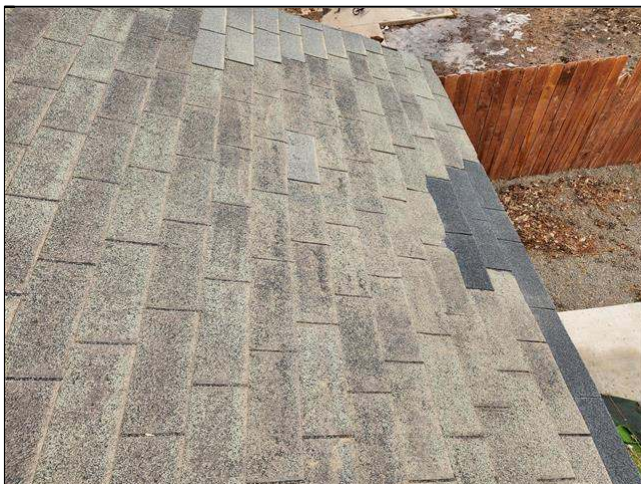
(1) North Slope... The roof covering appears to be original (30 years) and is a 20 year asphalt/fiberglass Composition shingle that appears to be near/at the end of its useful life. Typical loss of granules noted from shingles. No major problems noted at time of inspection, with a few "patched" roofing areas. Recommend further evaluation of roof covering materials by a licensed Roofing Contractor for estimated remaining life of roof, as desired.

2.1 Item 1(Picture) north slope roof shingles

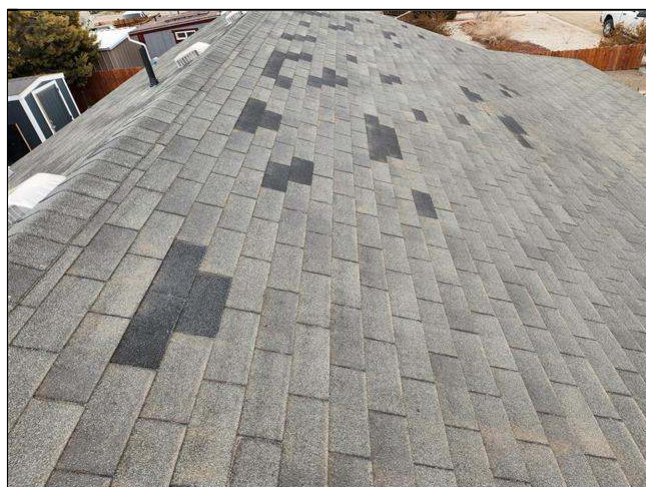
(2) The South Slope roof covering does not appear to be original, and is a 20 year asphalt/fiberglass Composition shingle with much of it's life remaining. Typical loss of granules noted from shingles. No problems noted at time of inspection. There are several replaced "wind-damaged" shingles, that appear to be installed correctly, and will not allow moisture intrusion. Recommend further evaluation of roof covering materials by a licensed Roofing Contractor for estimated remaining life of roof, as desired. Typically, the South facing roof covering materials would be deteriorated much sooner than the North facing shingles. The South slope roof covering appears in newer/better condition than the North slope, indicating they have been replaced.

2.1 Item 2(Picture) south slope roof shingles

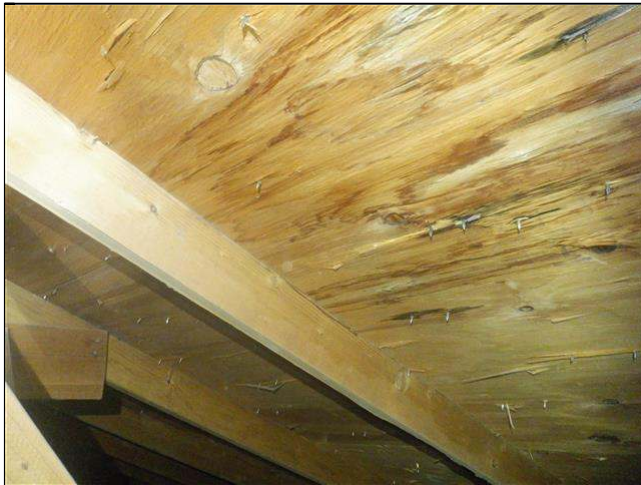
Moisture stains noted to roof sheathing at various locations, and appears to be caused from past roof covering issues that no longer exist. Stained areas are dry, and remain solid. No repairs needed at this time.

3.9 Item 1(Picture) moisture stains from past leaks

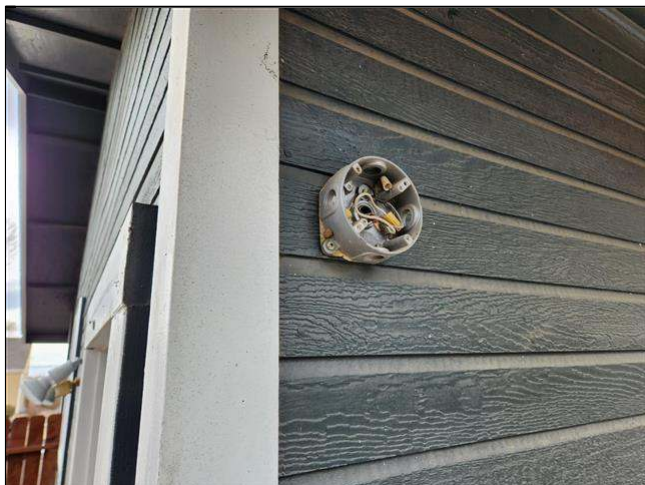
(1) Unused wall light fixture box located at the Northeast corner of home should be capped/covered to protect wiring from weather and moisture.

4.5 Item 1(Picture) electrical box at NE corner

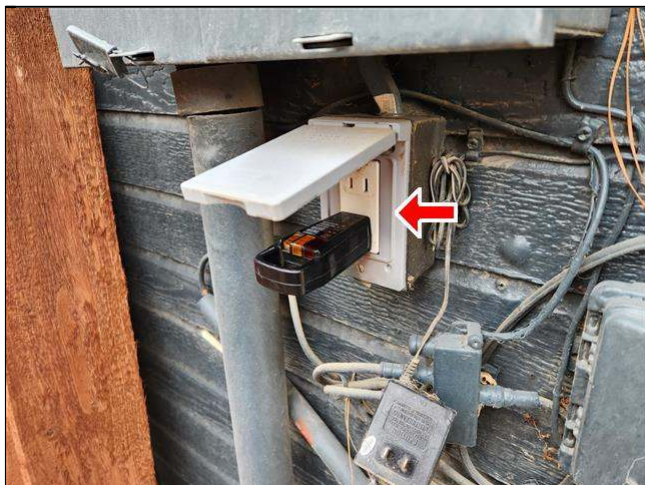
(2) Hot/Neutral wires are crossed (reverse polarity) at the following location: Exterior receptacle adjacent to the main electrical panel. Recommend repair by a qualified person.

4.6 Item 1(Picture) reverse polarity at exterior outlet

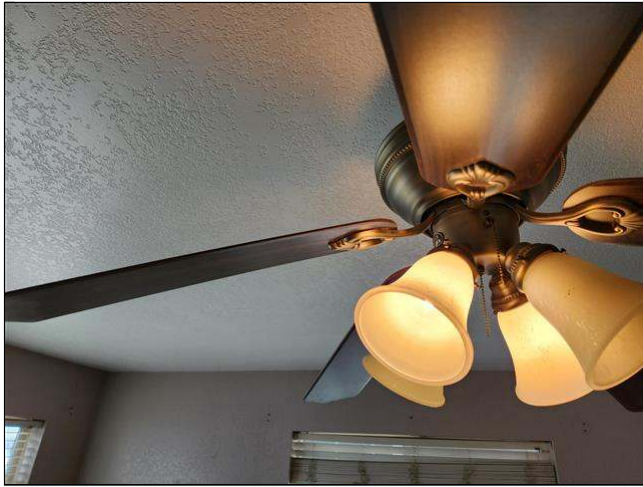
(3) Living room ceiling fan appears non-operational, however the fan blades are very loose and appear to be dragging. Recommend further evaluation by a qualified person.

4.6 Item 2(Picture) living room ceiling fan

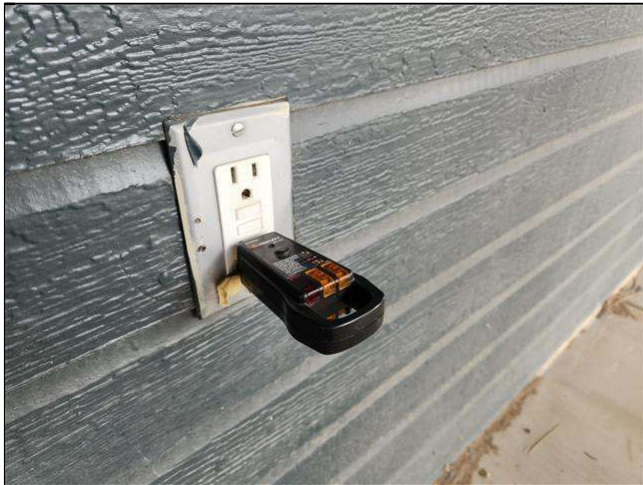
(1) GFCI (Ground Fault Circuit Interrupter) outlet at the front exterior wall of home, did not trip when tested (defective). Further inspection/repair is needed by a qualified licensed electrician.

4.7 Item 1(Picture) faulty GFCI at front exterior wall

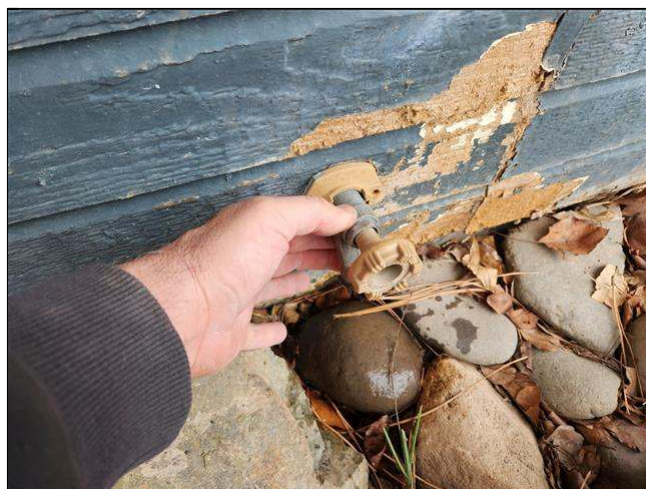
(1) Recommend securing North hose bib flange to wall, to prevent possible twisting and breakage of plumbing pipes/connectors. Recommend sealing around pipe to prevent moisture intrusion behind wall siding.

5.0 Item 1(Picture) north hose bib not secured

Seller is repairing Items 5.0(1) & 5.0(2)

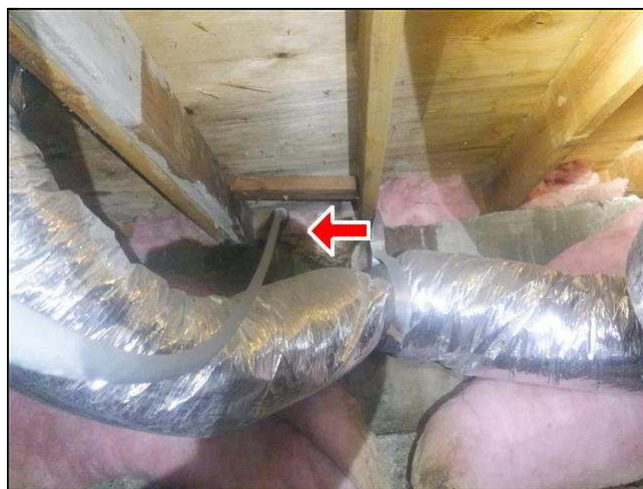
5.0 Item 2(Picture) north hose bib leaks into crawlspace

(2) The outside water faucet hose bib leaks when turned on at the (North side of home). Repairs are needed to stop leaking water from entering crawlspace area. Water leaking under home can cause problems such as mold, erosion or deterioration. A qualified licensed plumber should repair or correct as needed.

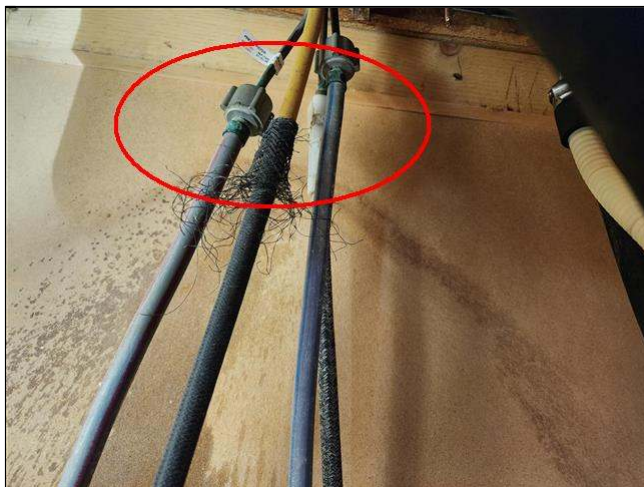
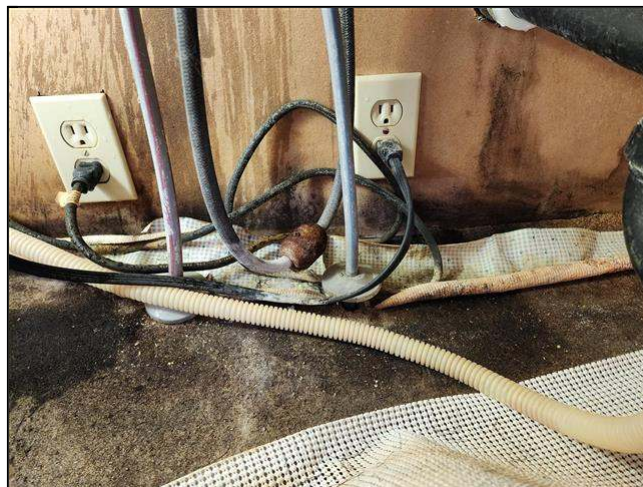
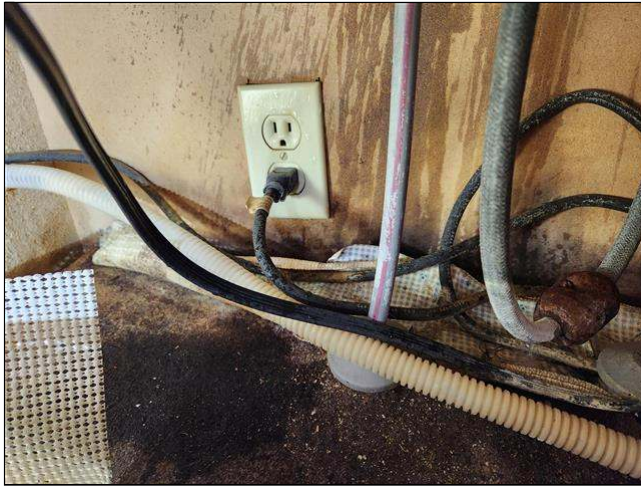
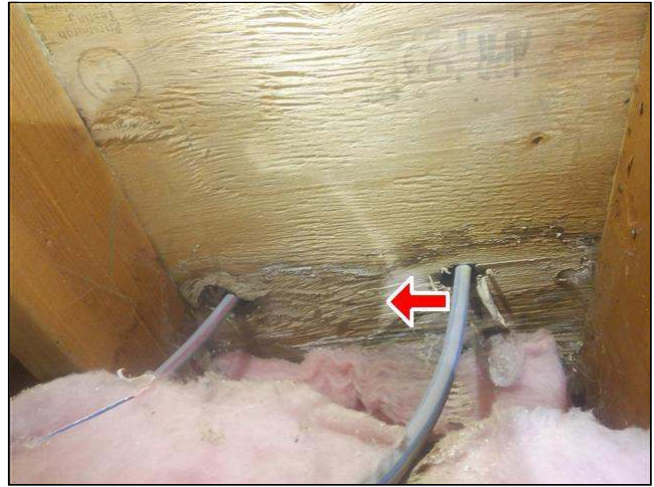
(1) Kitchen sink faucet leaks at under-sink hose, and appears has leaked for some time. This has caused moisture damage to the lower cabinet shelf. Subfloor plywood shows signs of past moisture, however remain solid and serviceable at time of inspection.

5.4 Item 1(Picture) leaks at faucet hose

5.4 Item 2(Picture) moisture damage to lower shelf

5.4 Item 3(Picture) leaking under kitchen sink

5.4 Item 4(Picture) subfloor under kitchen sink remains solid

Seller is repairing Item 5.4(1)

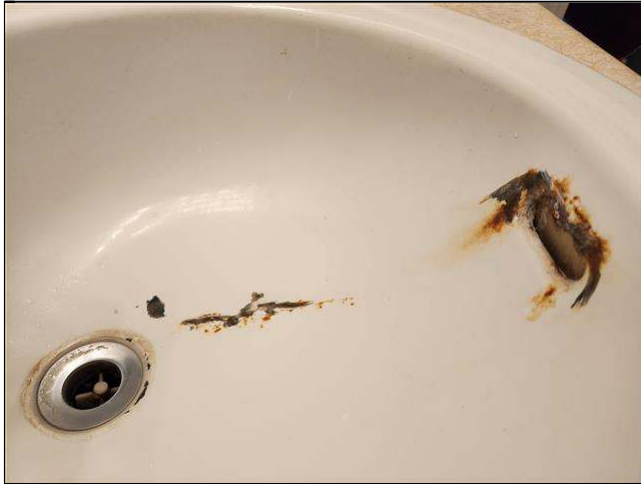
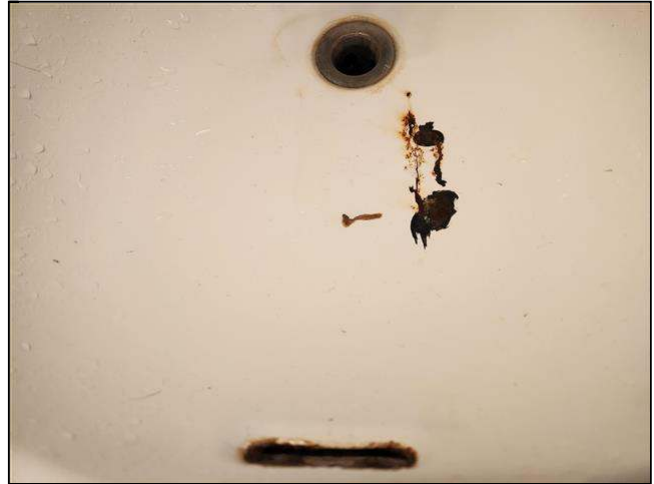
(2) NOTE: Guest Bathroom sink has chipped enamel/finish with rust showing, however there are no leaks noted. NOTE: Master bathroom sink is rusted, bent and seeps moisture through, and should be replaced.

5.4 Item 5(Picture) guest bathroom sink

5.4 Item 6(Picture) master bathroom sink

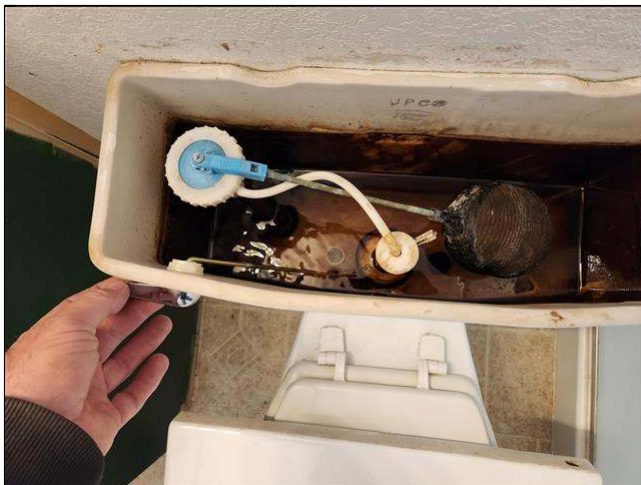
(3) Toilet flush handle does not function properly at the Master Bathroom. Recommend further evaluation and repair by a qualified person.

5.4 Item 7(Picture) master bathroom toilet flush handle

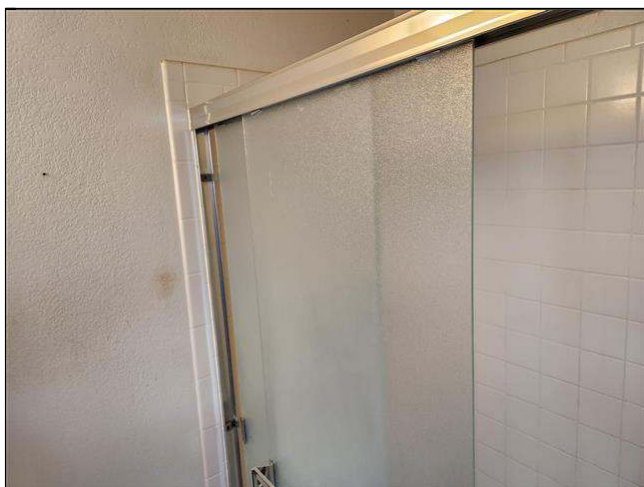
(1) Recommend adjustment or repairs to prevent dragging, and permit master bathroom shower doors to function as intended.

5.6 Item 1(Picture) master bathroom shower doors

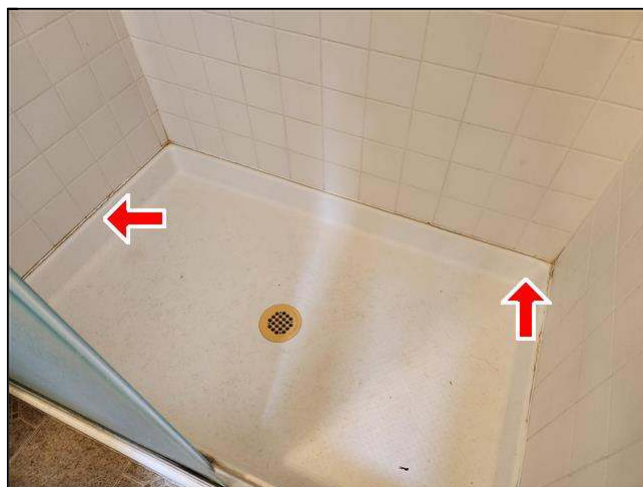
5.6 Item 2(Picture) seal shower enclosures as needed

(2) Recommend seal corners of tub/shower surrounds to prevent moisture intrusion into wall framing areas. Note: This is part of maintenance, and should be done as needed.

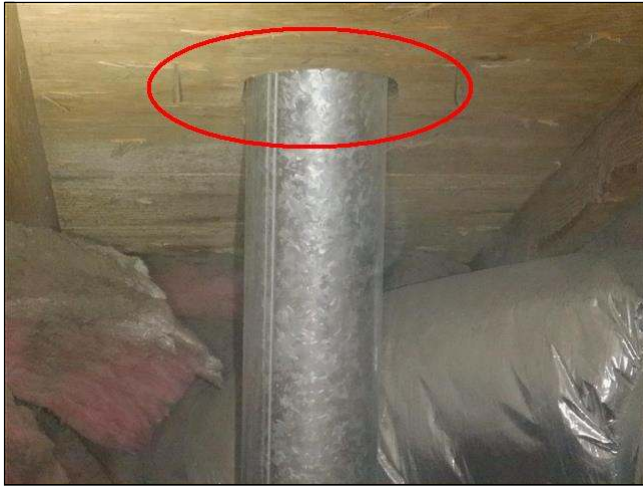
Water heater/furnace flue pipe does not maintain the required 1" clearance to combustible materials. Flue pipe is resting against the roof sheathing plywood, and needs repair to maintain the proper clearance.

5.7 Item 1(Picture) minimum 1" clearance from combustibles

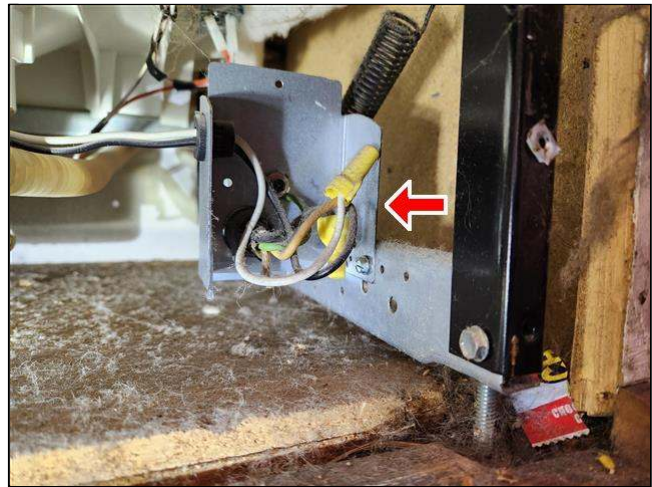
6.1 Item 2(Picture) open wire connection under dishwasher

(2) Improper electrical wiring connection beneath dishwasher, and needs to be placed inside a covered metal box.

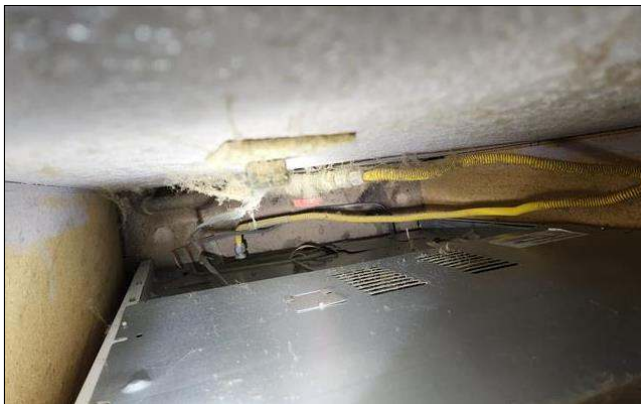
Note: This appliance does not have an anti-tip bracket installed. This is recommended by the MFG to prevent accidental tipping of the appliance, in the event of a child standing on the oven door.

6.2 Item 1(Picture) behind range

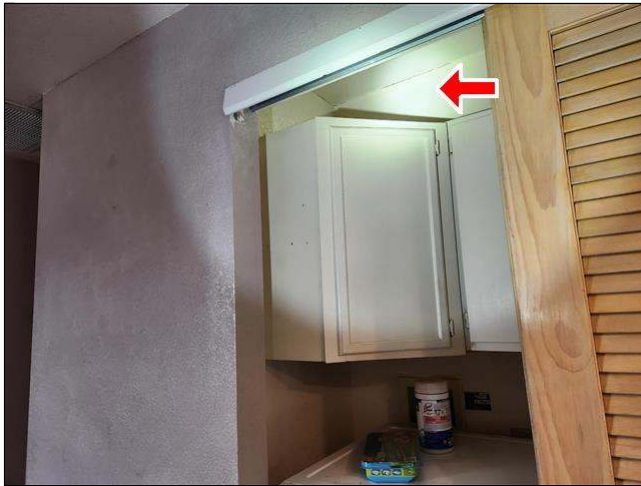
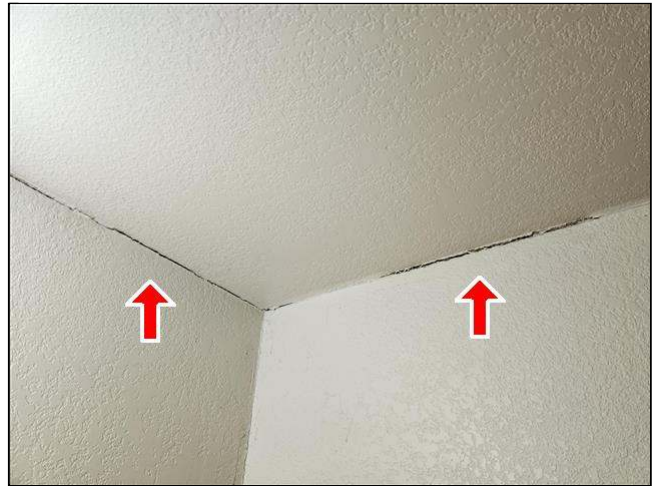
Settlement cracks noted at the Laundry closet wall/ceiling connection, and should be caulked.

7.0 Item 1(Picture) settlement cracks in laundry closet

7.0 Item 2(Picture) settlement cracks in laundry closet

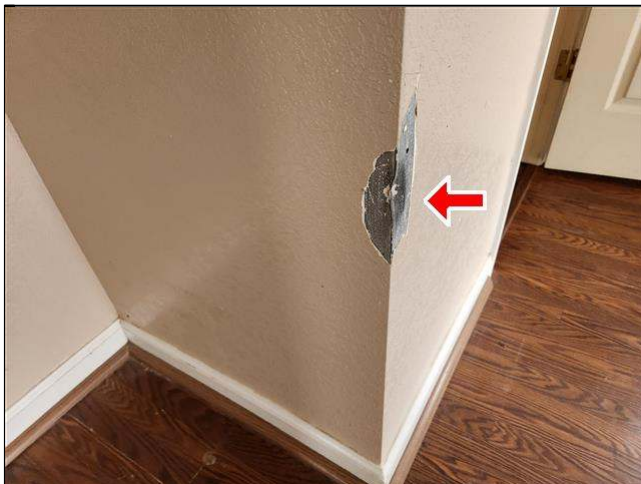
Drywall damage noted at the master bedroom corner, and should be repaired by a qualified person.

7.1 Item 1(Picture) master bedroom drywall damage

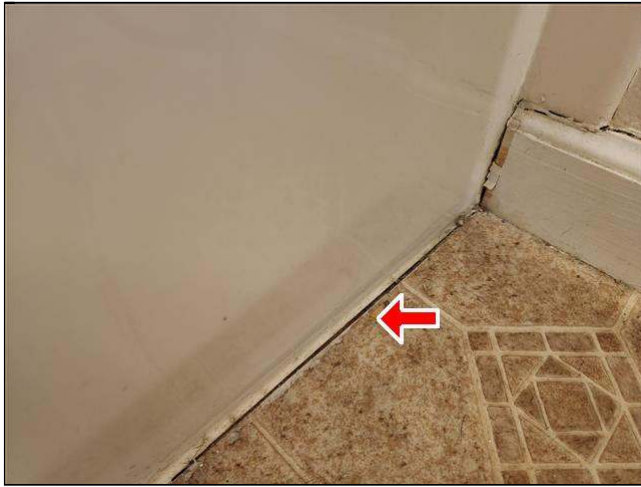
The Linoleum is curling around edges and is not impervious to water at the Guest bath. While this damage is cosmetic, it should be repaired. A qualified contractor should inspect and repair as needed.

7.2 Item 1(Picture) guest bathroom floor/tub

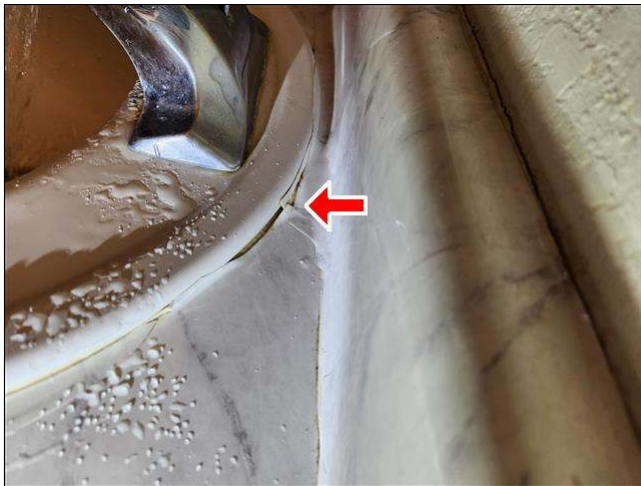
Recommend caulking around sink at master bathroom to prevent moisture intrusion into lower cabinet.

7.3 Item 1(Picture) recommend seal around master bath sink

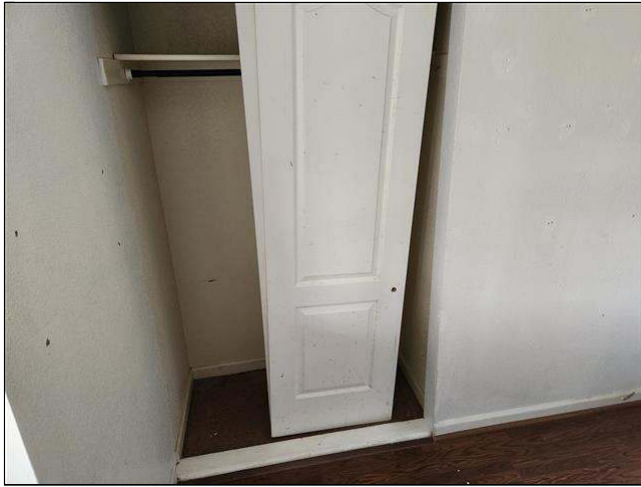
(1) Closet doors need adjusting to fit and operate properly at the Southeast guest bedroom.

7.5 Item 1(Picture) SE guest bedroom closet doors

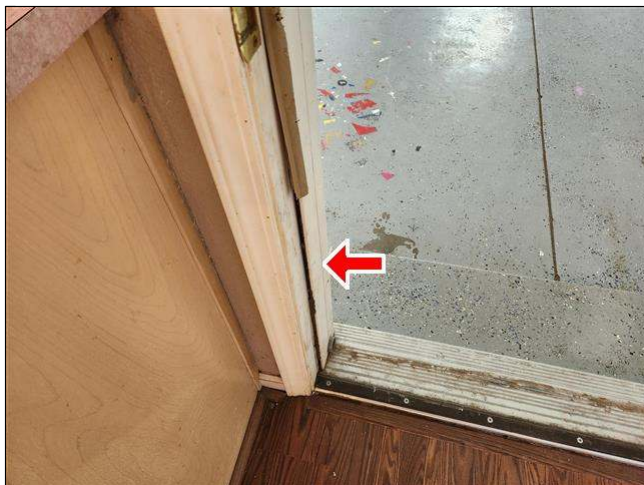
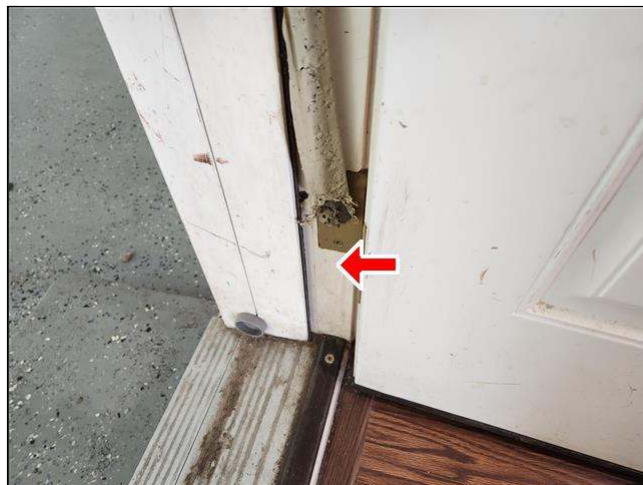
Occupant door is fire rated and (not completely) weather stripped, and completely closes with self closing hinges to prevent accidental carbon monoxide/fire intrusion to home. **Recommend repair/replace damaged weather stripping to function as intended.**

8.8 Item 1(Picture) damaged weather seal at occupant door

8.8 Item 2(Picture) damaged weather seal at occupant door

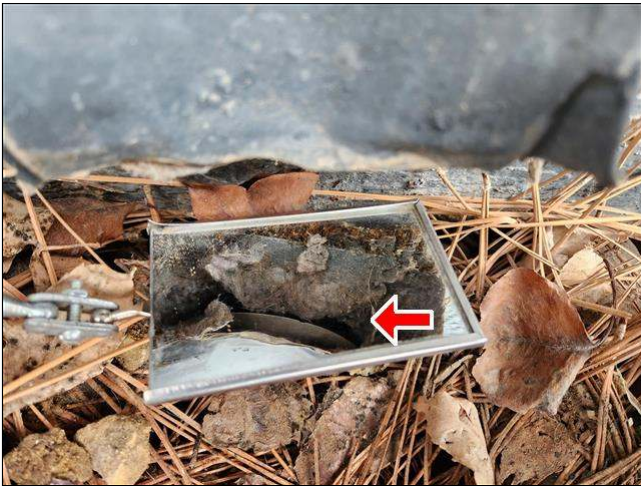
(2) The dryer vent piping has a damaged/bent/clogged vent hood outside, not allowing the vent to close when not in use. This condition could allow pest/rodent intrusion. I recommend repair as needed.

9.4 Item 2(Picture) clogged dryer vent hood

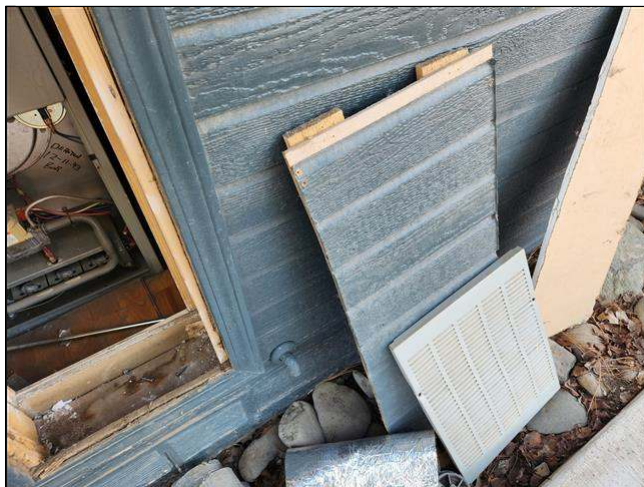
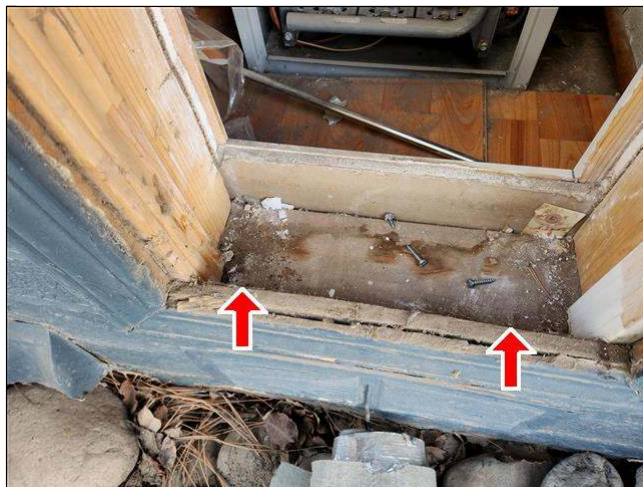
(2) NOTE: Heating equipment is difficult to access, requiring removal of several screws and a section of exterior siding. Recommend installing a more weather-resistant access door, as moisture stains are noted inside wall framing, indicating the access panel is not weather tight.

10.0 Item 3(Picture) access panel for furnace

10.0 Item 4(Picture) signs of moisture intrusion inside wall framing
