Inspection Report

Property Address:
1241 Esther Way
Minden NV 89423

Clear Choice Home Inspection Services

Date: 11/4/2024	Time: 09:00 AM	Report ID: CHA124
Property: 1241 Esther Way Minden NV 89423	Customer: Valerie Chargualaf	Real Estate Professional: Thomas Vander Laan Coldwell Banker

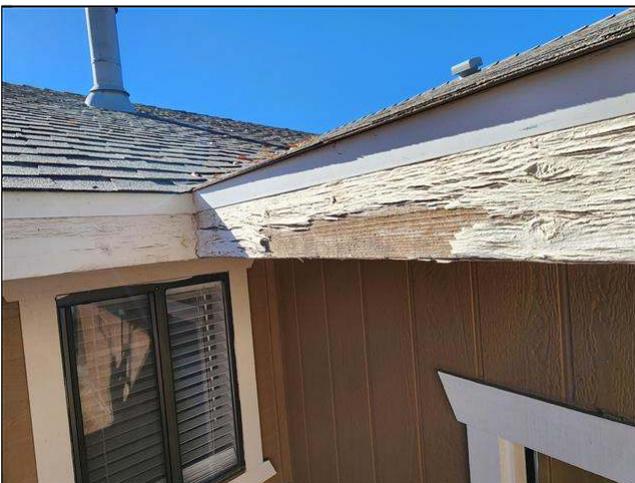
The fascia boards at eaves are peeling paint, with fascia board at East facing upper roof area being damaged from moisture absorption, and swollen/warped ends at South side of home. Further deterioration may occur if not corrected. Recommend paint fascia boards by a qualified person as needed.

1.5 Item 1(Picture) fascia peeling paint

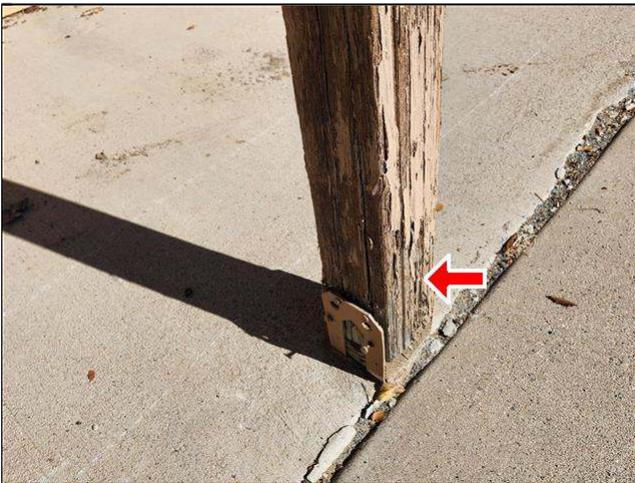
1.6 Item 1(Picture) showing deterioration from missing paint

Recommend caulking maintenance and prep/paint for weather protection at rear patio roof support posts.

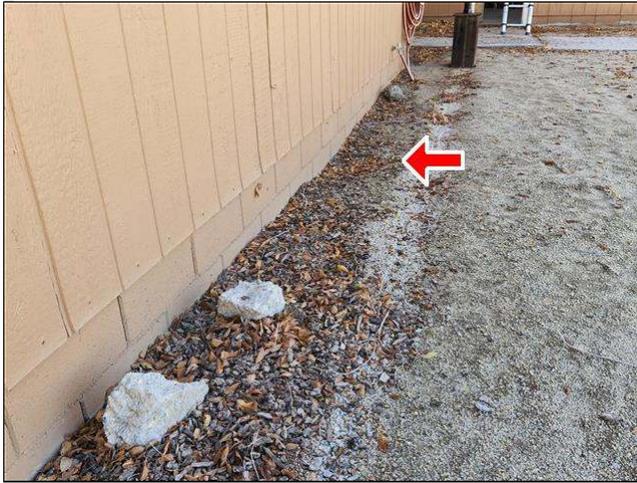
(1) Grading at North side of home does not slope away from the foundation. Recommend correct slope to prevent excessive moisture against foundation.

1.7 Item 1(Picture) foundation grading at north side

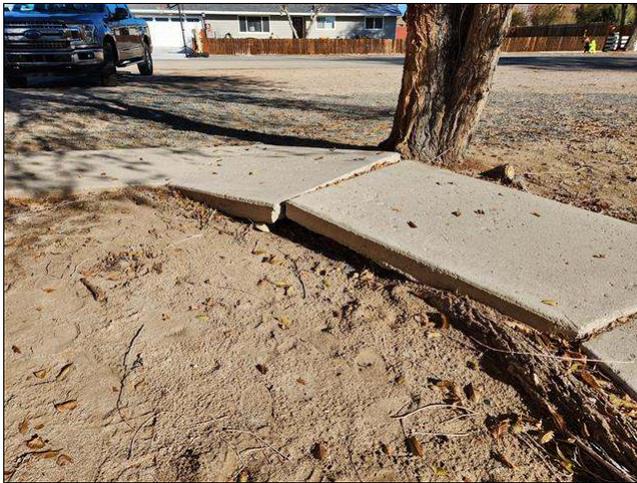
(2) Concrete walkway has been pushed-up (apparently from tree roots), creating an uneven surface and could pose a trip hazard.

1.7 Item 2(Picture) walkway pushed up

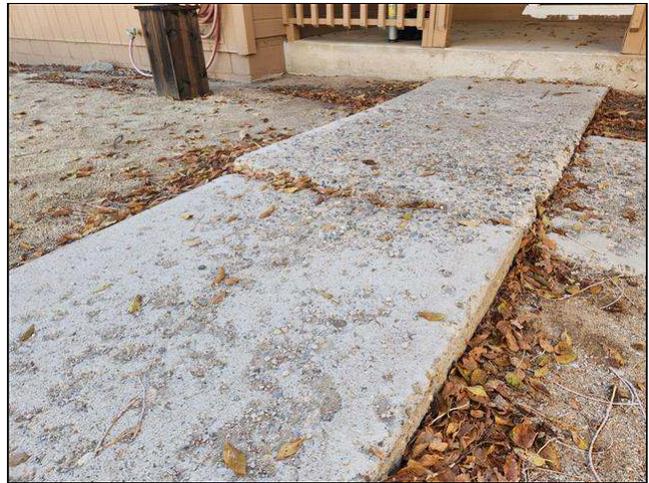
1.7 Item 3(Picture) walkway pushed up

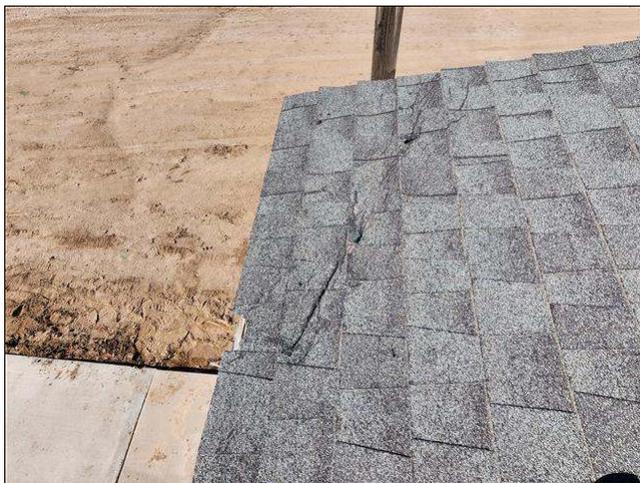
(2) South Slope of Roof... The roof covering does not appear to be original, and is a 30 year architectural, asphalt/fiberglass Composition shingle that is showing more advanced age, with approximately 5 to 7 years of it's life remaining, and several age cracked shingles noted. Advanced loss of granules noted from shingles. Recommend further evaluation of roof covering materials by a licensed Roofing Contractor for estimated remaining life of roof, as desired.

2.1 Item 1(Picture) damage at southwest corner

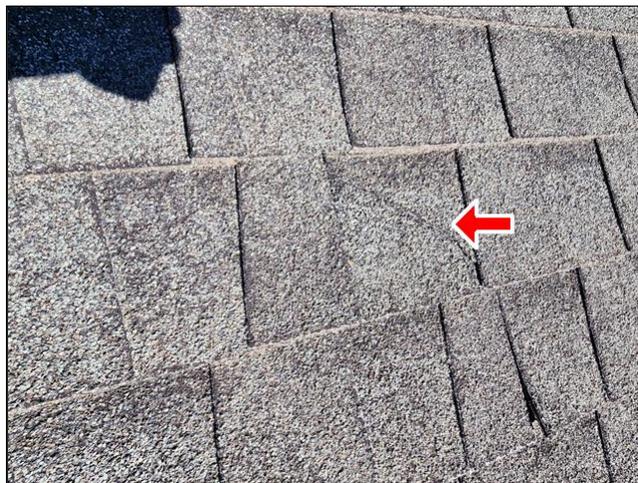
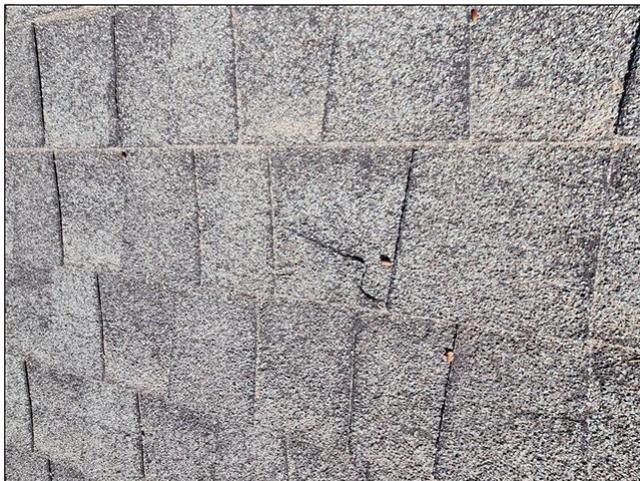
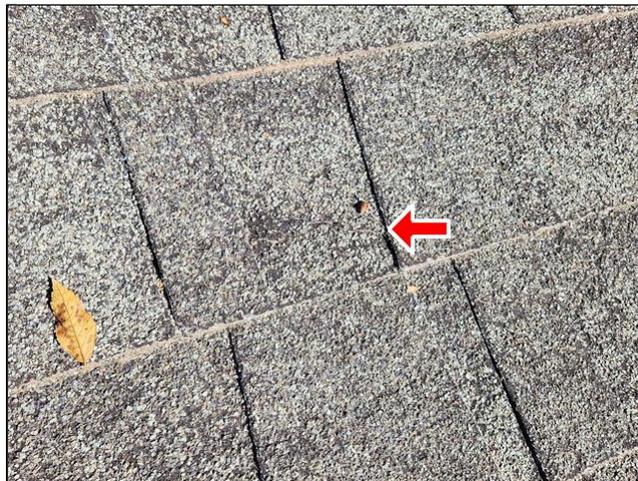
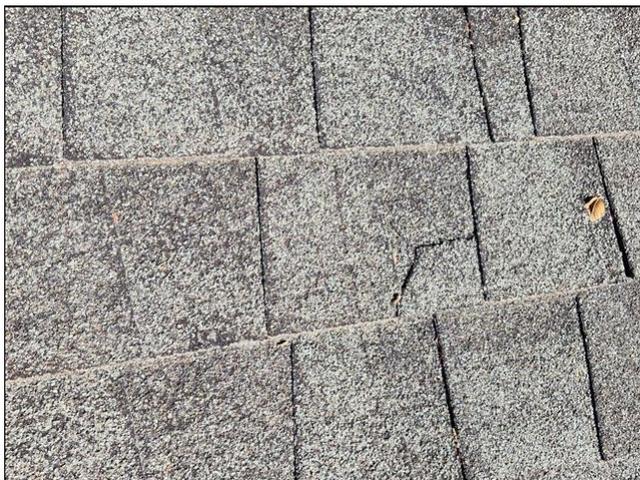
2.1 Item 2(Picture) age cracked shingle

2.1 Item 3(Picture) age cracked shingle

2.1 Item 4(Picture) age cracked shingle

2.1 Item 5(Picture) age cracked shingle

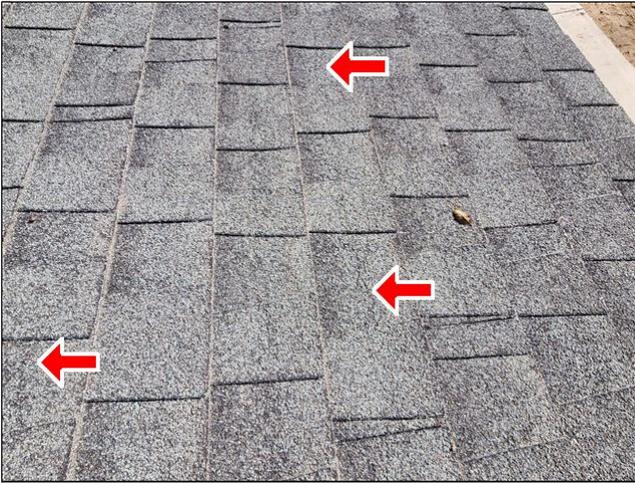
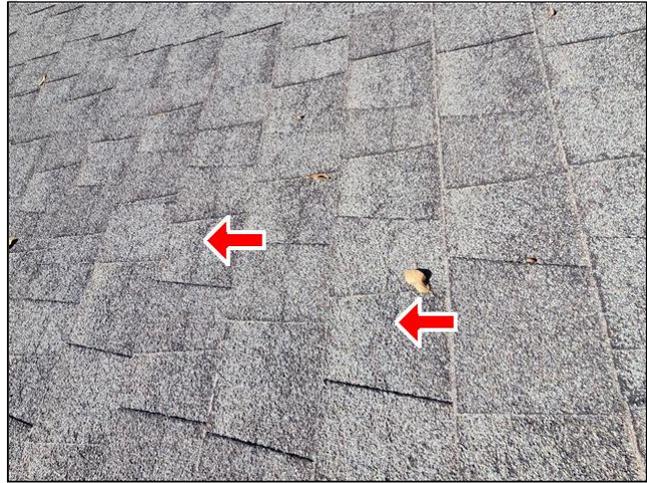
(3) South Slope of Roof... The asphalt composition shingle roof had visible widespread random cracking. This condition is called "craze cracking". Craze-cracking is a natural response to long-term shrinkage of the shingle asphalt surface layer and is a common sign of aging. The severity of craze-cracking indicated normal wear.

2.1 Item 6(Picture) craze cracking

2.1 Item 7(Picture) craze cracking

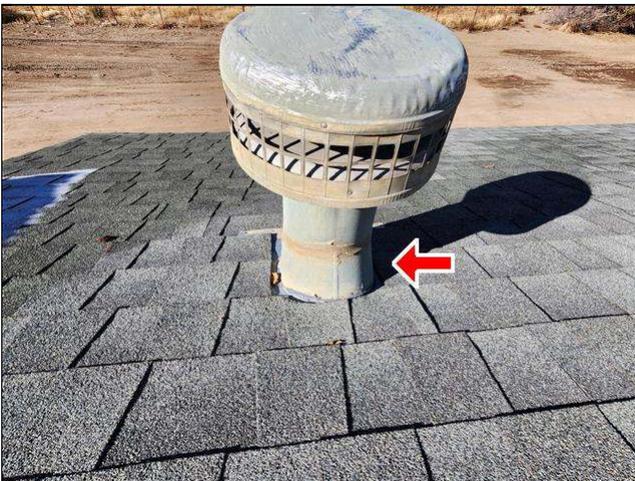
Plumbing and furnace vent pipes are sealed well against flashings to prevent moisture intrusion into attic framing areas.

2.3 Item 1(Picture) flue pipes sealed well

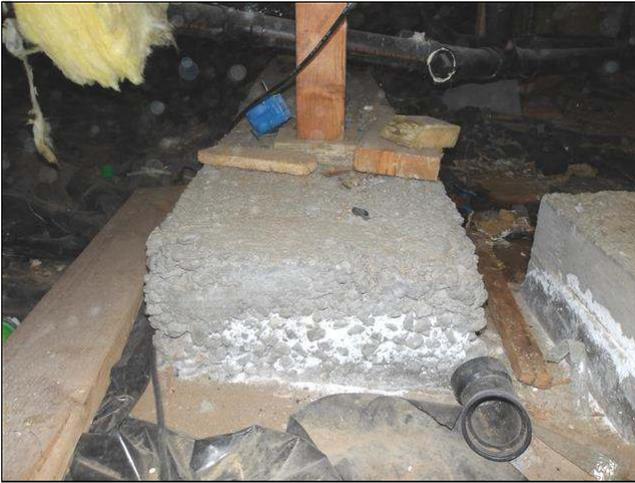
(3) Construction debris (and/or trash) should be removed from the crawlspace area. Trash/Debris noted at the following locations: Under guest bathroom area.

3.2 Item 1(Picture) construction debris in crawlspace

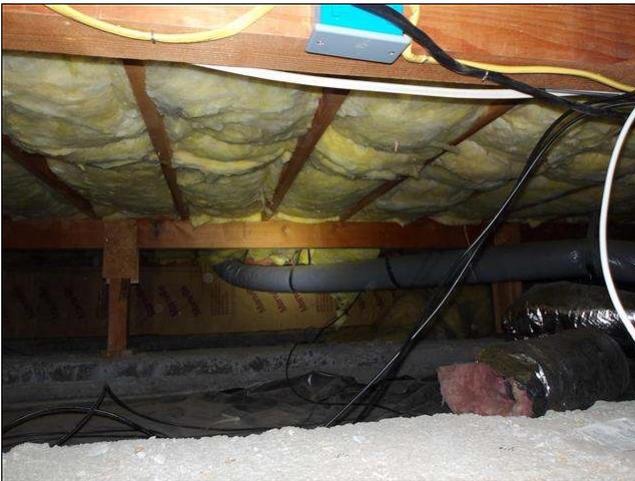
(1) Main House... NOTE: Subfloor area is NOT visually accessible for inspection, due to installation of floor insulation between the floor joists. Moisture Vulnerable areas such as adjacent to plumbing drain pipes, and exterior subfloor edges, were viewed by pulling back insulation. No obvious problems noted at time of inspection.

3.6 Item 1(Picture) subfloor not fully visible

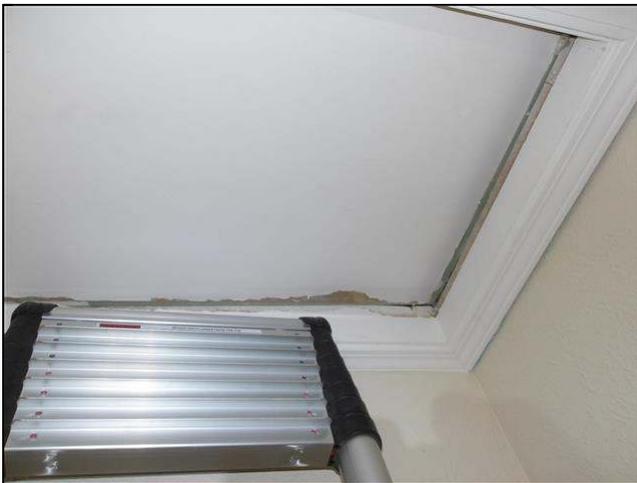
Scuttle hole located in Master Closet and Guest bedroom. Serviceable... NOTE: recommend repair/adjust main house attic access panel to fit properly into the opening, is currently too tight.

3.10 Item 1(Picture) access panel does not fit properly

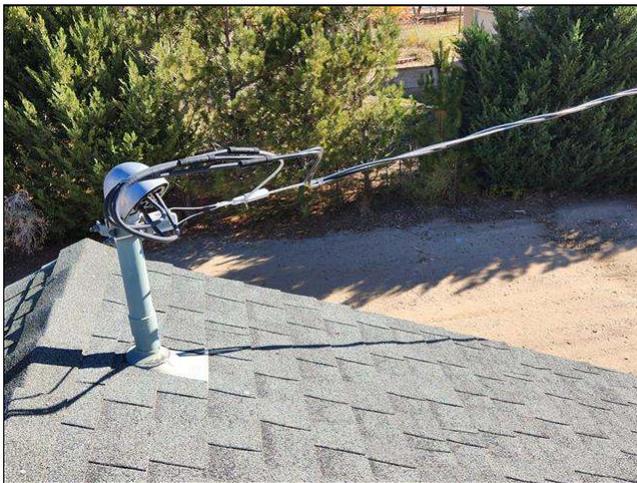
The Electrical Service Entrance is Overhead. Weather Bulkhead and connections appear in Serviceable condition. Conductors have proper clearance from ground, with "drip loop" noted.

4.0 Item 1(Picture) proper drip loop

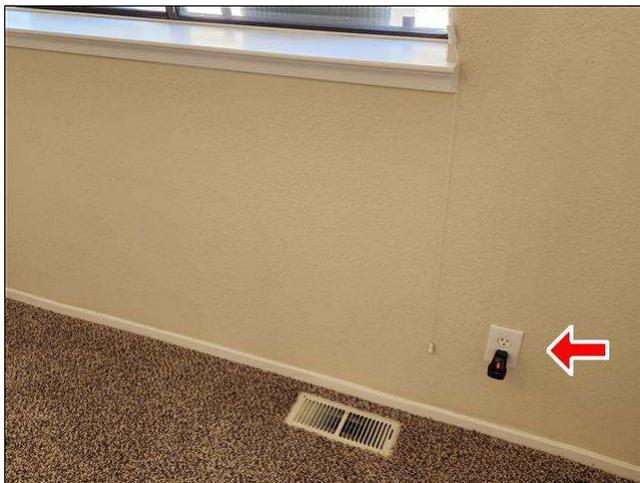
4.5 Item 1(Picture) open grounded outlet

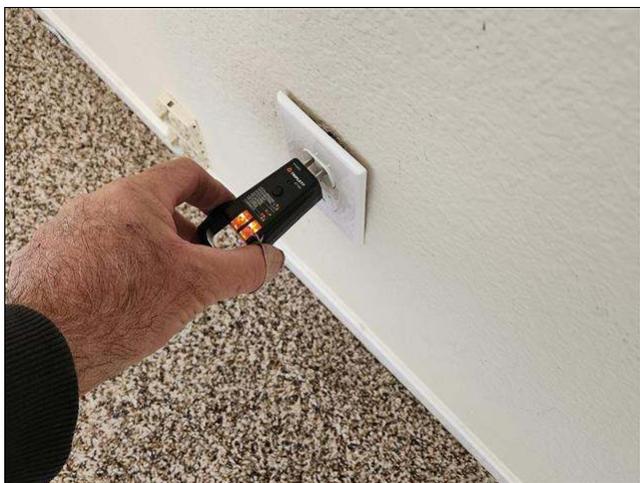
(2) Loose receptacle noted at the 2nd guest bedroom North wall. Though this is a minor repair, it needs to be corrected. I recommend repair as needed by a qualified person.

4.5 Item 3(Picture) loose receptacle

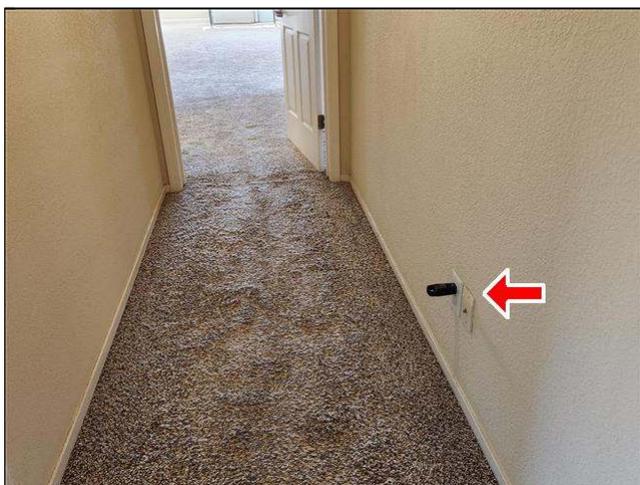
(3) Non-operational receptacle noted at the hallway. Recommend further evaluation/repair by a licensed Electrician.

4.5 Item 4(Picture) non-operational outlet at hallway

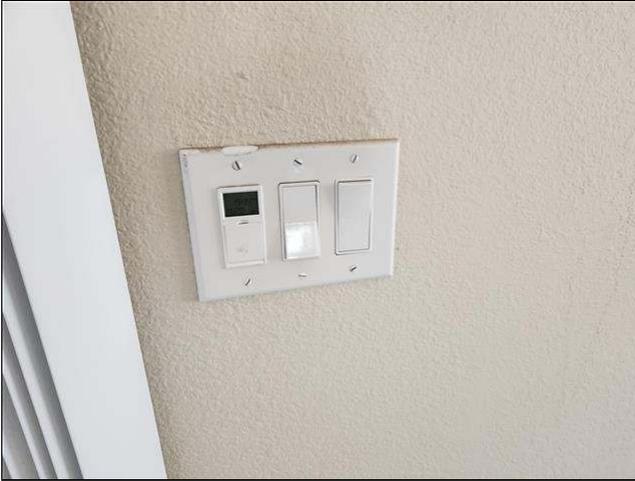
(1) Dual light switches are noted installed at living room and appears to be for individually controlled light and fan operation. The light/fan fixture presently operates from one control, leaving the second switch non-operational. No problems noted.

4.6 Item 1(Picture) dual switches for living room ceiling fixture

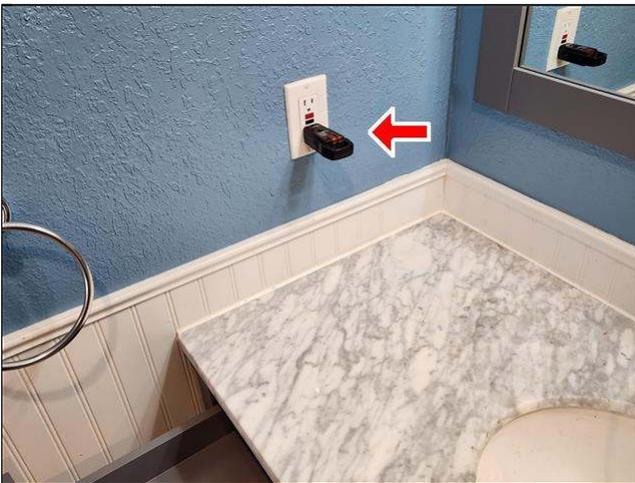
(2) Hot/Neutral wires are crossed (reverse polarity) at the following location: Guest Bathroom outlet. Recommend repair by a qualified person.

4.6 Item 3(Picture) reverse polarity outlet

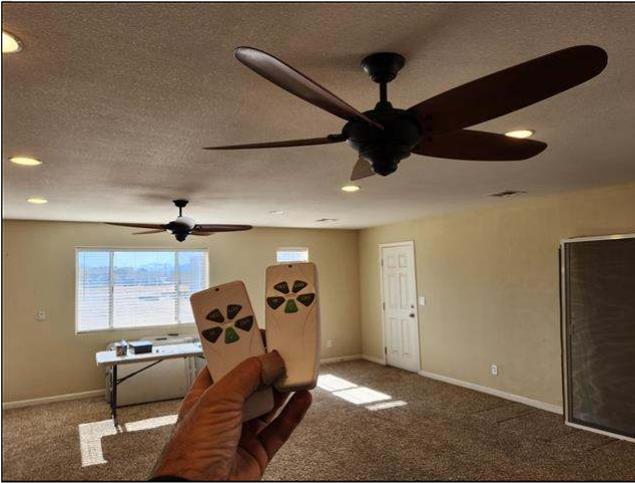
(3) I was unable to verify the operation of light switches/fixtures at the following locations: Ceiling light at Master bedroom entry, and Master bedroom ceiling fans. Recommend current owner to verify proper operation of this/these item(s).

4.6 Item 4(Picture) could not verify proper operation

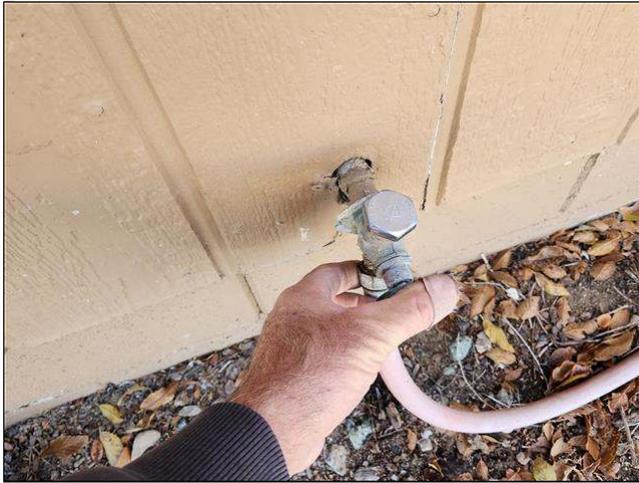
5.1 Item 1(Picture) north hose bib loose

Recommend securing North hose bib flange to wall, to prevent possible twisting and breakage of plumbing pipes/connectors. **RE: ITEMS 5.1 -- Please see Exhibit: Seller Repair Itemization**

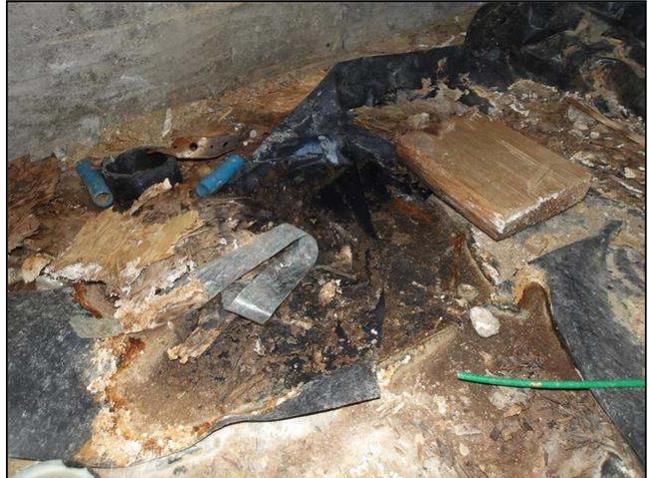
(1) The 2" waste line is cracked and leaks in the crawlspace area under the guest bathroom. Water leaking under home can cause problems such as mold, erosion or deterioration. A qualified licensed plumber should repair or correct as needed. **RE: ITEM 5.3(1) -- Please see Exhibit: Seller Repair Itemization**

5.3 Item 2(Picture) moisture from leak

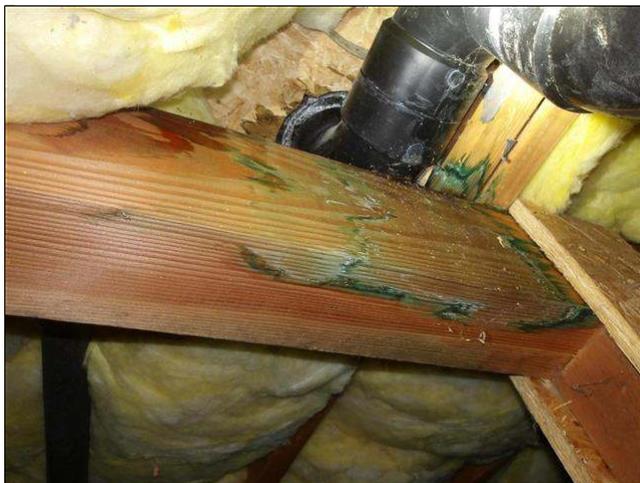
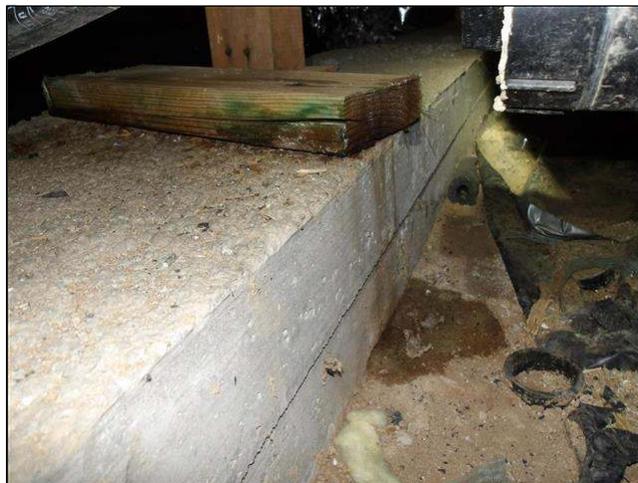
(2) Toilet drain is leaking in the crawlspace area under the Guest Bathroom, with drain pipe resting heavy on the subfloor girder beam. Recommend repair by a licensed plumbing contractor to prevent excessive moisture, which can lead to mold/fungus, in the crawlspace.

5.3 Item 3(Picture) leaking toilet drain under guest bathroom

5.3 Item 4(Picture) moisture from leak

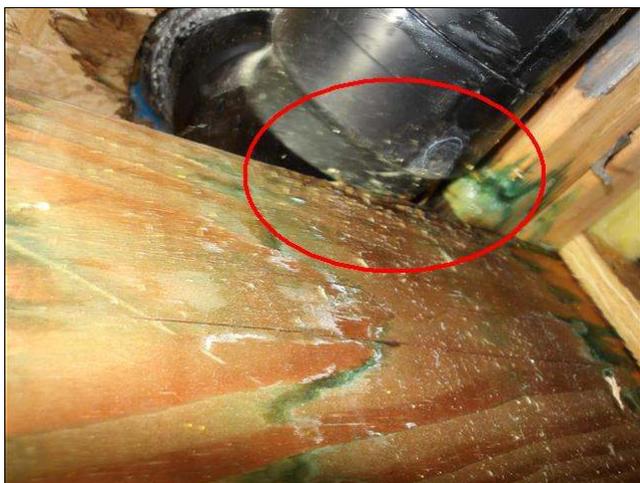
5.3 Item 5(Picture) pipe resting on girder beam

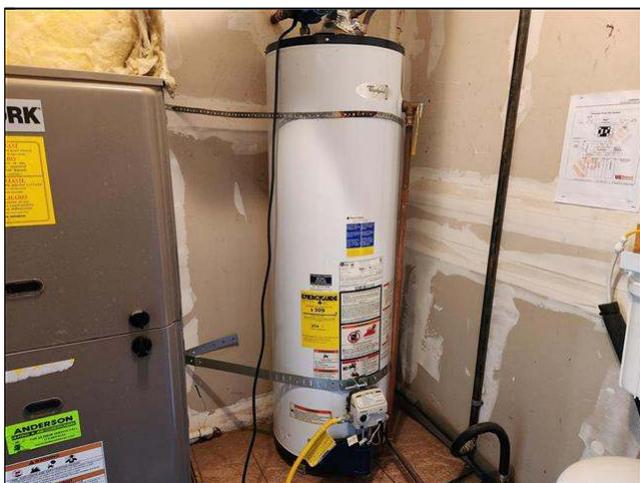
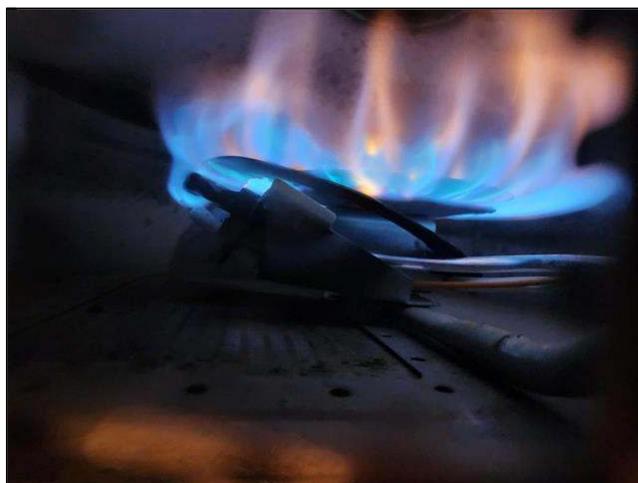
(1) Temperature and Pressure Relief valve is piped to the exterior of the house, or within 6 inches of the floor (for safety). Water Heater is partially strapped with approved strapping material, and is setting on a pedestal minimum of 18" above the garage floor. Water and fuel shut-off valves are present. Water heater operated as intended with no abnormal noises or leaks noted. No major problems noted at time of inspection... Manufactured in 2012 by US Craftmaster.

5.4 Item 1(Picture) water heater

5.4 Item 2(Picture) water heater burner compartment

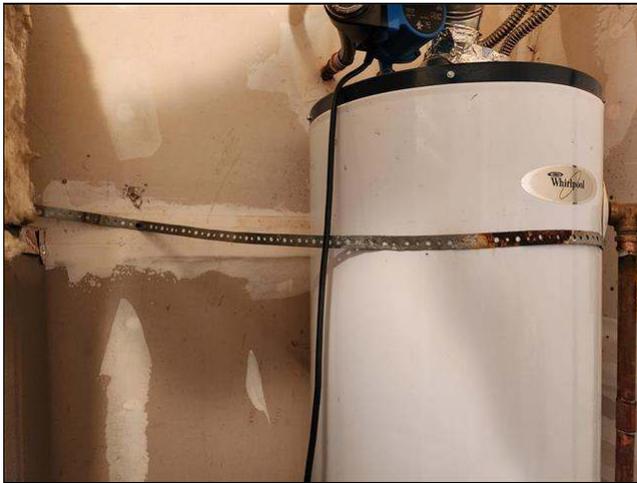
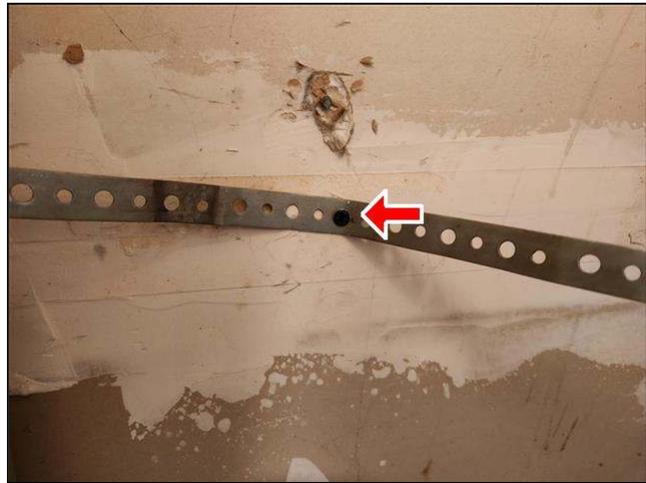
(2) Water heater is not properly strapped with approved seismic strapping material (**upper strap uses improper material, and fasteners**). The Uniform Plumbing Code (UPC), section 510.5 states "In seismic zones 3 and 4, water heaters shall be anchored or strapped to resist horizontal displacement due to earthquake motion. Strapping shall be at points within the upper one-third (1/3) and lower one-third (1/3) of its vertical dimensions".

5.4 Item 3(Picture) incorrect upper strap

5.4 Item 4(Picture) incorrect fasteners

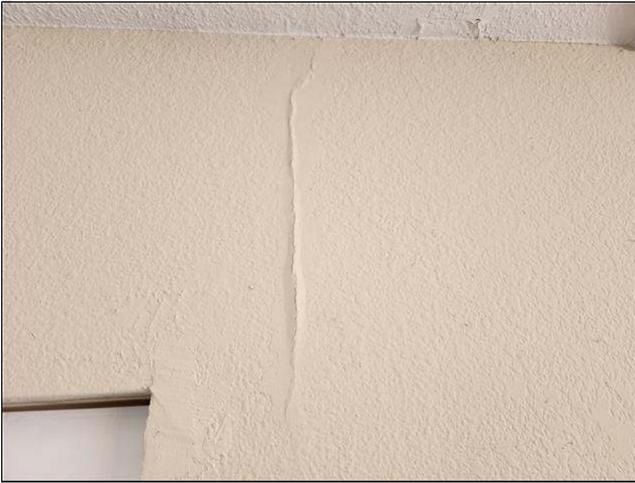
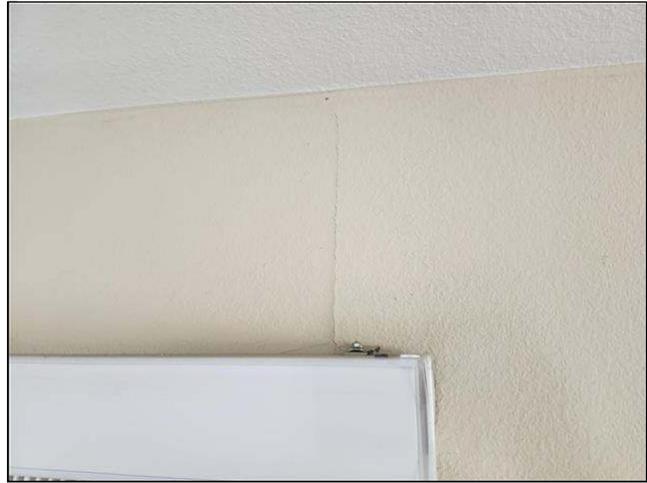
(1) The sheetrock on the wall has a few settlement cracks at the Living Room. This damage is considered cosmetic. A qualified person should repair or replace as needed.

7.2 Item 1(Picture) normal settlement cracks

7.2 Item 2(Picture) normal settlement cracks

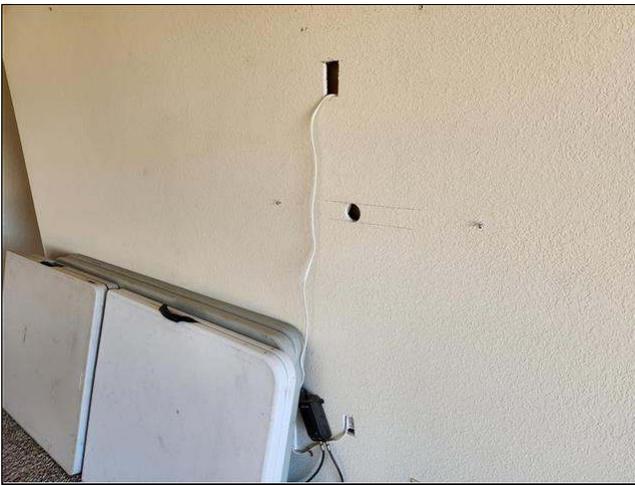
(2) NOTE: Minor drywall repairs are needed at the Living room East wall, where entertainment center was located.

7.2 Item 3(Picture) minor drywall repairs needed

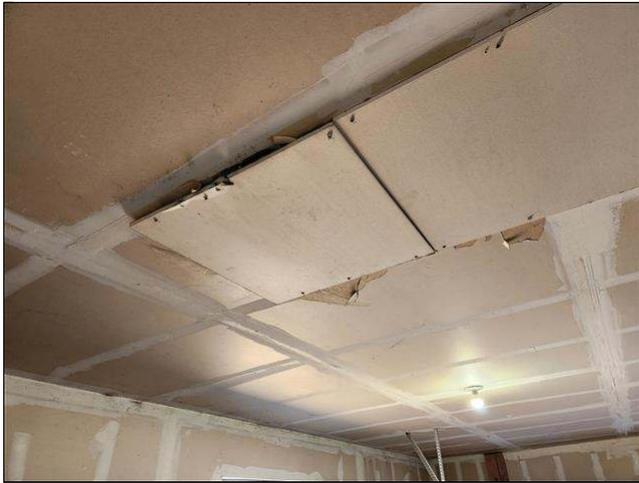
(2) Garage ceiling drywall is the Fire-separation wall between the garage and the house attic area, and should be repaired including mud and taped at seams.

8.2 Item 2(Picture) drywall repair needed at ceiling

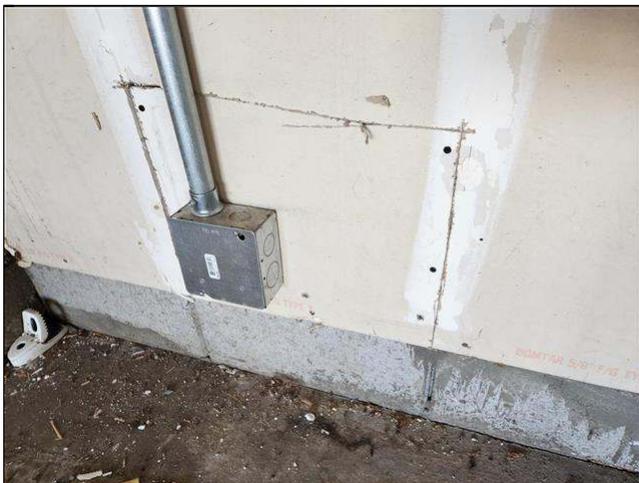
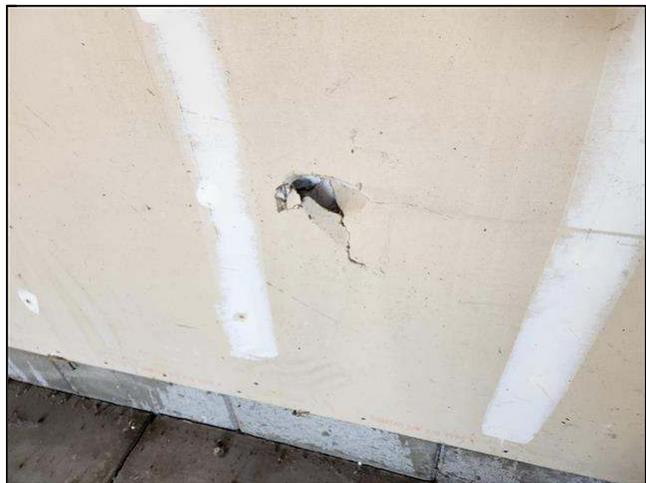
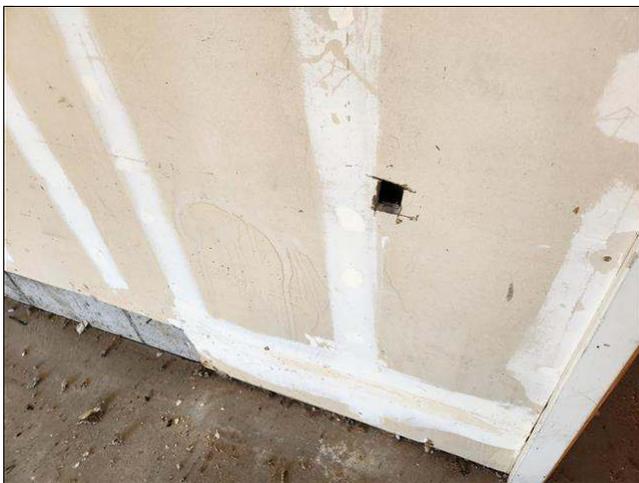
NOTE: There are a few minor drywall repairs needed at the garage Fire-separation wall between the garage and the house.

8.3 Item 1(Picture) needs mud and tape

8.3 Item 2(Picture) drywall needs repaired

8.3 Item 3(Picture) drywall needs repaired

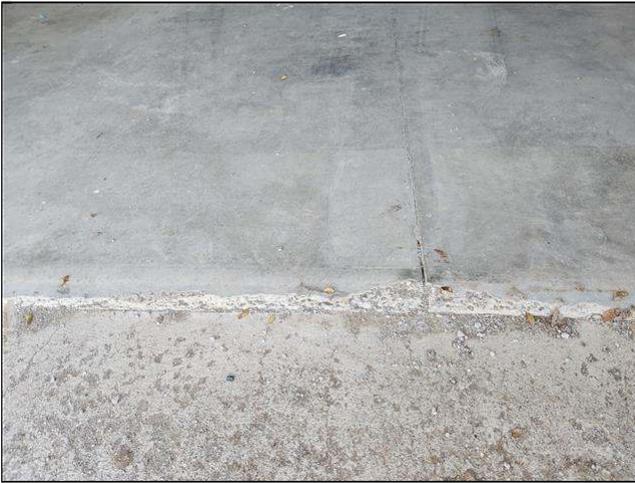
The Garage floors are poured concrete, and in good condition, with typical hairline cracks and slight crumbling of concrete at front exterior edge.

8.4 Item 1(Picture) slight crumbling of concrete

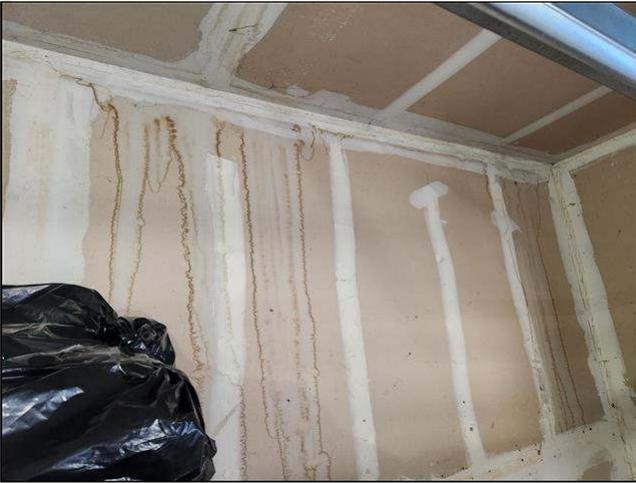
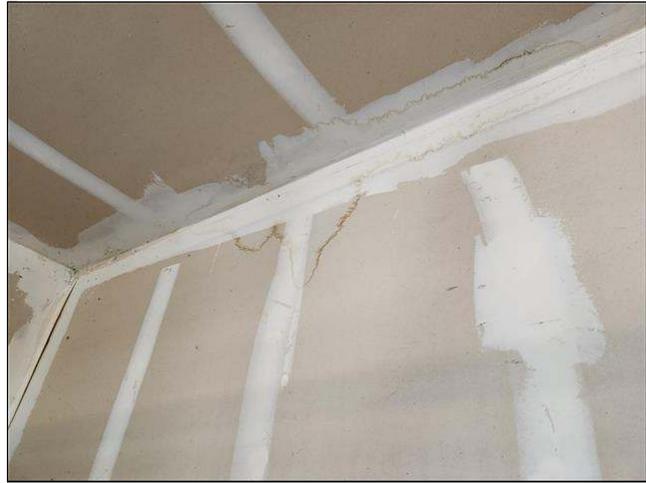
Moisture stains noted at the garage ceiling and wall finish, however appears to be caused from past roof covering issues that no longer exist.

8.11 Item 1(Picture) moisture stains from past leaks

8.11 Item 2(Picture) moisture stains from past leaks

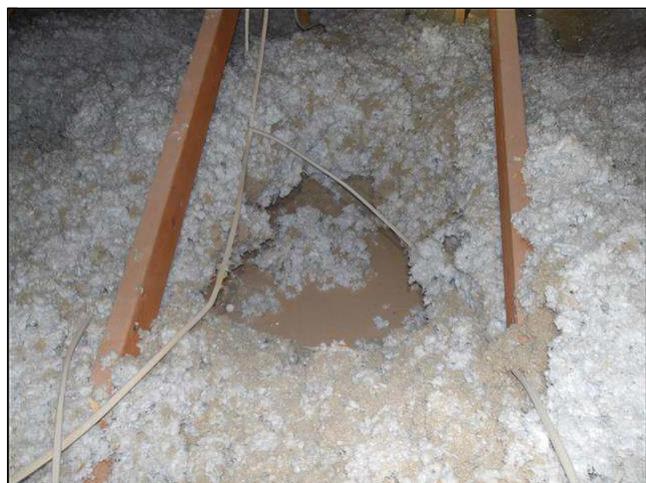
(2) The Main House attic insulation is loose-fill, and is approximately 14 to 16 inches deep. (R-38) No major problems noted... Attic insulation has been pulled back for installations/repairs over the hall bathroom area. Recommend re-installing insulation in this area to maximize heating/cooling efficiency and comfort.

9.0 Item 3(Picture) pulled back for past repairs

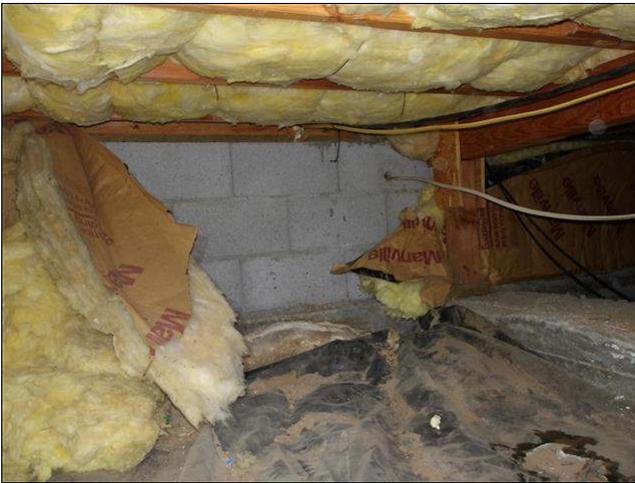
(2) Main House... The crawlspace area is insulated on the perimeter of the inner foundation wall using R13 fiberglass bats. Insulation is falling away from the foundation stemwall at various locations. Recommend securing insulation to foundation wall to maximize the home's efficiency and comfort.

9.1 Item 2(Picture) fallen crawlspace insulation

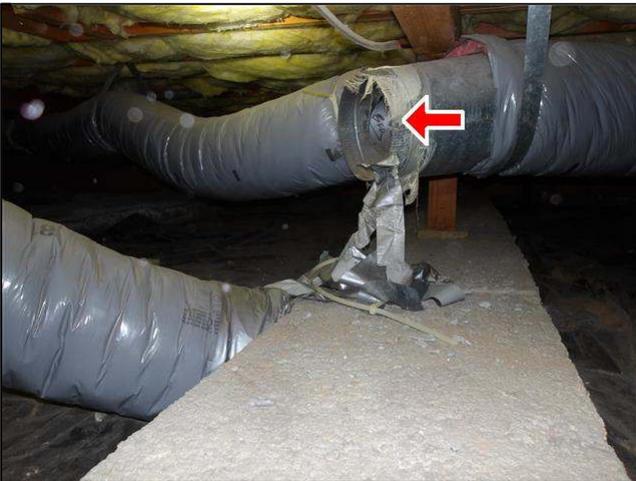
There is NO heating discharging from the South living room floor registers. Supply ducting was noted to be disconnected in the crawlspace area. Recommend further evaluation/repair by a qualified person.

10.3 Item 1(Picture) supply duct for living room

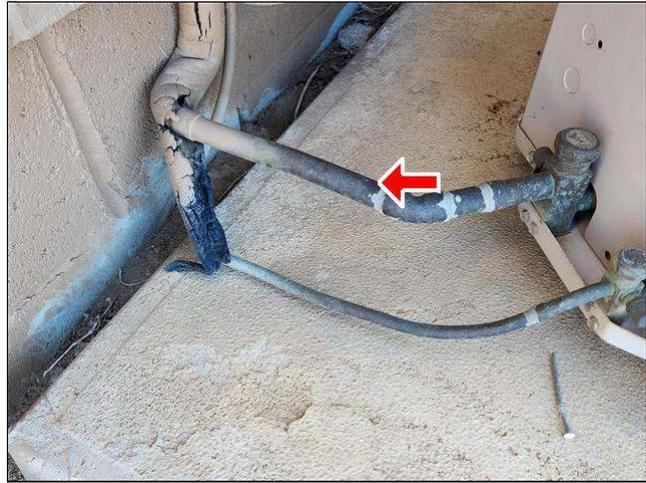
(1) Main House... Performed a visual only inspection. The A/C was not tested for proper operation due to the outside air temperature being 46 degrees or less, and possibility of cooling equipment failure could occur. 60 degree minimum ambient temperature must be achieved for safe compressor operation. NOTE: Licensed HVAC Contractors possess the required knowledge and equipment to check operation of cooling system in cold weather. Recommend consulting an HVAC Contractor for further evaluation of cooling system as desired. We did not inspect this unit(s). 3 ton unit Manufactured in 1992 by CARRIER.... NOTE: The foam sleeve on suction line is beginning to deteriorate. Missing foam on suction line can cause energy loss and condensation. I recommend service or repair as needed.

10.5 Item 2(Picture) missing insulation

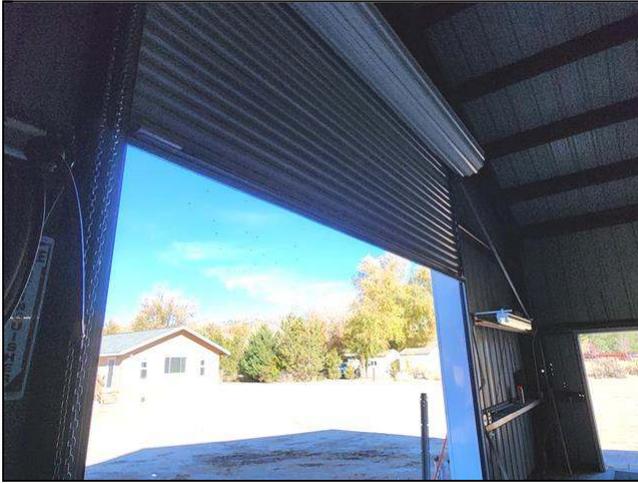
NOTE: Roll-up door at North side of garage begins to rub against side wall of building at approximately 60% open. Door operates and secures as intended.

12.2 Item 1(Picture) north roll-up door
