WOOD DESTROYING PESTS INSPECTION REPORT

Firm (PCO) Carson Valley Exi License No. 5599 Inspection Date 7-7-2022  
 Address P.O. Box 2306 Gardnerville NV 89410 FHA/VA/Escrow or Mortgage No. \_\_\_\_\_  
 Address of Property Inspected 307 East Peak Loop A Stateline 89449  
 Inspection Ordered by Thomas Van der Leam - Colleen Bunker City Zip Code  
 Inspection Report Sent to \_\_\_\_\_  
 Owner's Name and Address Gout

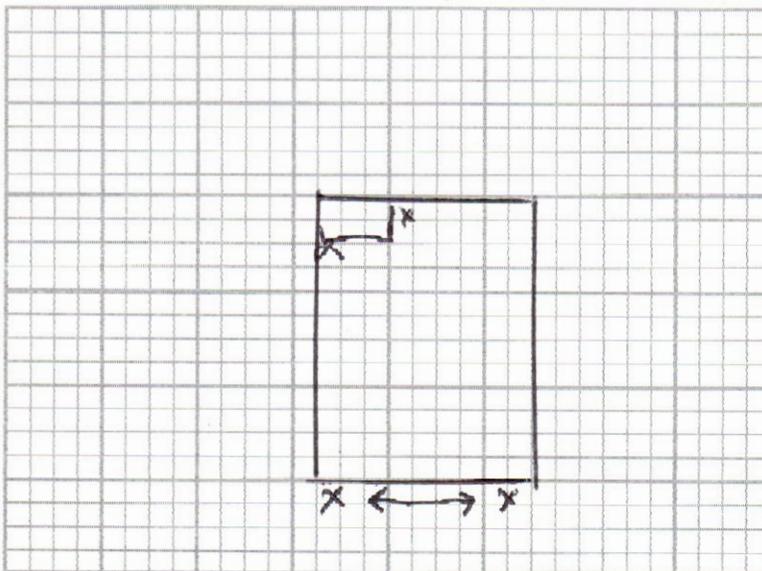
- \* Earth-Wood Contacts on siding Below Front Deck and water heater stand in Crawl Space
- Cellulose Debris in Crawl Space Large Wood-Tree Stump
- Tub Has a Leak in Crawl Space
