Inspection Report

Property Address:
2747 Stewart Ave.
Minden NV 89423

Date: 9/11/2023	Time: 07:30 AM	Report ID: BOR274
Property: 2747 Stewart Ave. Minden NV 89423	Customer: Suzanne Bornstein	Real Estate Professional: Thomas Vander Laan Coldwell Banker

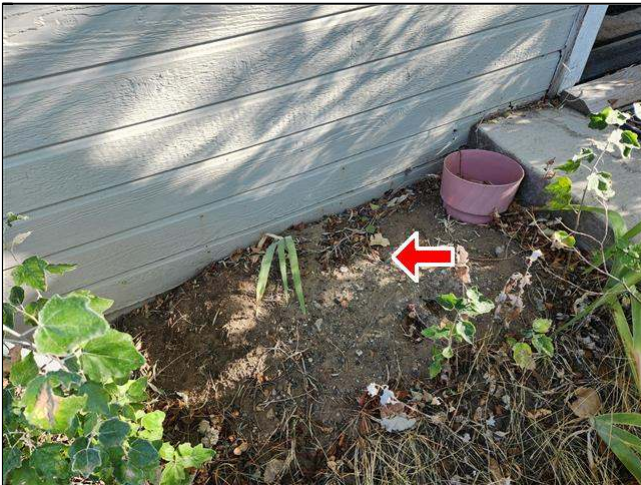
Siding in contact with the ground in areas across the South side, Southeast corner, and East side of the home. This condition can rapidly deteriorate siding materials. Recommend correct grade to eliminate ground contact.

1.1 Item 1(Picture) south wall siding

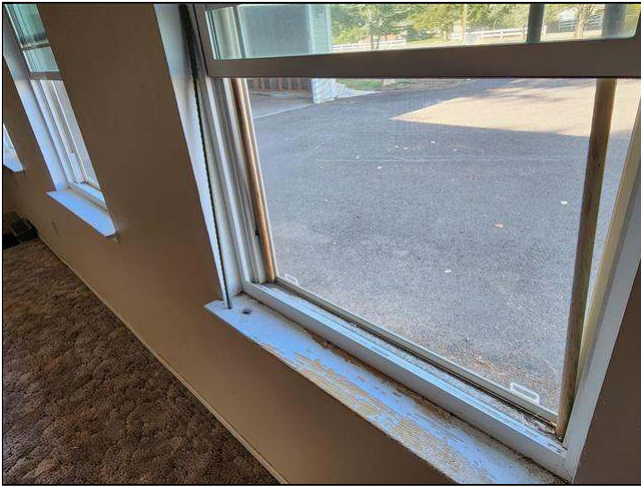
Jamb spring(s) is weak or no longer works properly at the living room window. A repair may be needed. A qualified contractor should inspect and repair as needed.... All other windows operate and secure as intended.

1.4 Item 1(Picture) living room window

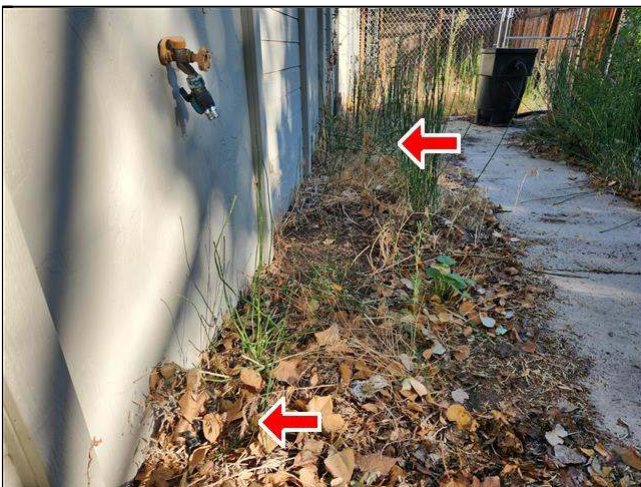
Grading at East side does not slope away from the foundation. Recommend correct slope to prevent excessive moisture against foundation.

1.7 Item 1(Picture) negative grade at east wal

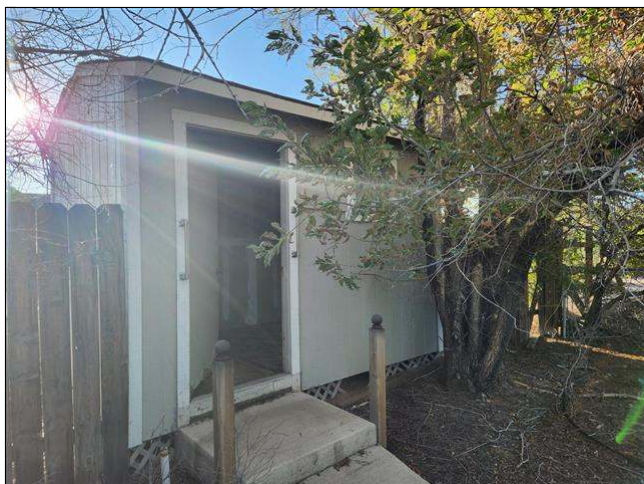
1.9 Item 1(Picture) rear property storage shed

Rear Property Storage Shed... Building shows signs of moisture intrusion at the interior drywall, with several damaged roof shingle areas noted. ... Electrical to shed was non-operational at time of inspection.... Entry door to shed is damaged from moisture absorption, and will need replacement.

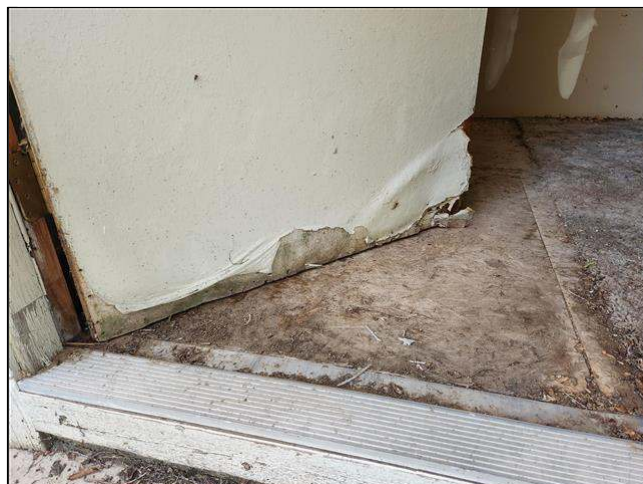
1.9 Item 2(Picture) moisture damaged door

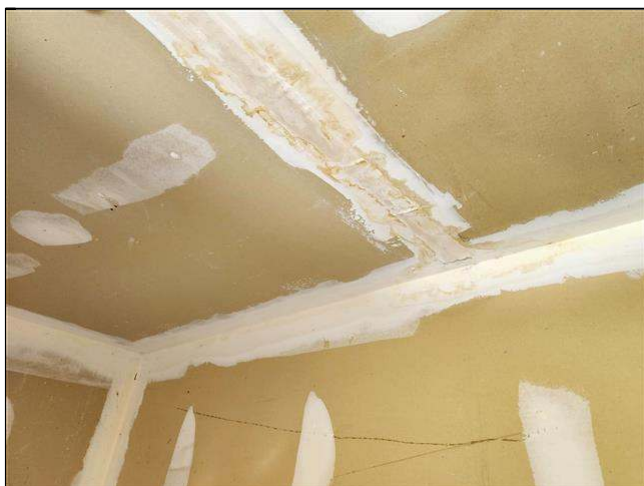
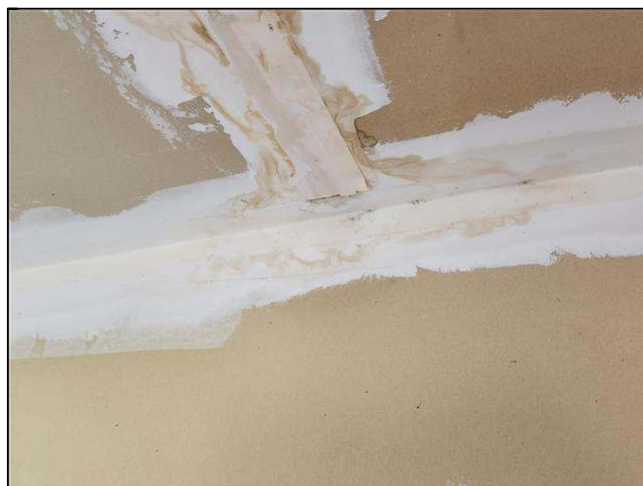
1.9 Item 3(Picture) signs of moisture intrusion

1.9 Item 4(Picture) signs of moisture intrusion

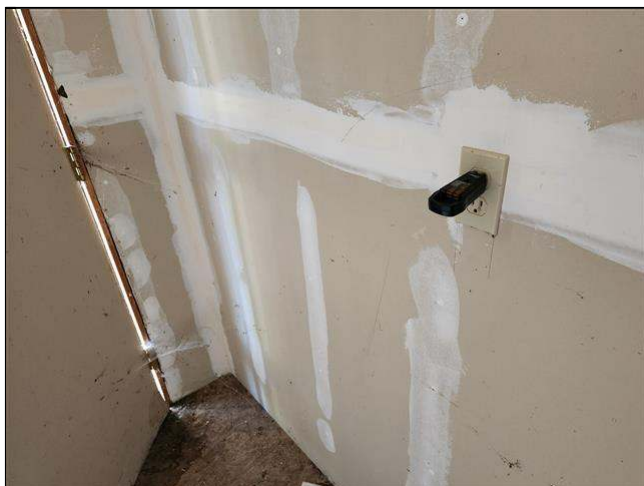
1.9 Item 5(Picture) electrical non-operational

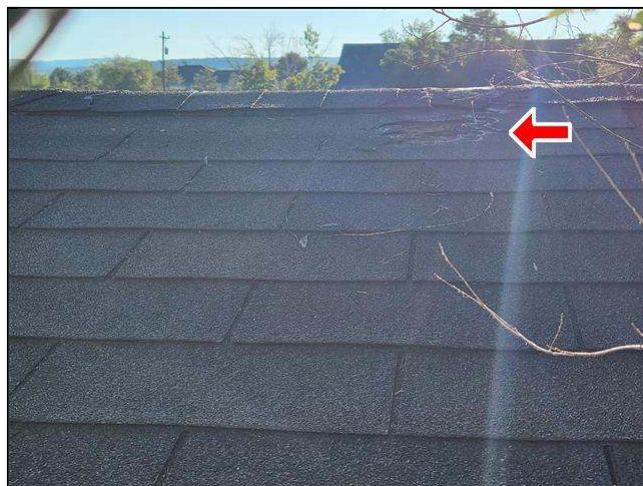
1.9 Item 6(Picture) damaged roofing shingles

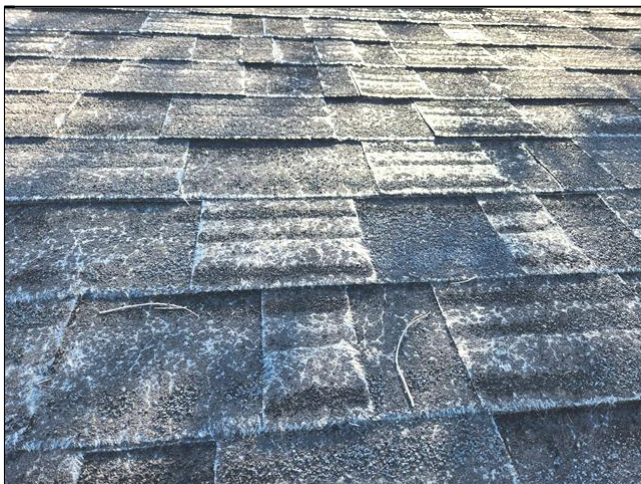
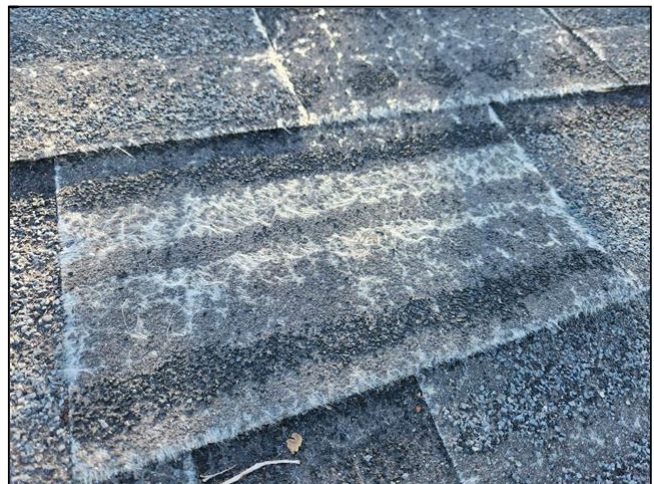
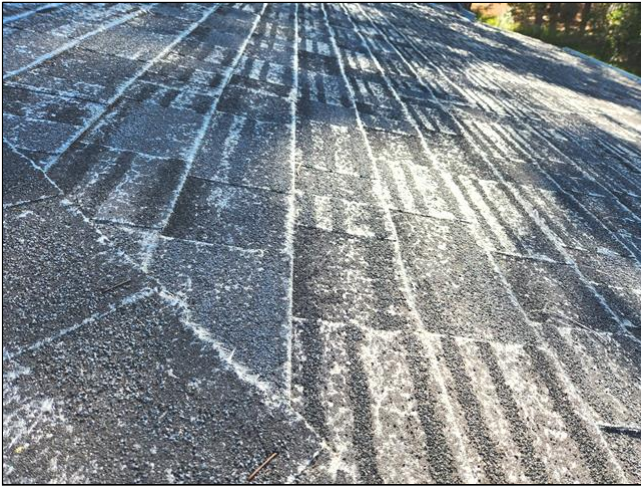
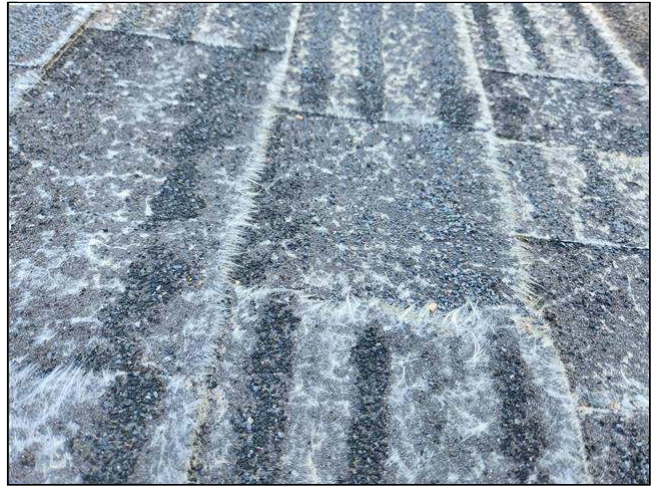
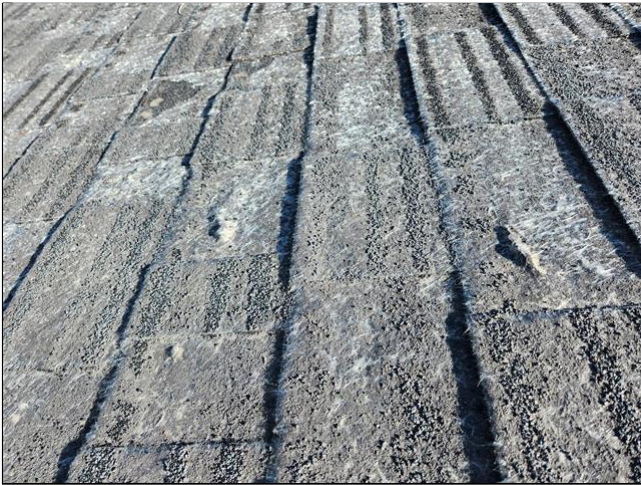
The roof covering appears to be original (33 years) and is a 30 year architectural, asphalt/fiberglass Composition shingle that appears to be at the end of it's useful life. Advanced loss of granules noted from shingles. Ridge cap shingles are missing in a few areas. Recommend further evaluation of roof covering materials by a licensed Roofing Contractor.

2.1 Item 1(Picture) condition of roofing

2.1 Item 2(Picture) condition of roofing

2.1 Item 3(Picture) condition of roof

2.1 Item 4(Picture) condition of roofing

2.1 Item 7(Picture) condition of roofing

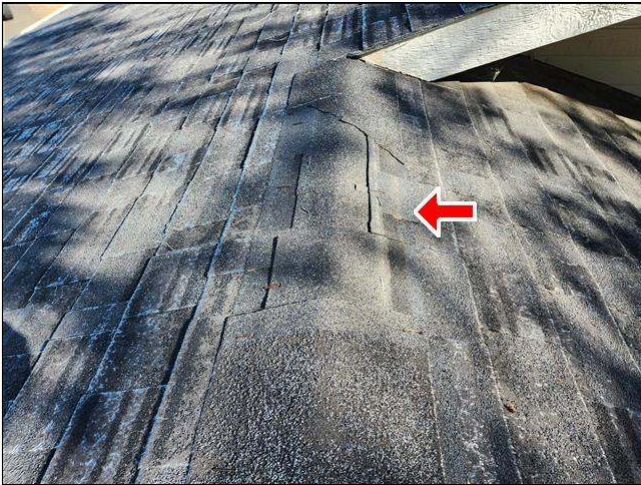
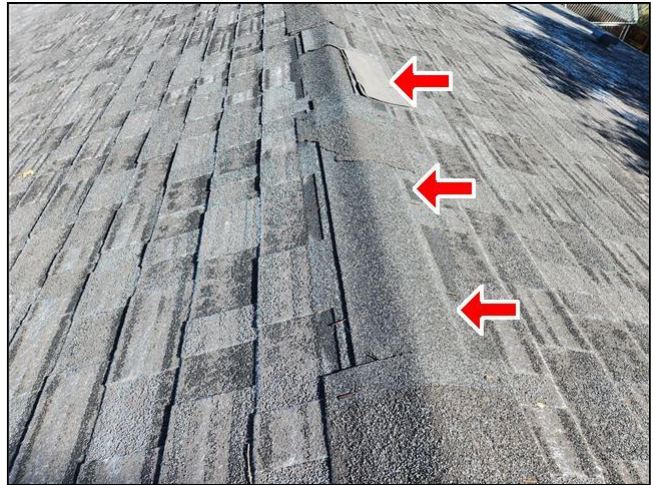
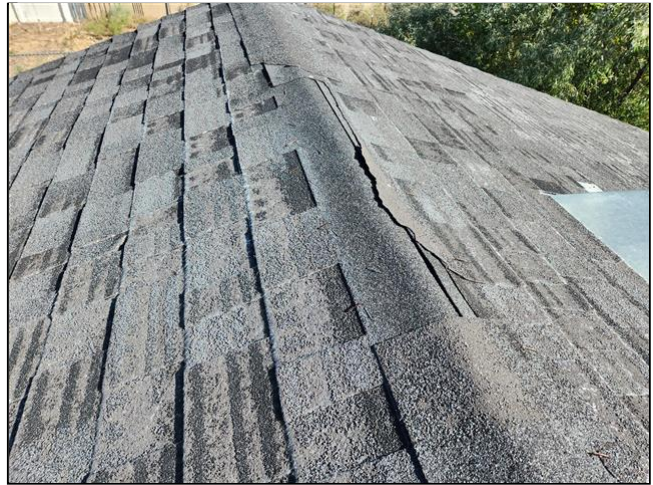
2.1 Item 5(Picture) missing ridge cap shingles

2.1 Item 6(Picture) missing ridge cap shingles

2.1 Item 8(Picture) missing ridge cap shingles

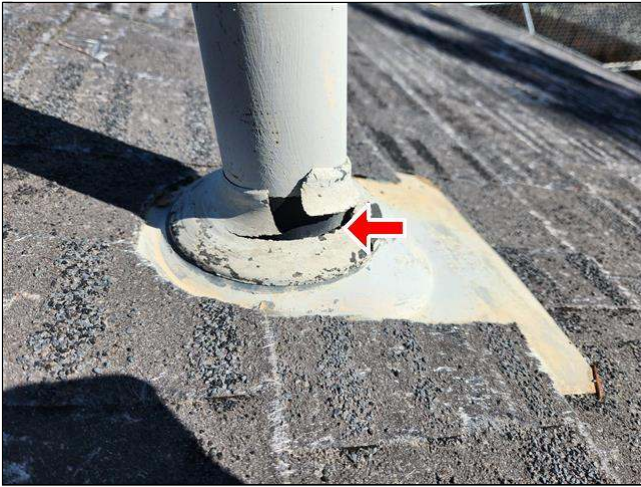
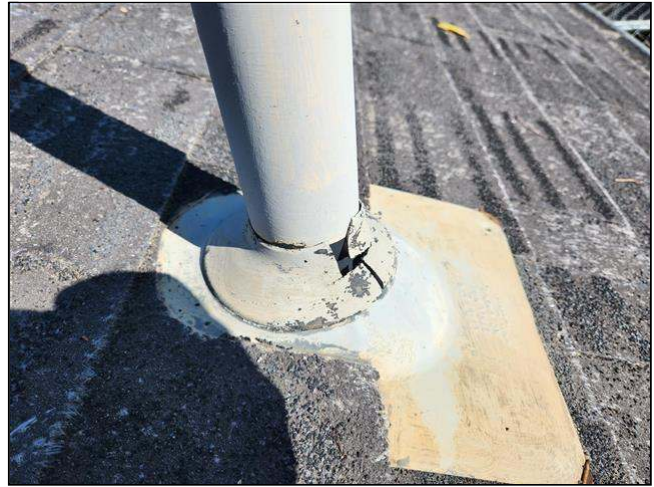
(1) There are a few plumbing vent pipe roof penetrations with failing/deteriorated rubber boots. Recommend replacement of boot seals to prevent moisture intrusion to roof framing areas.

2.3 Item 1(Picture) failing boot seals

2.3 Item 2(Picture) failing boot seals

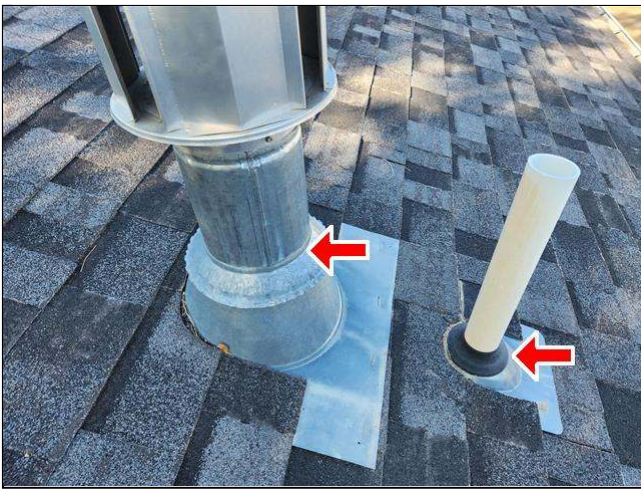
(2) Furnace vent pipes are sealed well against flashings to prevent moisture intrusion into attic framing areas.

2.3 Item 3(Picture) flue pipes well sealed

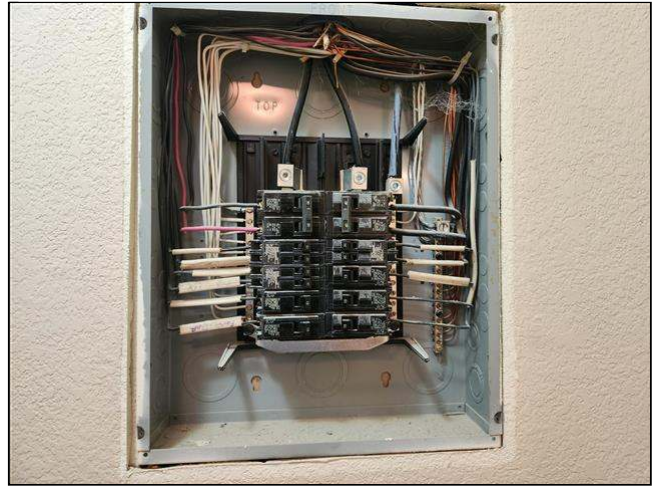
Circuit identification labels are missing and/or illegible at the Laundry room panel. Recommend identifying and labeling circuits, to ensure proper circuit disconnection when needed.

4.1 Item 4(Picture) laundry room panel conductors

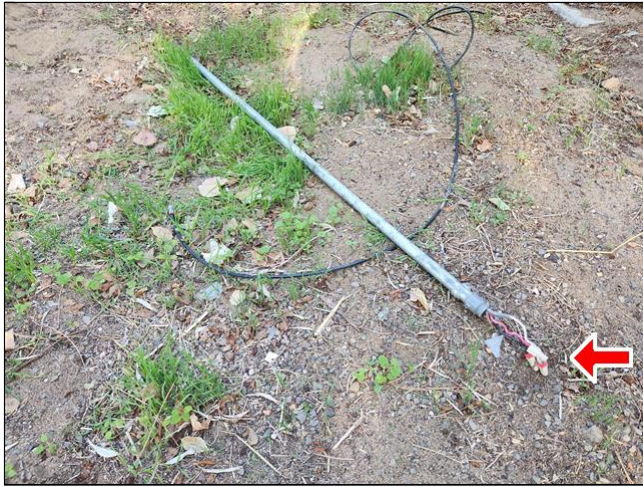
Loose wire end needs placing inside a box with a cover-plate at the South exterior. A qualified licensed electrician should perform repairs that involve wiring.

4.5 Item 1(Picture) loose wire ends at south exterior

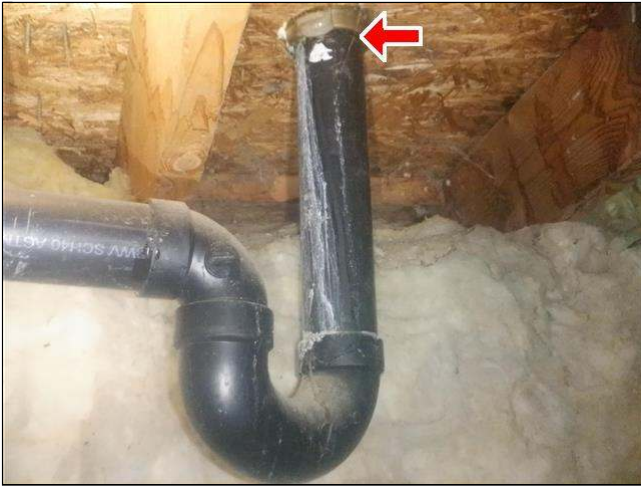
Shower drain is leaking (slow drip) in the crawlspace area under the Guest Bathroom. Recommend repair by a licensed plumbing contractor to prevent excessive moisture, which can lead to mold/fungus, in the crawlspace.

5.3 Item 1(Picture) slow drip at shower drain

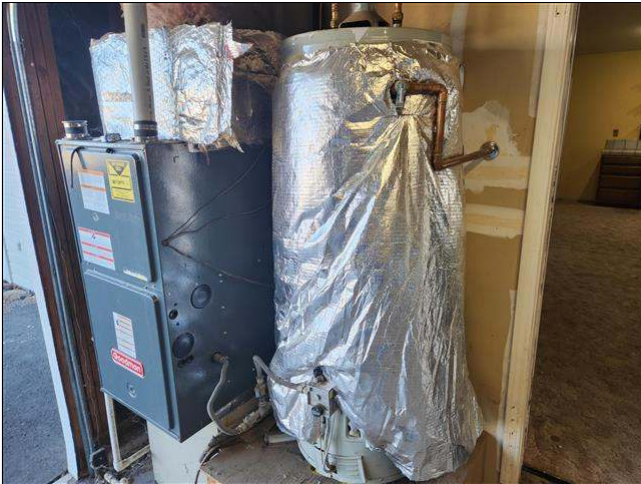
5.4 Item 1(Picture) water heater

(1) Temperature and Pressure Relief valve is piped to the exterior of the house, or within 6 inches of the floor (for safety). Water Heater is NOT properly strapped with approved strapping material, and is setting on a pedestal minimum of 18" above the garage floor. Drip leg is NOT installed in the gas line, water and fuel shut-off valves are present. Water heater COULD NOT be operated as the gas utility was locked OFF at time of inspection. No obvious problems noted at time of inspection... Manufactured in 1989 by State Industries (34 years old). Recommend further evaluation of water heater by a qualified person, once gas supply has been restored.

- 🏠 (2) Water heater is not properly strapped with approved seismic strapping material. The Uniform Plumbing Code (UPC), section 510.5 states "In seismic zones 3 and 4, water heaters shall be anchored or strapped to resist horizontal displacement due to earthquake motion. Strapping shall be at points within the upper one-third (1/3) and lower one-third (1/3) of its vertical dimensions".

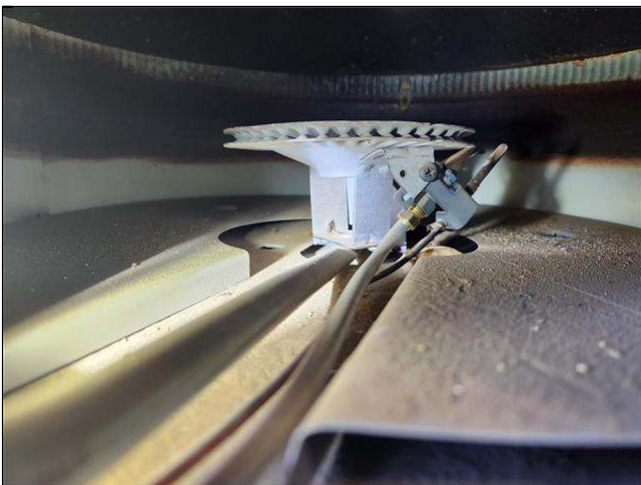
5.4 Item 3(Picture) water heater burner compartment

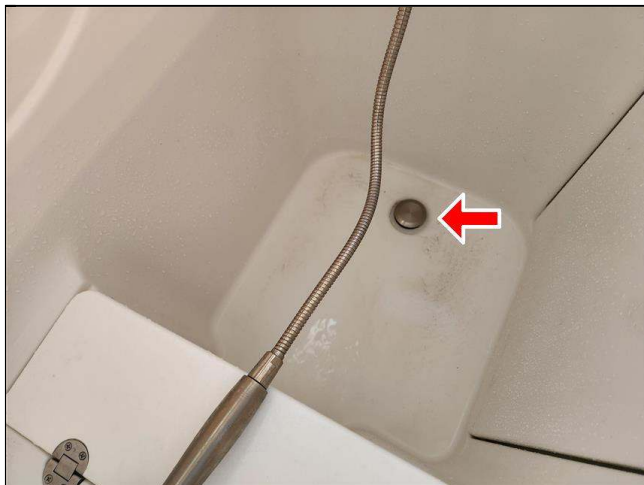
- 🏠 Master Bathroom Walk-in tub could not be filled to check door seals, due to drain plug NOT holding. Diverter valve on faucet does not function properly, and will not switch from the spray hose to the faucet fixture. Recommend repair by a qualified person as needed.

5.5 Item 1(Picture) drain plug does not hold

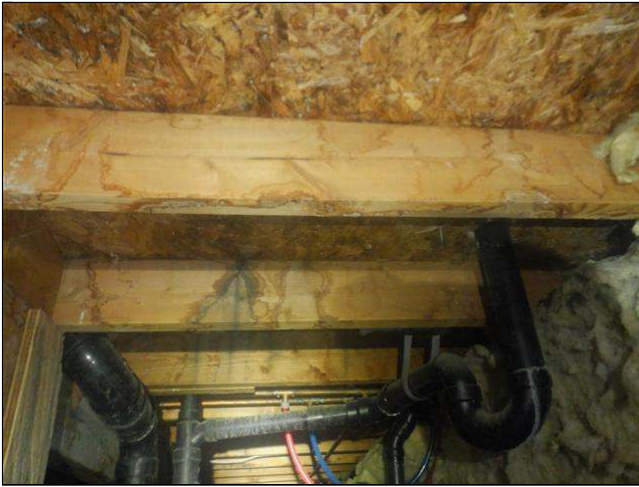
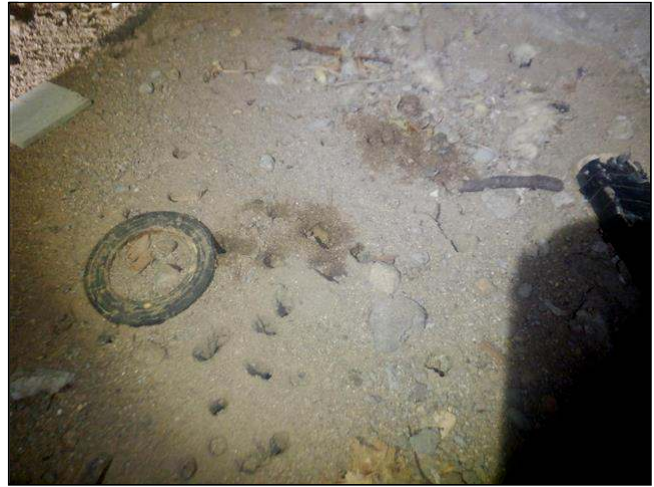
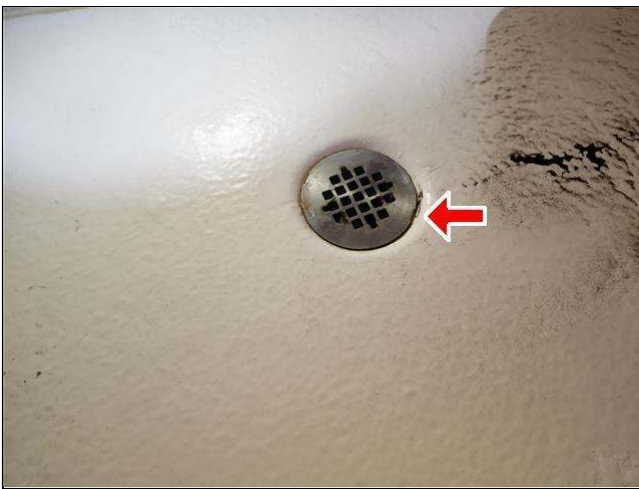
- 🏠 NOTE: moisture drips were noted on the ground under the guest bathroom shower, with moisture stains also noted on the subfloor surrounding the shower area. There are no obvious signs of issues noted at the shower enclosure, however should be further evaluated by a qualified person to locate the source of the moisture. Possibly leaking around the drain, and migrating on the subfloor?

5.7 Item 1(Picture) moisture stains under shower

5.7 Item 2(Picture) moisture drips from subfloor under shower

5.7 Item 3(Picture) possibly leaking around shower drain

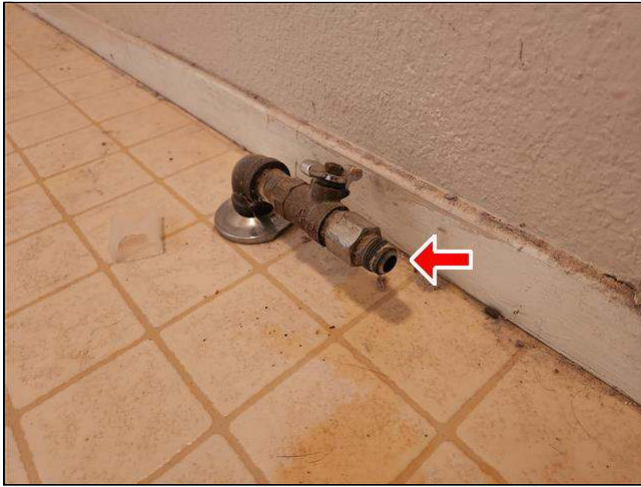
Gas outlets that do not connect to appliances should be capped gas-tight in case the shut-off valve opens or fails. Laundry room connection is currently uncapped.

5.10 Item 1(Picture) dryer gas valve uncapped

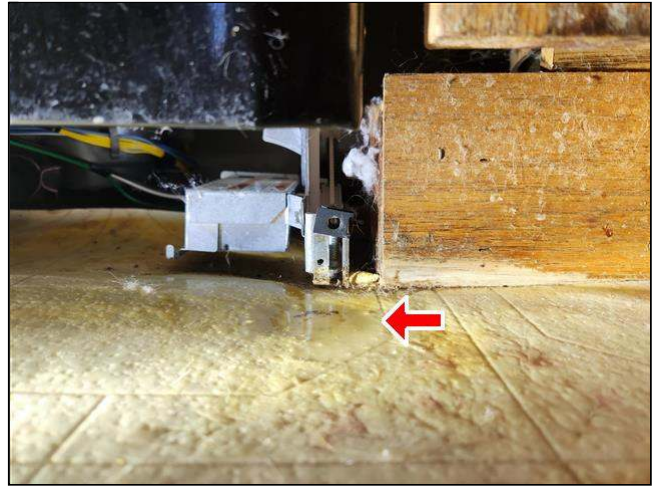
6.1 Item 2(Picture) pooled moisture under door seal

(2) Pooled moisture noted under the dishwasher right side door seal during normal operation. Recommend further evaluation and repair by a qualified appliance technician.

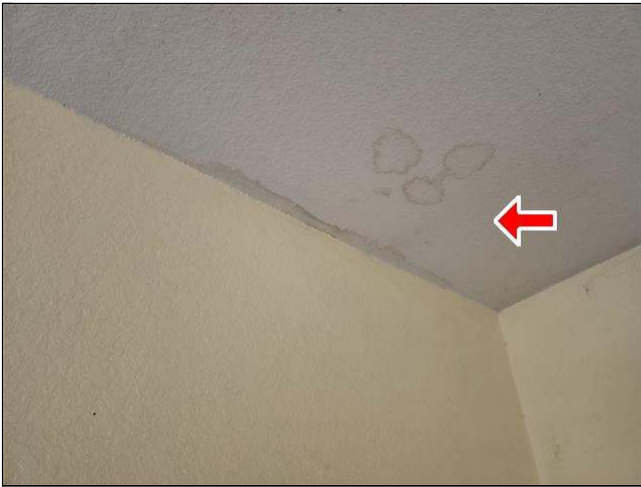
(1) Moisture stains noted at the Family room ceiling. There is a repaired roof shingle area above this location, and appears was the cause for this moisture stain.

7.1 Item 1(Picture) past moisture at family room ceiling

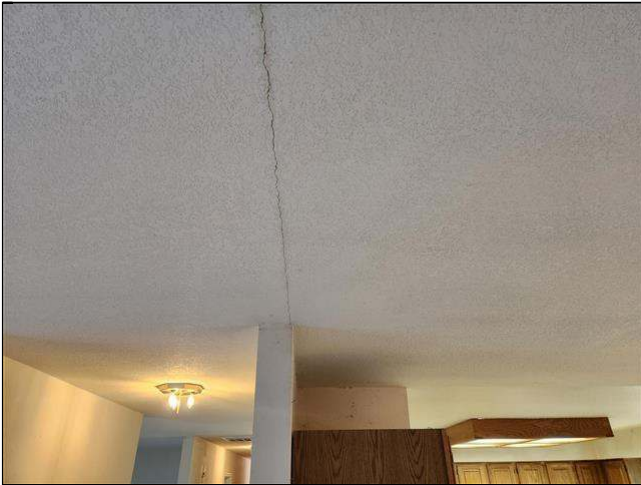
(2) The Drywall on the ceiling has hairline settling cracks in various areas. This is a cosmetic issue for your information. A qualified person should repair or replace as needed.

7.1 Item 2(Picture) hairline settlement cracks at ceilings

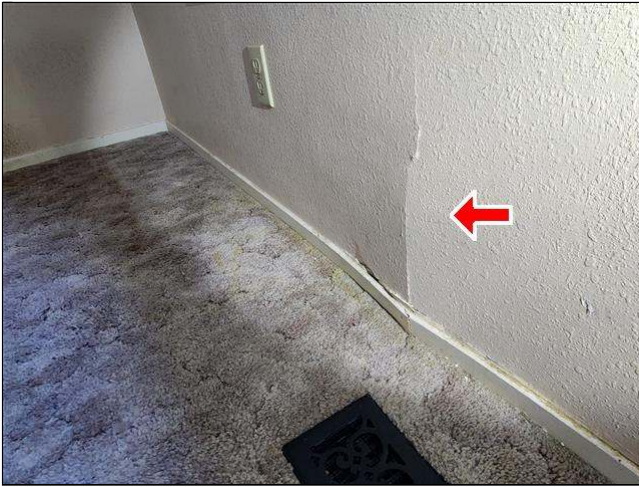
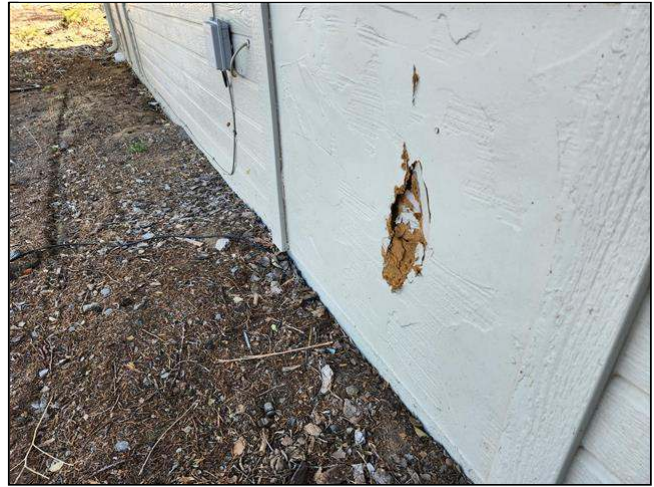
(1) Lower wall is pushed in at the West wall in West guest bedroom, and appears was caused from impact at the exterior wall of home. Recommend repair interior and exterior damage by a qualified person.

7.2 Item 1(Picture) impact damage at west wall

7.2 Item 2(Picture) impact damage at west wall

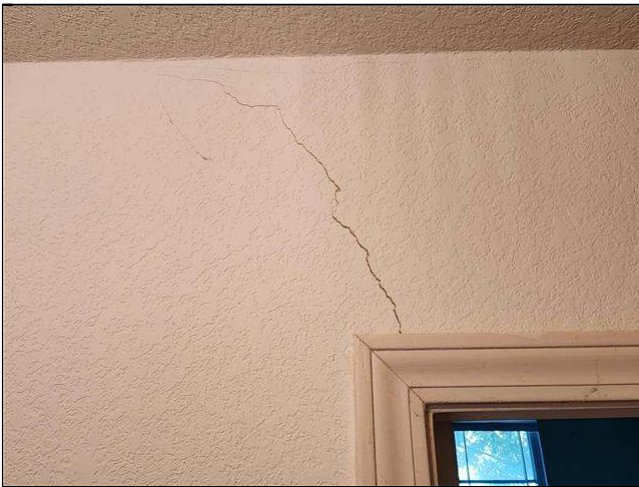
(2) Cracks at interior drywall noted at hallway and bedrooms, that appear to be caused from normal settling. Foundation was inspected under settled areas, with no problems or settlement cracks noted. Drywall cracking is possibly caused from "green" lumber used during construction with shrinkage over time, or from earthquake/tremmers. Walls appear, and feel solid. These cracks are considered to be cosmetic only.

7.2 Item 3(Picture) settlement crack at hallway

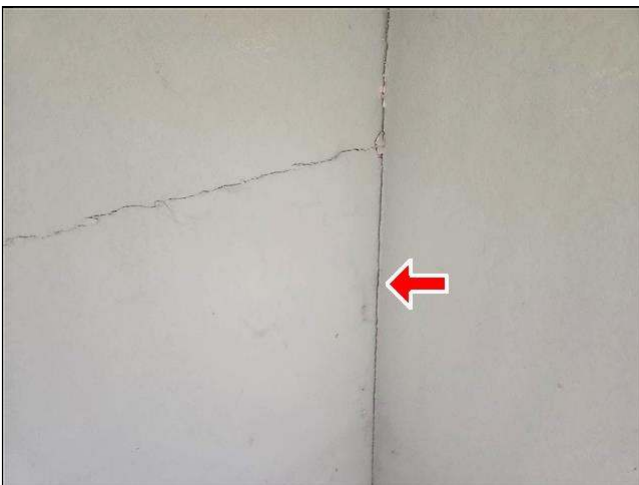
(3) NOTE: Excessive settlement cracks noted at the Southwest bedroom West wall, and may have been caused by the exterior wall impact.

7.2 Item 4(Picture) SW bedroom corner walls

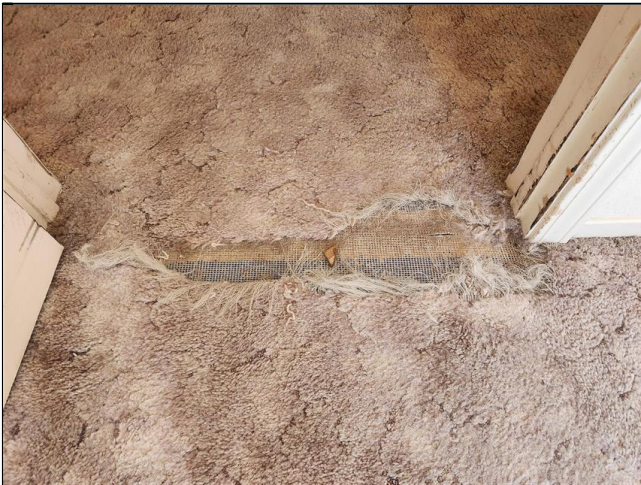
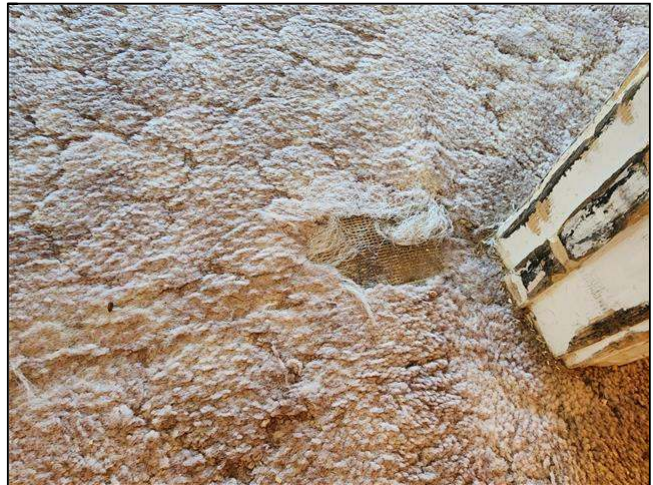
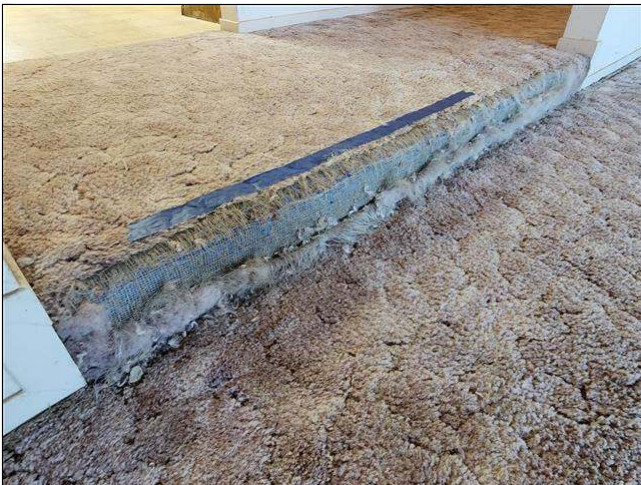
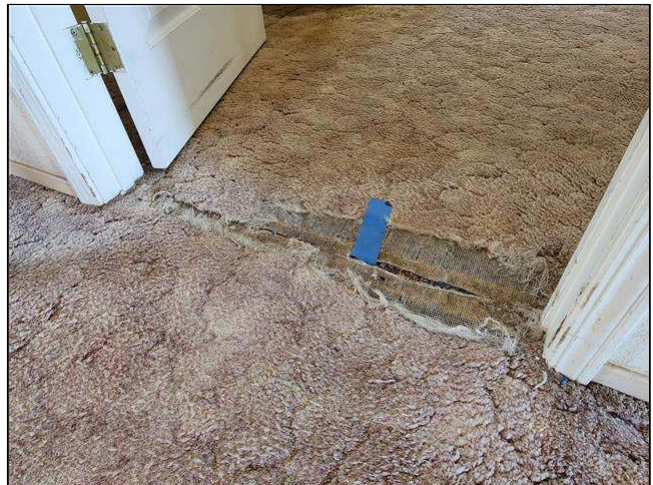
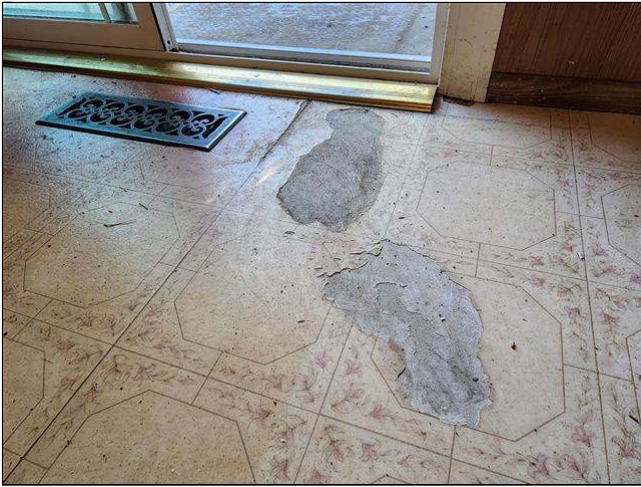
Finish flooring is very worn/aged, with several areas of damage and staining noted. This appears will need replacement.

7.3 Item 1(Picture) worn/damaged carpet

7.3 Item 2(Picture) worn/damaged carpet

7.3 Item 3(Picture) worn/damaged carpet

7.3 Item 4(Picture) worn/damaged flooring

7.3 Item 5(Picture) worn/damaged flooring

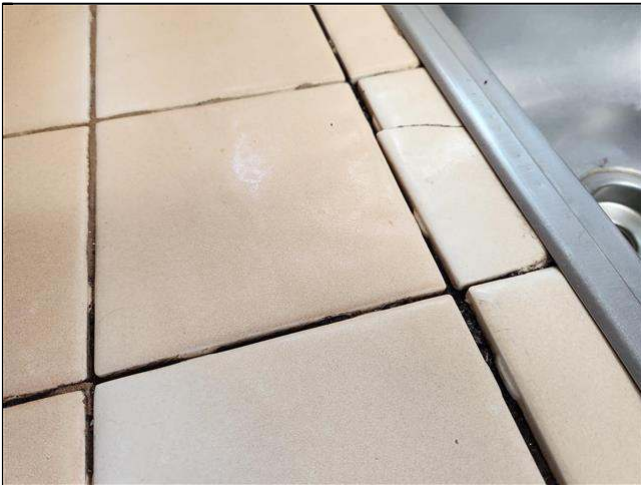
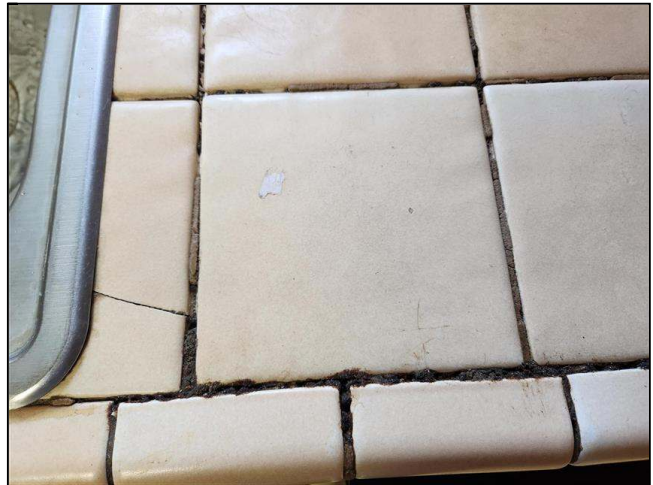
(1) Countertop tiles are cracked/broken (and missing grout) adjacent to the sink at the Kitchen. Though this appears to be a cosmetic item, recommend sealing against sink to prevent possible moisture intrusion under sink into cabinet.

7.4 Item 1(Picture) kitchen countertop tiles

7.4 Item 2(Picture) kitchen countertop tiles

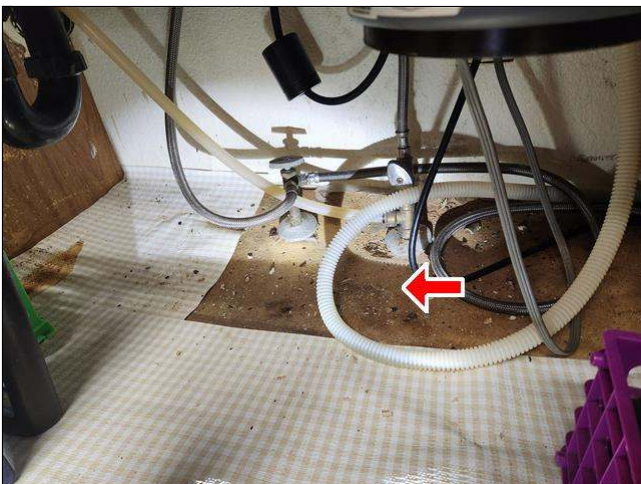
(2) Lower cabinet shelving is swollen, sags or is warped, under sink at bottom shelf (from a previous leak) at Kitchen. Recommend repair or replace damaged cabinet shelving with new material as needed.

7.4 Item 3(Picture) sagging lower cabinet shelf

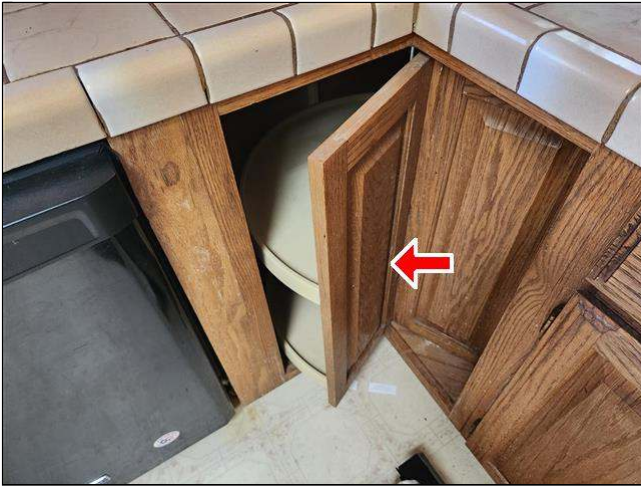
(3) NOTE: Corner carousel cabinet at Kitchen drags, making for difficult use.

7.4 Item 4(Picture) corner cabinet drags

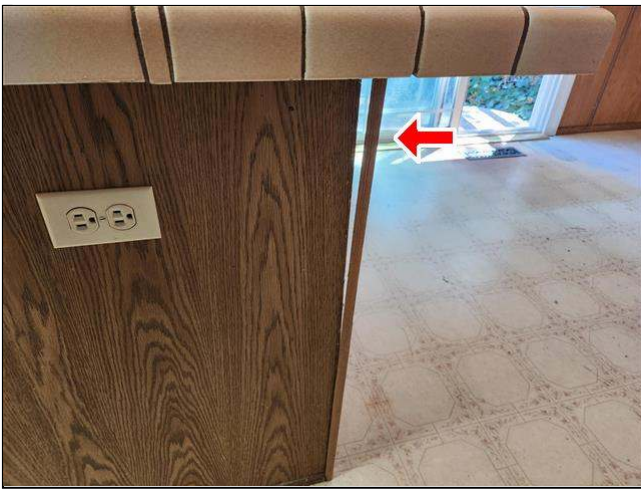
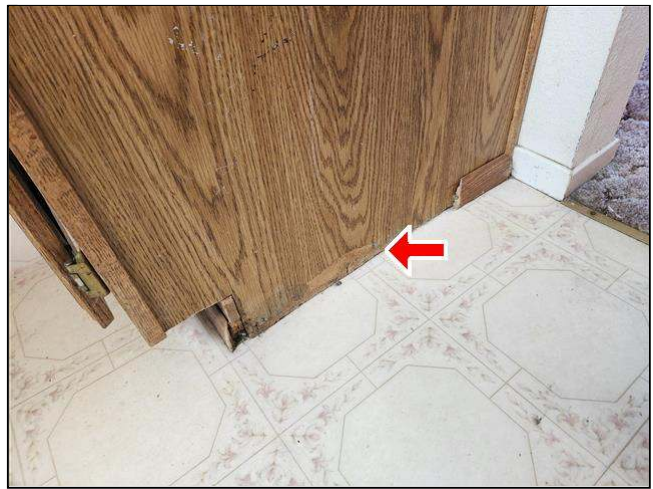
(4) Miscellaneous trim repairs are needed at the kitchen area.

7.4 Item 5(Picture) loose trim

7.4 Item 6(Picture) missing trim

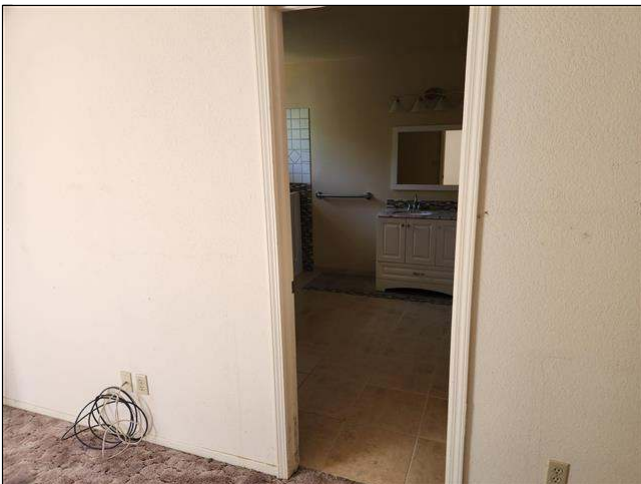
NOTE: Privacy door is missing at the master bathroom.

7.5 Item 1(Picture) missing door at master bathroom

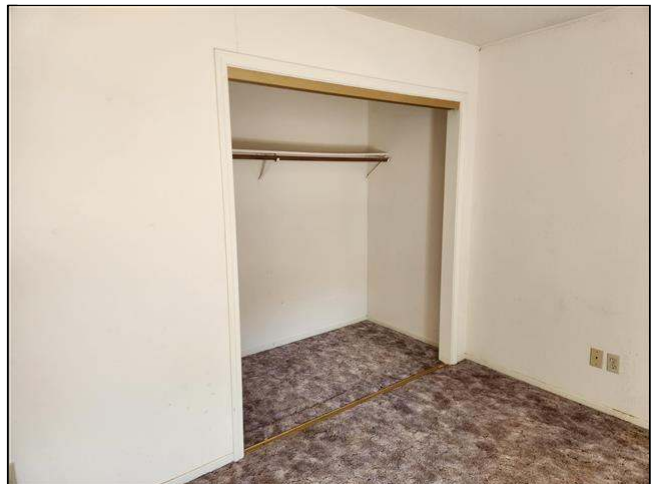
7.5 Item 2(Picture) missing doors at all closets

NOTE: All closet doors are missing.

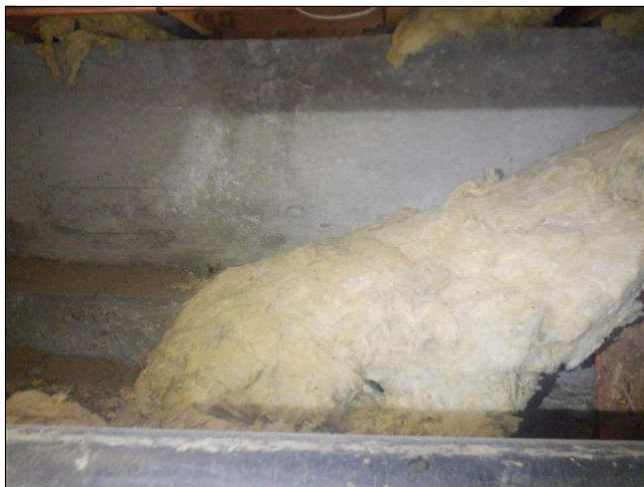
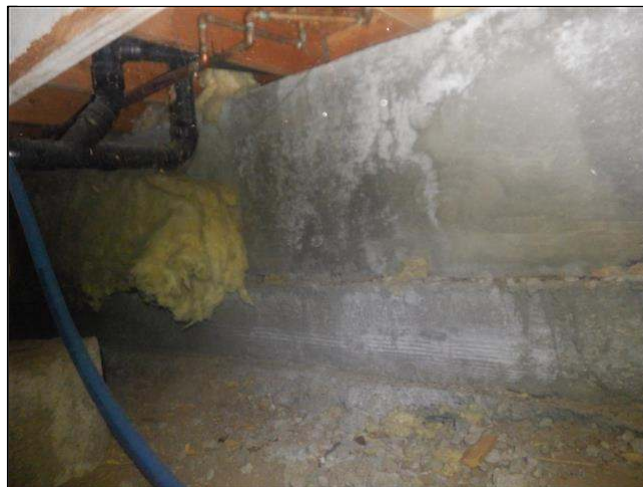
The crawlspace area is insulated on the perimeter of the inner foundation wall. Insulation is falling away from the foundation stemwall under the master bedroom, Kitchen and Family room areas. Recommend securing insulation to foundation wall to maximize the home's efficiency and comfort.

9.1 Item 1(Picture) falling foundation insulation

9.1 Item 2(Picture) falling foundation insulation

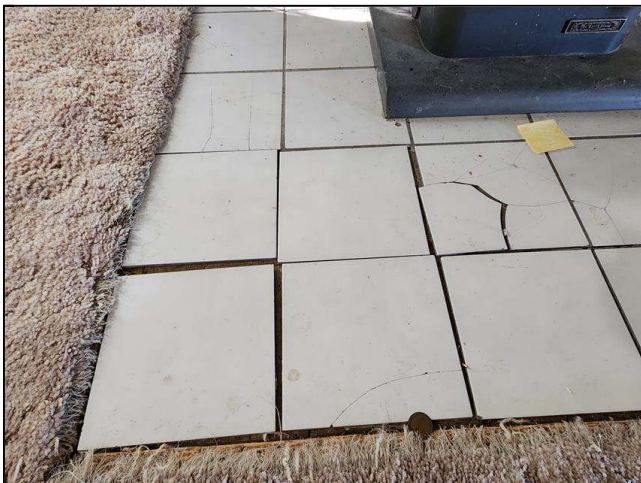
11.3 Item 3(Picture) cracked/loose tiles
