INSPECTION REPORT
3895 Golden Eagle
Manhattan KS 66502

INSPECTED BY
Todd Thompson
Trust Inspection
Services

INSPECTION DATE
📅 5/14/2024
🕒

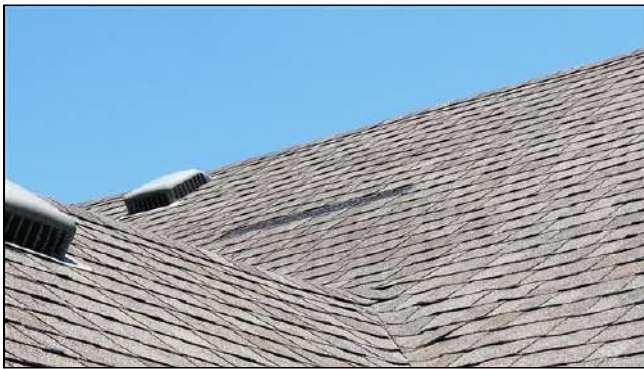
1.0 Item 5(Picture)

There's some missing shingles on the south facing roof.

Recommend having a roofer further evaluate the roof for life expectancy. Weddle and Sons roofing does free inspections and provides a report with life expectancy and estimates for any recommended repairs.

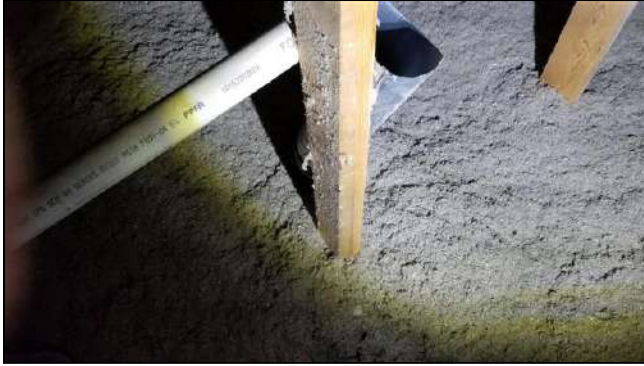
1.5 Item 1(Picture)

1.5 The bathroom exhaust fans vent into the attic space - while not ideal, no excessive moisture was noticed in the attic.

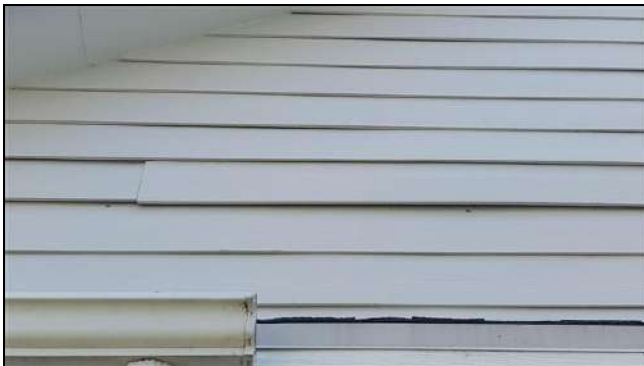
2.0 Item 1(Picture)

2.0 There are some loose pieces of siding in the upper West gable end. Some cracking can be seen in one of the pieces of siding - treat this as a butt joint and caulk it. The siding butt joints appear to have a building paper behind them - making it not necessary to caulk the butt joints

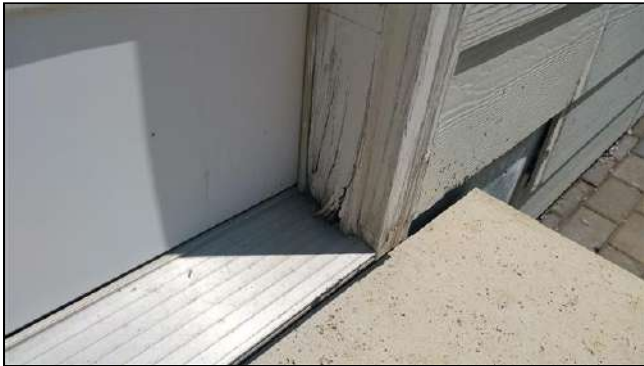
2.1 Item 1(Picture)

2.1 Water damage, chipping paint, and damage to the weather seal can be seen on the south patio door. Daylight can be seen from the inside.

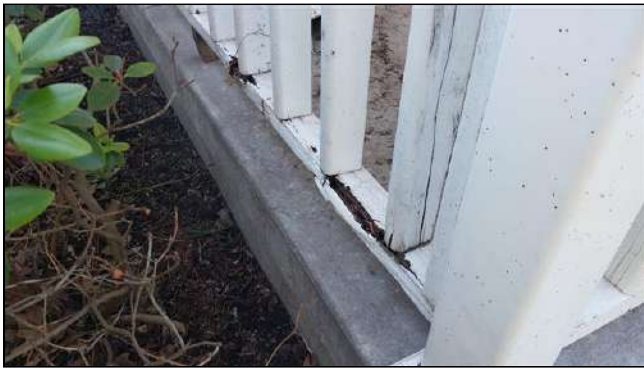
2.3 Item 2(Picture)

(2) Areas of chipping paint and water damage can be seen on the front porch railing.

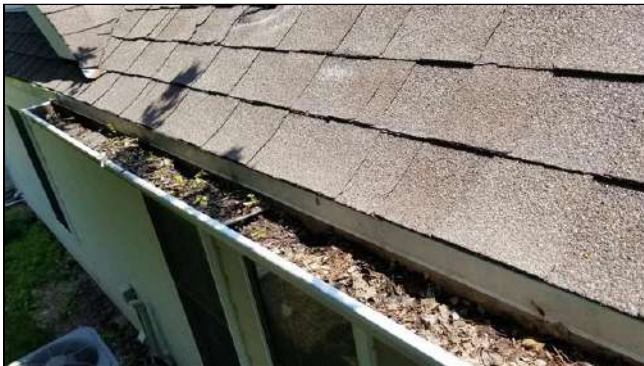
2.5 Item 7(Picture)

(2) The gutter at the Southwest corner of the home needs to be cleaned.

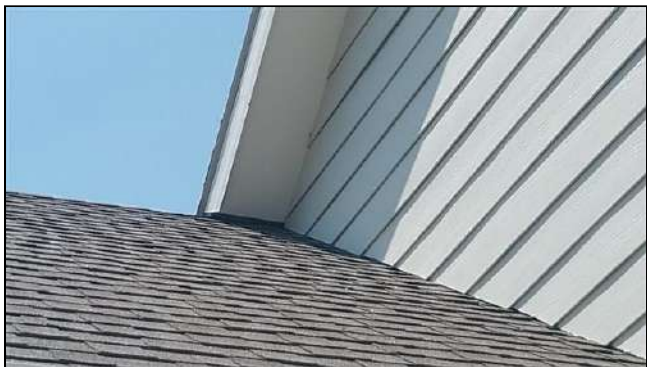
2.6 Item 1(Picture)

There is some cracking in areas of the soffit board

2.6 Recommend installing some flashing to seal off the gap in the soffit above the garage roof and at the NW corner.

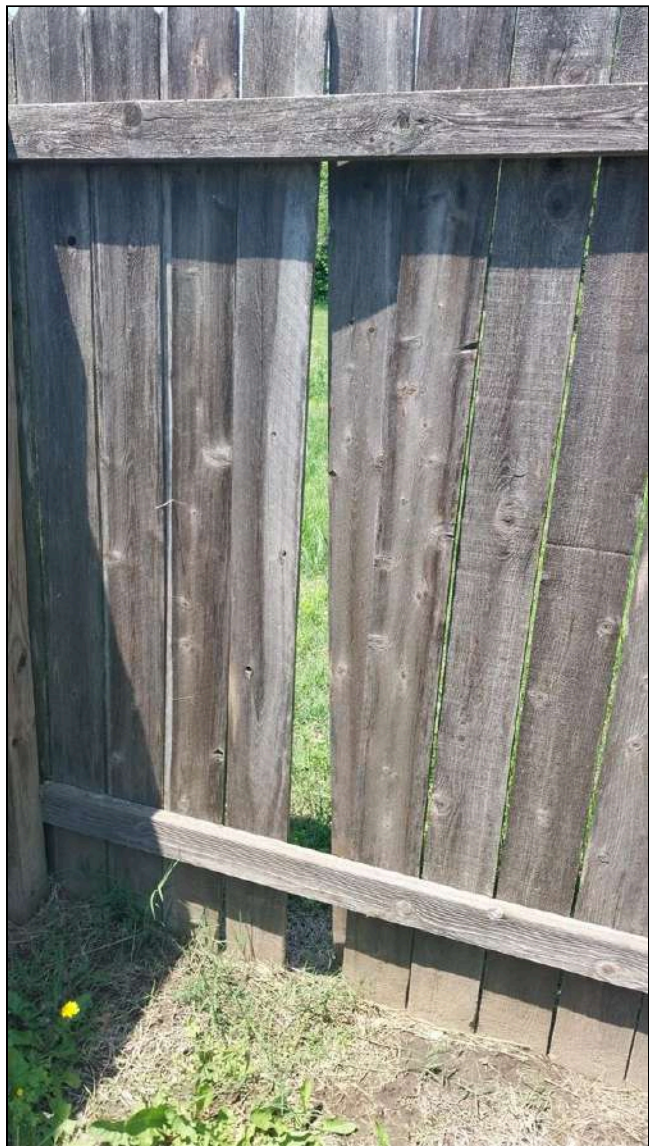
2.9 Item 1(Picture)

2.9 There's a little bit of repair needed on the fence.

There are some twisted boards. The fence needs to be power washed and water treated in the near future

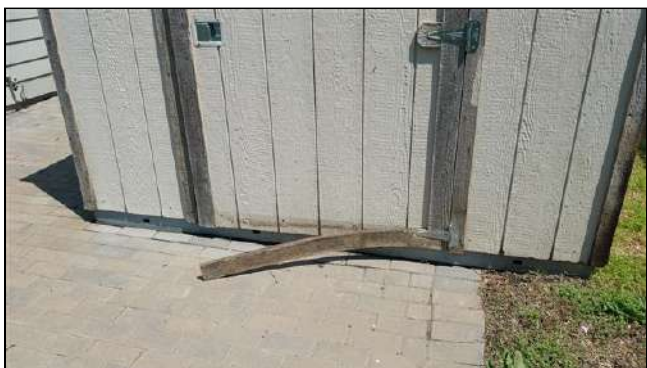
2.10 Item 1(Picture)

2.10 The shed has areas that need some repair and the exterior needs to be painted.

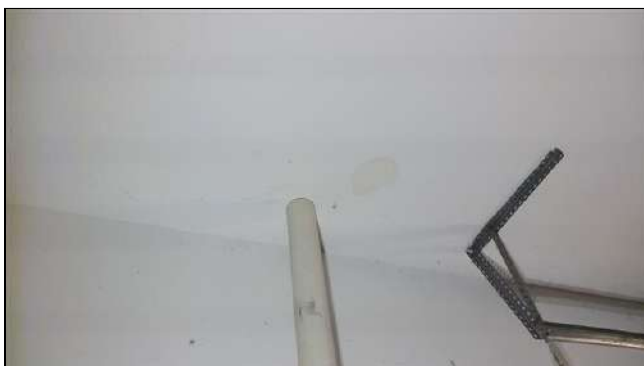
3.0 Item 1(Picture)

3.0 There is a stain in the garage ceiling.

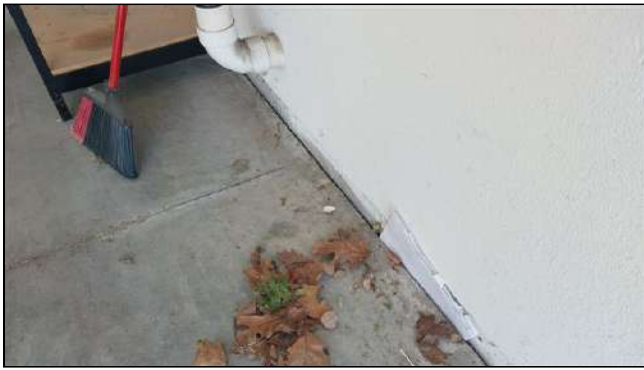
3.2 Item 1(Picture)

There are some cracks in the garage floor

These do not appear to be a structural concern at the moment

3.2 Recommend caulking the gap along the garage floor to wall joint.

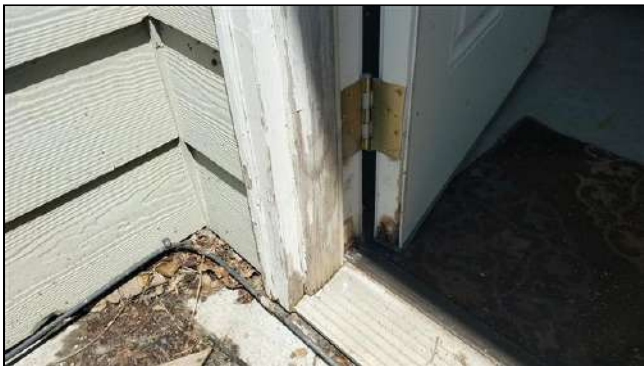
3.3 Item 1(Picture)

3.3 Some water damage and chipping paint that can be seen on the rear entry garage door and frame.

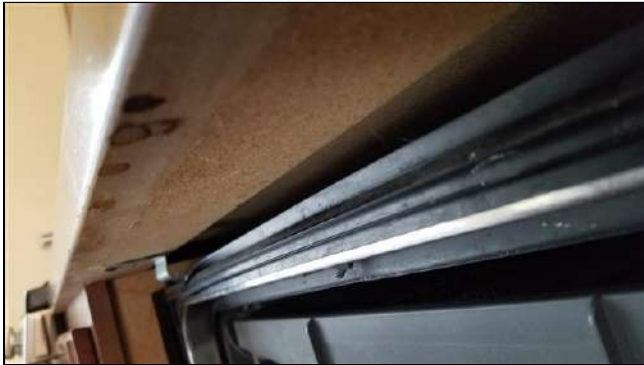
4.5 Item 1(Picture)

There's some water damage to the cabinet base under the kitchen sink.

4.5 Recommend sealing the bottom of the countertop above the dishwasher to prevent steam damage. A simple piece of aluminum tape will suffice.

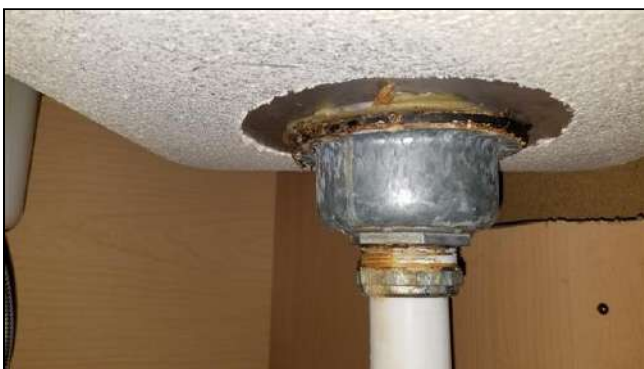
4.6 Item 1(Picture)

4.6 There was some active leakage noted under the right kitchen sink.

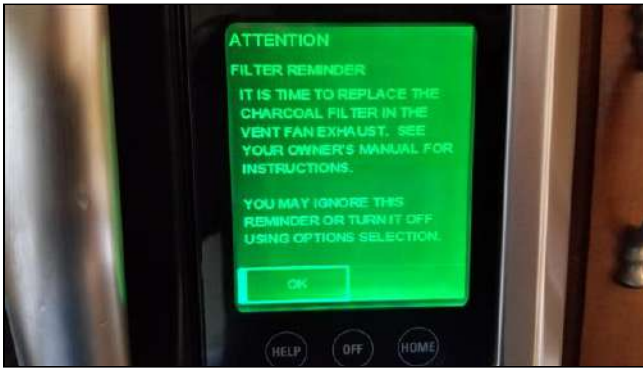
4.14 Item 1(Picture)

There was a notification on the microwave display stating that the charcoal filter needs to be replaced in the

exhaust fan.

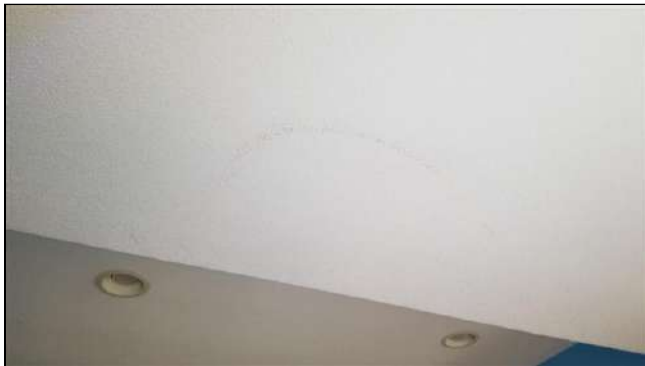
5.0 Item 1(Picture)

There's a small stain in the master bedroom ceiling.

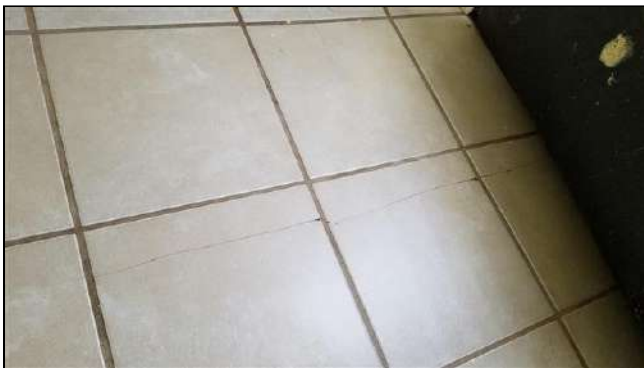
5.2 Item 1(Picture)

5.2 There are several cracked tiles in the Southwest bedroom floor by the exterior doorway.

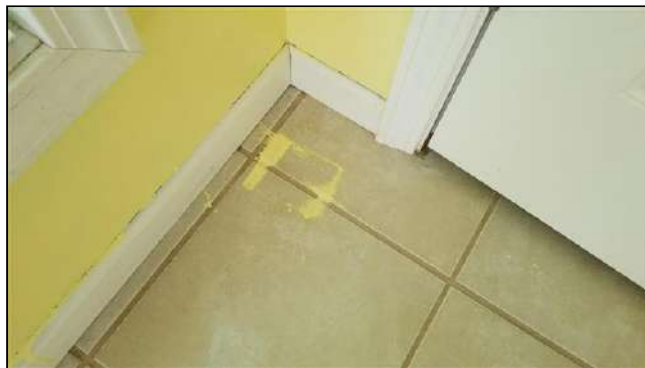
5.2 Item 2(Picture)

There are some paint stains on the southwest bedroom tile floor.

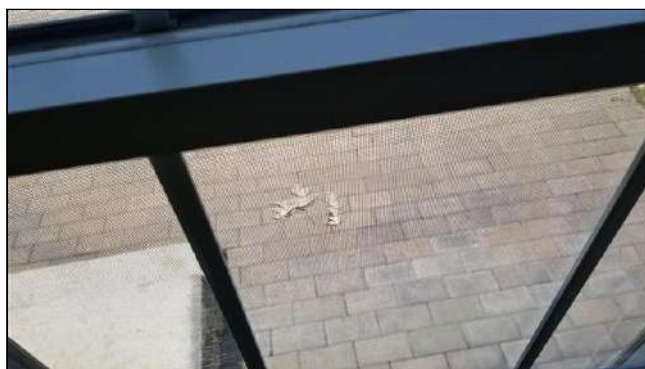
5.5 Item 2(Picture)

5.5 The operate assist is failing on the northwest bedroom window causing the sash to be dead weight.

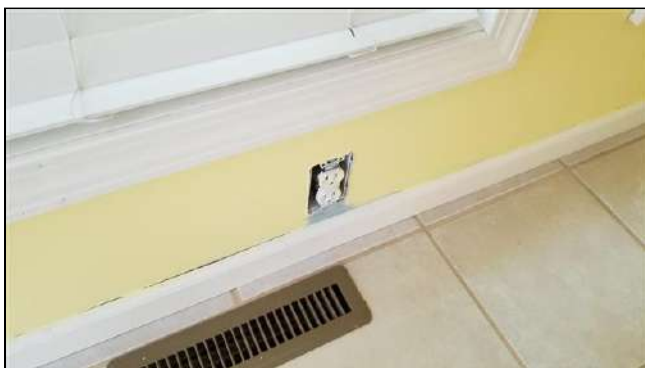
5.6 Item 1(Picture)

5.6 There's a missing outlet cover in the southwest bedroom.

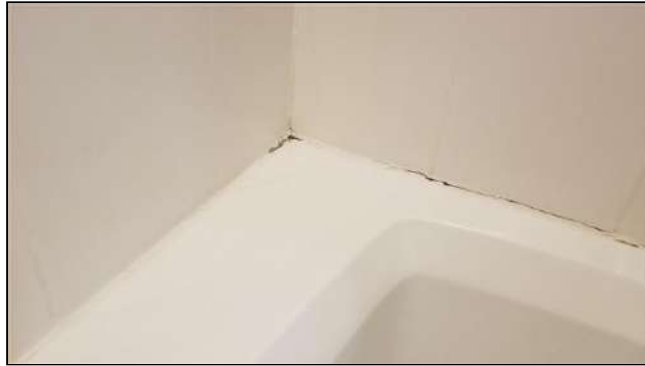
6.0 Item 4(Picture)

6.0 There's a little bit of water damage to the drywall and base trim on either side of the master shower.

Recommend maintaining the caulking around the edges of the tub deck to prevent water from getting behind the tile.

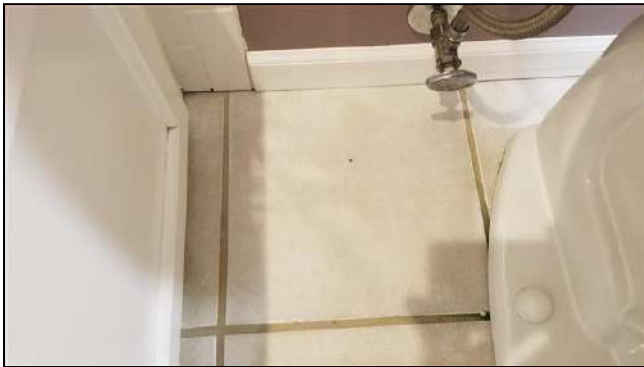
6.1 Item 1(Picture)

6.1 There's a cracked tile in the guest bathroom floor.

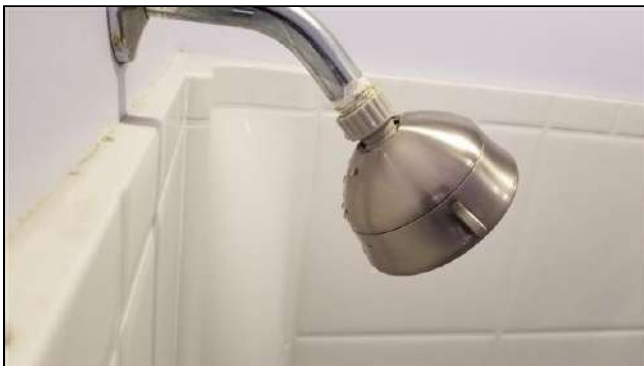
6.6 Item 1(Picture)

6.6 The master bathroom shower head leaks when running.

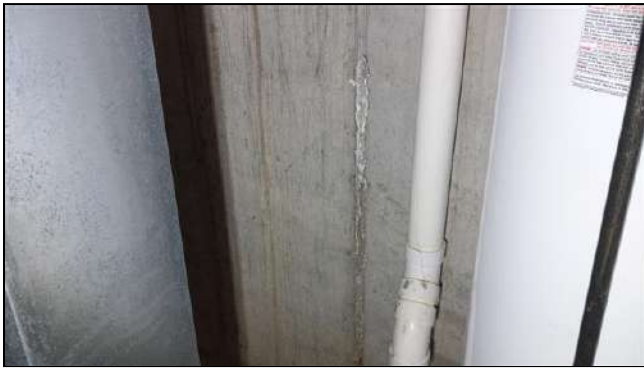
7.0 Item 1(Picture)

7.0 There are several areas where evidence of previous moisture entry can be seen on the basement walls.

Creating and maintaining positive exterior drainage is essential

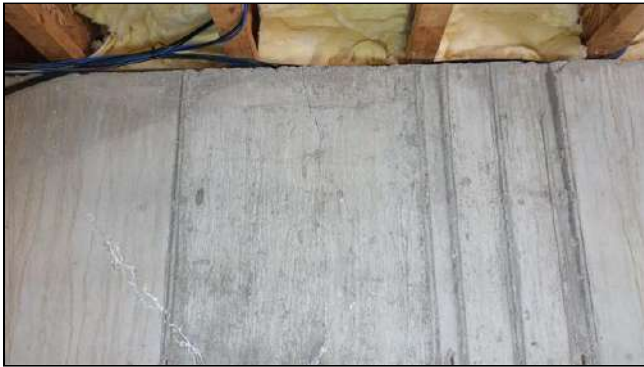
7.1 Item 1(Picture)

7.1 Small cracks do not represent a structural concern at the moment.

Recommend sealing the cracks to establish a baseline - monitor for any future movement.

Creating and maintaining positive exterior drainage is essential.

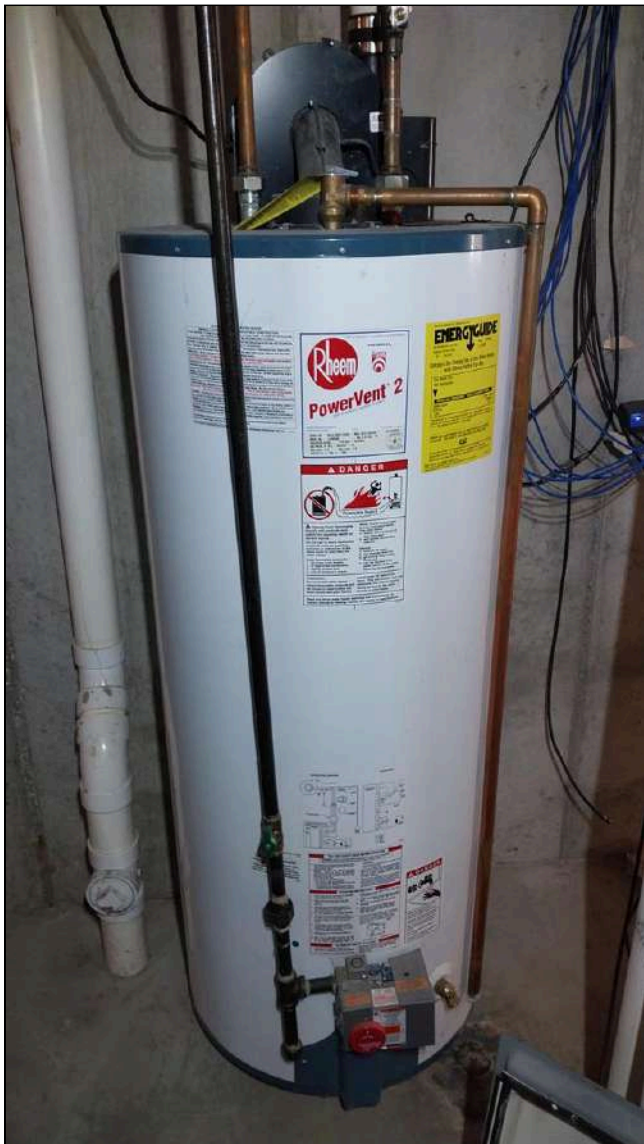
8.2 Item 1(Picture)

There's quite a bit of corrosion around the dielectric union, but no leakage was noted at time of inspection

There is a small amount of leakage from the pressure relief valve

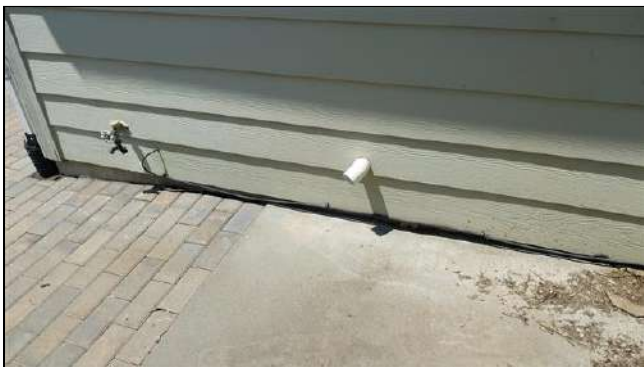
8.6 Item 1(Picture)

8.6 There is a sump pump located in the basement. The pump ejects on the south. side of the home

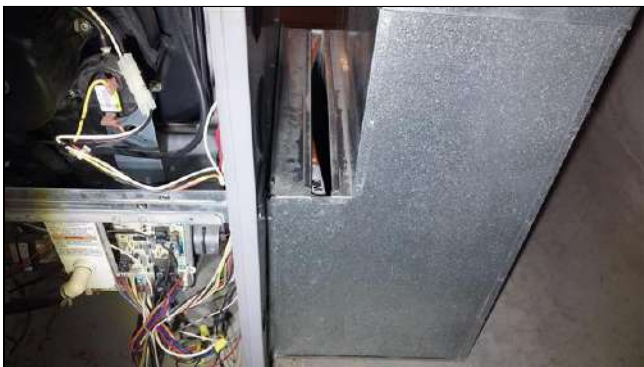
10.3 Item 1(Picture)

The filter needs to be changed in the near future.

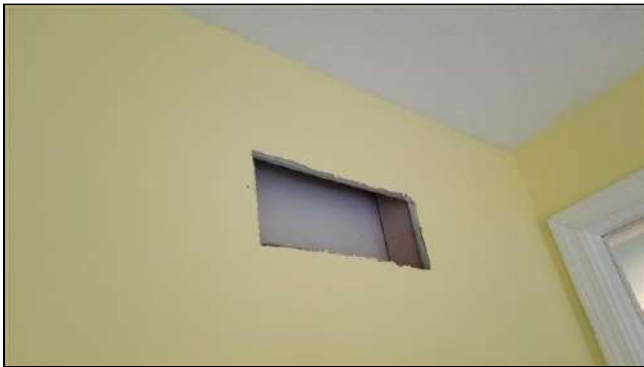
10.4 Item 1(Picture)

10.4 There's a missing return air vent register in the southwest bedroom wall.

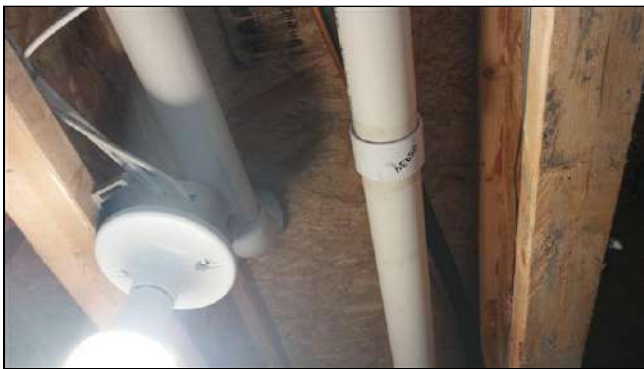
10.5 Item 1(Picture)

10.5 Evidence of a previous leak from the furnace flue pipe can be seen in the basement. Unknown if this has been fixed or not.
