Home Inspection Report

PROPERTY INSPECTED:
5125 Lewies Way
Shepherd, MT 59079

Date of Inspection: 04/23/2024

Inspection No. 45957-1-1041

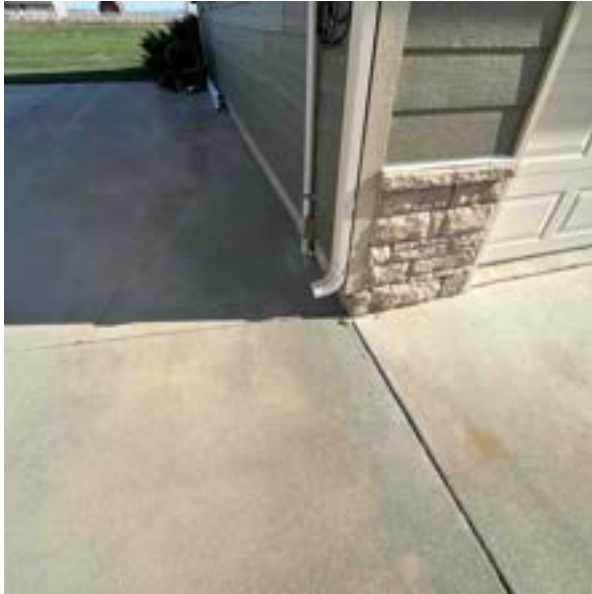
4.5.3 Caution is advised. Downspout discharges on to walkway causing potential safety hazards. **(Exterior West)**

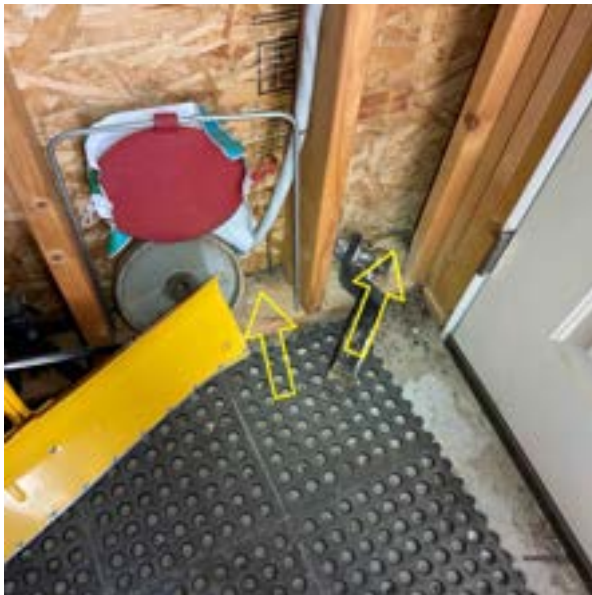
6.6.1 Stains

6.6.2 Further investigate cause and extent of wall staining and repair as required to prevent further damages. No moisture detected at time of inspection. **(Shop)**

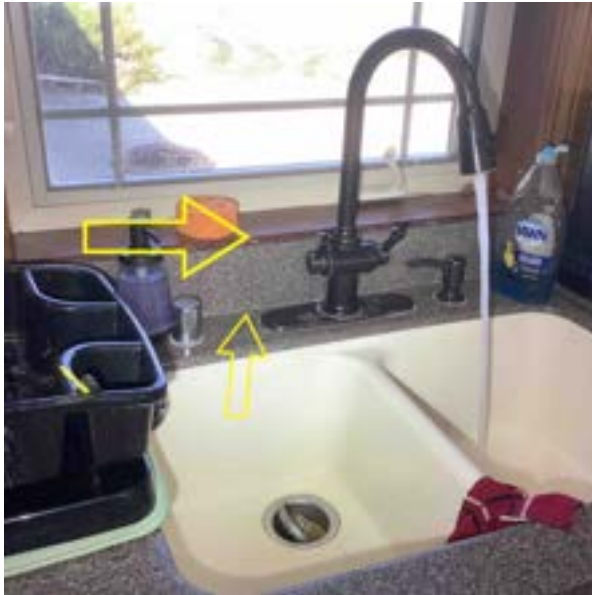
- Hallway Bathroom
- Kitchen
- Laundry area
- Master Bathroom

11.6.3 Previous water damages noted - No moisture detected at time of inspection.

11.6.4 Recaulk counters to prevent moisture intrusion and subsequent damages.
