WOOD DESTROYING PESTS INSPECTION REPORT

No 649333

Firm (PCO) Carson Valley Ext License No. 5599 Inspection Date 2-21-2023
 Address P.O. Box 2306 Gardnerville, NV 89440 FHA/VA/Escrow or Mortgage No. _____
 Address of Property Inspected 304 Kathy Ave Yerington 89447
 Inspection Ordered by Thomas Vander Loan - Coldwell Banker City Zip Code
 Inspection Report Sent to same
 Owner's Name and Address... [REDACTED]

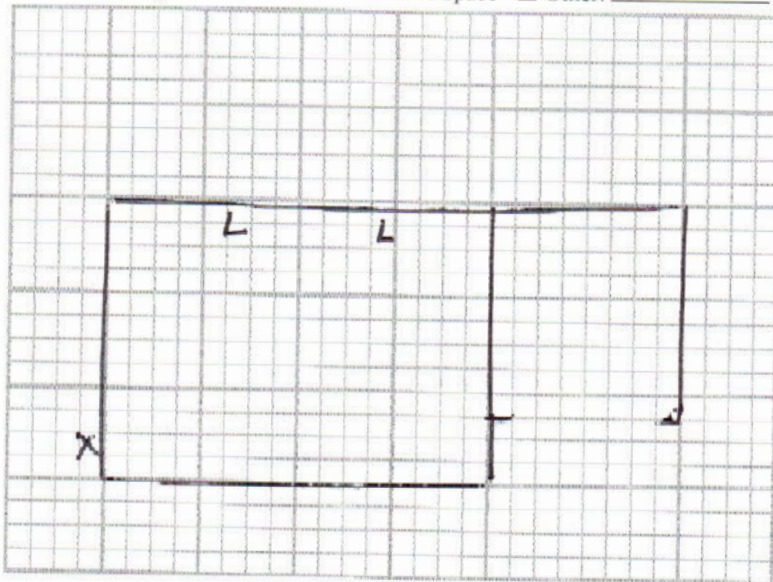
Earth wood contacts on
terrace post.
Leak inside kitchen
sink cabinet some damage
House Bio Leaking in
crawl space when on.

Leaks (L) are being repaired. Please reference 5.0(1), 5.0(2), and 5.4(1) of Home Inspection Report
