Inspection Report

Property Address:
3115 Imperial Way
Carson City NV 89706

Clear Choice Home Inspection Services

Date: 6/1/2023	Time: 09:00 AM	Report ID: BRO311
Property: 3115 Imperial Way Carson City NV 89706	Customer:	Real Estate Professional: Thomas Vander Laan Coldwell Banker

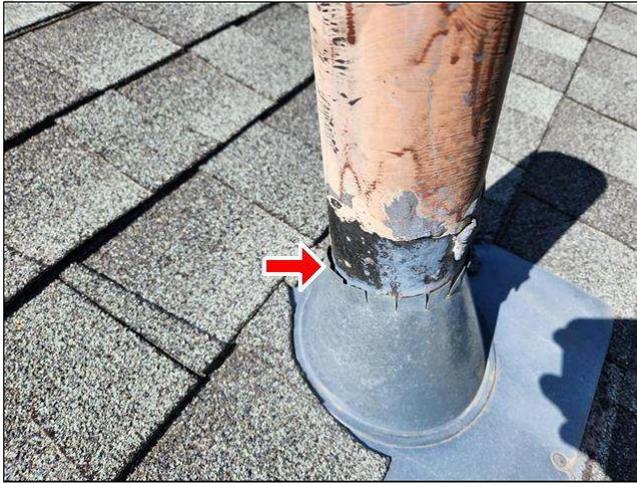
(2) The main soil stack plumbing vent pipe should be sealed against flashing to prevent moisture intrusion into attic framing areas.

2.3 Item 1(Picture) seal main soil stack

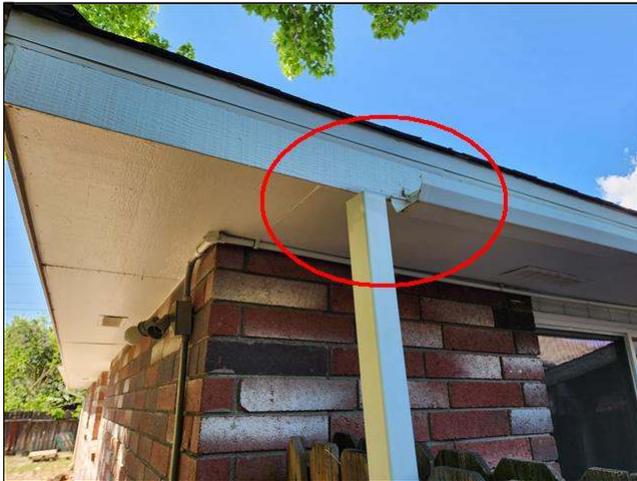
Recommend connecting gutter and downspout at the Northeast corner of home, to control roof run-off moisture and ground erosion.

2.4 Item 1(Picture) gutter and downspout at NE corner

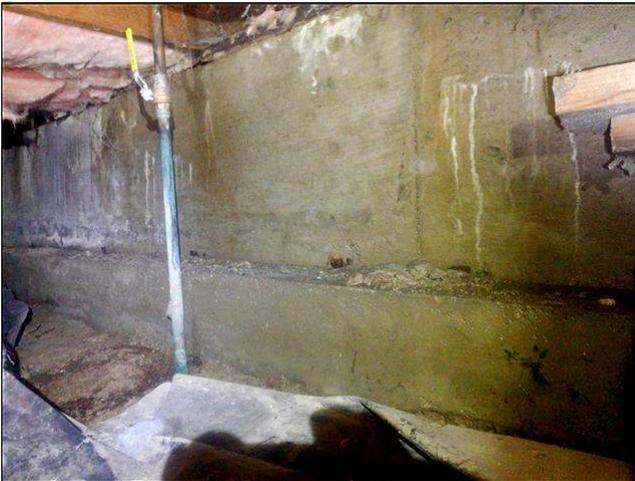
NOTE: Several areas of pooled moisture were noted in the crawlspace area on top of the vapor barrier. Moisture intrusion through the foundation and stemwall noted at the North wall, appears from the pooled moisture outside. Sounds of water running could be heard at the main water inlet pipe, indicating the main supply pipe is most likely leaking just outside the home's foundation. The pooled moisture could also be caused from poor ventilation in the crawlspace area, as fungus growth was noted on the subfloor rim joist at the Northwest corner of home. Pooled exterior moisture appears has been going on for some time, with moisture saturated "sole" plate noted in areas at the North side foundation. This has caused moisture damage in a few areas of the sole plate. Recommend further evaluation of moisture damage by a qualified licensed contractor as needed. Also recommend verifying all foundation vents are clear and operating as intended.

3.2 Item 1(Picture) moisture at north foundation

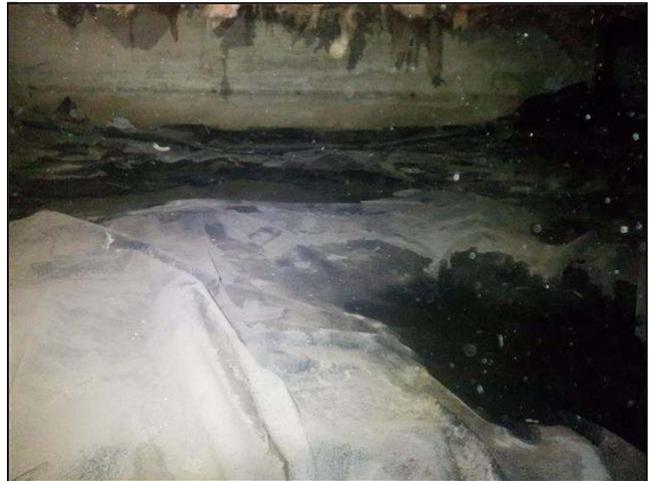
3.2 Item 2(Picture) pooled moisture at north side

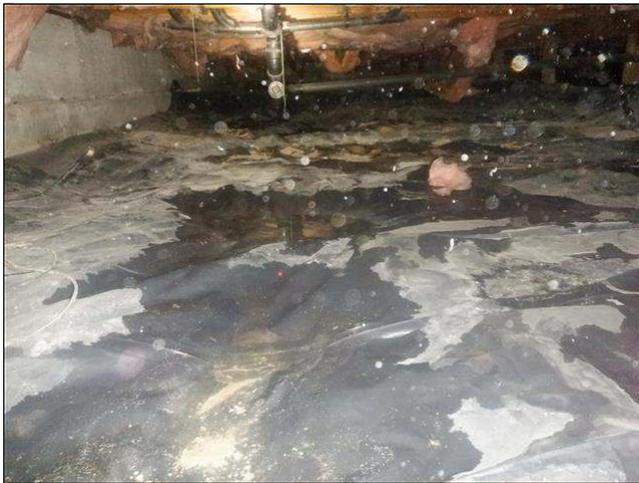
3.2 Item 3(Picture) pooled moisture at south side

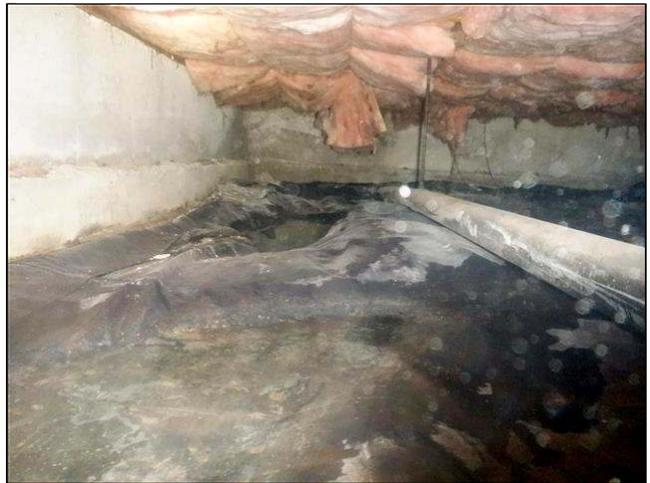
3.2 Item 4(Picture) pooled moisture at SW corner

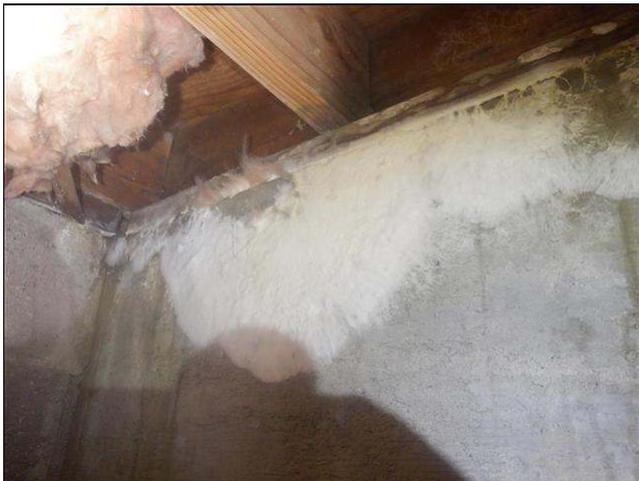
3.2 Item 5(Picture) fungus growth at NW corner

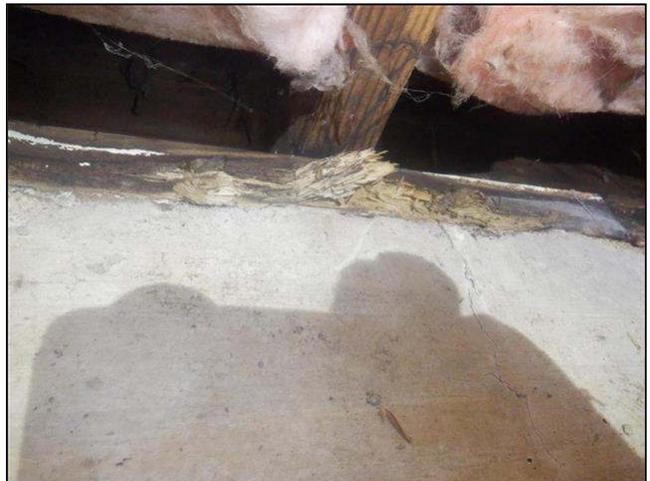
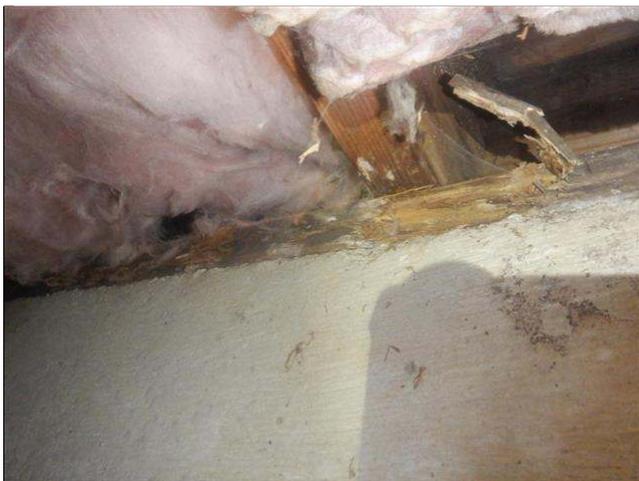
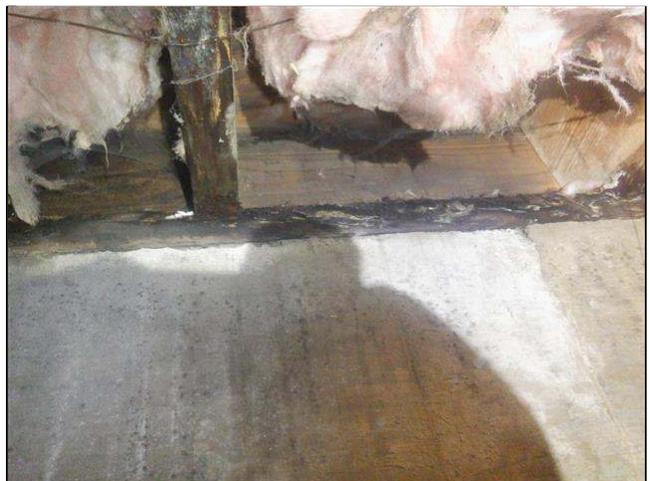
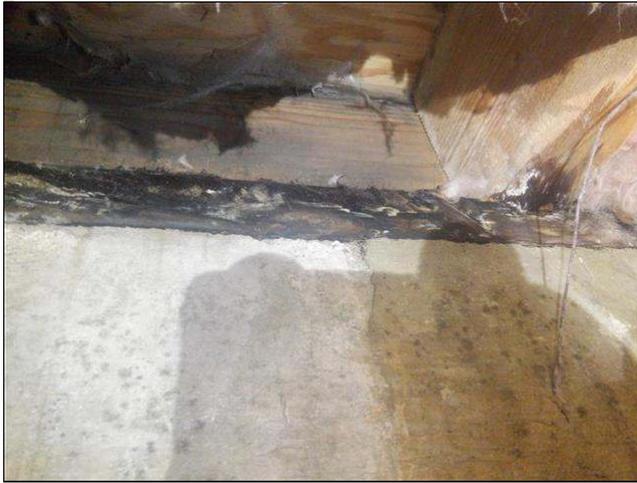
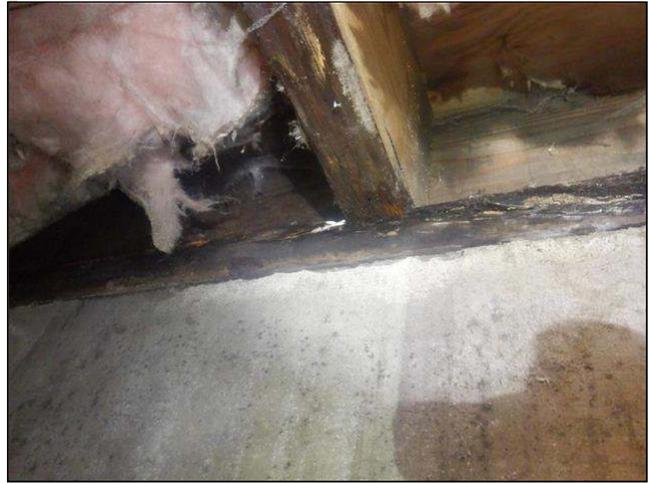
3.2 Item 6(Picture) moisture affected sole plate

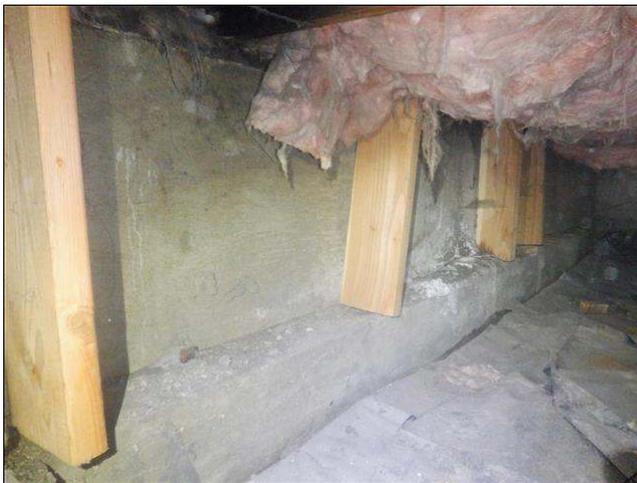
NOTE: There are a few additional support posts installed along the North foundation (near rear entry), that are resting on the concrete footings. These should have been Pressure-Treated materials used, due to concrete contact.

3.4 Item 1(Picture) additional support posts installed

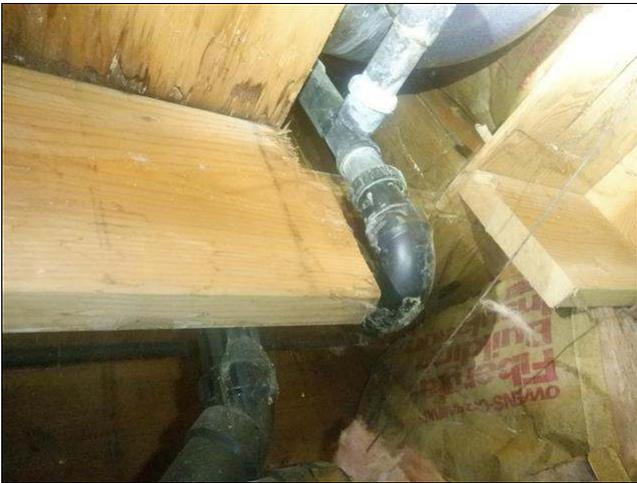
- 🏠 (2) The floor joist has been cut completely through under the master tub/shower, leaving an unsupported subfloor area. Recommend additional support, backing or pier and post (with proper footings), as preferred by contractor.

3.6 Item 2(Picture) cut joist under master bath

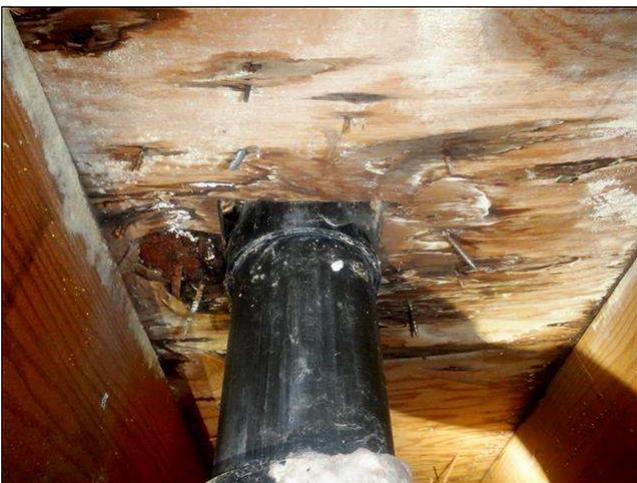
- 🏠 (3) NOTE: Subfloor plywood is moisture damaged under the master bathroom, appears from a leaking toilet seal. Recommend further evaluation of subfloor once toilet is removed for seal replacement, and repair/replace as needed.

3.6 Item 3(Picture) subfloor under master toilet

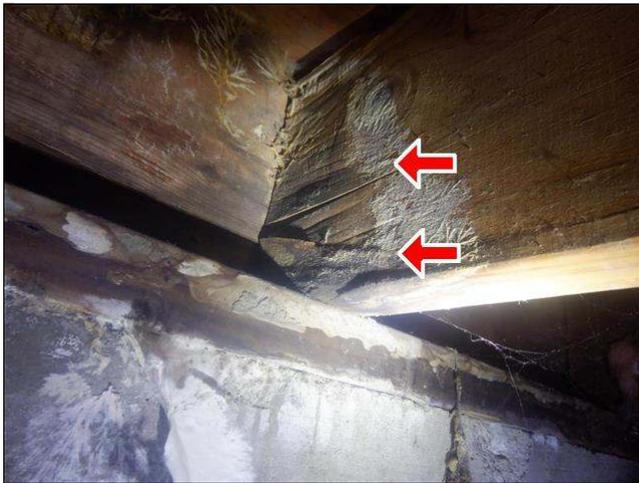
- 🏠 (4) NOTE: Northwest floor joist outer edge has been affected by the elevated moisture levels in the crawlspace, beginning to crush the lower edge of the joist. Recommend repair/replace by a qualified person as needed.

3.6 Item 4(Picture) soft joist from moisture

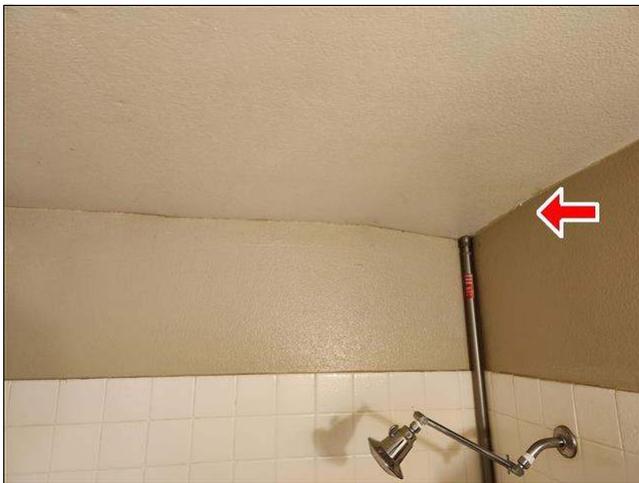
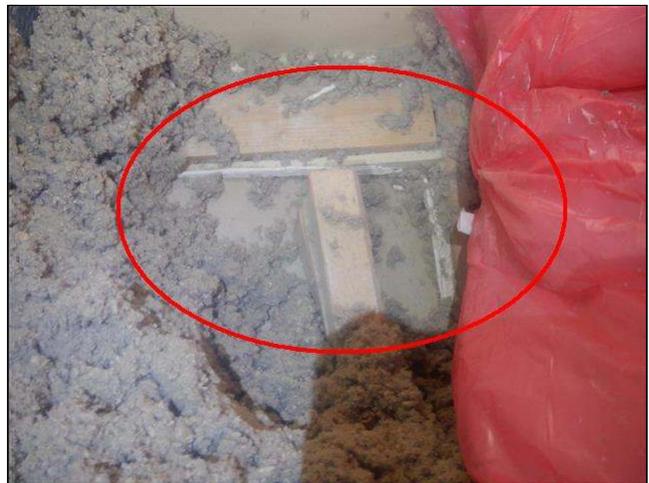
(2) NOTE: Ceiling is "sagging" at the corner of Guest Bathroom shower area, and appears was caused from a support block installed for the drywall being too short to rest in the wall framing. This appears to have allowed settlement over the years. No structural issues noted, leaving this a cosmetic item.

3.7 Item 1(Picture) corner appears to sag

3.7 Item 2(Picture) sagging corner area

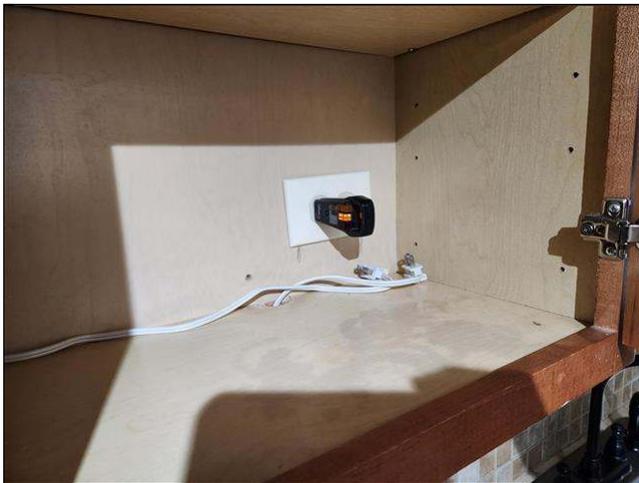
- 🏠 (1) Open grounded receptacles noted at the kitchen (inside upper cabinets), which does not afford electrical circuit ground protection. Recommend further evaluation/repair by a licensed Electrician.

4.5 Item 1(Picture) open grounded outlets

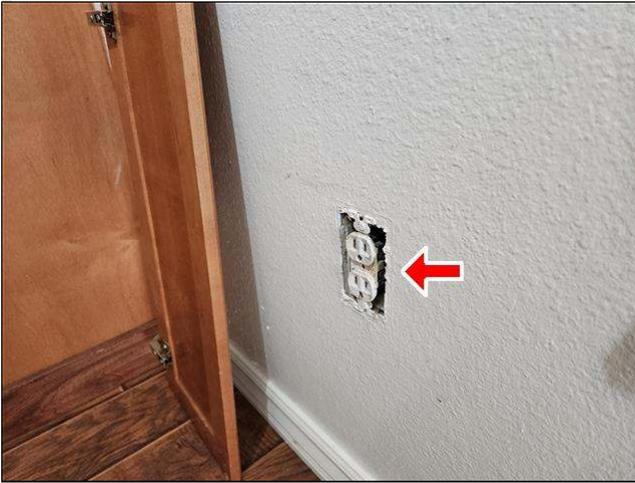
- 🏠 (2) Recommend replacing any outlet and switch cover plates that are missing.

4.5 Item 2(Picture) replace missing cover plates

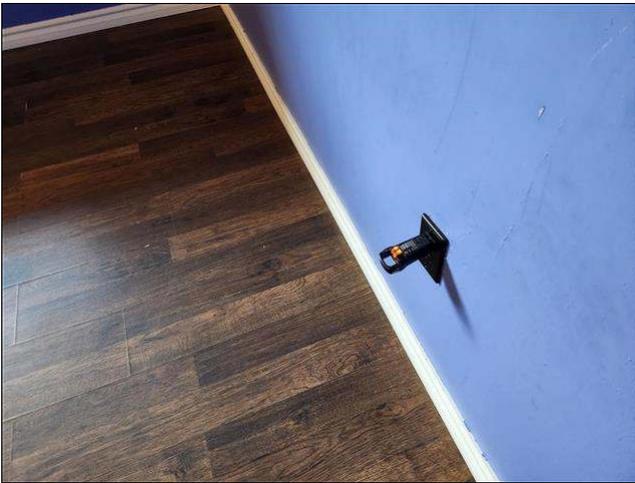
(3) Loose receptacle noted at the Northeast guest bedroom East wall. Though this is a minor repair, it needs to be corrected. I recommend repair as needed by a qualified person.

4.5 Item 3(Picture) loose outlet at NE bedroom

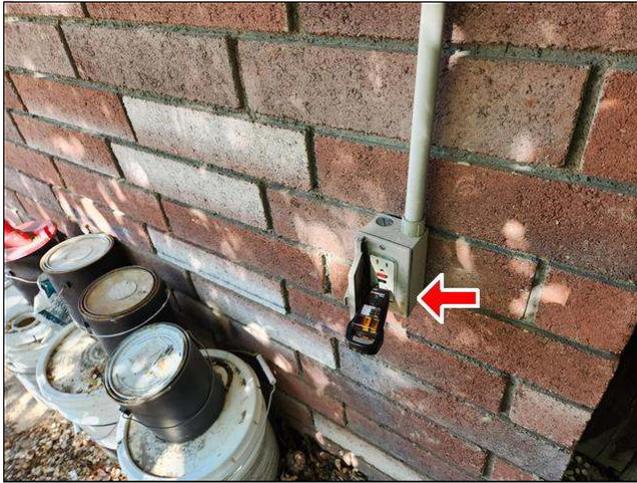
GFCI (Ground Fault Circuit Interrupter) outlet at the rear exterior wall of home, did not reset properly when tested (defective). Further inspection/repair is needed by a qualified licensed electrician.

4.7 Item 1(Picture) faulty gfci at rear exterior

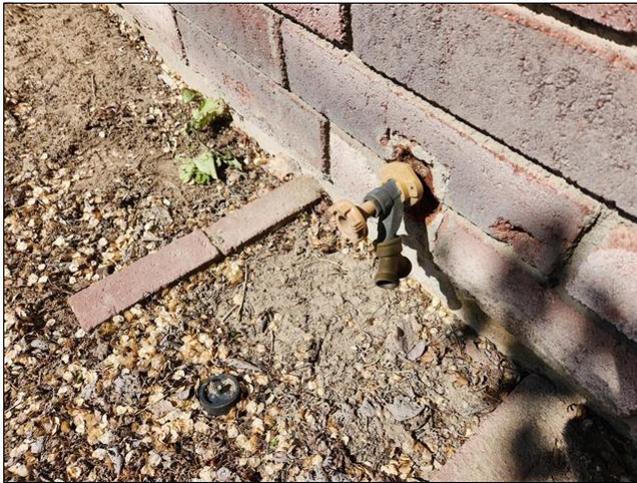
(1) Rear exterior hose bib is non-operational (frozen shut). Recommend repair by a qualified person as needed.

5.0 Item 1(Picture) east hose bib non-operational

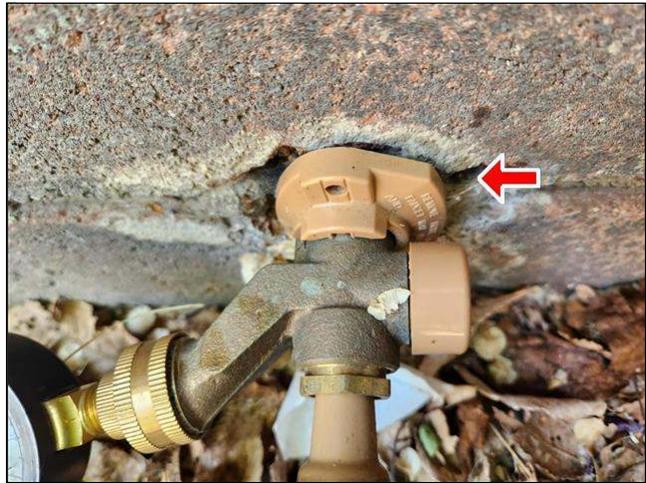
5.0 Item 2(Picture) secure and seal flange

(2) Recommend securing North hose bib flange to wall, to prevent possible twisting and breakage of plumbing pipes/connectors. Recommend sealing around pipe to prevent moisture intrusion behind wall siding.

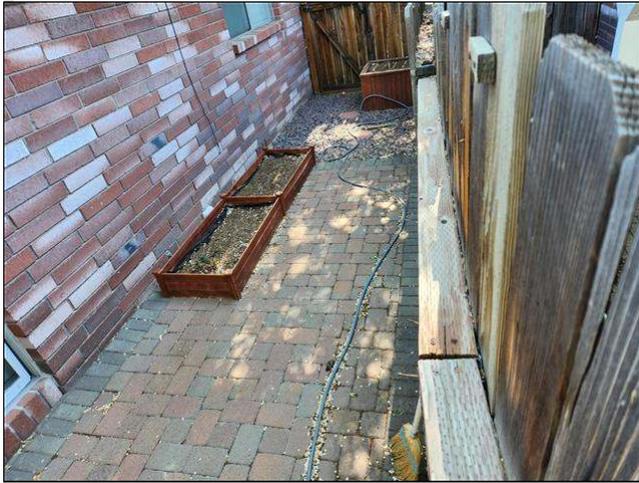
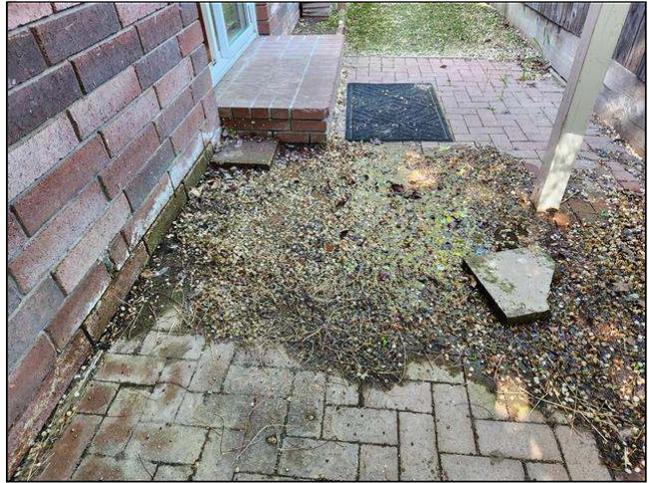
(1) NOTE: Pooled ground moisture was observed at the North patio area, however was not noted at the neighboring yard. This could be a damaged plumbing supply pipe under this patio area. Recommend further evaluation by a qualified person.

5.1 Item 1(Picture) neighbor's patio was dry

5.1 Item 2(Picture) pooled moisture at north patio

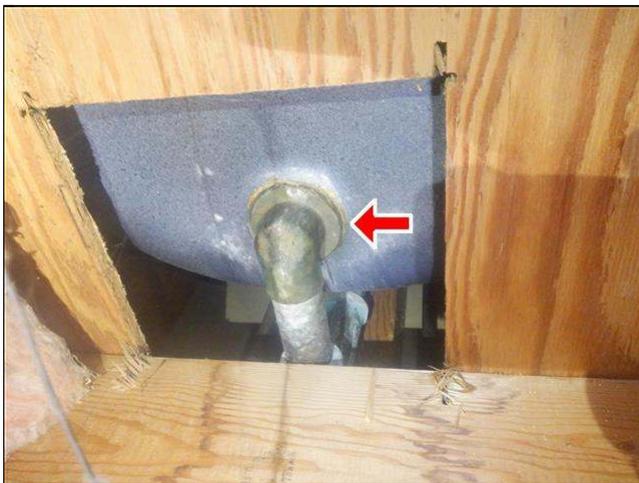
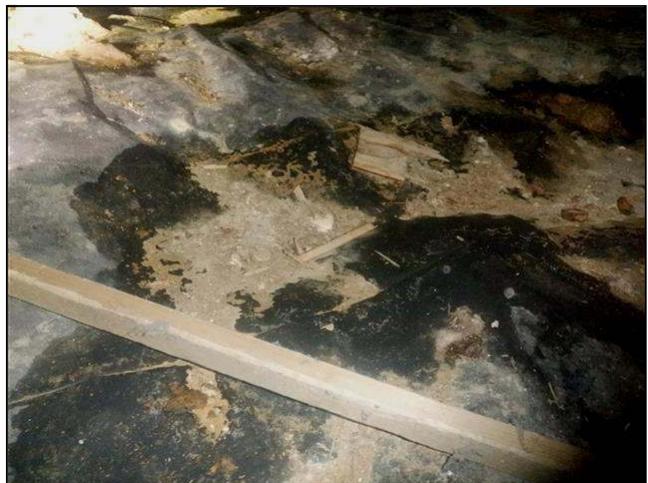
(1) Shower/tub drain is leaking in the crawlspace area under the Guest Bathroom. Recommend repair by a licensed plumbing contractor to prevent excessive moisture, which can lead to mold/fungus, in the crawlspace.

5.2 Item 1(Picture) guest bathtub drain

5.2 Item 2(Picture) moisture from leak

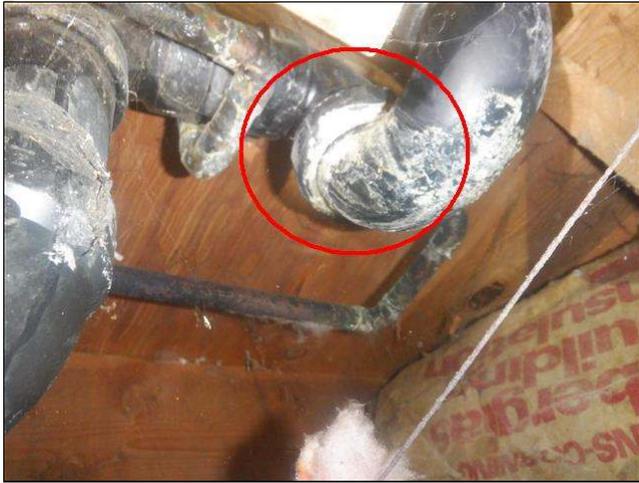
(2) Shower/tub drain is leaking in the crawlspace area under the Master Bathroom. Recommend repair by a licensed plumbing contractor to prevent excessive moisture, which can lead to mold/fungus, in the crawlspace.

5.2 Item 3(Picture) leaking drain under master tub

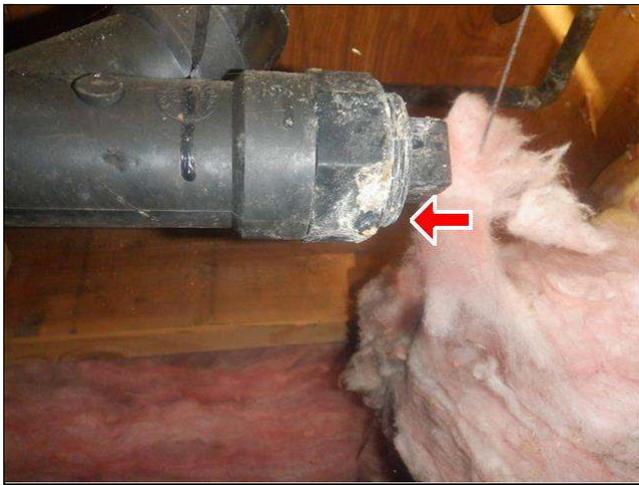
(3) Clean-out threaded plug is leaking in the crawlspace area under the master bathroom, and should be corrected.

5.2 Item 4(Picture) leaking clean-out plug under master bath

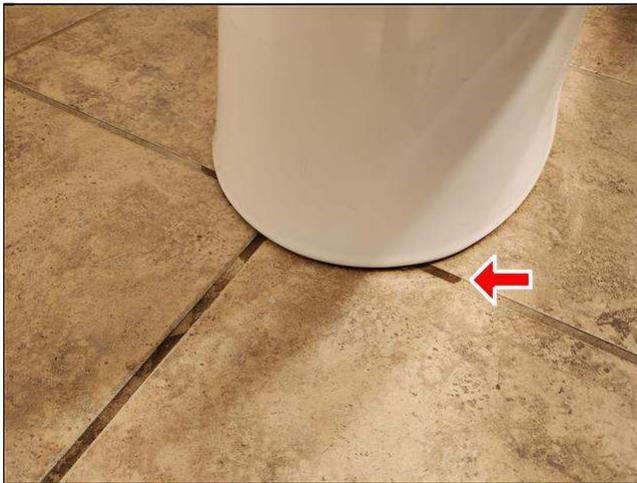
(2) The toilet is beginning to loosen at floor at the guest bath. Loosely mounted toilet can break the wax seal. Moisture was noted at the front of toilet base indicating the seal is leaking. Recommend replacing the wax seal, and securing toilet to prevent movement.

5.4 Item 1(Picture) moisture at guest bathroom toilet base

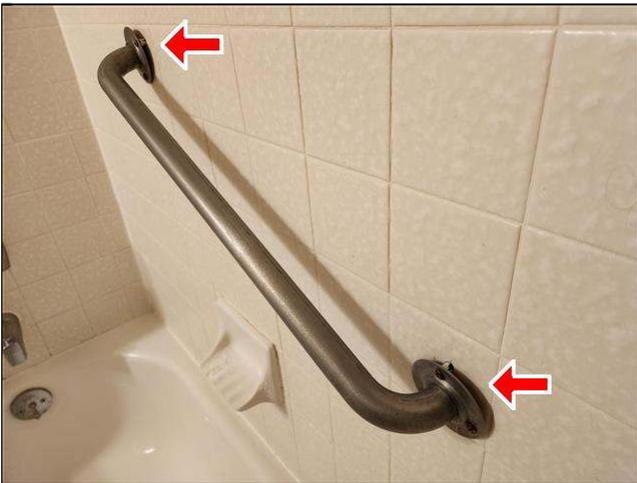
- 🏠 (1) Safety bar at master bathroom shower is very loose, and should be secured to the wall.

5.6 Item 1(Picture) safety bar at master shower

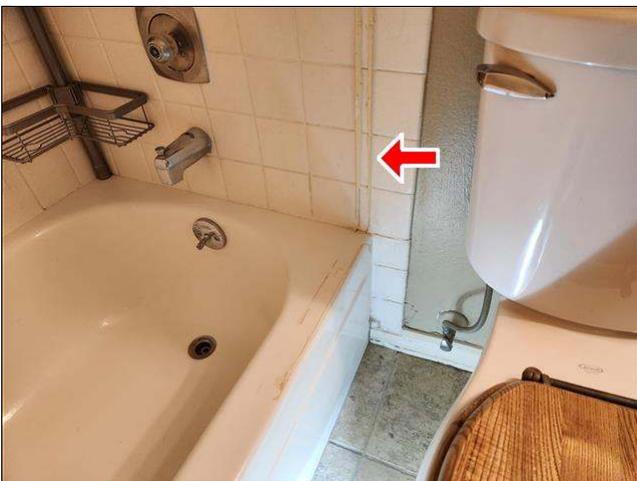
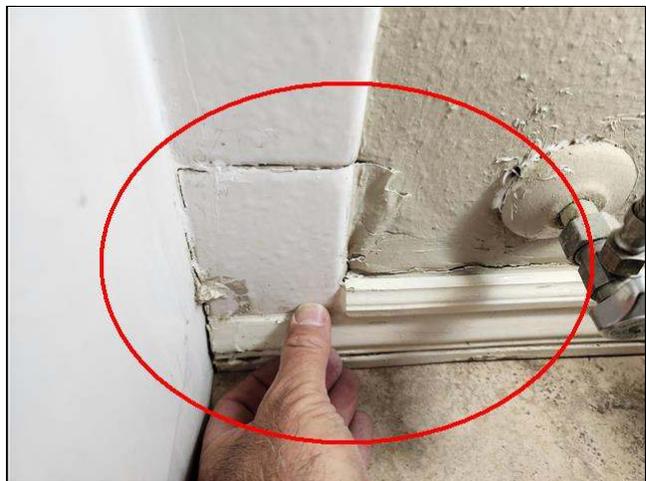
- 🏠 (2) Hall bathroom tub/shower shows signs of past moisture leaking out of the shower at the right side, possibly from the missing shower curtain or splash guard. This moisture has caused damage to the drywall behind the tiles. Recommend further evaluation and repair by a qualified person as needed.

5.6 Item 2(Picture) missing splash guard

5.6 Item 3(Picture) moisture damaged drywall area

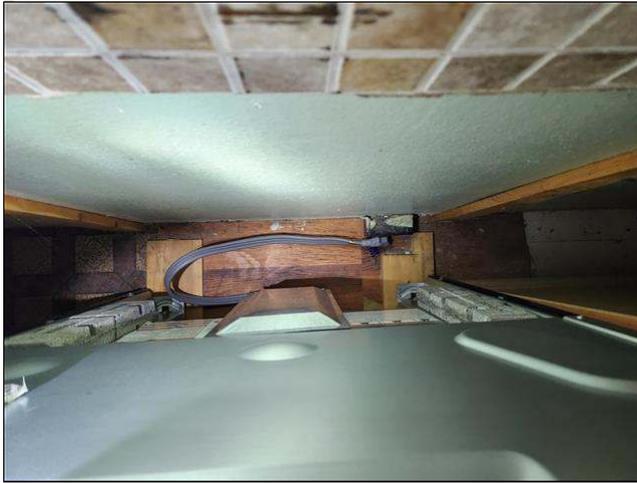
Note: This appliance does not have an anti-tip bracket installed. This is recommended by the MFG to prevent accidental tipping of the appliance, in the event of a child standing on the oven door.

6.2 Item 1(Picture) behind range

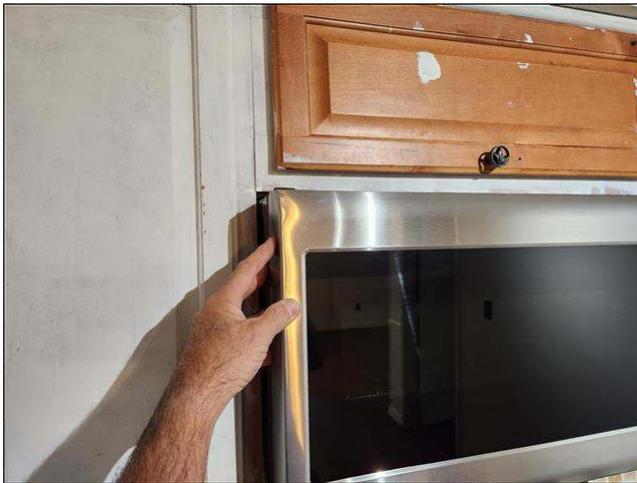
(2) NOTE: Left upper microwave fastener has pulled through the cabinet, and is no longer supporting the microwave. Recommend repair by a qualified person.

6.5 Item 1(Picture) microwave not properly supported

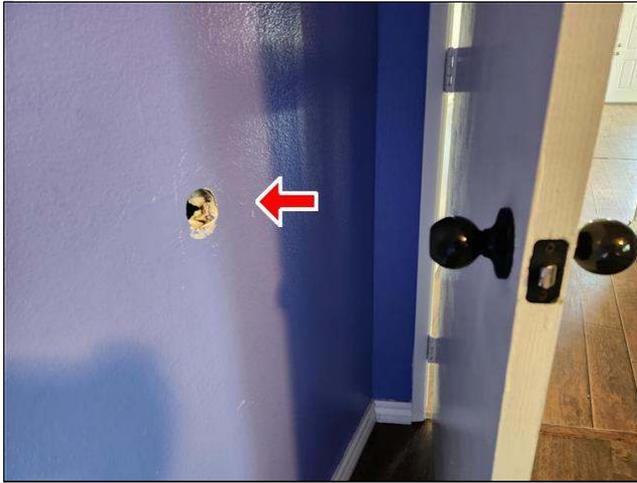
Recommend drywall repair at Northeast guest bedroom, behind the entry door, which appears was caused from the door knob.

7.2 Item 1(Picture) drywall damage at NE bedroom

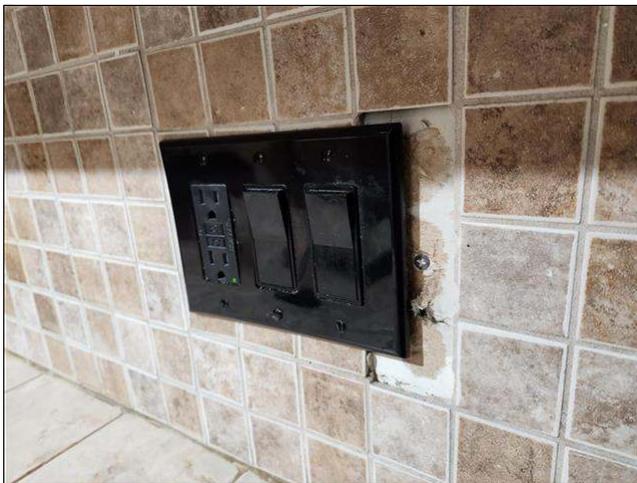
(1) Missing backsplash tiles noted at the kitchen sink area.

7.4 Item 1(Picture) missing backsplash tiles

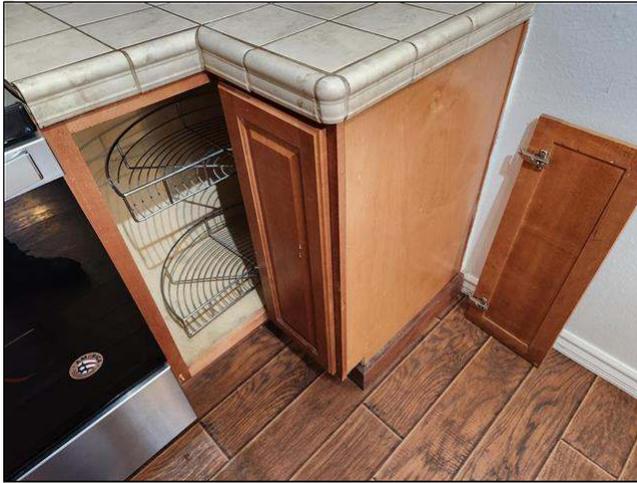
7.4 Item 2(Picture) lower cabinet door not installed

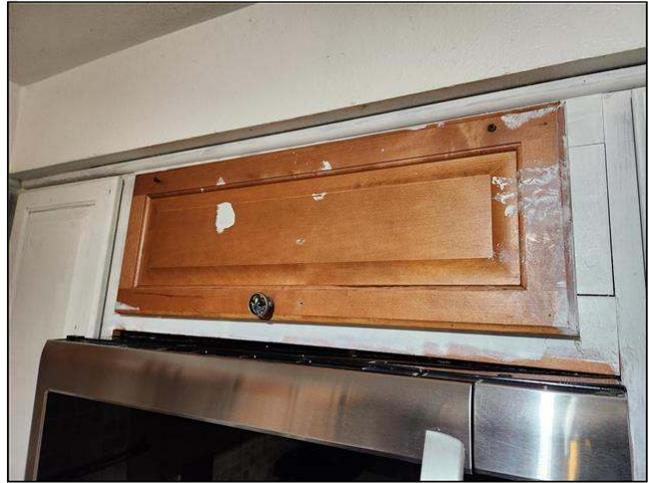
7.4 Item 3(Picture) improper upper cabinet door

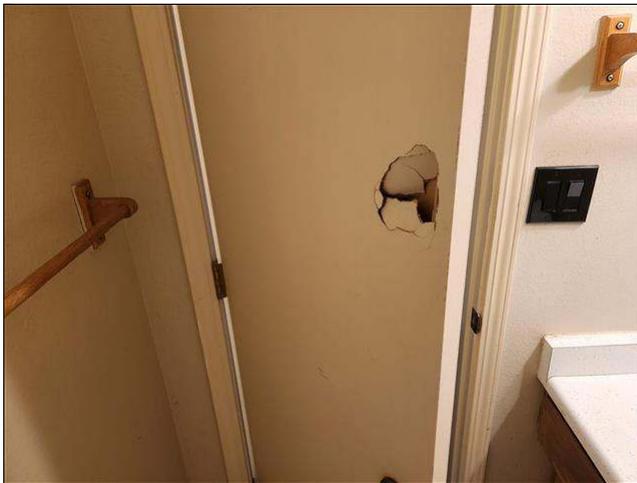
Master Bathroom door is damaged at the inside, and should be repaired or replaced by a qualified person.

7.6 Item 1(Picture) master bathroom door

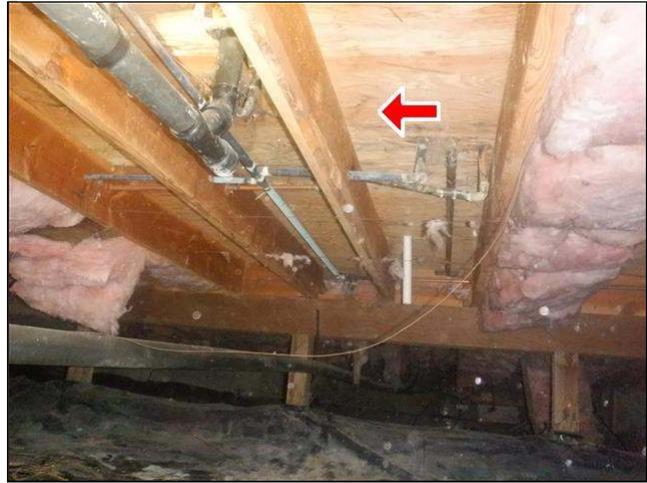
8.1 Item 2(Picture) missing insulation under bathroom

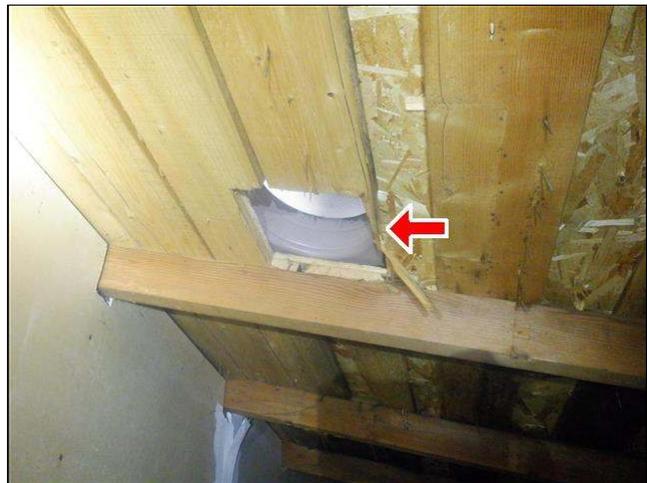
8.3 Item 2(Picture) additional roof vents installed

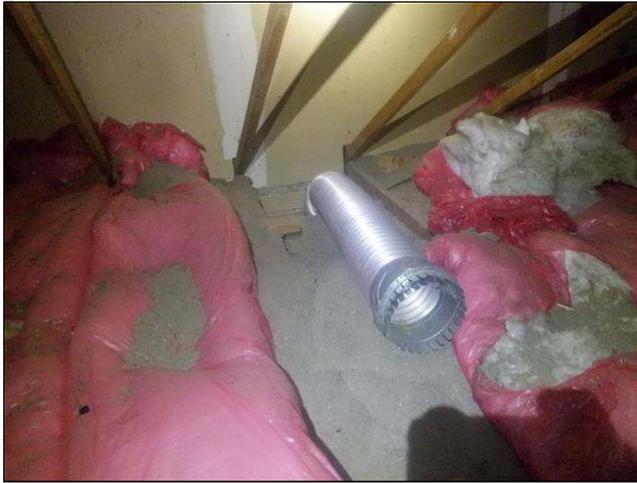
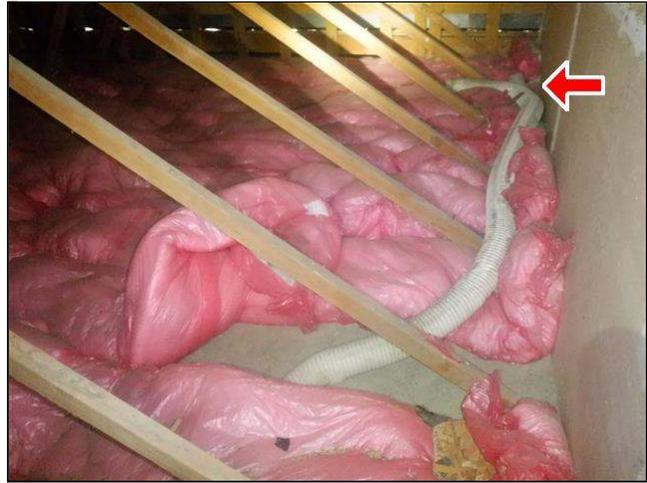
The Exhaust fan does not vent to outside at the Bathrooms or Kitchen. Vent pipes that terminate in attic space can sometimes cause moisture that can lead to mold or cause condensation. A qualified person should repair or replace as needed.

8.4 Item 1(Picture) kitchen vents into attic

8.4 Item 2(Picture) guest bathroom vents into attic
