## Inspection Report

1731 Bougainvillea  
Minden NV 88423

### Clear Choice Home Inspection Services

<b>Date:</b> 4/20/2023	<b>Time:</b> 08:30 AM	<b>Report ID:</b> BEA173
<b>Property:</b> 1731 Bougainvillea Minden NV 88423	<b>Customer:</b>	<b>Real Estate Professional:</b> Thomas Vander Laan Coldwell Banker

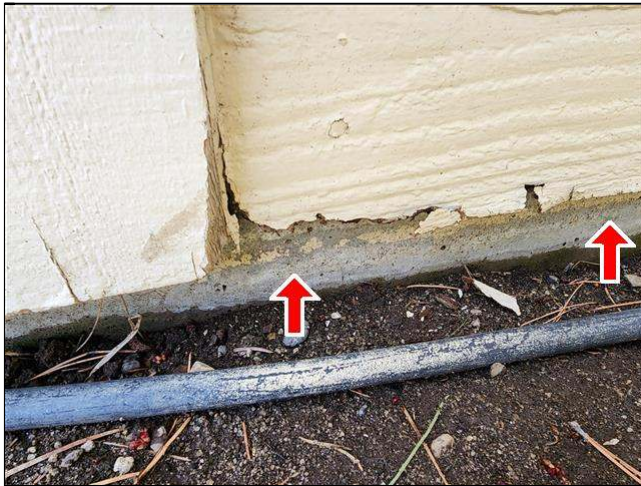
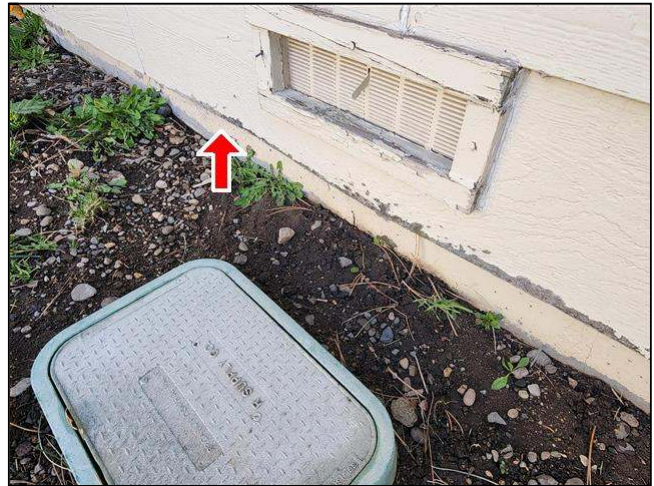
(2) NOTE: Northwest corner siding, materials show advanced wear/age, and appears to be caused from irrigation overspray. The North wall lower siding is deteriorated across the lower end (from excessive moisture), and appears will need replacement. Recommend further evaluation and repair of siding at this location by a qualified person.

1.1 Item 3(Picture) lower edge siding at NW corner

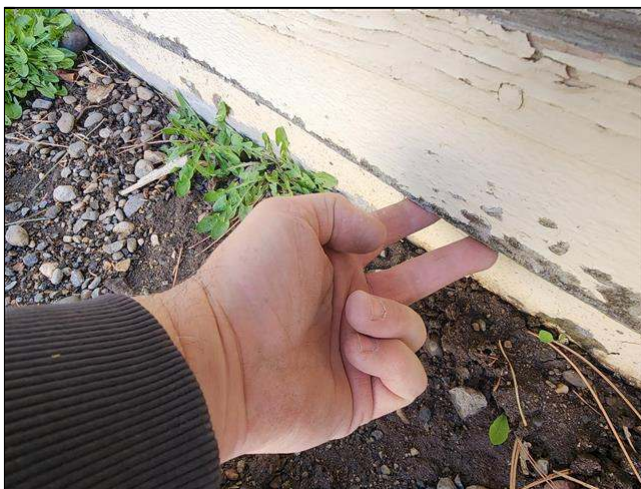
1.1 Item 5(Picture) lower edge of siding is wet

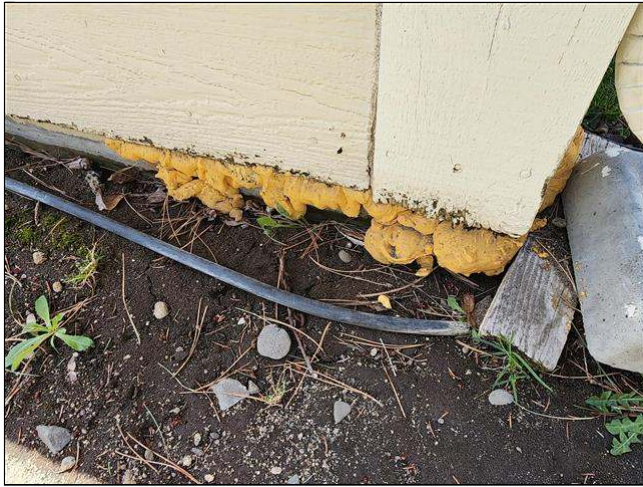
(3) NOTE: Expanding foam noted at Northwest corner of home, appears may have been installed to prevent moisture intrusion? No signs of past moisture intrusion into the crawlspace area were noted at time of inspection.

1.1 Item 6(Picture) foam/sealant at NW corner of home

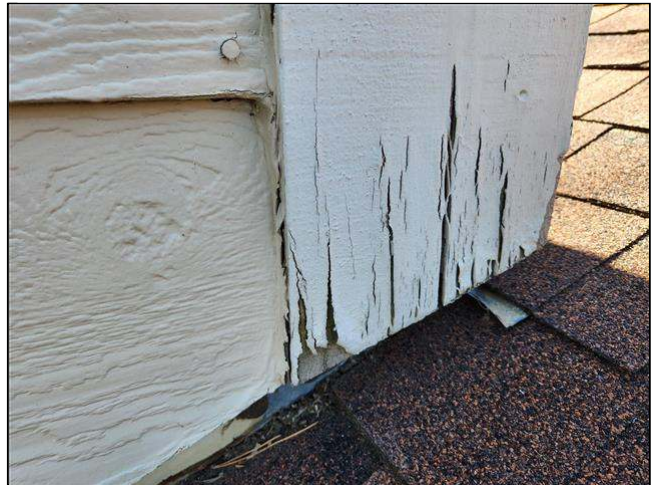
Fireplace chimney trim boards need to be secured tightly, caulked in seams and dry weathered cracks, and painted for moisture protection.

1.2 Item 2(Picture) cracked chimney trim boards

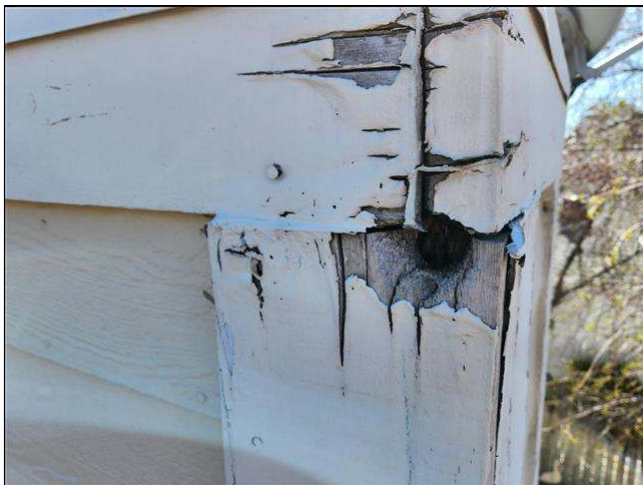
1.2 Item 3(Picture) hole through chimney trim board

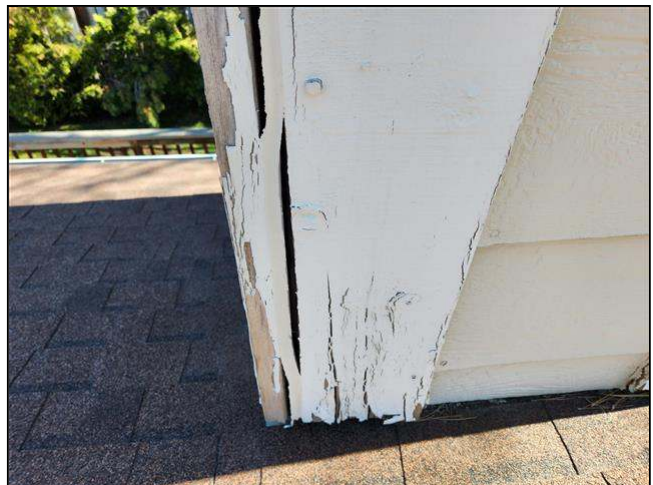
1.2 Item 4(Picture) loosened chimney trim boards

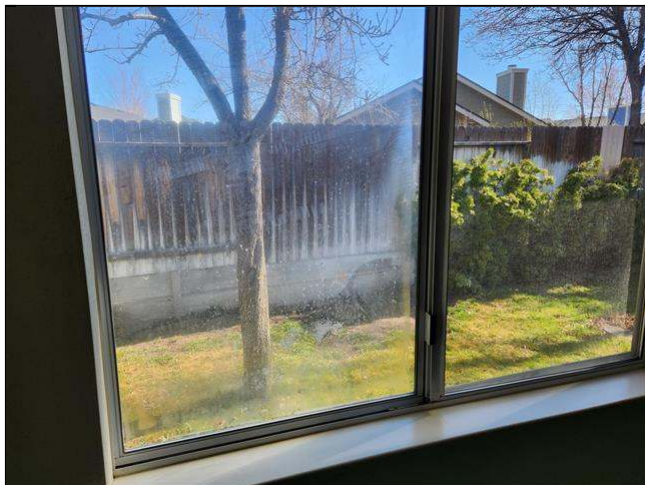
(1) Window is cloudy/condensation (lost seal) at the South guest bedroom, SW guest bedroom, Living room North wall, West guest bathroom, Master bedroom and bathroom windows. This is a cosmetic issue for your information. In order to correct the cloudy appearance of glass, a replacement of glass pane or the unit will be necessary. A qualified person should repair or replace as needed.

1.4 Item 1(Picture) cloudy window

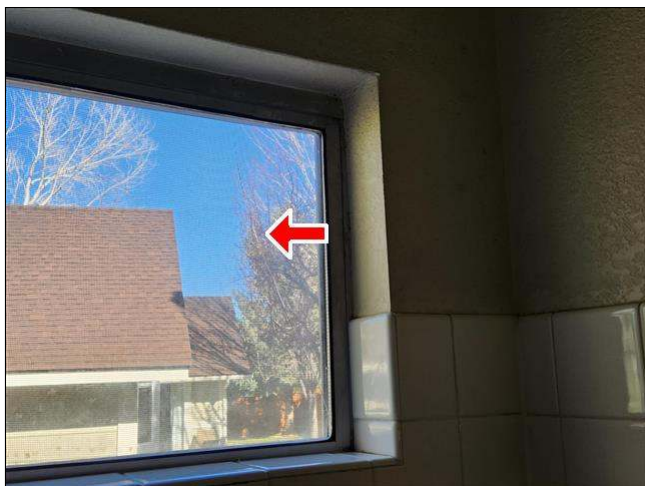
(2) Window pane is cracked at the West guest bathroom.

1.4 Item 3(Picture) cracked window panel

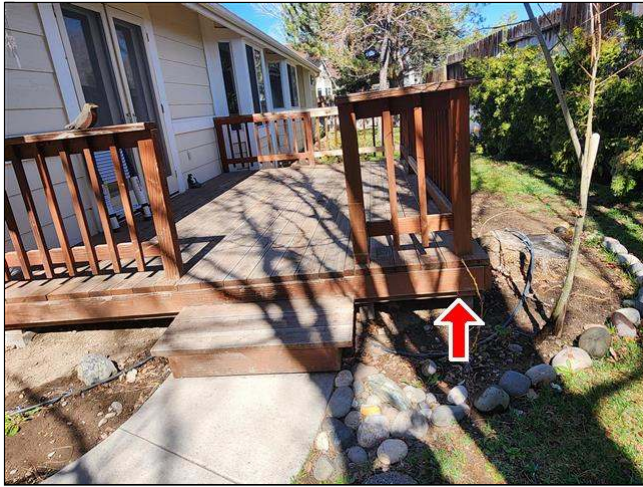
NOTE: Tree stump/roots are lifting the Northeast corner of rear deck off it's pier foundation. Recommend removing roots to allow deck to set properly on the foundation blocks.

1.6 Item 1(Picture) lifted corner of rear deck

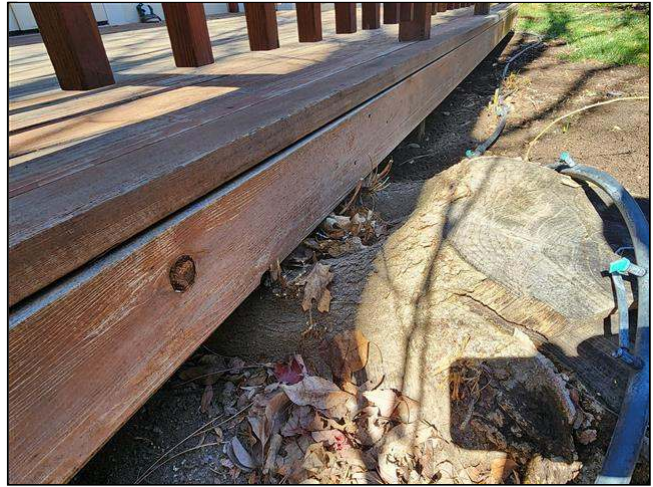
1.6 Item 2(Picture) tree root lifting deck

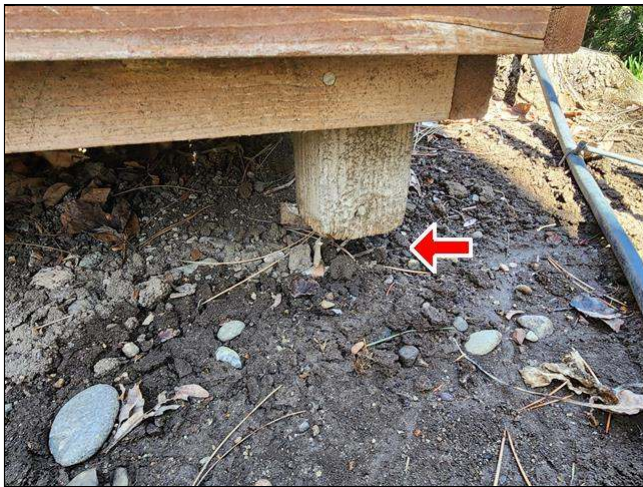
1.6 Item 3(Picture) not setting on footings

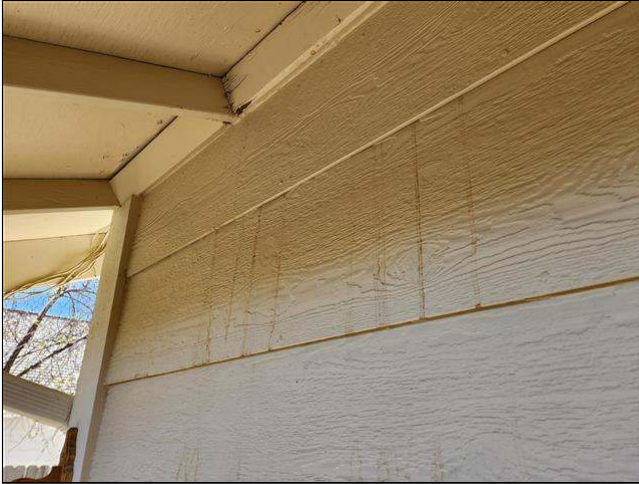
(2) NOTE: There are signs of past leaking noted at the Northeast corner area, with drip stains noted on siding and soffit blocking. This may have been caused from "ice dams" from this past winter. There are no issues noted with roof covering materials or flashings.

2.1 Item 1(Picture) stains at NE corner

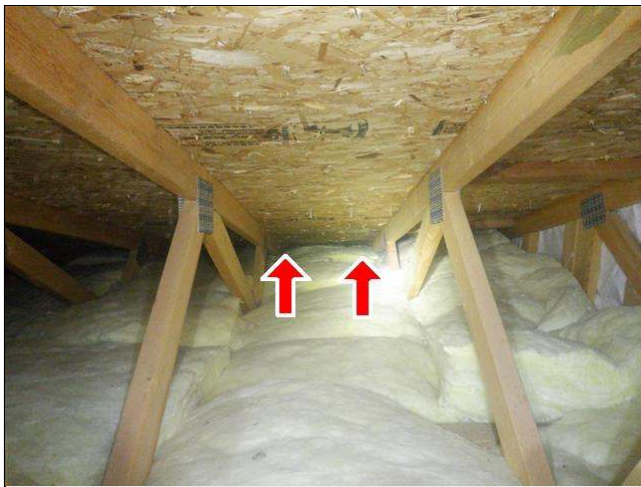
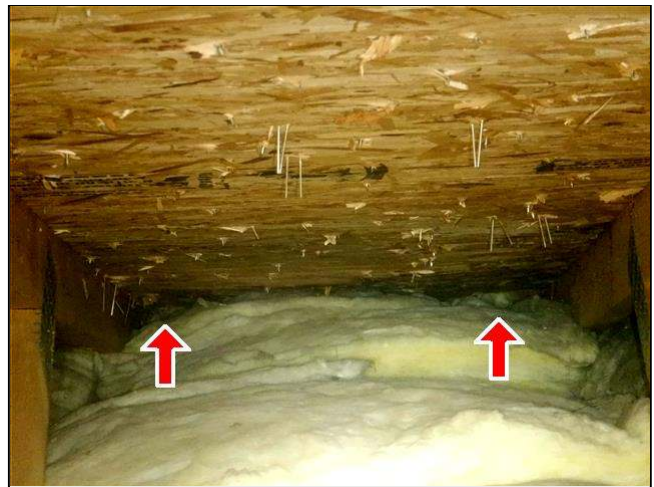
NOTE: Slight blackening of plywood was noted at the Northeast corner of roof structure area, adjacent to the fireplace chimney. This appears may have been caused from past roof covering and/or flashing issues that no longer exist. I am unable to access this area close enough to properly assess the condition of the roof sheathing plywood, however appears to remain solid.

3.8 Item 1(Picture) blackening plywood at NE corner

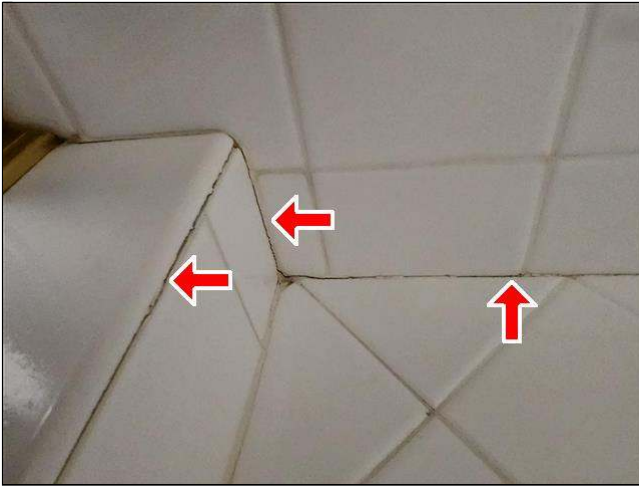
Recommend seal corners of tub/shower surrounds to prevent moisture intrusion into wall framing areas. Note: This is part of maintenance, and should be done as needed.

5.7 Item 1(Picture) recommend sealing shower surrounds as needed

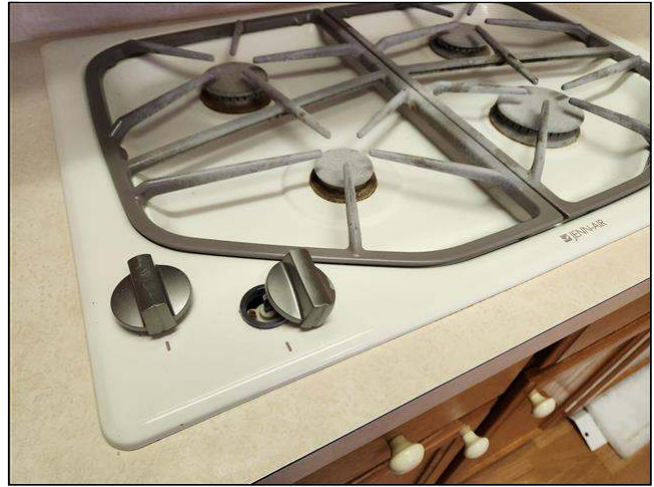
6.2 Item 2(Picture) loose/worn knobs

(2) NOTE: cooktop range burner control valve handles are worn/loose and will need replacement to function as intended.

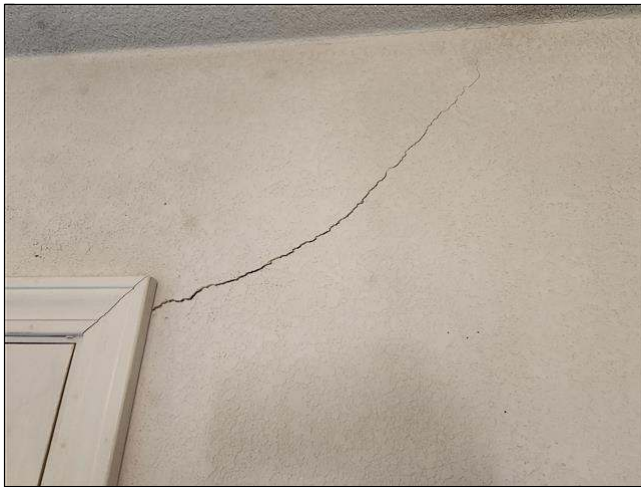
(1) Cracks at interior drywall noted at Northeast corner of living room, that appears to be caused from normal settling. Foundation was inspected under settled areas, with no problems or settlement cracks noted. This appears to be caused from ground moisture, and is typical for this area. Walls appear, and feel solid. Recommend further "invasive" evaluation of wall structure by a qualified contractor as desired.

7.2 Item 1(Picture) larger settlement crack at living room

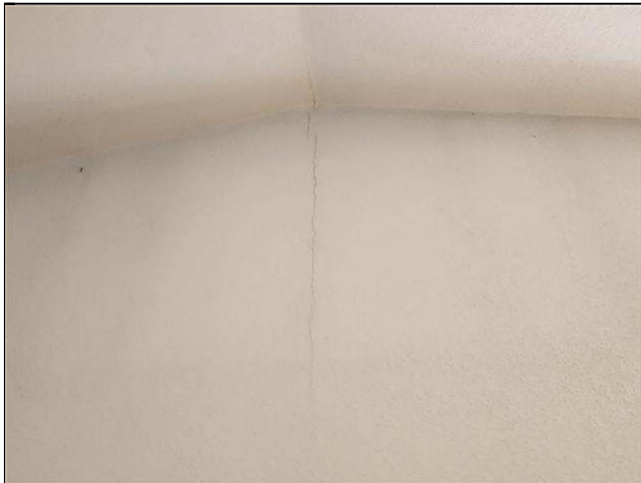
(2) The sheetrock on the wall has several hairline settlement cracks at various locations throughout the home. This is considered cosmetic. A qualified person should repair/caulk/paint as needed.

7.2 Item 3(Picture) average settlement cracks

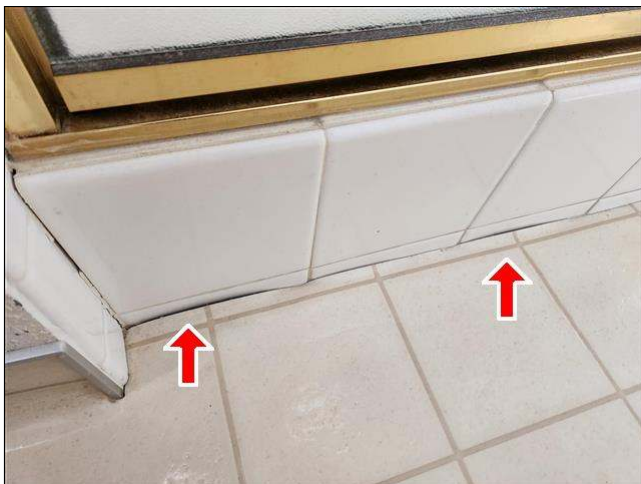
(1) Recommend silicone caulk maintenance along floor and shower at Laundry area Hall Bath, to prevent moisture intrusion to floor framing materials.

7.3 Item 1(Picture) seal floor at shower

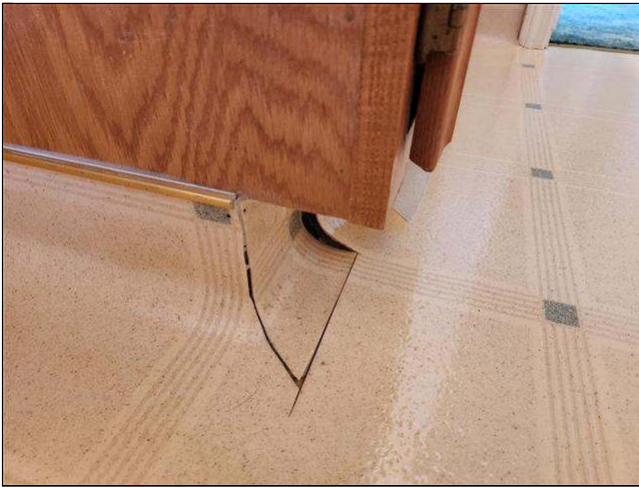
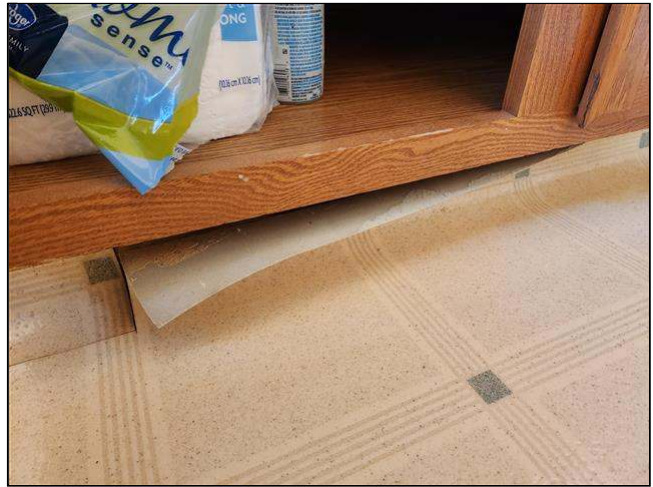
(2) NOTE: Linoleum flooring is cracked and pulling loose from the sink cabinet at the West guest bathroom, and should be repaired to prevent possible moisture intrusion into subfloor area.

7.3 Item 3(Picture) west guest bathroom floor

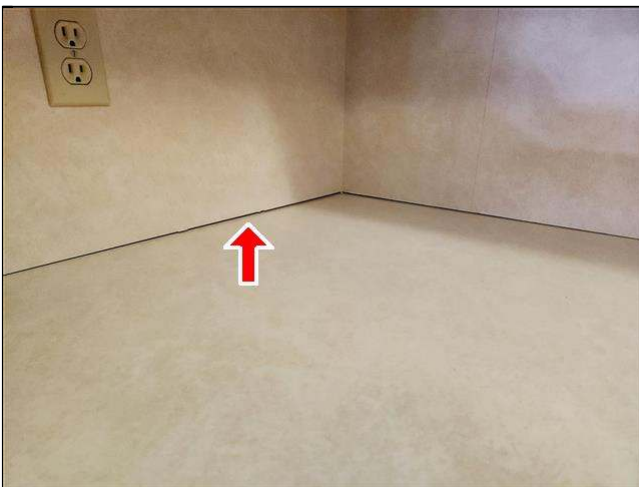
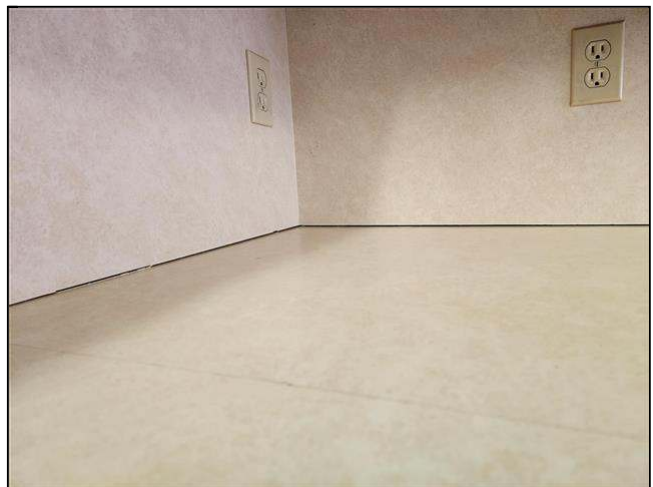
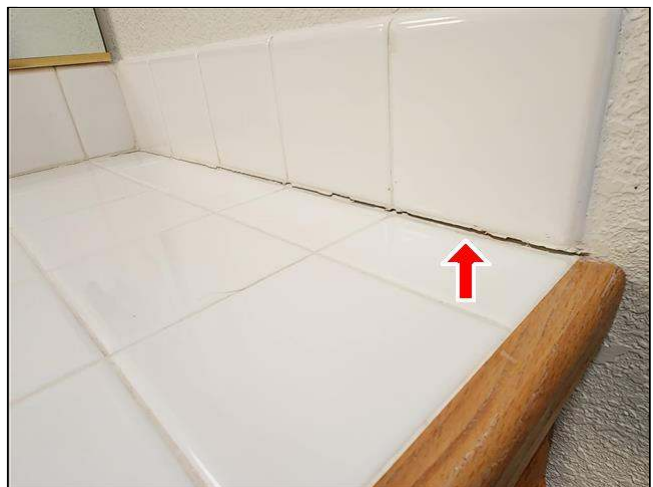
(1) Recommend caulking maintenance along backsplash at Kitchen Countertop (also master bathroom). This is a small maintenance repair that should be done to prevent moisture intrusion behind cabinet.

7.4 Item 1(Picture) caulking at kitchen

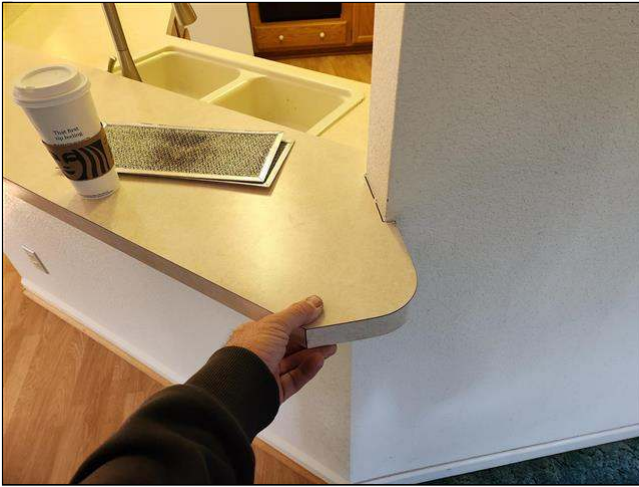
(2) Kitchen peninsula bar countertop is loose at the right side facing, and should be secured.

7.4 Item 5(Picture) loose bar countertop

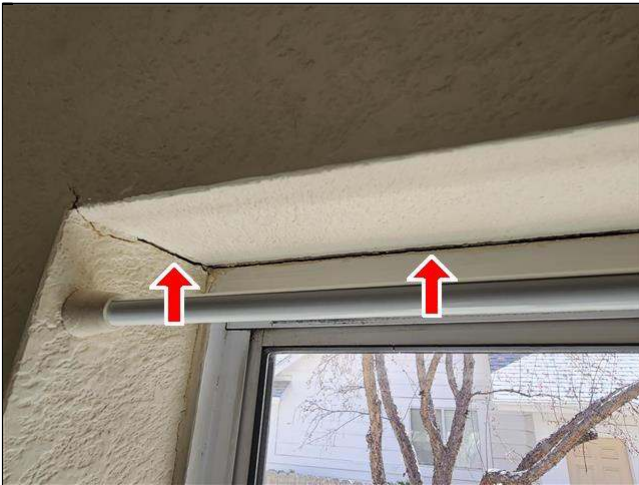
Recommend caulking maintenance at interior window sills where settling has occurred, to prevent drafts and maintain the home's integrity and efficiency.

7.5 Item 1(Picture) interior window opening caulking

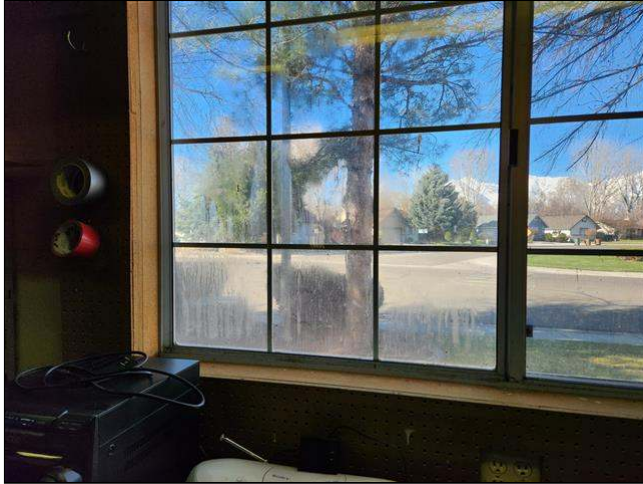
Window is cloudy (lost seal) at the East wall of Garage. This is a cosmetic issue for your information. In order to correct the cloudy appearance of glass, a replacement of glass pane or the unit will be necessary. A qualified person should repair or replace as needed.

8.6 Item 1(Picture) cloudy window at garage

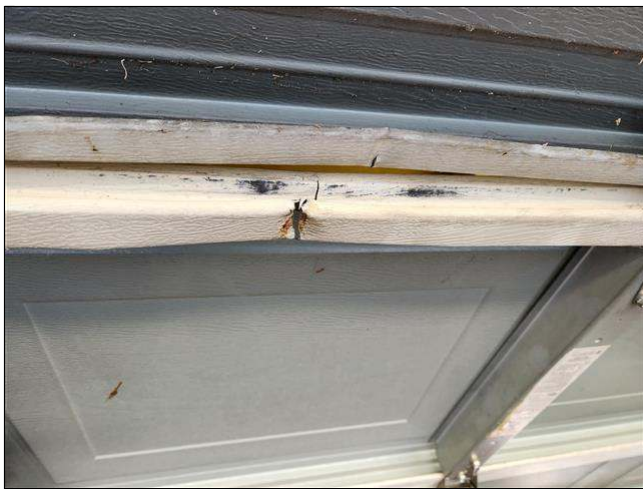
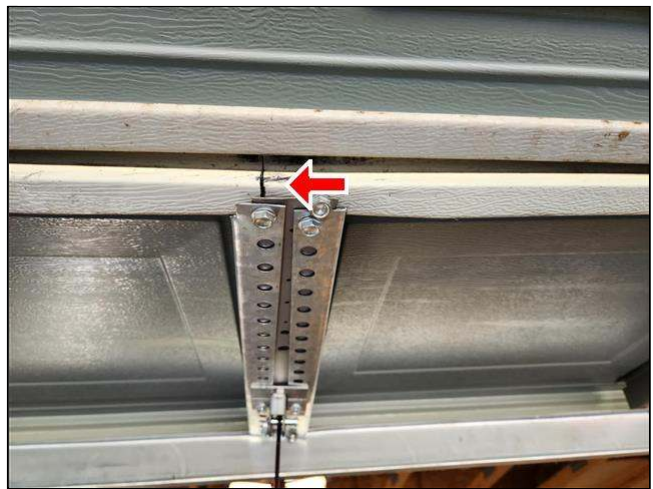
NOTE: Both garage doors show signs of physical damage to the lower panels (creased), however the doors open and close as intended. **NOTE: small garage door lower panel is bent out at the bottom edge, and drags against the door header when opening.**

8.7 Item 1(Picture) creases at garage door panels
