# Inspection Report

**Property Address:**  
2988 Del Rio Ln  
Minden NV 89423

**Clear Choice Home Inspection Services**

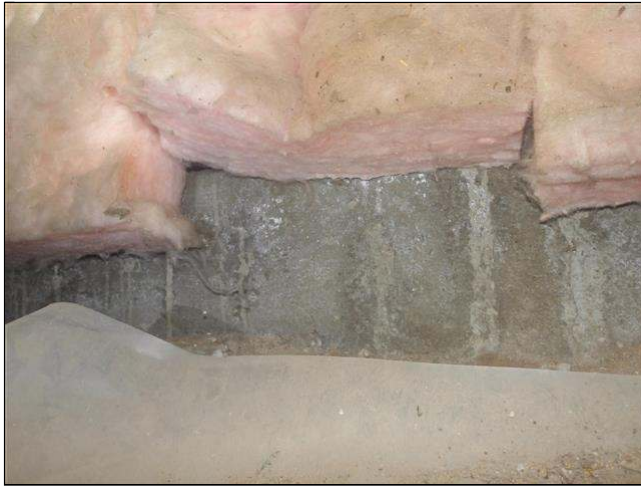
- 🏠 Grading at North side does not slope away from the foundation. Recommend correct slope to prevent excessive moisture against foundation. NOTE: Moisture stains were noted at the inside of the foundation at this location, indicating excessive moisture has been present against the exterior of the foundation in the past, however not enough to cause moisture pooling under the home.

1.7 Item 1(Picture) signs of past moisture against the exterior foundation

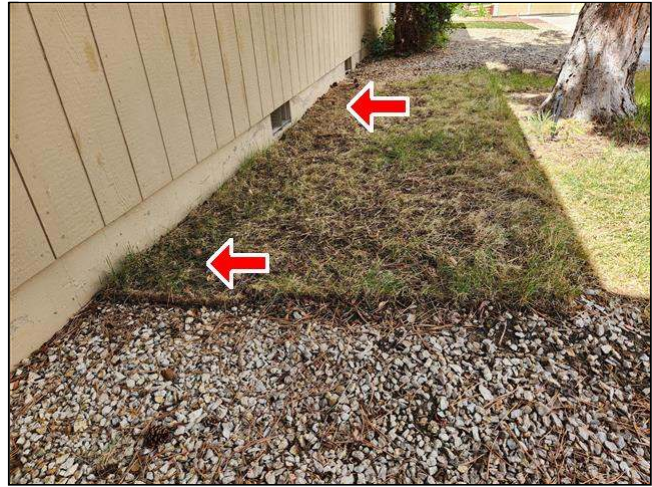
1.7 Item 2(Picture) negative grade at north side

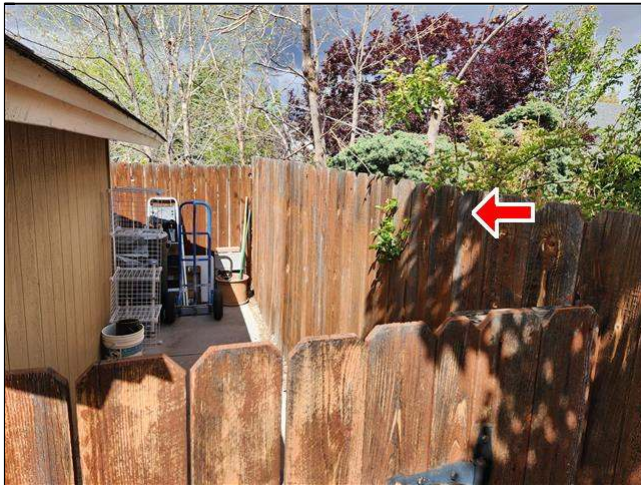
NOTE: Fencing at Northwest corner area is loose, appears a fence post may have a deteriorated base.

1.8 Item 1(Picture) Fencing at Northwest corner area is loose

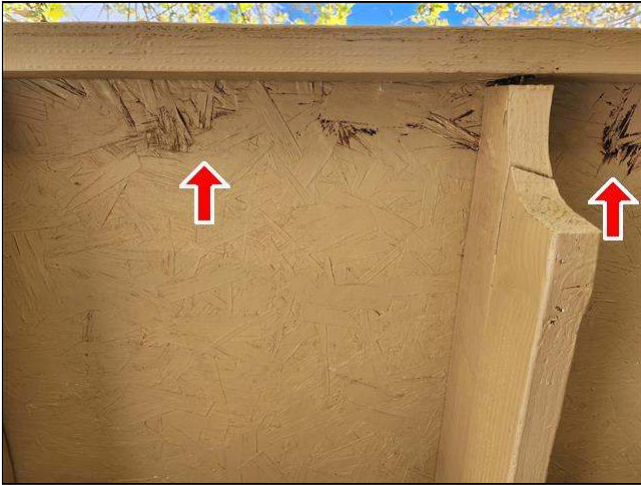
(2) NOTE: Signs of past moisture intrusion were noted at the West eave plywood of rear patio roof, however appear to be caused from past roof covering issues that no longer exist. Past moisture appears to have caused slight swelling of the plywood eaves, however not requiring replacement. Recommend maintaining good paint coverage to protect eave plywood. **RE: ITEM 2.1(2)—Seller touched up paint of eaves.**

2.1 Item 1(Picture) Signs of past moisture intrusion were noted

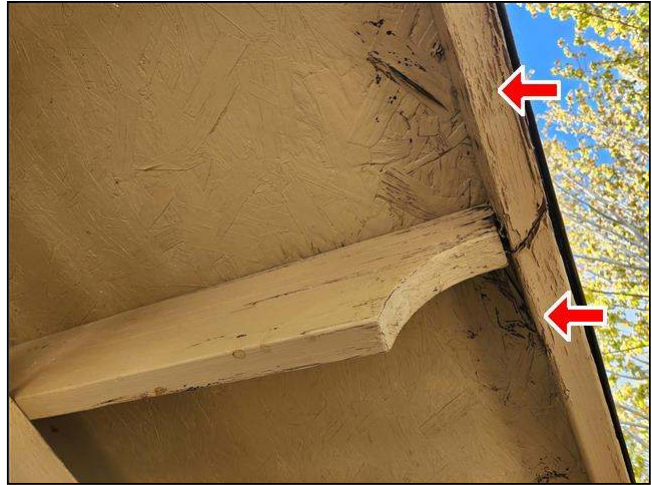
2.1 Item 2(Picture) Signs of past moisture intrusion were noted

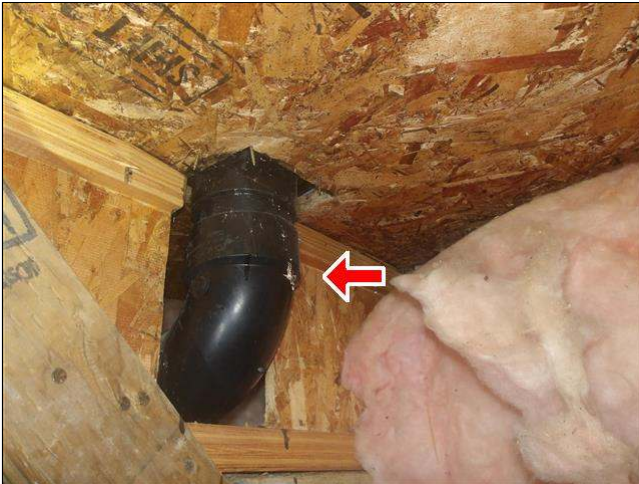
(1) The floor joist top cord (and webbing) has been cut through at the master bathroom toilet drain plumbing. Pre-manufactured or engineered floor joist should not be cut at the top or bottom cords. Recommend additional support, either headered off from adjacent floor joists (preferred) or pier and post installed directly beneath the damaged area (with proper footings), as preferred by contractor. NOTE: Temporary angled brace installed is pushing up on the subfloor plywood, and causing it to come loose from the floor joist.

3.6 Item 1(Picture) floor joist top cord (and webbing) has been cut through

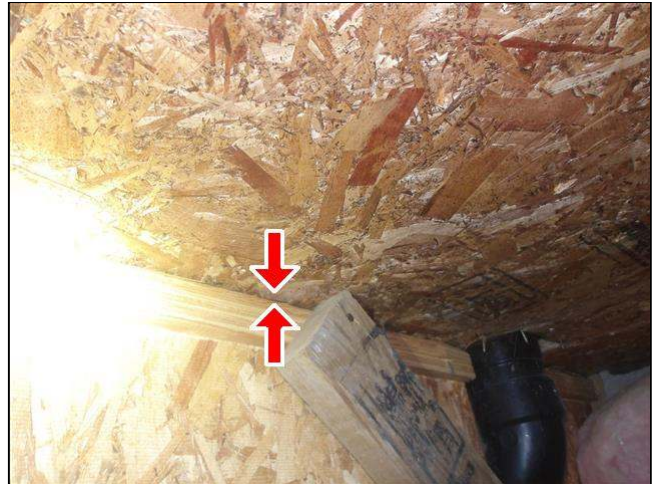
3.6 Item 2(Picture) causing it to come loose from the floor joist

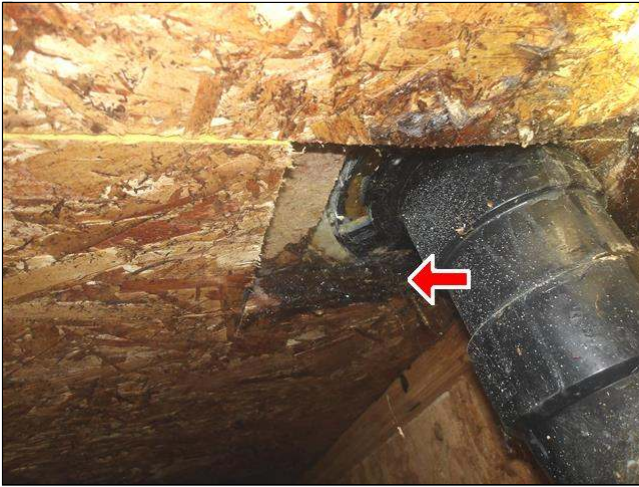
(2) NOTE: Subfloor plywood is saturated from a leaking toilet wax seal under the guest bathroom. This damage does not appear significant to warrant replacement of the plywood, however the leaking toilet needs to be repaired, and additional blocking to create a solid mount for the toilet mounting flange. Recommend repair by a qualified person as needed.

3.6 Item 3(Picture) saturated from a leaking toilet wax seal

**RE: ITEM 3.6(2)—Plumber determined able to repair toilet without need of additional blocking.**

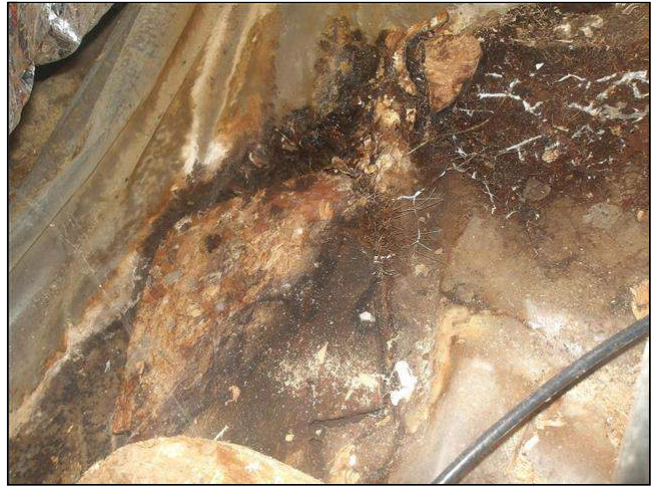
3.6 Item 4(Picture) moisture from leak

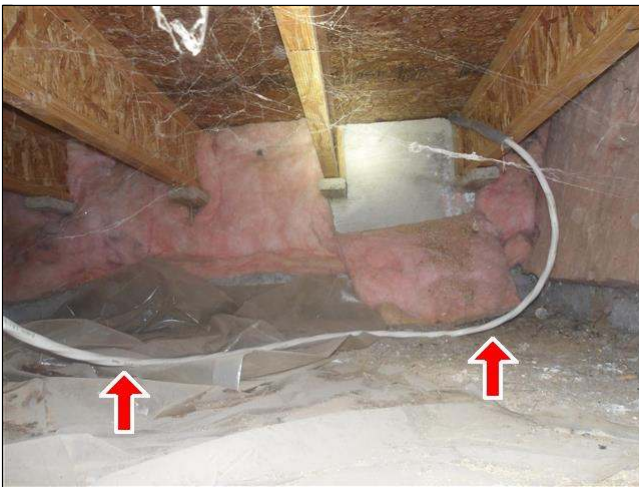
The electrical wiring under master bedroom area in crawlspace was not secured to wood members properly, and was not installed in standard workmanlike practice. Recommend securing electrical wiring to floor joists at 4' on center, by a qualified person.

4.5 Item 1(Picture) not secured to wood members properly

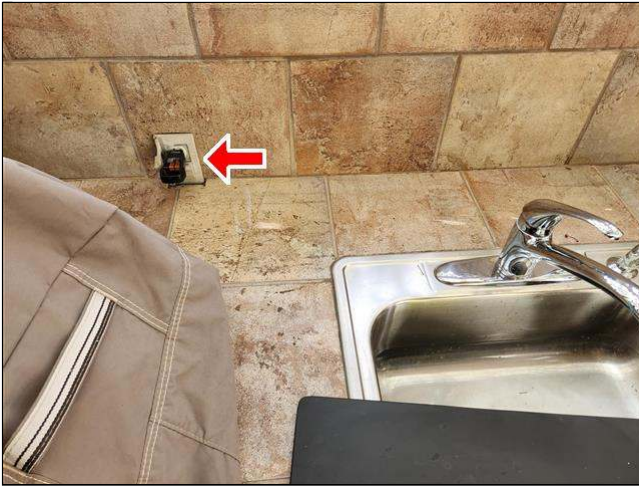
There is NO GFCI protection at the outside Kitchen sink area outlets. Recommend upgrading to GFCI outlets in areas within 6 feet of plumbing fixtures, by a qualified person... All other GFCI outlets "trip" and "reset" as intended.

4.7 Item 1(Picture) NO GFCI protection at the outside Kitchen sink area

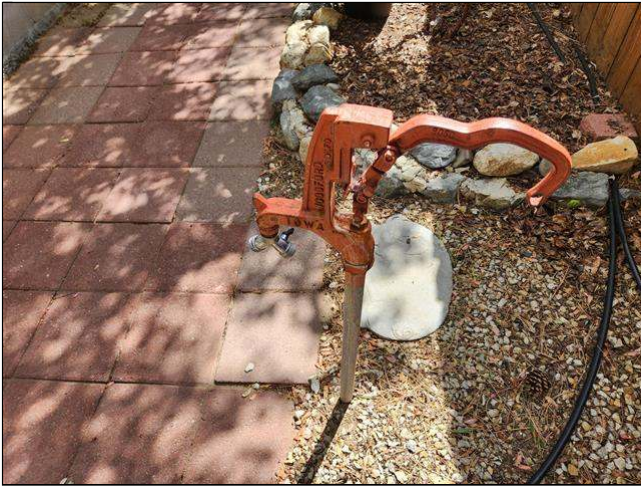
(1) NOTE: Exterior rear yard hydrant was non-operational at time of inspection. Recommend current owner to verify proper operation of this item.

5.1 Item 1(Picture) non-operational at time of inspection

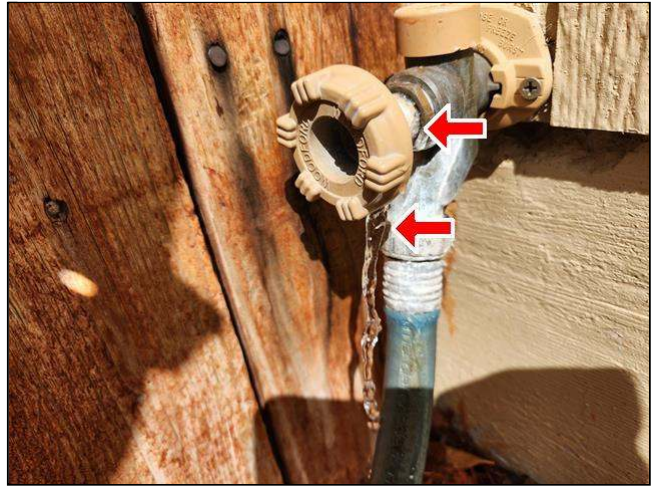
5.1 Item 2(Picture) hose bib leaks around main shaft seal

(2) NOTE: Front exterior hose bib leaks around main shaft seal when in use.

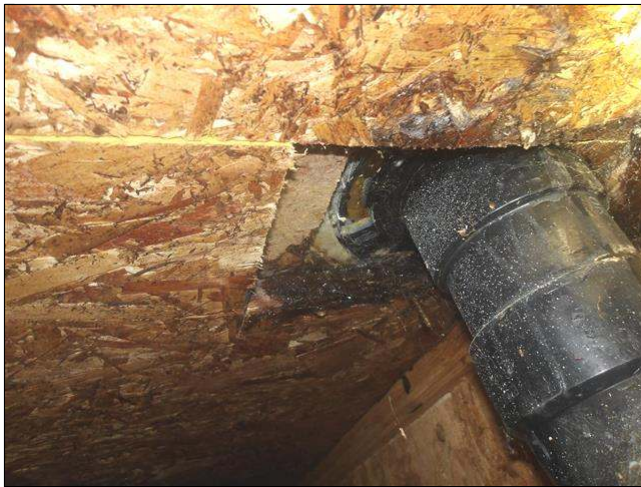
The toilet is loose at floor at the Guest Bathroom. Repairs may involve re-setting the toilet on a new wax seal. I recommend a qualified licensed plumber repair or correct as needed. NOTE: Moisture was noted dripping in the crawlspace area when toilet is flushing.

5.5 Item 1(Picture) saturated plywood subfloor from leak

**Comments:** Inspected **RE: ITEM 5.5—\*\*REPAIRED\*\*** Please see *Exhibit: Seller Repair Itemization for Updates*

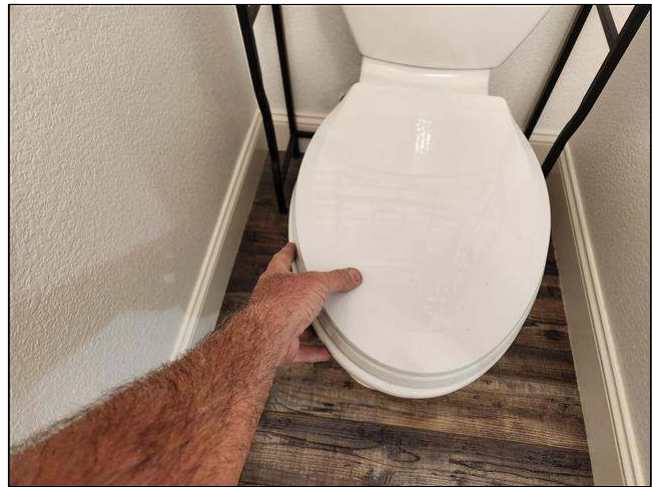
5.5 Item 2(Picture) toilet is loose at floor at the Guest Bathroom

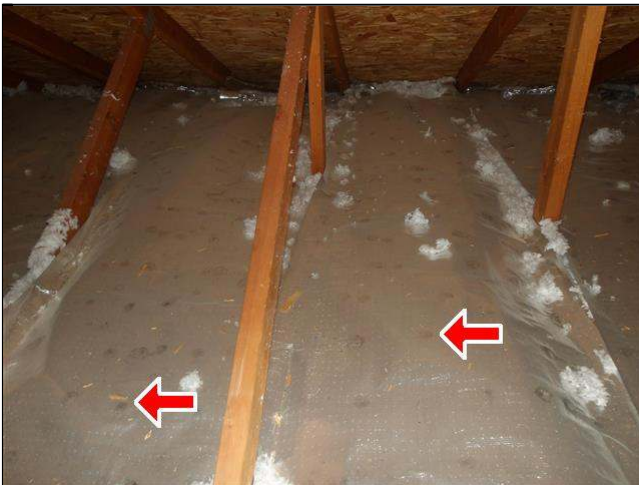
The ventilation in the attic is achieved through the use of soffit, and roof vents. The crawlspace uses foundation vents, and appears adequate... NOTE: There are water drip stains in the attic area, which indicate moisture has been condensing on protruding roofing nails from poor ventilation. It appears Roof vents have been added during the last roof covering replacement, giving the attic space soffit and roof venting, which now appears adequate.

9.3 Item 1(Picture) drip stains from condensation

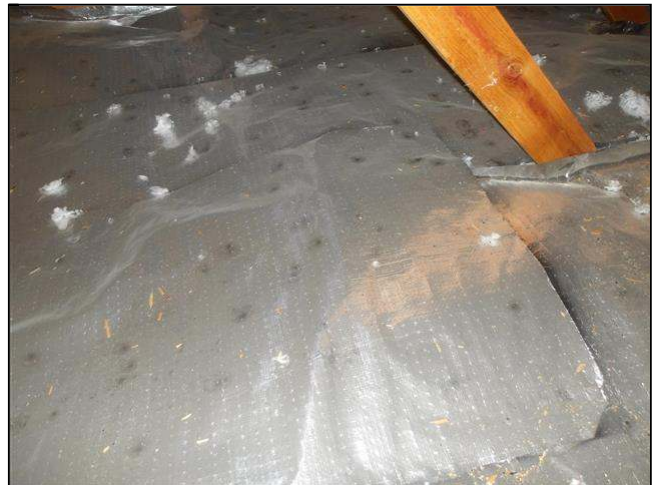
9.3 Item 2(Picture) drip stains from condensation

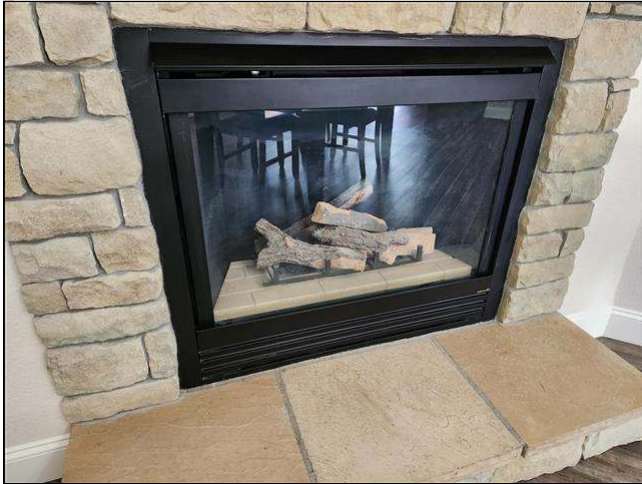
NOTE: I was unable to verify proper operation of the living room fireplace. PIEZO ignitor appears to function as intended, appears may be excessive air in the gas supply pipe. Recommend further evaluation of fireplace by a licensed Fireplace Contractor as needed.

11.0 Item 1(Picture) living room gaslog fireplace
