RESIDENTIAL STRUCTURAL CONDITION ASSESSMENT

July 11, 2024

Single Family Residential Dwelling located at 6227 Western Bluffs Boulevard, Billings, MT

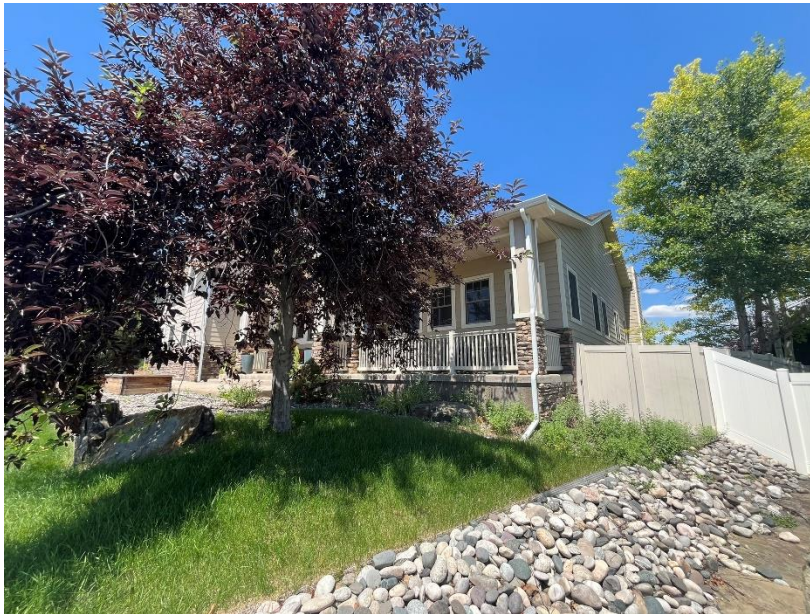
Photo 1:

Exterior profile

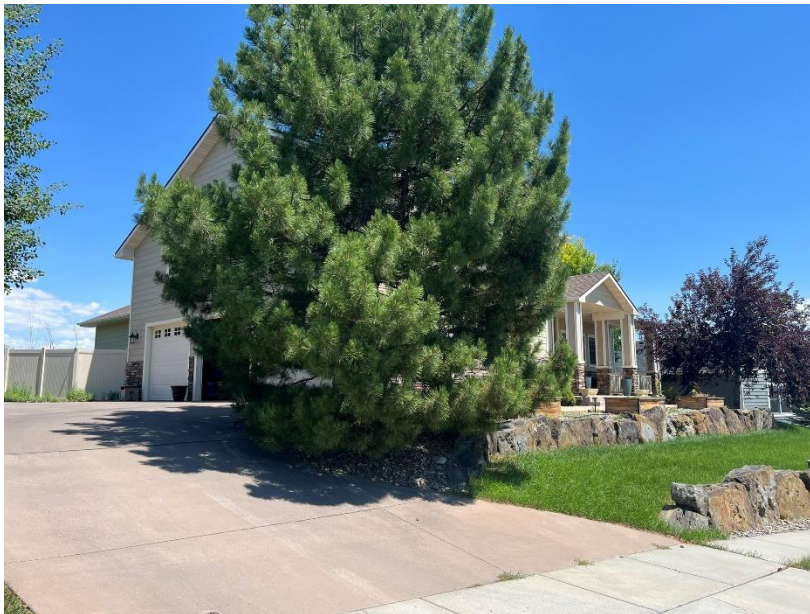
Photo 2:

Exterior profile

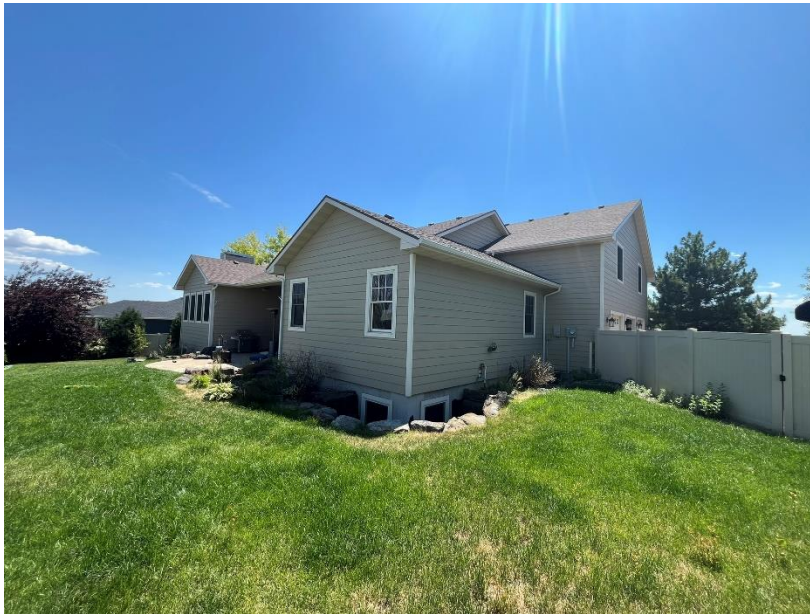
Photo 3:

Exterior profile

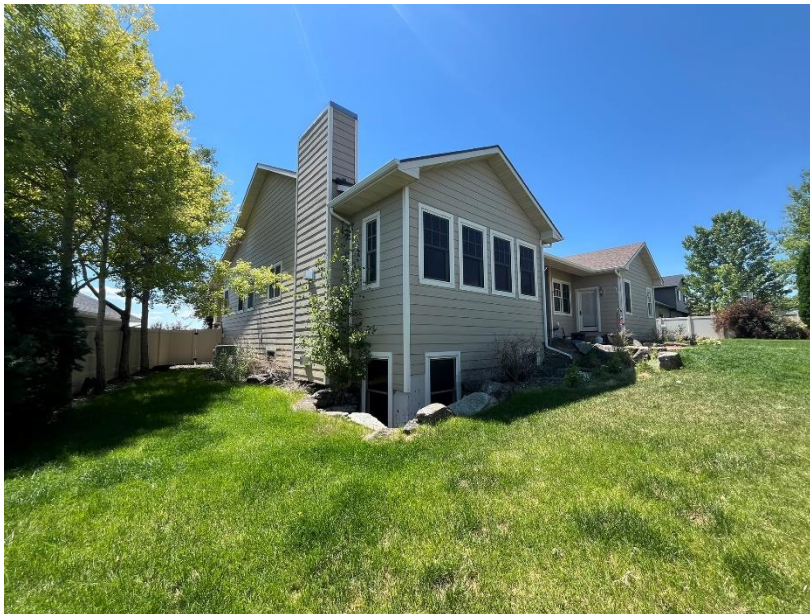
Photo 4:

Exterior profile

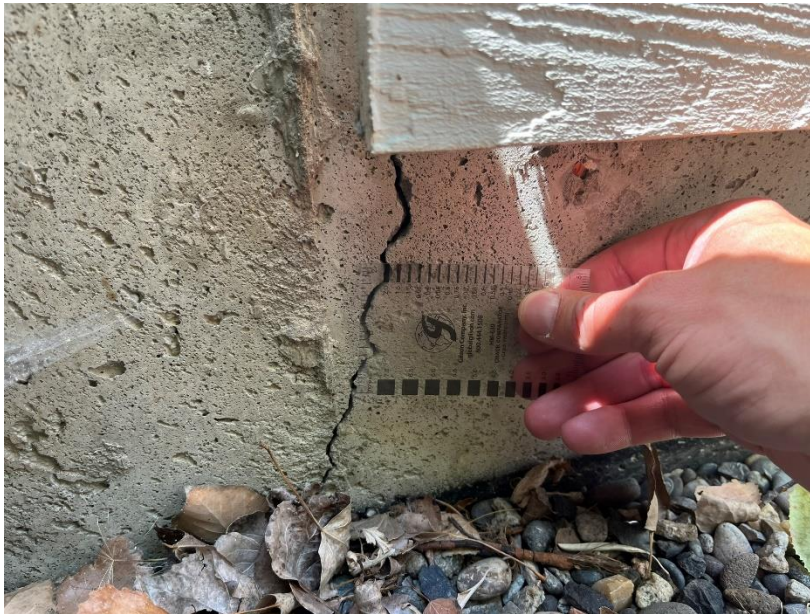
Photo 5:

There are a few foundation cracks around the egress windows on the east side of the home. Although these cracks are not structurally significant, they should be professionally sealed to prevent water or insect ingress into the basement, which is a standard aspect of home maintenance.

*2.0mm foundation crack
around egress window*

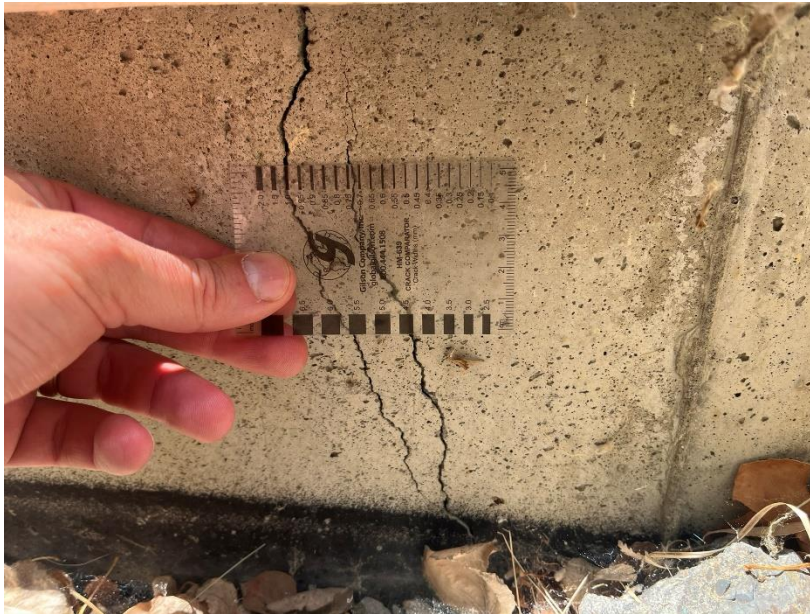
Photo 6:

*1.5mm foundation crack
around egress window*

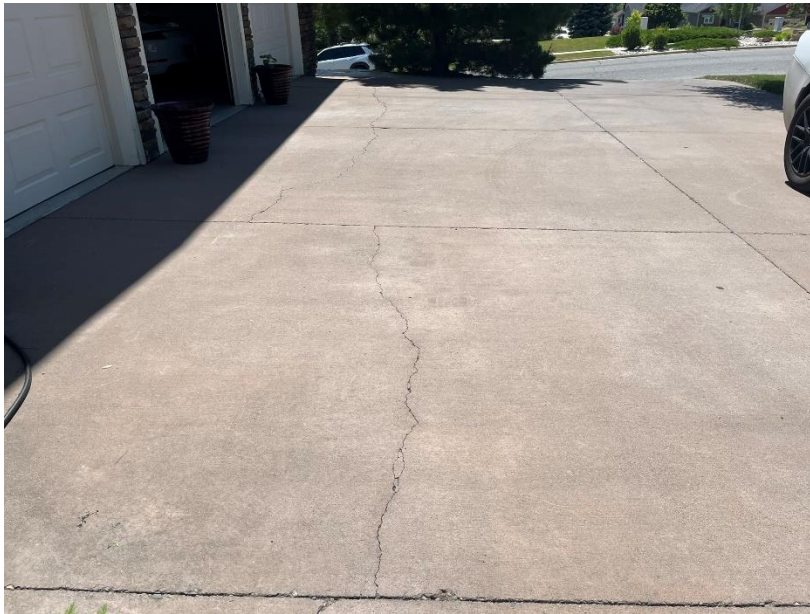
Photo 7:

Crack in driveway – not a concern

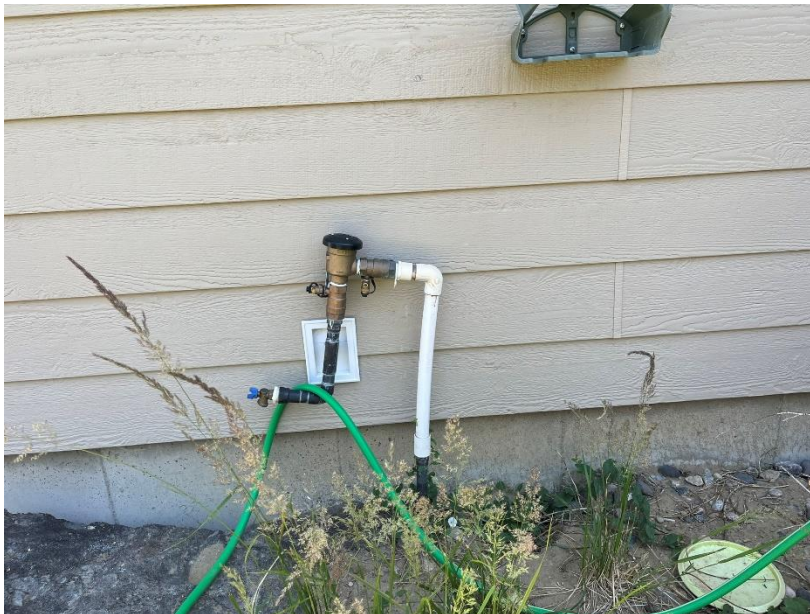
Photo 8:

Irrigation vacuum breaker
torqued – but not due to
foundation settlement.
Possibly backfill settlement.

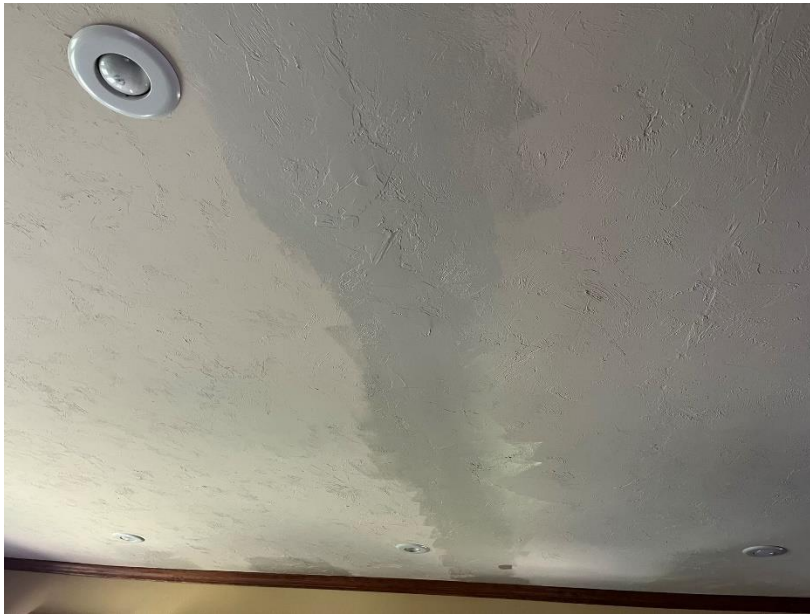
Photo 9:

The home was well constructed, exhibiting rational structural load paths from the roof to the foundation. During their ownership, the current owners have only patched a ceiling crack in the living room and have not undertaken any other similar repairs. A ceiling crack of this nature could be attributed to various factors and is not structurally concerning.

Patched drywall crack in
ceiling
