Inspection Report

973 Hillside Dr.
Carson City NV

Revised 10/11/2021

Parodi Inspection Co

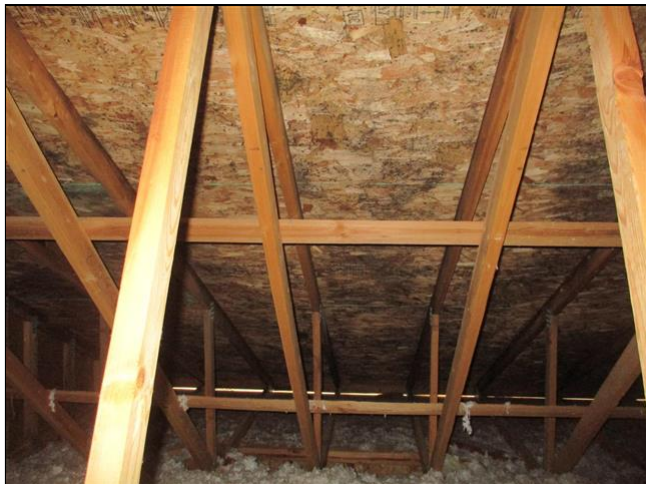
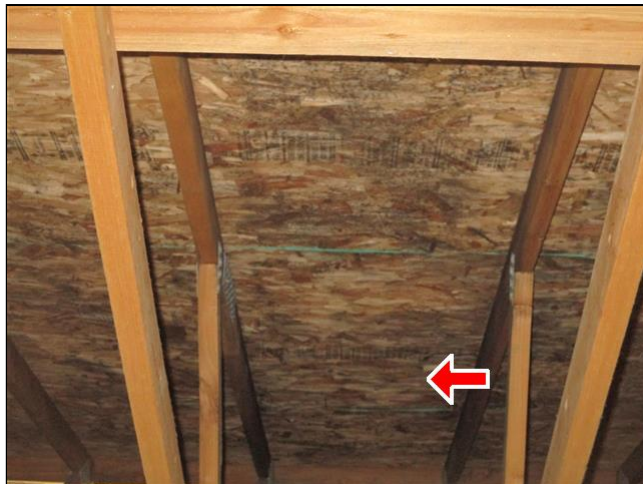
1.13 Item 1(Picture)

There is some visible darkening to some of the underside plywood sheets on the north side of the home. The darkening looks to have been from condensation or moisture at some point during the homes life. The darkening looks to be inactive organic growth. Some of the accessible areas were tested with a moisture meter and showed to have 0% moisture present at the time of my inspection and there are no visible areas of damage or defects on the roofing above. I suggest consulting a licensed professional with any concerns or questions.

Refer to question 1.13. I would suggest clearing of insulation by soffit vents and possible additional venting.

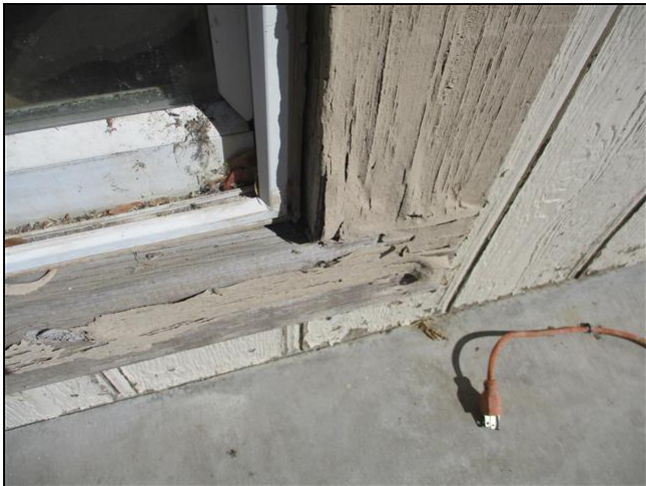
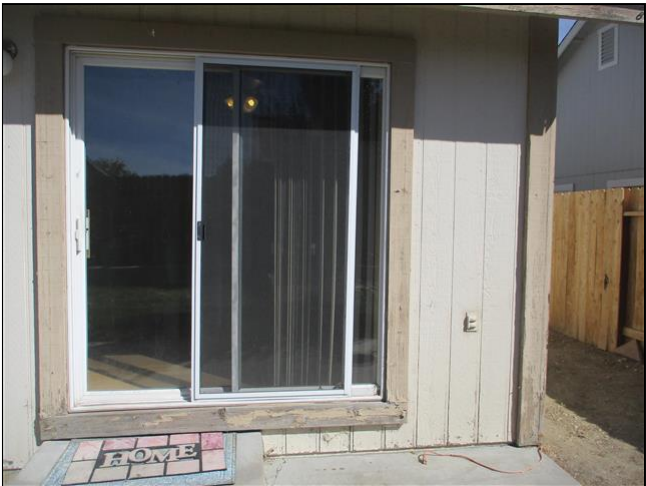
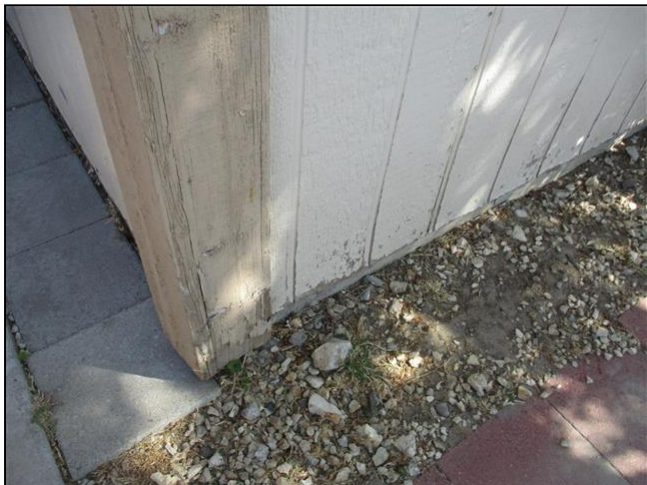
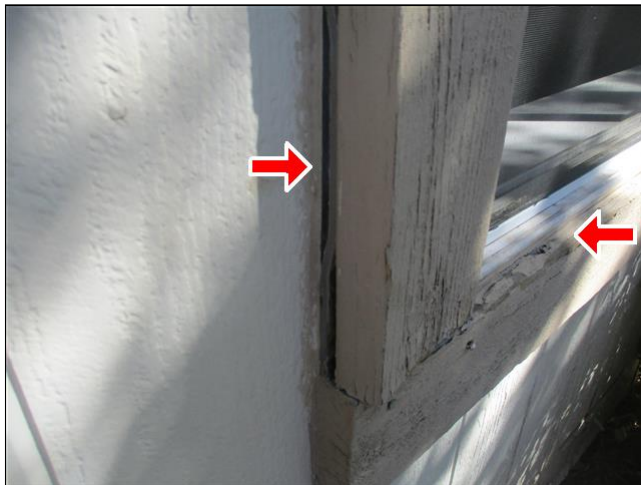
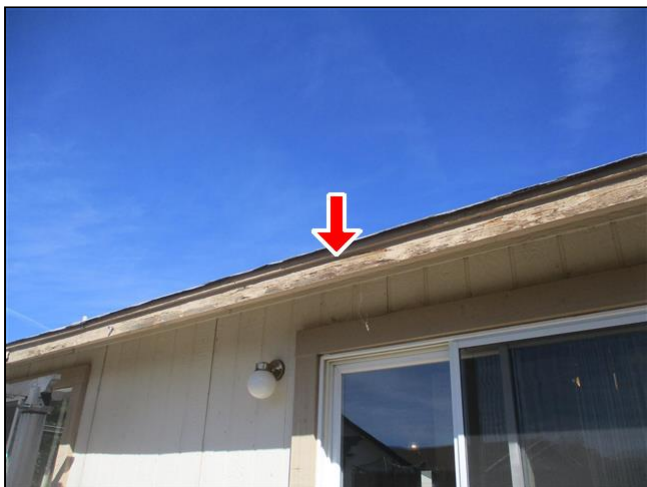
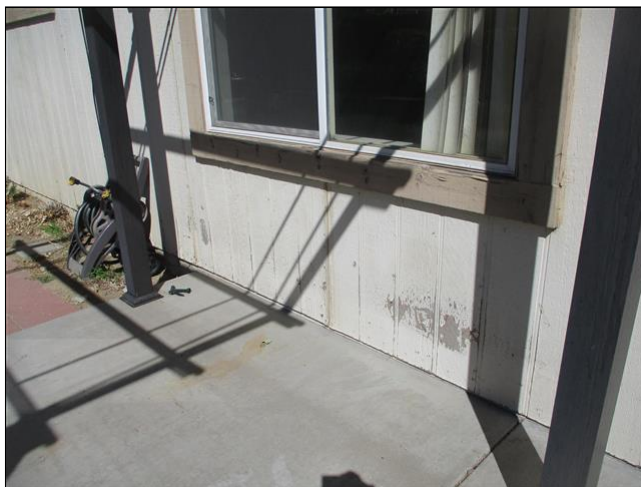
2.0 Item 1(Picture)

There are several areas around the of the home mostly the southern exposures where there is visible exposed wood and peeling paint on the siding, fascia, and trim boards. I suggest that any and all areas of visible exposed wood be properly repaired, caulked, and repainted to prolong the life of the wood.(see photos) It should be noted that every area was not photographed.

2.0-Window/door trim on south-facing side of home was cleaned, prepped, and painted on 9/30/2021. See provided invoice.

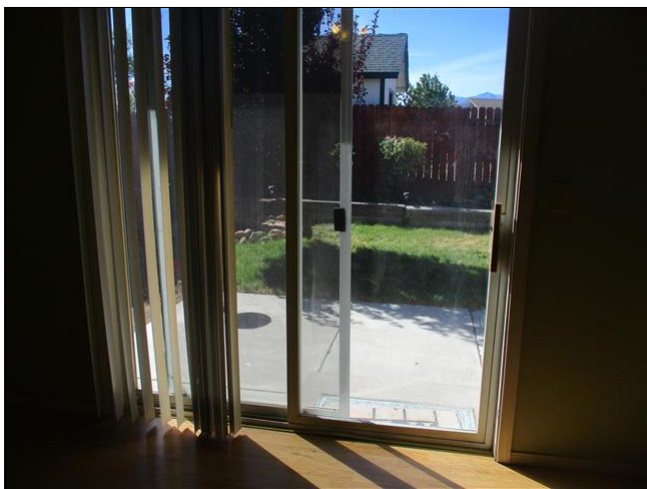
2.1 Item 1(Picture)

The back sliding glass door looks to have moisture stains between the panes of glass. I suggest that the door be thoroughly cleaned inside and out to be 100% certain.

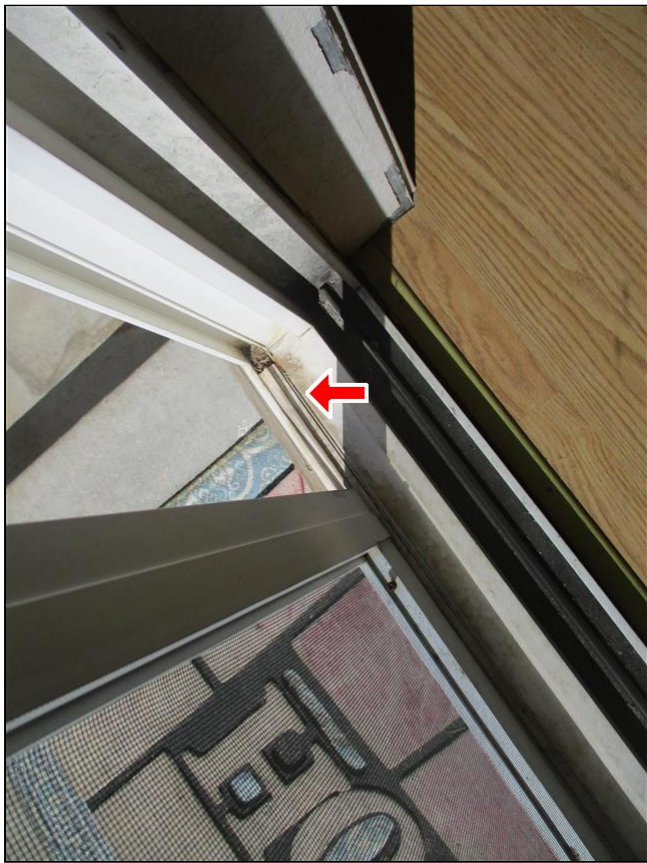
2.3 Item 1(Picture)

The back sliding glass door screen door catches on its raised track when fully closed. The raised track looks the due to sand and debris beneath.(see photo)

2.3-Serviced by handyman and the door screen no longer catches.

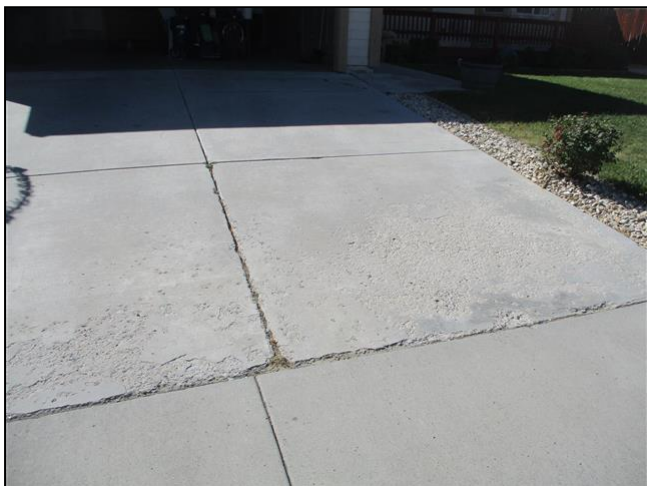
2.4 Item 1(Picture)

The driveway has areas with visible settling cracks and surface chipping. None of these areas are structural issues or tripping hazards at this point.(see photos)

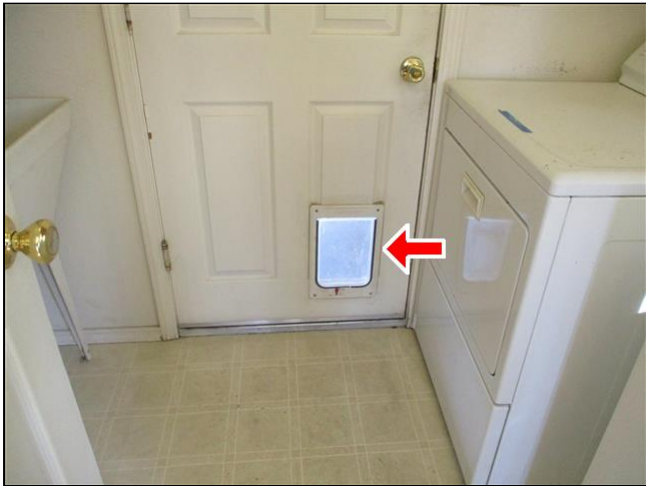
4.6 Is The Garage To House Door Self Closing and Fire Rated
The pet access cut into the garage to living space door is a breach of the firewall between the garage and living space.

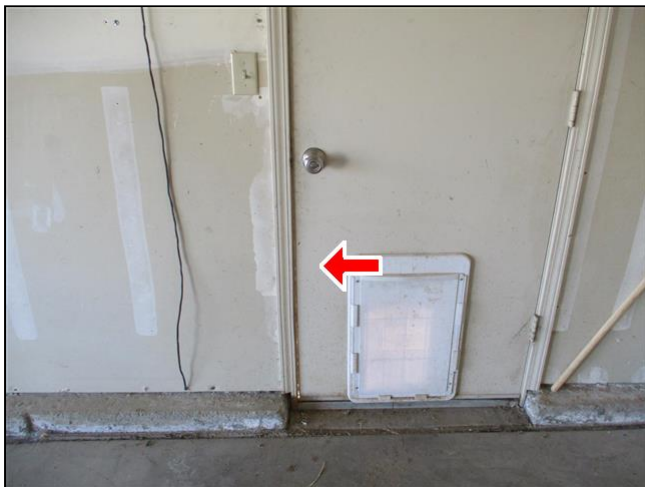
4.8 Item 1(Picture)

The garage side man door has visible light along the door jamb due to a poor seal.(see photo)

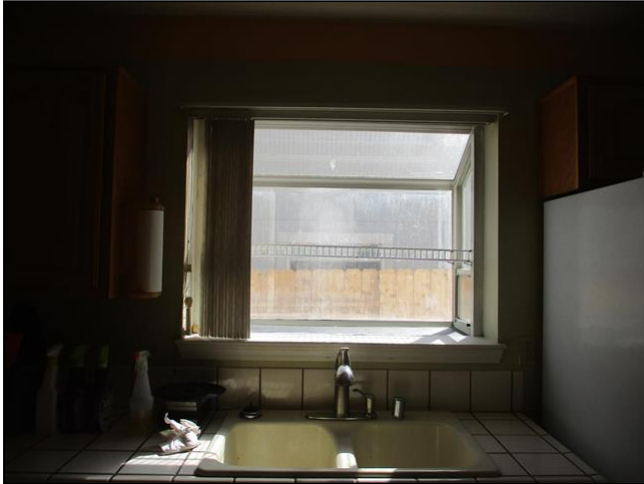
5.4 Item 1(Picture)

The kitchen garden window looks to have visible moisture stains between the panes of glass due to broken seal.(see photo)

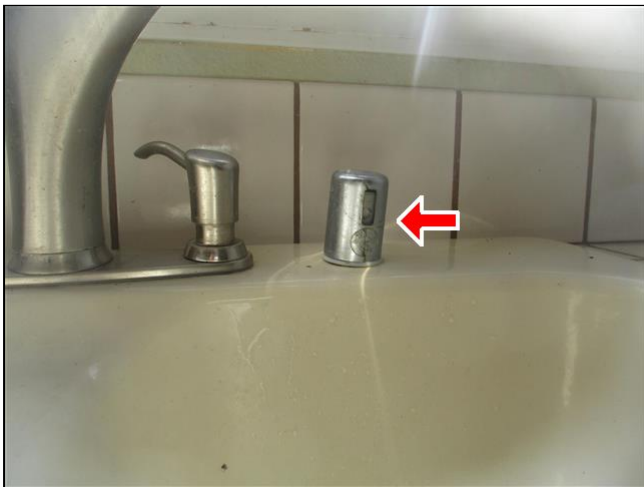
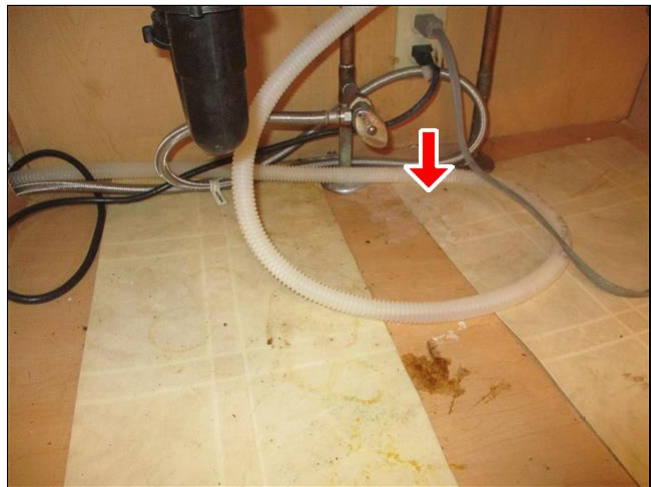
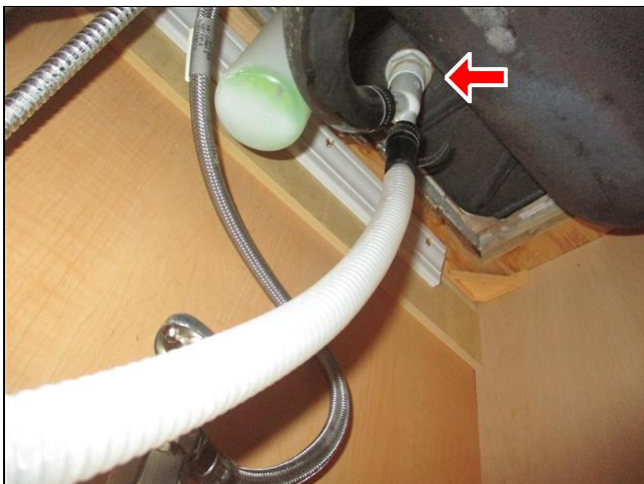
5.5 Item 1(Picture)

The dishwasher discharged at the overflow/air gap at the top of the sink and inside the sink base cabinet. The dishwasher line may have a blockage or the air gap/overflow valve may need to be replaced. All of the water was dried with towels before leaving the area. I suggest that a licensed plumber evaluate and address this issue.

5.5-Serviced by Summit Plumbing on 10/7/2021. See provided invoice.

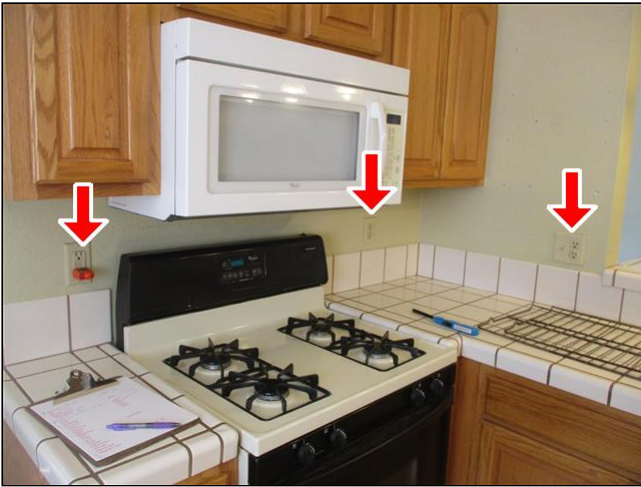
5.11 Item 1(Picture)

The three outlets on the south wall by the oven showed to have an open ground when tested. I suggest that a licensed electrician evaluate and address these issues.

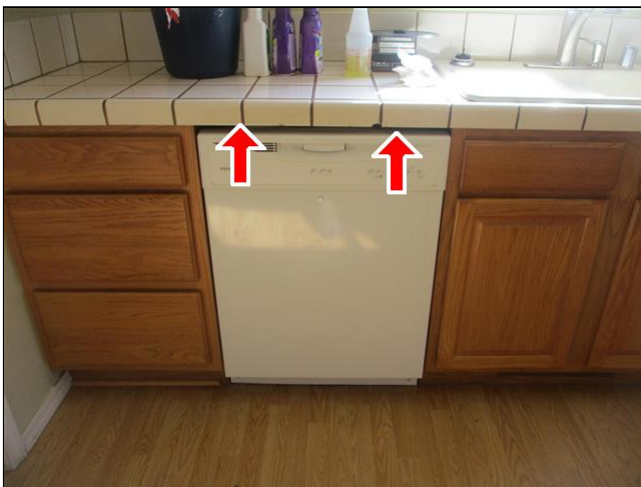
5.13 Item 1(Picture)

Refer to question 5.5 it should also be noted that the dishwasher needs to be properly attached to the underside of the countertop.(see photo)

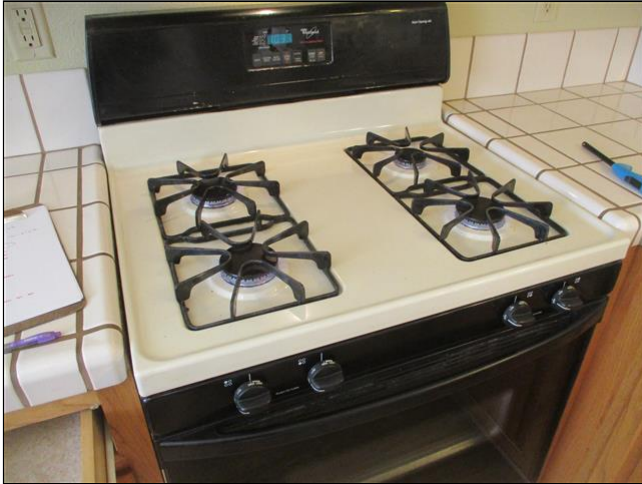
5.14 Item 1(Picture)

The igniter for the range burners was not functional. I suggest that a licensed appliance technician evaluate and address this issue.(see photo)

5.14-Scheduled to be inspected by appliance technician on 10/12.
Invoice will be uploaded upon completion.

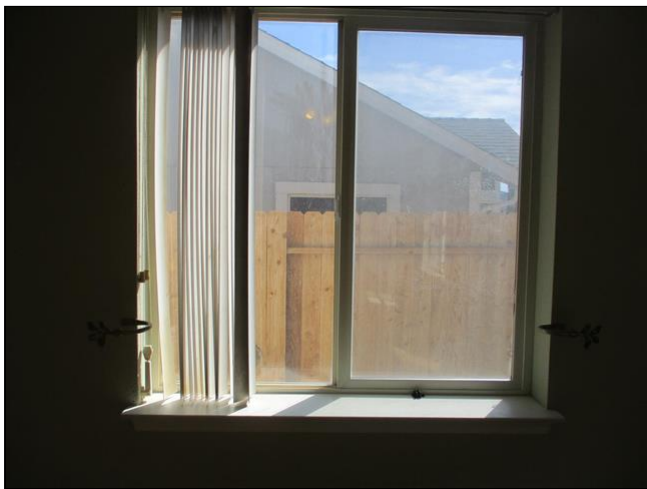
7.4 Item 1(Picture)

The window on the east wall looks to have visible moisture stains between the panes of glass. I suggest that this window be thoroughly cleaned inside and out to be 100% certain.

7.4-Windows cleaned by House Cleaners. See provided invoice.

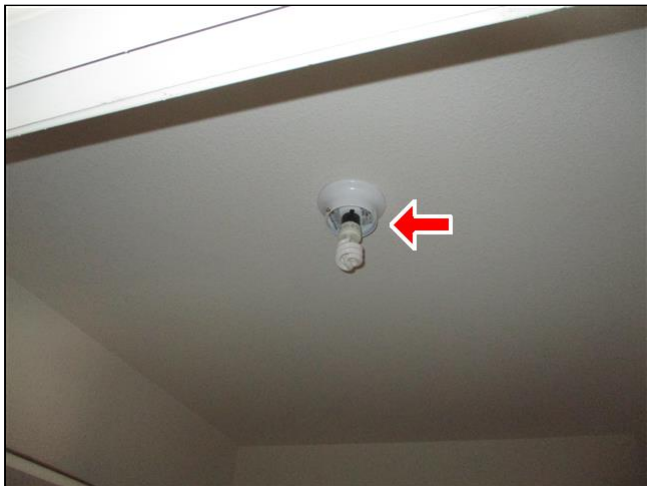
8.5 Item 1(Picture)

The master bedroom closet light fixture no longer has its cosmetic cover installed.(see photo)

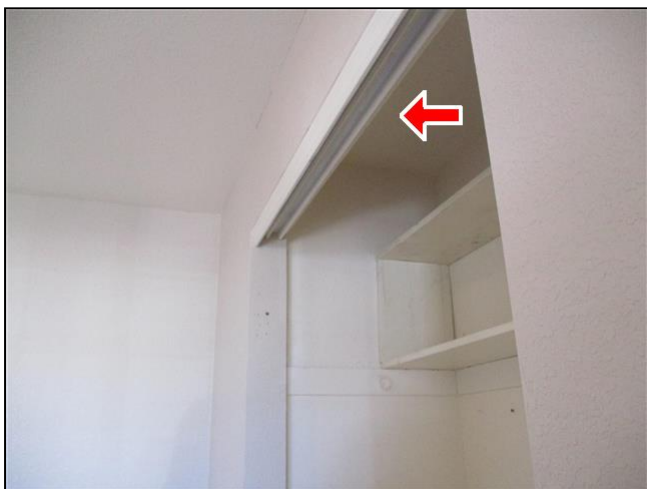
8.8 Item 1(Picture)

The front middle bedroom closet has a track present with no doors installed.(see photo)

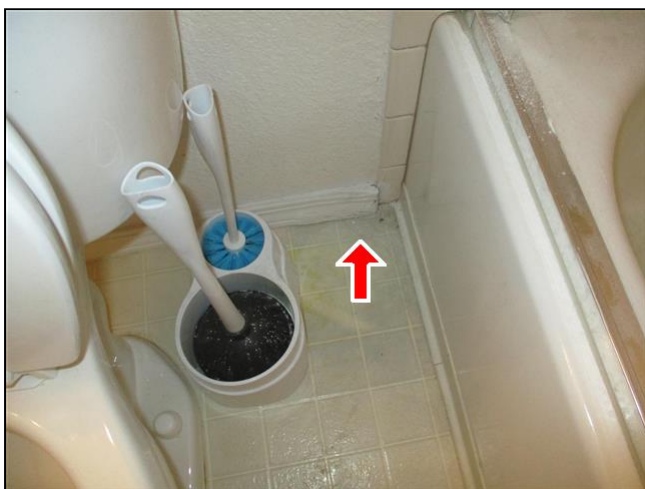
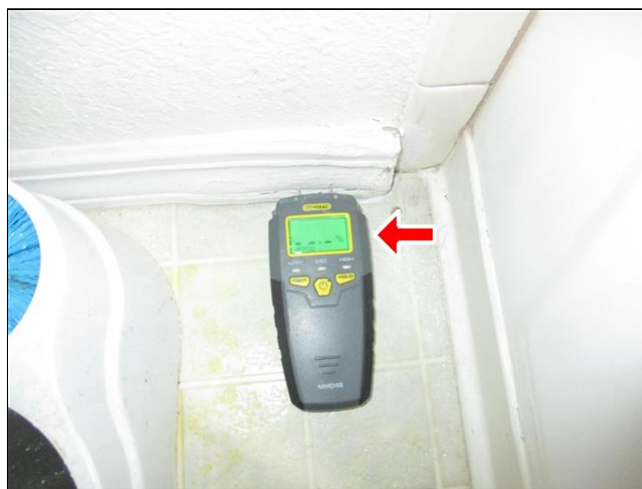
9.1 Item 1(Picture)

The lower wall by the shower next to the toilet in the hall bathroom has some visible moisture swelling. This area was thoroughly tested with a moisture meter and showed to have 0% moisture present at the time of my inspection. The moisture swelling looks to have been caused from shower over spray and not a leak.

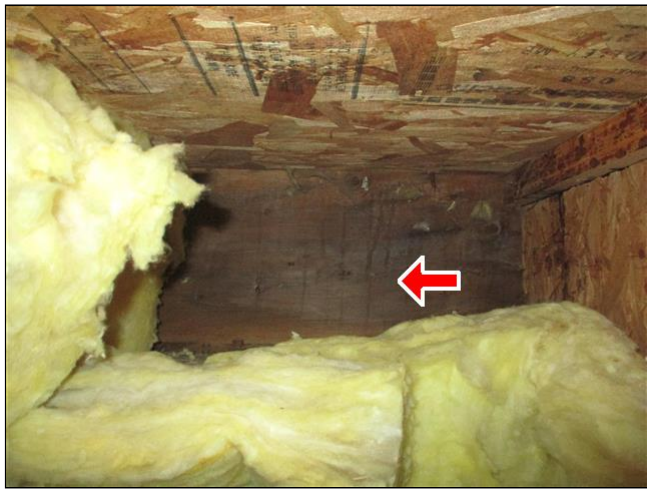
10.2 Item 1(Picture)

There were no areas of standing water under the home at the time of my inspection only some typical minor moisture content in the soil below the moisture barrier. There is some evidence of moisture under the home present along the front rim joist area. The areas have some moisture staining but were dry at the time of my inspection. I would suggest regular inspections of the crawlspace during heavy rainy seasons.

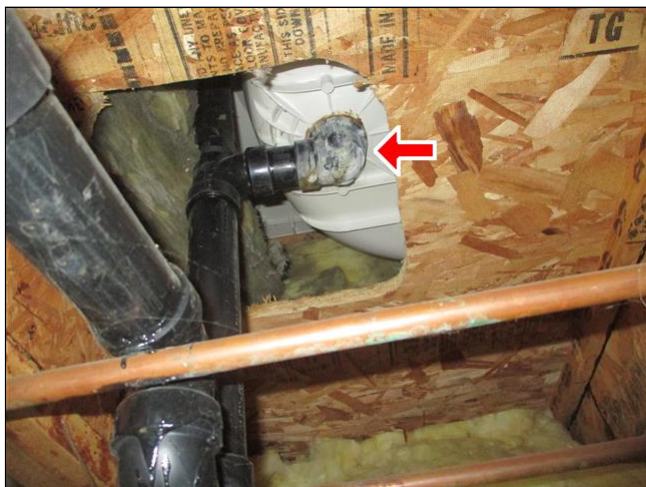
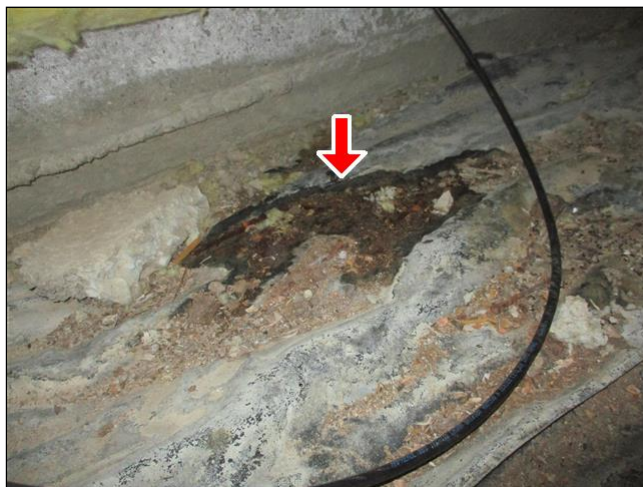
10.5 Item 1(Picture)

There is an active leak at the master bathroom tub drain line connection. I suggest that a licensed plumber evaluate and address this issue.

10.5-Serviced by Summit Plumbing on
10/7/2021. See provided invoice.

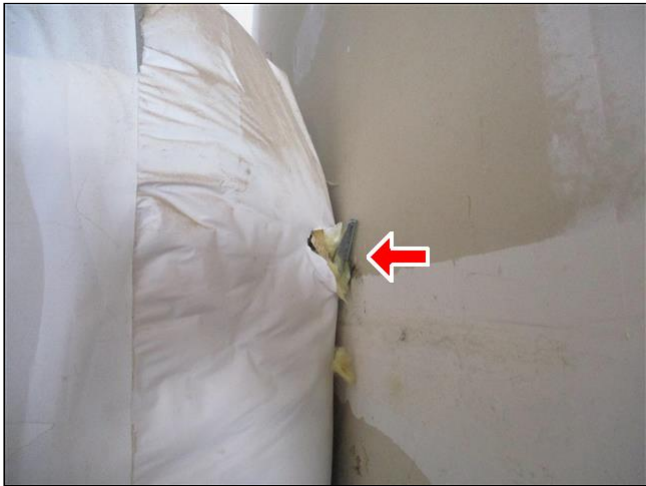
11.5 Item 1(Picture)

Although present TP valve line release lever is in close contact with the wall which may prevent it from properly opening and releasing pressure in emergencies. If needed the TP valve line or safety relief valve line will release a large amount of very hot water at very high pressure.

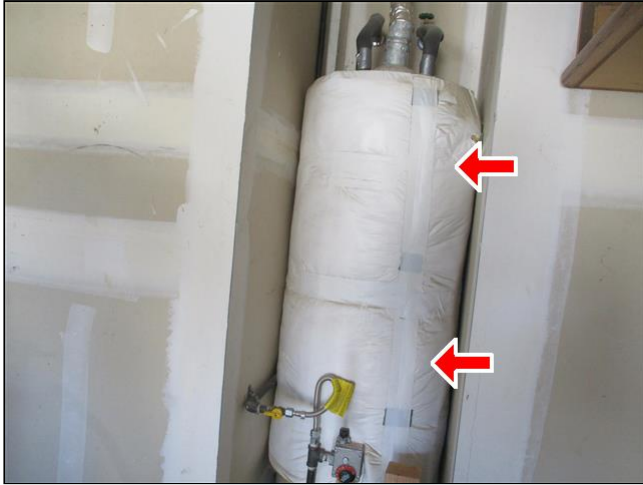
11.9 Item 1(Picture)

I suggest that the water heater have to approved seismic straps installed. One within the top one third of the tank and one within the bottom one third of the tank.(see photo)

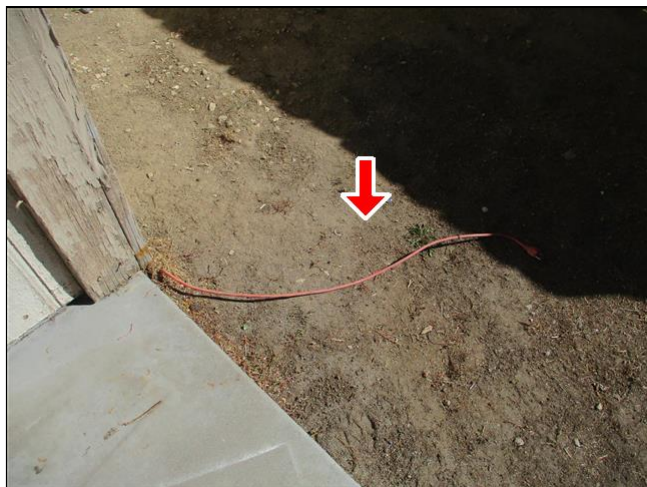
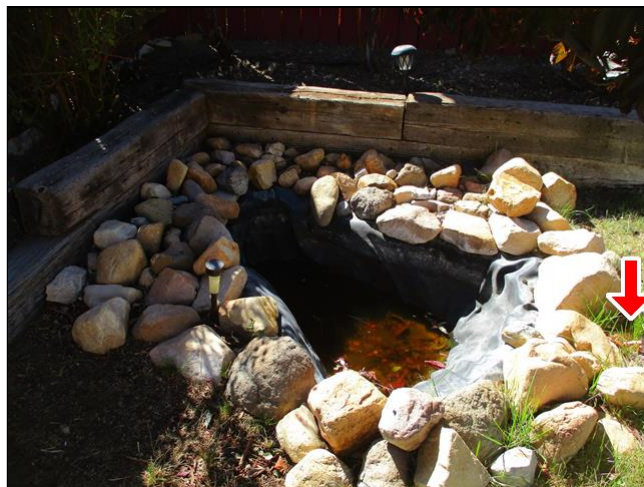
12.6 Item 1(Picture)

The buried extension cord leading to the pond is not a proper or safe method for powering the pump. I suggest a licensed electrician evaluate and address this issue.

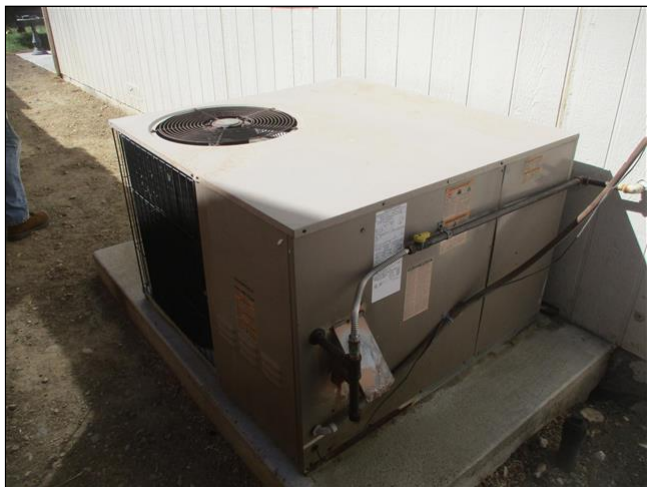
13.0 Item 1(Picture)

Although functional, I suggest that the heating unit be cleaned serviced and evaluated by licensed HVAC technician, or if the seller can provide an invoice of service within the past one year. This is general maintenance that should be done from year-to-year depending on usage.

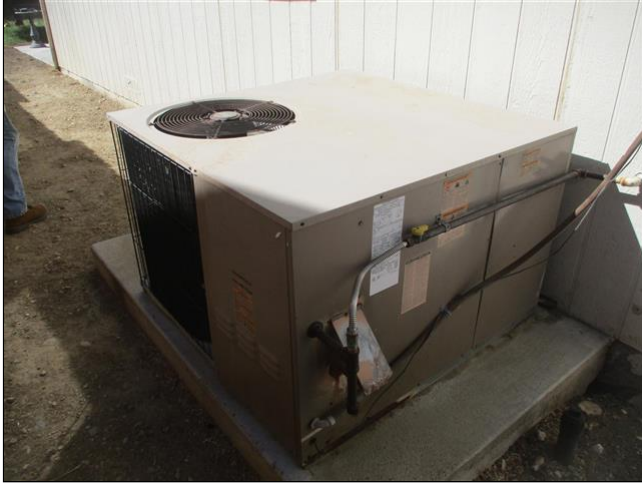
13.5 Item 1(Picture)

I suggest that the AC unit be cleaned serviced and evaluated by licensed HVAC technician, or if the seller can provide an invoice of service within the past one year. This is general maintenance that should be done from year-to-year depending on usage.
