## Home Inspection Report

**1718 Iris Lane  
Billings, MT 59102**

**Date of Inspection: 08/16/2024**

Inspection No. 45957-1-1121

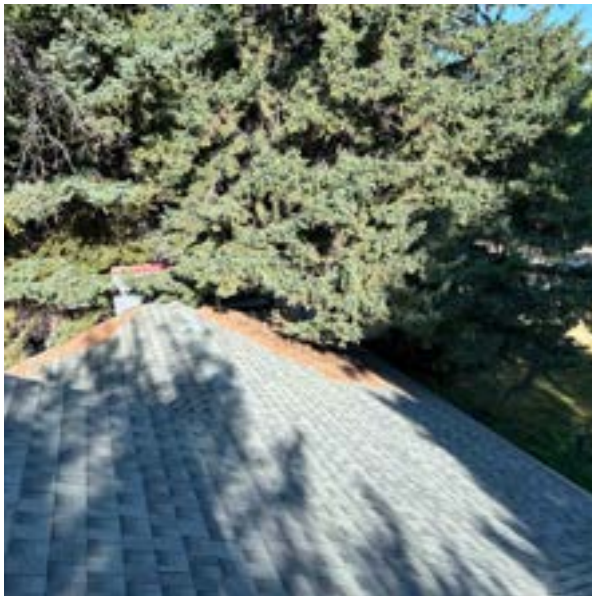
2.2.3 Trim and maintain trees, bushes and vines away from the structure to minimize damage/wear to structure and to discourage animal activity.

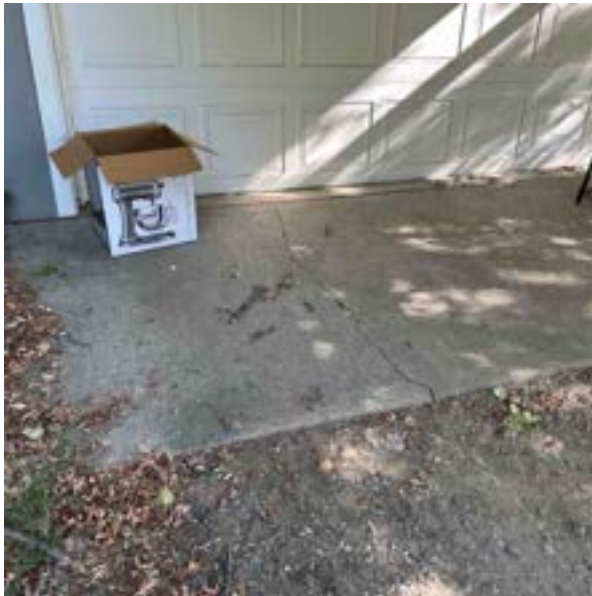
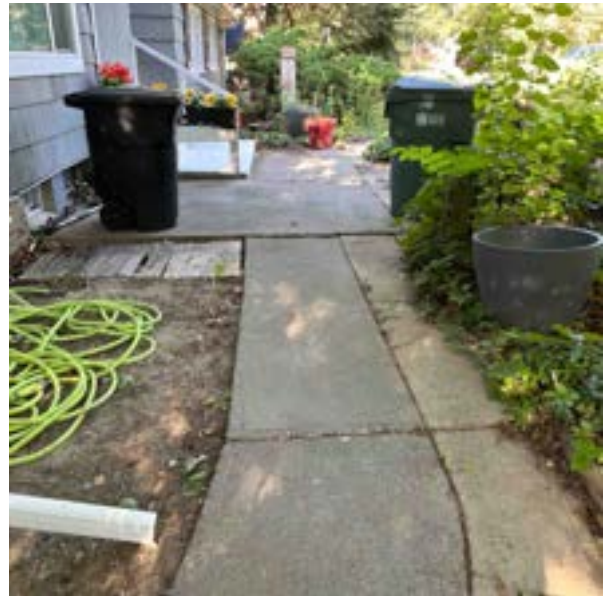
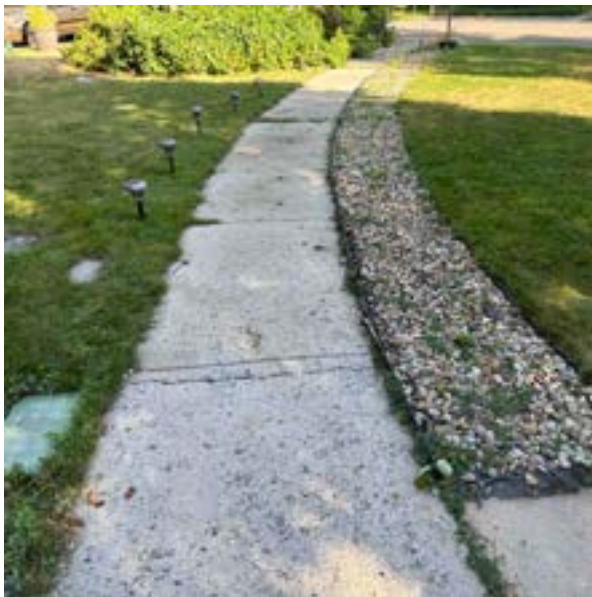
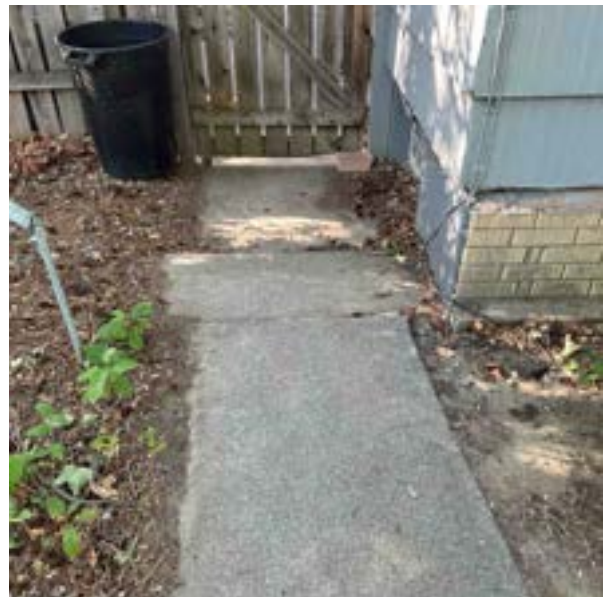
2.3.2 Repair damaged/deteriorated/uneven walkways/driveway/patio to prevent further damage and prevent safety hazards.

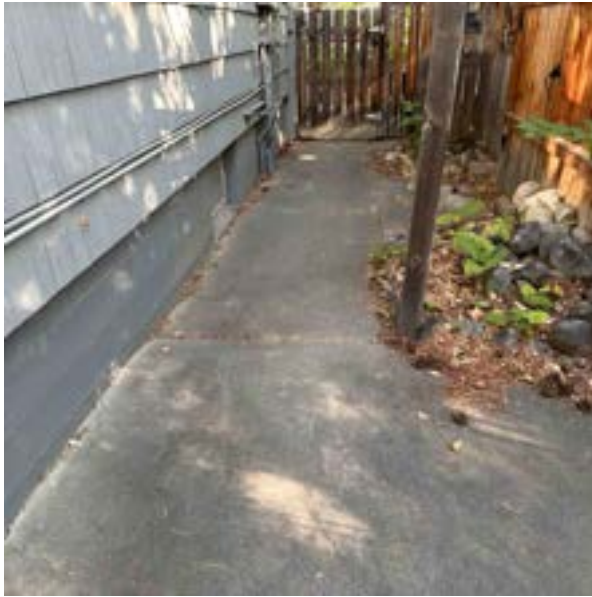
2.3.3 Reslope walkway to drain away from structure to prevent deterioration and water entry. **(Exterior East)**

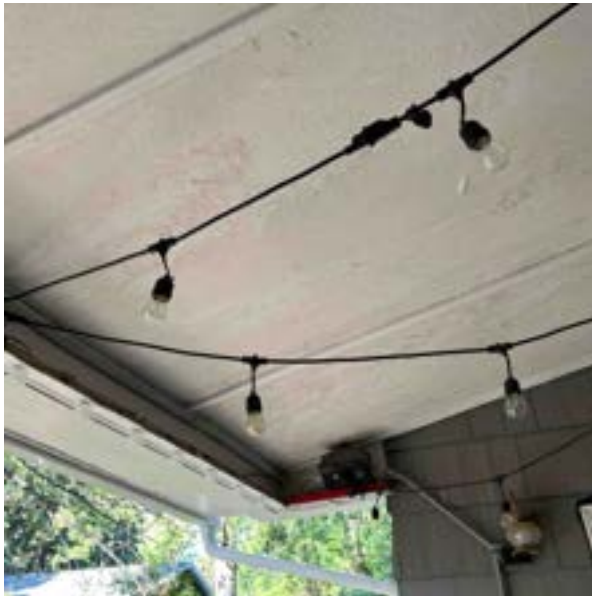
2.5.2 Further investigate cause and extent of water damage in patio cover and repair as required to promote stability and prevent further damage. **(Exterior South)**

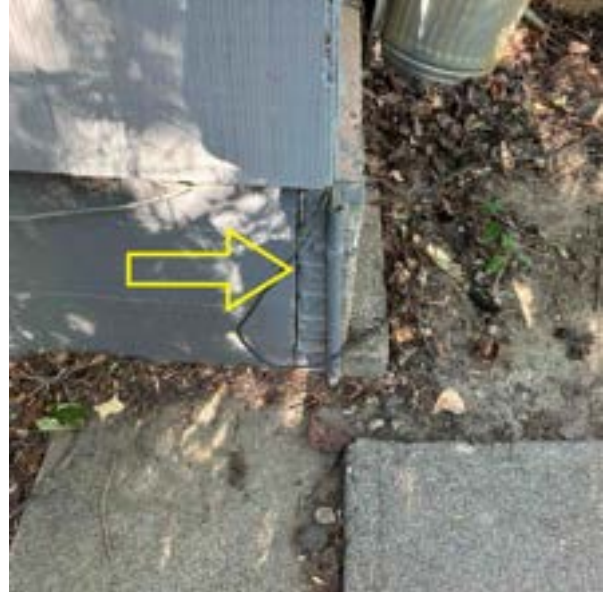
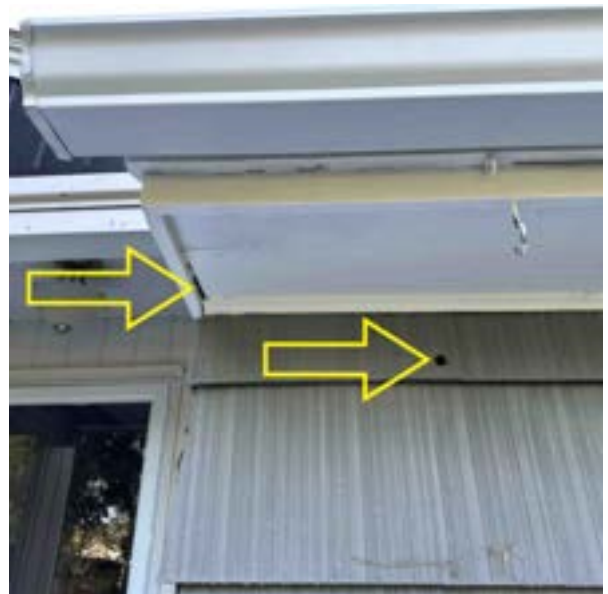
3.3.3 Ensure proper caulking and weather seal at all required locations and junctions such as windows, doors, dissimilar materials junctions, etc. **(Throughout)**

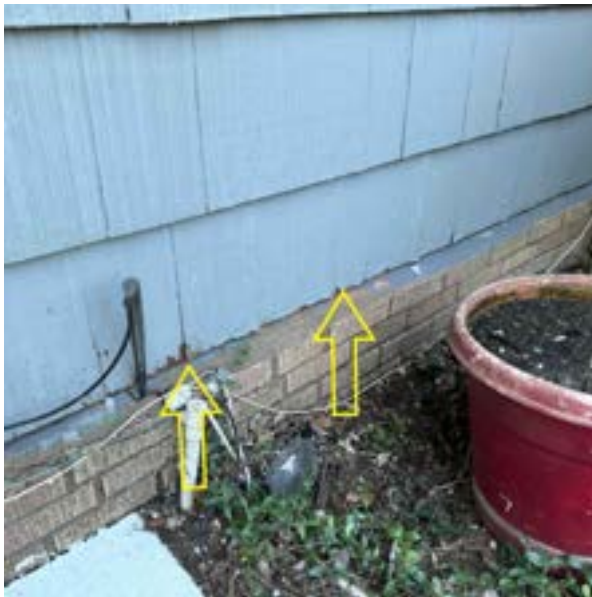
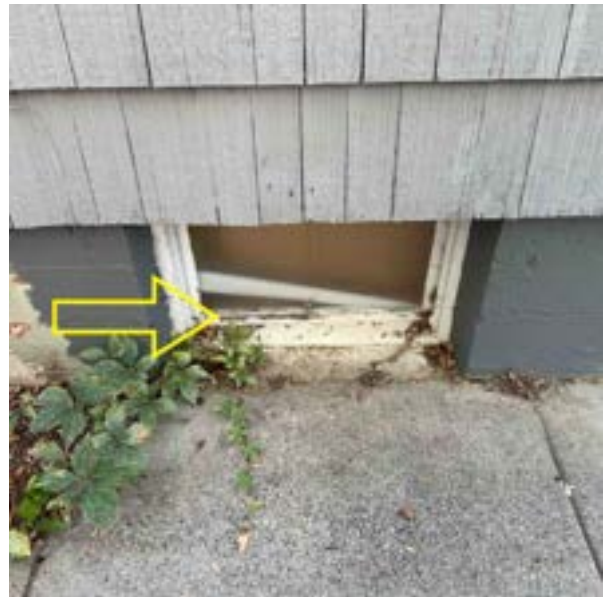
3.3.4 Clean, seal/paint/stain all exposed wood siding/trim to promote weathering protection. **(Throughout)**

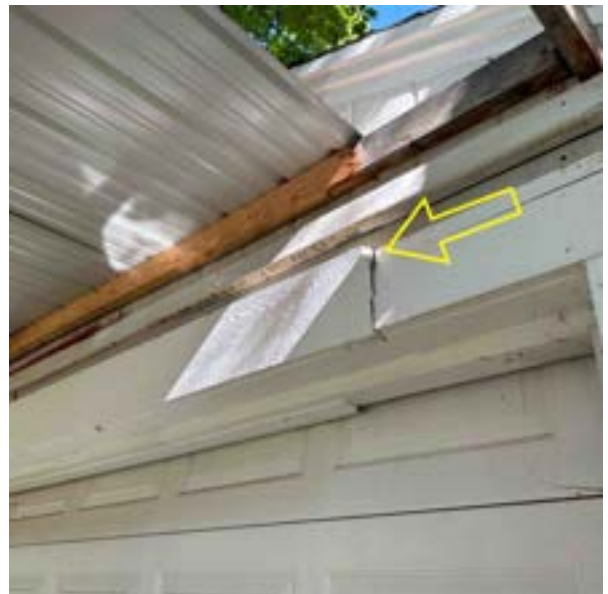
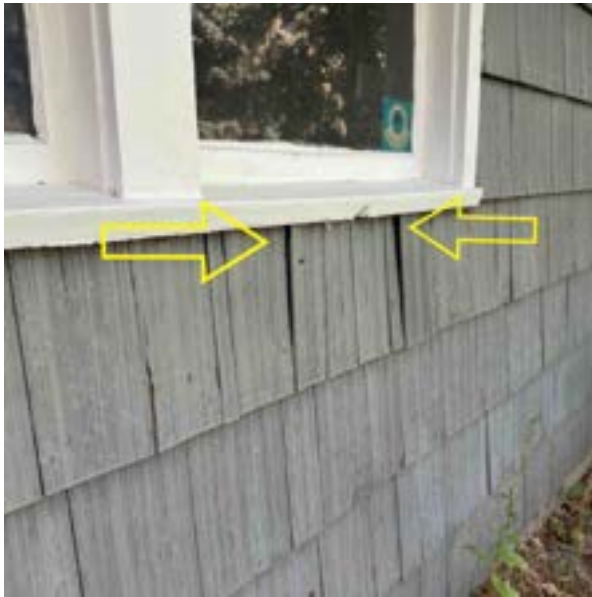
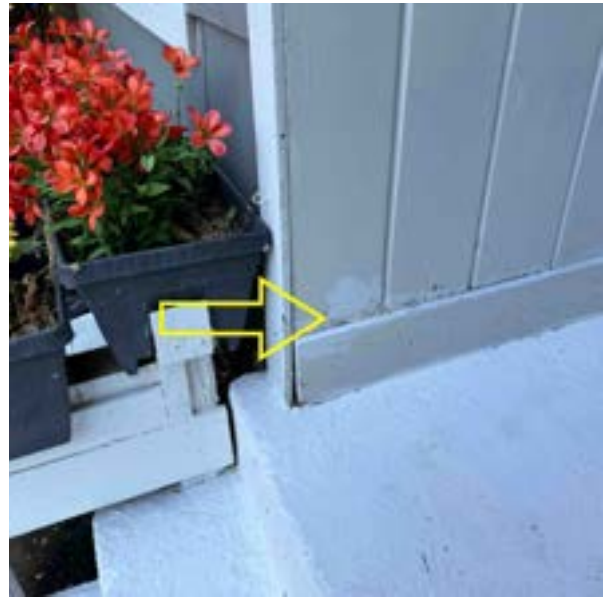
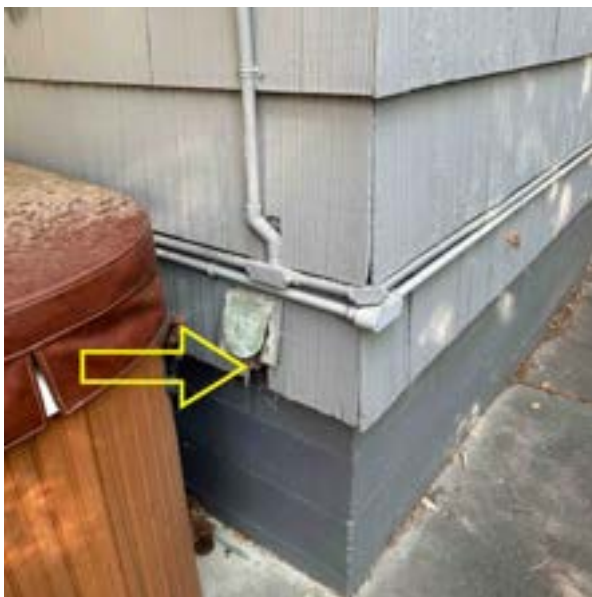
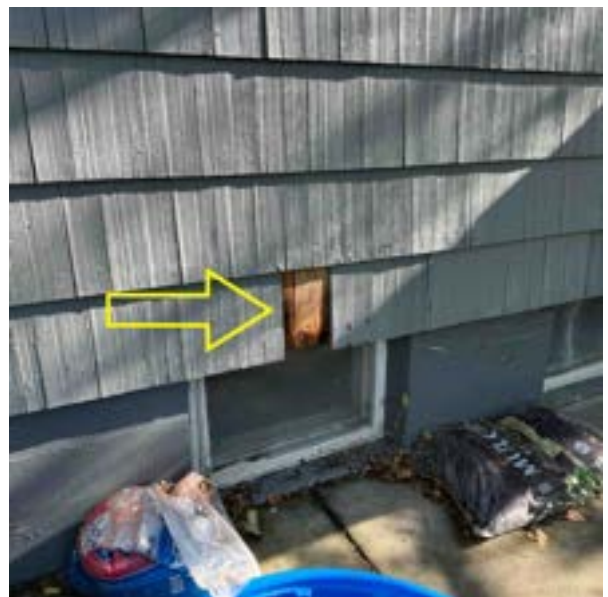
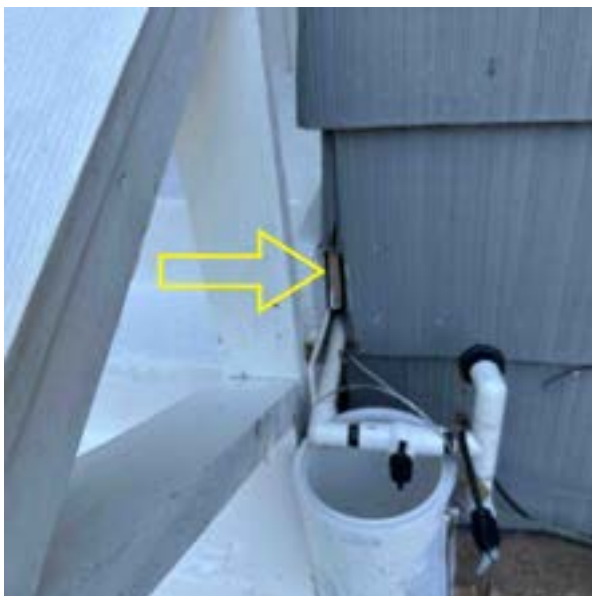
3.3.5 Replace damaged/deteriorated/missing siding/trim to prevent further damage and promote weathering protection.

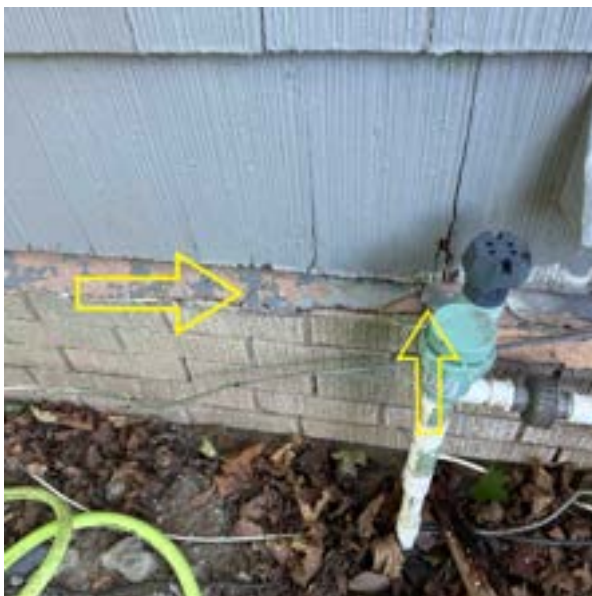
3.3.6 Repair/repoint damaged brickwork to prevent further damage and promote weathering protection.

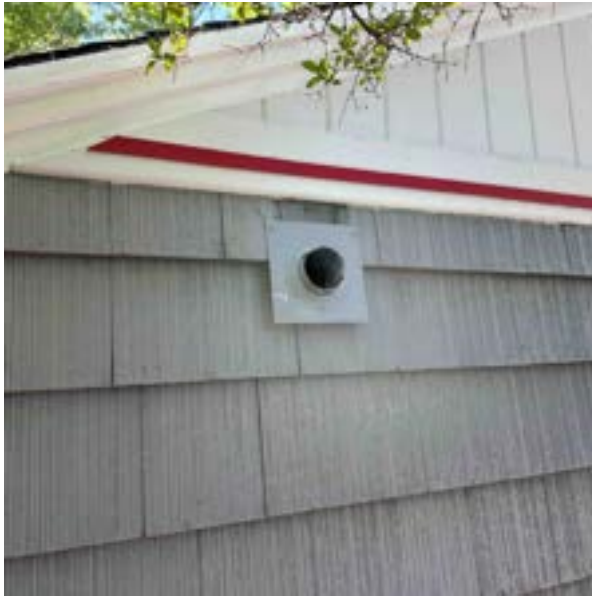
3.3.7 Replace missing vent cover to prevent further damages and promote weathering protection/deter pest entry. **(Garage)**

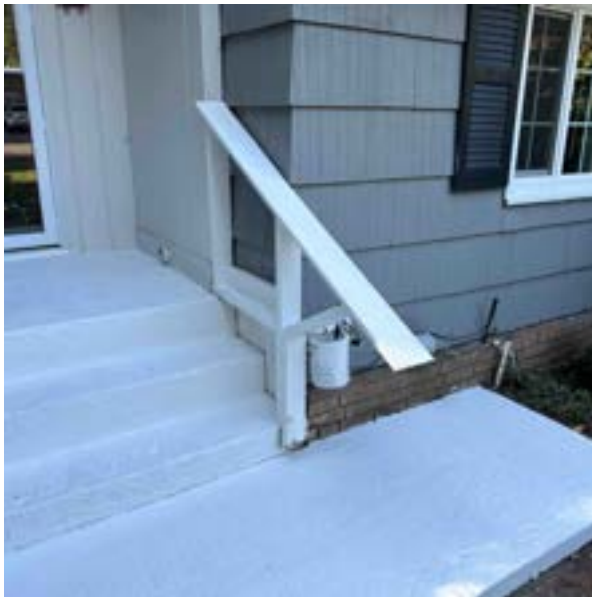
3.6.2 Secure loose railing to promote safety. **(Exterior North)**

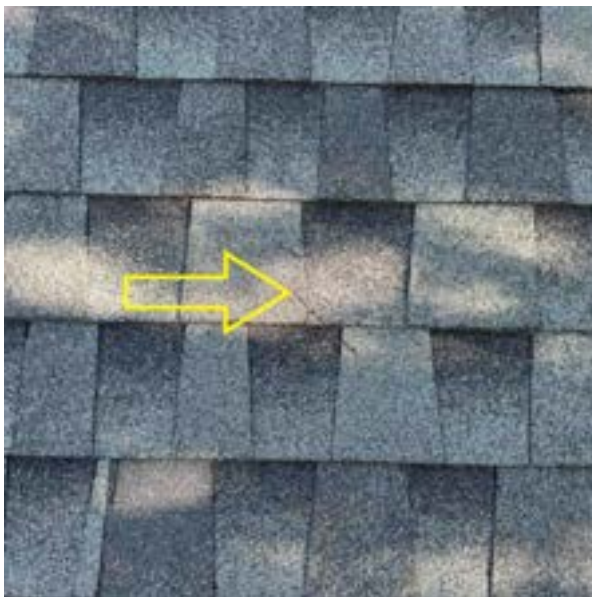
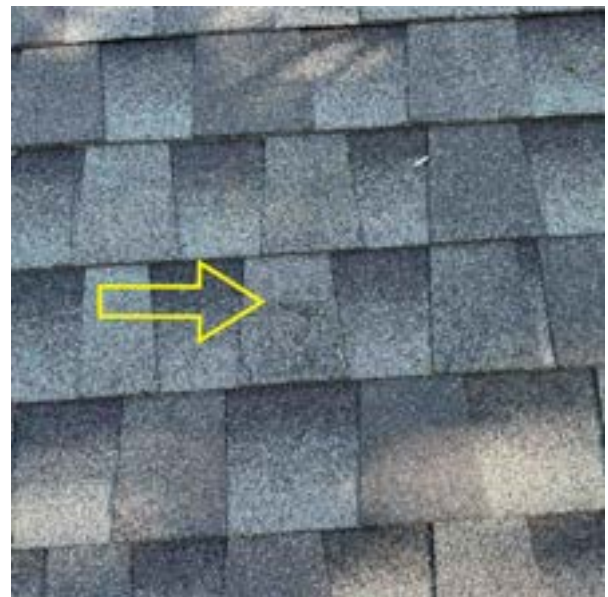
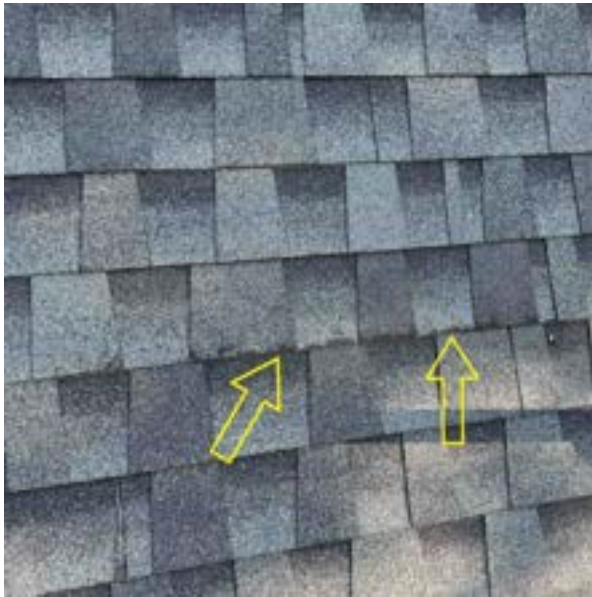
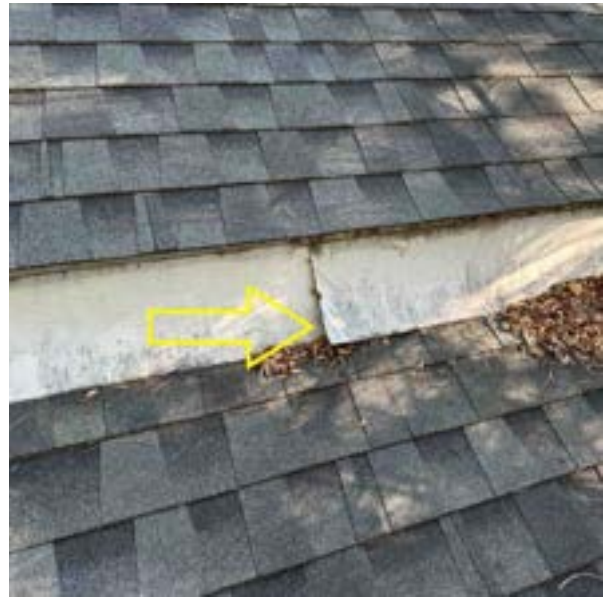
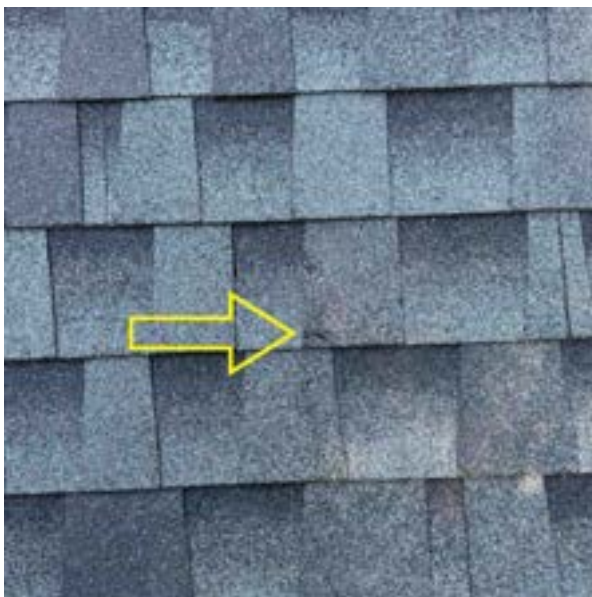
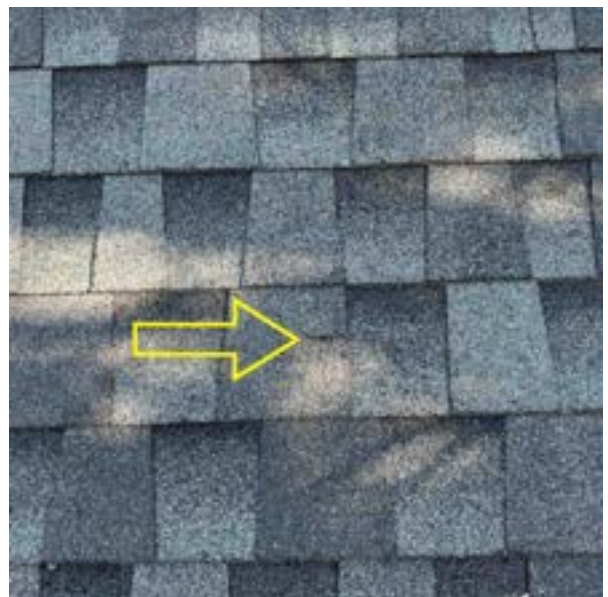
4.2.1 Consult a qualified roofer to evaluate scarred/damaged shingles, lifting flashing, and exposed nailheads and repair as recommended.

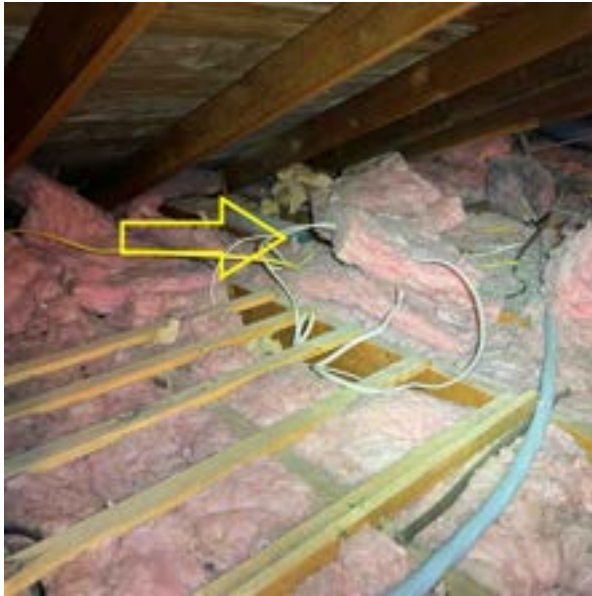
5.5.2 Ensure bathroom exhaust fans vent to the exterior to prevent moisture/condensation related damages.

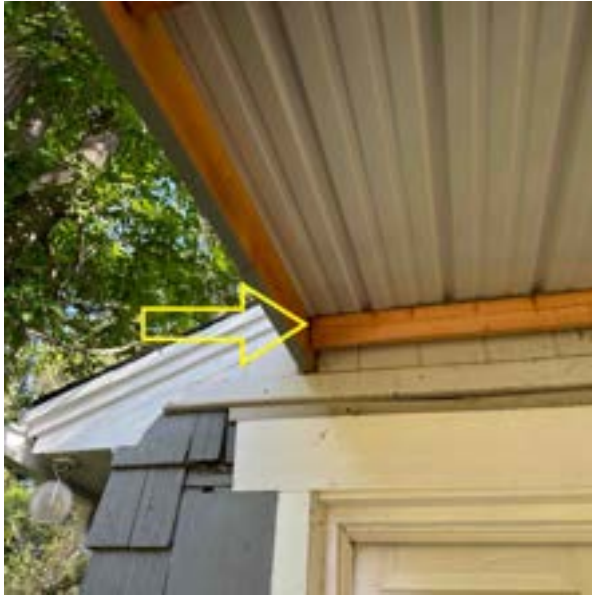
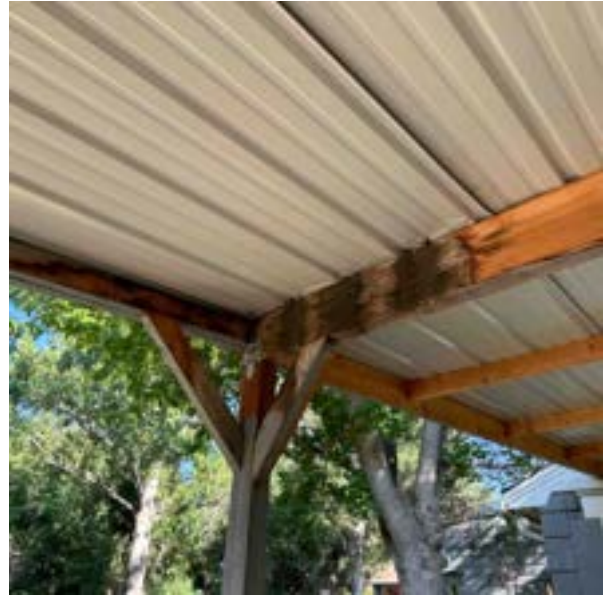
6.2.1 Consult a qualified contractor to evaluate carport installation/construction/deterioration/slope and repair as recommended. **(Garage)**

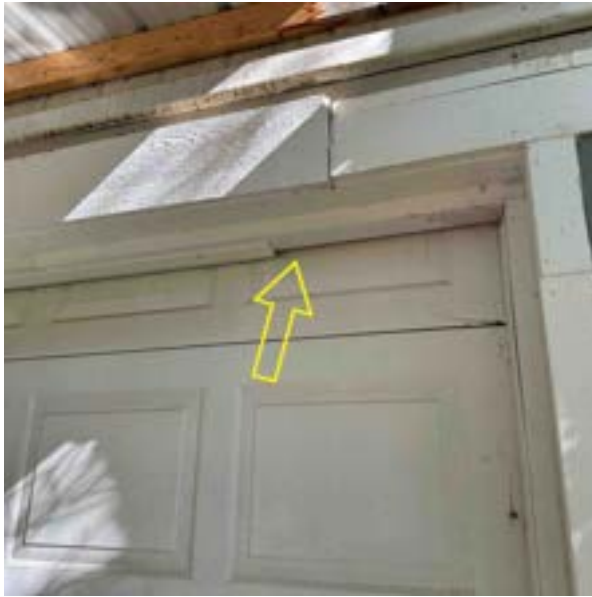
6.3.2 Replace damaged weather seal to promote weathering protection. **(Garage)**

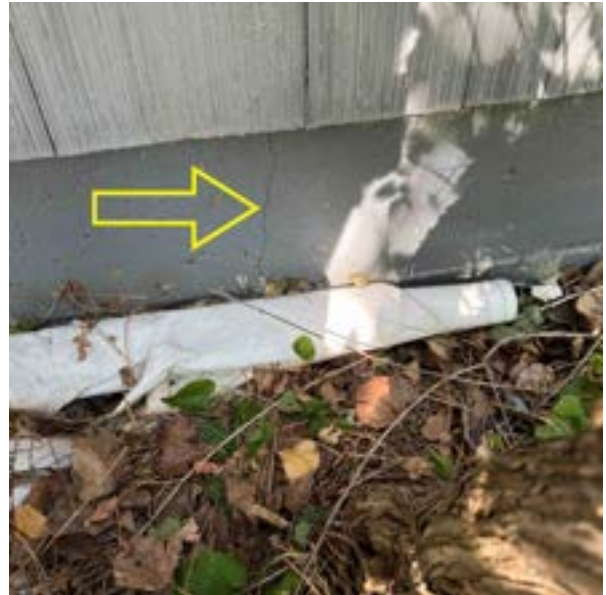
7.2.1 Consult a qualified contractor to evaluate foundation cracks and repair as recommended.

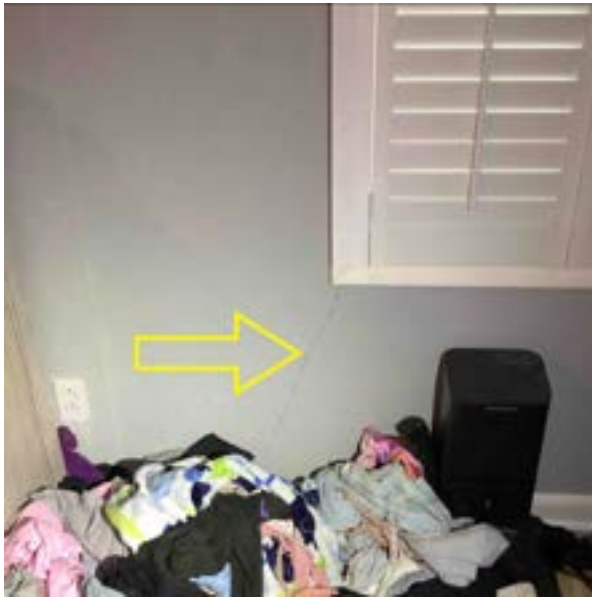
7.5.1 Consult contractor to evaluate wall crack and repair as required to prevent further damage. **(Northwest Bedroom)**

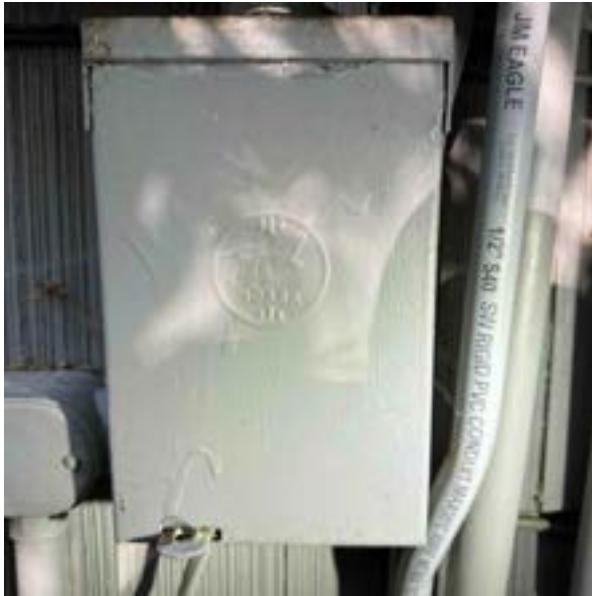
8.5.3 Consult a qualified electrician to evaluate Federal Pacific breaker panel and repair/replace as recommended. **(Exterior East)**

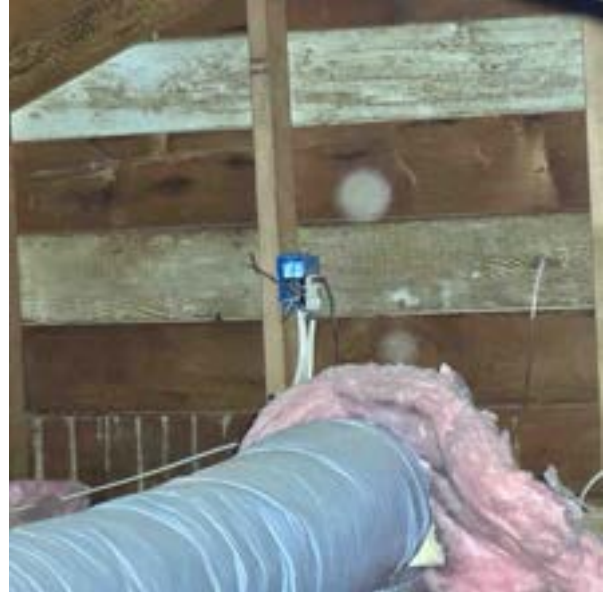
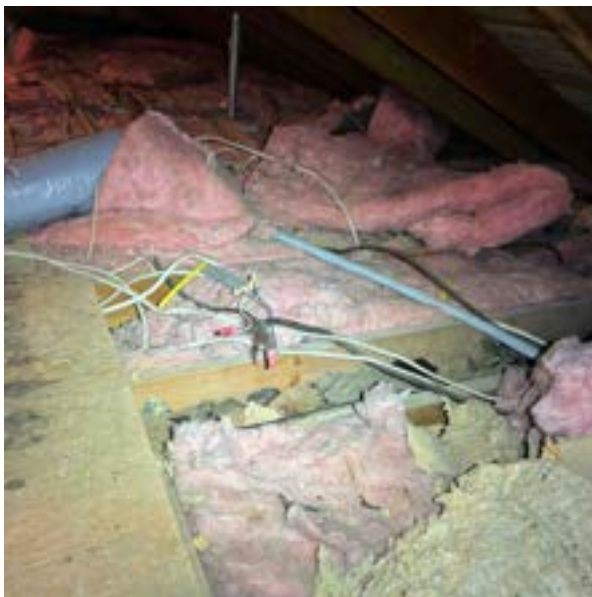
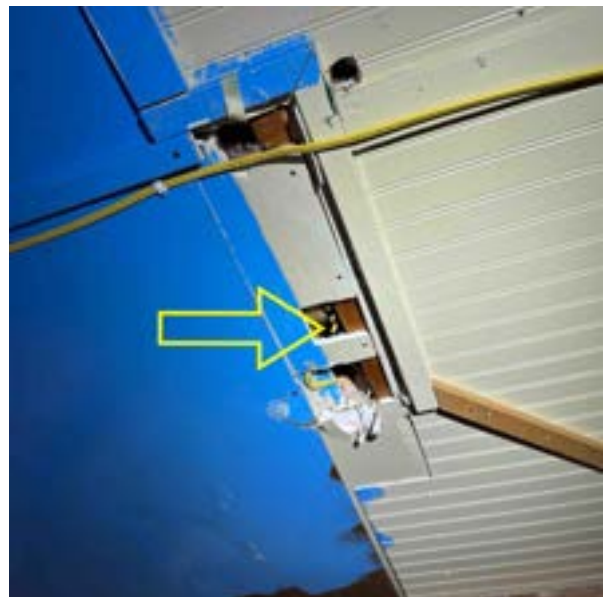
8.7.1 Provide junction box with cover at exposed wiring to prevent electrical hazards.

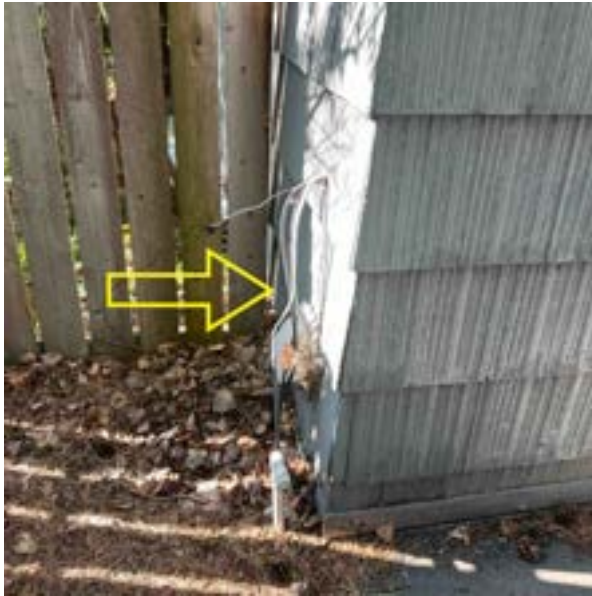
8.7.2 All unprotected exterior wiring should be placed in proper conduit to prevent possible wire damage and associated electrical safety concerns. **(Exterior East)**

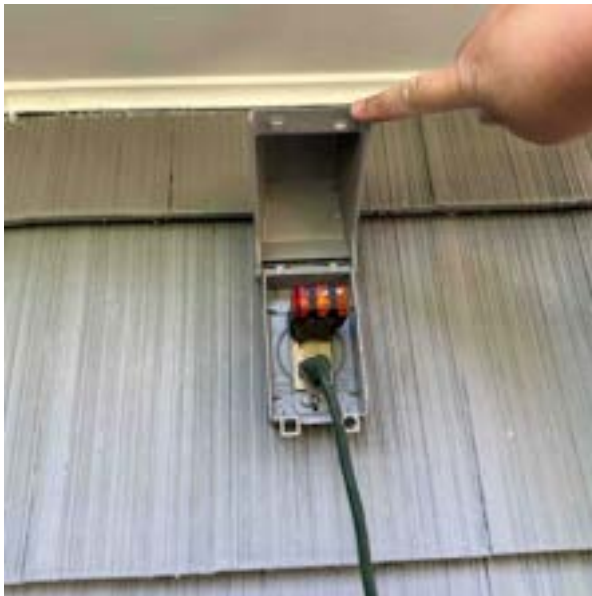
8.8.2 Repair hot/neutral reverse outlet to prevent electrical hazard. **(Exterior North)**

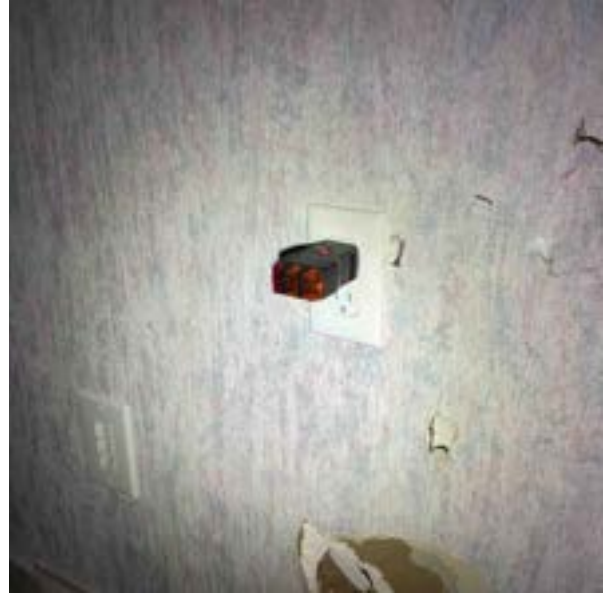
8.8.3 Further investigate cause of inoperable outlets and repair as required.

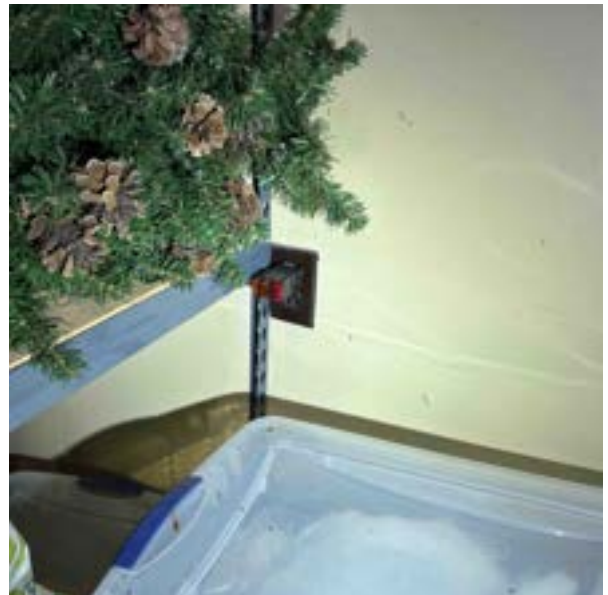
8.8.4 Further investigate cause of inoperable outlets throughout garage and repair as required. **(Garage)**

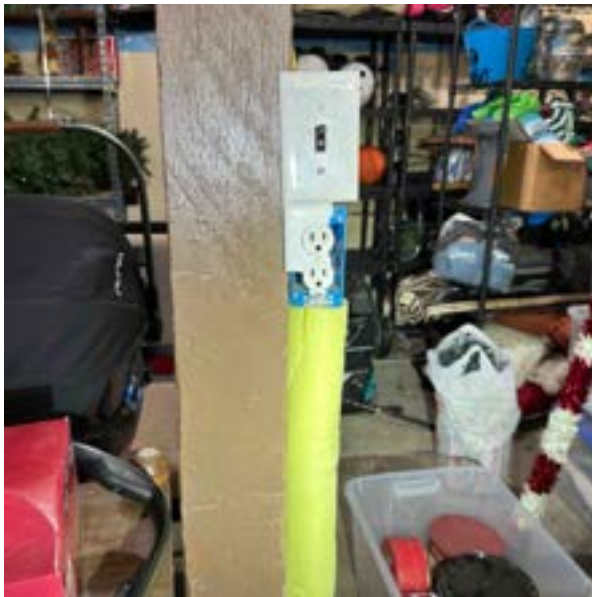
8.8.5 Replace missing switch plate/junction box cover to prevent electrical hazards. **(Garage)**

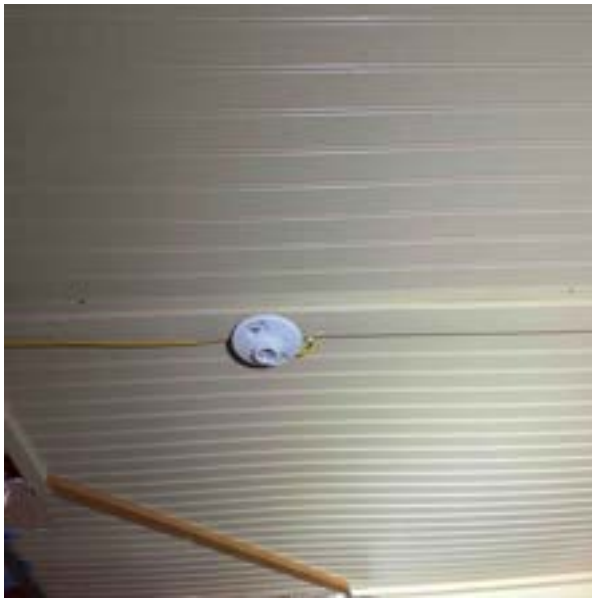
8.9.2 Further evaluate light fixture when bulbs are installed. **(Garage)**

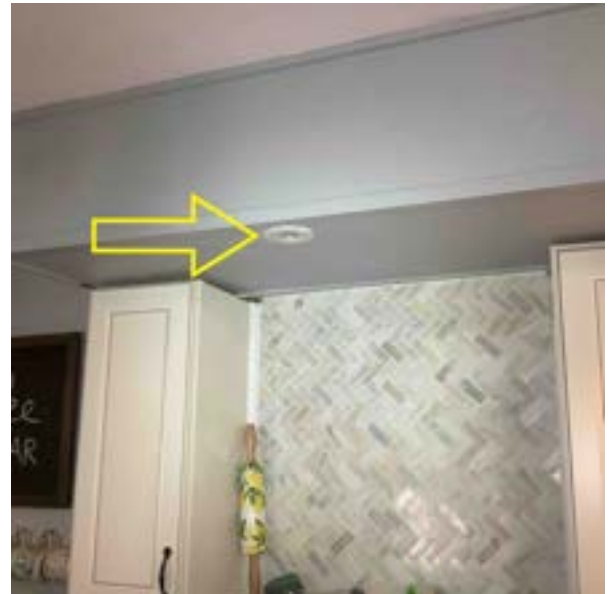
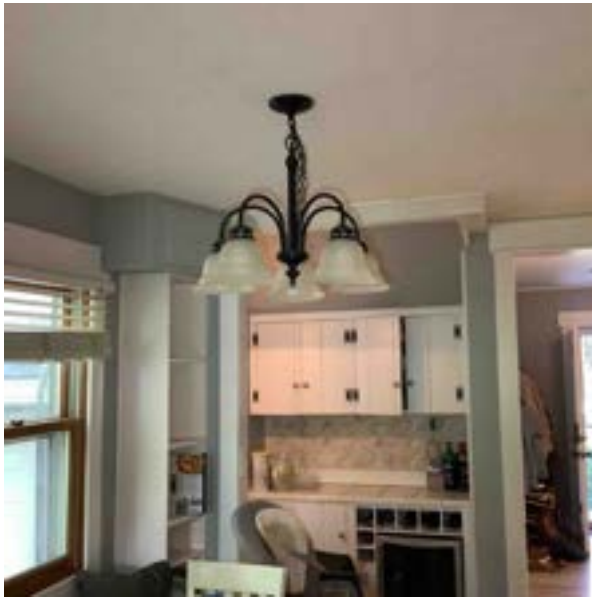
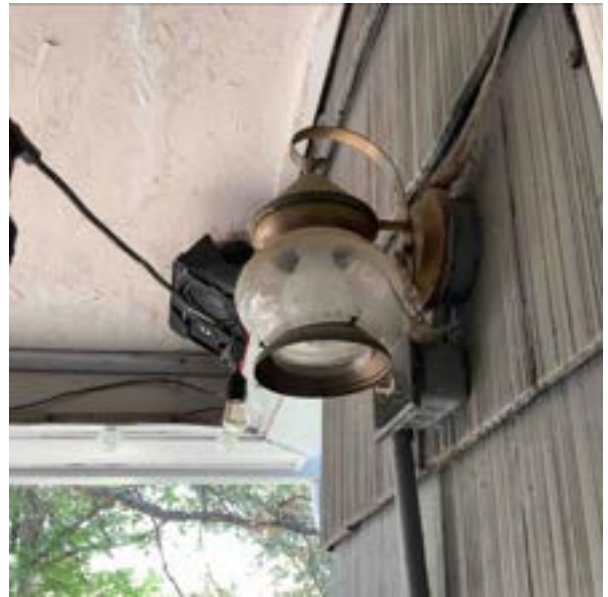
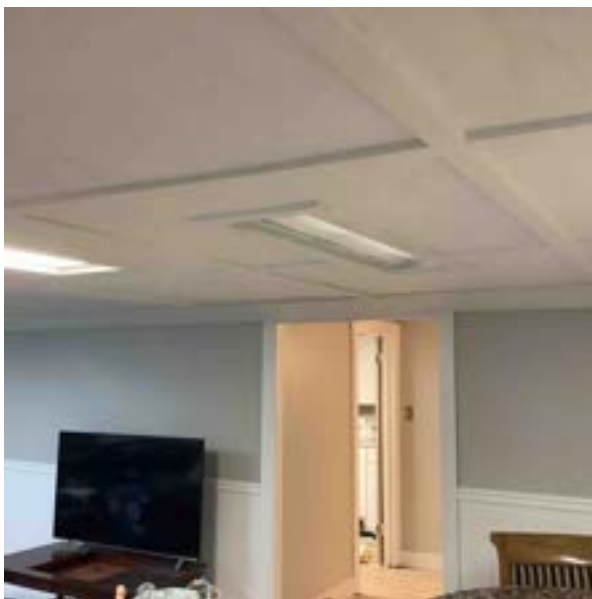
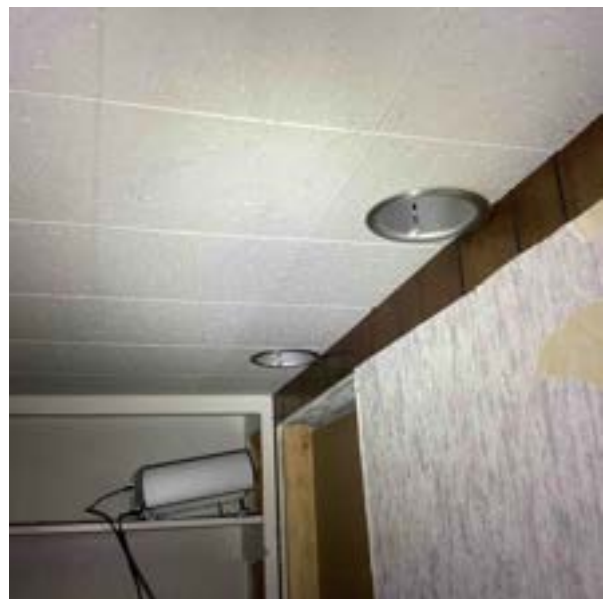
8.9.3 Determine cause of inoperable light fixtures and repair as required. Replace bulb prior to further investigation.

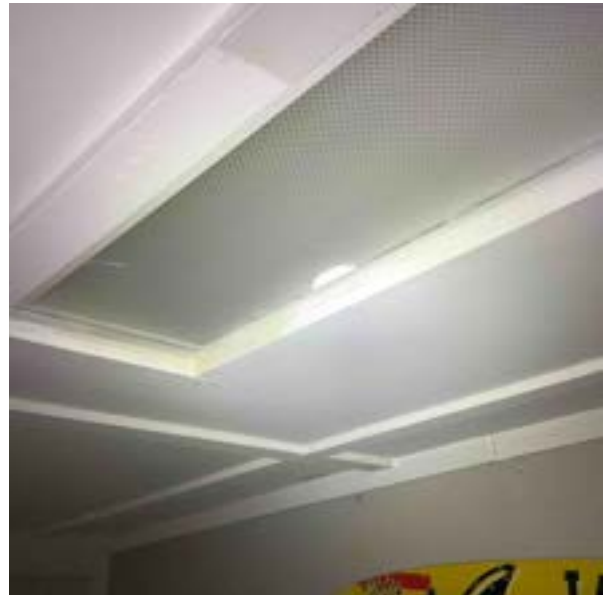
8.9.4 Replace missing/damaged light globe covers to prevent electrical hazards. **(Basement Living Room)**

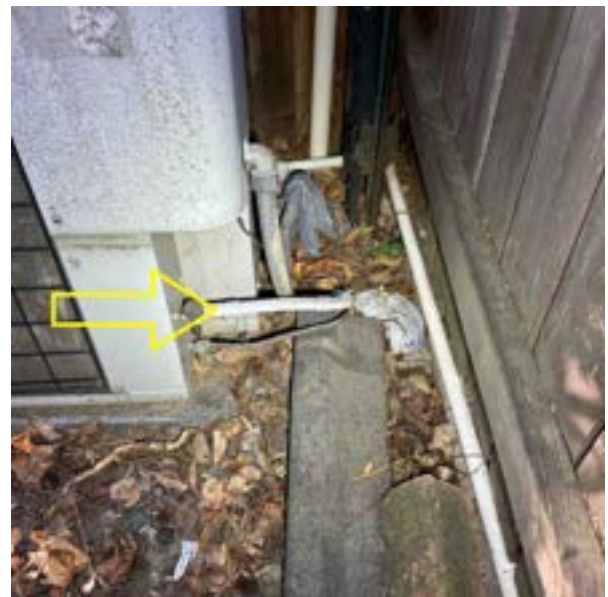
9.4.4 Replace missing refrigerant line insulation to prevent condensation related damages and promote efficient operation.

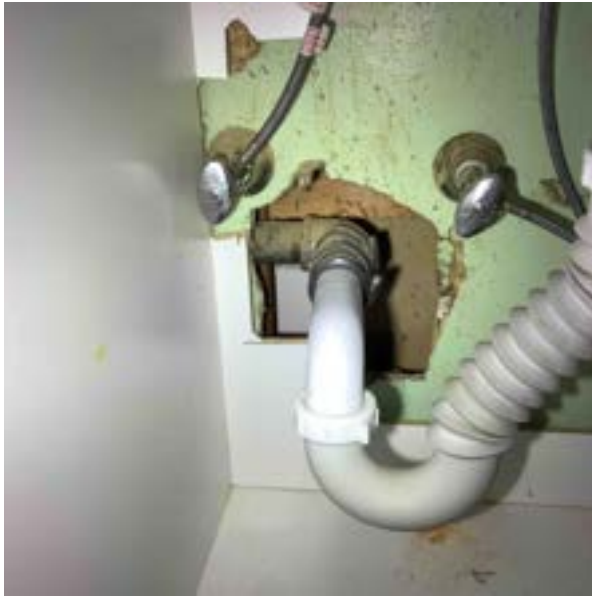
10.3.5 Budget to replace galvanized pipe. Galvanized plumbing is corrosive by nature. Monitor for decreased water flow indicating initial signs of failure. **(1st Floor Hall Bathroom)**

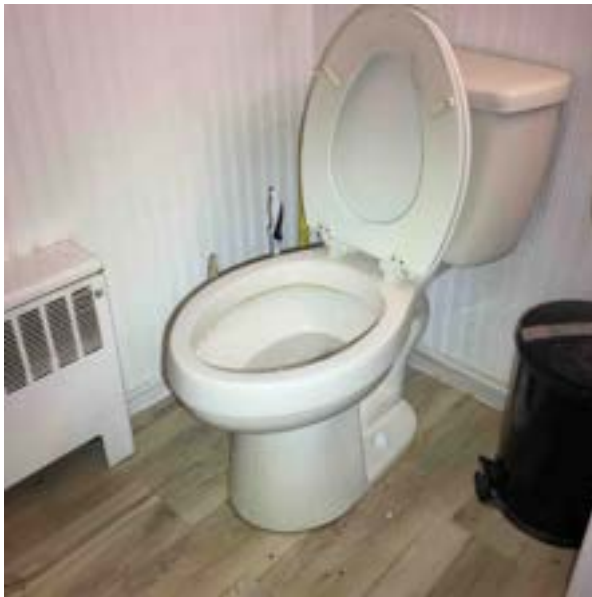
10.9.2 Secure bathroom stool to reduce secondary water damages. (1st Floor Hall Bathroom)

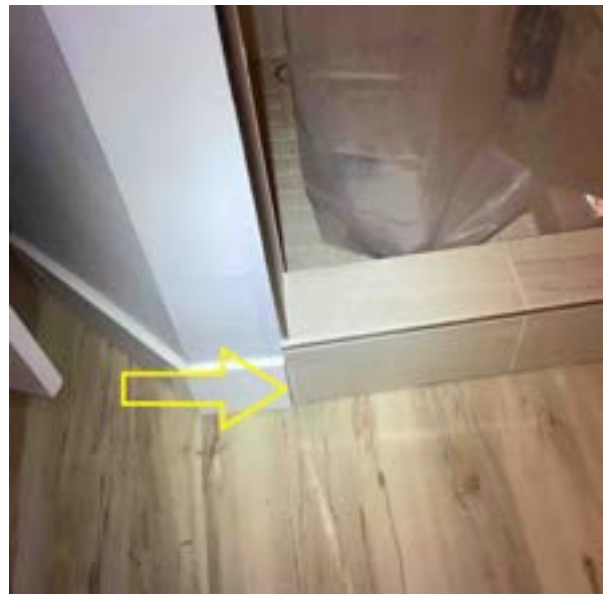
10.10.4 Seal all cracks/gaps/joints in and around tubs and showers to reduce water penetration and subsequent deterioration.

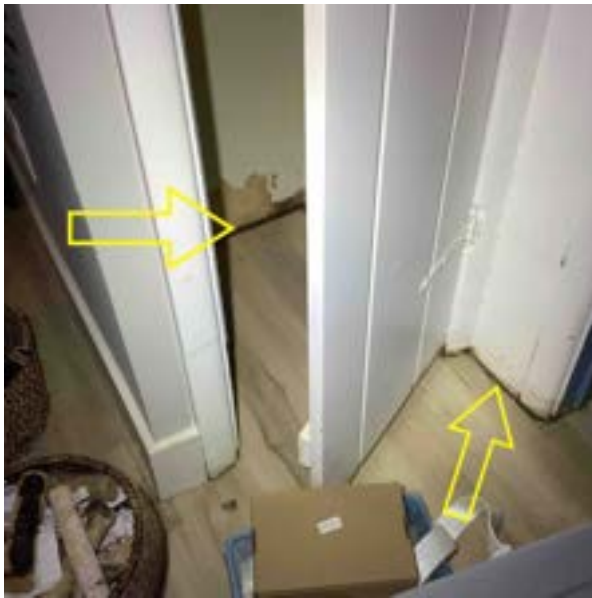
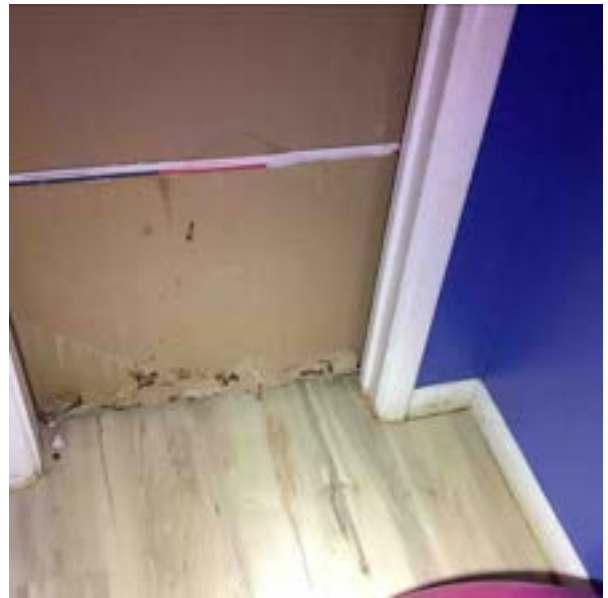
11.2.4 Further investigate cause and extent of staining/damage and correct as required. No moisture detected at time of inspection. **(Basement Southwest Room)**

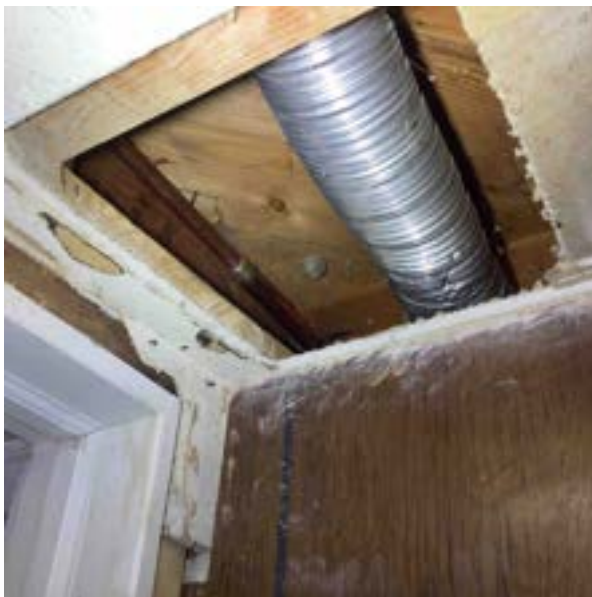
11.2.5 Further investigate source of exports entry and seal as required to promote safety and prevent damage. Clear wasp nesting to promote safety. **(Basement Living Room)**

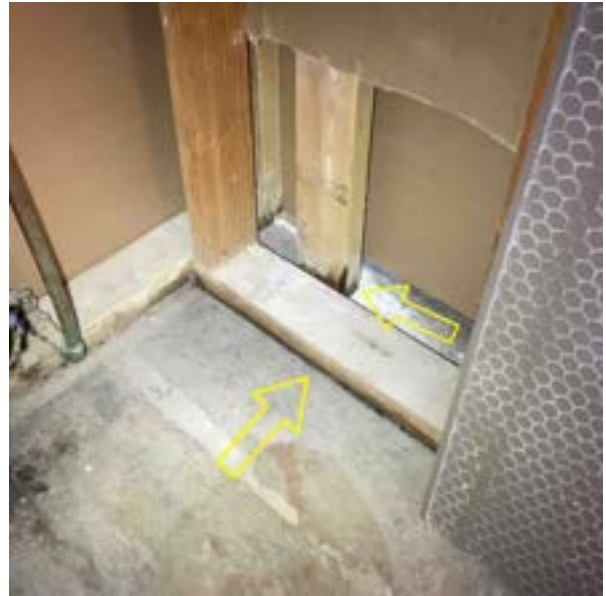
11.2.8 Further investigate cause and extent of staining/damages and suspected mold growth and correct as required. No moisture detected at time of inspection. **(Utility Area)**

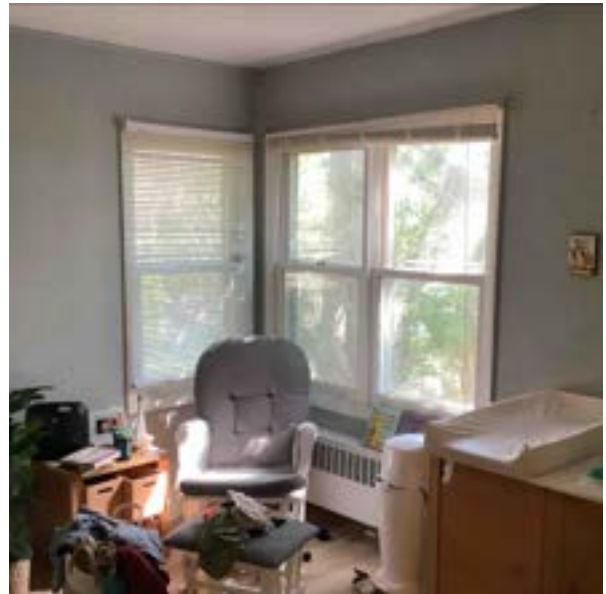
11.3.4 Repair/adjust window trim to reduce window binding and regain intended operation.

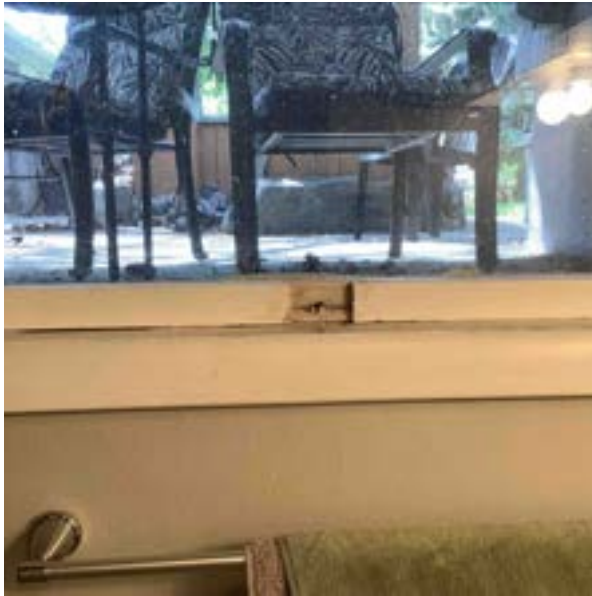
11.3.5 Repair damaged/missing window latch to promote intended operation and prevent further damages.  
**(Basement Bathroom)**

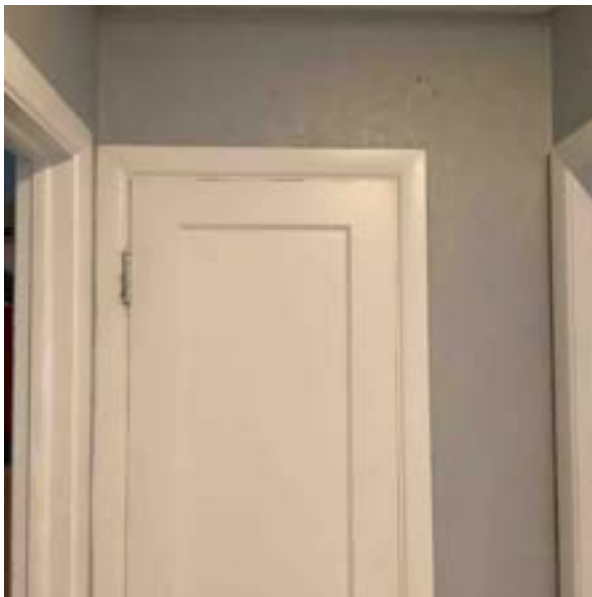
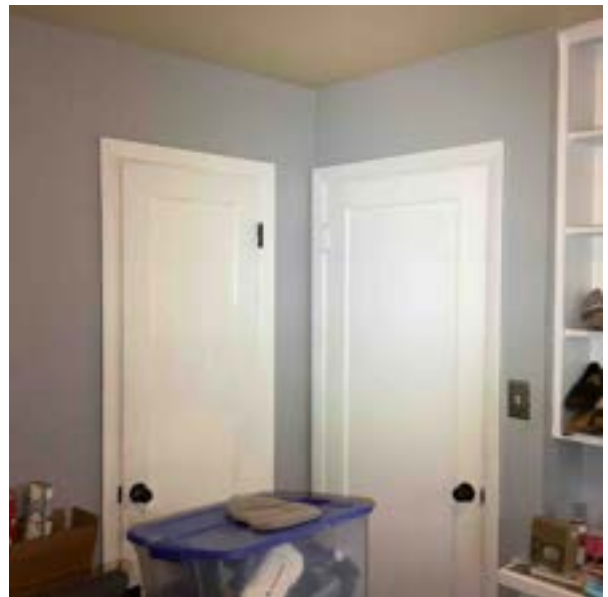
11.4.4 Adjust door to reduce binding and latch securely.
