## Home Inspection Report

**1718 Iris Lane  
Billings, MT 59102**

**Date of Inspection: 08/16/2024**

Inspection No. 45957-1-1121

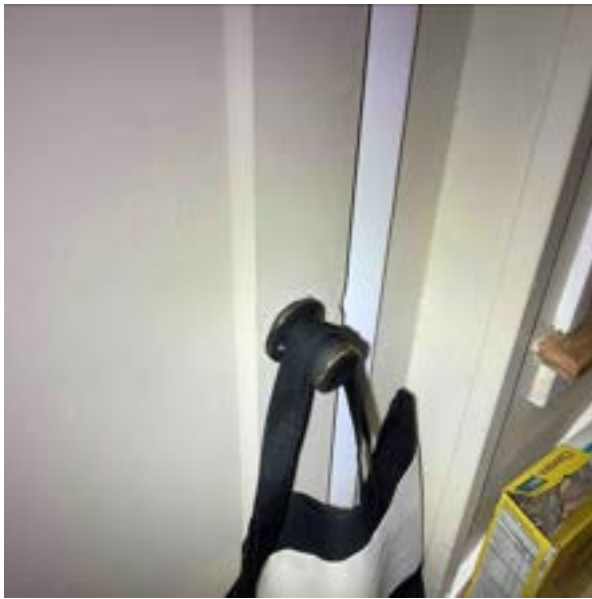
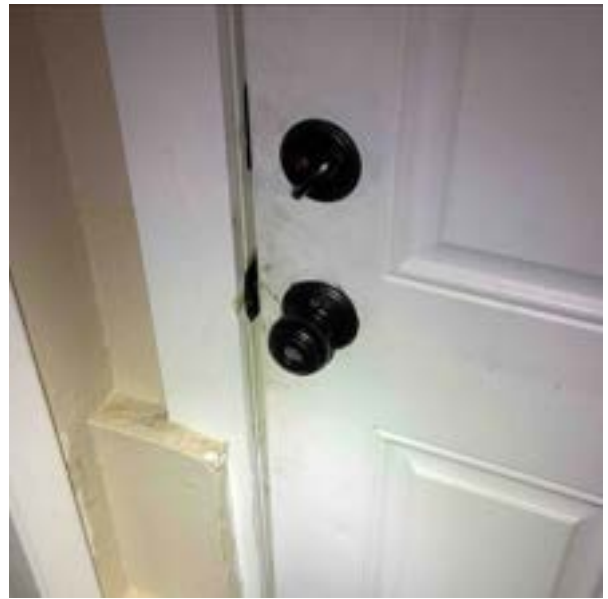
11.4.5 Secure loose door hardware to promote intended operation. **(Stairway)**

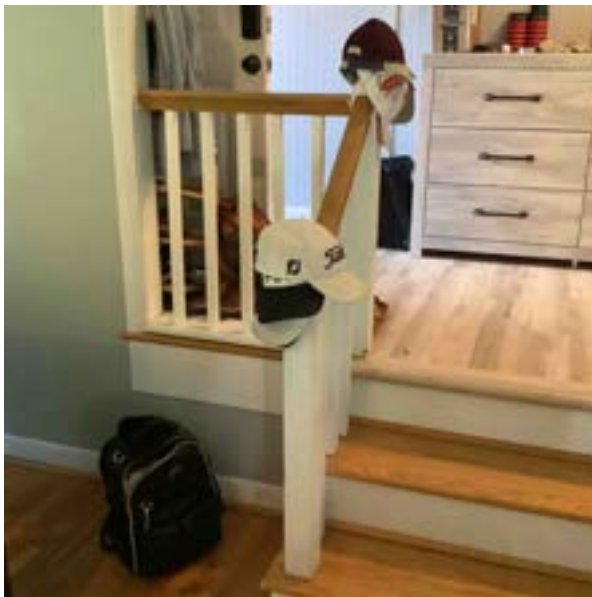
11.6.2 Secure loose railing to promote safety. **(Living Room)**

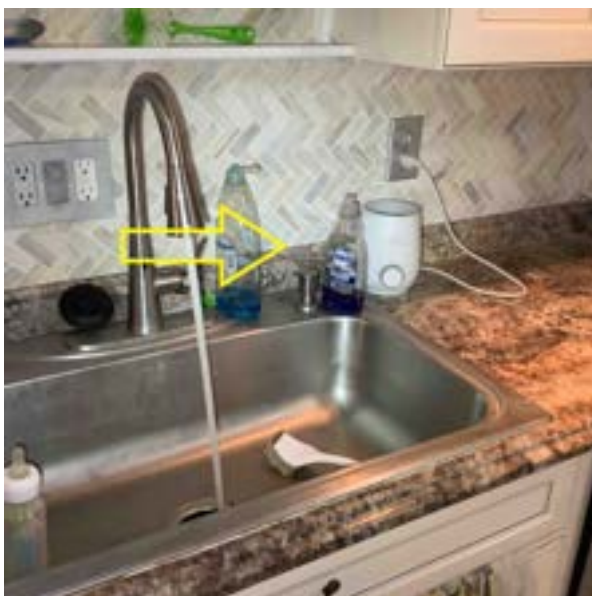
11.7.5 Recaulk counters to prevent moisture intrusion and subsequent damages.
