Inspection Report

Property Address:
1840 Ty Lane
Minden NV 88423

Clear Choice Home Inspection Services

Date: 5/17/2024	Time: 08:00 AM	Report ID: HER184
Property: 1840 Ty Lane Minden NV 88423	Customer: Herbert Mitchell Megan Horan	Real Estate Professional: Thomas Vander Laan Coldwell Banker

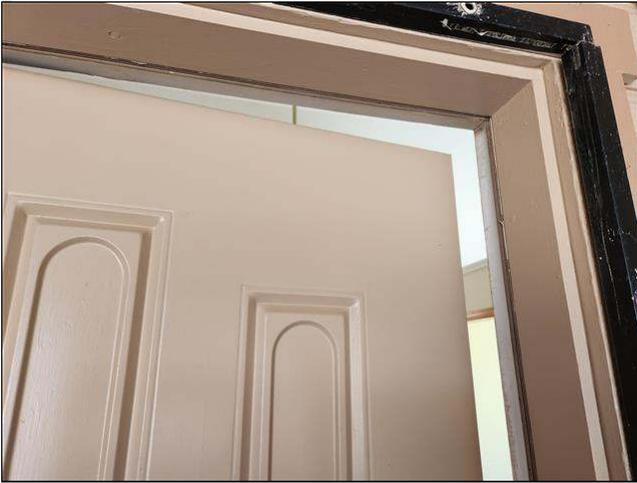
(1) The front entry door sags at hinges, and rubs at jamb when closing. This is a maintenance issue and is for your information. A qualified person should repair as needed.

1.3 Item 1(Picture) main entry door sags

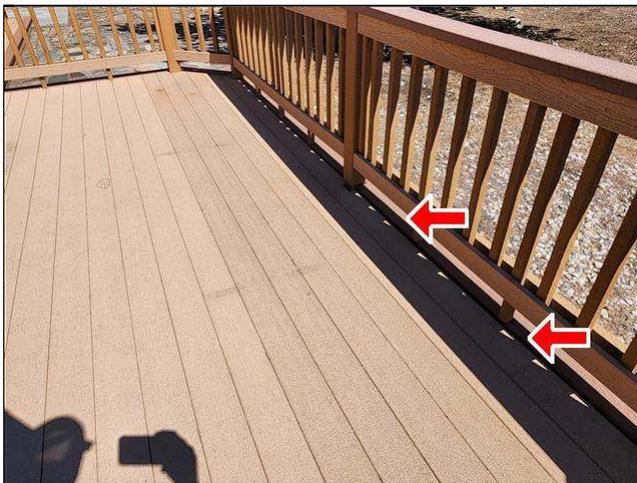
(2) Outer deck framing at rear deck rim joist area, shows settlement and separation. Recommend further evaluation by a qualified person as needed.

1.6 Item 2(Picture) rear deck

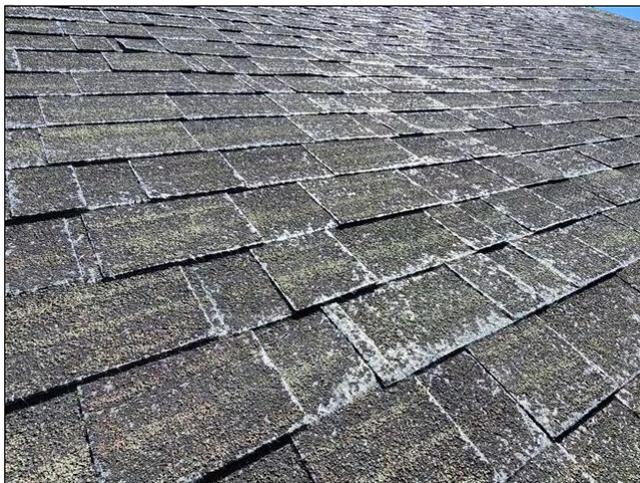
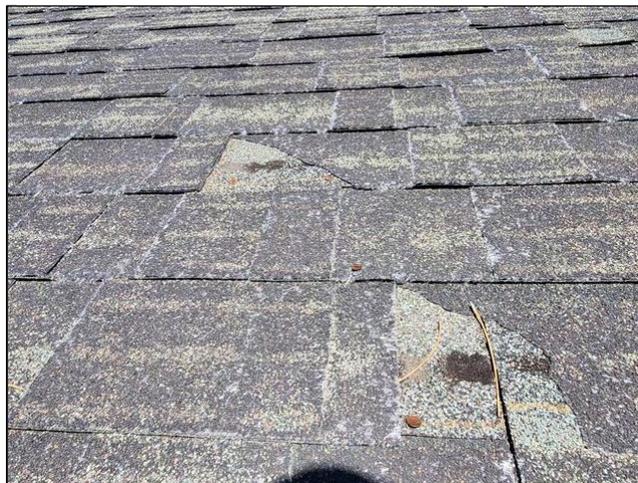
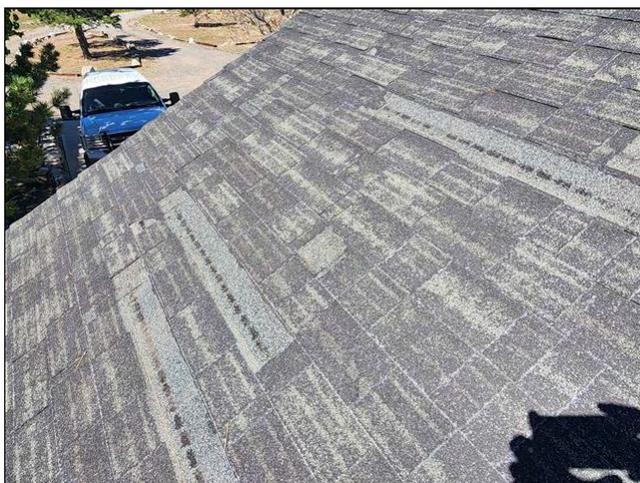
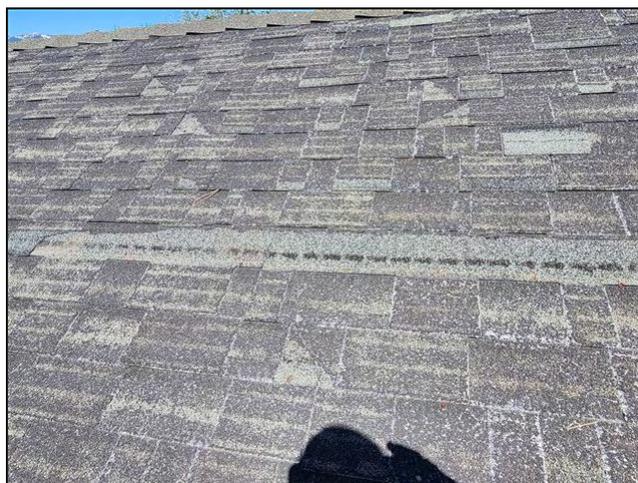
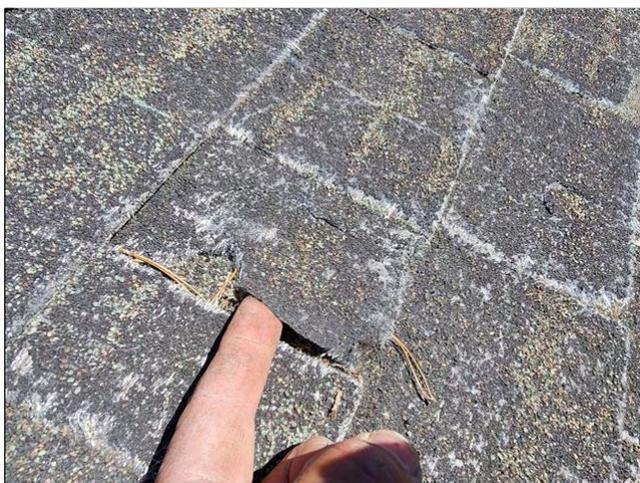
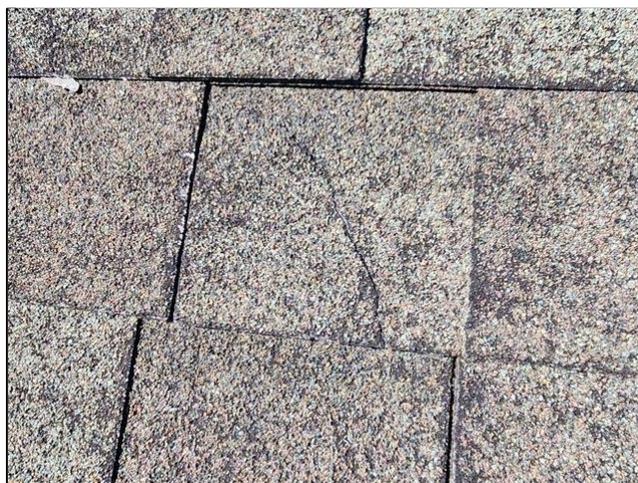
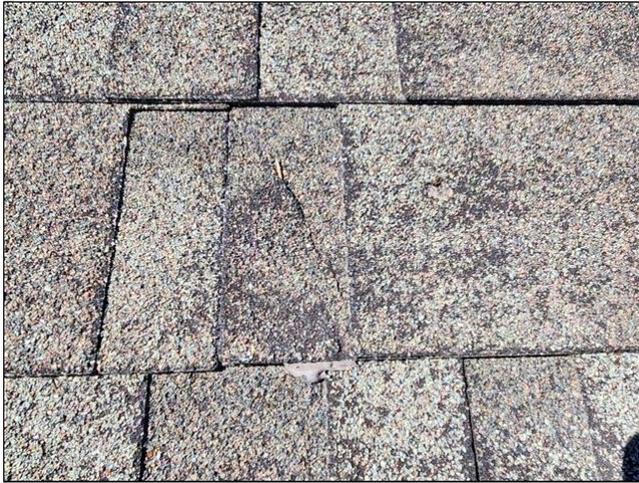
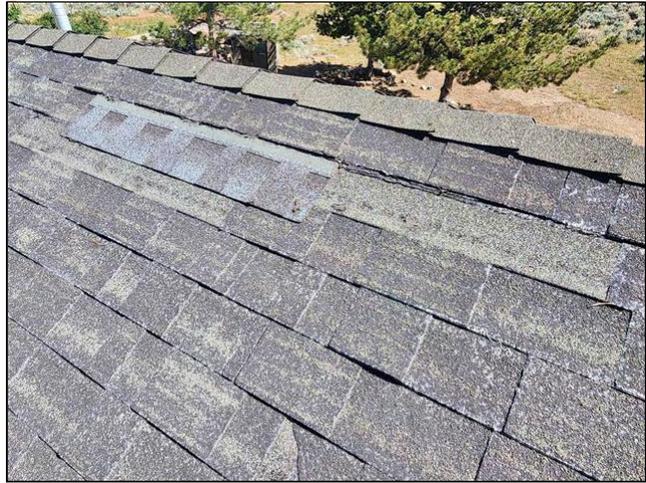
The roof covering appears to be original (31 years) and is a 30 year architectural, asphalt/fiberglass Composition shingle that appears to be at the end of its useful life. Typical loss of granules noted from North slope shingles, however is more advanced at the South slope of roof. Recommend further evaluation of roof covering materials by a licensed Roofing Contractor.

2.1 Item 1(Picture) granule loss at shingles

2.1 Item 2(Picture) condition of shingles

2.1 Item 3(Picture) wind damaged shingles

2.1 Item 4(Picture) wind damaged shingles

2.1 Item 5(Picture) condition of shingles

2.1 Item 6(Picture) condition of shingles

2.1 Item 7(Picture) condition of shingles

2.1 Item 8(Picture) condition of shingles

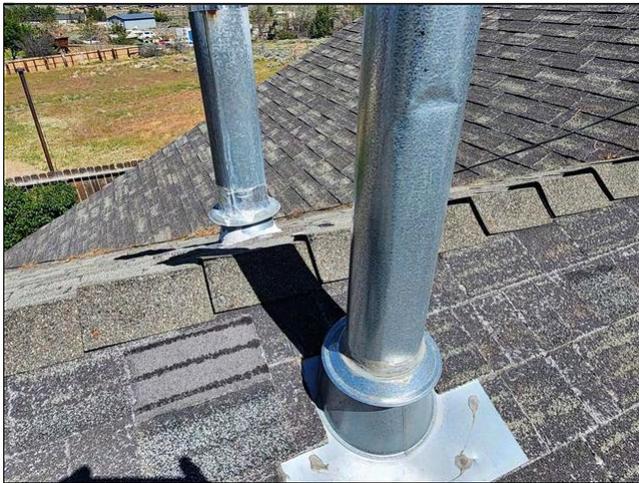
(1) Furnace vent pipes are sealed well against flashings to prevent moisture intrusion into attic framing areas.

2.3 Item 1(Picture) flue pipes sealed well

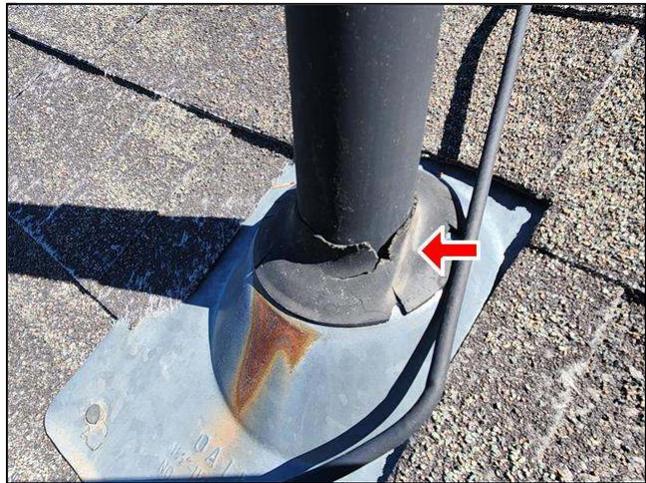
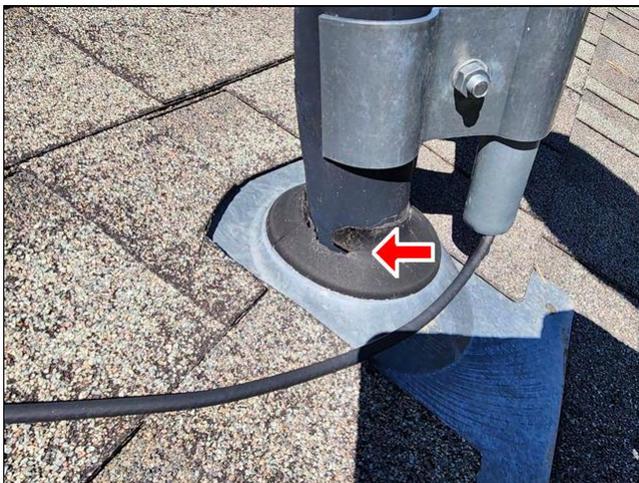
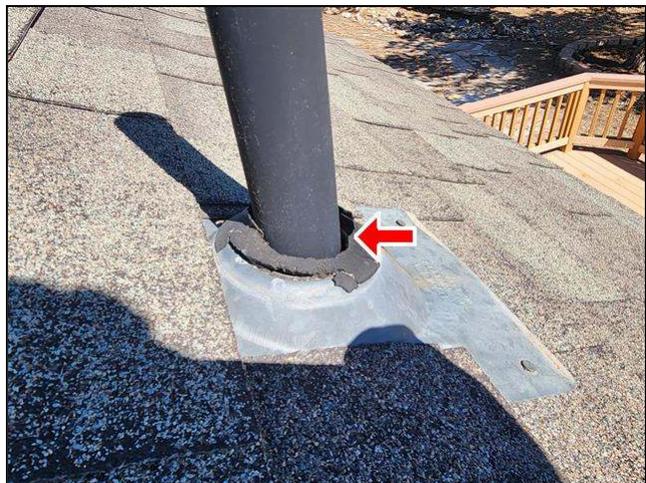
2.3 Item 2(Picture) deteriorated boot seal

2.3 Item 3(Picture) deteriorated boot seals

2.3 Item 4(Picture) deteriorated boot seal

(2) There are a few plumbing vent pipe roof penetrations with failing/deteriorated rubber boots. Recommend replacement of boot seals to prevent moisture intrusion to roof framing areas. NOTE: Leaking moisture around these vent pipes is causing moisture staining at the underside of the roof sheathing plywood.

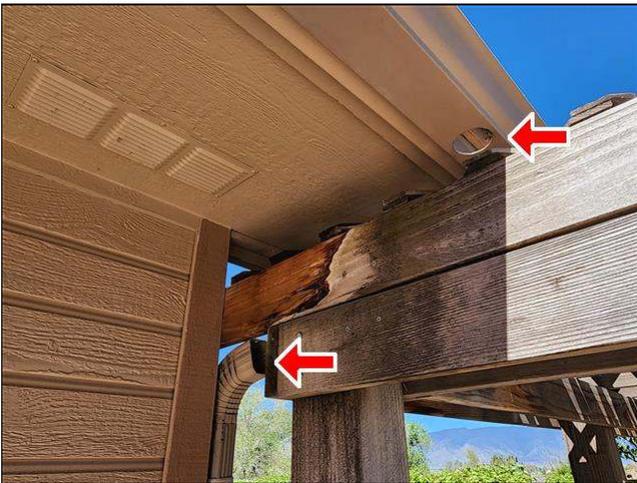
(2) Northwest corner gutter downspout is not connected to the gutter. Recommend repair by a qualified person.

2.4 Item 1(Picture) downspout not connected to gutter

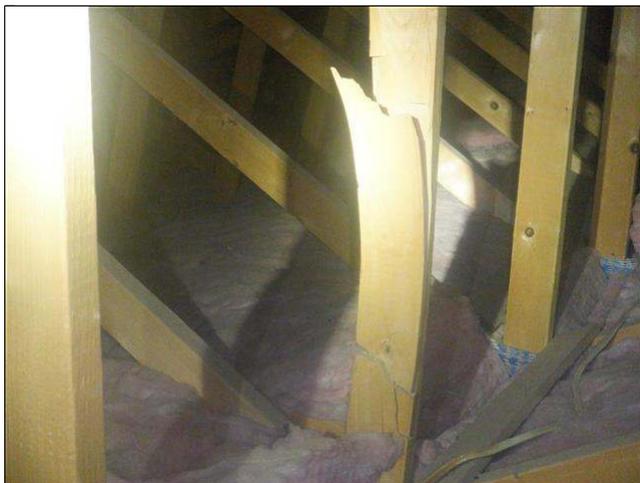
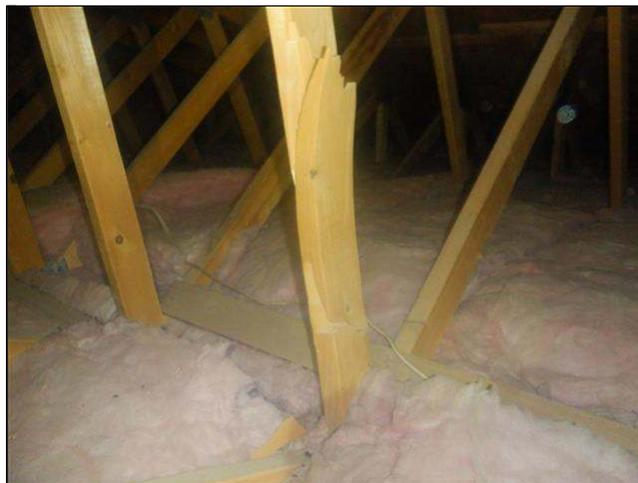
(1) NOTE: Broken roof truss vertical web support noted at the center of attic area, and should be repaired by a qualified person.

3.9 Item 1(Picture) broken truss web support

3.9 Item 2(Picture) broken truss web support

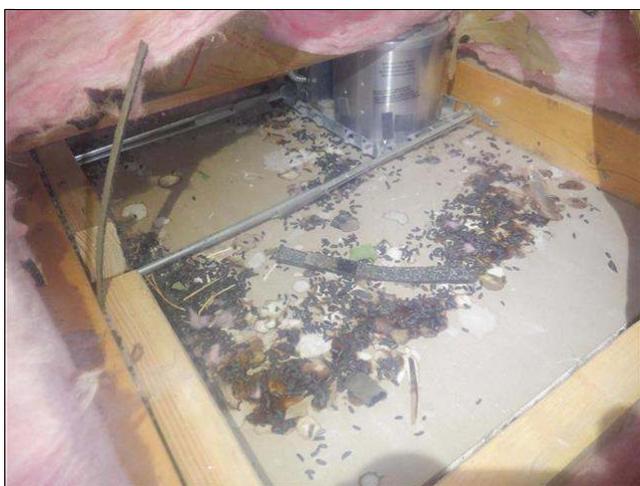
(2) NOTE: Moderate rodent activity noted in the attic area, however I am unable to determine if this is recent.

3.9 Item 3(Picture) past rodent activity in attic

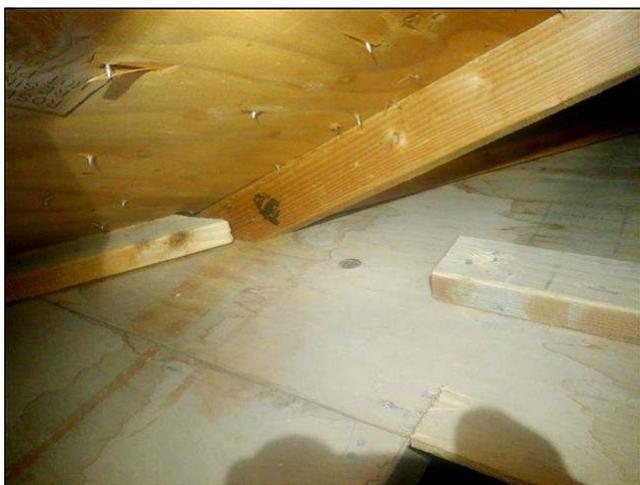
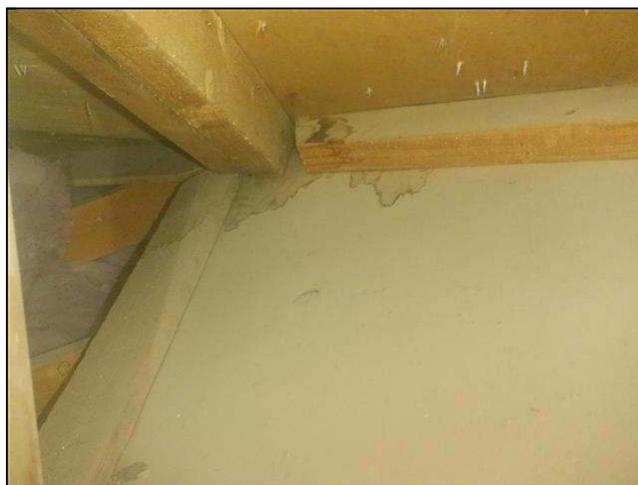
(3) NOTE: Moisture stains noted on roof framing materials at the connection of garage/house roof area. Due to the lack of rain, I am unable to determine if these are from active leaks, or past issues.

3.9 Item 4(Picture) moisture stains in attic

3.9 Item 5(Picture) moisture stains in attic

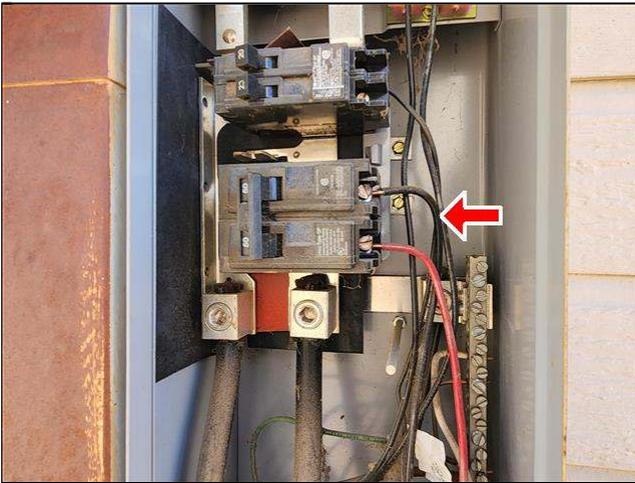
- 📍 (2) Double Pole 50 amp circuit breaker has been installed in the Main Panel, supplying current through 30 amp rated wire. This breaker does not afford overload protection for this wire and circuit. Recommend repair by a licensed electrician.

4.4 Item 1(Picture) 50 amp breaker, 30 amp wire

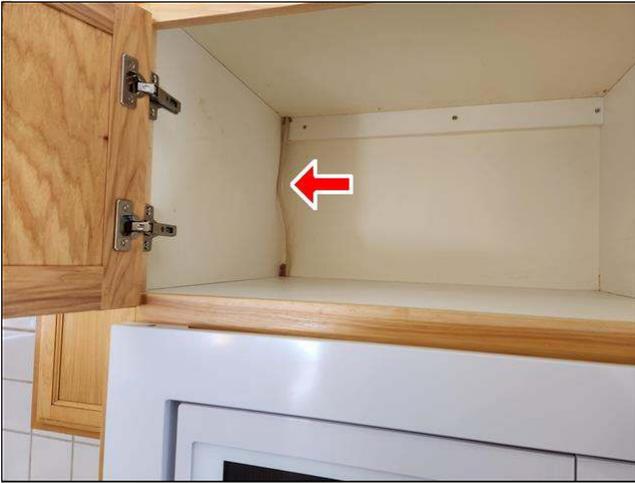
- 📍 (1) Exposed electrical wire noted in the following locations: Inside upper kitchen cabinet over microwave. Electrical wiring below 7 feet high, or inside cabinets, should be covered for protection of wiring damage, and also for personal protection. Recommend repairs by a qualified person.

4.5 Item 1(Picture) exposed wire above microwave

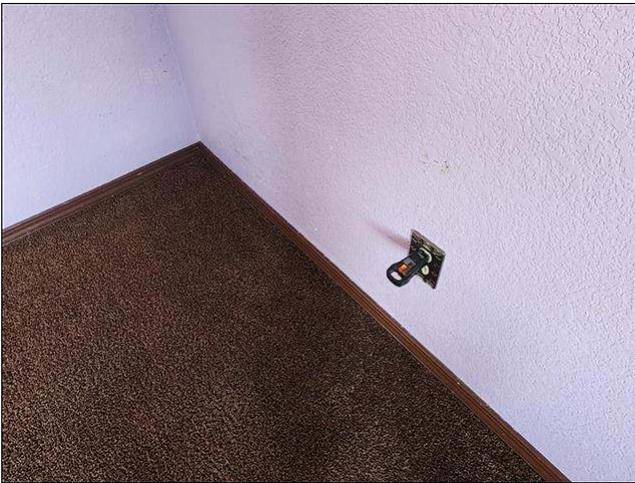
- 🏠 (2) Open grounded receptacle noted at the South wall of SW guest bedroom, which does not afford electrical circuit ground protection. Recommend further evaluation/repair by a licensed Electrician.

4.5 Item 2(Picture) southwest guest bedroom

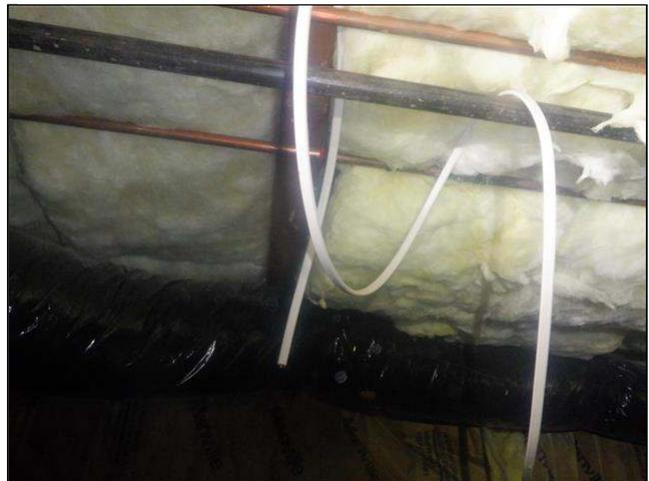
4.5 Item 4(Picture) loose wire end under kitchen

- 🏠 (4) Loose wire end needs placing inside a box with a cover-plate in the crawlspace area under the kitchen. A qualified licensed electrician should perform repairs that involve wiring.

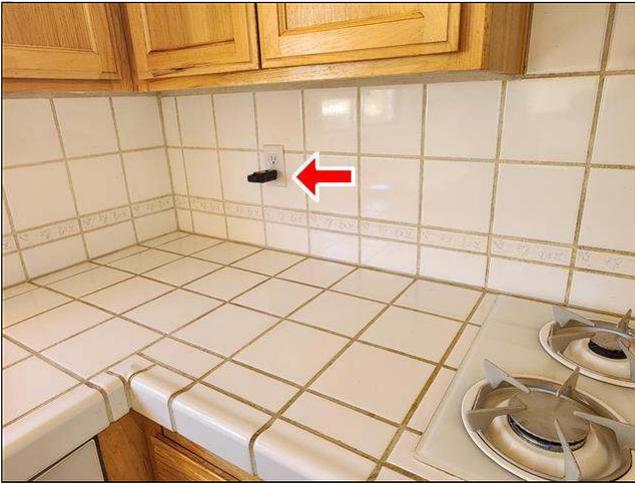
(5) Non-operational receptacle noted at the Kitchen East wall. Recommend further evaluation/repair by a licensed Electrician.

4.5 Item 5(Picture) non-operational outlet at kitchen

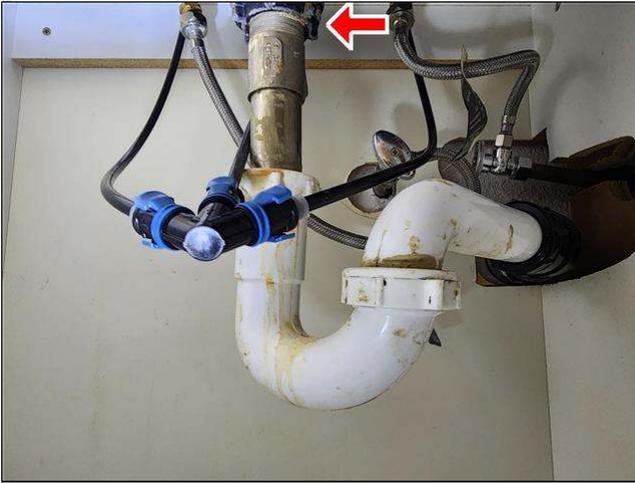
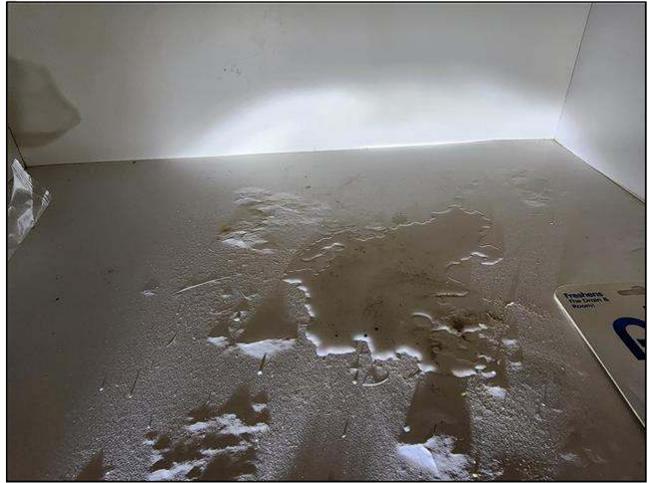
- 🏠 Sink drain is leaking at the Guest Bathroom sink, Appears to be from the drain connection. Recommend repair to prevent moisture damage to sink cabinet.

5.3 Item 1(Picture) leaking sink drain at guest bathroom

5.3 Item 2(Picture) moisture from leak

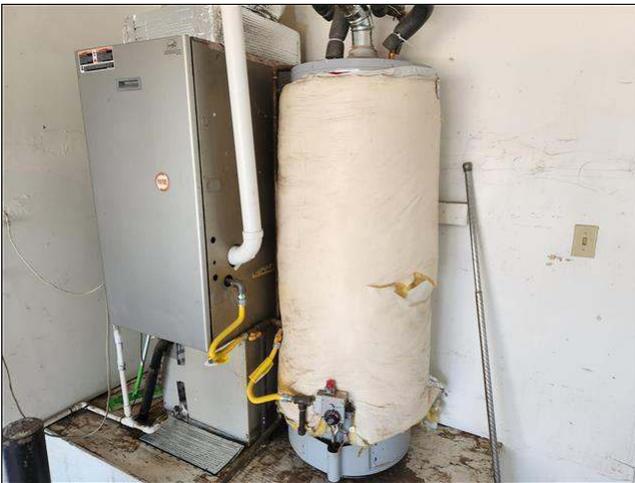
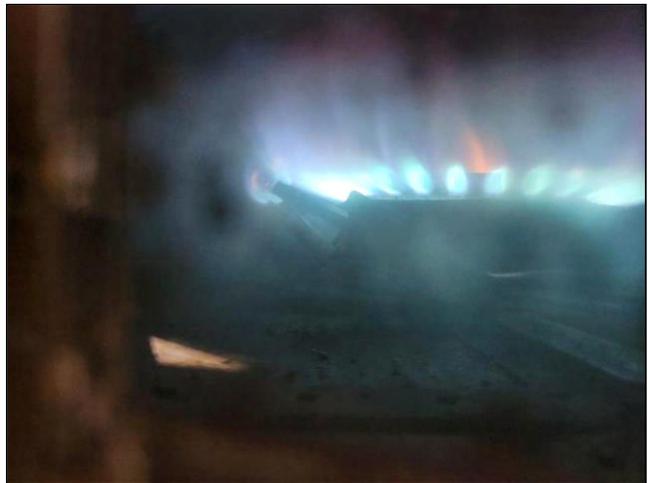
Temperature and Pressure Relief valve is piped to the exterior of the house, or within 6 inches of the floor (for safety). Water Heater is strapped with approved strapping material, and is setting on a pedestal minimum of 18" above the garage floor. Drip leg is installed in the gas line, water and fuel shut-off valves are present. Water heater operated as intended with no abnormal noises or leaks noted. No problems noted at time of inspection... Manufactured in 2009 by State Industries.

5.4 Item 1(Picture) water heater

5.4 Item 2(Picture) water heater burner compartment

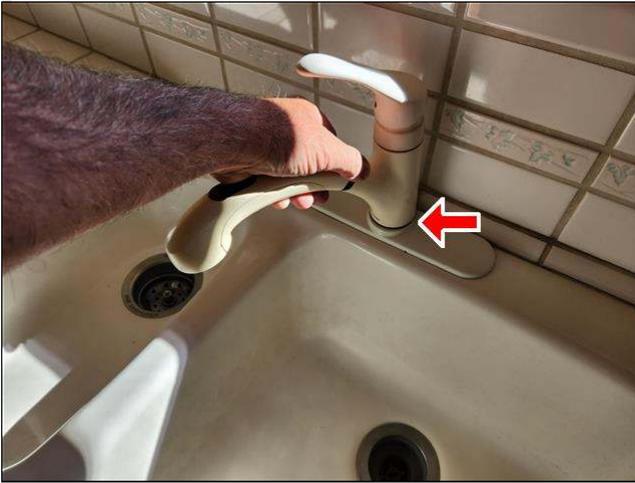
(1) Kitchen sink faucet swivel base is stiff, almost seized up, and needs repaired or replaced.

5.5 Item 1(Picture) kitchen sink faucet

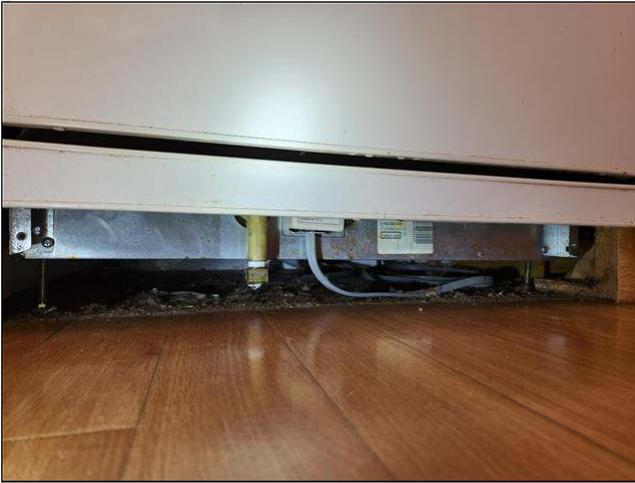
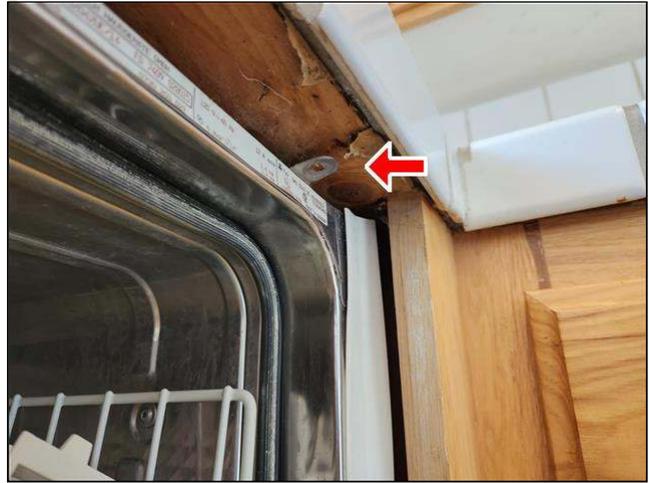
(1) The Dishwasher was run through a complete cycle, with no leaks or abnormal noises noted. Inspection cover was removed to view the Dishwasher electric/plumbing hook-ups, Door seals and dish racks appear in serviceable condition. NOT mounted securely to under countertop. Drain hose is routed to a high loop prior to connecting to drain, as required to prevent backflow/siphon of waste into dishwasher.

6.1 Item 1(Picture) dishwasher hook-ups

6.1 Item 2(Picture) loose upper mount

(2) The dishwasher is loose and needs securing to underside of countertop (using a proper length screw). I recommend repair as necessary.

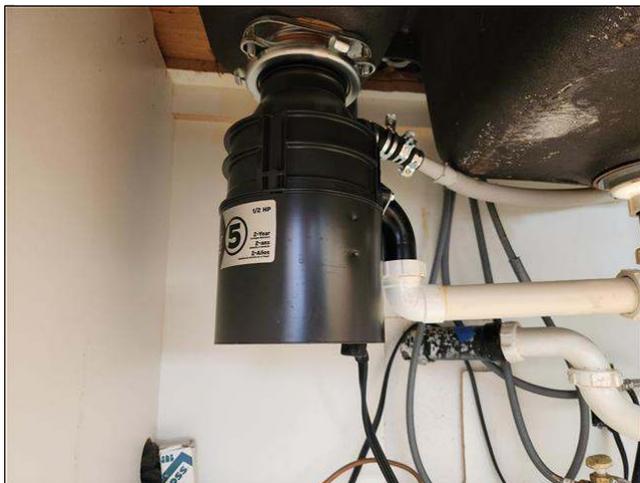
Disposer circuit breaker was "tripped" upon arrival to home. After resetting the circuit breaker, the disposer motor was noted to be "froze-up".

6.5 Item 1(Picture) disposer was non-operational

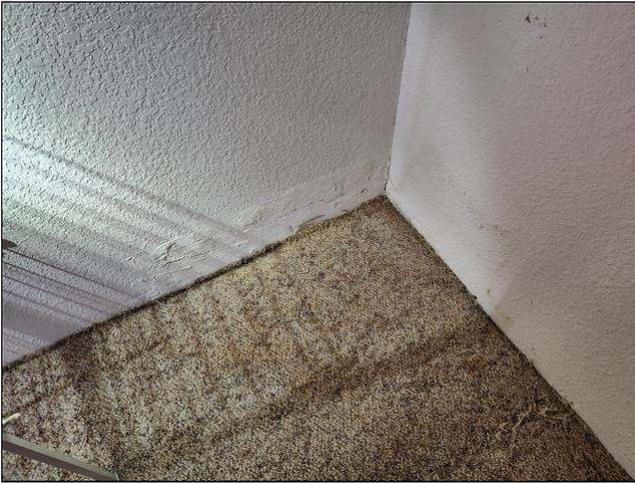
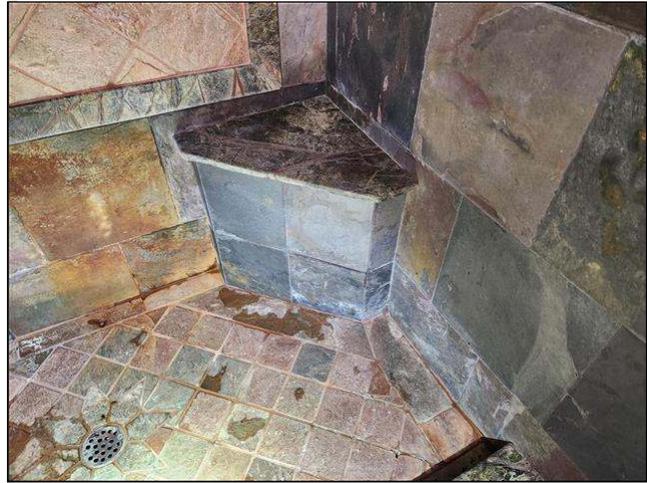
(1) Signs of past moisture noted at the master bedroom closet wall, and appears was caused from the master shower leaking in the past. No problems noted with the current shower enclosure, however should be well maintained at corners with silicone caulking to prevent possible future leaks.

7.2 Item 1(Picture) past moisture damage at drywall

7.2 Item 2(Picture) master shower enclosure

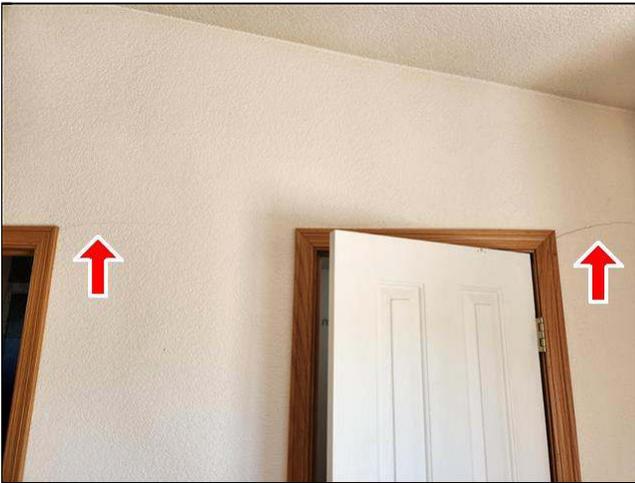
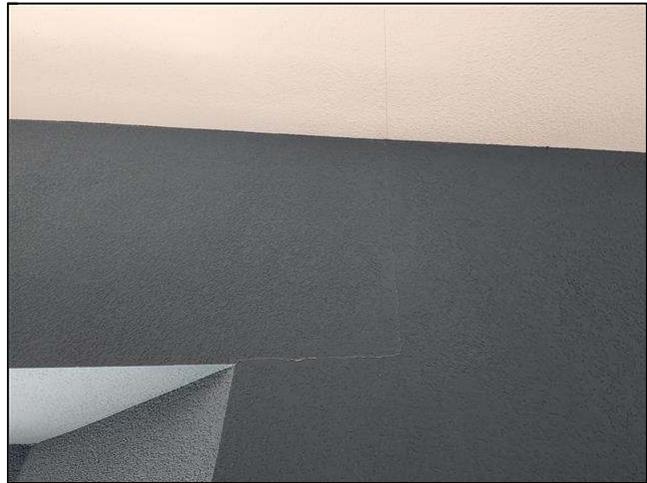
(2) Cracks at interior drywall noted at master bedroom, and living room areas that appear to be caused from normal settling. Foundation was inspected under settled areas, with no problems or settlement cracks noted. Walls appear, and feel solid. Recommend further "invasive" evaluation of wall structure by a qualified contractor as desired.

7.2 Item 3(Picture) settlement cracks at master bedroom

7.2 Item 4(Picture) settlement cracks at living room

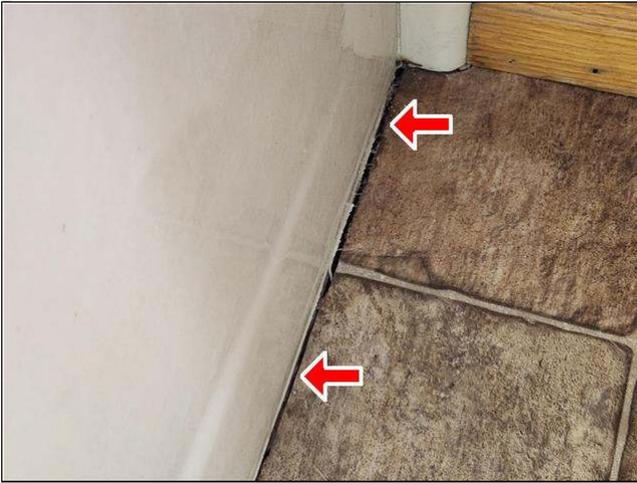
(1) Recommend silicone caulk maintenance along floor and tub at Guest Bath, to prevent moisture intrusion to floor framing materials.

7.3 Item 1(Picture) guest bathroom floor/tub

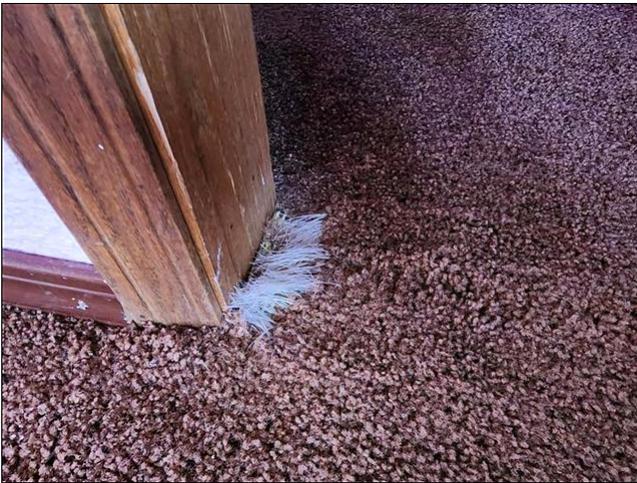
🏠 (2) There are a couple flaws in the carpet at the Southwest guest bedroom. Additional damaged carpet noted at the dining area floor (also stained).

7.3 Item 2(Picture) southwest guest bedroom carpet

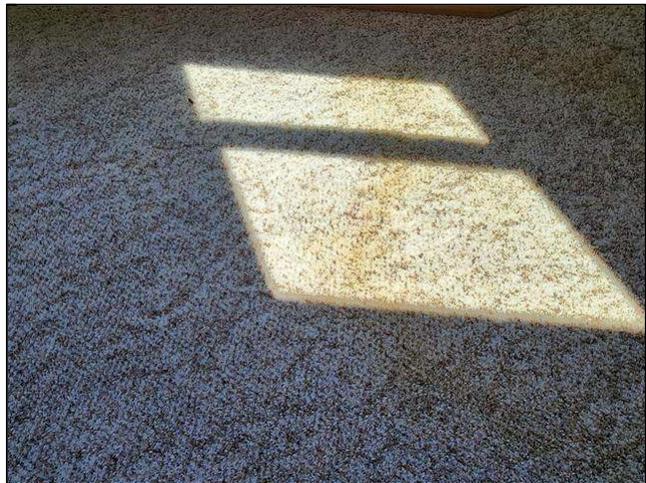
7.3 Item 5(Picture) stain at dining room

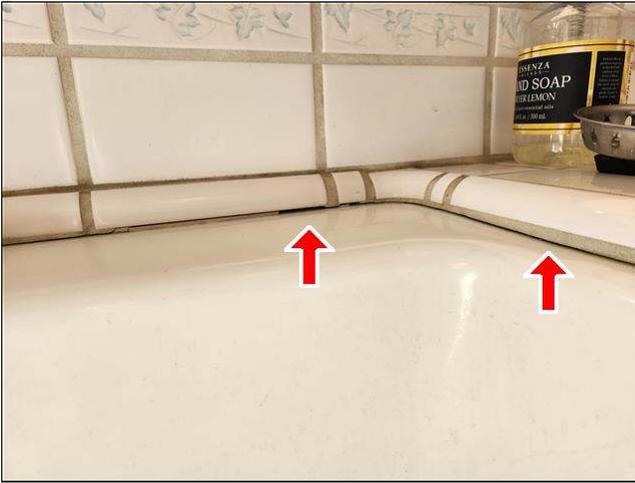
🏠 (1) Recommend caulking/grouting at kitchen sink-to-countertop.

7.4 Item 1(Picture) caulking maintenance at kitchen sink

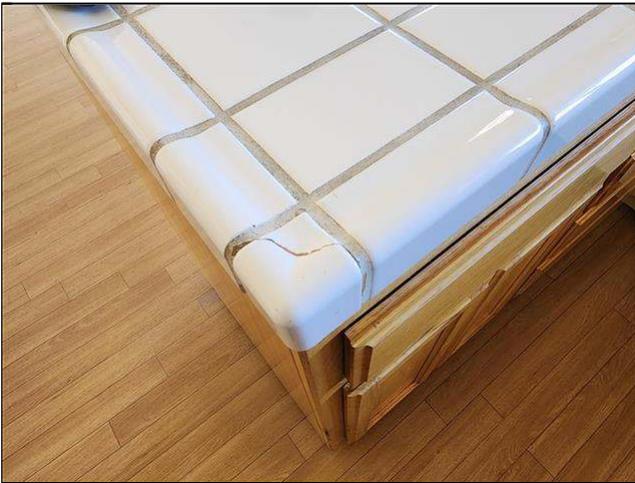
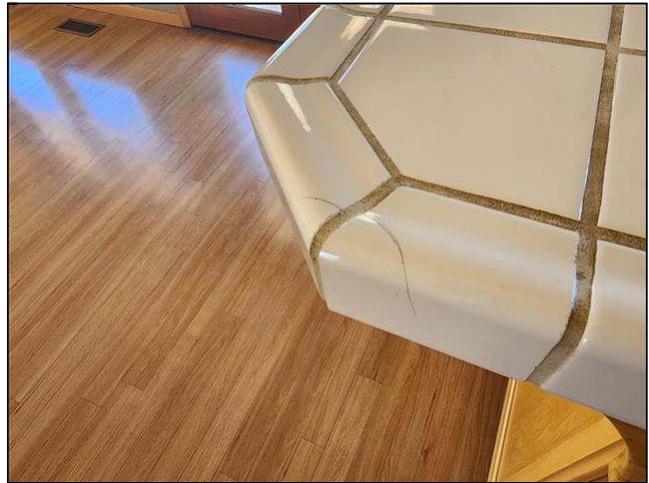
(2) There are a few cracked tiles noted at the kitchen countertop. This is considered to be a cosmetic item and is for your information.

7.4 Item 2(Picture) cracked tiles at kitchen

7.4 Item 3(Picture) cracked tiles at kitchen

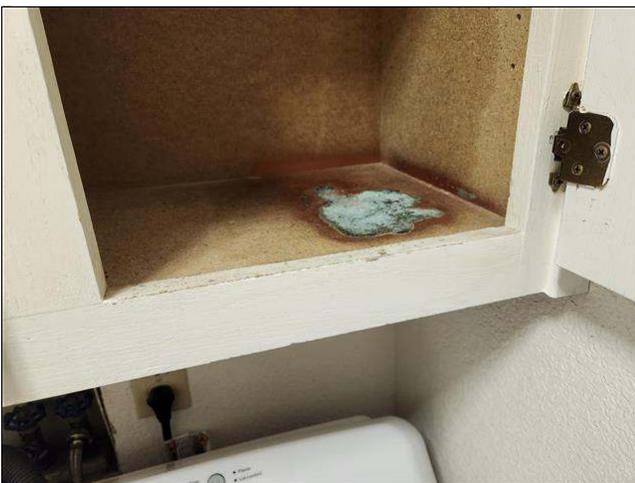
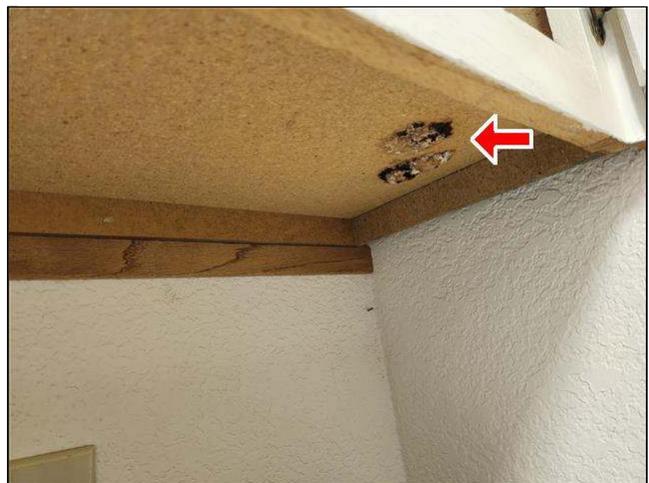
(3) Laundry Room cabinet had a spill that is eating completely through the lower shelf board, and should be replaced.

7.4 Item 4(Picture) laundry room cabinet

7.4 Item 5(Picture) deterioration through cabinet shelf

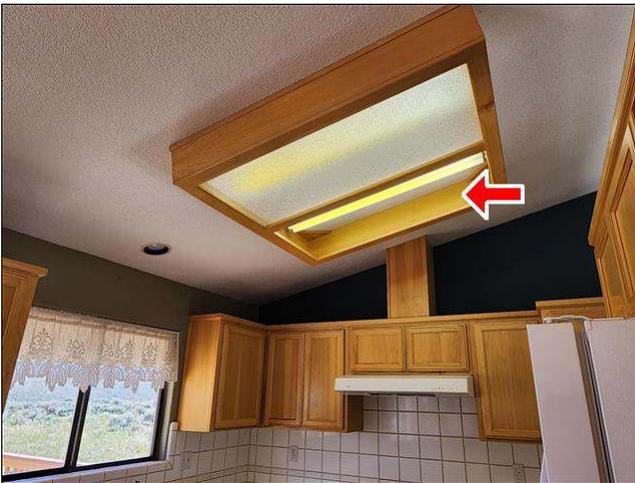
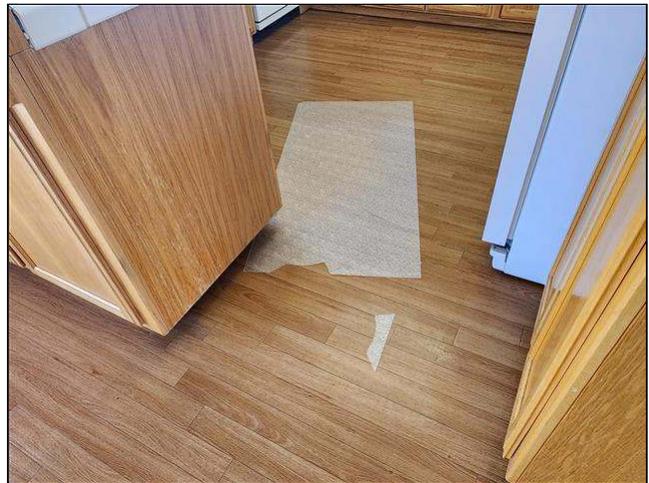
NOTE: Kitchen ceiling light fixture cover fell out when walking on the roof. This will need replacement and better secured.

7.7 Item 1(Picture) kitchen ceiling light

7.7 Item 2(Picture) shade/cover fell out

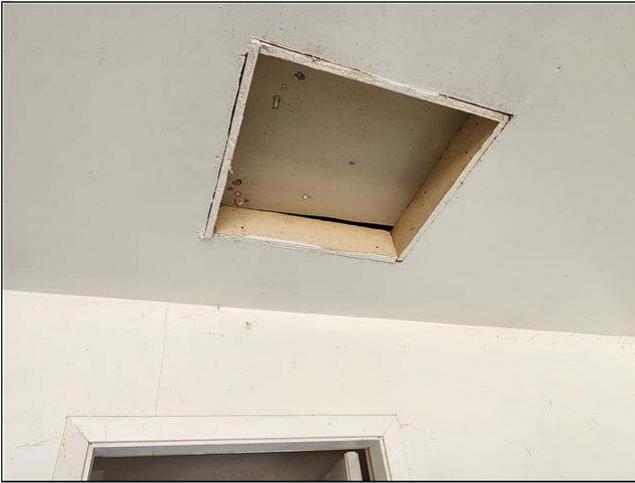
Ceilings finished with drywall... NOTE: Local codes for garage Fire-separation wall state the ceiling must be drywall with ALL seams taped. The scuttle hole installed at the garage does not access storage space, and is NOT needed due to original access located at the master bedroom closet. Recommend repair by a qualified person.

8.2 Item 1(Picture) scuttle hole does not meet local codes

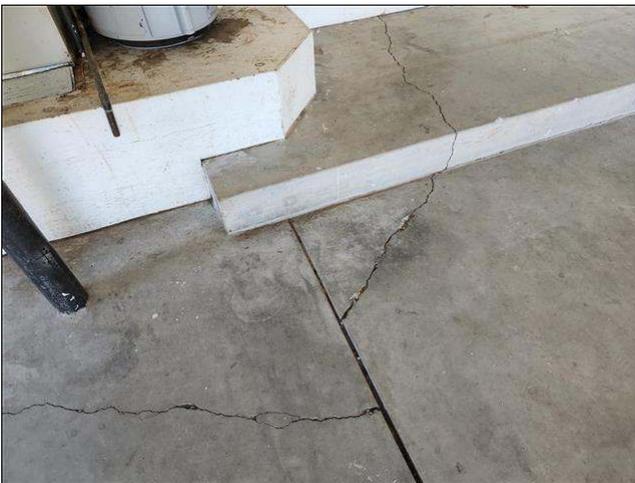
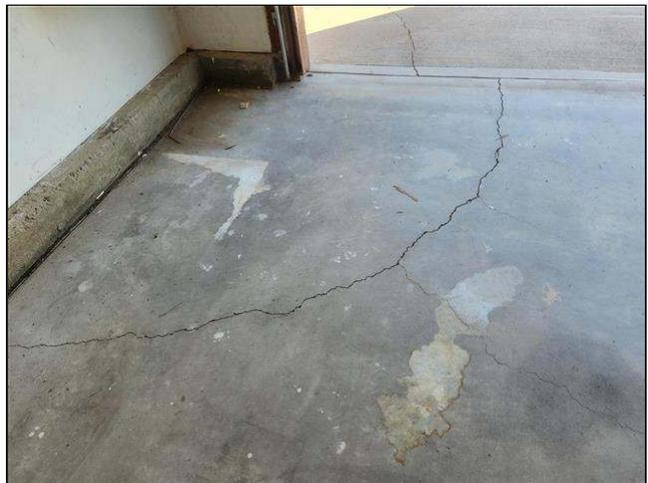
The Garage floors are poured concrete in serviceable condition, with normal settlement cracks.

8.4 Item 1(Picture) normal settlement cracks

8.4 Item 2(Picture) normal settlement cracks

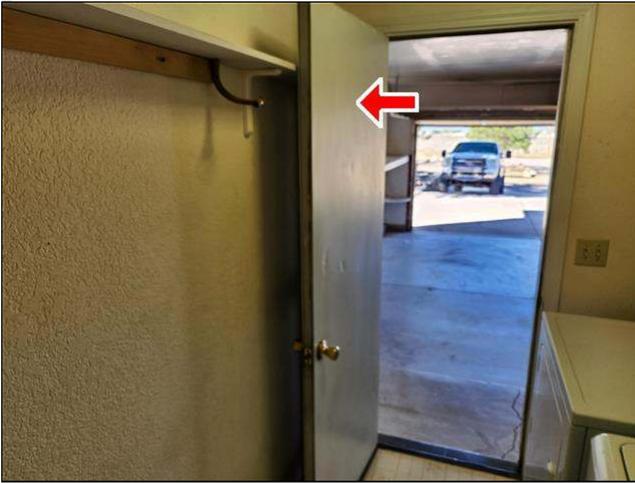
Occupant door from Garage to Interior of house, does not completely self-close on it's own momentum. Recommend repair/adjust door to close completely to prevent accidental carbon monoxide or fire intrusion into home.

8.7 Item 1(Picture) door does not self close

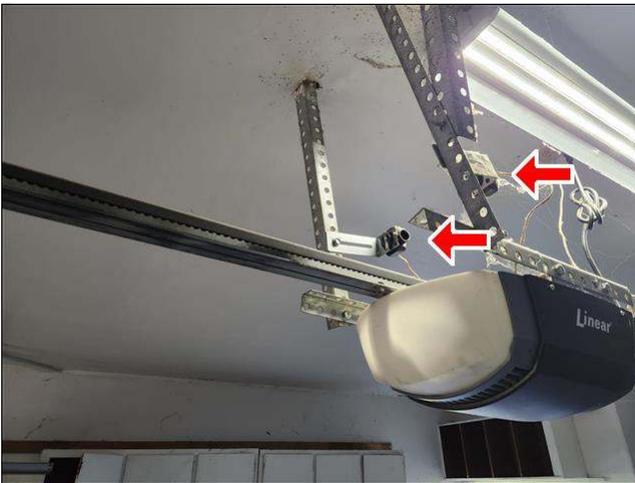
The floor sensors for the garage door were installed facing each other on the operator framing near the ceiling of the garage. The sensors need to be installed about six inches from the ground on both sides of the door, and are provided as a safety feature for the automatic opener. Recommend have the sensors properly installed for safety.

8.9 Item 1(Picture) floor sensors not properly located

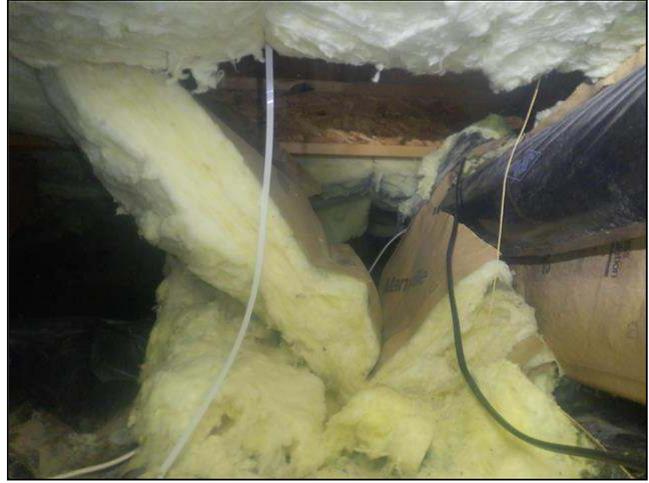
9.1 Item 2(Picture) sagging/falling insulation

(2) The subfloor area is insulated between the floor joists using R19 fiberglass Batts, with a couple sagging/fallen areas, no major problems noted.

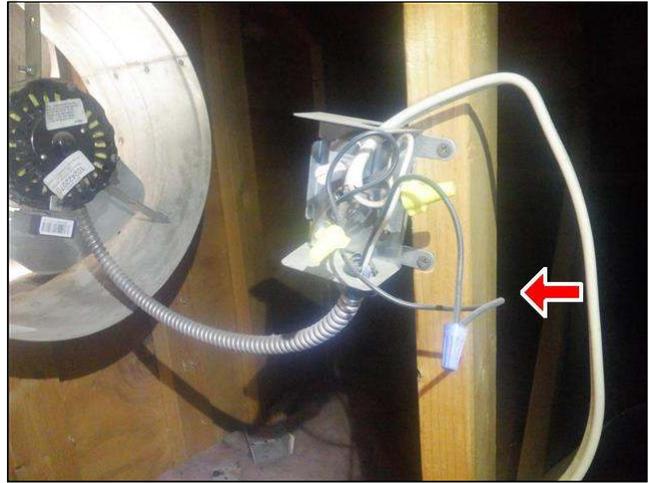
9.5 Item 2(Picture) recommend securing wires inside covered box

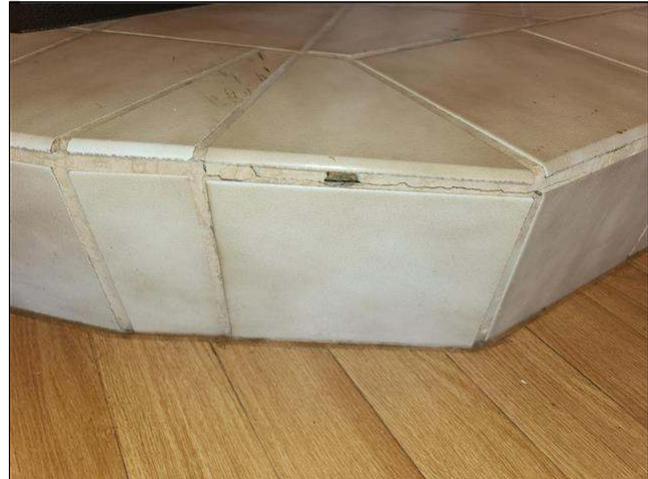
11.3 Item 2(Picture) cracked hearth tiles and grout

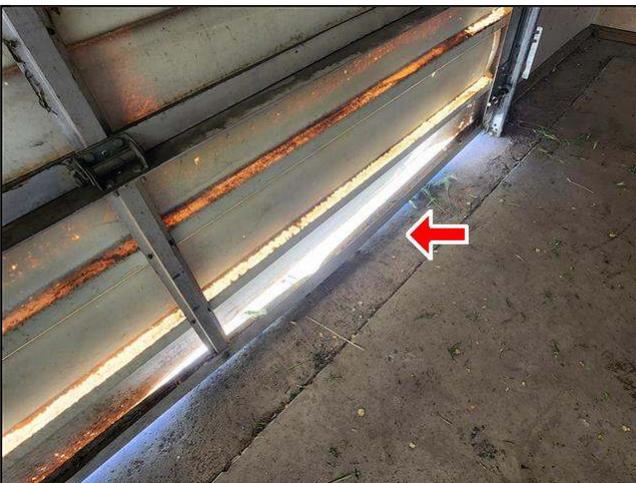
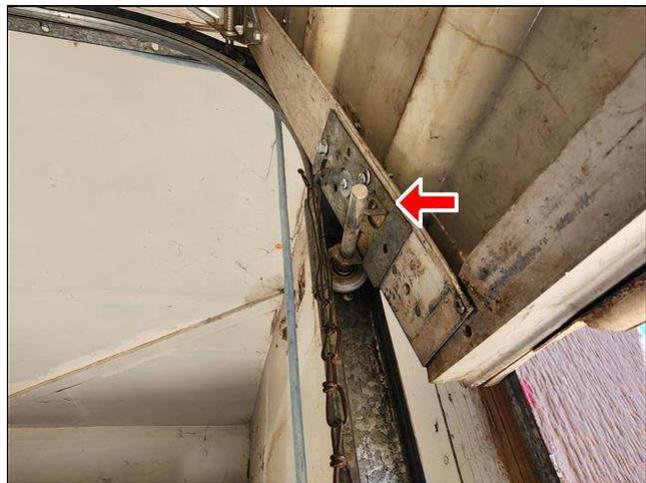
Lower door panel shows slight physical damage, however the door opens and closes as intended... NOTE: Lower door roller has come out of the bracket, and needs a small repair.

12.2 Item 1(Picture) slight damage to lower door panel

12.2 Item 2(Picture) lower roller out of bracket

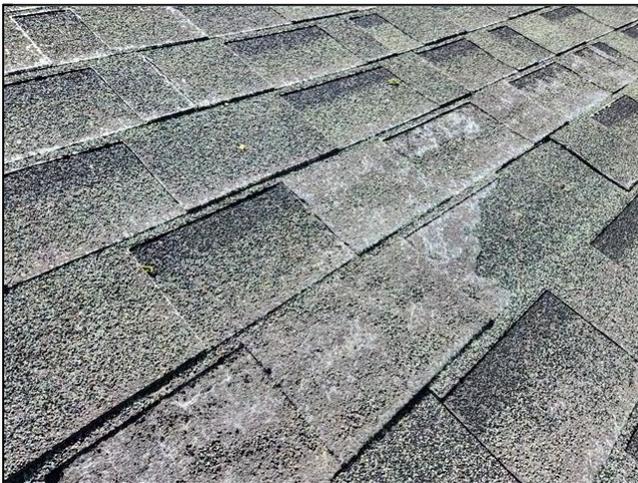
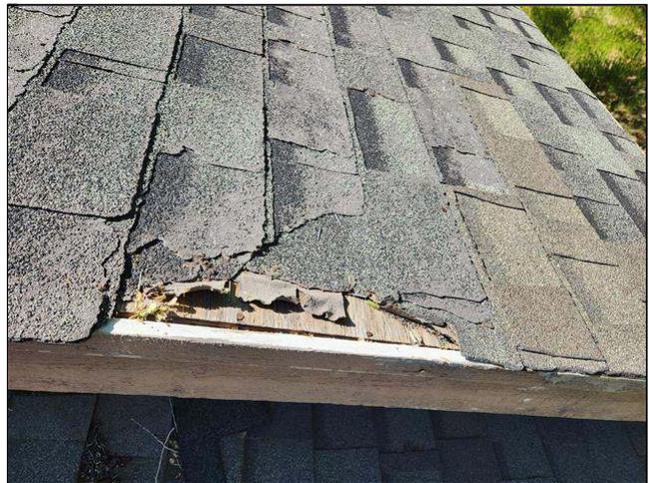
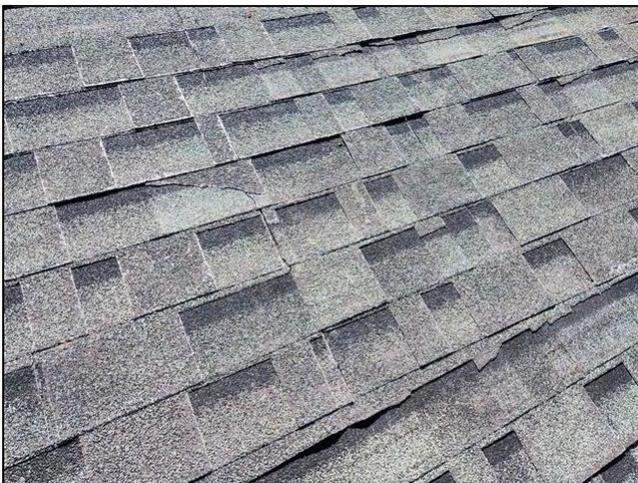
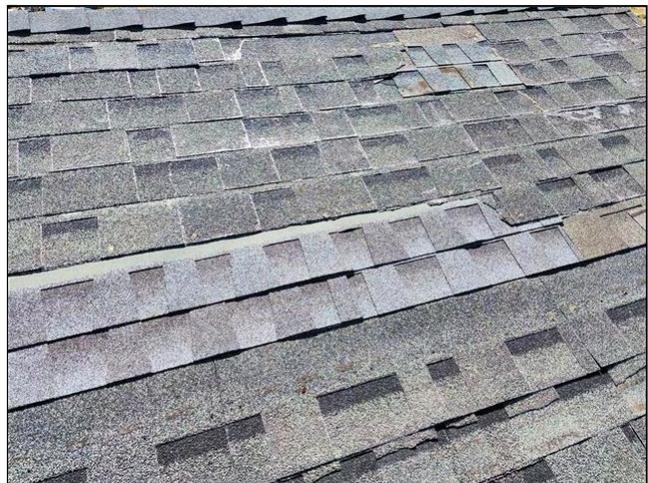
(2) Left Side Garage... The roof covering is a 30 year architectural, asphalt/fiberglass Composition shingle that appears to be at the end of it's useful life. Typical loss of granules noted from North slope shingles, however is more advanced at the South slope of roof, with exposed roof sheathing plywood noted. Recommend further evaluation of roof covering materials by a licensed Roofing Contractor.

12.3 Item 2(Picture) condition of shingles

12.3 Item 3(Picture) exposed roof sheathing

12.3 Item 4(Picture) wind damaged shingles

12.3 Item 5(Picture) wind damaged shingles

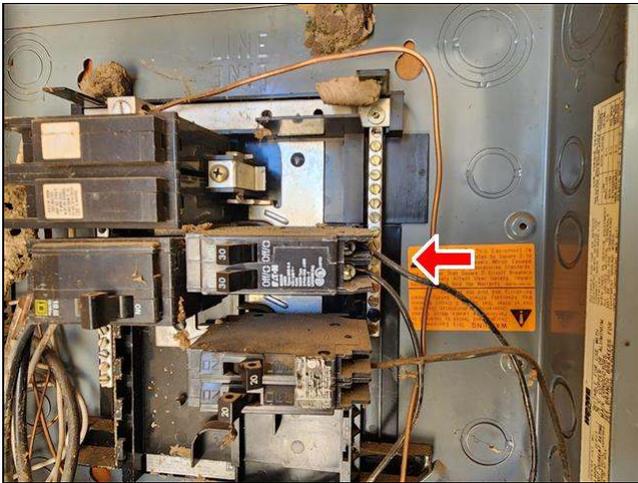
(2) Double Pole 30 amp circuit breaker has been installed, supplying current through 20 amp rated wire. This breaker does not afford overload protection for this wire and circuit. Recommend repair by a licensed electrician.

12.6 Item 3(Picture) 30 amp breaker, 20 amp wire
