Inspection Report

Property Address:
2422 Hunterwood Ct.
Carson City NV 89706

Date: 3/6/2023	Time: 09:00 AM	Report ID: KIN242
Property: 2422 Hunterwood Ct. Carson City NV 89706	Customer:	Real Estate Professional: Thomas Vander Laan Coldwell Banker

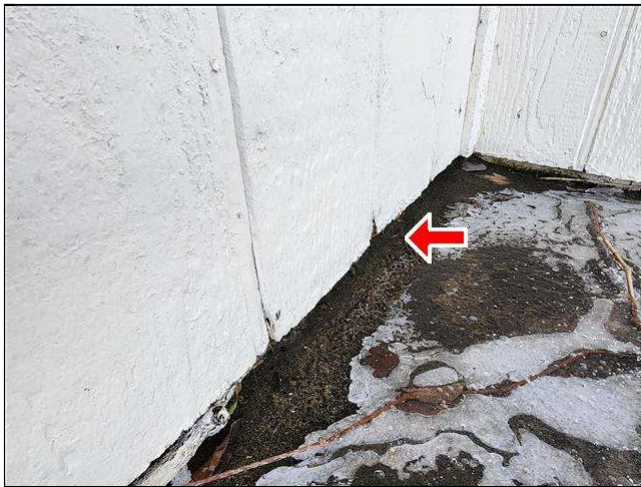
(1) Exterior wall cladding appears original to the home, and is T-111 and Horizontal lap style compressed board that appears in average condition for the age home. Normal aging and wear was noted, with slight deterioration at the lower edges, possibly from irrigation over-spray or roof run-off splashing on the ground. No problems were noted with the siding materials, and appears properly secured to wall framing.

1.1 Item 1(Picture) slight deterioration at lower edge

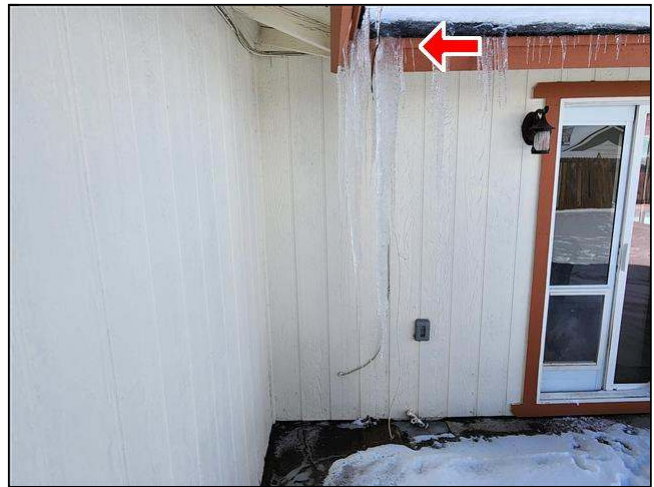
1.1 Item 2(Picture) from roof drainage splashing on patio

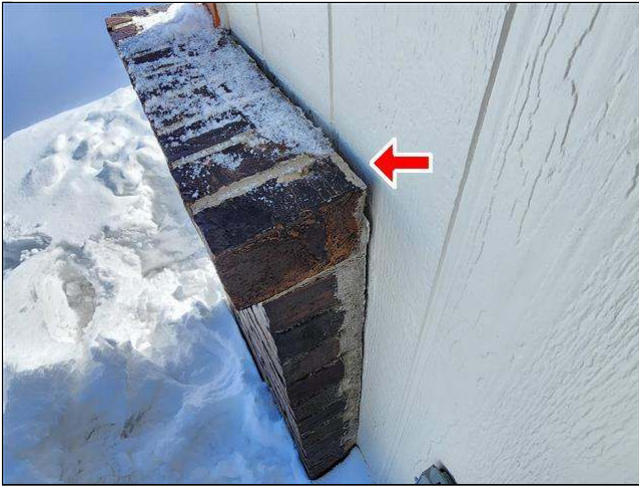
(2) Brick wainscoting at right front corner of garage, has pulled away from the home's siding/wall, and should be trimmed or filled to prevent trapping moisture against siding.

1.1 Item 3(Picture) bricks pulled away at right front corner

RE: 1.1(2)—Please see *Exhibit: Seller Repair Itemization*

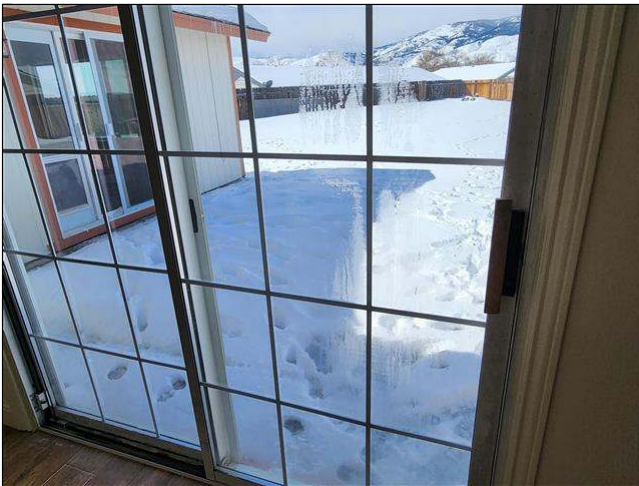
Window is cloudy/condensation (lost seal) at the master bedroom sliding glass door. This is a cosmetic issue for your information. In order to correct the cloudy appearance of glass, a replacement of glass pane or the unit will be necessary. A qualified person should repair or replace as needed.

1.4 Item 1(Picture) condensation at master bedroom slider door

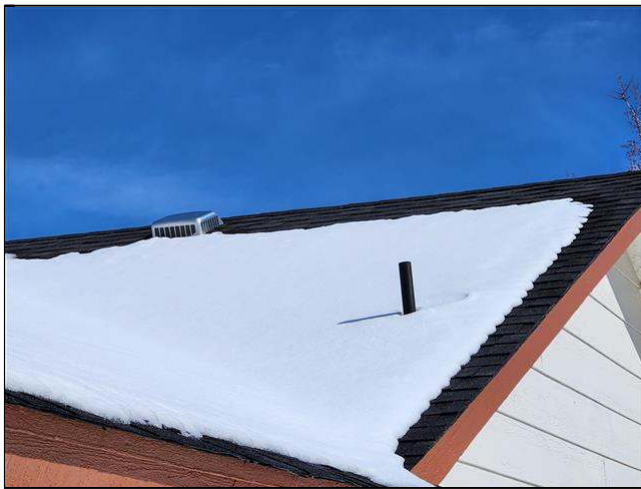
NOTE: Roof was not inspected due to being covered with snow at time of inspection, and NOT safe to access.

2.0 Item 1(Picture) snow covering roof

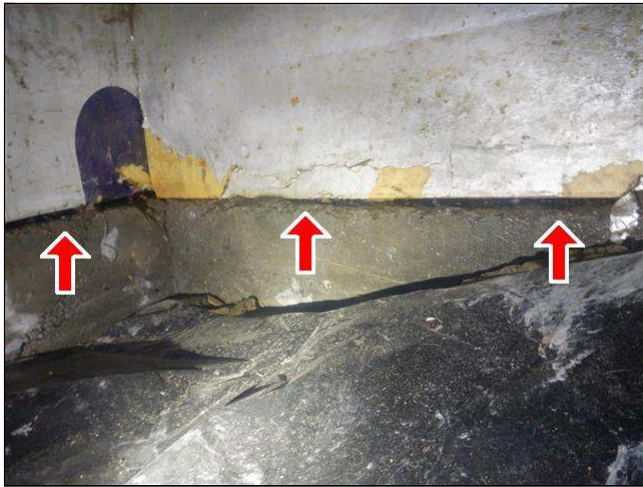
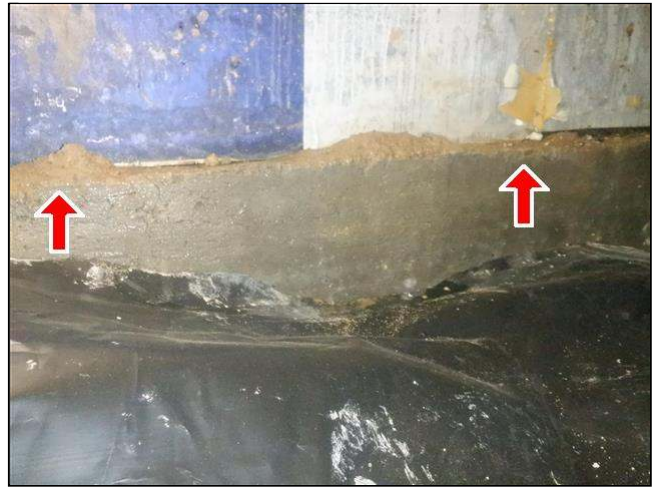
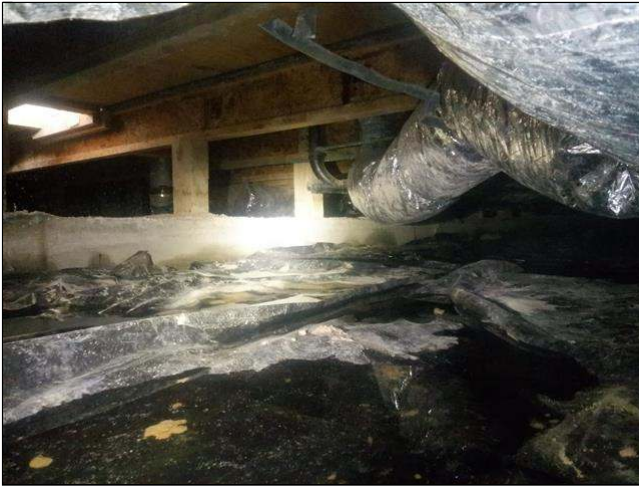
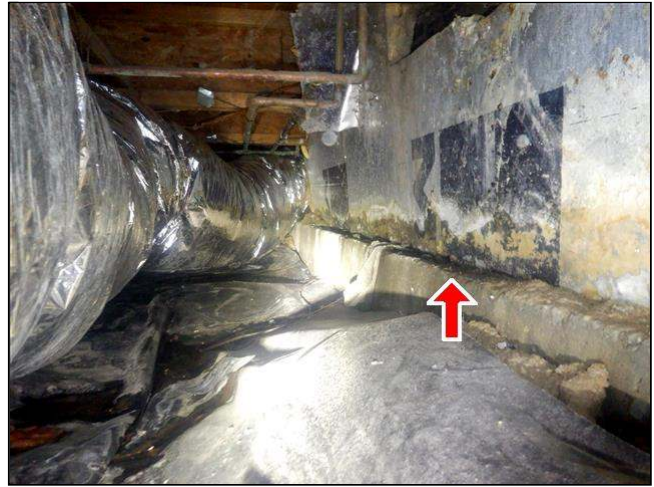
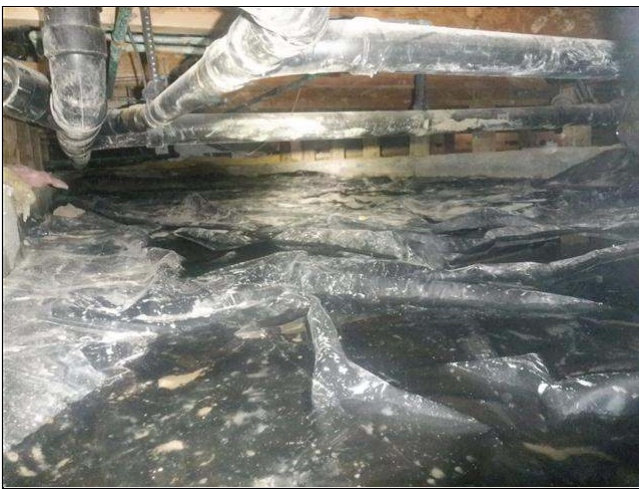
There were several pooled moisture areas in the crawlspace area at time of inspection, and appears the moisture is migrating through the foundation (noted at the right rear corner of home, and adjacent to the rear wall of home where pooled moisture is resting against the home's foundation). There is also an active plumbing supply leak under the Laundry room area.

3.2 Item 1(Picture) moisture intrusion at right rear corner

3.2 Item 2(Picture) moisture intrusion at right rear corner

3.2 Item 3(Picture) pooled moisture in crawlspace

3.2 Item 4(Picture) moisture intrusion at south foundation

3.2 Item 5(Picture) pooled moisture in crawlspace

Comments: Inspected **RE: 3.2—Please see *Exhibit: Seller Repair Itemization***

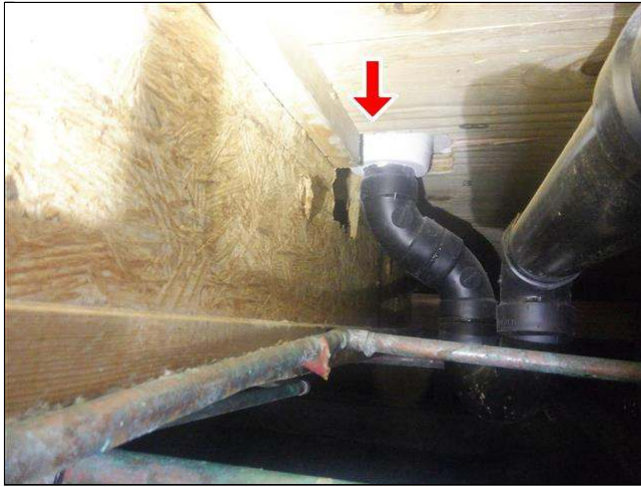
The floor joist top cord has been cut through at the guest tub drain plumbing. Pre-manufactured or engineered floor joist should not be cut at the top or bottom cords. Recommend additional support, either headered off from adjacent floor joists (preferred) or pier and post installed directly beneath the damaged area (with proper footings), as preferred by contractor.

3.6 Item 1(Picture) cut joist under guest bathroom

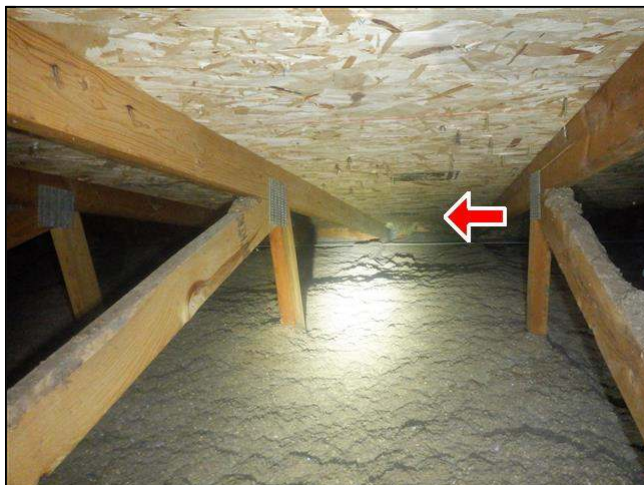
Scuttle hole located in ceiling of Hallway. Serviceable. NOTE: No access is provided for the rear living room roof structure and attic area.

3.10 Item 1(Picture) no access from main attic area

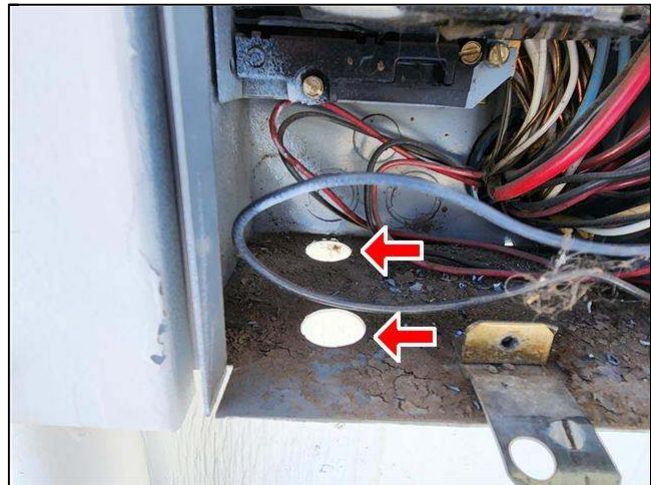
4.1 Item 2(Picture) knock out plugs missing

(2) NOTE: "knock-out" plug covers are missing at Main Panel bottom. Recommend installing plugs to eliminate rodent access. **RE: 4.1(2)**—Please see *Exhibit: Seller Repair Itemization*

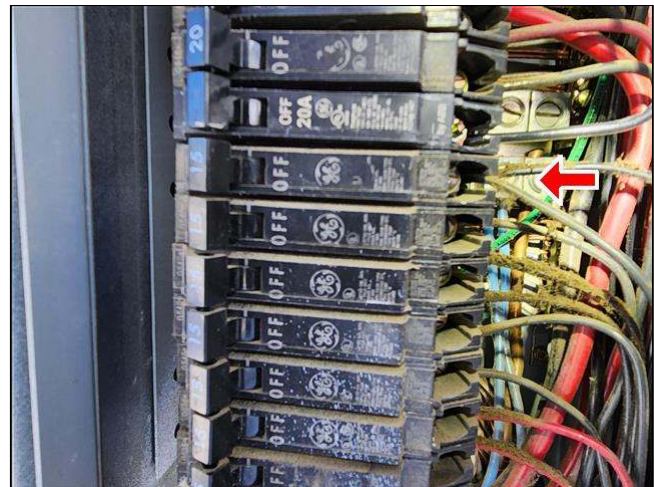
4.4 Item 2(Picture) double tap circuit breaker

(2) Note: There is a "double tap" circuit breaker noted inside the main panel. Each conductor should be wired and connected to separate circuit breakers. Recommend repair by a licensed electrician.

4.5 SWITCHES, RECEPTACLES, AND WIRE **RE: 4.4(2)**—Please see *Exhibit: Seller Repair Itemization*

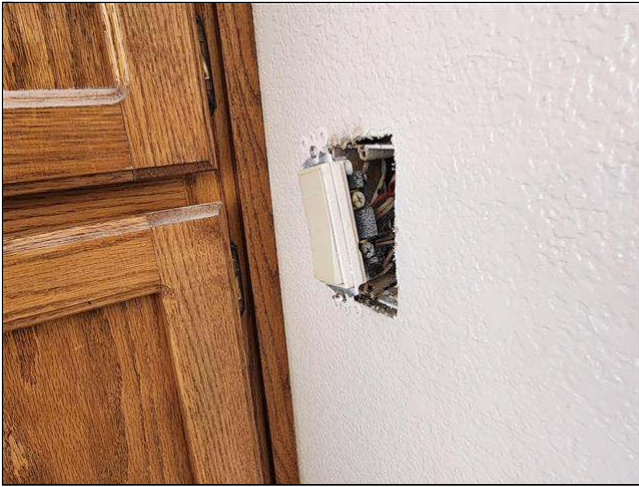
(1) Recommend securing loose electrical switch at kitchen entry area.

4.5 Item 1(Picture) loose electrical switch at kitchen

RE: 4.5(1)—Please see *Exhibit: Seller Repair Itemization*

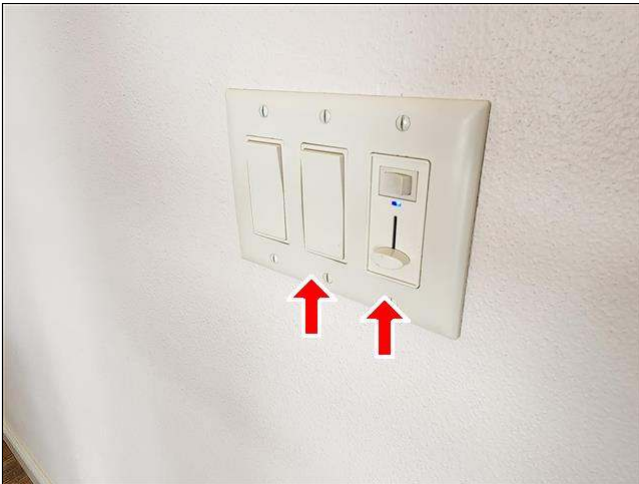
(2) Triple switch installed at master bedroom do not appear to function properly. There are 2 switches that operate the light (fan/light fixture), and nothing controlling the ceiling can lights.

4.5 Item 2(Picture) both switches operate ceiling light

RE: 4.5(2)—Please see *Exhibit: Seller Repair Itemization*

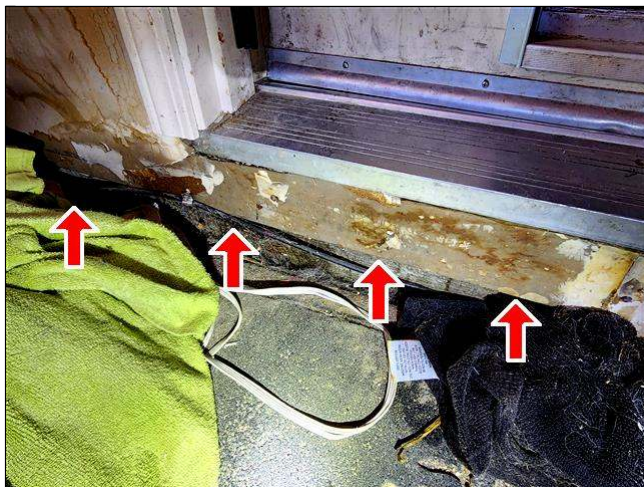
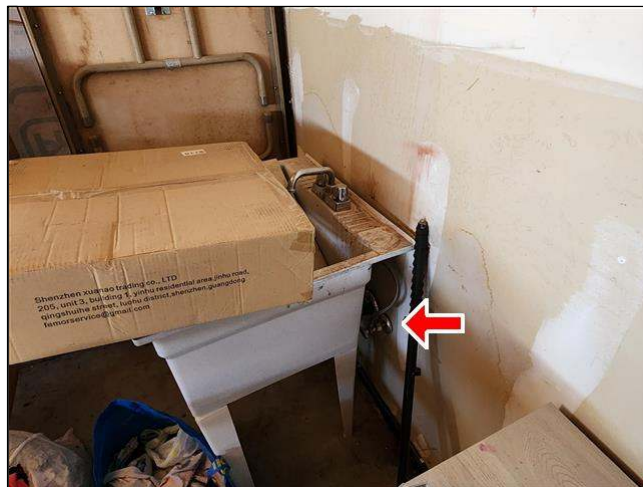
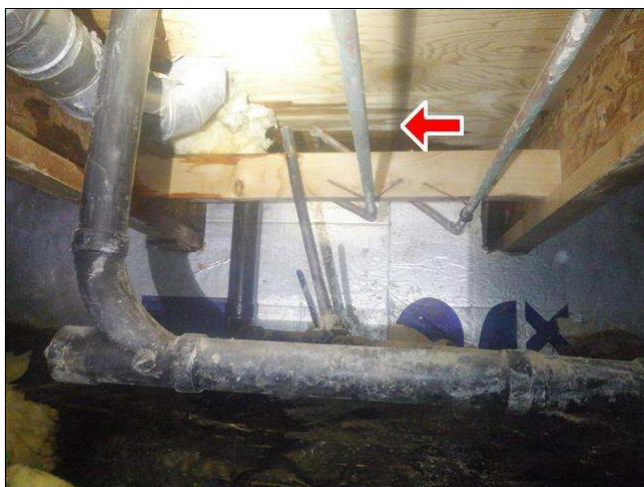
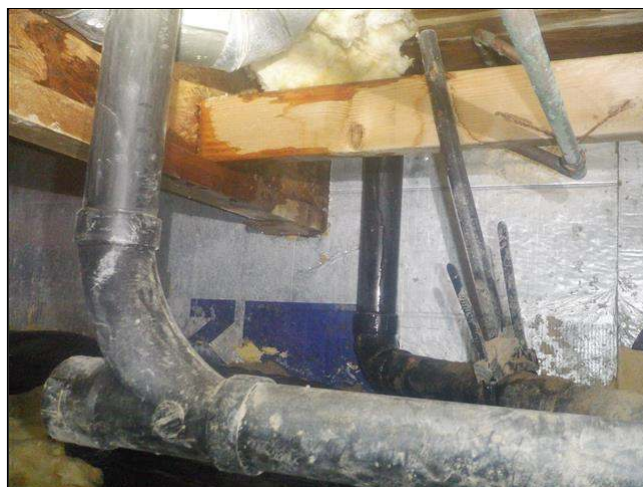
(1) NOTE: Water was noted to be dripping from the subfloor at the garage occupant door and in crawlspace area under the Laundry room. This appears may be a plumbing supply pipe leak. Recommend further evaluation of source of moisture, and repair by a qualified person.

5.2 Item 1(Picture) moisture dripping at garage occupant door area

5.2 Item 2(Picture) plumbing supply to this sink

5.2 Item 3(Picture) wet subfloor under laundry room

5.2 Item 4(Picture) wet subfloor under laundry room

RE: 5.2(1)—Please see *Exhibit: Seller Repair Itemization*

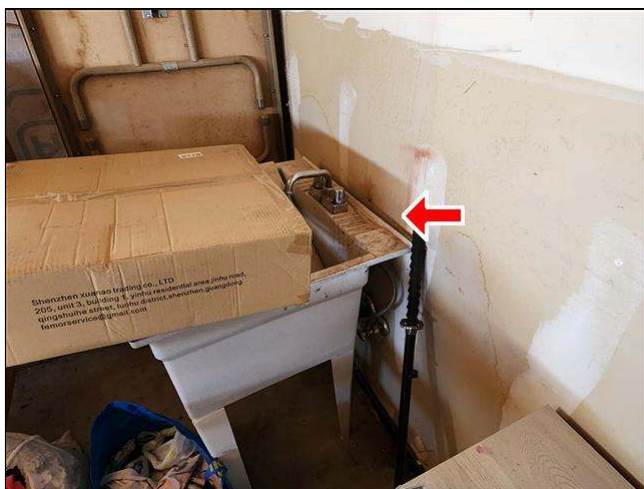
(1) The utility sink is loose and needs securing to wall at the Garage. The associated plumbing supply and drain lines for faucet do not appear to be leaking at time of inspection. A qualified person should repair as necessary.

5.5 Item 1(Picture) utility sink not secured

RE: 5.5(1)—Please see *Exhibit: Seller Repair Itemization*

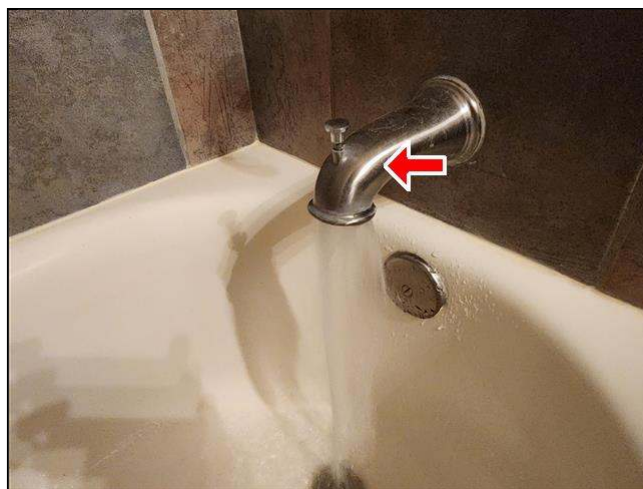
5.5 Item 2(Picture) guest bathroom shower diverter valve

(2) Faulty shower diverter valve at Guest Bathroom does not allow for shower operation, and should be replaced.

RE: 5.5(2)—Please see *Exhibit: Seller Repair Itemization*

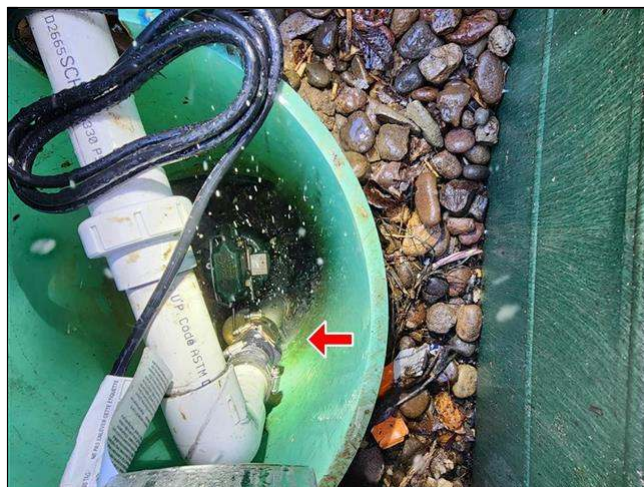
Sump Pump was noted at the North side exterior of the home, and functions as intended when manually lifting the float. NOTE: There is water pumping back into the sump pump well when pump is operating, causing the pump to operate for longer periods of time. Recommend further evaluation of system by a qualified person.

5.12 Item 2(Picture) pumping water back into the pump well

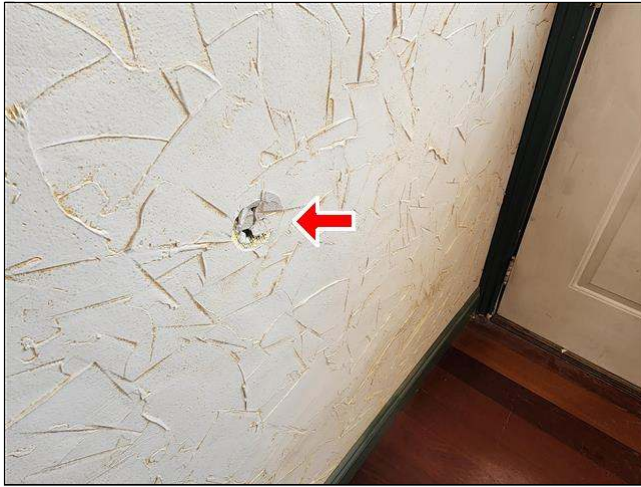
(2) Recommend repairing hole in drywall at main entry, from door-knob.

7.2 Item 1(Picture) drywall repair needed at main entry

RE: 7.2(2)—Please see *Exhibit: Seller Repair Itemization*

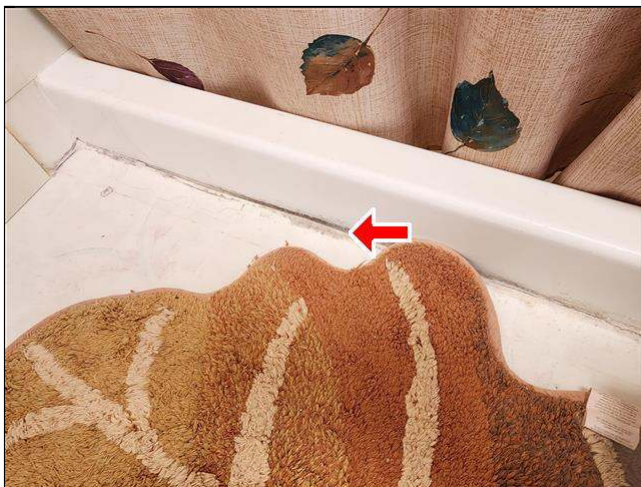
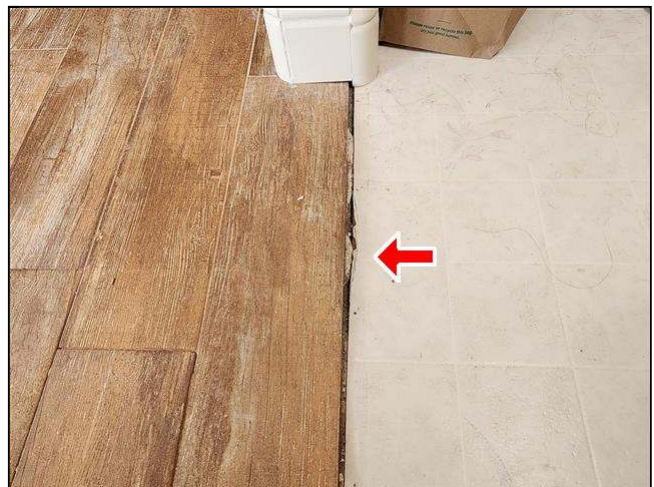
(2) The Linoleum is curling around edges and is not impervious to water at the Master bath. While this damage is cosmetic, it should be repaired. A qualified contractor should inspect and repair as needed.

7.3 Item 1(Picture) flooring at master bathroom

7.3 Item 2(Picture) flooring at master bathroom

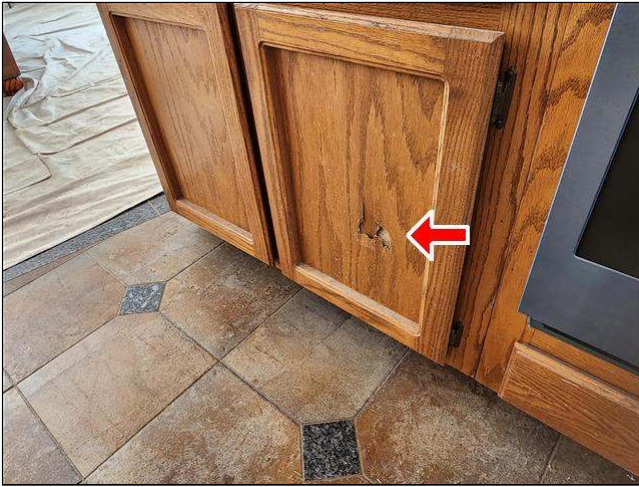
(1) Recommend repair or replace damaged cabinet door in kitchen, adjacent to the oven.

7.4 Item 1(Picture) damaged cabinet door in kitchen

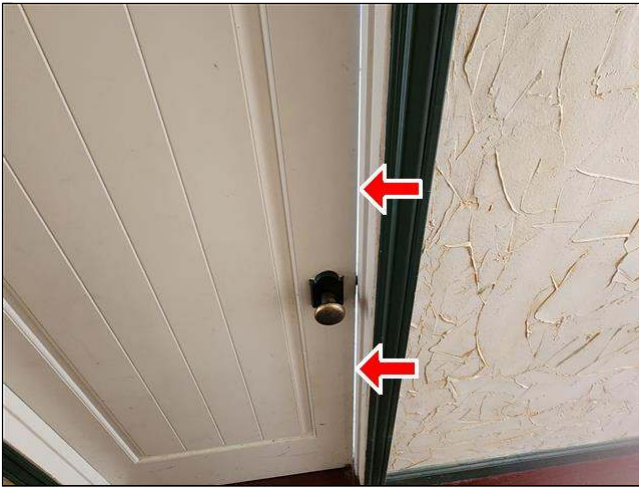
Northeast guest bedroom door does not fit properly inside the door opening, leaving a gap.

7.5 Item 1(Picture) NE guest bedroom door

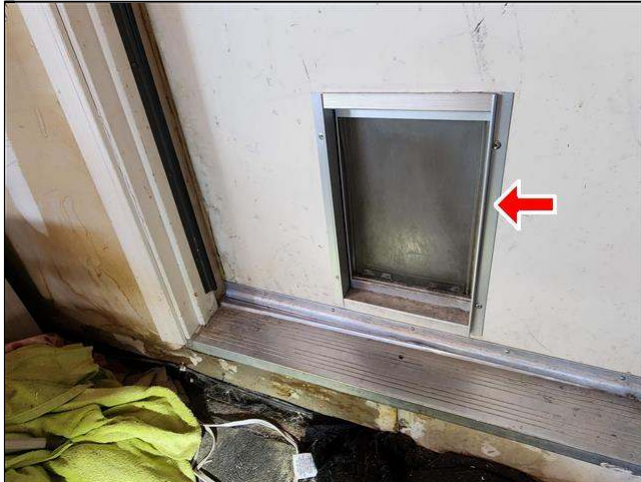
Occupant door from Garage to Interior of house has a "doggy door" installed, and compromises the integrity of the fire rating. This door must be fire rated, weather stripped, and fully self close on it's own momentum to prevent accidental carbon monoxide/Fire intrusion into home. Recommend repair door, or replace by a qualified person.

8.8 Item 1(Picture) compromised fire-separation door

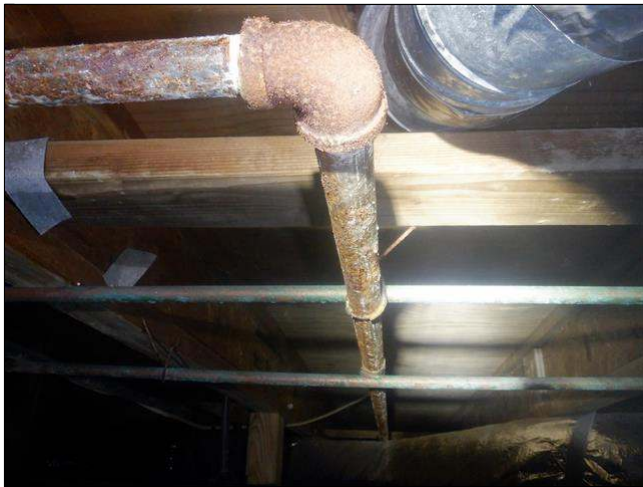
Some rust noted on gas lines in crawlspace area, appears from past moisture in the crawlspace area and lack of ventilation.

9.3 Item 1(Picture) rust on gas supply pipes

RE: 9.3(1)—Please see *Exhibit: Seller Repair Itemization*

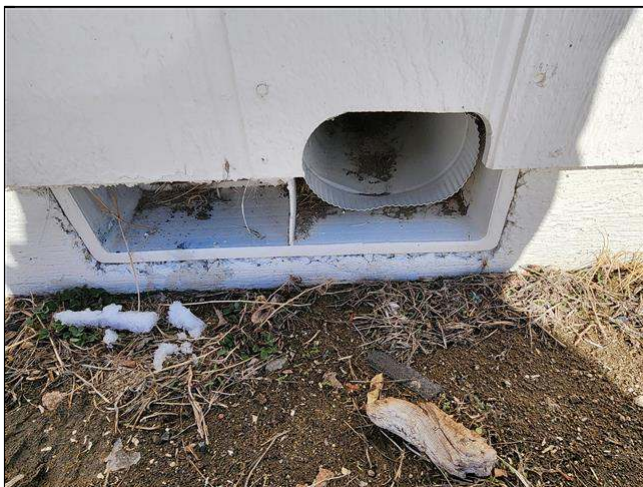
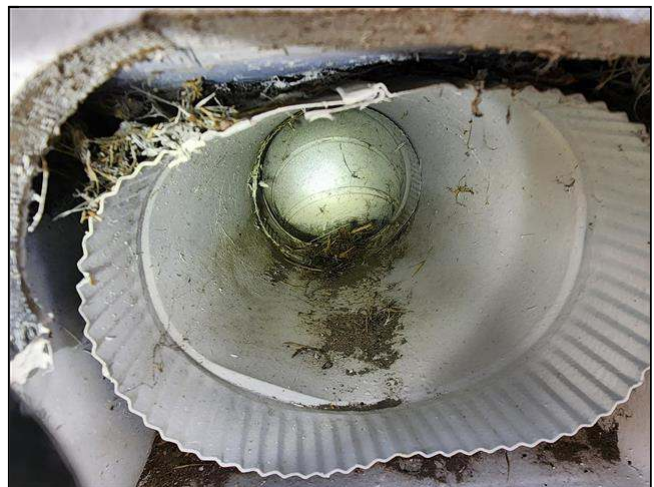
9.4 Item 1(Picture) open vent for kitchen range

9.4 Item 2(Picture) open for pest access

Recommend installing a screen over the kitchen range vent at South exterior wall of home, to prevent pest/rodent entrance.

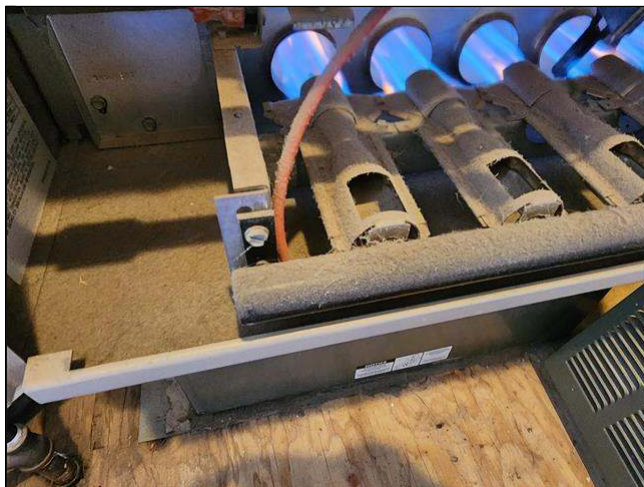
(2) Debris/Dust noted at the furnace's combustion area. Recommend service/cleaning by a qualified person as needed.

10.0 Item 3(Picture) excessive dust in furnace burner compartment

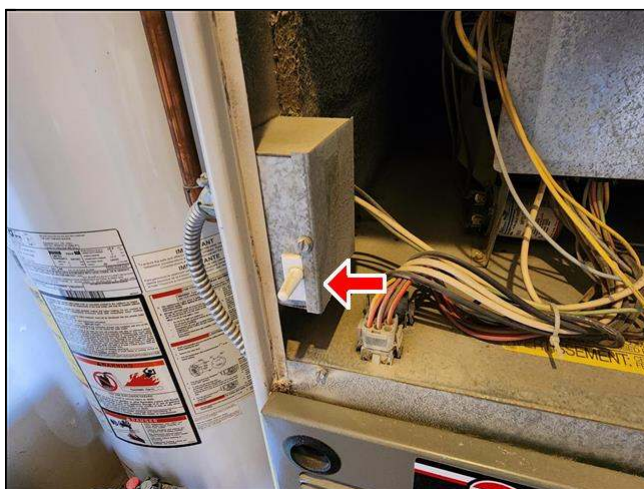
Safety shut-off switch is non-operational, and should be repaired or replaced by a qualified person.

10.2 Item 1(Picture) automatic safety switch

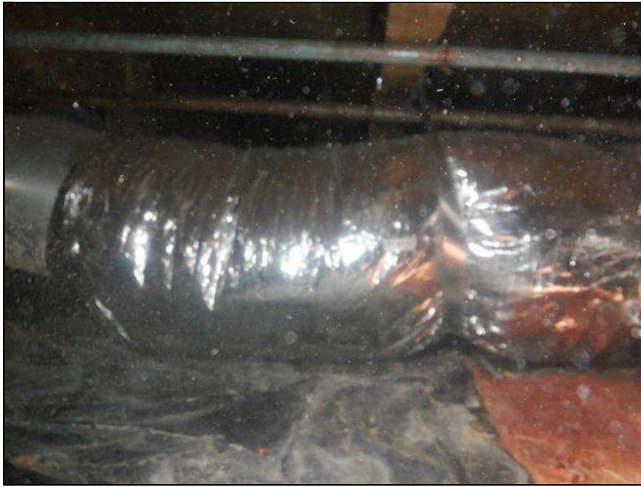
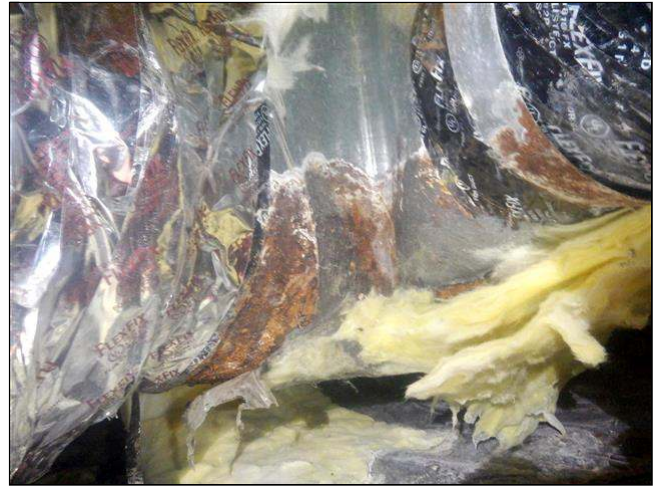
Insulated heating duct is lying on the ground in the crawlspace area under the NE guest bedroom, and appears has soaked-up moisture into the insulation (which could turn into mold). Recommend repair/replace water damaged ducting by a qualified person. NOTE: some rust on this heat ducting connector sleeve noted from past standing water in crawlspace.

10.3 Item 1(Picture) wet duct on crawlspace ground

10.3 Item 2(Picture) rust on heat duct connector sleeve
