Home Inspection Report

PROPERTY INSPECTED:
4139 Julaura Lane
Billings, MT 59106

Date of Inspection: 06/11/2024

Inspection No. 45957-1-1079

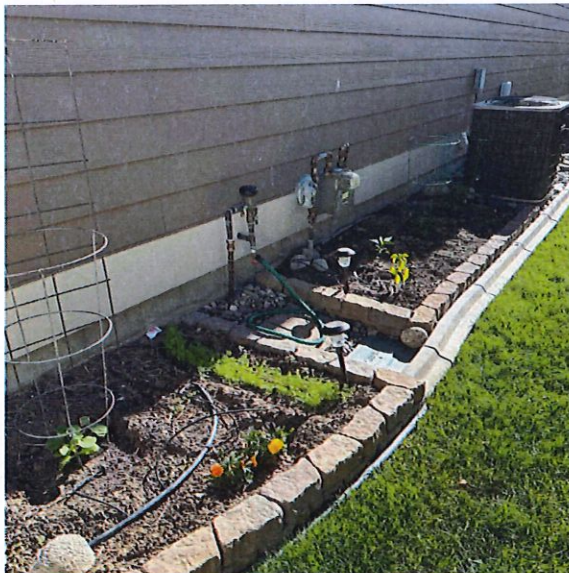
2.2.2 Regrade to slope away from structure to reduce foundation deterioration potential water entry and subsequent damage. Monitor landscape grading near foundation for signs of normal soil compaction and correct as required. **(Exterior South)**

DONE
RAKED
DIRT

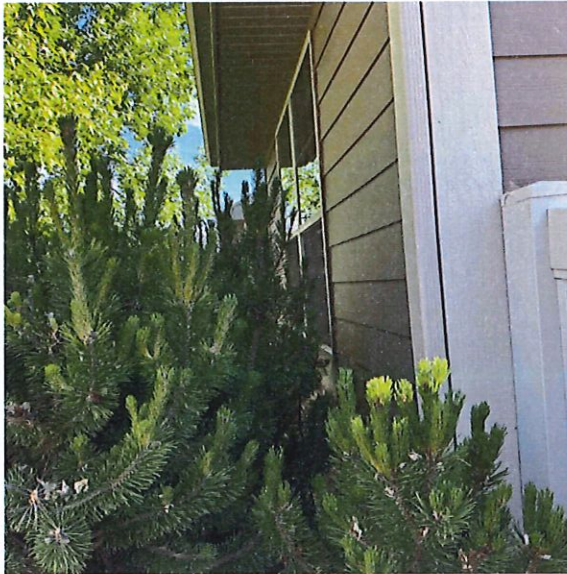
- Exterior East
- Exterior South
- Exterior West

2.2.3 Trim and maintain trees, bushes and vines away from the structure to minimize damage/wear to structure and to discourage animal activity.

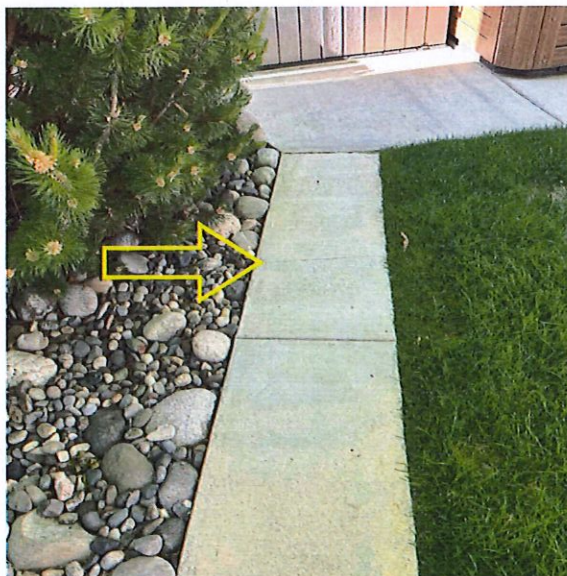
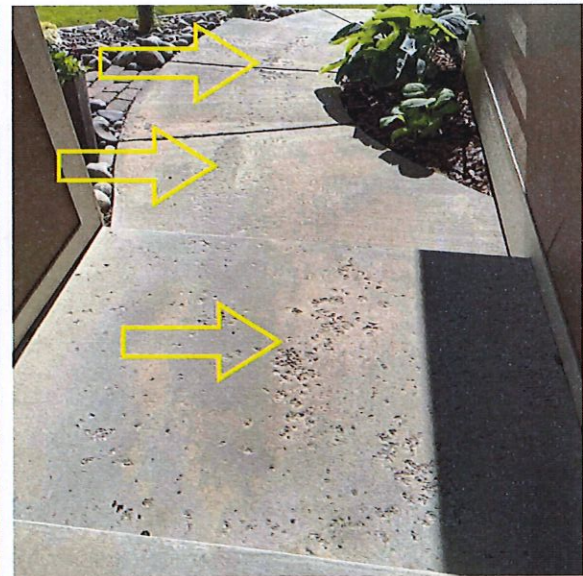
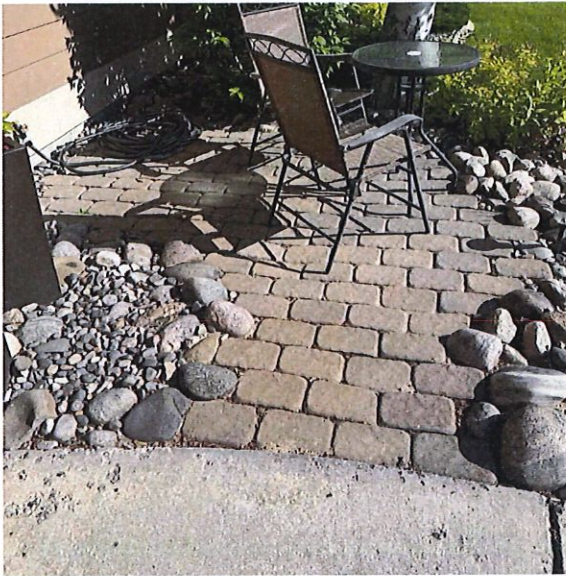
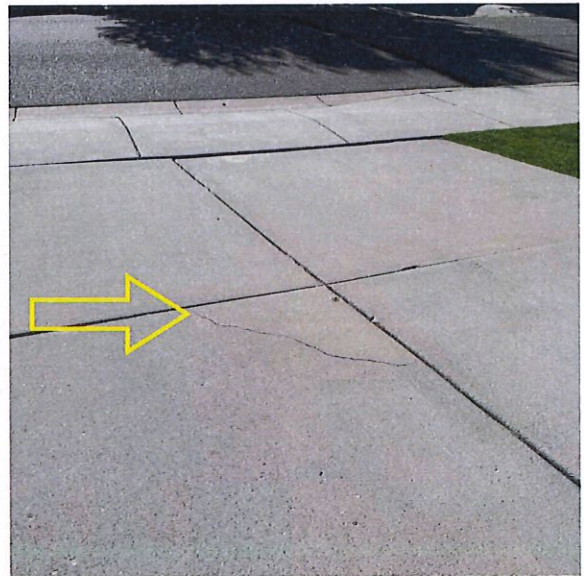
- Exterior East
- Exterior West

2.4.2 Repair settled/cracked/uneven driveway/walkways/patio to prevent further damage, moisture related damage, and trip hazards.

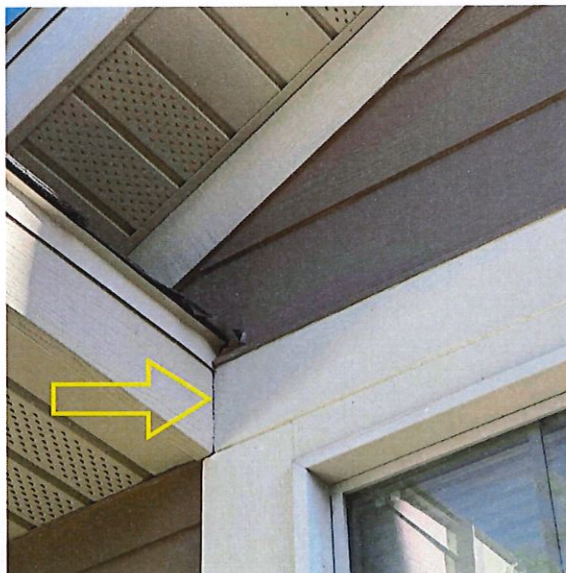
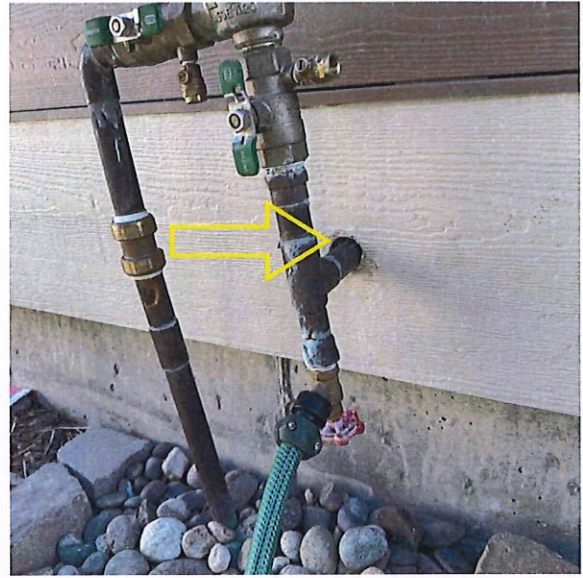
- Exterior East
- Exterior South
- Exterior West

3.3.3 Ensure proper caulking and weather seal at all required locations and junctions such as windows, doors, dissimilar materials junctions, etc.

DONE
CAULK &
PAINT

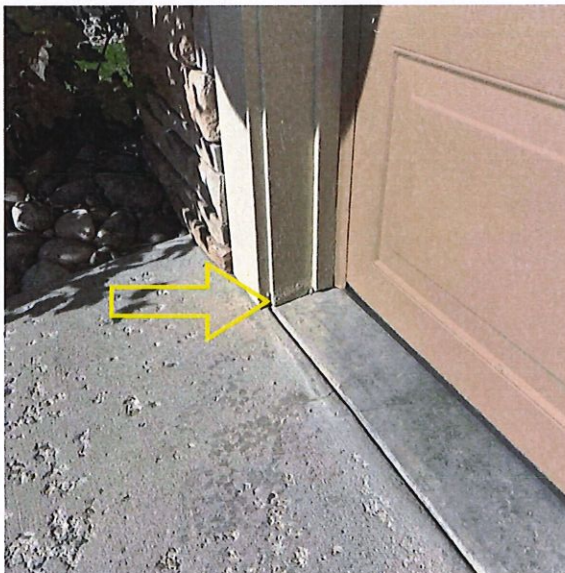
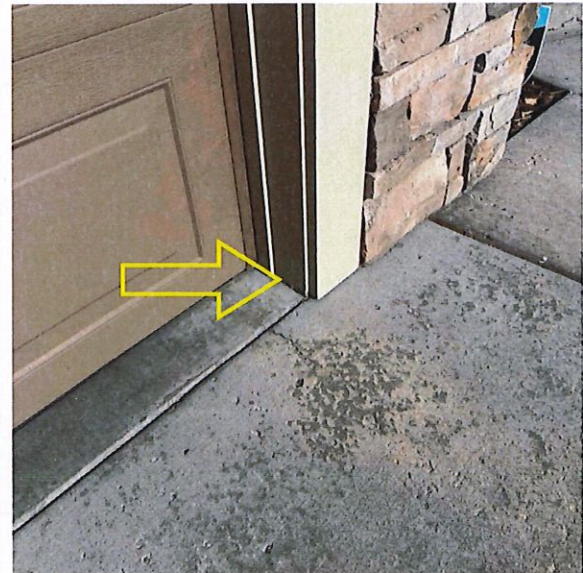
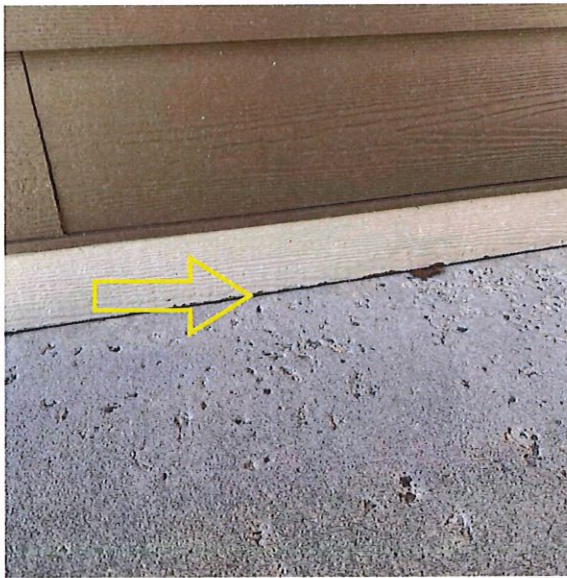
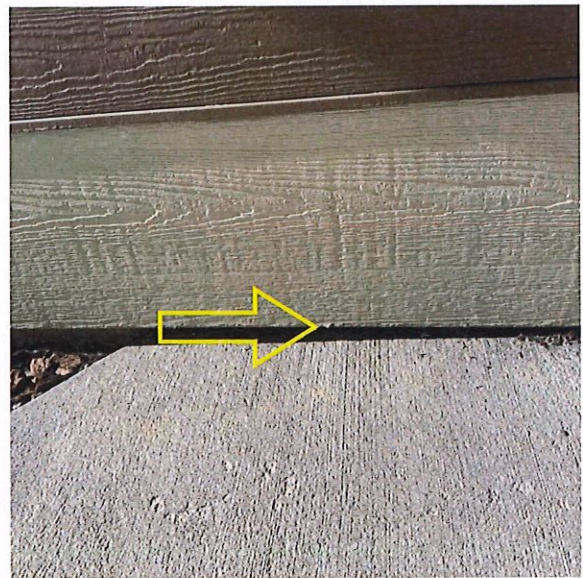
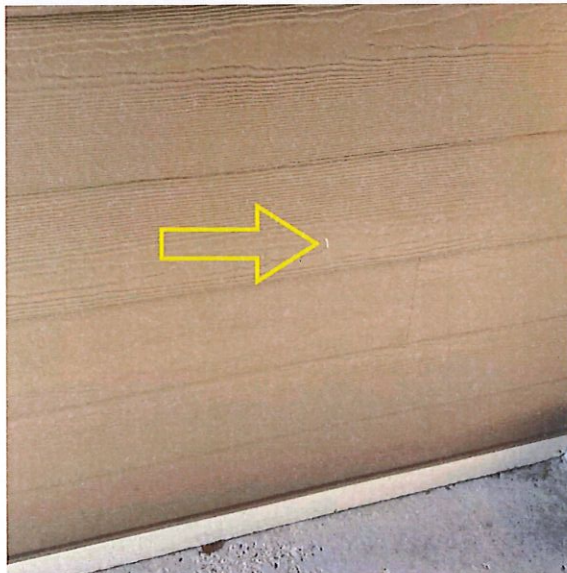
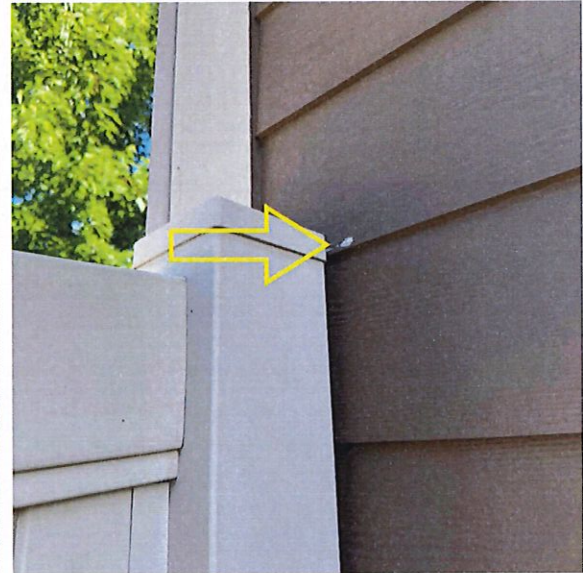
- Exterior East
- Exterior South

3.3.4 Clean, seal/paint/stain all exposed wood siding/trim to promote weathering protection.

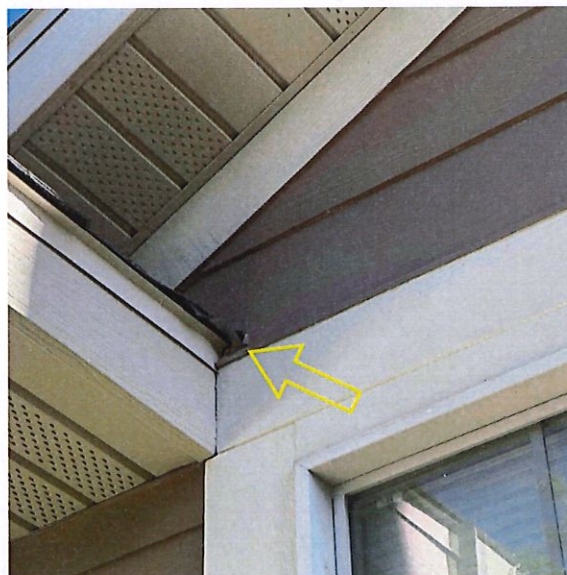
- Exterior South
- Exterior West

3.3.5 Replace damaged/deteriorated siding/trim to prevent further damage and promote weathering protection.

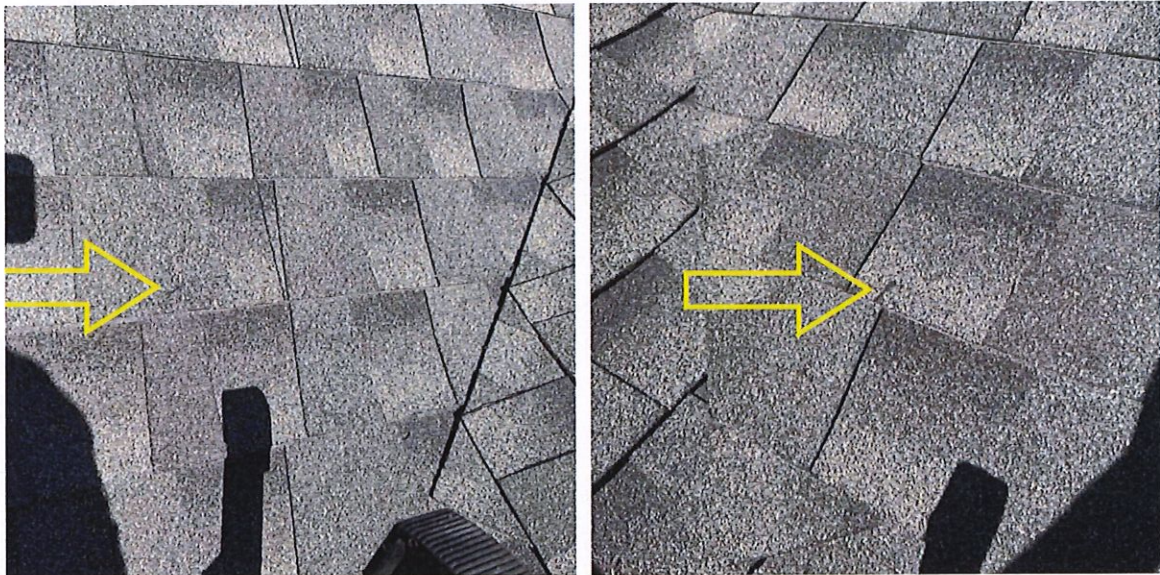
4.2.1 Consult a qualified roofer to evaluate scarred/damaged shingles and repair as recommended.

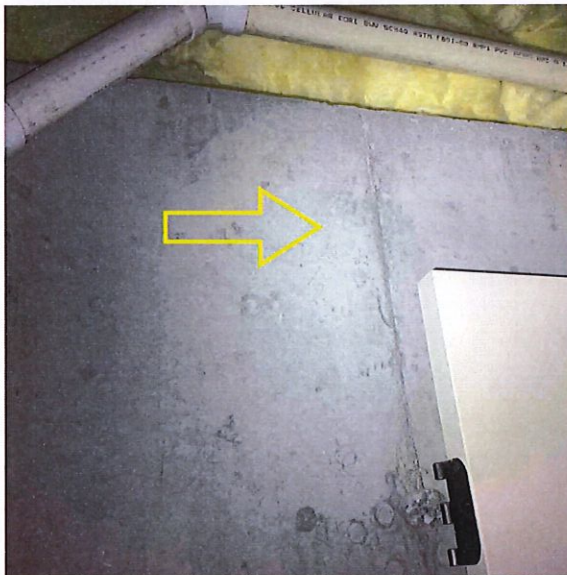
7.2.1 Consult a qualified contractor to evaluate foundation cracks and repair as recommended.

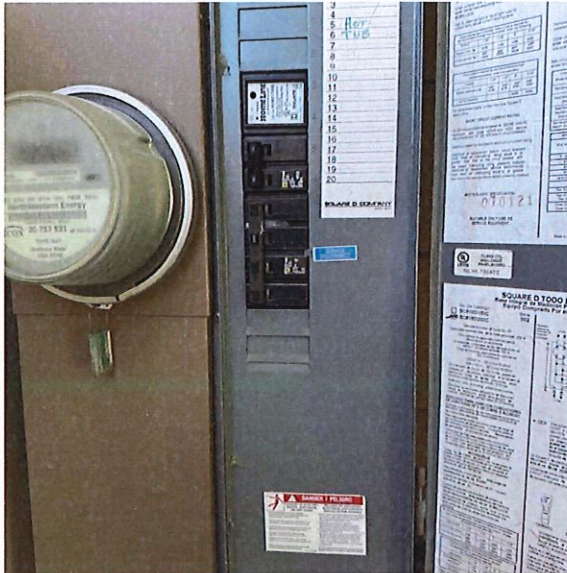
8.4.1 Location: **(Exterior South)**

8.5.2 Caution is advised. This type of disconnect panel does not have an interior cover. Consider replacing or locking to prevent safety hazards. **(Exterior South)**

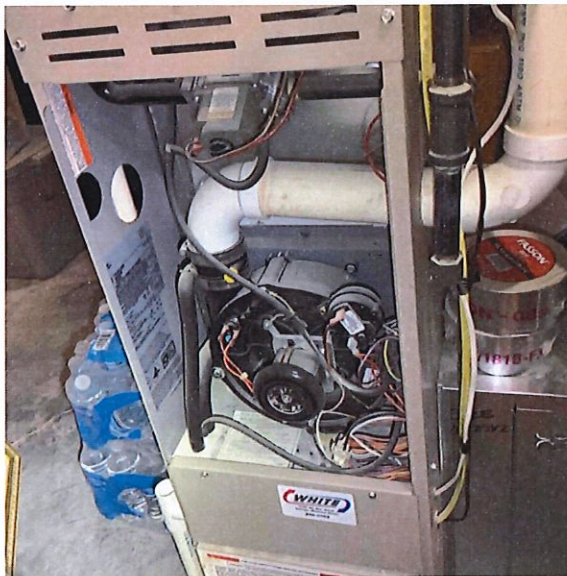
9.5.4 Clean and service furnace to promote system longevity. (Utility Area)

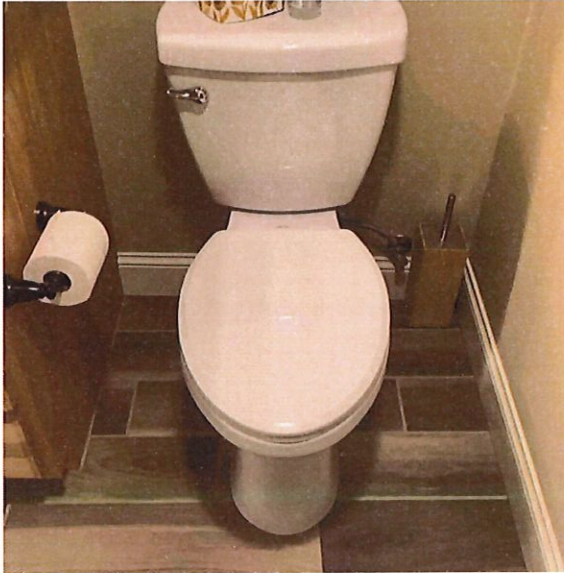
10.9.2 Secure bathroom stool to reduce secondary water damages. (Basement Bathroom)

DONE
TIGHTED
BOLT

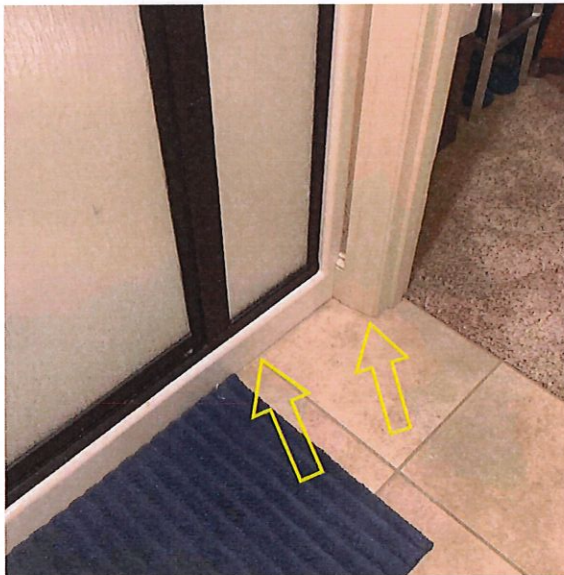
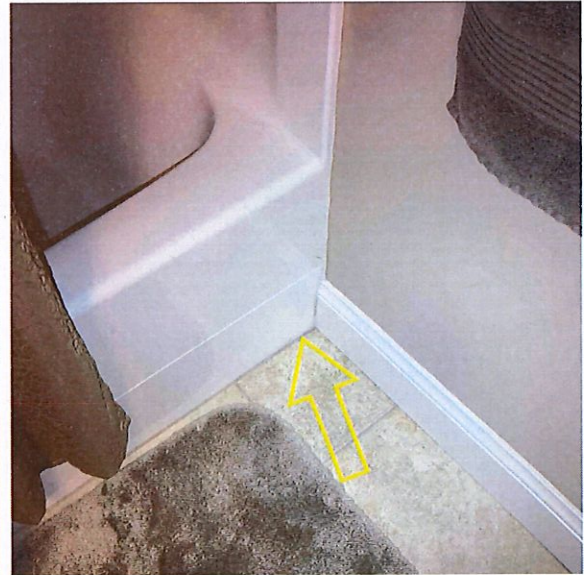
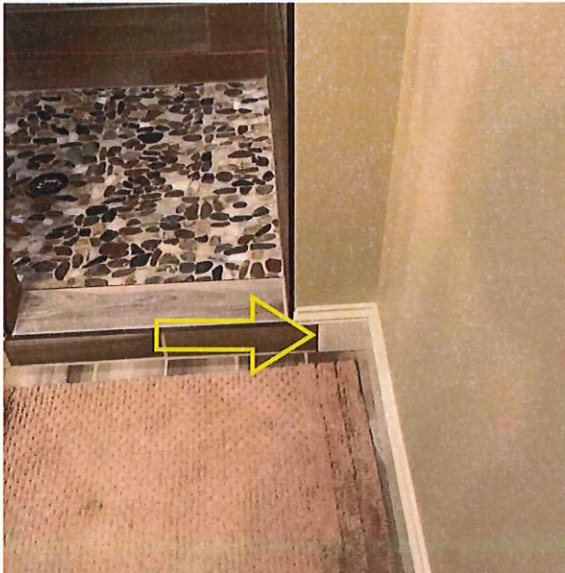
- 1st Floor Hall Bathroom
- Basement Bathroom
- Master Bathroom

10.10.2 Seal all cracks/gaps/joints in and around tubs and showers to reduce water penetration and subsequent deterioration.

DONE
CAULK

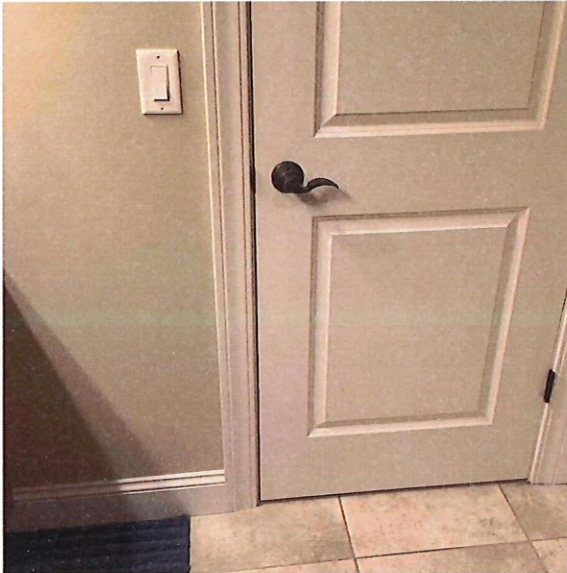
11.4.4 Adjust door striker plate to latch securely. **(Master Bathroom)**

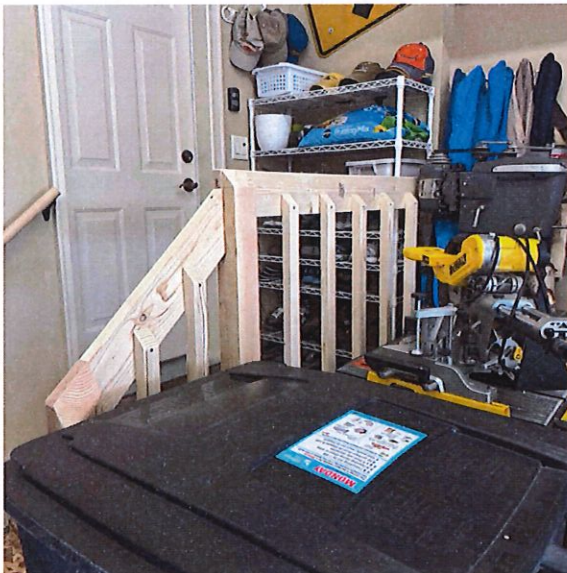
11.6.1 Caution is advised. Railing poses potential safety hazards due to design. Spindle span in greater than 4". **(Garage)**

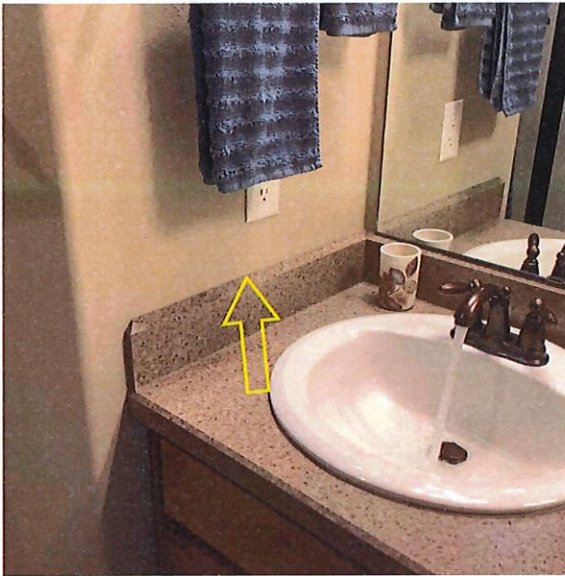
- 1st Floor Hall Bathroom
- Master Bathroom

11.7.4 Recaulk counters to prevent moisture intrusion and subsequent damages.

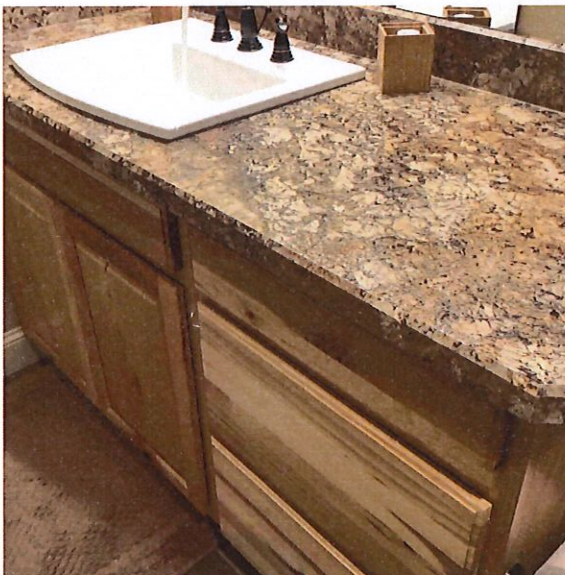
11.7.5 Secure countertop to cabinets to promote stability and prevent further damages. (Basement Bathroom)
