MONTANA ASSOCIATION OF REALTORS®
PROPERTY DISCLOSURE STATEMENT

Home Inspection Report

PROPERTY INSPECTED:
4043 Rifle Creek Trail
Billings, MT 59106

Date of Inspection: 01/09/2024

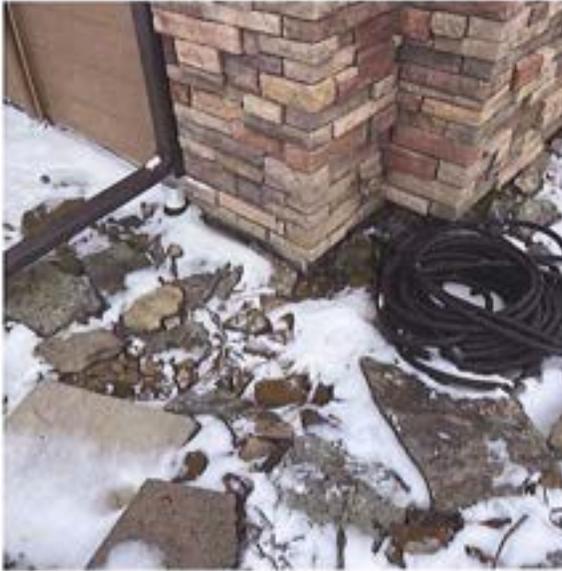
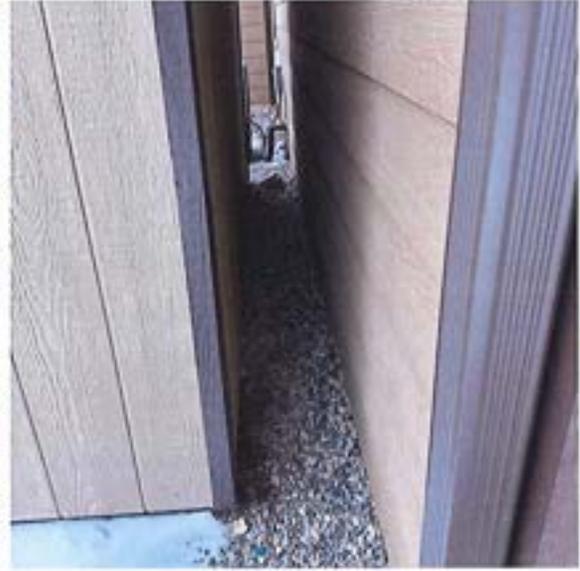
- Exterior East
- Exterior North
- Exterior West

2.2.1 Regrade to slope away from structure to reduce foundation deterioration potential water entry and subsequent damage. Monitor landscape grading near foundation for signs of normal soil compaction and correct as required.

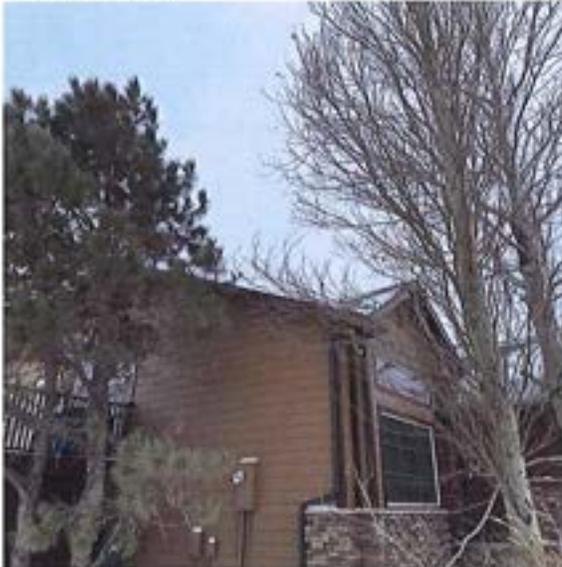
- Exterior North
- Exterior West

2.2.2 Trim and maintain trees, bushes and vines away from the structure to minimize damage/wear to structure and to discourage animal activity.

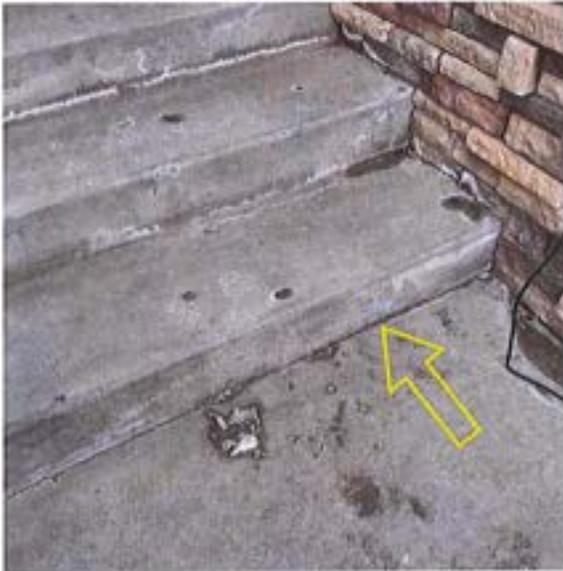
2.3.1 Fill and seal cracks to reduce water penetration further separation and potential trip hazards

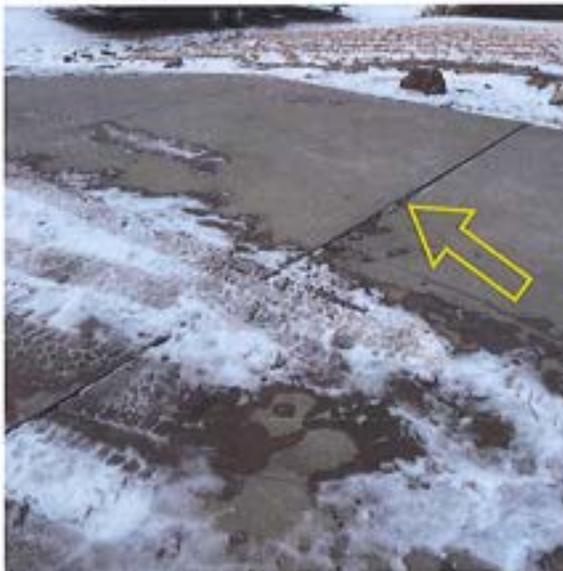
(Exterior West)

2.4.1 Repair settled driveway to prevent further damage, moisture related damage, and trip hazards.

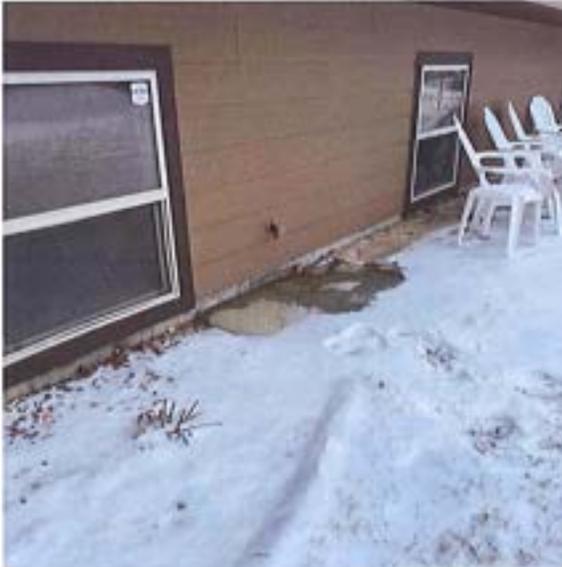
2.5.1 Reslope concrete slab to drain away from structure to prevent deterioration and water entry. **(Exterior East)**

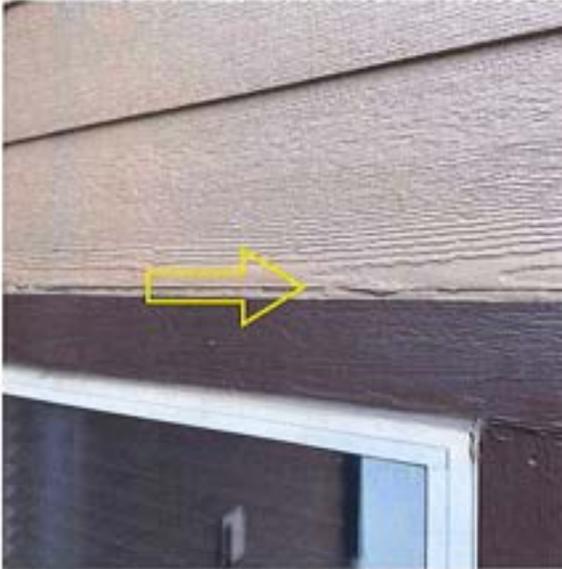
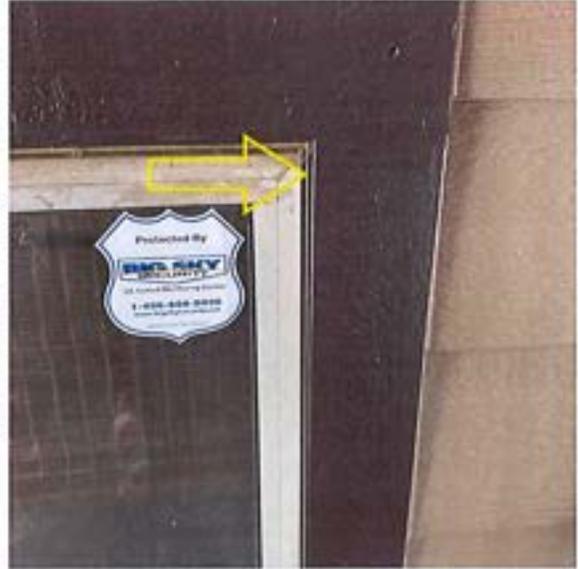
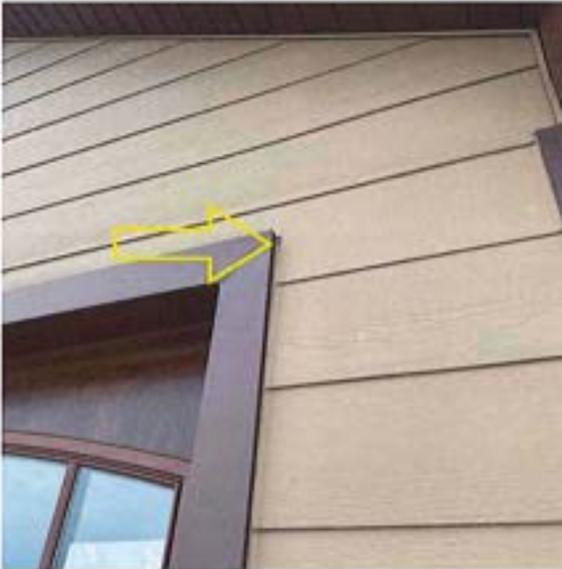
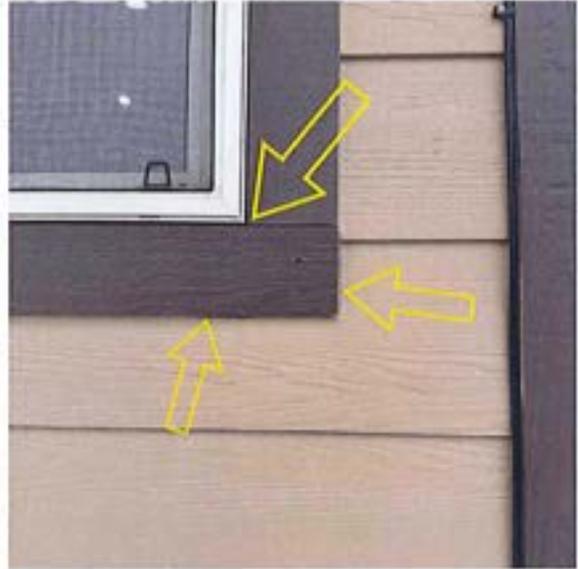
- Exterior East
- Exterior North
- Exterior South
- Exterior West

3.3.2 Ensure proper caulking and weather seal at all required locations and junctions such as windows, doors, dissimilar materials junctions, etc.

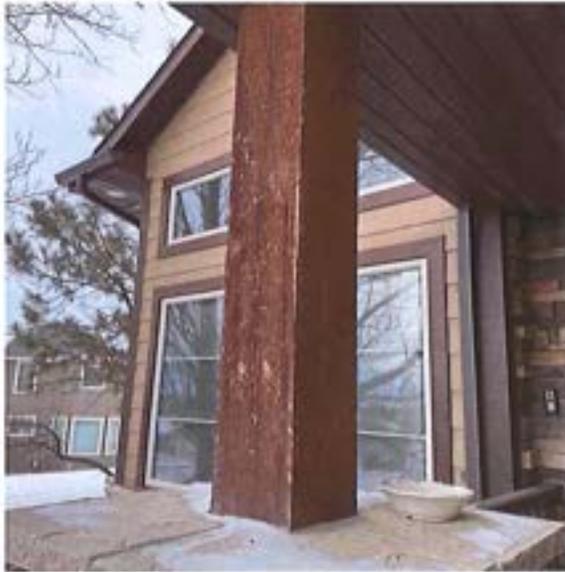
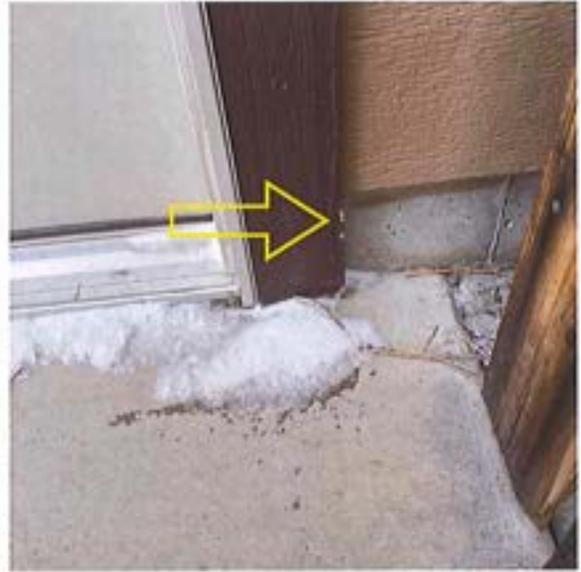
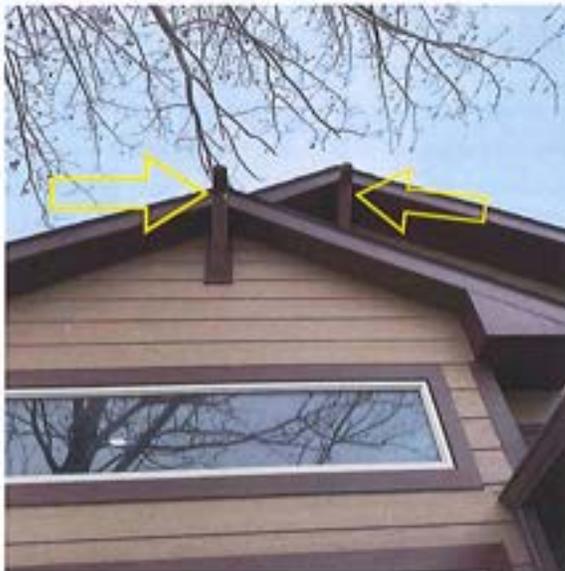
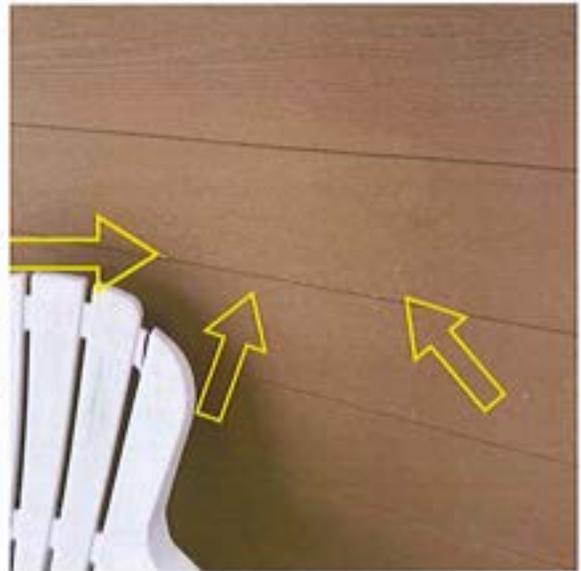
- Exterior East
- Exterior North
- Exterior South
- Exterior West

3.3.3 Clean, seal/paint/stain all exposed wood siding/trim to promote weathering protection.

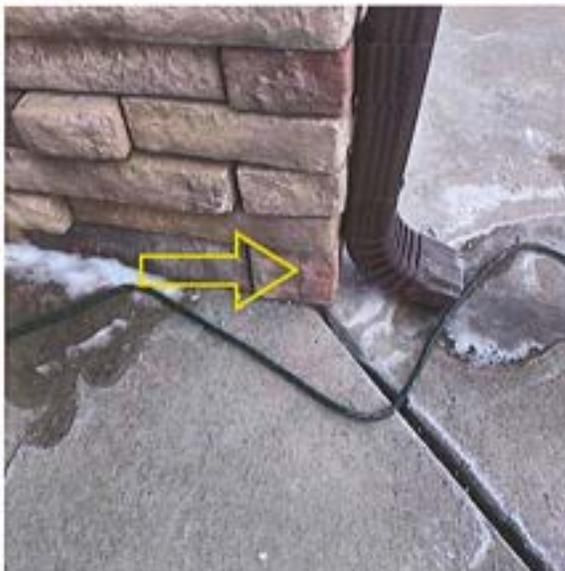
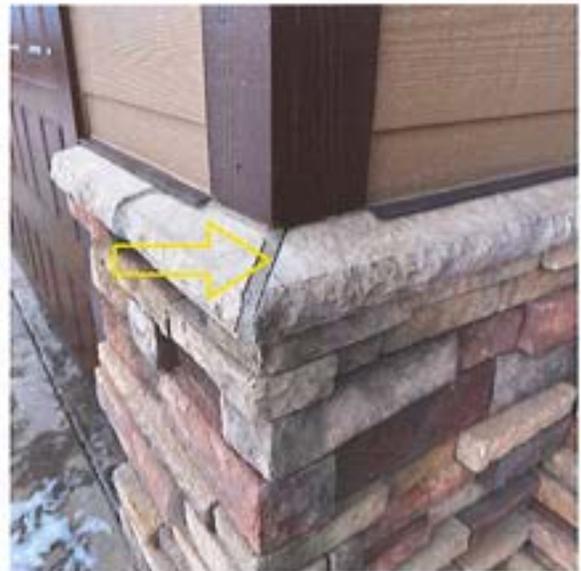
3.3.4 Repair/repoint stonework to prevent further damages and promote weathering protection. (Exterior West)

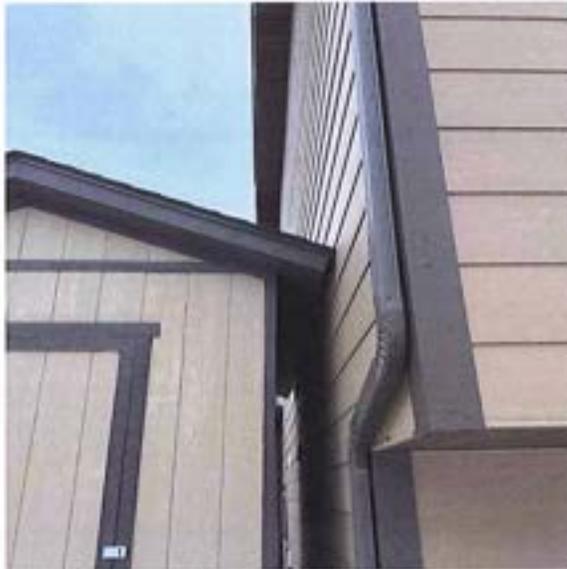
3.3.5 Caution is advised. Placement of shed can cause damage to siding. (Exterior South)

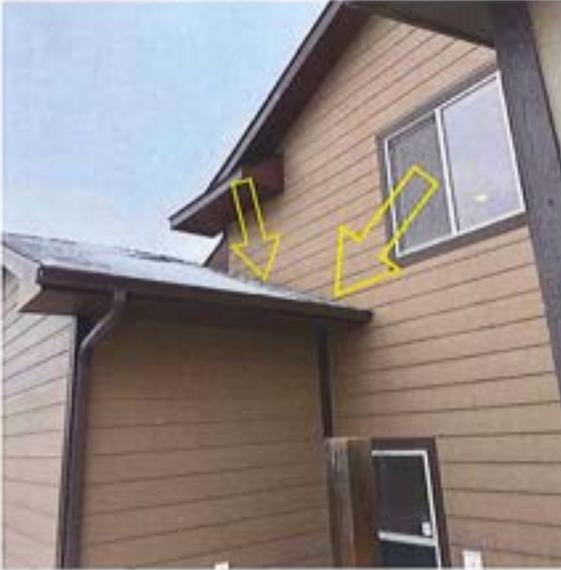
3.3.6 Replace damaged siding/trim to prevent further damage and promote weathering protection. (Exterior South)

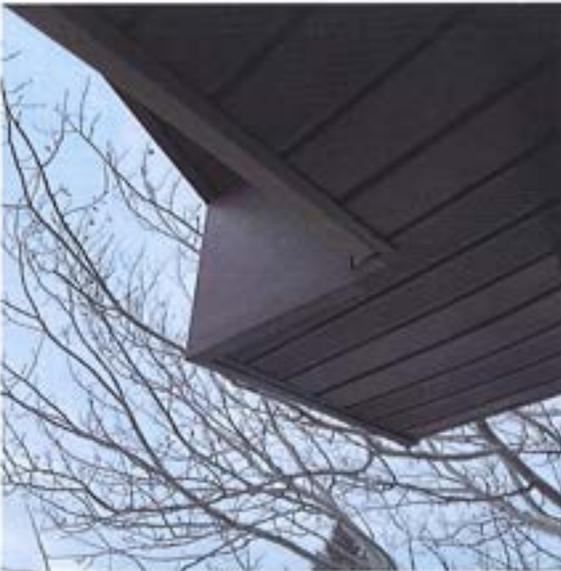
3.4.2 Secure loose soffit/fascia to prevent damage and deter pest entry. (Exterior West)

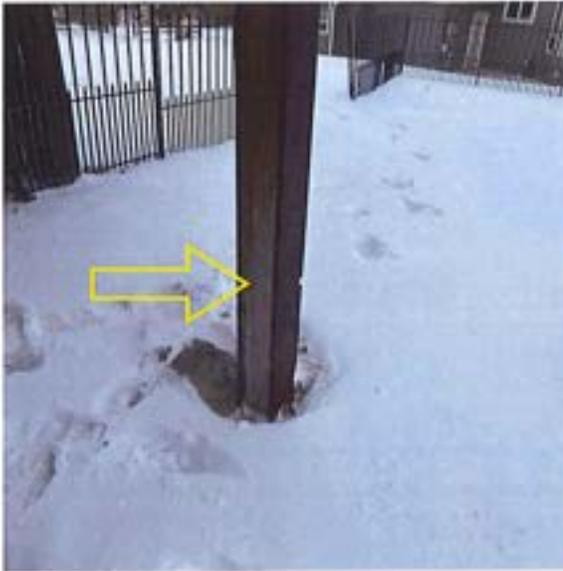
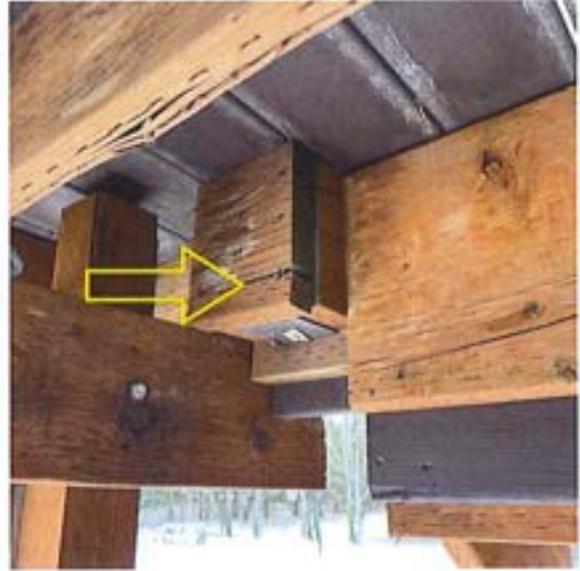
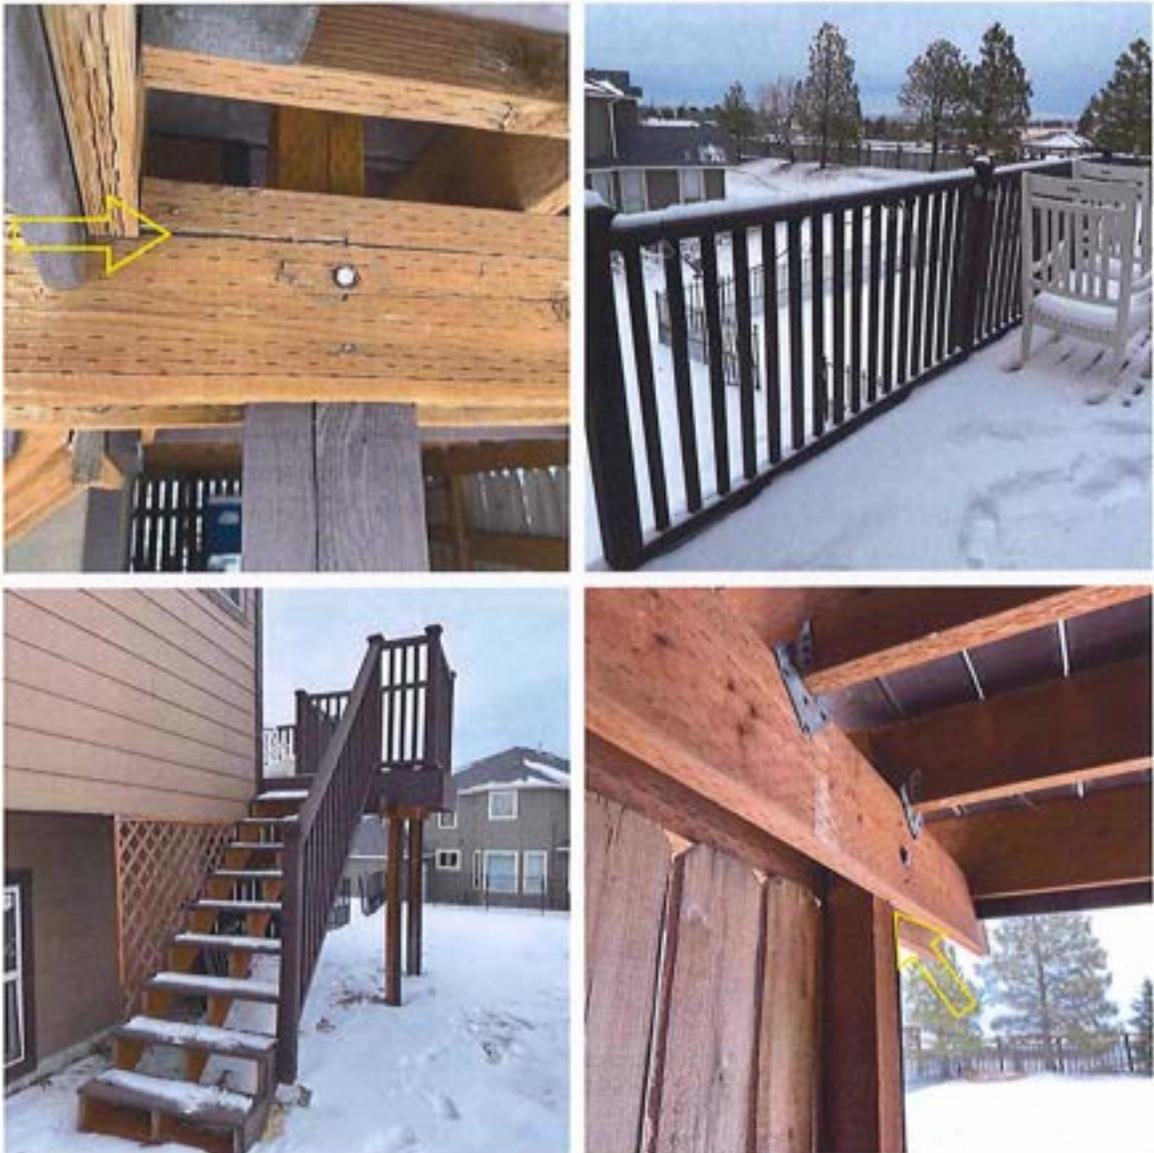
3.7.2 Consult a qualified contractor to evaluate decks and repair as recommended. A partial list of defects include:

- missing weather seal
- deteriorating support post
- improper support
- loose railings
- stair movement
- split/damaged support boards (Exterior East)

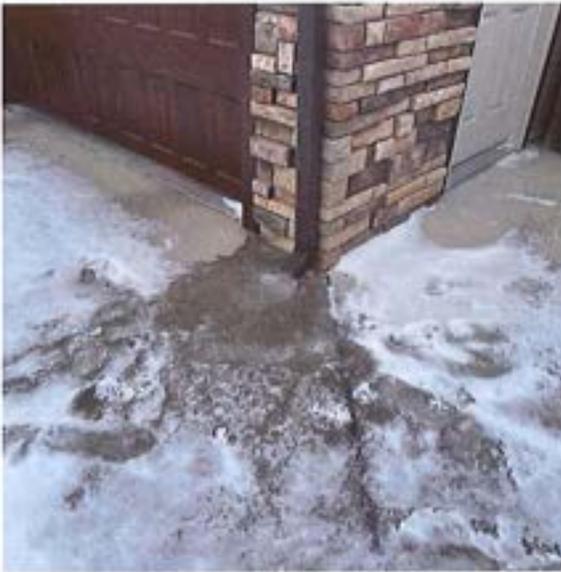
4.2.1 Caution is advised. Downspouts discharge on to walkway causing potential safety hazards. **(Exterior West)**

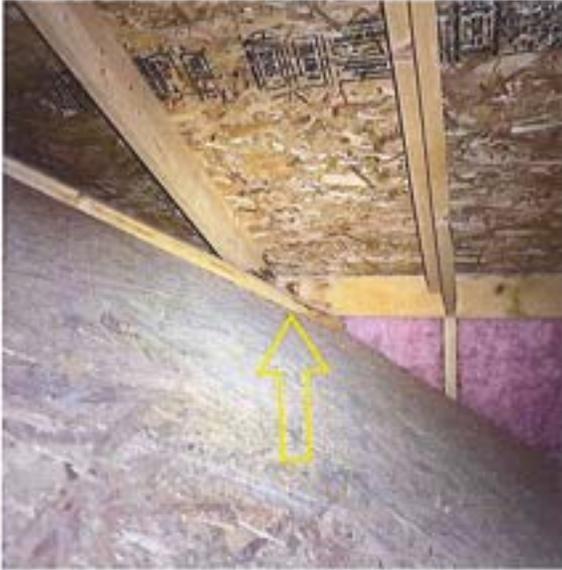
5.4.1 Stains noted - No moisture detected at time of inspection.

5.4.2 Further investigate cause and extent of staining/damage in attic and repair as required to prevent further damage.

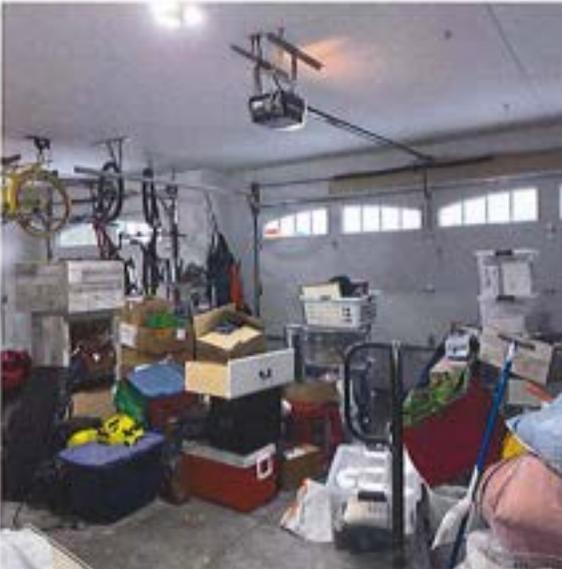
6.2.1 Further evaluate garage and all components when access is available. Belongings obstructing access at time of inspection.

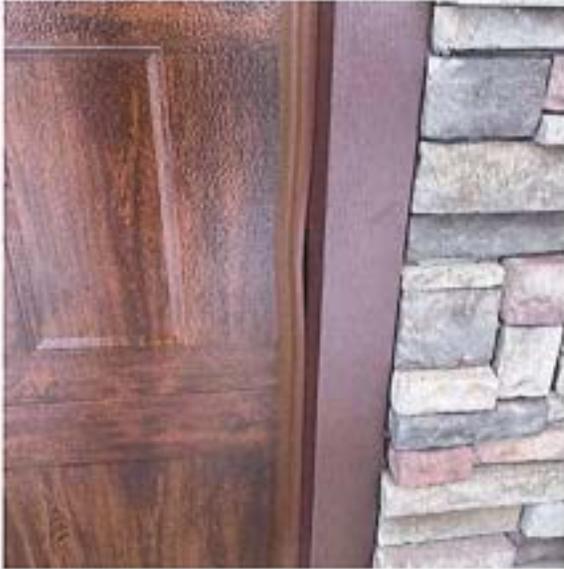
6.4.2 Secure loose weather seal to promote weathering protection. (Exterior West)

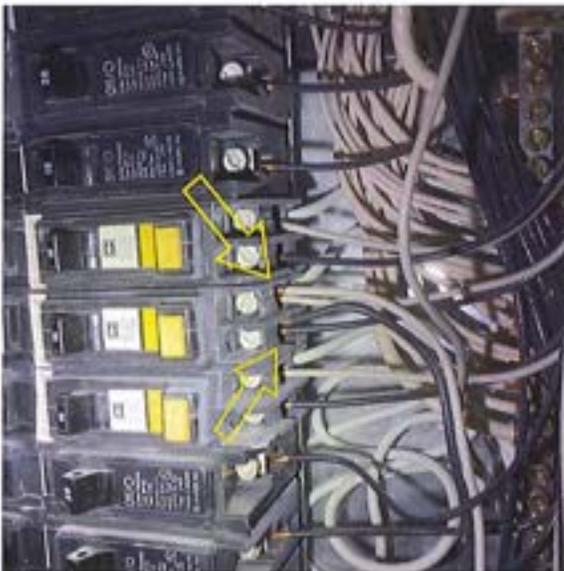
8.5.2 Consult qualified electrician to correct double tapped connections in distribution panel to reduce hazards associated with over fusing. **(Sub Basement)**

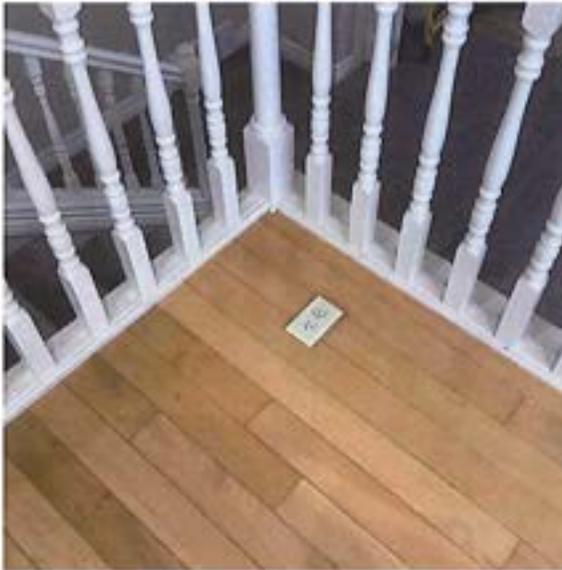
- 2nd Floor Hallway
- Dining room
- Kitchen
- Living Room
- Sub Basement

8.8.2 Secure loose receptacles to prevent stress wiring and electrical hazards.

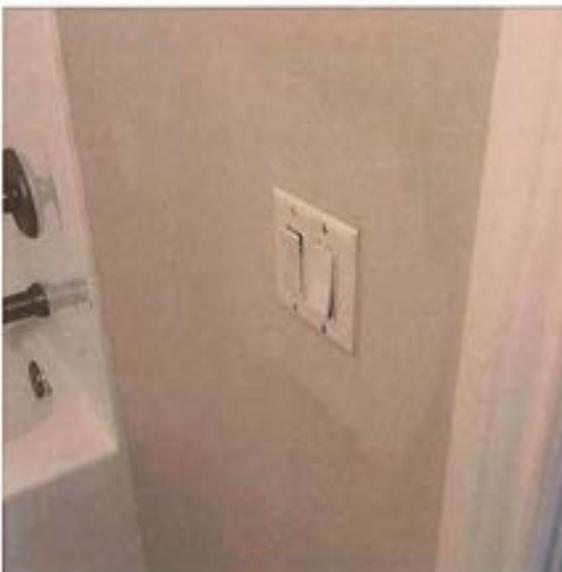
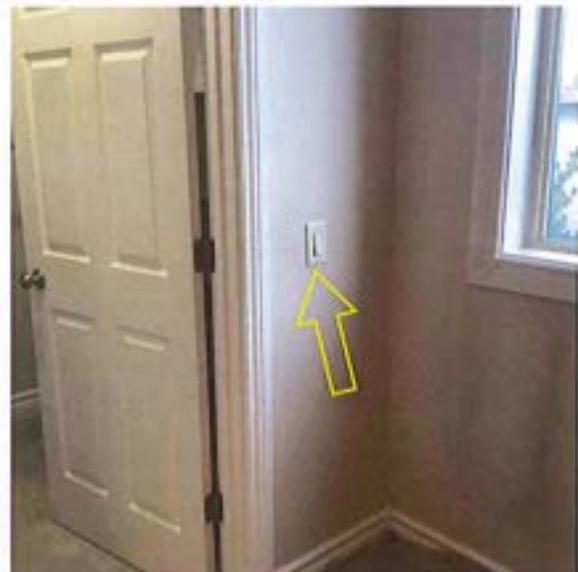
- 2nd Floor Hallway Bathroom
- Basement Bathroom
- Basement Southeast Room
- Laundry area
- Master Bedroom

8.9.2 Loose switch(es) should be replaced for improved electric safety.

8.9.2 - Replacement switches purchased but not installed (located on bench in garage).

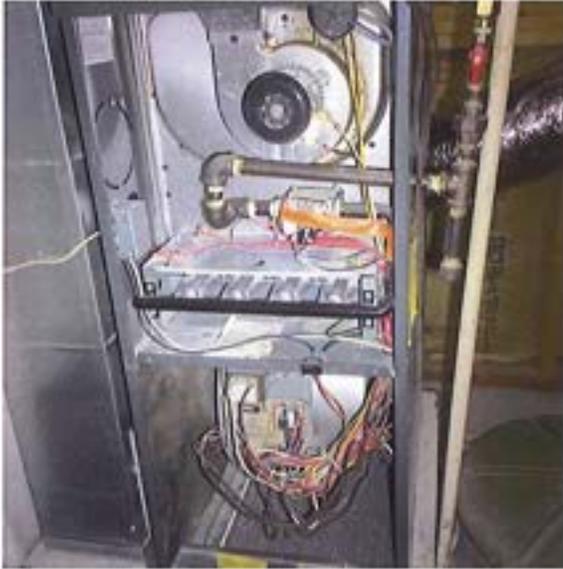
9.6.4 Clean and service furnace to promote system longevity. (Utility Area)

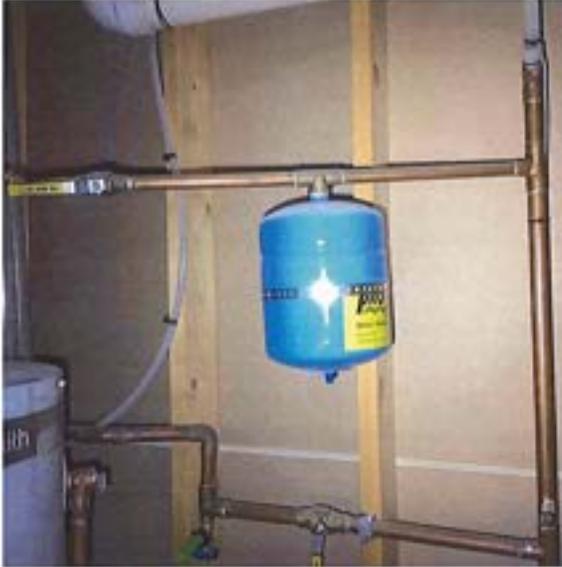
10.2.4 Provide additional support for expansion tank to prevent stressed water line connection and subsequent water damages. **(Utility Area)**

10.2.4 - Additional support installed by owner (see attached photo).

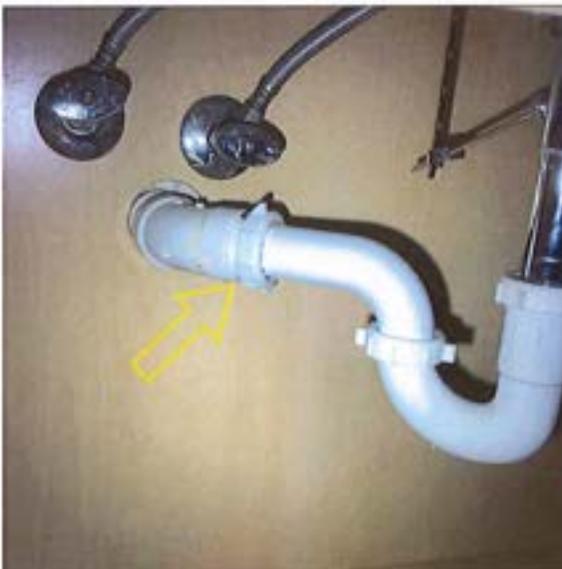
10.3.3 Repair leaking drain line to prevent secondary water damages. **(Basement Bathroom)**

10.3.3 - Leaking drain line repaired by owner.

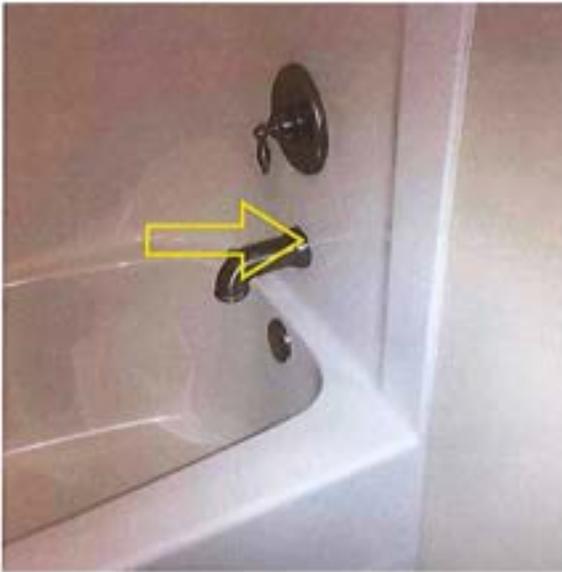
- 2nd Floor Hallway Bathroom
- Basement Bathroom

10.10.2 Seal all cracks/gaps/joints in and around tubs and showers to reduce water penetration and subsequent deterioration.

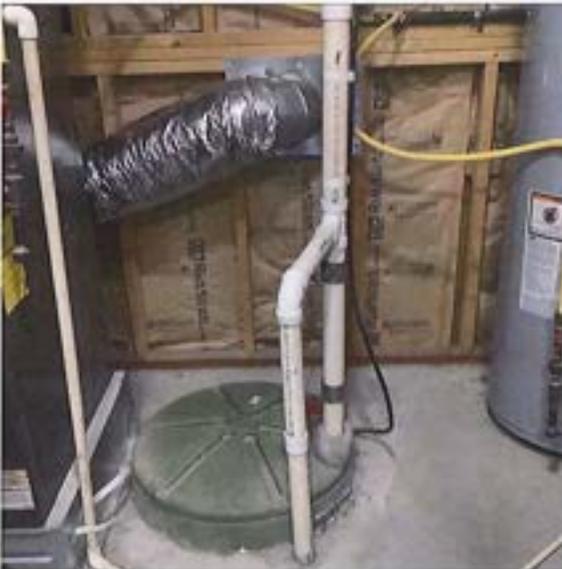
10.12.2 Properly install one way check valve at lift station to prevent stressed lines and subsequent water damages. (Utility Area)

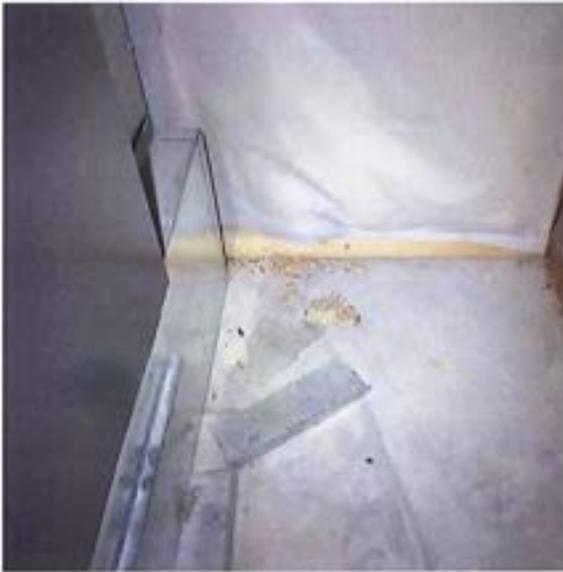
- ⊙ Staining/Minor Damages
- ⊙ Worn

11.1.1 Consult a pest control inspector to further investigate rodent activity and exterminate/ treat as required.

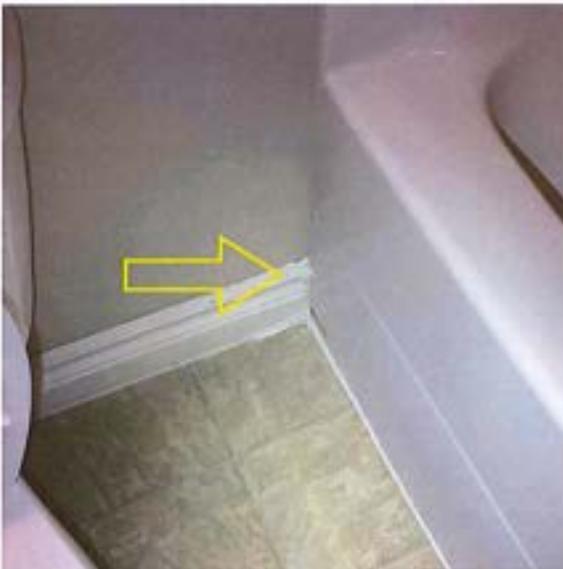
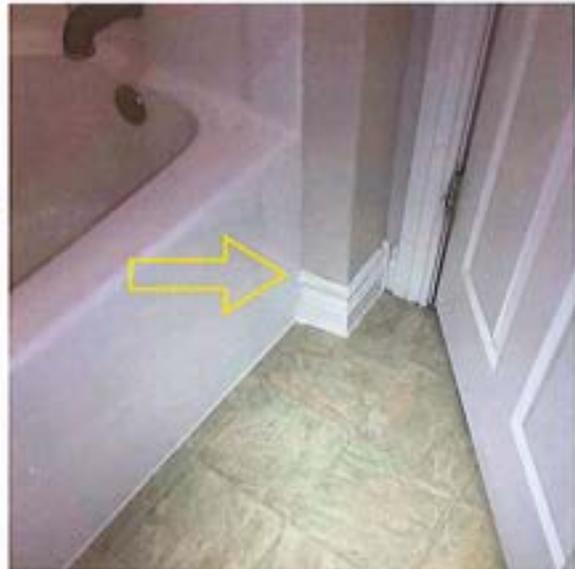
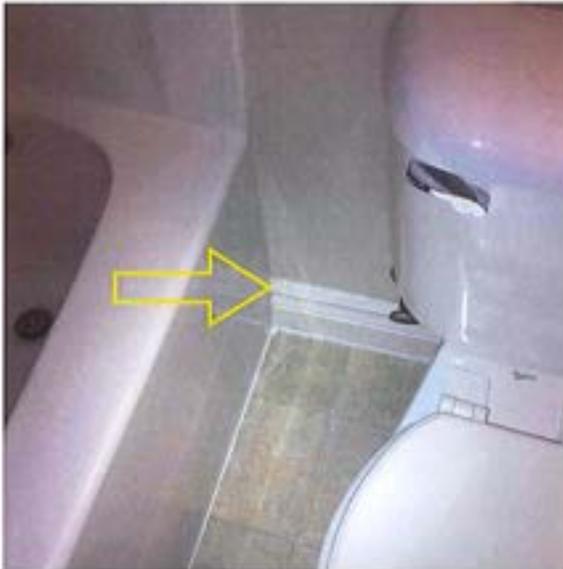
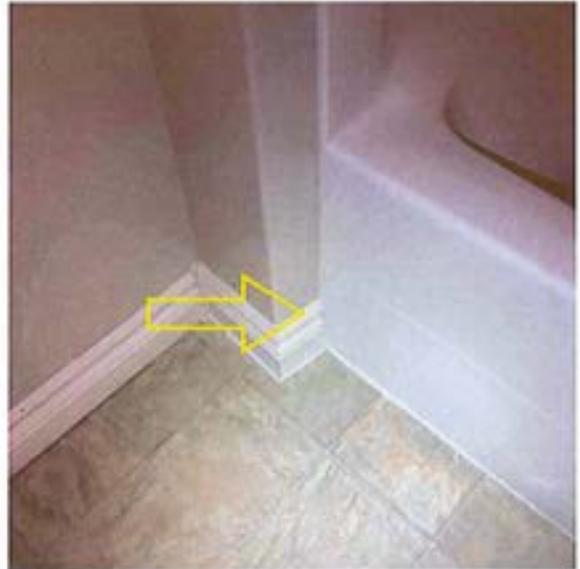
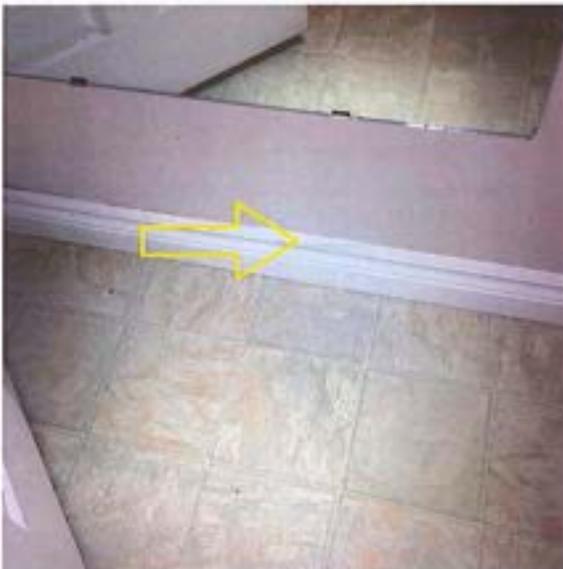
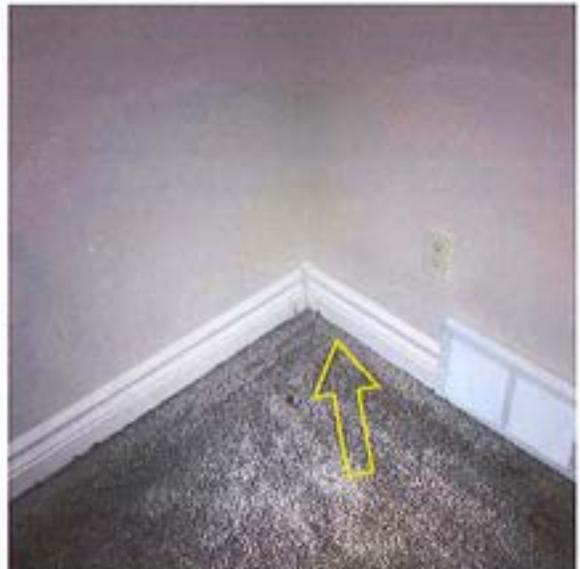
- 2nd Floor Hallway Bathroom
- Basement Bathroom
- Garage
- Master Bathroom

11.2.1 Further investigate cause and extent of staining/damage and correct as required. No moisture detected at time of inspection.

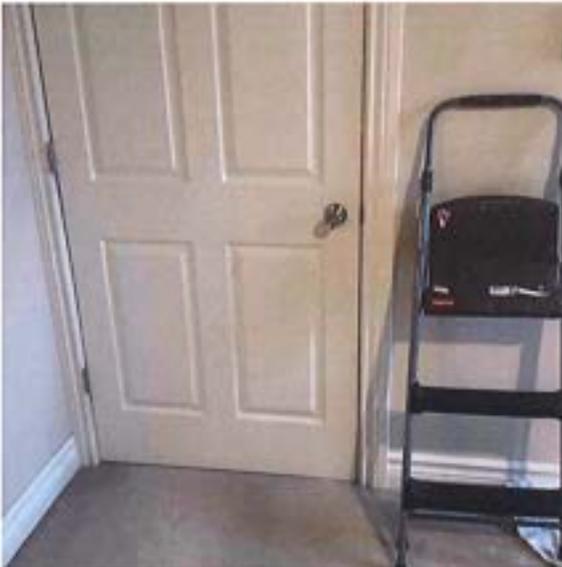
11.4.4 Adjust door striker plate to latch securely. (Master Bedroom)

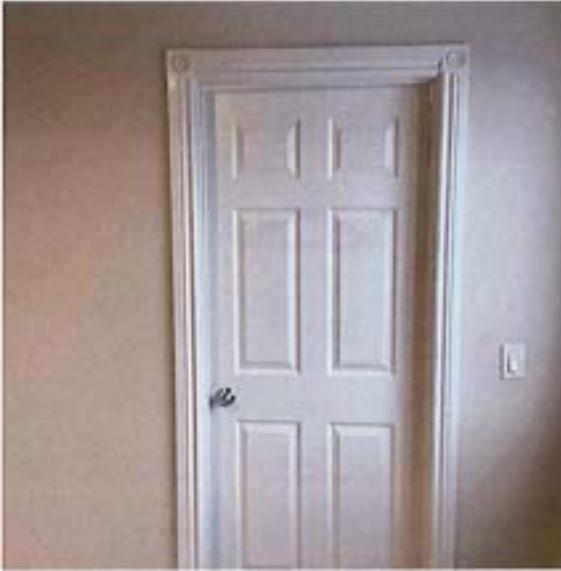
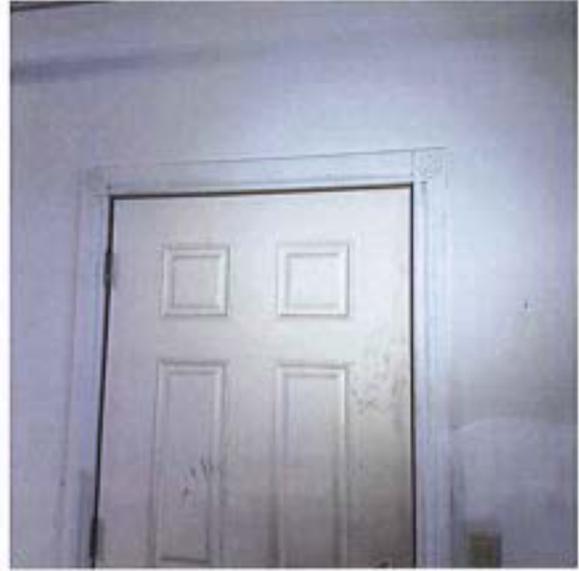
- Garage
- Master Bedroom

11.4.5 Adjust doors to reduce binding.

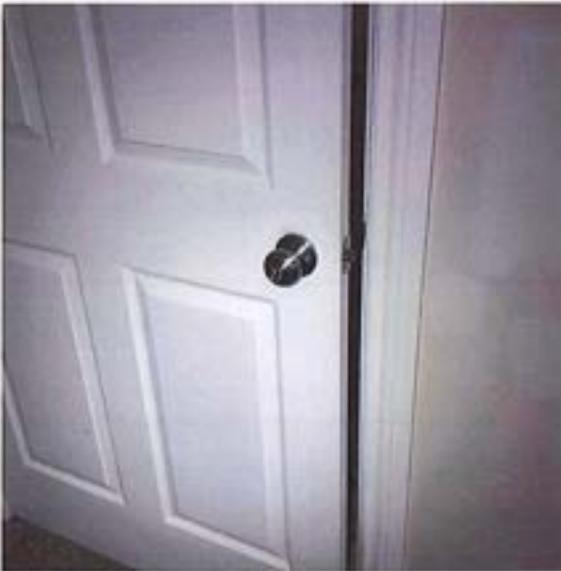
11.4.6 Secure loose door hardware to promote intended operation. (Basement Southeast Room)

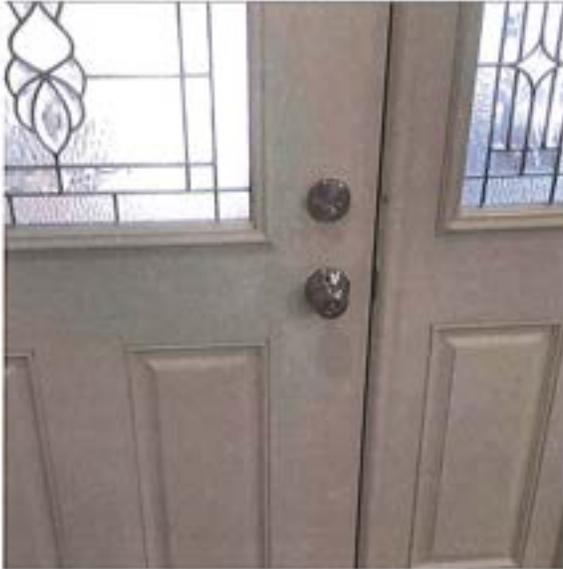
11.5.3 Secure loose door hardware to prevent damages and promote intended operation. (Living Room)

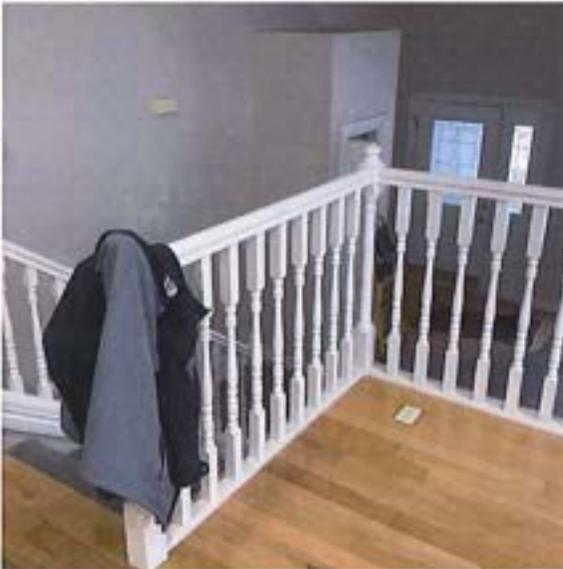
11.6.1 Worn**11.6.2 Secure loose railing to promote safety. (Dining room)**

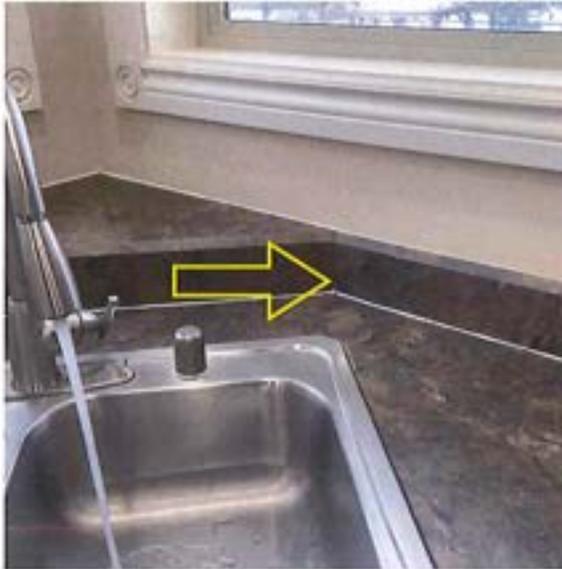
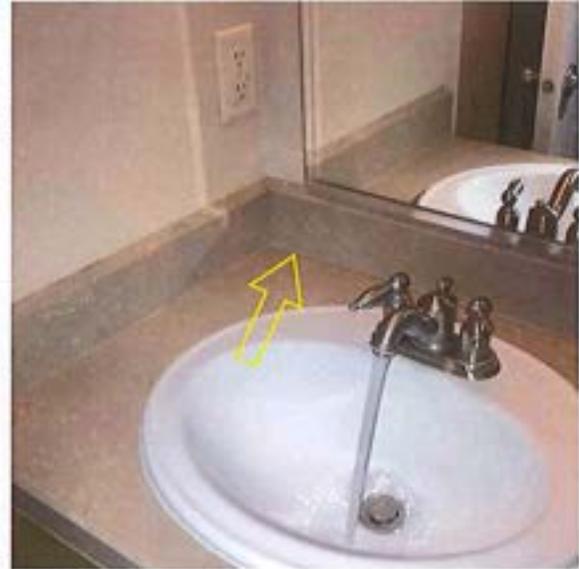
- 2nd Floor Hallway Bathroom
- Basement Bathroom
- Kitchen
- Laundry area
- Master Bathroom

11.7.1 Minor Damage/Scratches/Worn**11.7.2 Missing/Loose Hardware****11.7.3 Previous water damages noted - No moisture detected at time of inspection.**

11.7.4 Recaulk counters to prevent moisture intrusion and subsequent damages.
