HOLLOWTOP INSPECTION

HOLLOWTOP INSPECTION REPORT

803 Parkhill Dr
Billings, MT 59102

08/27/2025

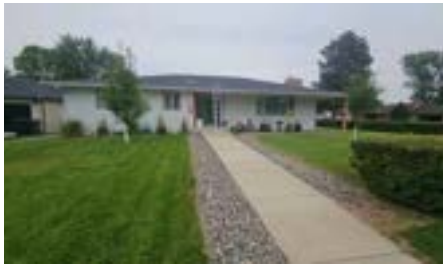
Temperature (approximate)
72 Fahrenheit (F)

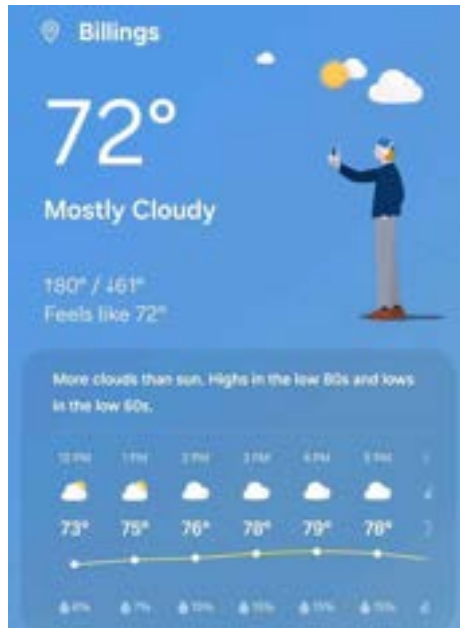
Main Entrance Door Direction
South

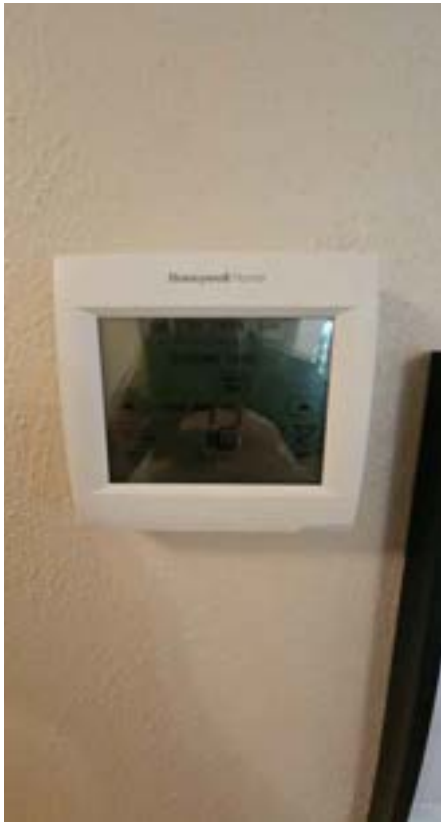
Cloudy

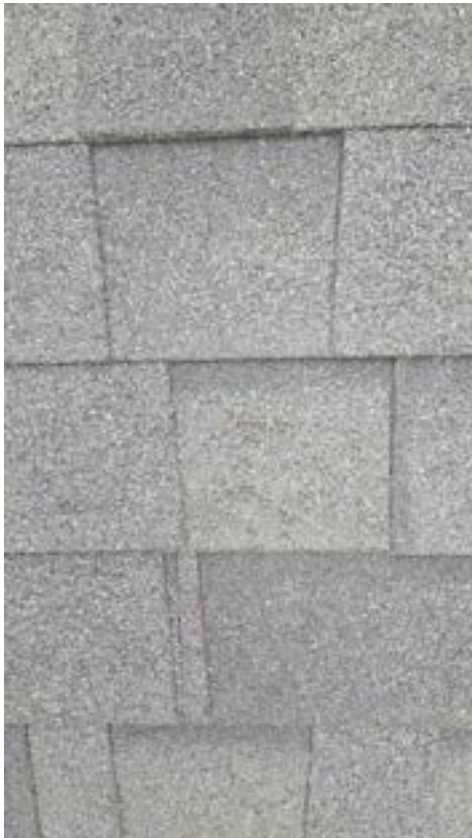
South

DAMAGED (GENERAL)

Roof coverings had visible damage. Recommend a qualified roofing professional evaluate and repair.

Contact a qualified roofing professional.

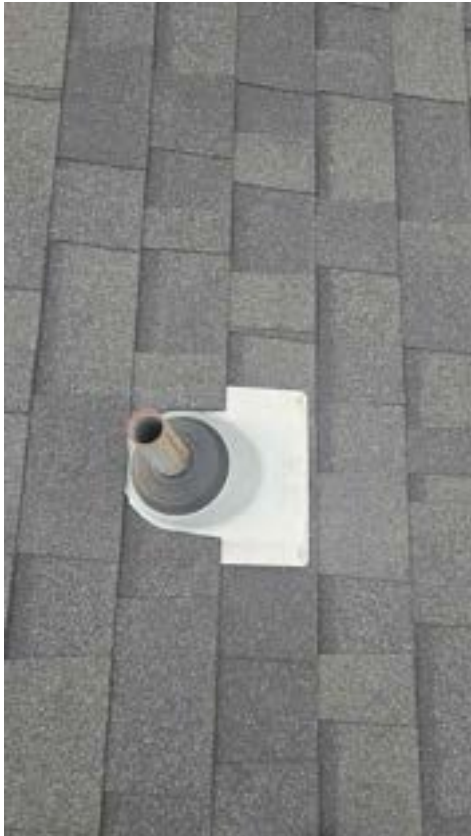
Northwest

NAILING MISSING WATER PROOFING

The nailing on the roof covering or on a roof vent is nailed correctly, but the nails do not have any water proofing. Whenever you put a hole into a roof you should properly water proof the intrusion. Recommend a qualified professional reapply water proofing caulk.

Contact a qualified roofing professional.

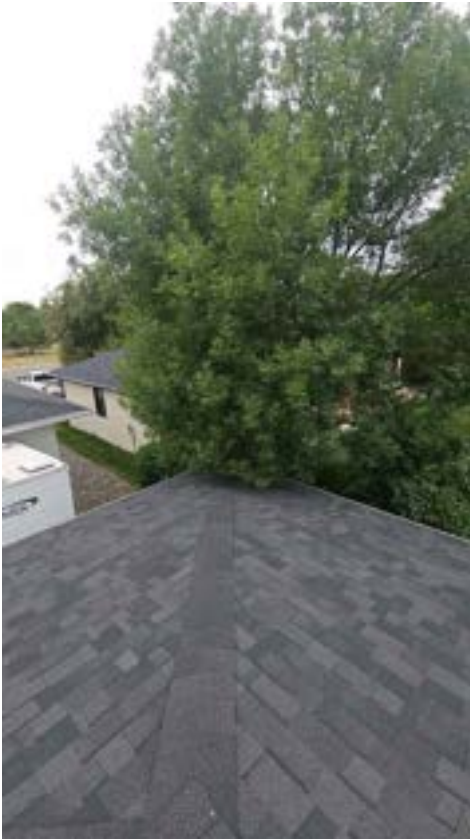
Garage

One or more trees were observed overhanging or in contact with the roof. This condition can lead to roof damage, debris accumulation, and provide a pathway for pests. Recommend a qualified tree service evaluate if branches should be trimmed or tree is in need of removal.

Contact a qualified professional.

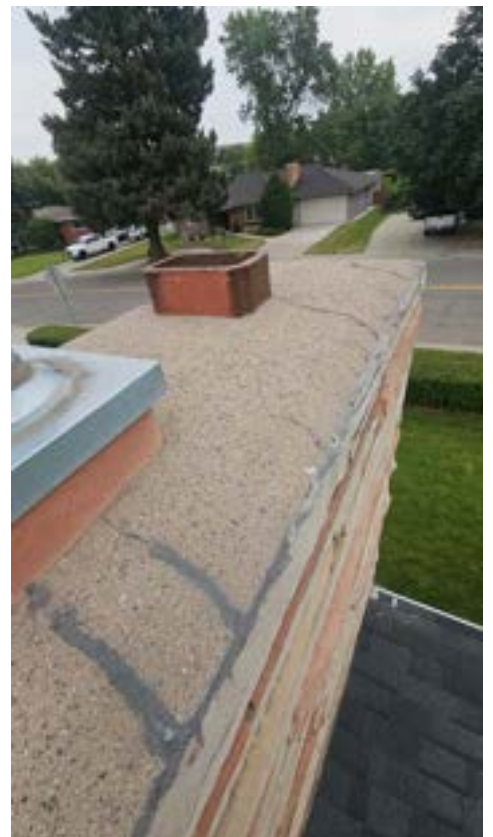
East

CROWN CAP CRACKING

Chimney crown cap is cracking and deteriorating. Recommend a qualified professional evaluate.

Contact a qualified chimney contractor.

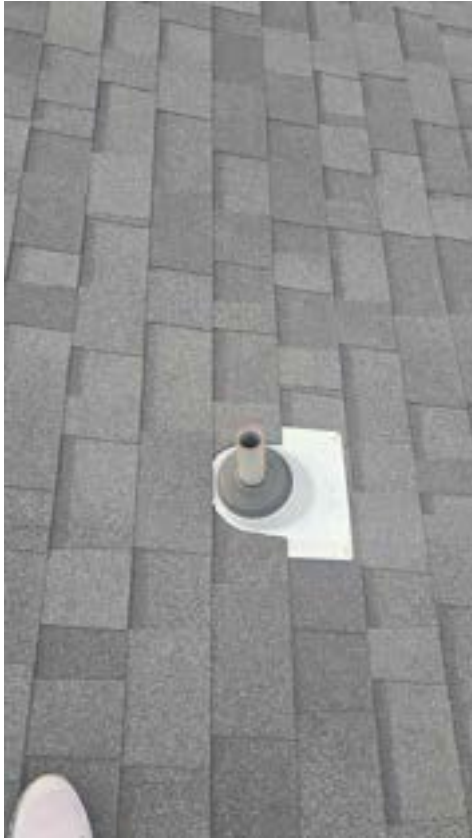
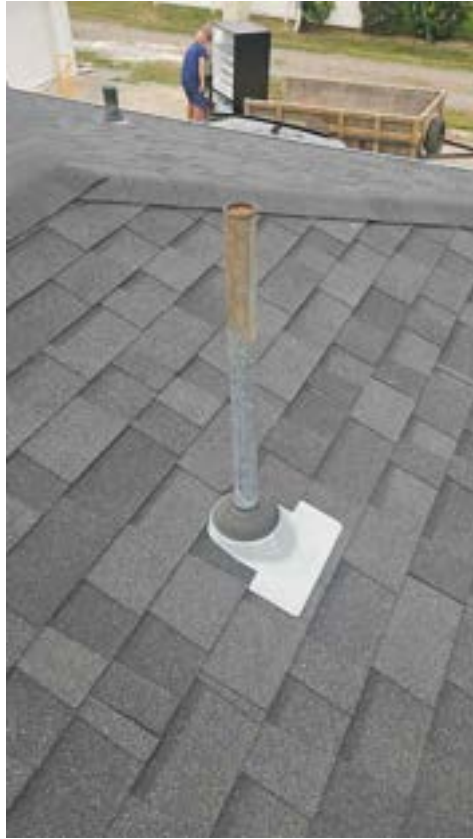
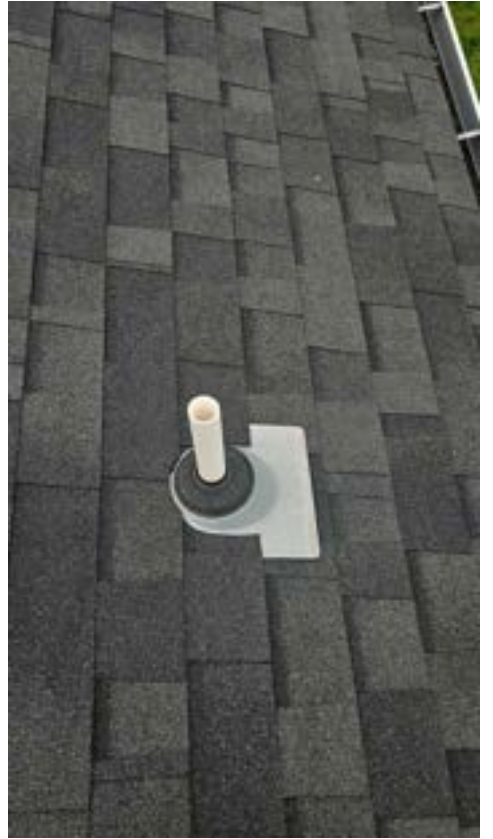
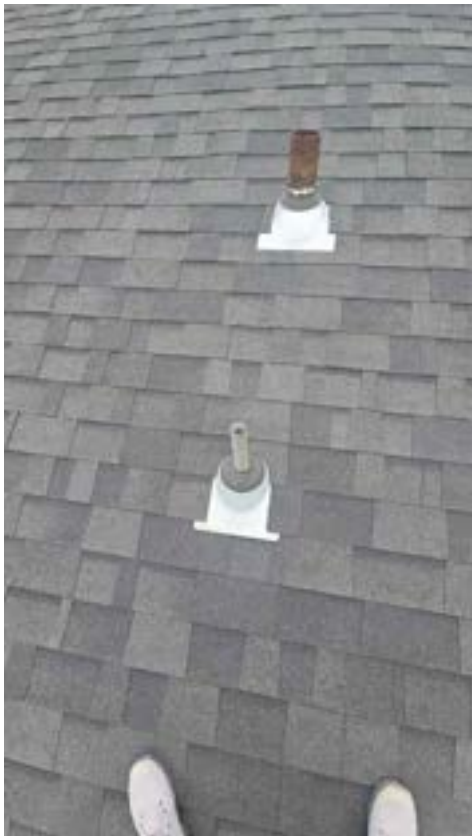
PLUMBING VENT DIAMETER

One or more of the plumbing vents had a diameter less than 3". Modern standards in Montana would have plumbing vent penetrations be 3" in diameter to stop freezing over in the winter. In older homes this was not a requirement. Recommend a qualified professional evaluate.

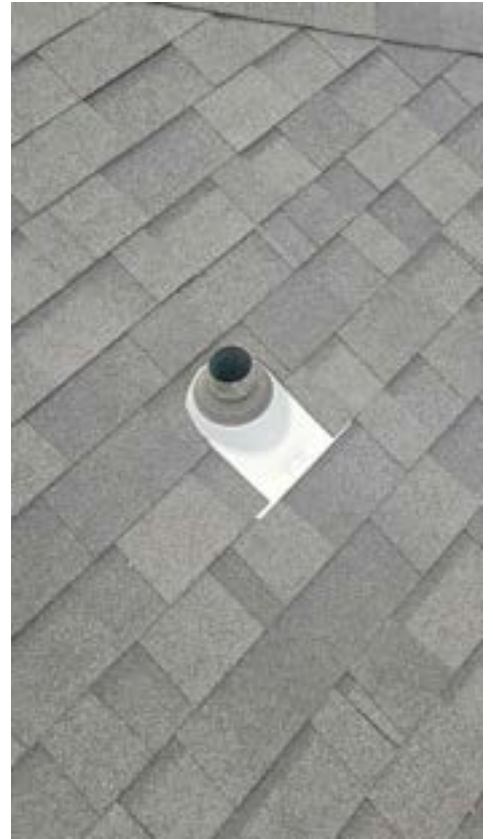
North

PLUMBING VENT HEIGHT OFF ROOF

One or more of the plumbing vents was not at least 12" off the roof. Recommend a qualified professional evaluate and correct.

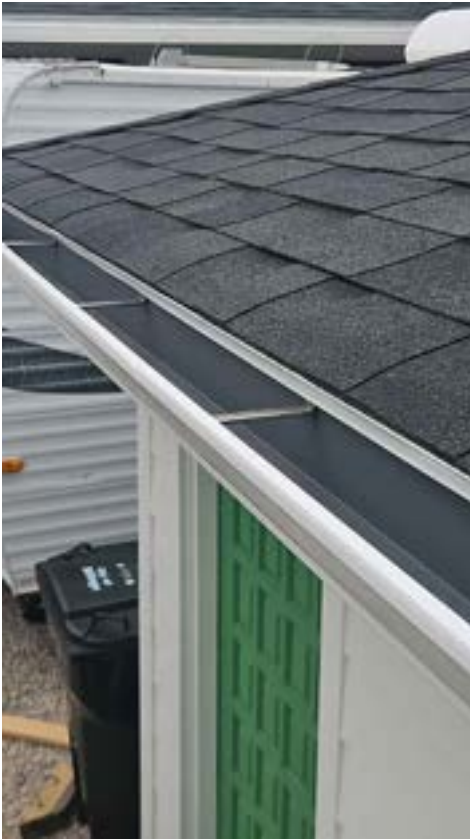
Garage

HAIL DAMAGE

In one or more areas the gutters or downspouts have visible hail damage. Recommend inquiring with sellers on any hail claims made and a roofing professional evaluate for any further damage.

Contact a qualified roofing professional.

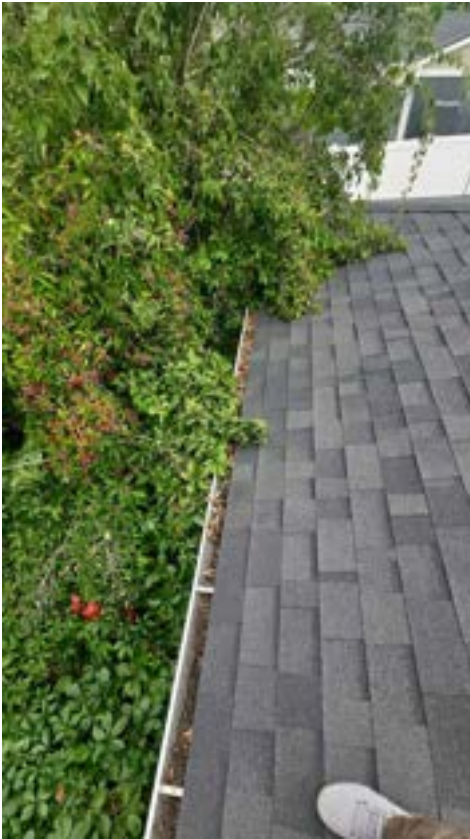
Garage

Debris has accumulated in the gutters. Recommend cleaning to facilitate water flow.

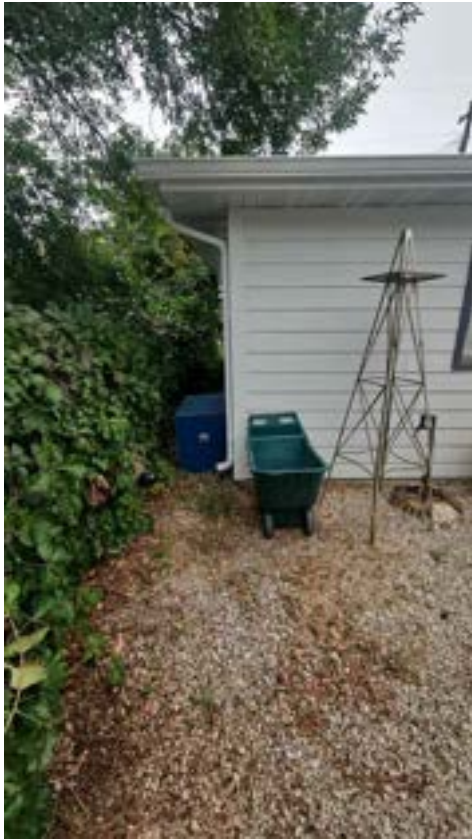
Garage

One or more downspouts drain too close to the home's foundation. This can result in excessive moisture in the soil at the foundation, which can lead to foundation/structural movement. Recommend a qualified contractor adjust downspout extensions to drain at least 6 feet from the foundation.

Contact a qualified gutter contractor

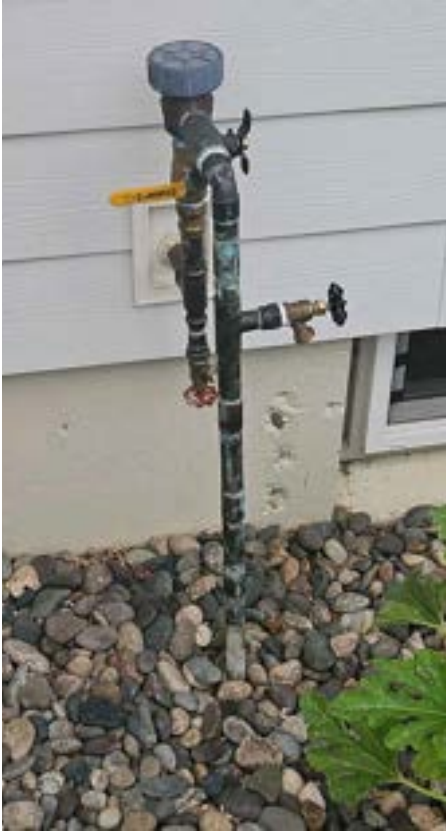
Vegetation, Grading, Drainage & Retaining Walls: Sprinkler System

There was a sprinkler system installed this item is not in the scope of inspection. Recommend a qualified professional evaluate.

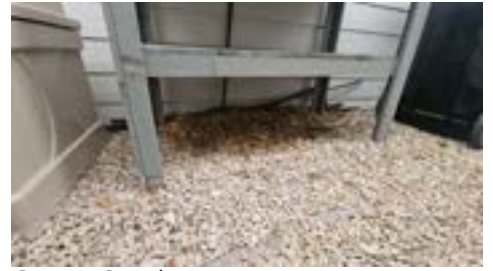
Garage Southeast

GROUND CLEARANCE

Inadequate clearance between siding and ground. Recommend a minimum ground clearance between bottom of siding and ground of 4". Siding in contact with the ground or soil is a serious concern because that condition can provide direct access for wood destroying insects.

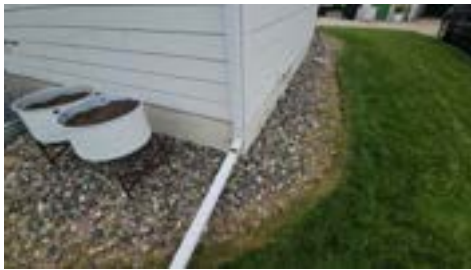
Northeast

In one or more places there was visible paint discoloration and/or peeling. Recommend a qualified painter evaluate and repair.

Contact a qualified painting contractor.

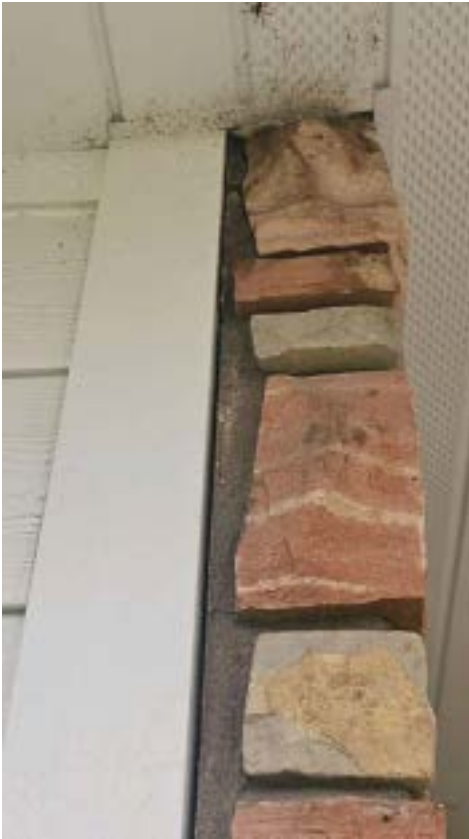
South

GROUT CRACKING

One or more areas of the brick or stone veneer had visible cracking to the grout. This can lead to loose sections over time. Recommend a qualified professional evaluate and correct.

Contact a qualified professional.

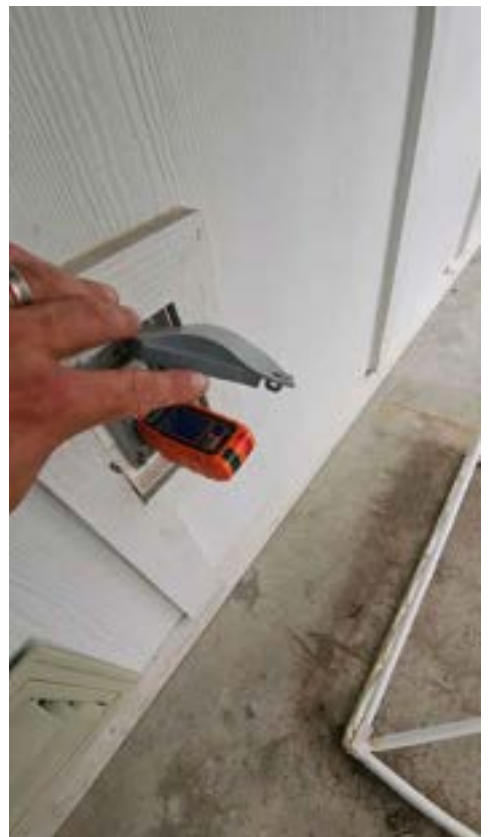
North

No GFCI protection present in one or more locations. Recommend licensed electrician upgrade by installing ground fault receptacles in all locations.

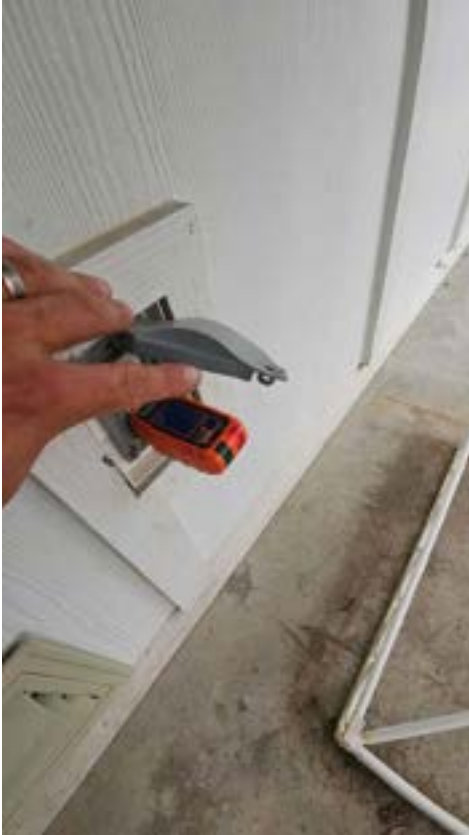
North

One or more of the exterior outlets was ungrounded. Recommend a qualified professional evaluate.

Contact a qualified professional.

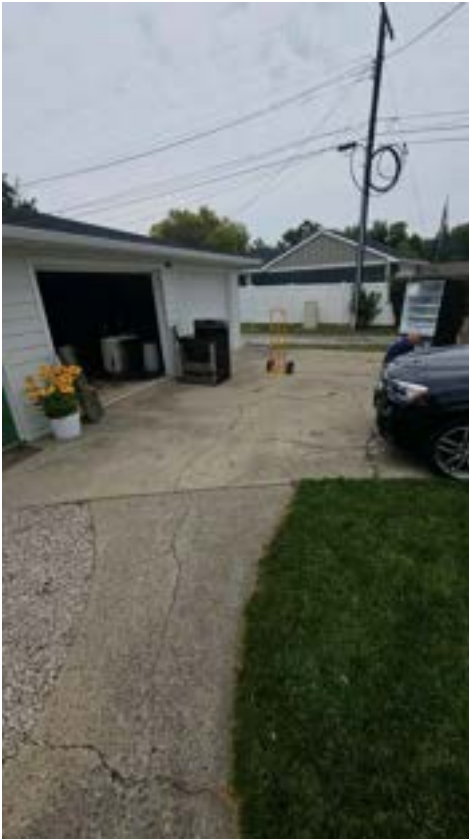
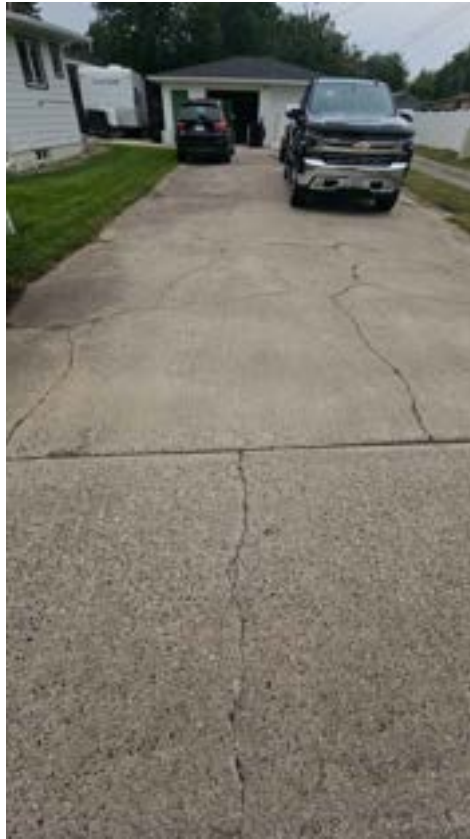
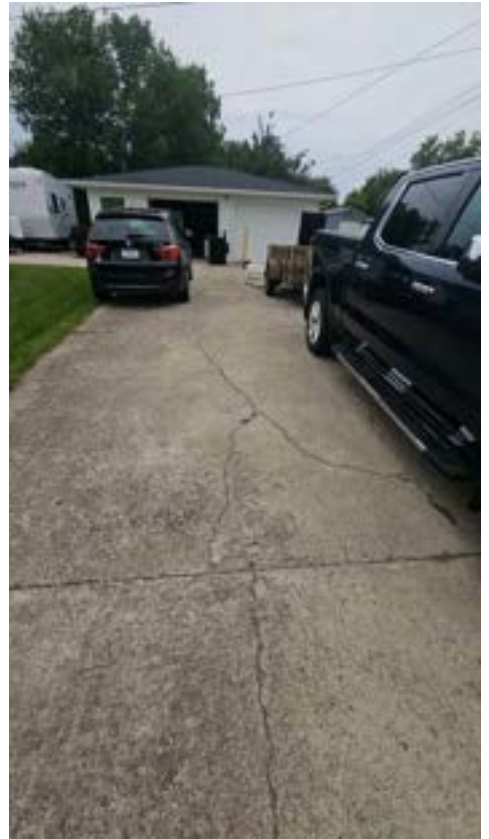
North

DRIVEWAY CRACKING

Cracks observed, which may indicate movement in the soil. Recommend monitor and/or have concrete contractor patch/seal.

Contact a qualified concrete contractor.

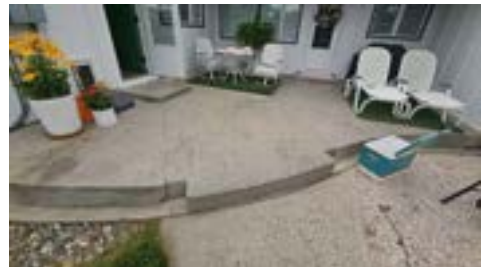
PATIO CRACKING

Settling and cracking observed on properties patio. Recommend a qualified professional evaluate and/or patch/seal.

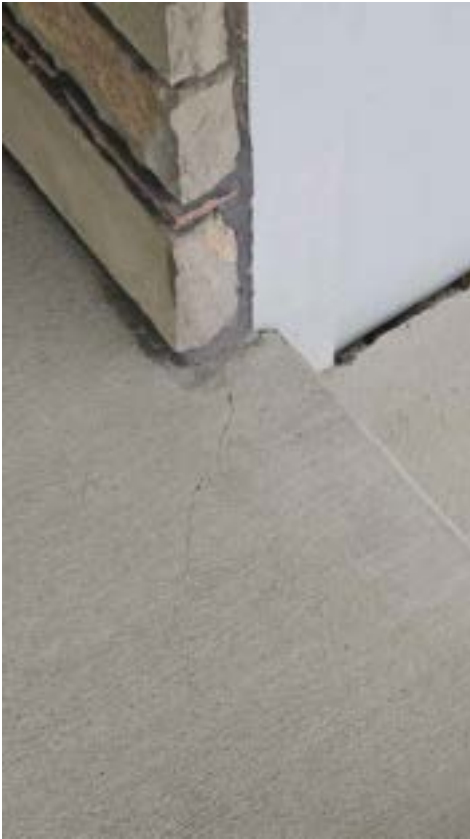
South

WALKWAY CRACKING

Cracks observed on the walkway. Recommend concrete contractor evaluate and patch and seal as needed.

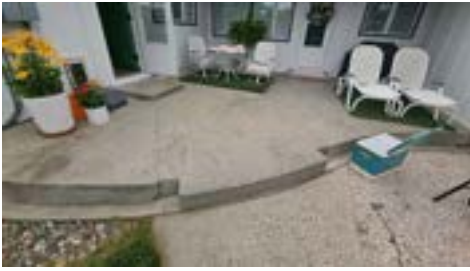
CONCRETE SPALLING- MINOR

Concrete has minor wear and spalling, watch for worsening condition, and cause of issue. Most likely weather or water wearing away the concrete.

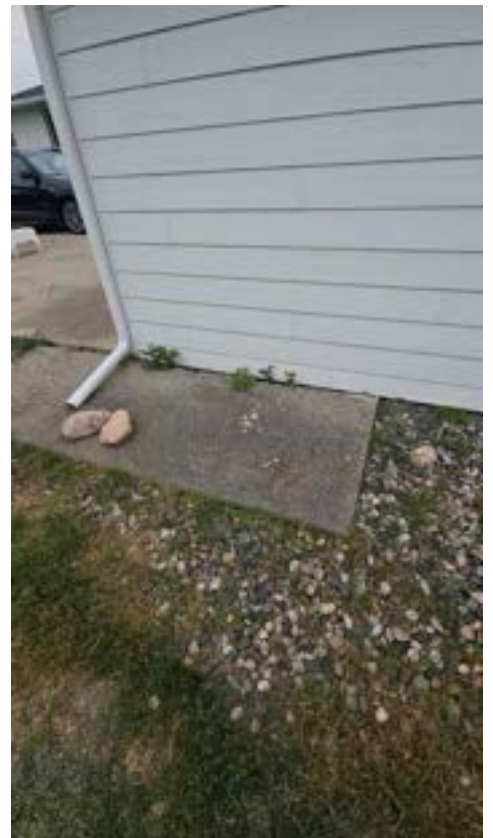
Garage Northeast

3.4.5 Walkways, Patios & Driveways
SETTLEMENT/SLOPING

There was visible exterior patio or walkway settlement and sloping. Recommend a qualified professional evaluate and repair as needed.

Contact a qualified professional.

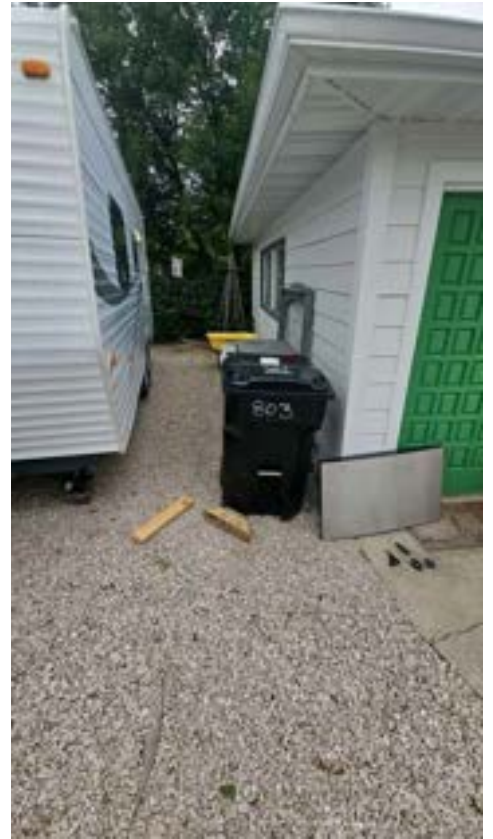
Garage South

Grading is sloping towards the home in some areas. This could lead to water intrusion and foundation issues. Recommend qualified landscaper or foundation contractor regrade so water flows away from home.

Contact a qualified grading contractor.

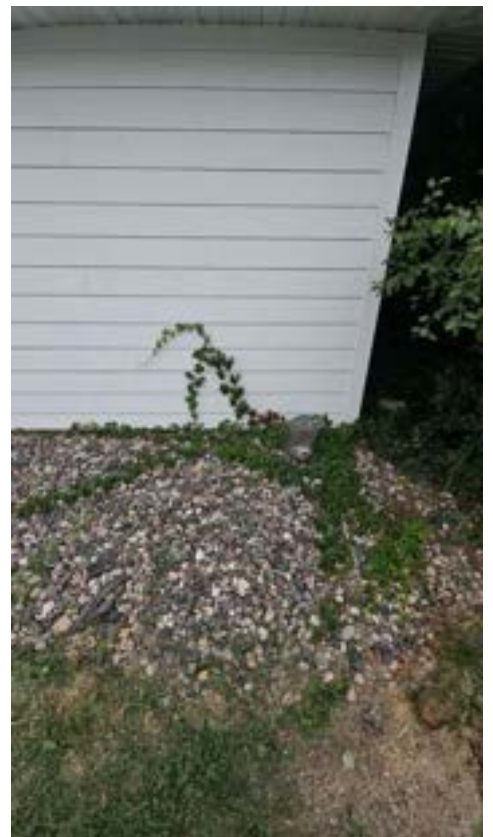
Garage Northwest

Vines or other vegetation has grown into the structure, although this may look nice it is very bad for the home. This can cause water intrusion, siding and roof damage, and also general decay of materials.

Contact a qualified tree service company.

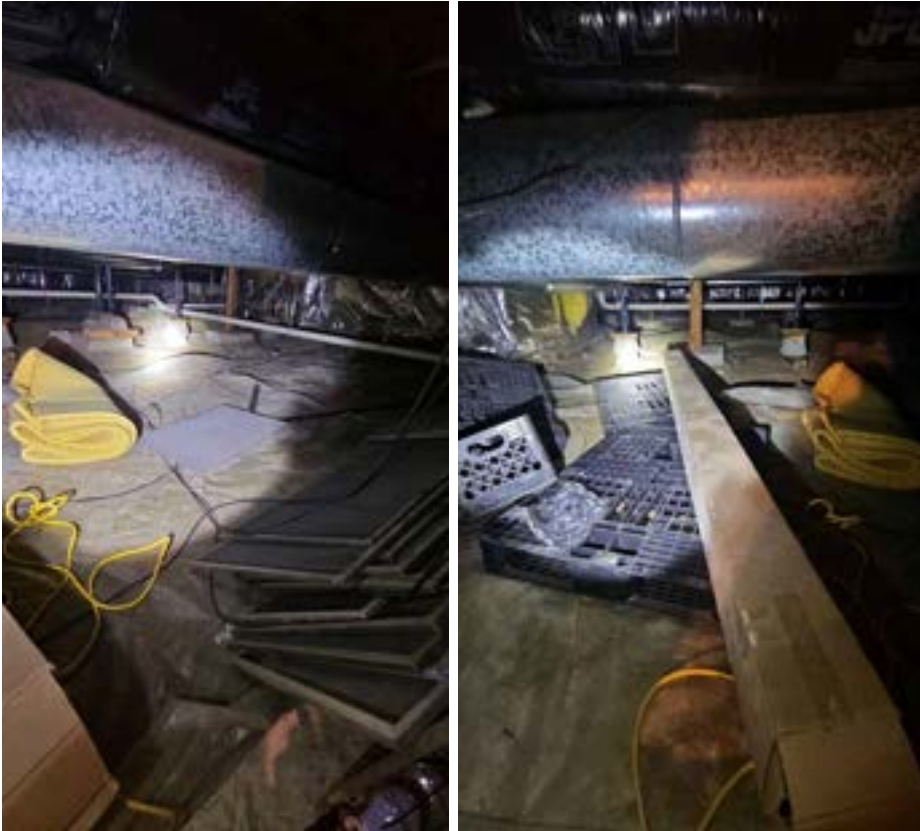
Floor Structure: Basement/Crawlspace Floor

Dirt, Sealed

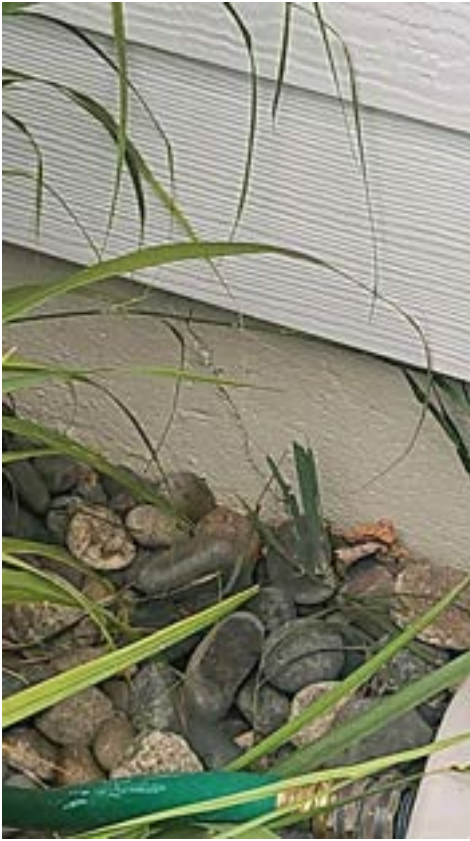
Southwest

FOUNDATION CRACKS

Cracking was noted at the foundation. Some cracking is common as concrete ages and shrinks. Recommend the cracks be evlouted and properly sealed by a foundation contractor.

Contact a foundation contractor.

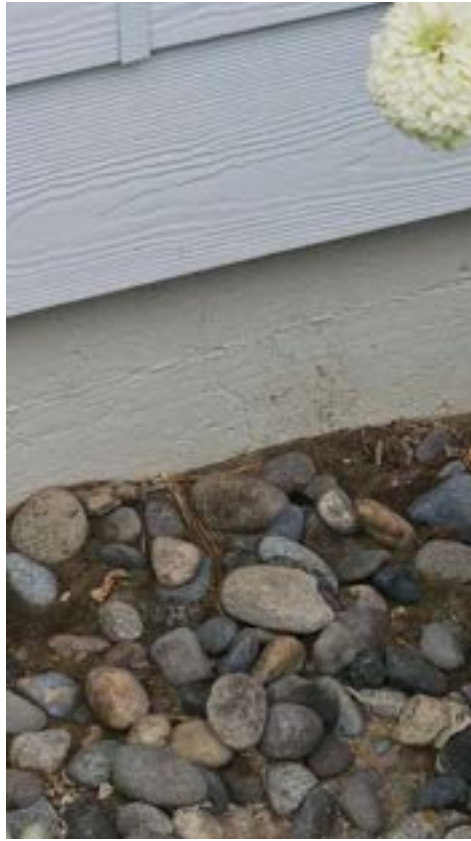
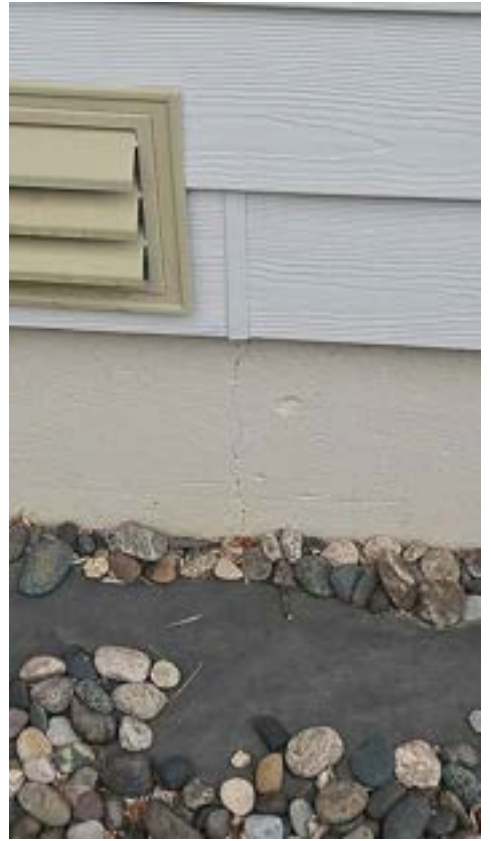
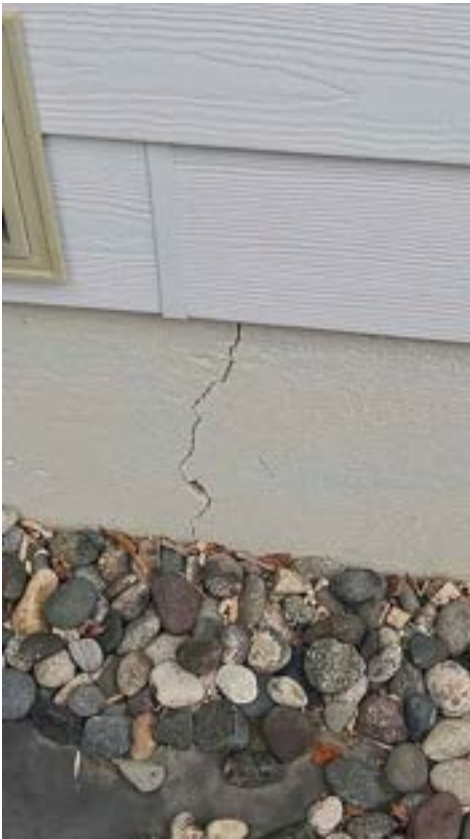
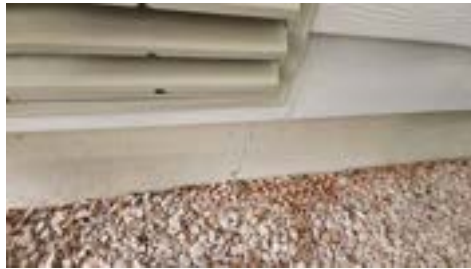
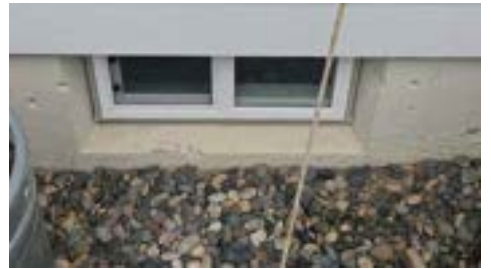
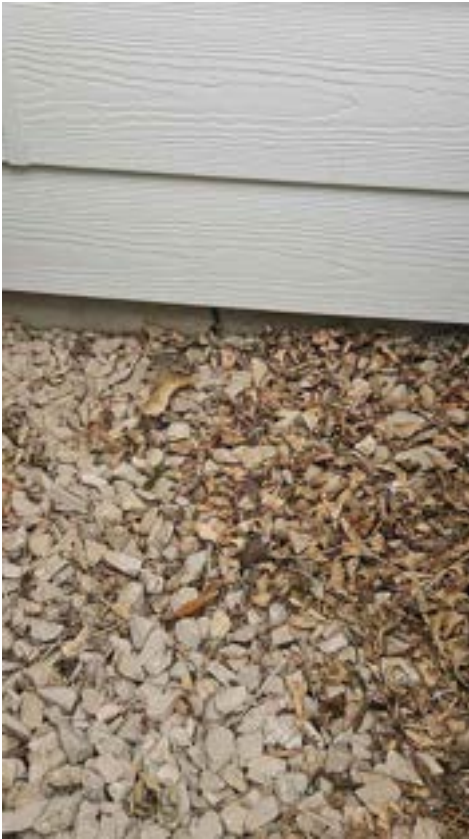
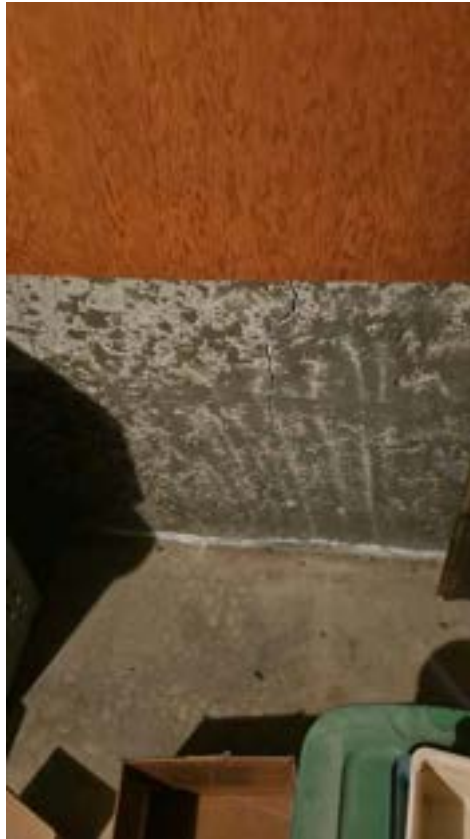
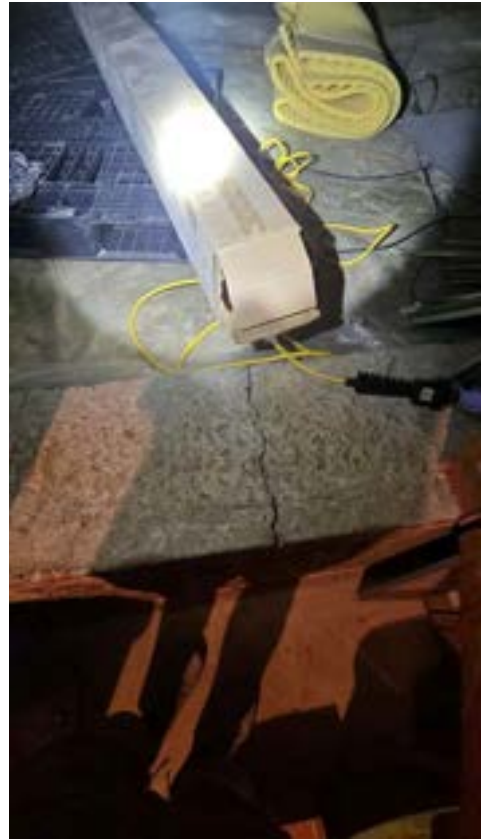
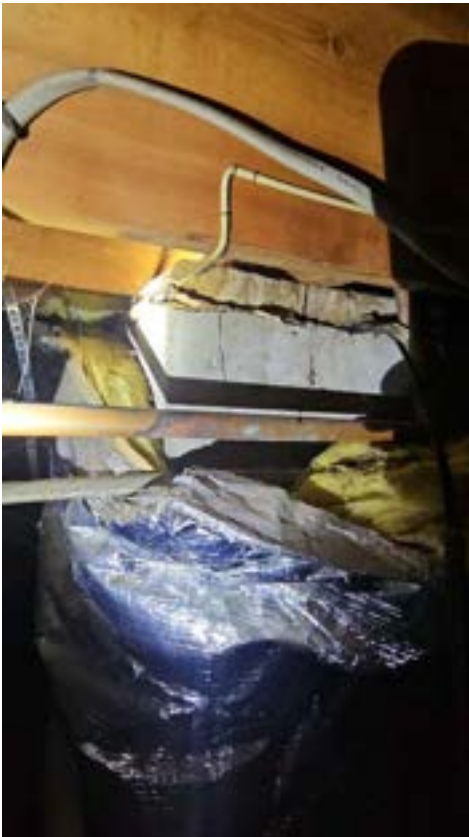
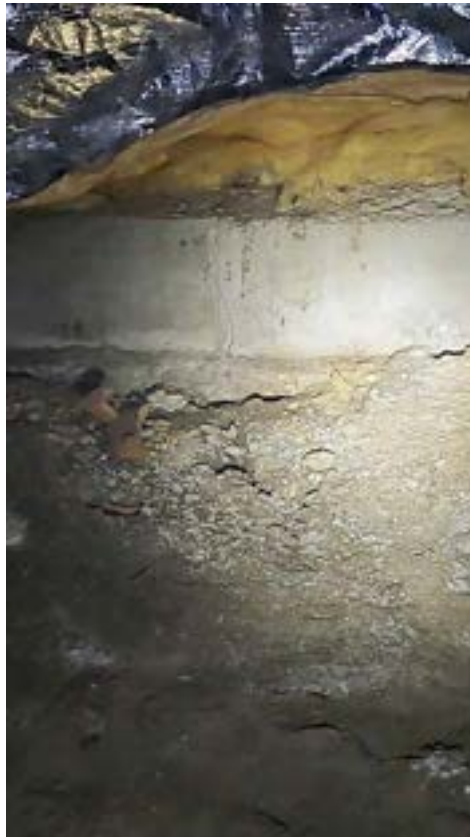
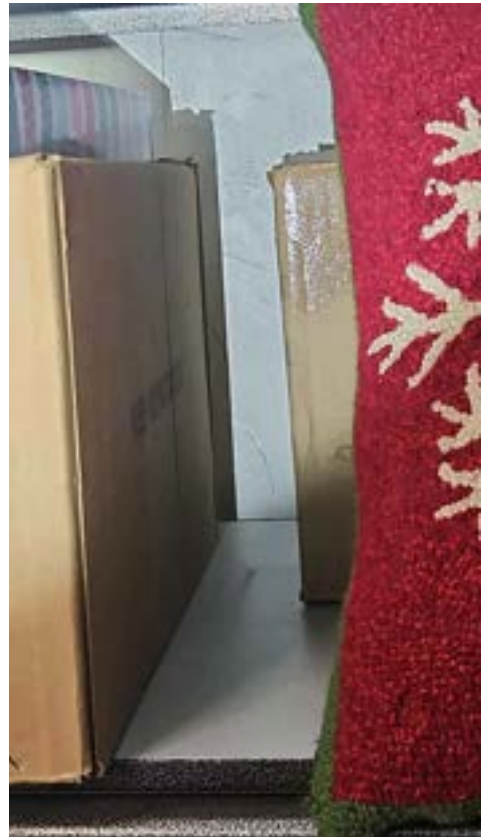
4.1.1 Foundation

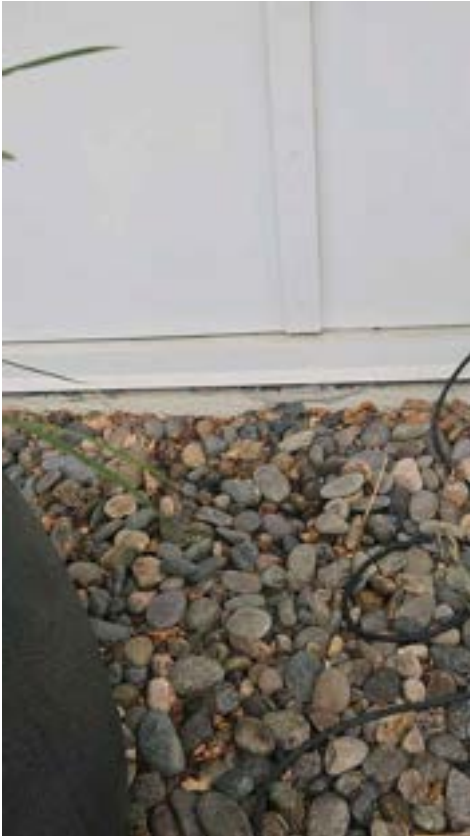
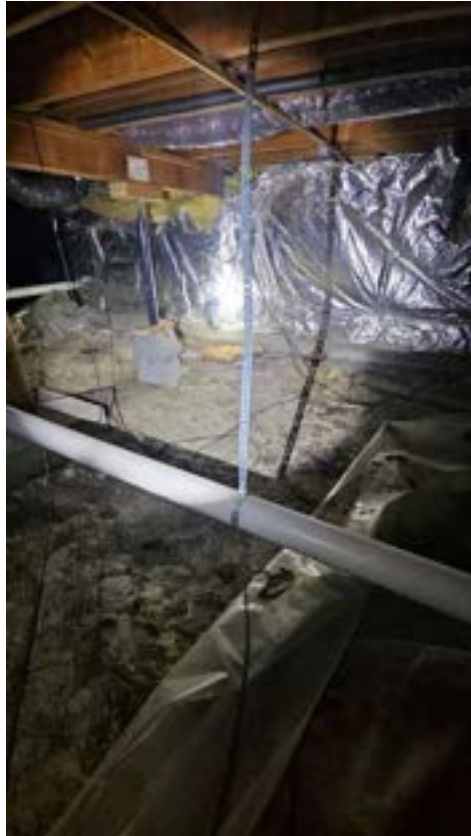
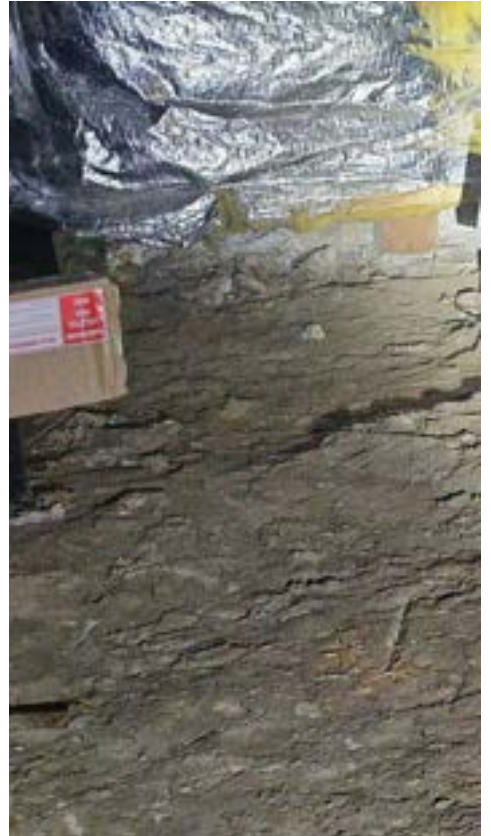
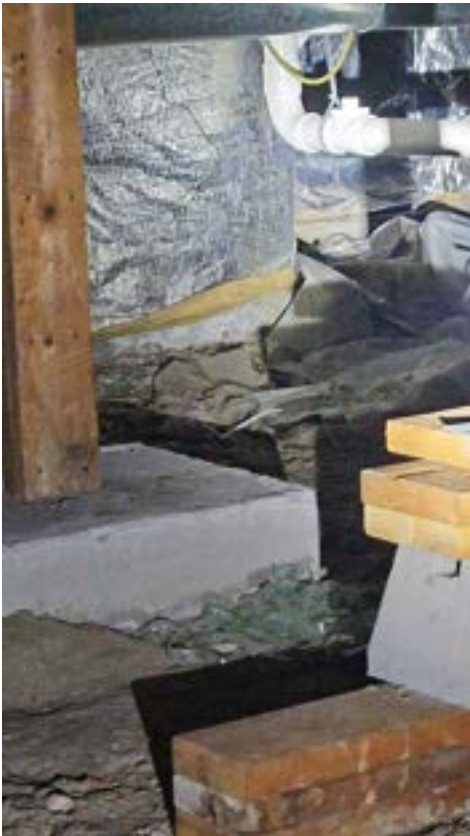
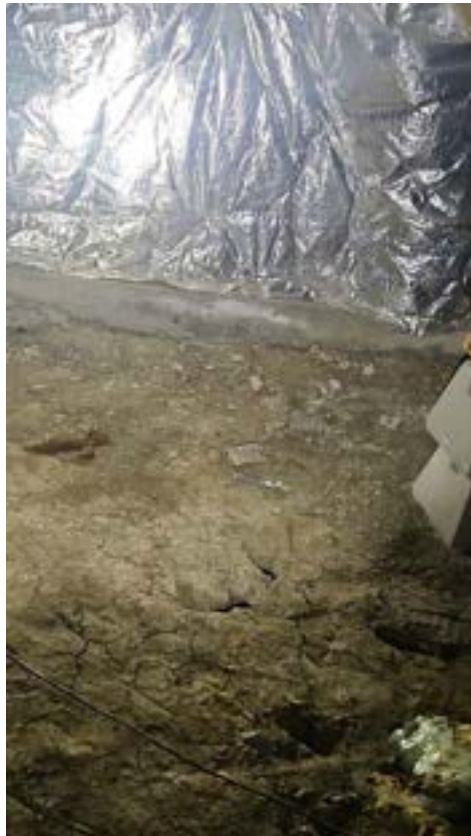
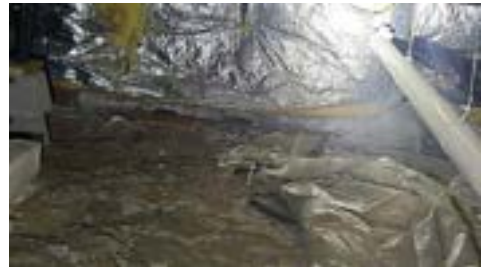
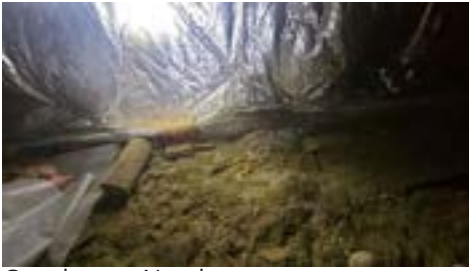
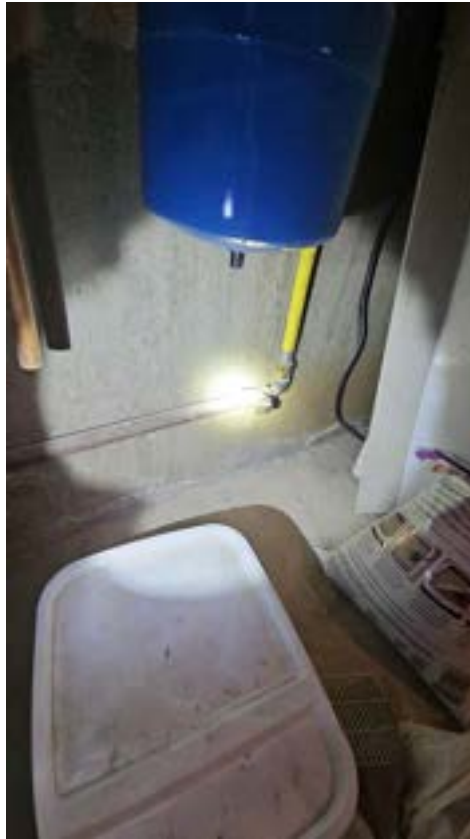
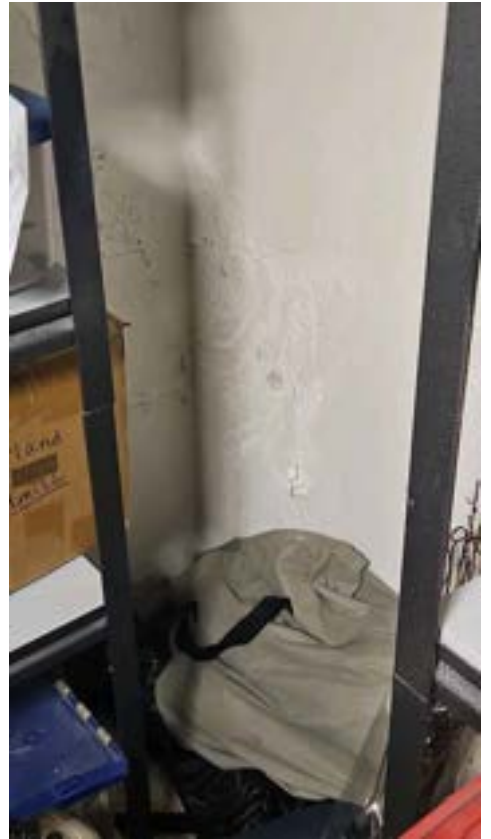
4.2.1 Basements & Crawlspace
EFFLORESCENCE

Efflorescence noted on the crawlspace or basement surface. This a white, powdery deposit that is consistent with moisture intrusion. This can compromise the soil's ability to support the home structure and/or lead to mold growth. Recommend a qualified contractor identify source or moisture and correct.

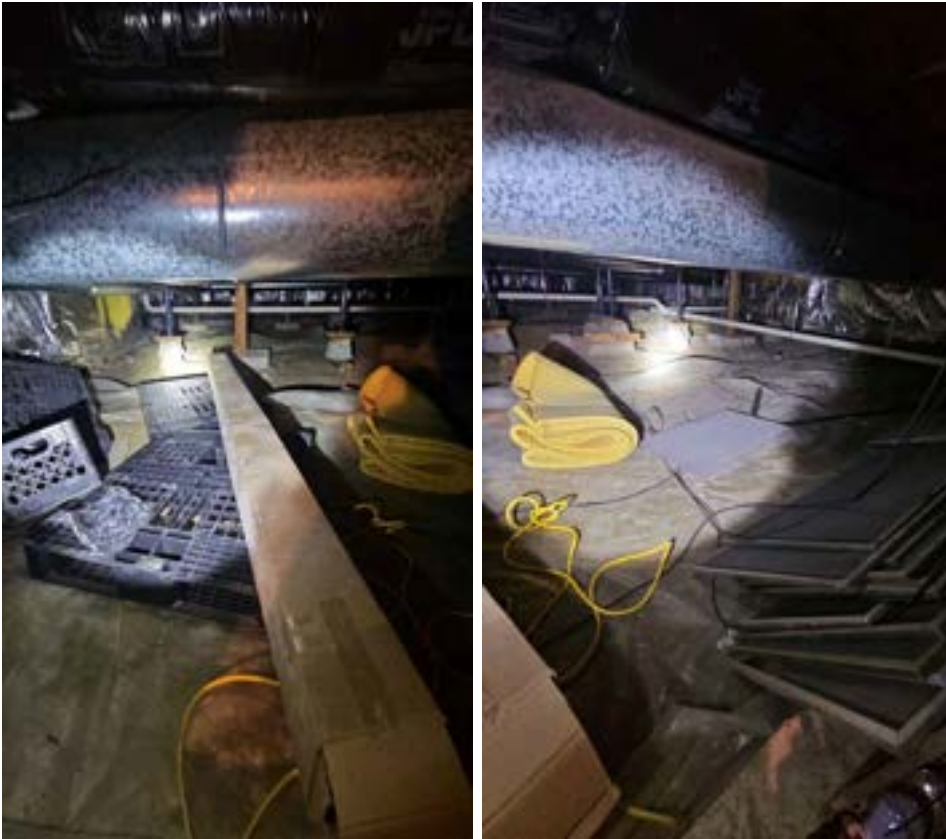
In one or more areas of the crawlspace there is no vapor barrier installed. This could lead to unwanted moisture from the exposed ground. Recommend a qualified professional install

Contact a qualified professional.

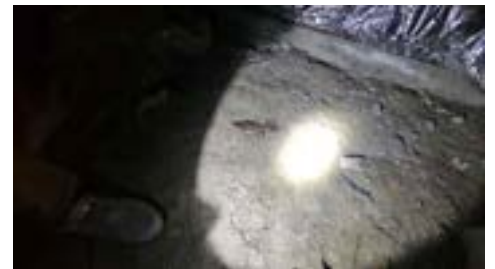
Crawlspace

Evidence of vermin intrusion was noted in the crawlspace, including signs such as droppings or possible nesting activity. Vermin in crawlspaces can damage insulation, wiring, and vapor barriers while also creating sanitation and odor issues. Recommend evaluation and treatment by a licensed pest control professional, along with sealing potential entry points and removing any contaminated materials to prevent recurrence.

Contact a qualified professional.

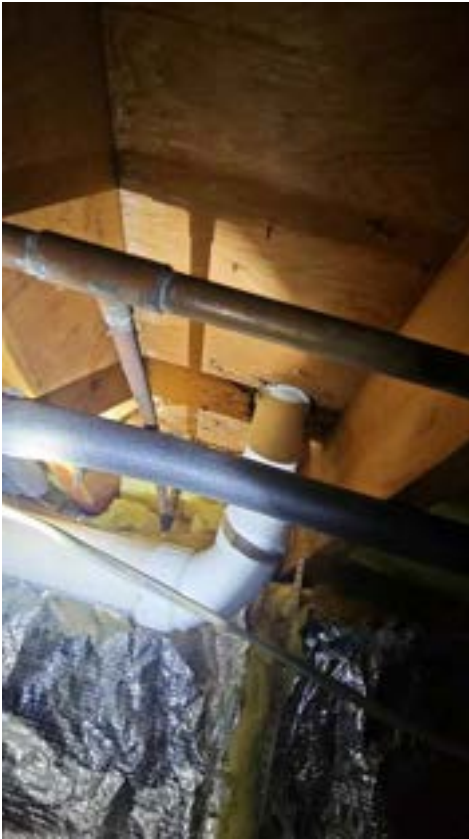
Crawlspace North

MOISTURE DAMAGE

One or more floor members had moisture damage. This can lead to mold growth. Recommend a qualified contractor evaluate and repair.
