HOLLOWTOP INSPECTION

HOLLOWTOP INSPECTION REPORT

803 Parkhill Dr
Billings, MT 59102

08/27/2025

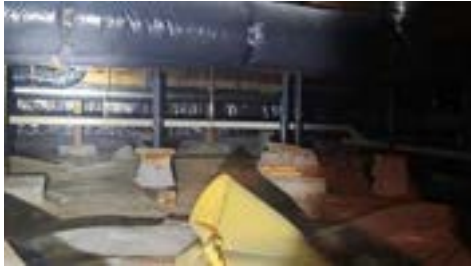
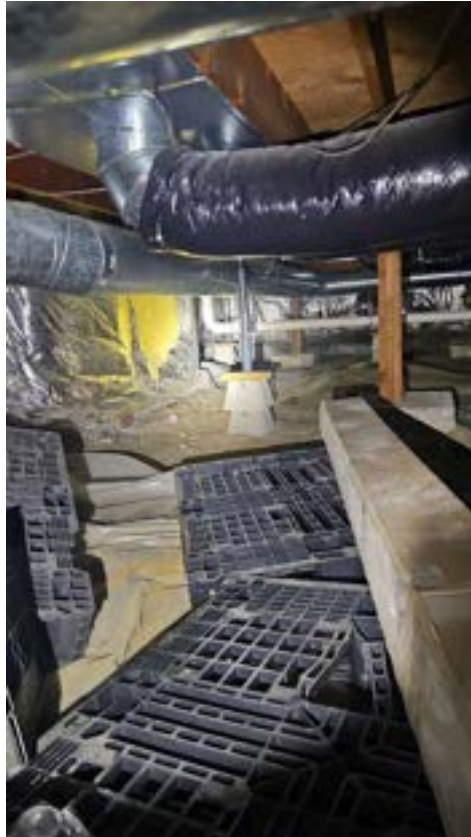
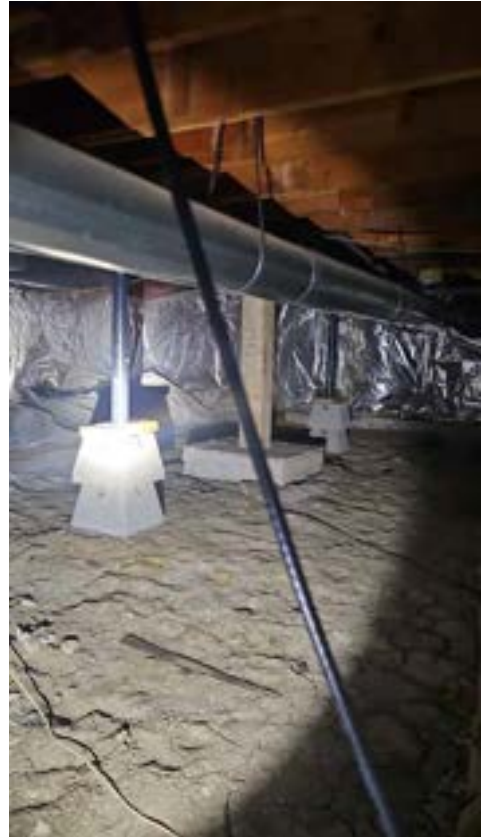
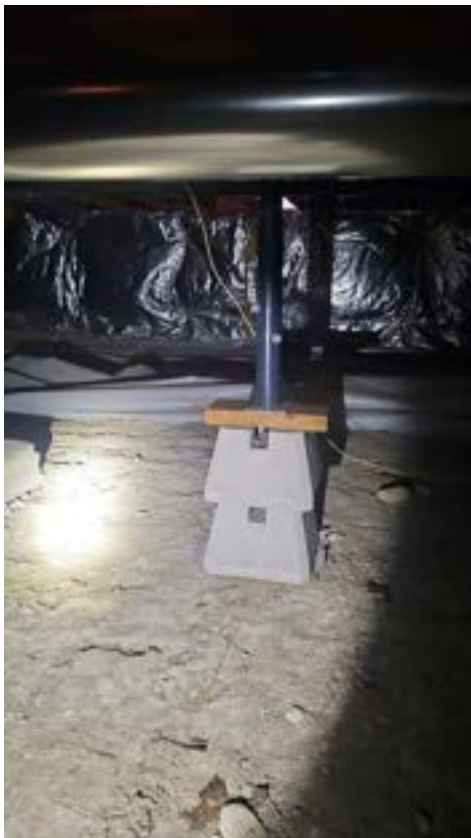
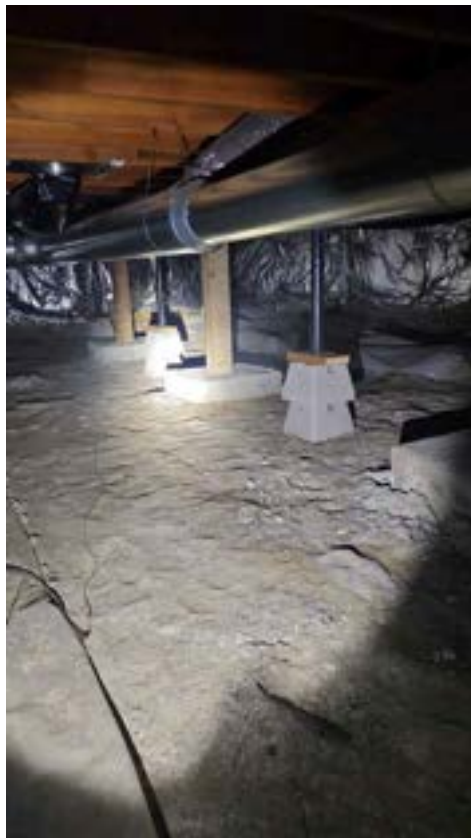
Semi-permanent floor beam supports were observed in the crawlspace. These supports may not be rated for permanent structural use, and relying on them long-term can create safety and stability concerns for the home. Recommend evaluation by a qualified structural or foundation professional to confirm whether the supports are properly rated for permanent use, and to install permanent supports if needed to ensure the integrity of the floor system.

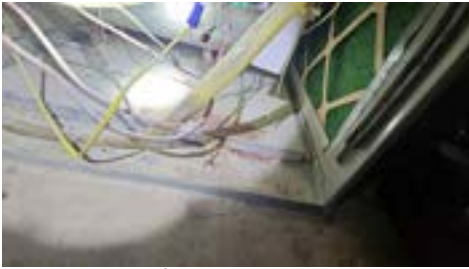
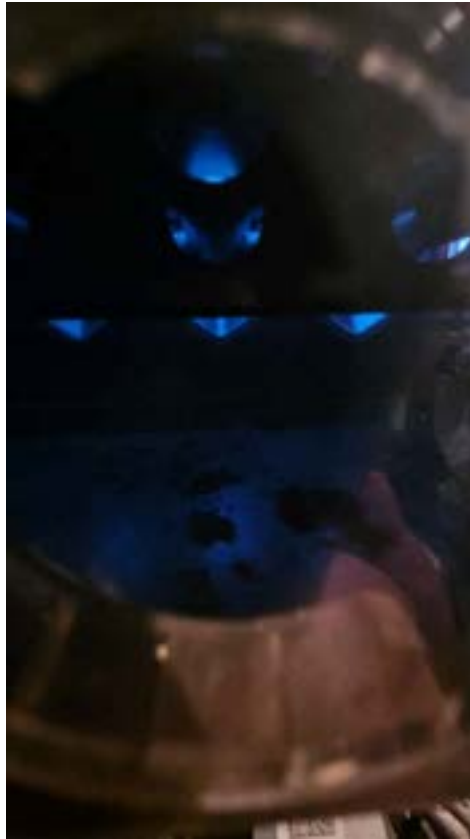
5.1.1 Equipment

CORROSION

Furnace was corroded in one or more areas. This could be the result of improper venting, which the source would need to be identified. Recommend a HVAC contractor evaluate and repair.

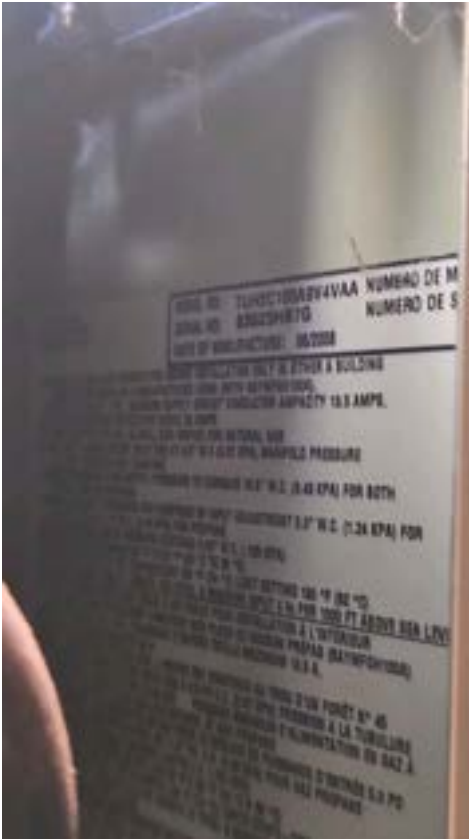
The furnace appears to be nearing the end of its typical average lifespan of 15–20 years. While it may currently be functional, older systems may become less efficient and more prone to failure. Recommend a qualified professional evaluate and to budget for possible replacement costs. The Trane furnace was manufactured in 2008.

Contact a qualified heating and cooling contractor

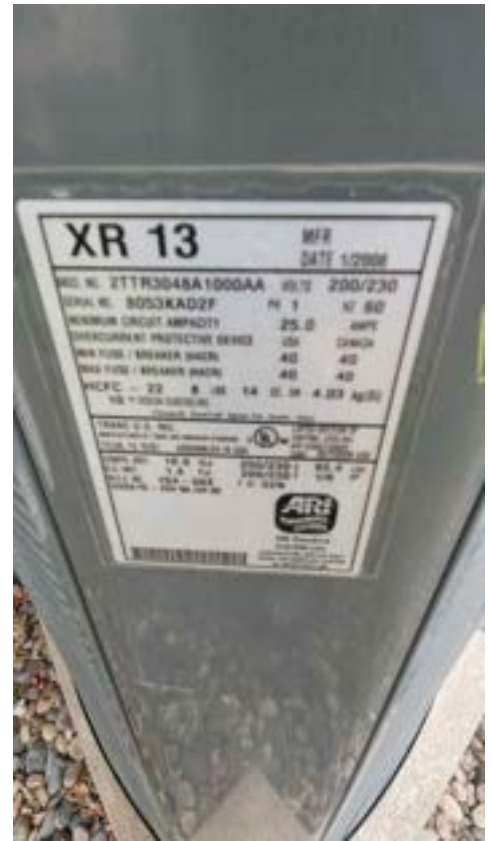
Defect Or Recommendation
NEARING AVERAGE LIFESPAN

The air conditioning unit appears to be nearing the end of its typical average lifespan of 10–20 years. While it may currently be operational, aging units can become less efficient and more susceptible to failure. Recommend a qualified professional evaluate and budgeting for replacement as needed. The Trane ac unit was manufactured in January 2008.

Contact a qualified heating and cooling contractor

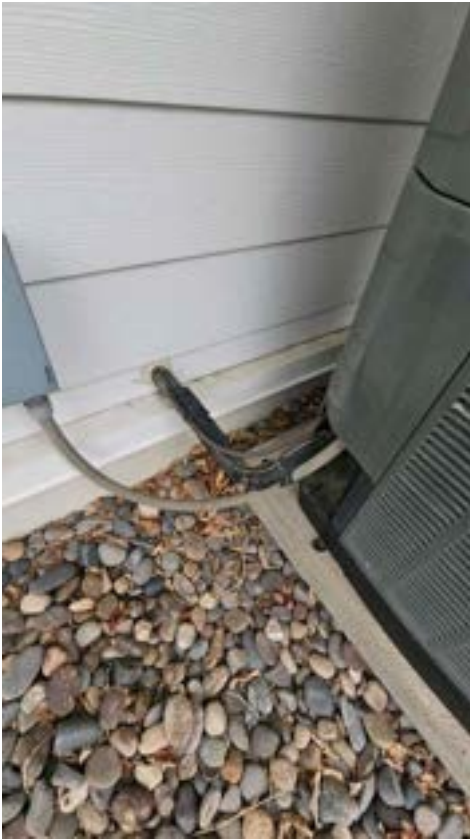
Southeast

Defect Or Recommendation
INSULATION MISSING OR DAMAGED

Missing or damaged insulation on refrigerant line can cause energy loss and condensation. Recommend replacing insulation by a qualified professional.

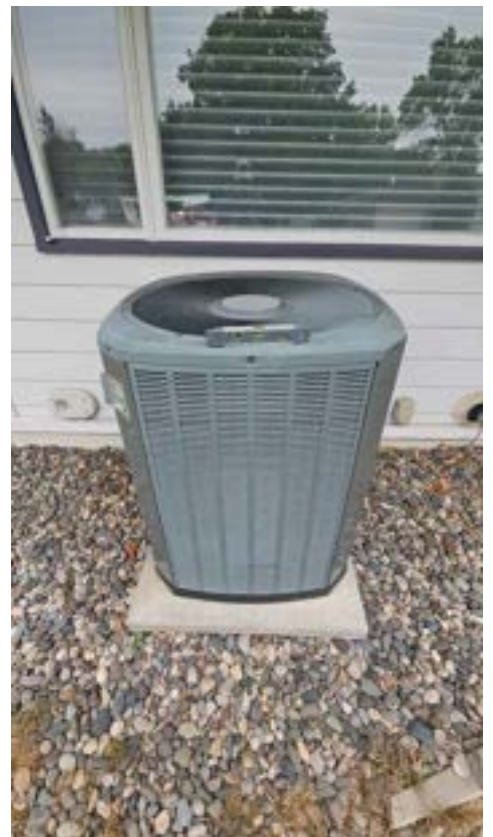
Southeast

The outdoor condensing unit is not level. This can cause accelerated deterioration of components. Recommend licensed HVAC contractor level the unit.

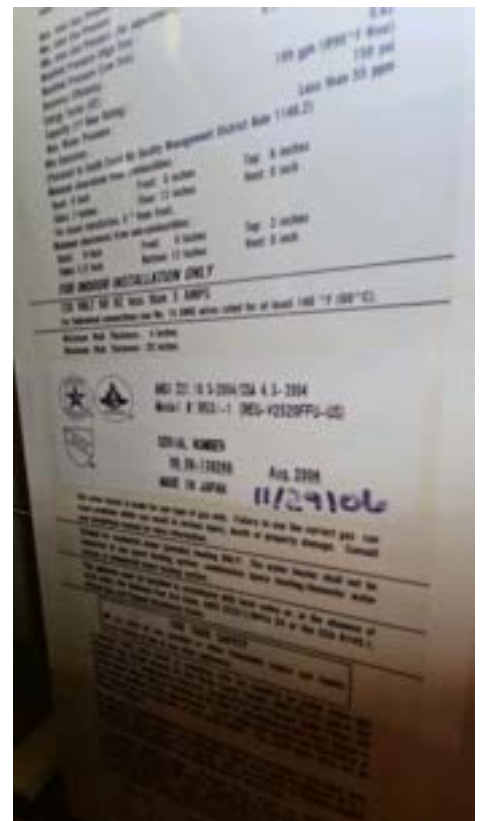
Hot Water Systems, Controls, Flues & Vents: Location

Basement, Utility Room

The Rinnai tankless water heater was manufactured in August 2006.

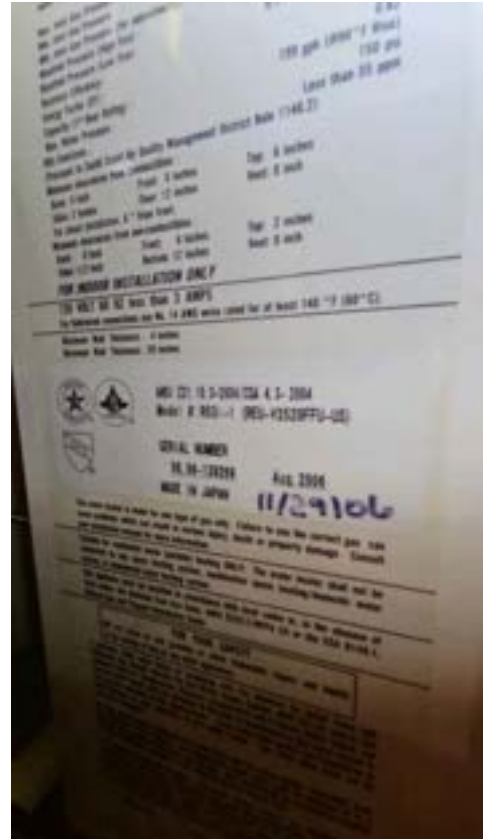
The water heater appears to be beyond its typical average lifespan of 8-12 years. While it may still be functional, older units are at increased risk of leakage or failure. Recommend evaluation by a qualified plumber and budgeting for replacement. The water heater was manufactured in 2006.

Contact a qualified professional.

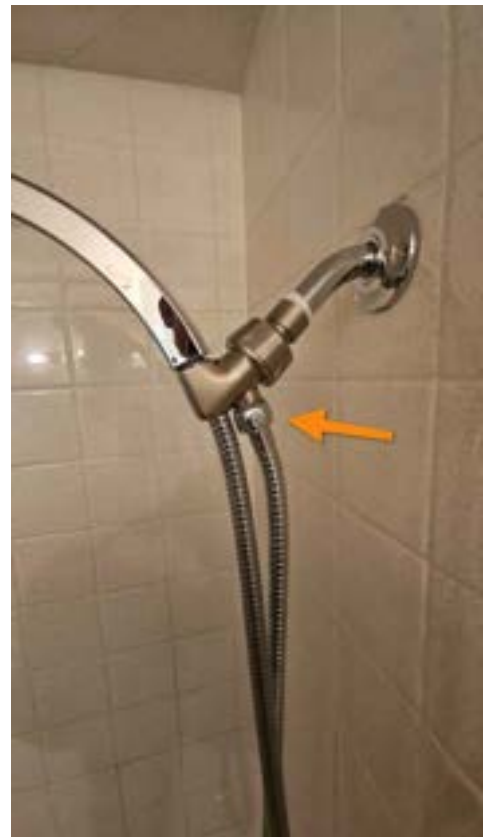
7.4.1 Fixtures, Sinks, Tubs and Showers

LEAKING FIXTURE

In one or more areas there is a leaking sink or tub fixture. Recommend a qualified professional evaluate.

Contact a qualified plumbing contractor.

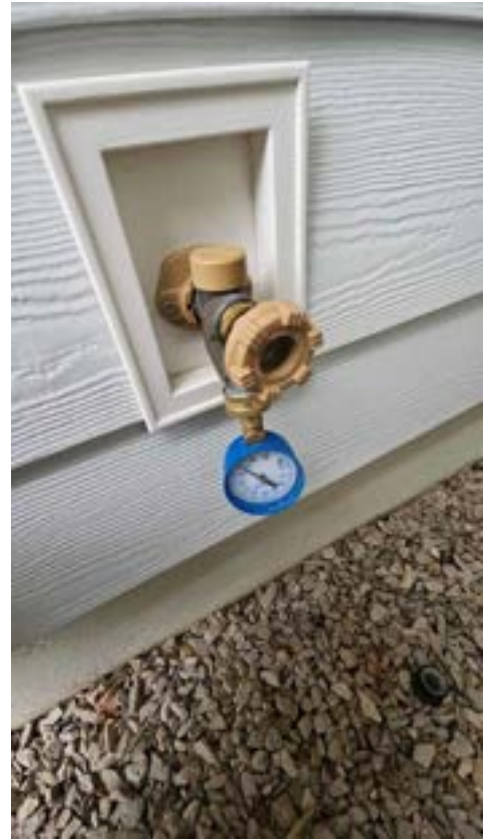
Northwest

WATER PRESSURE TO HIGH

The homes water pressure was higher than the recommended 40-80psi. This can lead to leaking at connections. Recommend a qualified professional evaluate and correct.

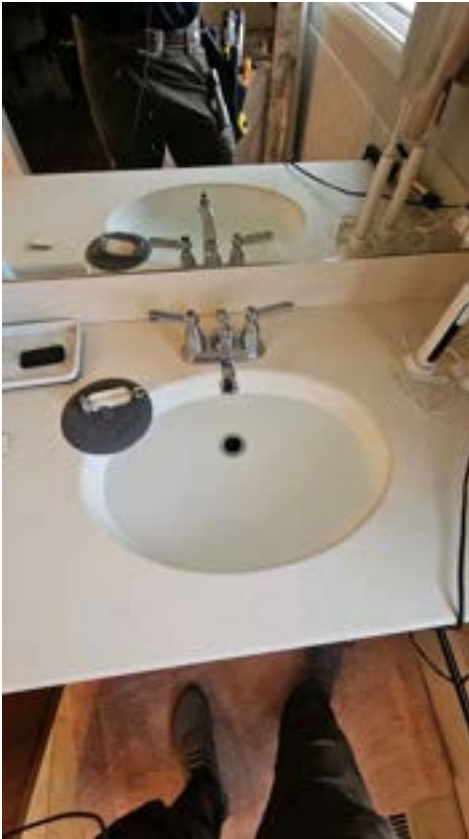
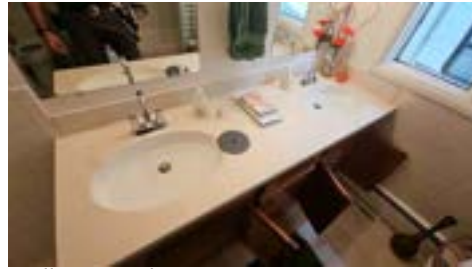
Sink had slow/poor drainage. Recommend a qualified plumber repair.

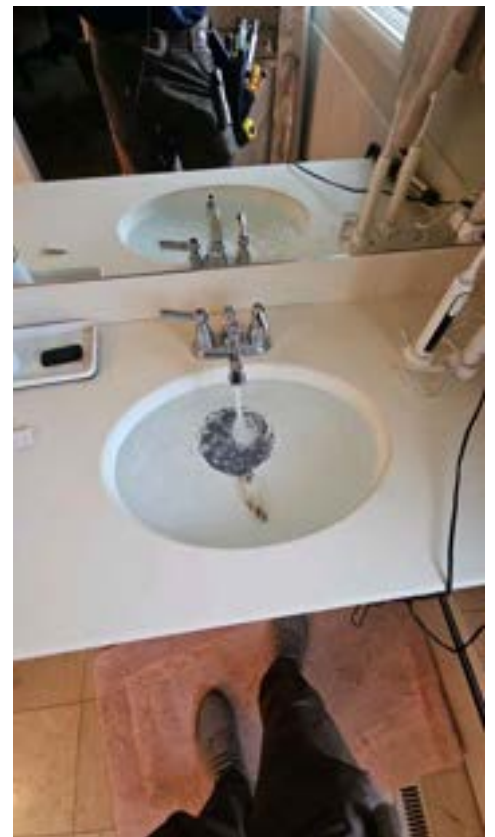
7.4.4 Fixtures, Sinks, Tubs and Showers

MISSING OR INOPERABLE DRAIN PLUG

Sink or bathtub has a missing or inoperable drain plug. Recommend a qualified professional repair.

Contact a handyman or DIY project

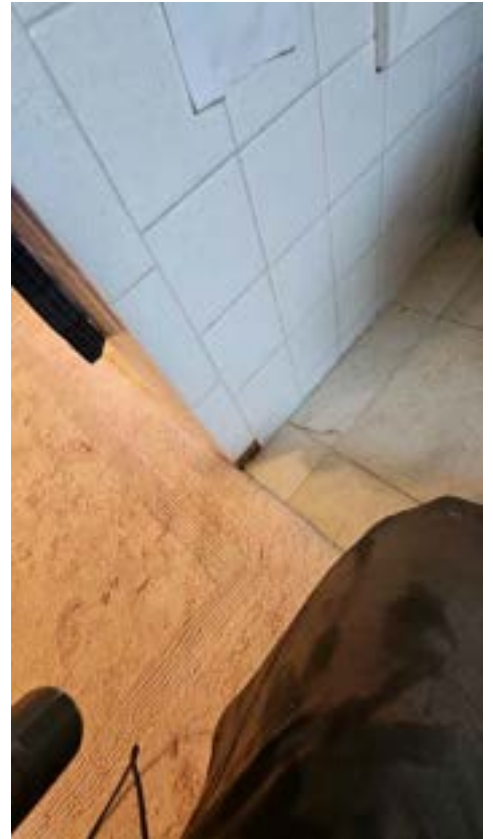
7.4.5 Fixtures, Sinks, Tubs and Showers

Defect Or Recommendation**TILE DAMAGE**

One or more of the showers tiles was cracked or damaged. Recommend a qualified professional evaluate and correct.

Contact a qualified professional.

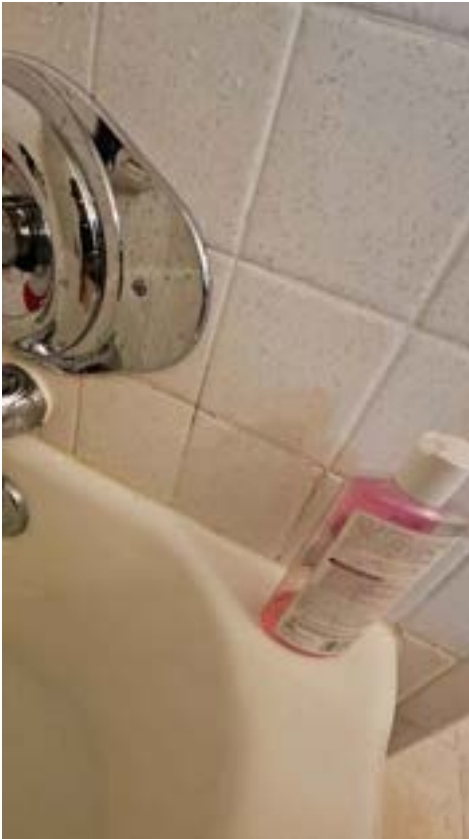
7.4.6 Fixtures, Sinks, Tubs and Showers

Defect Or Recommendation**TILE GROUT OR CAULKING CRACKING**

Cracking or deterioration of grout or caulking was observed in the bathroom shower, wall, or floor tile areas. This condition can allow water intrusion, potentially leading to moisture damage. Recommend repair and resealing by a qualified professional to help maintain a watertight seal.

Contact a qualified professional.

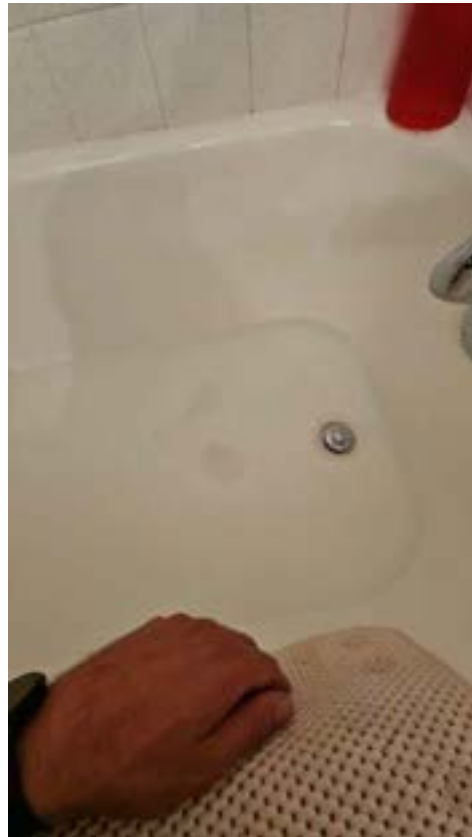
Hallway Bathroom

One or more of the sink basins had visible damage. Recommend a qualified professional evaluate and repair.

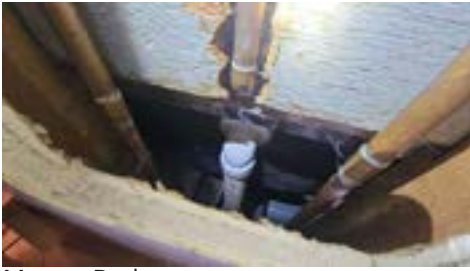
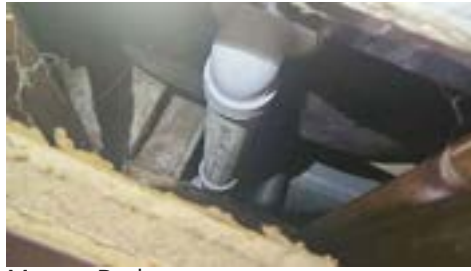
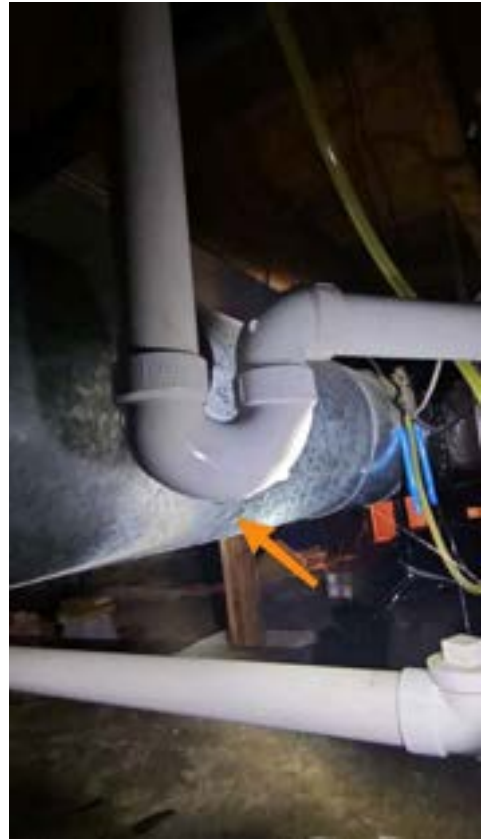
7.6.1 Drain, Waste, & Vent Systems

LEAKING PIPE

A drain, waste and/or vent pipe showed signs of a leak. Recommend a qualified plumber evaluate and repair.

Contact a qualified plumbing contractor.

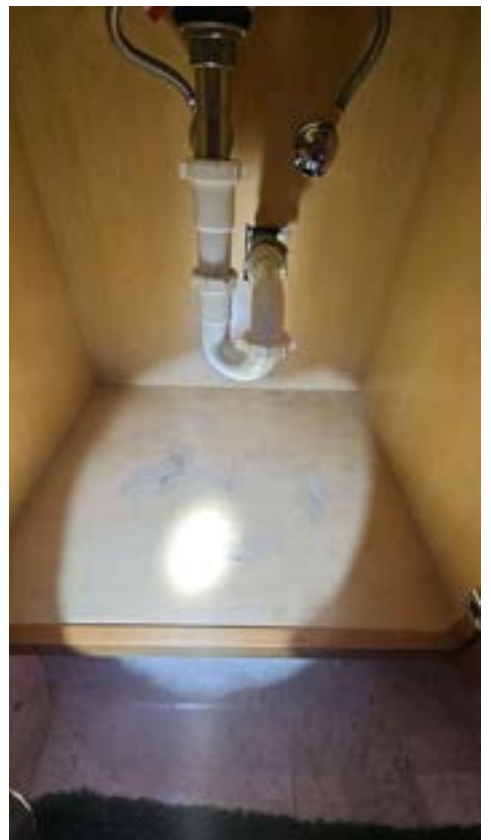
Hallway Bathroom Left

One or more of the homes sink cabinets had visible moisture damage from a leak. Recommend a qualified professional evaluate and repair.

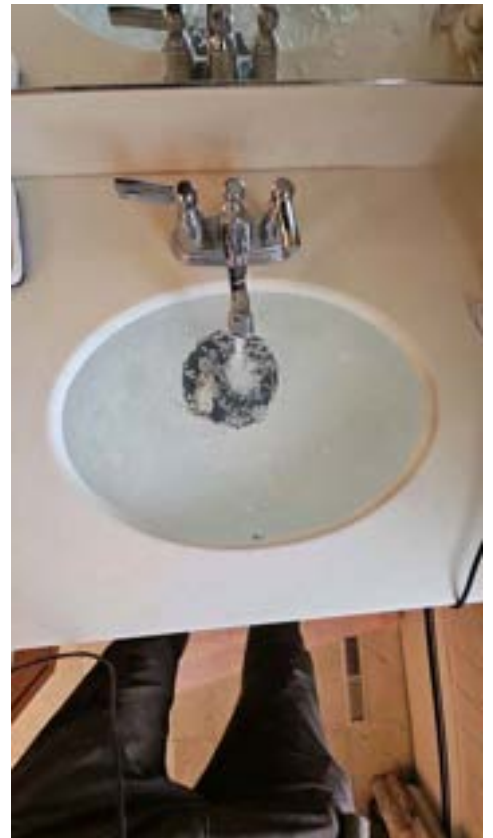
Master Bathroom

One or more of the homes sink over flows were clogged at the time of the inspection. Recommend a qualified professional evaluate.

Contact a qualified professional.

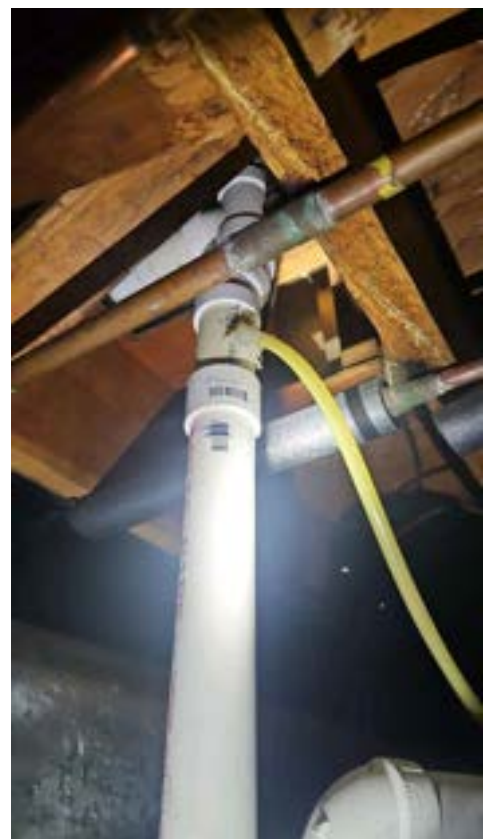
Crawlspace South

Defect Or Recommendation**IMPROPER CONNECTION**

An improper connection was observed at a drain, waste or vent pipe. Recommend a qualified plumber evaluate and repair.

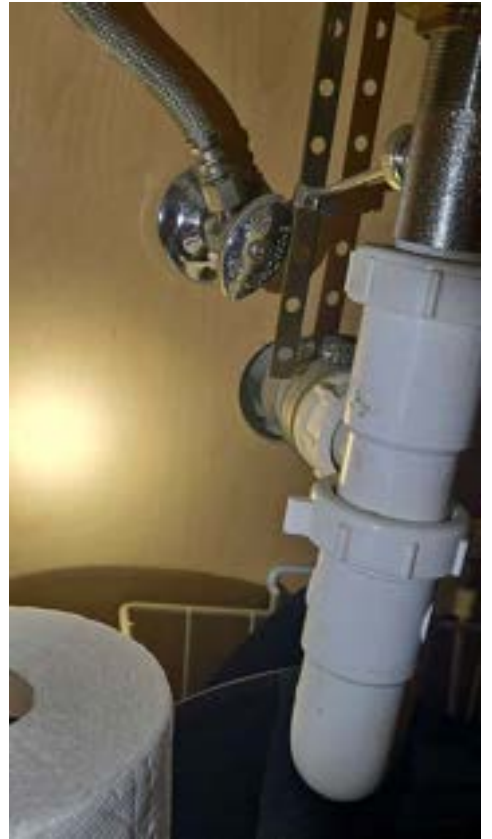
Master Bathroom

There was galvanized drain line present under the kitchen sink. Galvanized line has an average life span of 40-100 years. Based on the age of the home this piping could be nearing the average lifespan. Recommend a qualified professional evaluate.

Contact a qualified professional.

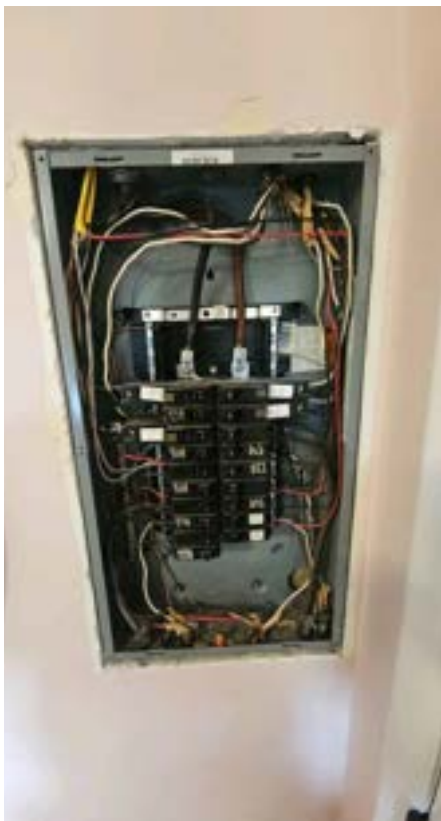
Branch Wiring Circuits, Breakers & Fuses: Wiring Method NM, Fabric Insulated Wires

Cloth insulated wiring can wear over time exposing hot or live wires. Recommend a qualified professional evaluate.

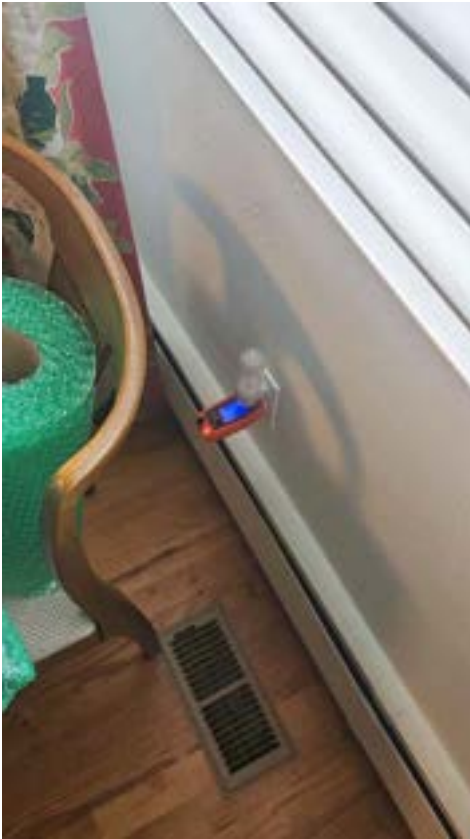
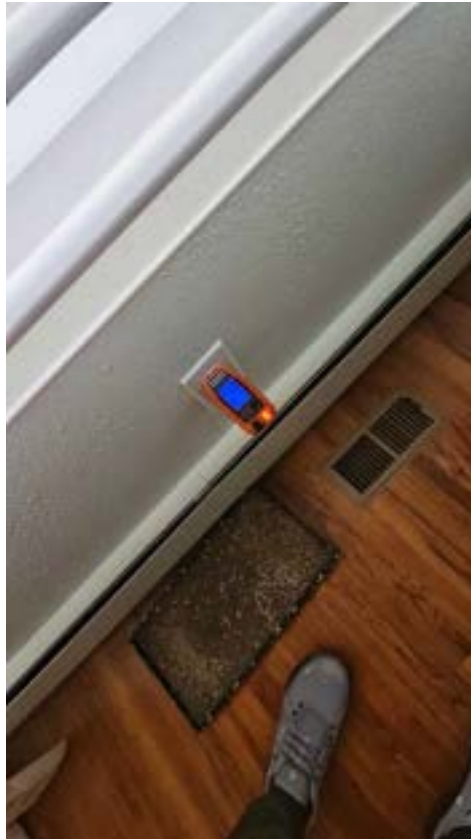
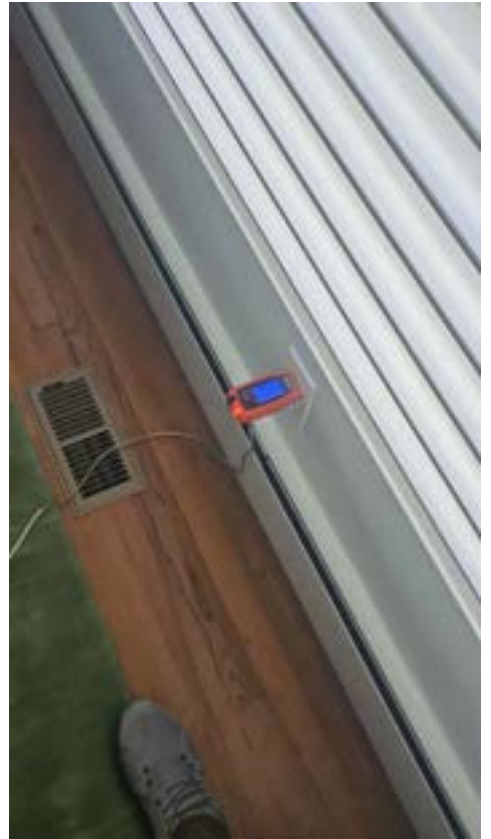
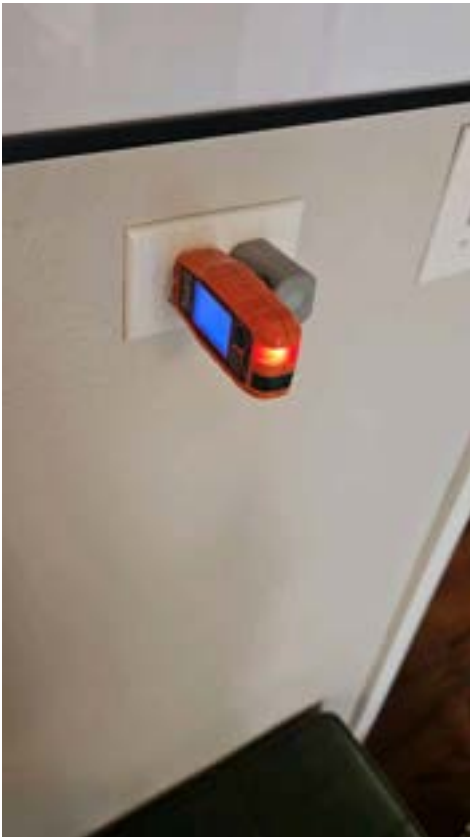
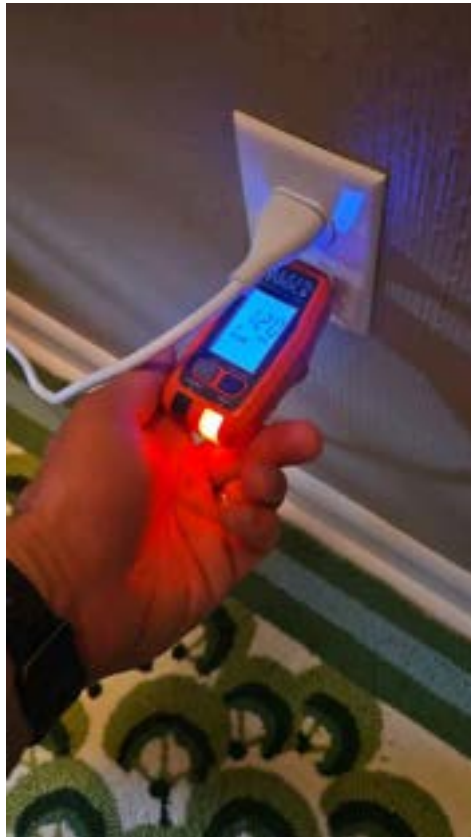
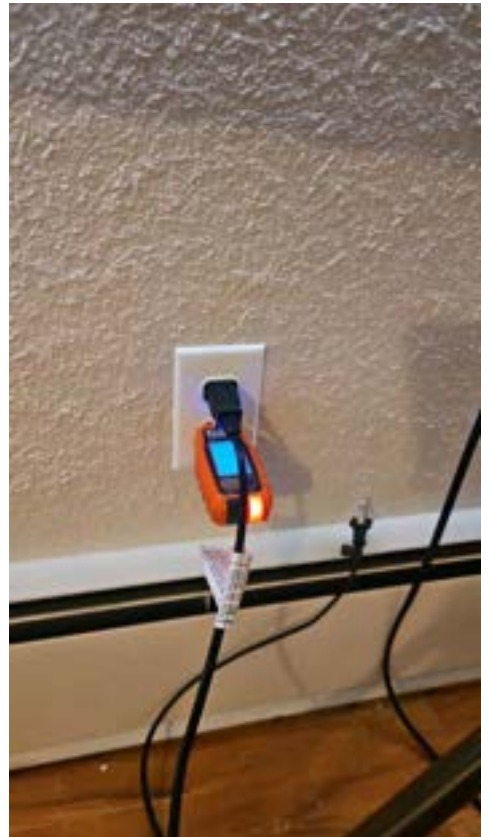
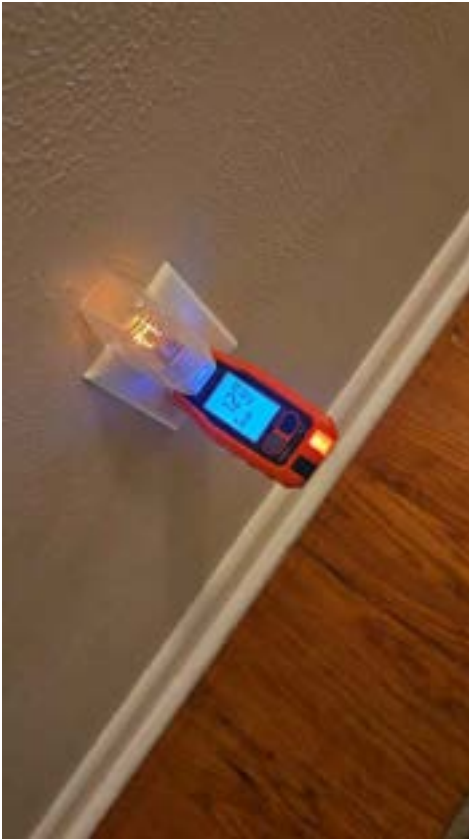
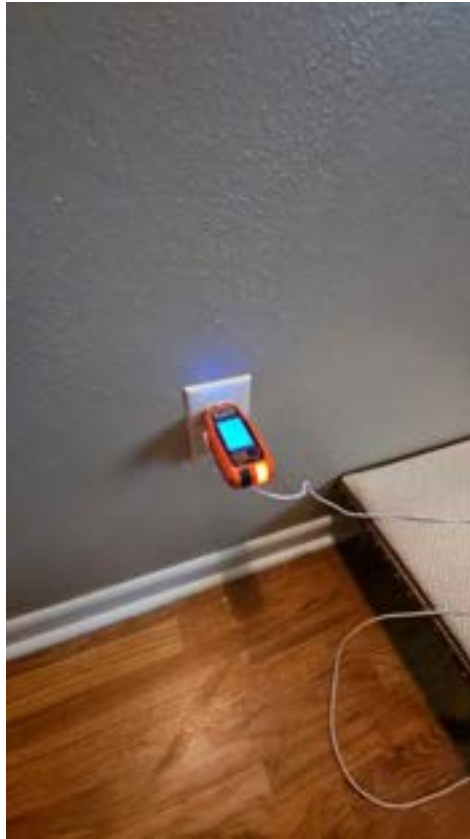
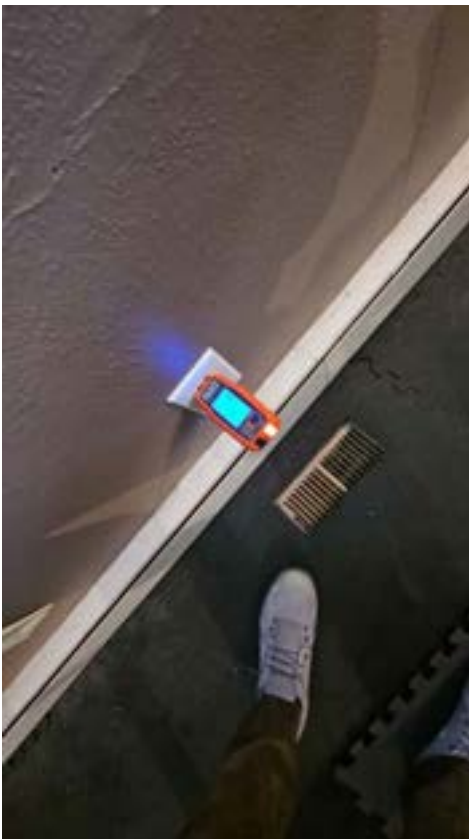
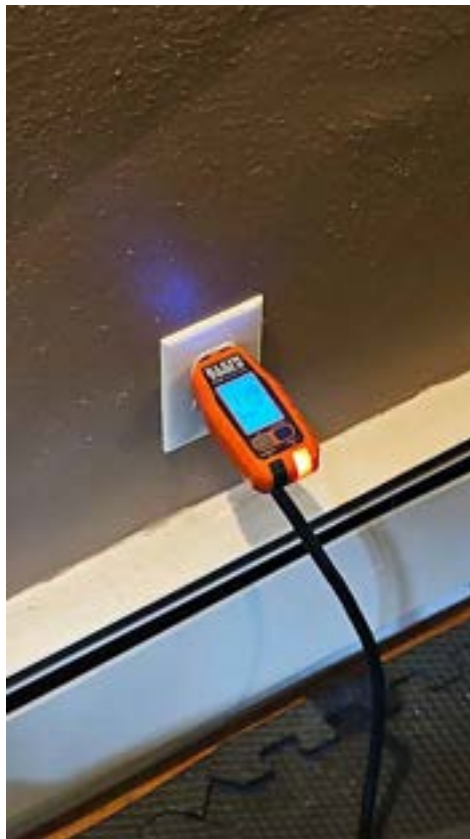
One or more receptacles are ungrounded. To eliminate safety hazards, all receptacles should be grounded especially in the kitchen, bathrooms, garage & exterior. Recommend a licensed electrician evaluate.

Contact a qualified electrical contractor.

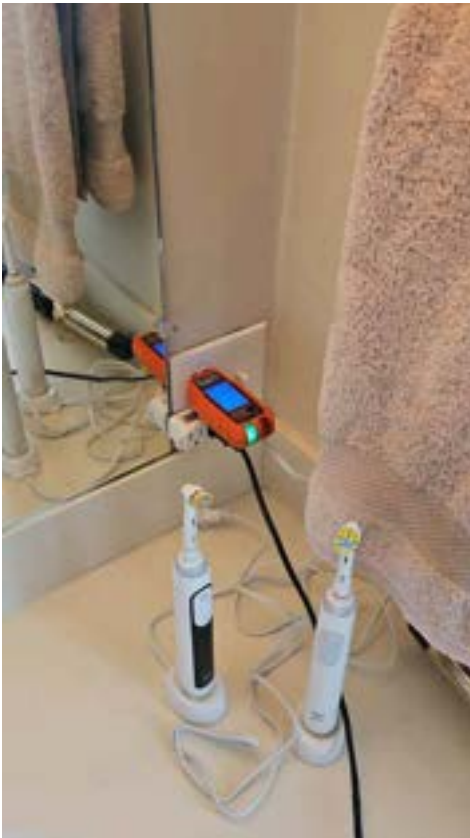
Master Bathroom

No GFCI protection present in one or more locations. Recommend licensed electrician upgrade by installing ground fault receptacles in all locations.

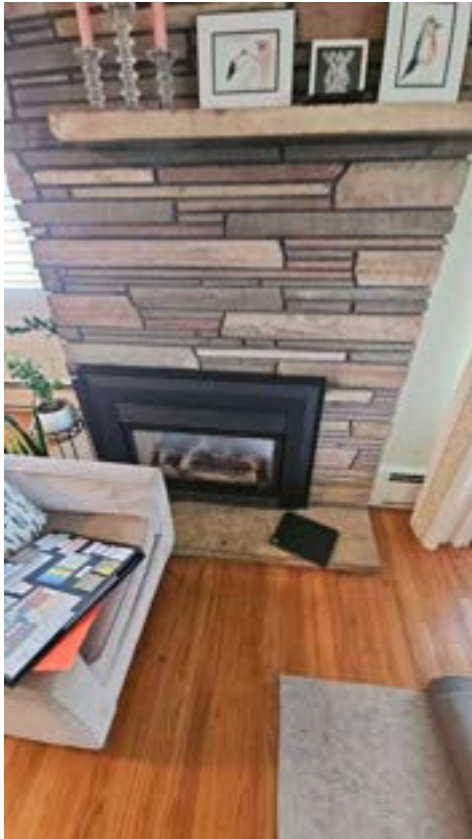
Living Room East

The fireplace could not be turned on. Recommend inquiring with sellers for proof of functionality. If proof can not be given recommend a qualified professional evaluate.

Contact a qualified professional.

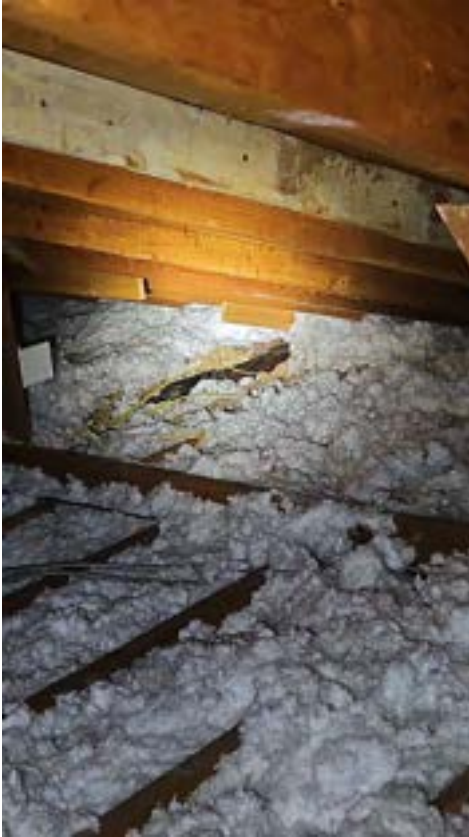
Northeast

Insulation depth was inadequate. Recommend a qualified attic insulation contractor install additional insulation.

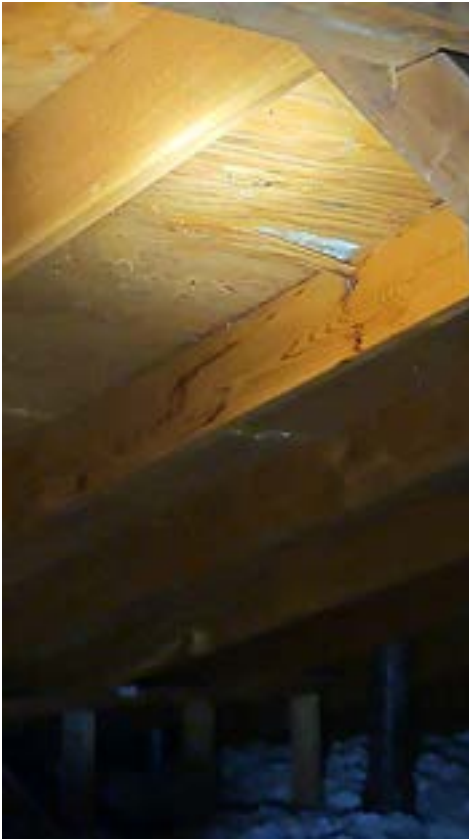
Attic South

MOISTURE STAINING

In one or more area of the attic there was visible moisture staining. The areas did not have high levels of moisture when tested and no visible damage to the roof structure was noted. Recommend a qualified professional evaluate.

Contact a qualified professional.

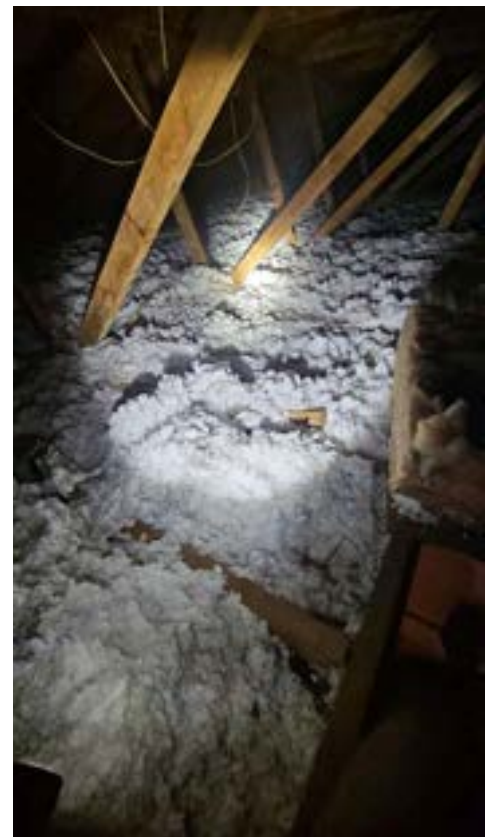
The home had vintage insulation that does not meet modern energy standards. Insulation depth and materials provide low R-values, leading to reduced efficiency and higher energy costs. Recommend evaluation and upgrade by a qualified insulation contractor to improve comfort and performance.

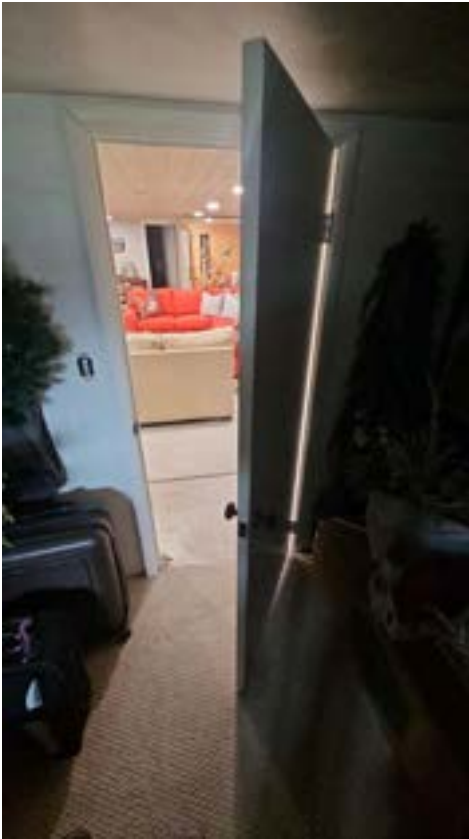
Basement Northeast

Door sticks and is tough to open. Recommend sanding down offending sides.

Contact a handyman or DIY project

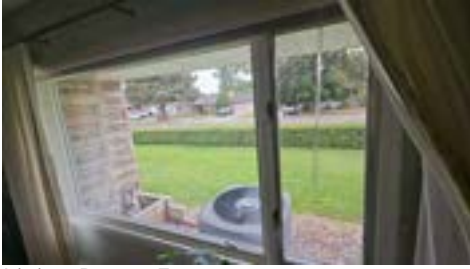
Living Room East

WINDOW CRACKED OR BROKEN

The window is cracked or broken this could cause water intrusion and will get worse over time. Recommend repair or replace by a qualified professional.

Contact a qualified window repair/installation contractor.

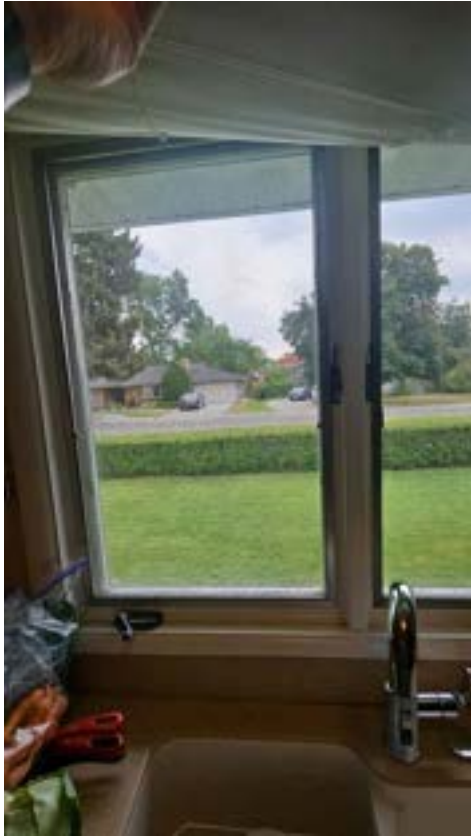
Kitchen

WINDOW WOULDN'T SHUT WITHOUT ASSISTANCE

The basement window would not shut without pushing it from the exterior. This indicates the window is misaligned, warped, or has damaged hardware preventing proper operation. A window that cannot close securely can allow drafts, water intrusion, and pest entry, and also poses a security concern. Recommend evaluation and adjustment or repair by a qualified contractor to ensure the window closes and locks properly.

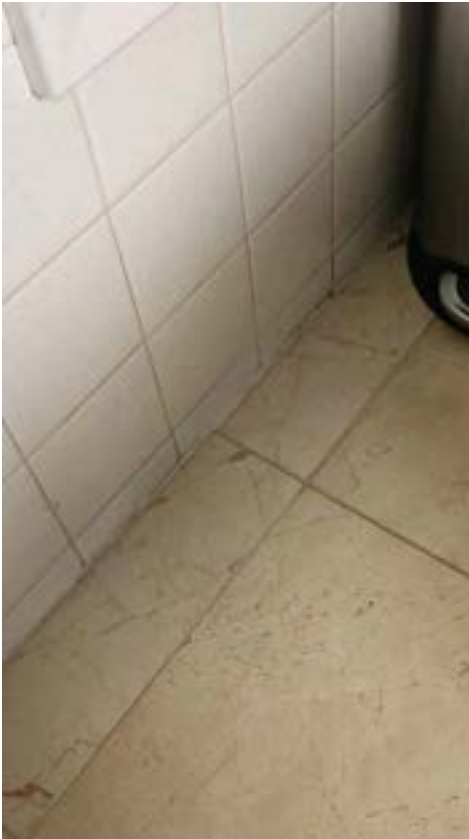
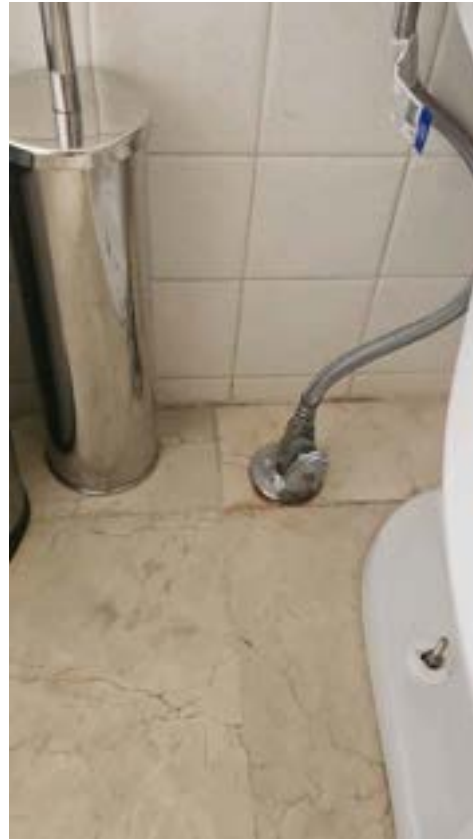
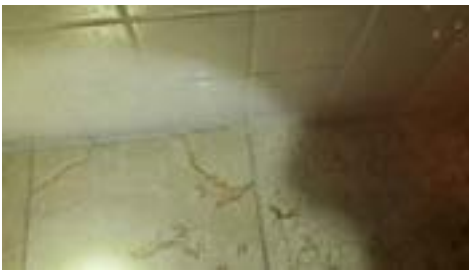
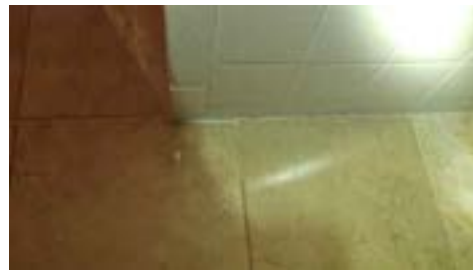
TILE GROUT CRACKING

In one or more areas there was visible tile grout cracking of the floor structure. Recommend a qualified professional evaluate.

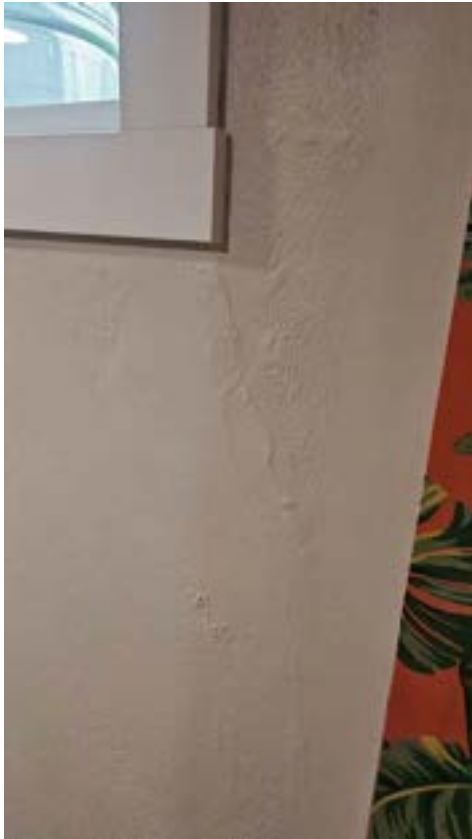
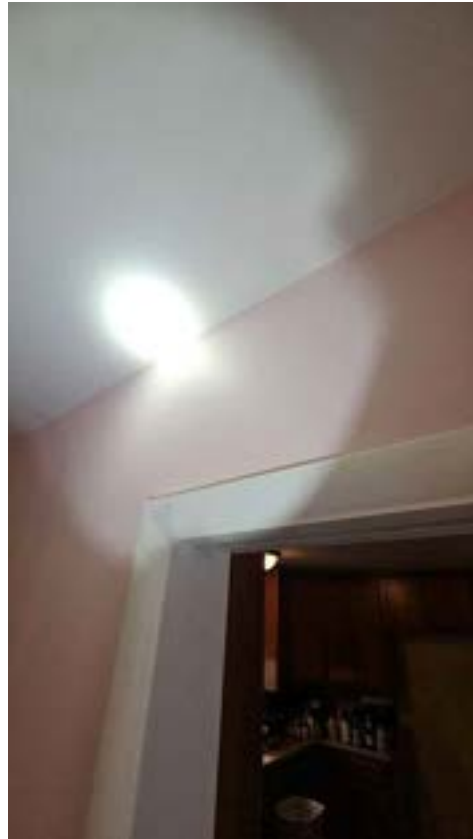
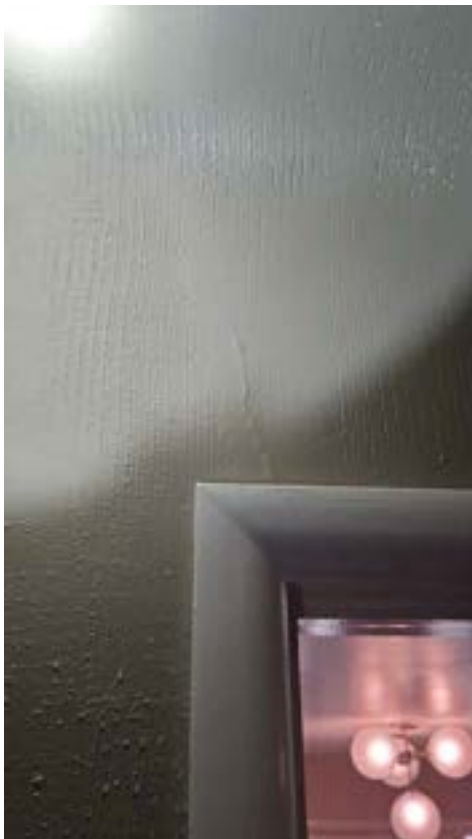
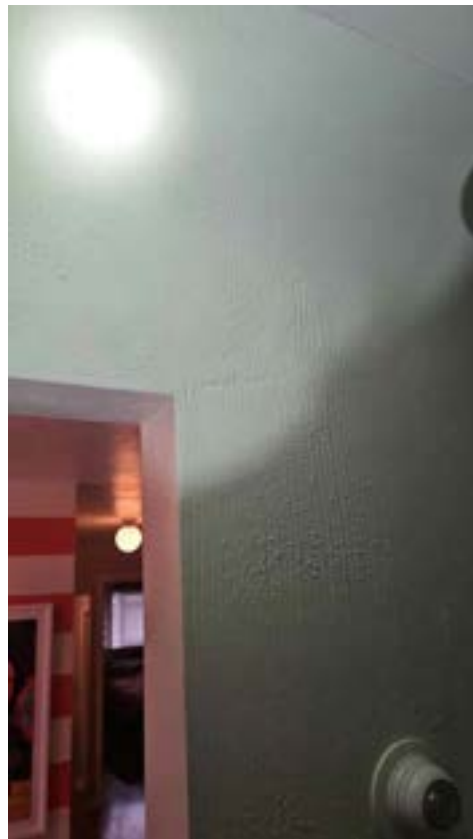
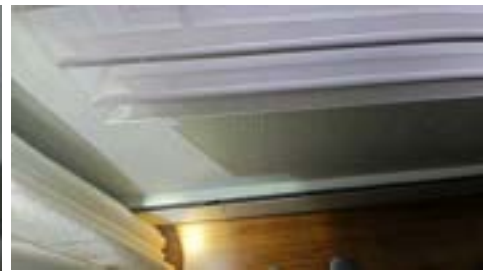
CORNER CRACKS

Cracks at the corners of doors and windows in walls. Appeared to be the result of long-term settling. Recommend a qualified professional evaluate.

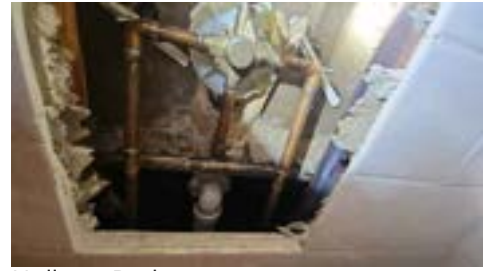
Hallway Bathroom

MOISTURE DAMAGE

Stains on the walls visible at the time of the inspection appeared to be the result of moisture damage. Recommend a qualified professional evaluate and repair as needed.

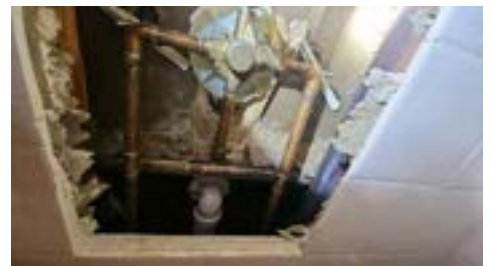
Hallway Bathroom

One or more areas of the interior walls had visible possible mold growth. This could indicate flooding or moisture intrusion of the home. Recommend a qualified professional evaluate and mitigate.
