HOLLOWTOP INSPECTION

HOLLOWTOP INSPECTION REPORT

803 Parkhill Dr
Billings, MT 59102

08/27/2025

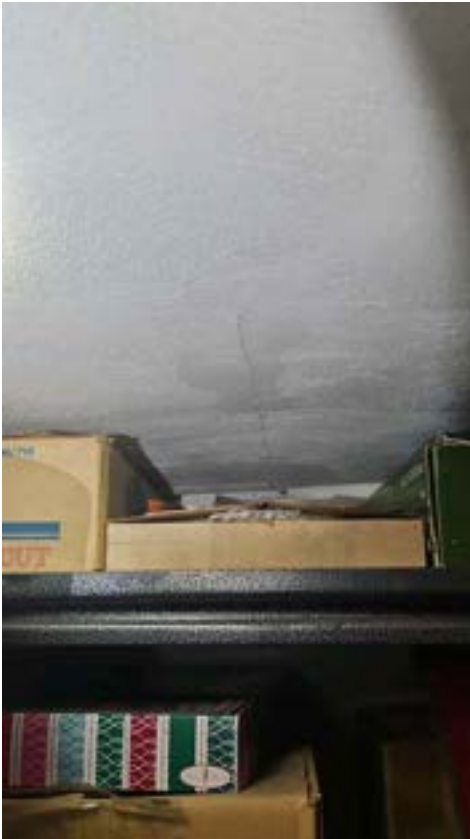
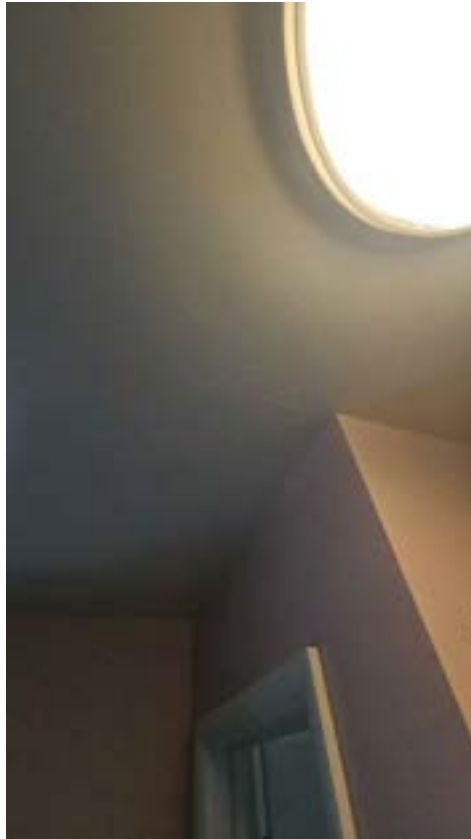
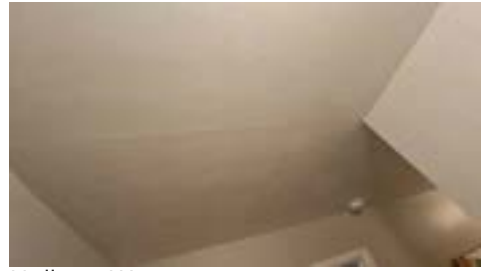
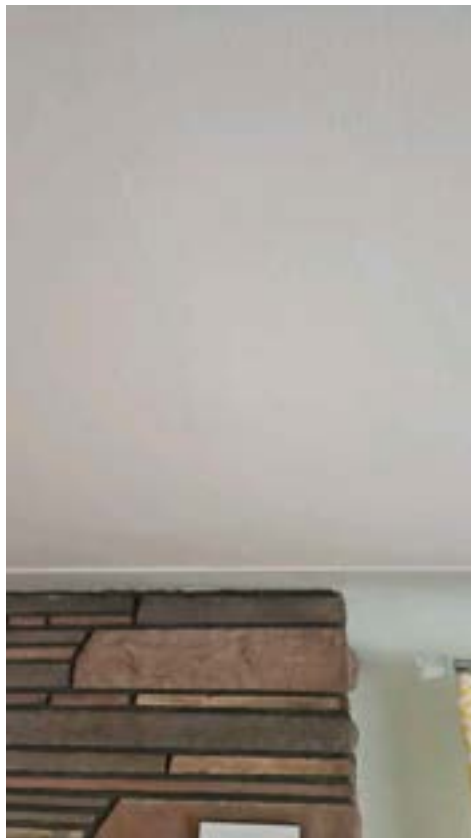
CRACKING

Cracking was visible on the ceiling structure. This could be due to home settlement over time. Recommend a qualified professional examine.

Contact a qualified professional.

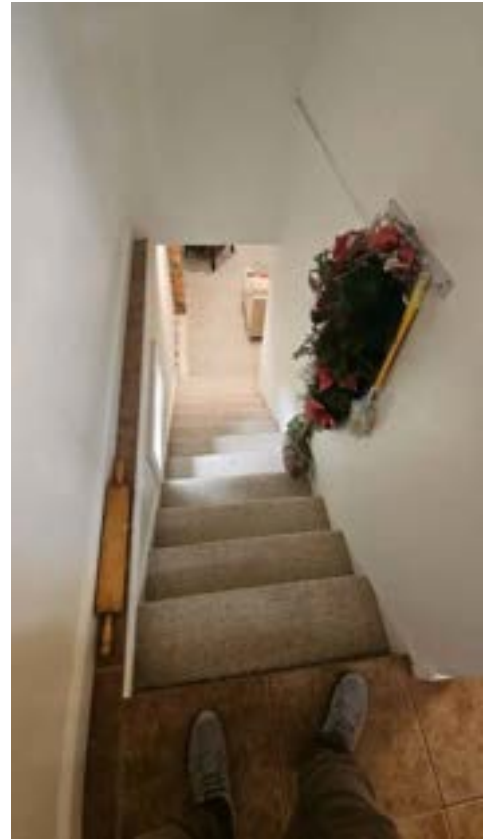
Basement

**Safety Hazard Or Serious Defect****NO RAILING**

Missing railing on the steps. This is a safety hazard. Recommend a qualified professional evaluate and repair.

Contact a qualified professional.

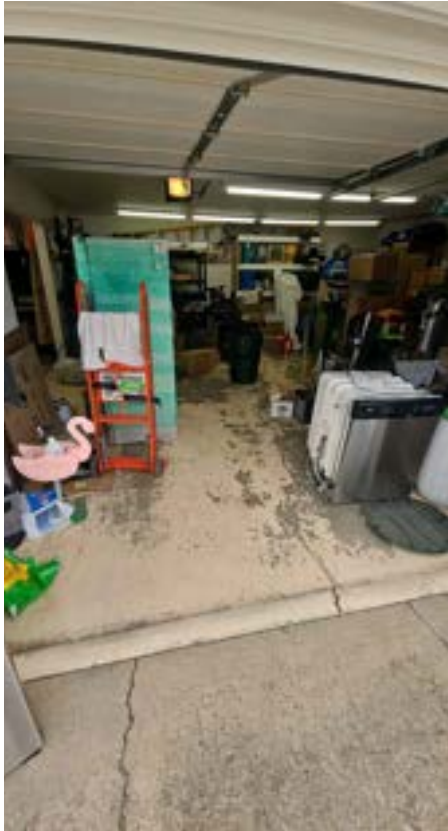
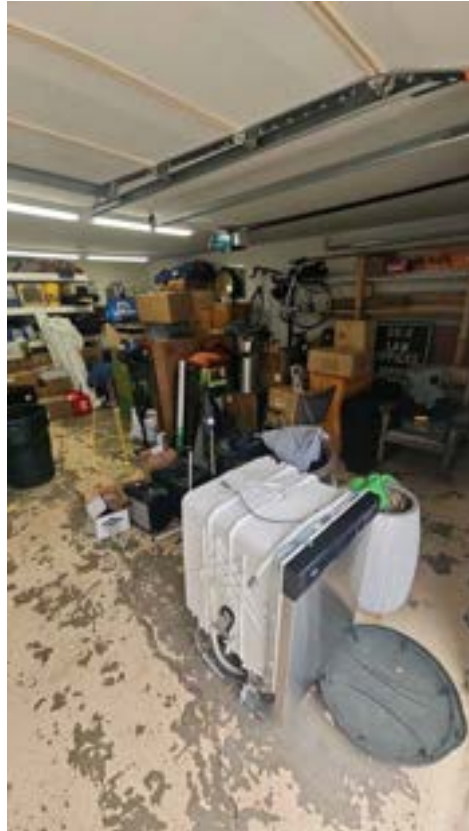
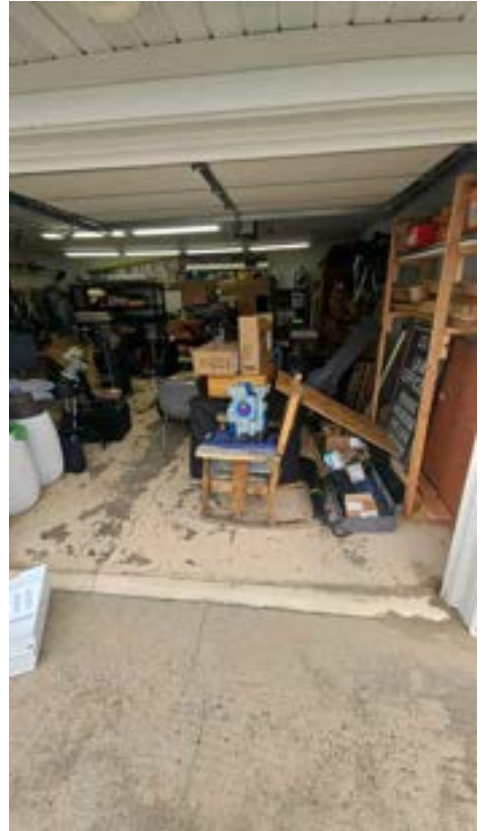
Floor: Material

Concrete

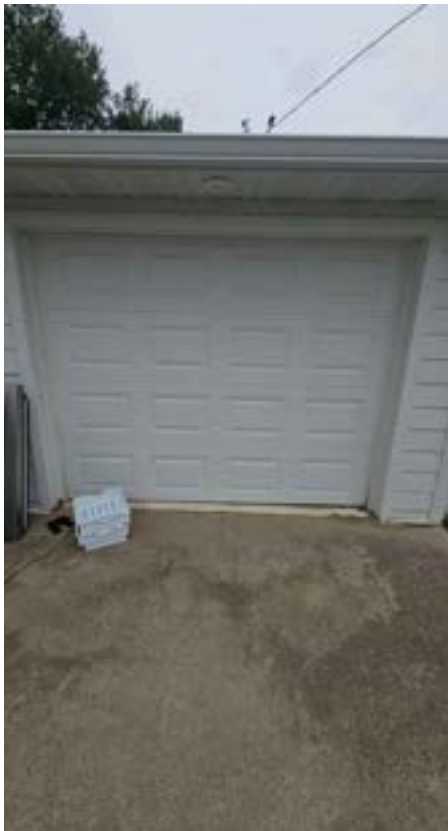
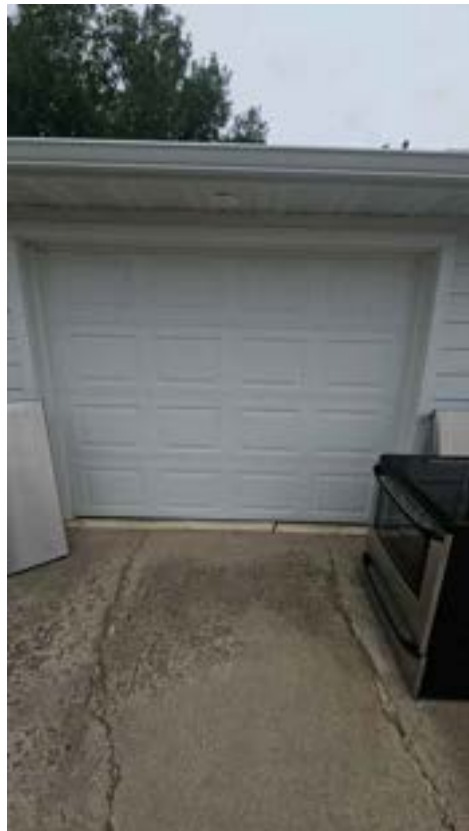
Garage Door: Material

Metal

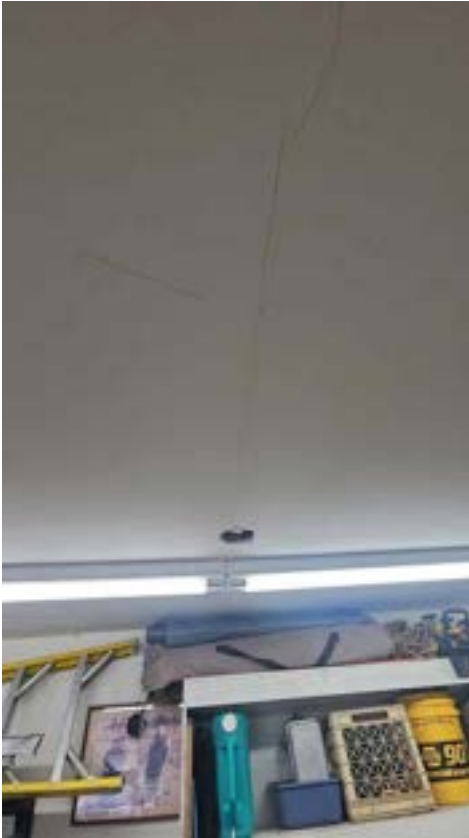
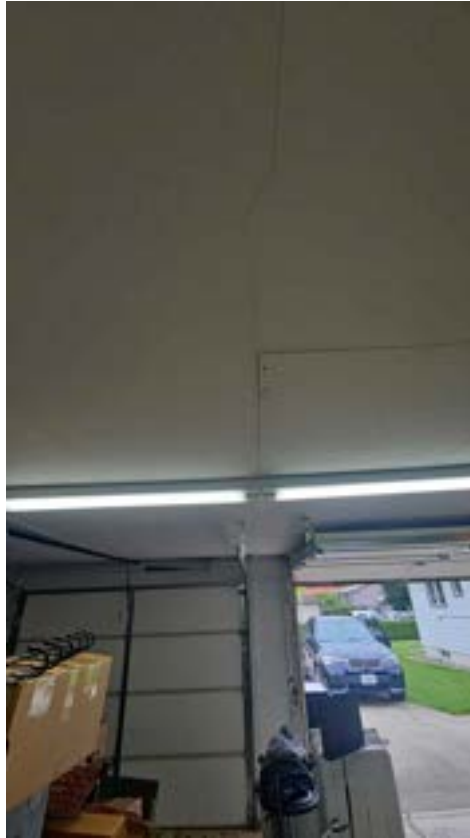
13.2.1 Ceiling

CRACKING

Visible cracking was observed in the ceiling structure of the garage or outbuilding. This may be due to normal settling, thermal expansion, or potential structural movement. While the extent of the cracking was not fully assessed, it is recommended that a qualified contractor or structural professional evaluate the condition to determine if repairs or reinforcement are necessary to ensure the structural integrity of the building.

Contact a qualified professional.

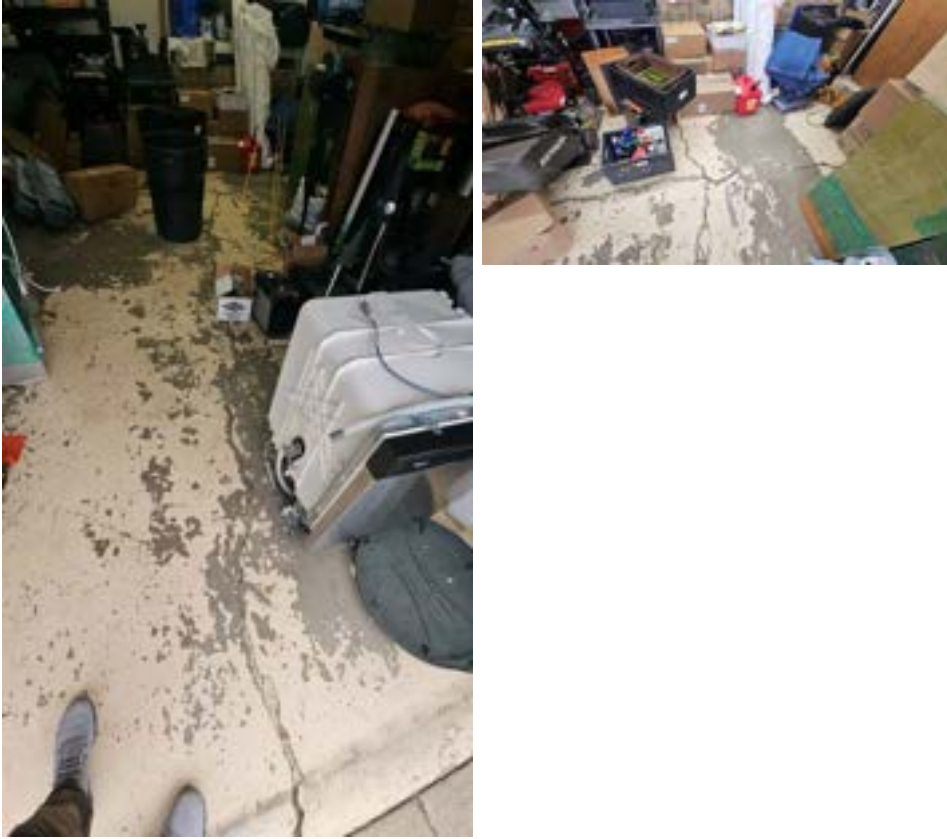
13.3.1 Floor

CRACKING

Cracking visible in the garage floor. Concrete is expected to crack, recommend a concrete contractor evaluate and seal as needed.

Contact a qualified concrete contractor.

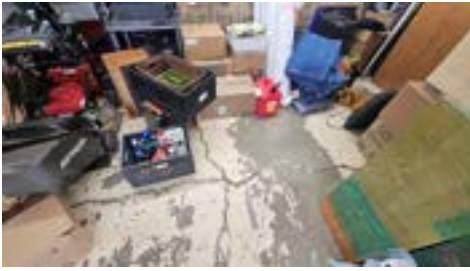
13.3.2 Floor

SETTLING

Garage floor shows signs of settling in the soil beneath the slab. Recommend a foundation or concrete contractor evaluate for potential repairs.

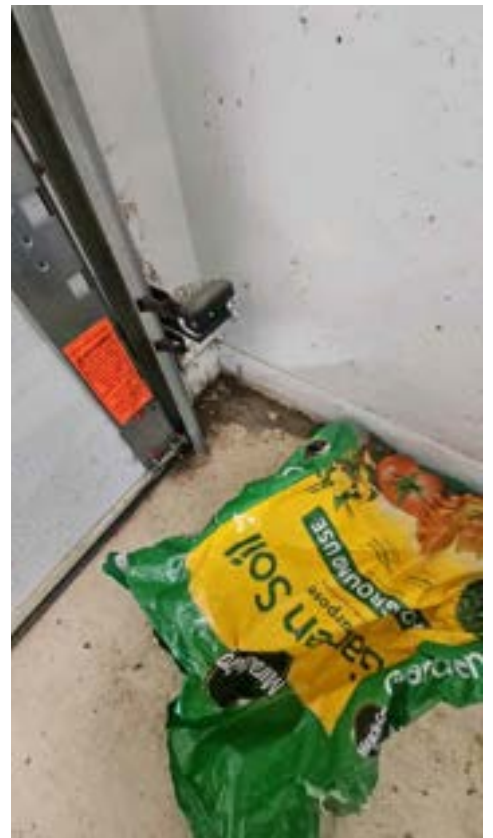
Garage East

MOISTURE DAMAGE

Garage walls showed signs of moisture damage. Recommend a qualified contractor evaluate and find source of moisture to prevent further damage and/or mold.

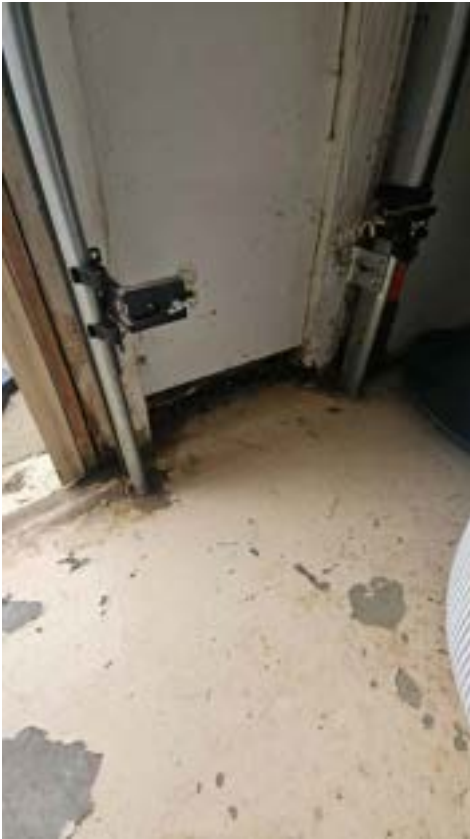
Garage East

Wood rot or decay was observed in the garage. This condition is typically caused by prolonged moisture exposure and can weaken framing members, trim, or siding. Left unaddressed, it may spread further and compromise the structural integrity of the garage. Recommend evaluation and repair by a qualified contractor, which may include replacing decayed wood and correcting any moisture sources to prevent future deterioration.

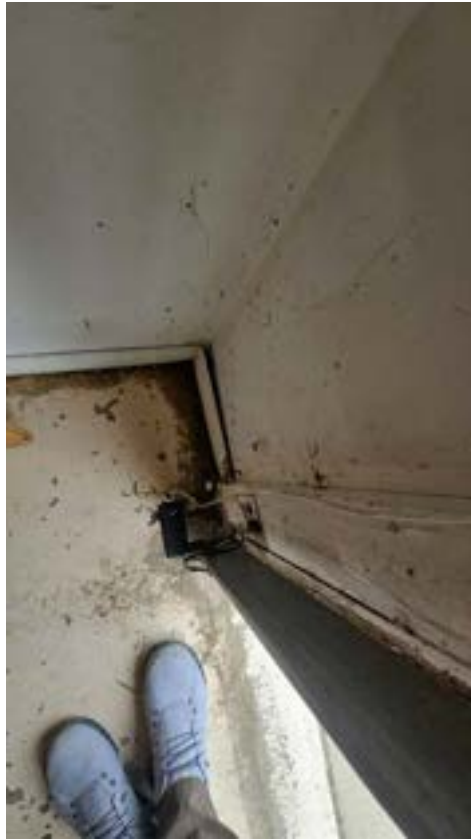
13.4.3 Walls & Firewalls

WOOD ROT OR DECAY

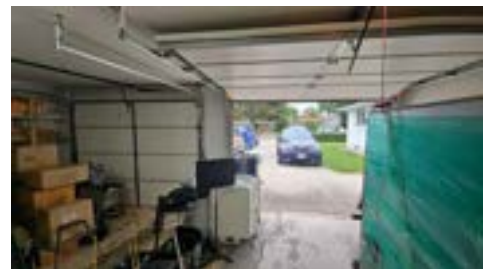
13.5.1 Garage Door

The auto reverse sensor was not responding at time of inspection. This is a safety hazard to children and pets. Recommend a qualified garage door contractor evaluate and repair/replace.

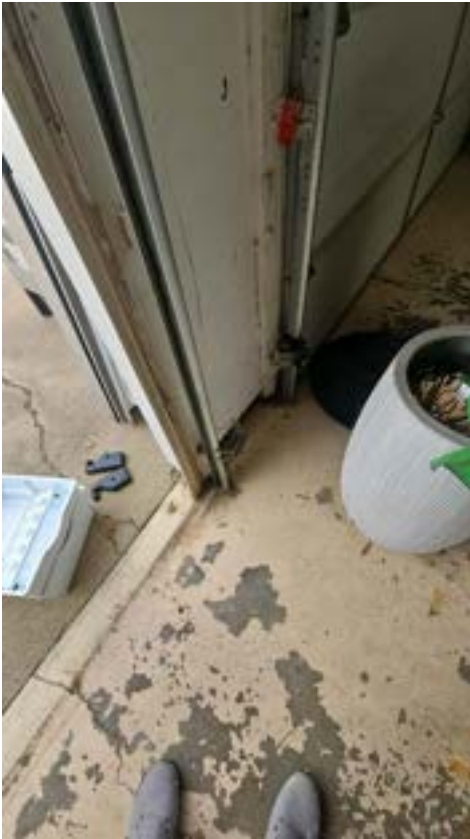
13.5.2 Garage Door

In one or more areas the garage door safety sensor were installed to high. The sensor should be within 6" of the ground. Recommend a qualified professional repair.
