HOLLOWTOP INSPECTION REPORT

5211 Golden Hollow Rd
Billings, MT 59101

Amber Uhren
05/07/2025

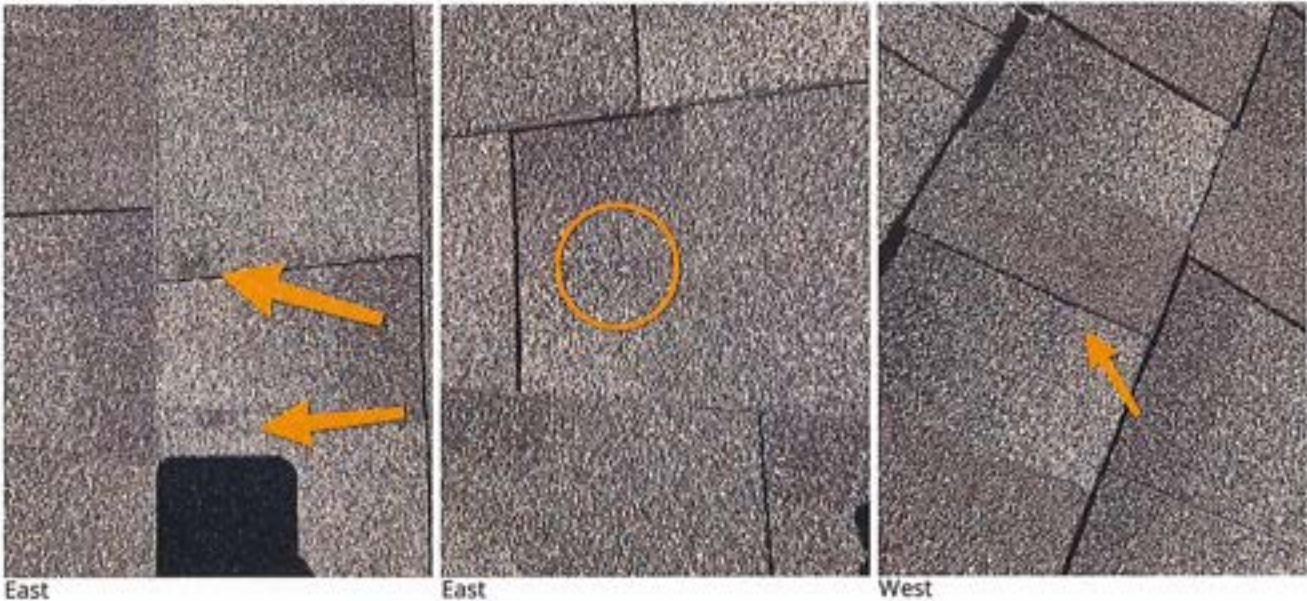
West

Roof coverings had visible damage. Recommend a qualified roofing professional evaluate and repair.

Contact a qualified roofing professional.

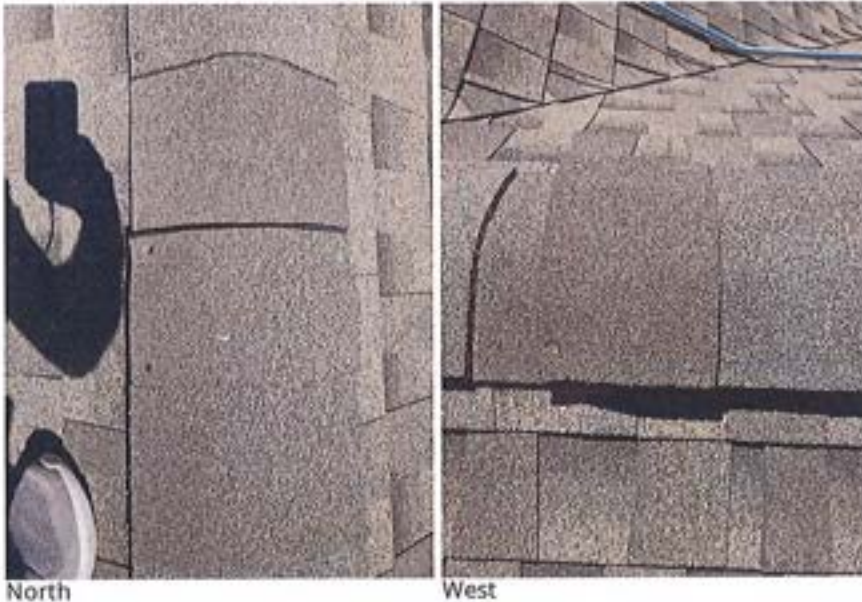
The nailing on the roof covering or on a roof vent is nailed correctly, but the nails do not have any water proofing. Whenever you put a hole into a roof you should properly water proof the intrusion. Recommend a qualified professional reapply water proofing caulk.

Contact a qualified roofing professional.

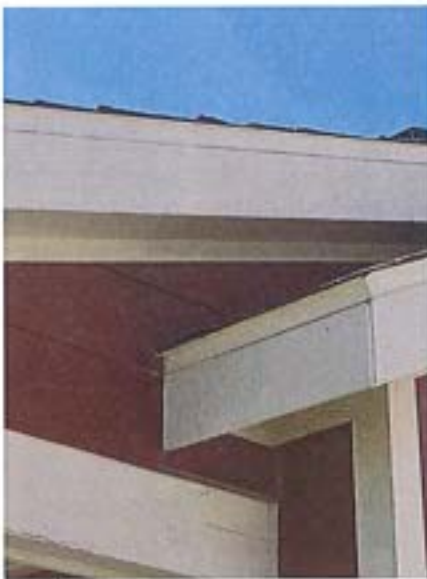
Northeast

In one or more areas kickout flashing is missing. This can lead to water intrusion and damage. Recommend a qualified roofing contractor evaluate.

Contact a qualified roofing professional.

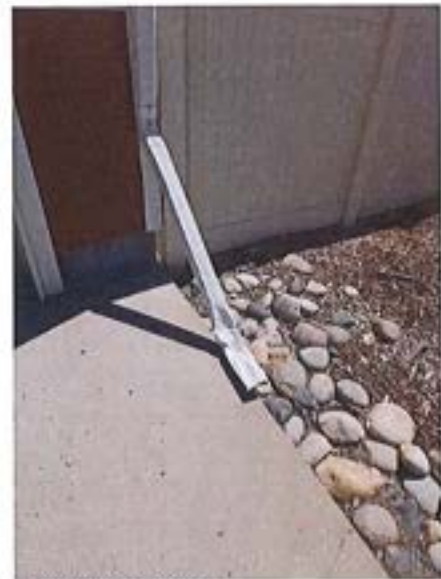
Garage Southwest

One or more areas had downspout damage. Recommend a qualified professional repair or replace as needed.

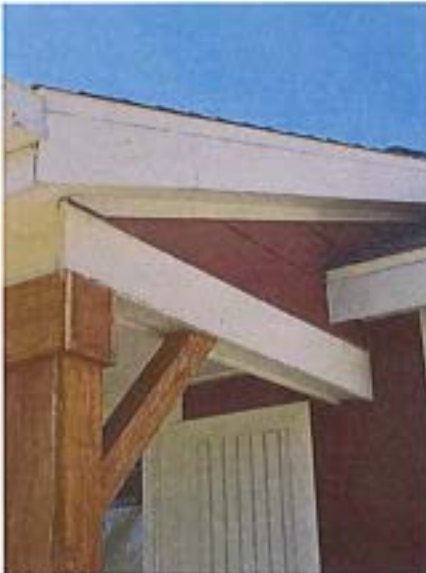
Northeast

In one or more places there was visible paint discoloration and/or peeling. Recommend a qualified painter evaluate and repair.

Contact a qualified painting contractor.

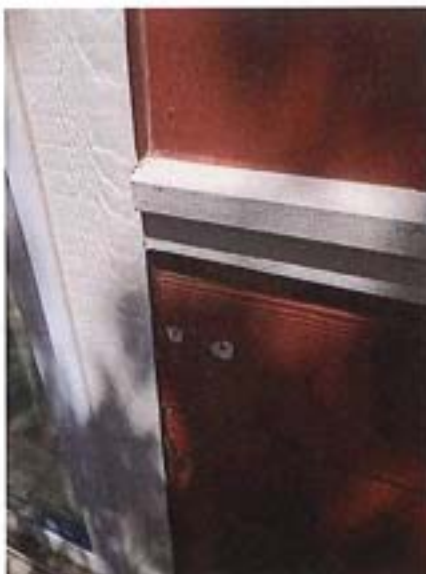
South

In one or more areas there was general siding damage. Recommend a qualified professional evaluate.

Contact a qualified siding specialist.

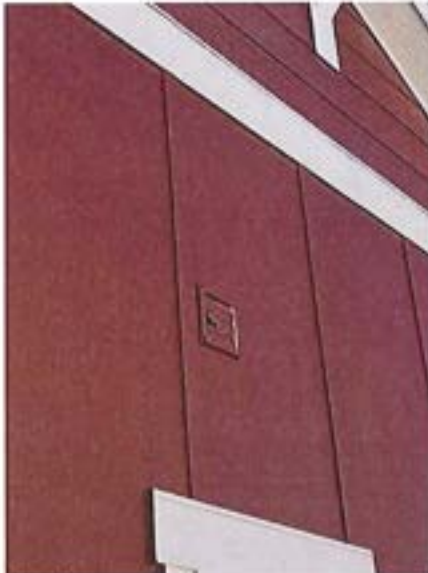
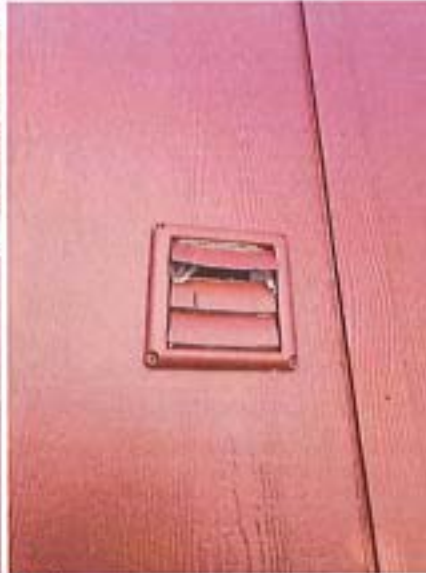
North

One or more exterior vent has damage. Recommend a qualified professional repair or replace as needed.

Contact a qualified professional.

*Replaced
see invoice*

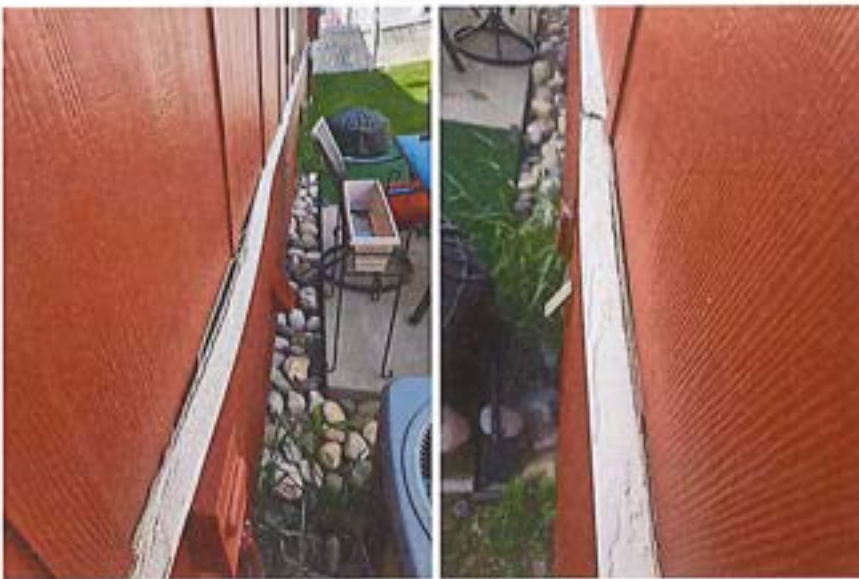
North

In one or more areas there is exterior trim damage and deteriorating. Recommend a qualified professional evaluate.

Contact a qualified professional.

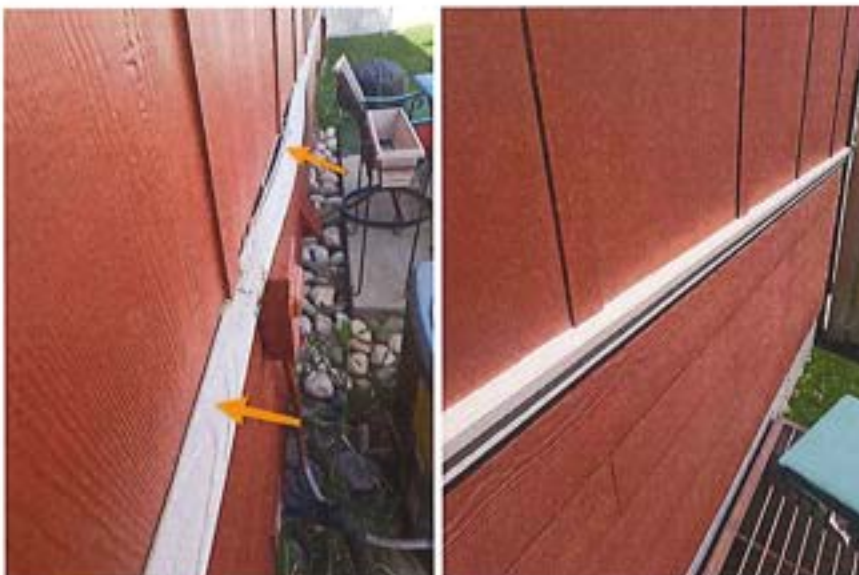
In one or more areas there is missing flashing on the exterior. Recommend a qualified siding contractor evaluate.

Z Flashing At Transition North

Contact a qualified siding specialist.

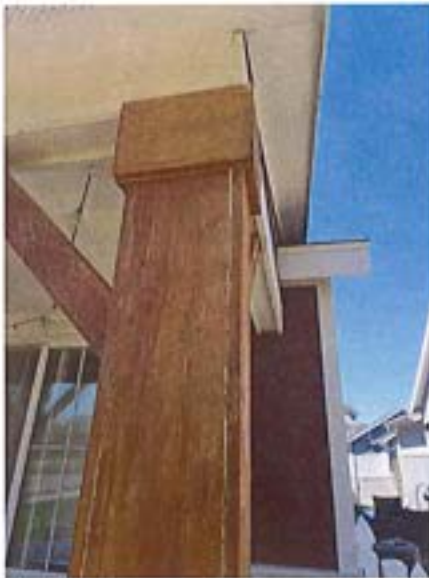
Northeast

At one or more areas of the exterior there was visible caulking cracking or missing caulking. Recommend a qualified professional evaluate and reapply.

Contact a qualified professional.

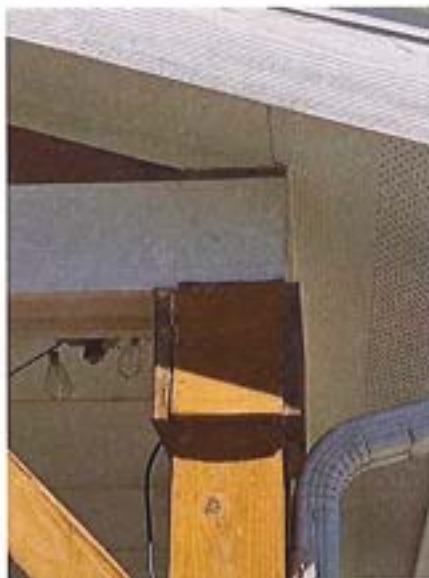
Southeast

Visible moisture swelling or damage was observed on portions of the exterior trim or siding. Recommend evaluation and repair or replacement by a qualified contractor to prevent further damage and maintain the integrity of the exterior envelope.

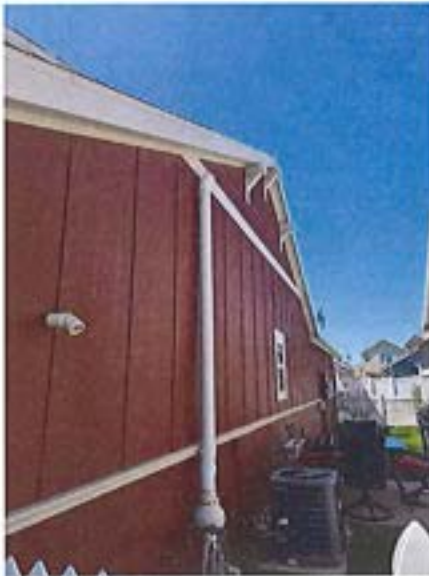
Northeast

The radon mitigation system vent was not terminated at least 12 inches above the roofline, as recommended by the EPA. Proper termination height is important to ensure safe dispersion of radon gas away from living areas. Recommend evaluation and correction by a qualified radon mitigation professional to bring the system into compliance with EPA guidelines.

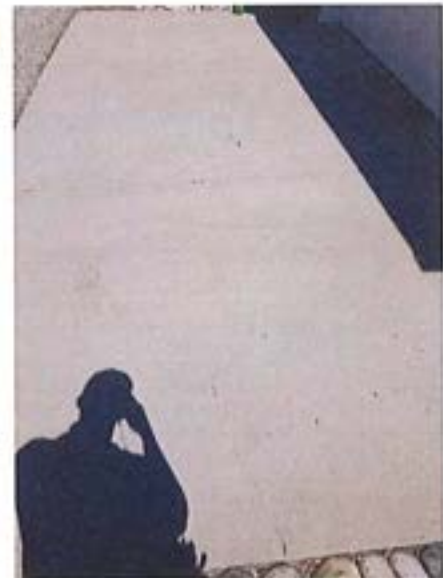
Southwest

Cracks observed, which may indicate movement in the soil. Recommend monitor and/or have concrete contractor patch/seal.

Contact a qualified concrete contractor.

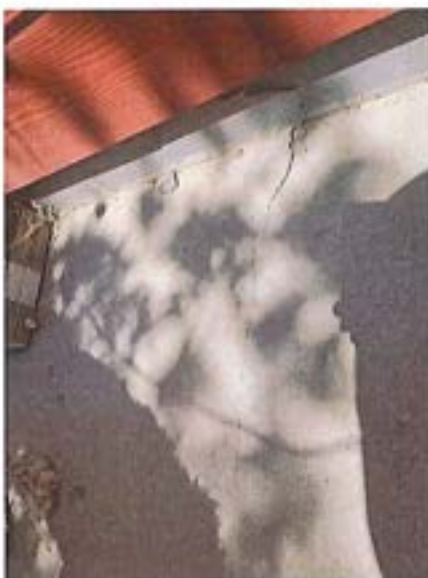
South

Significant settling & cracking observed. Further deterioration could result. Recommend concrete contractor evaluate & repair.

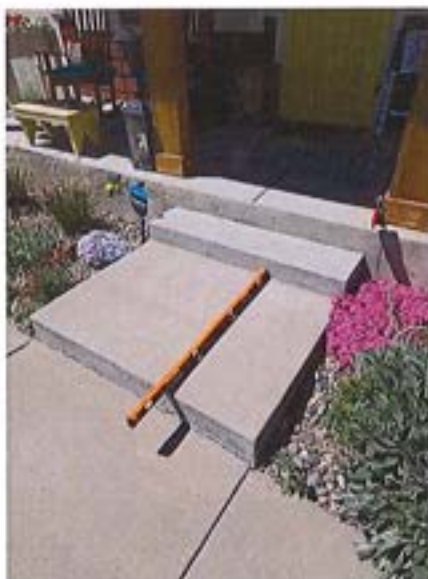
East

Minor settlement was observed in the concrete step, causing it to slope toward the structure. This condition may lead to water drainage issues and potential moisture intrusion at the foundation. Recommend monitoring and evaluation by a qualified professional to determine if leveling or corrective measures are needed.

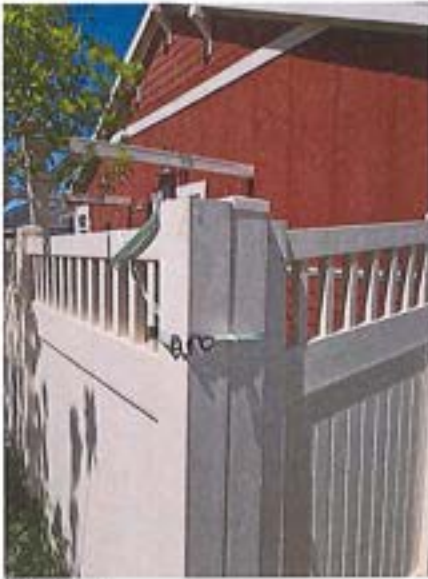
Southeast

The fence had visible damage at the time of the inspection. Recommend a fence contractor repair.

Contact a qualified fencing contractor

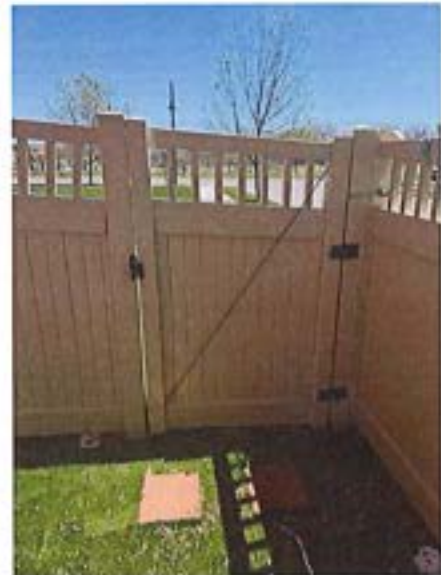
Southeast

The fence gate does not open smoothly, likely due to loose posts or misaligned hinges. This can affect functionality and may lead to further wear or damage over time. Recommend evaluation and adjustment or repair by a qualified professional to ensure proper operation.

*repair
me invoice*

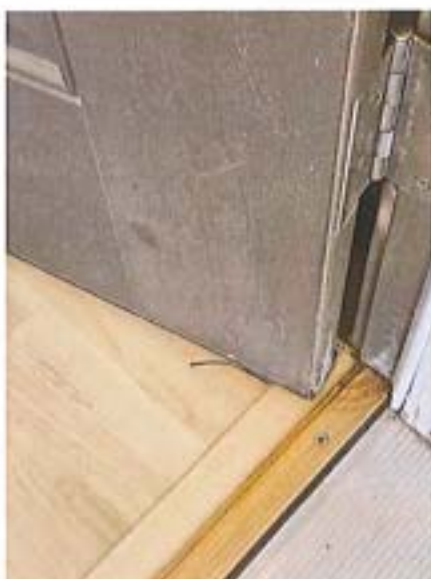
East

Weather striping shows wear, damage, or is in need of reinstallation. Could lead to drafts and lose of energy efficiency. Recommend a qualified professional evaluate.

Contact a qualified door repair/installation contractor.

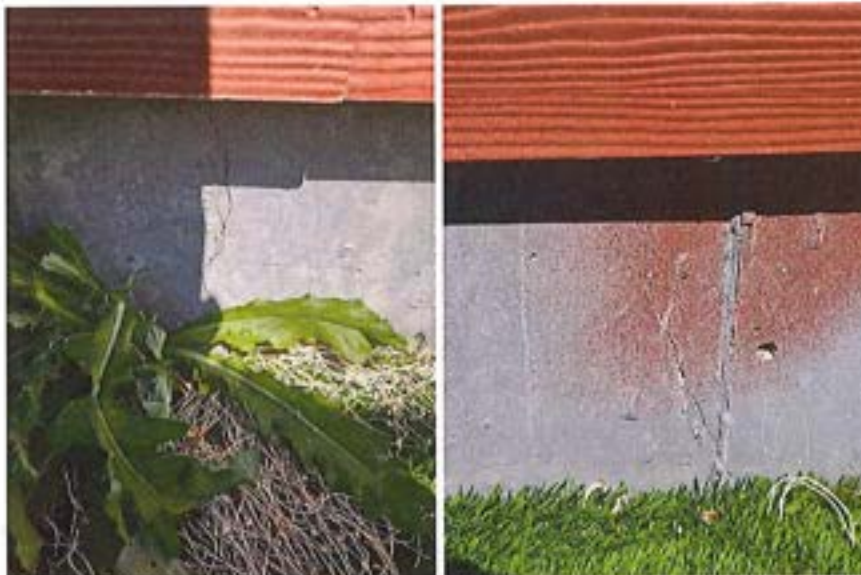
Garage Southwest

Small foundation cracks were observed, which appear typical of normal settlement. While not currently a structural concern, these cracks should be monitored over time. If any crack widens beyond 1/8 inch, it is recommended that they be sealed and further evaluated by a qualified professional to prevent potential water intrusion or structural issues.

Contact a foundation contractor.

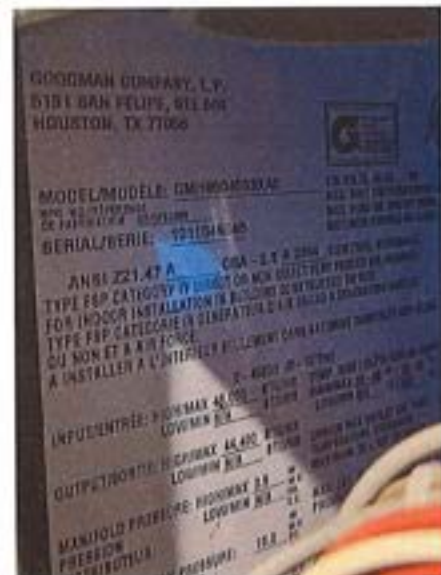
The average lifespan of a furnace is 15-20 years. Recommend a professional examine furnace because of it's age. The Goodman furnace was manufactured in 2010.

Contact a qualified heating and cooling contractor

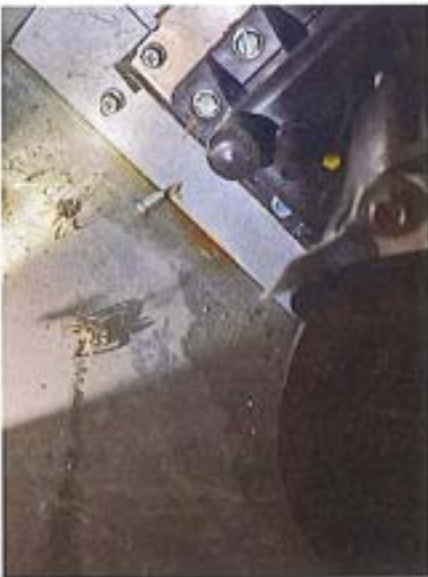
At the time of the inspection there was visible rusting of the furnace. Recommend a qualified professional evaluate and repair.

Contact a qualified professional.

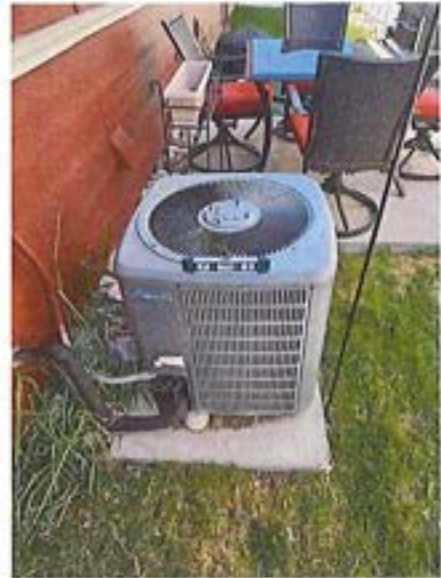
North

The outdoor condensing unit is not level. This can cause accelerated deterioration of components. Recommend licensed HVAC contractor level the unit.

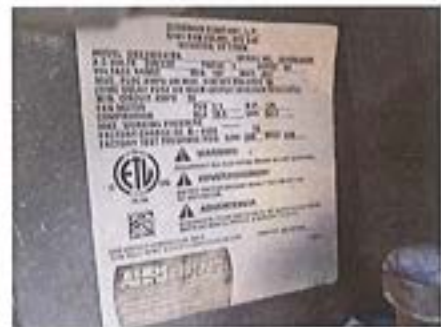
Averages lifespan is 15-20 years. Recommend a Heating and Cooling Professional evaluate because of age. The Goodman ac unit was manufactured in 2010.

Contact a qualified heating and cooling contractor

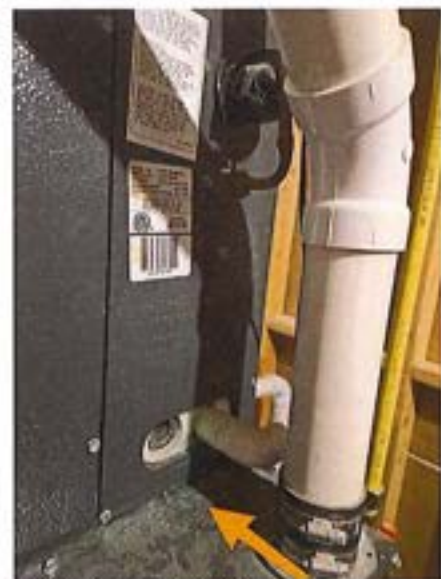
Basement Utilityroom

Where the coolant line enters the air handler the insulation is damaged. This is causing the line to drip condensation. Recommend a qualified professional evaluate and repair.

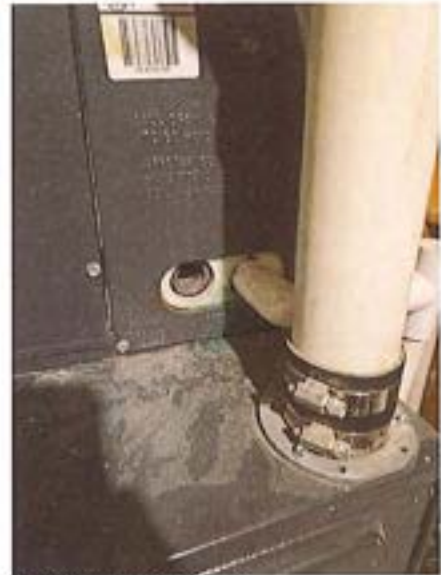
Basement Utilityroom

The air handler's secondary condensation drain was missing a plug or attached drain line. This drain is intended as a backup to help prevent overflow if the primary drain becomes clogged. Without a proper plug or drain line, moisture could leak into the surrounding area. Recommend correction by a qualified HVAC professional to ensure proper drainage and prevent potential water damage.

*Replaced.
M-11/2016*

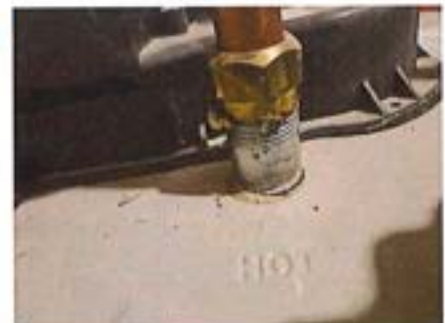
Basement Utilityroom

Corrosion was noted at the burn chamber or pipe fittings. The water heater had corrosion at the cold water inlet. Recommend a qualified plumber evaluate for repair/replacement.

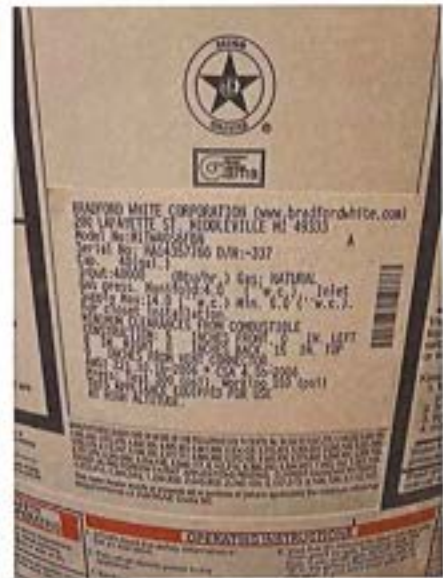
Average lifespan of a water heater is 8-12 years. Recommend a professional examine water heater because of it's age. The Bradford White water heater was manufactured in 2011.

Contact a qualified plumbing contractor.

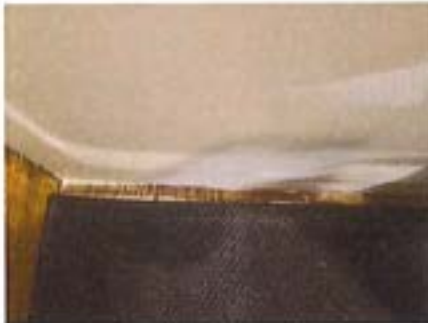
Basement Bathroom

One or more of the sinks or bathrooms has missing or deteriorating caulking. Recommend caulking be reapplied by a qualified professional.

Contact a qualified professional.

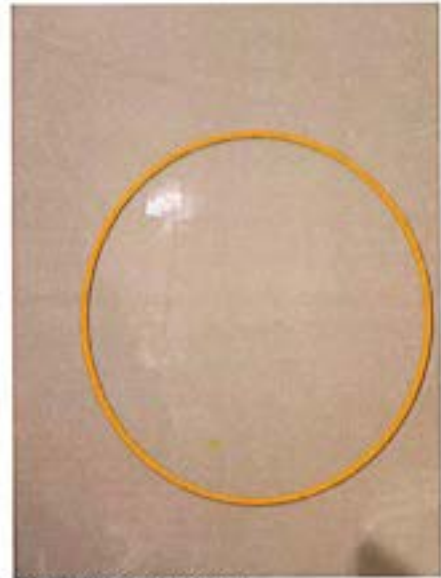
Basement Bathroom

The shower stall wall had visible cracking. This may be due to normal wear, age, or minor structural movement. Recommend evaluation by a qualified professional.

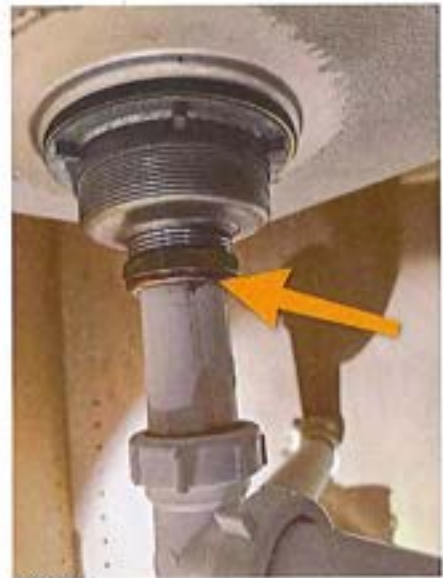
Kitchen

One or more of the homes plumbing drain pipes had visible corrosion. This can be caused by hard water. Recommend a qualified professional evaluate.

Contact a qualified professional.

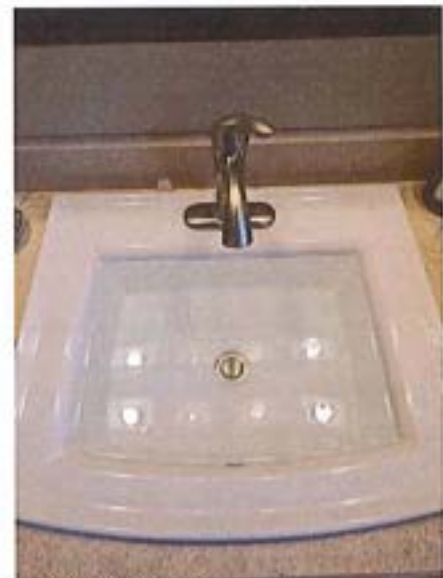
Master Bathroom

One or more of the homes sink over flows were clogged at the time of the inspection. Recommend a qualified professional evaluate.

Contact a qualified professional.

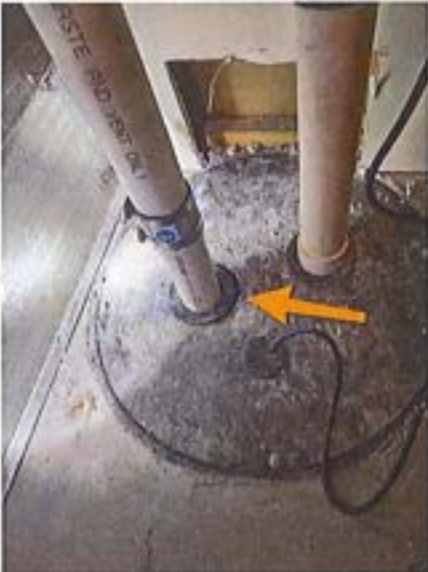
Basement Utilityroom

The sump pump's rubber gasket was not properly installed, resulting in an improper seal. Recommend evaluation and correction by a qualified professional to ensure proper sealing and function of the sump pump system.

*Repaired
see invoice*

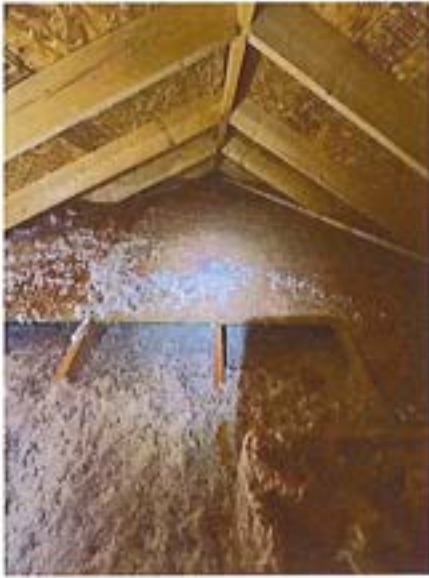
A portion of the attic was inaccessible due to having less than 18 inches of clearance, which limited safe entry and inspection. This is noted as an inspection limitation.

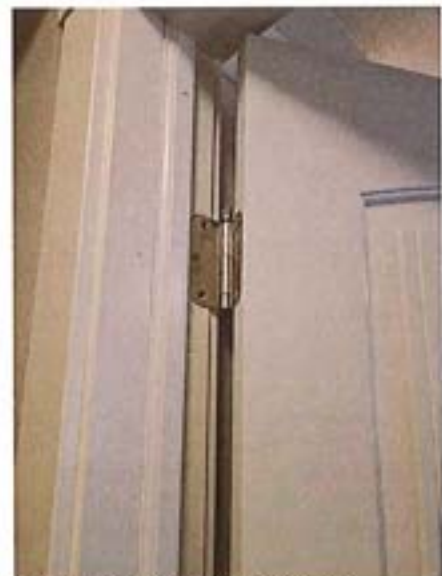
Basement Southeast Bedroom

Loose hinges can cause door to stick or eventually fall out of place. Recommend handyman tighten hinges.

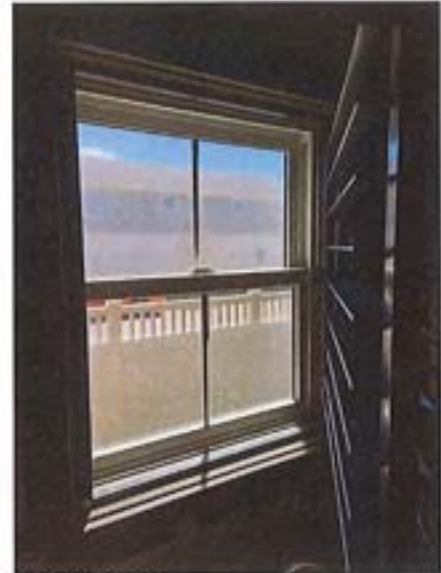
Kitchen South

Window's lock has failed and no longer latches and locks properly. Recommend a qualified professional evaluate.

Contact a qualified window repair/installation contractor.

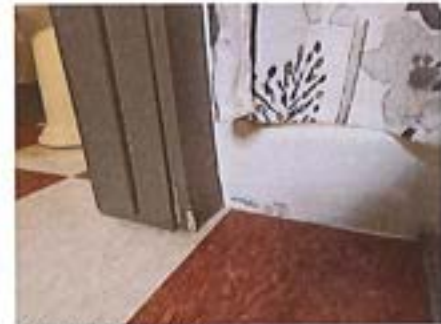
Master Bathroom

Stains on the walls visible at the time of the inspection appeared to be the result of moisture damage. Recommend a qualified professional evaluate and repair as needed.

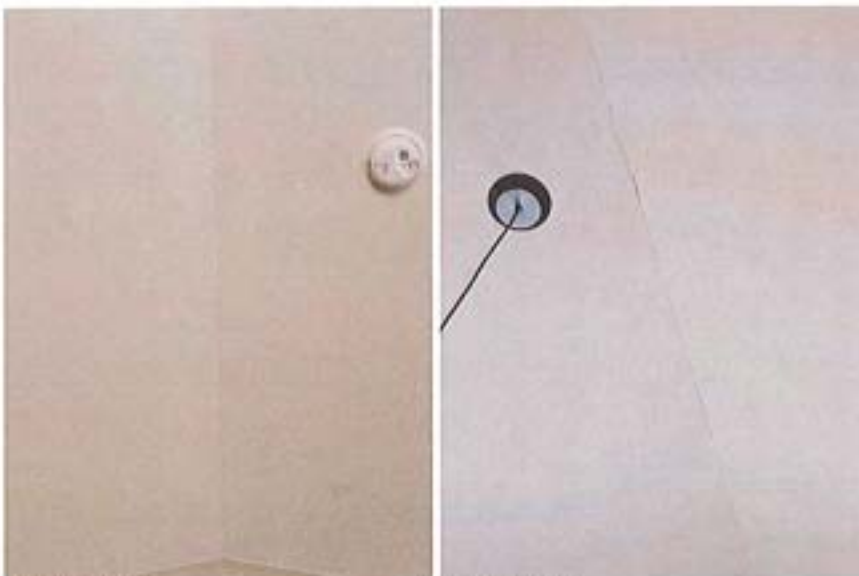
Dining Room

Cracking was visible on the ceiling structure. This could be due to home settlement over time. Recommend a qualified professional examine.

Contact a qualified professional.

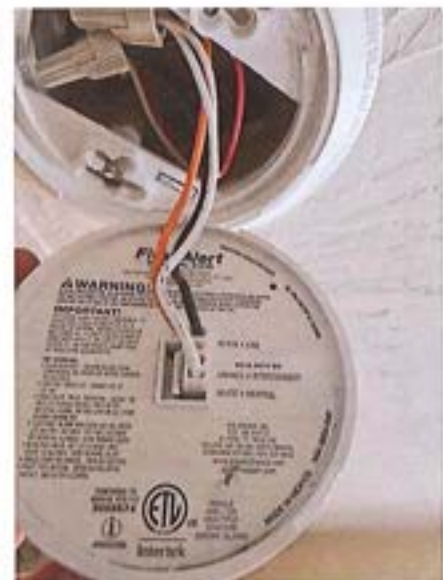
I observed indications of old smoke detectors in the house. Detectors should be replaced every 5-10 years. They should be hard-wired with electricity and have a battery backup feature in case the electricity turns off. New smoke detectors are recommended.

Contact a qualified professional.

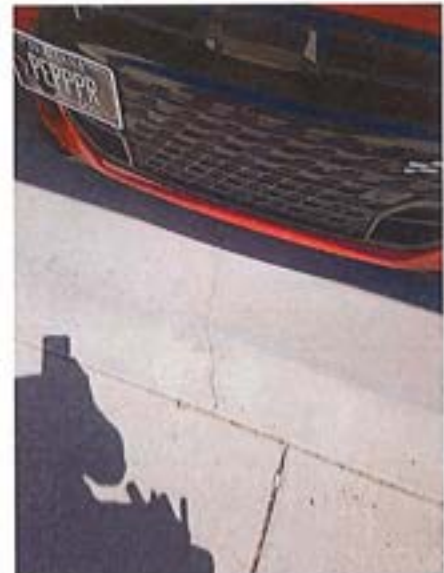
Cracking visible in the garage floor. Concrete is expected to crack, recommend a concrete contractor evaluate and seal as needed.

Contact a qualified concrete contractor.

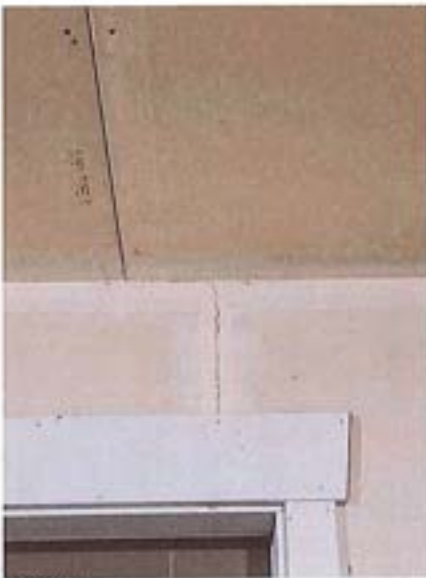
Garage

In one or more areas the garage wall had visible cracking. Recommend a qualified professional evaluate and repair.

Contact a qualified professional.

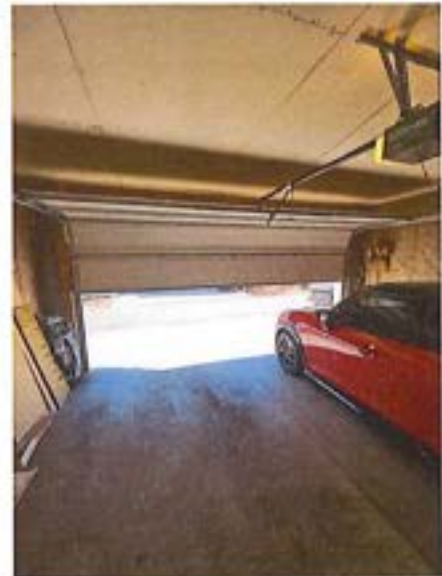
The auto reverse sensor was not responding at time of inspection. Recommend a qualified garage door contractor evaluate and repair/replace.

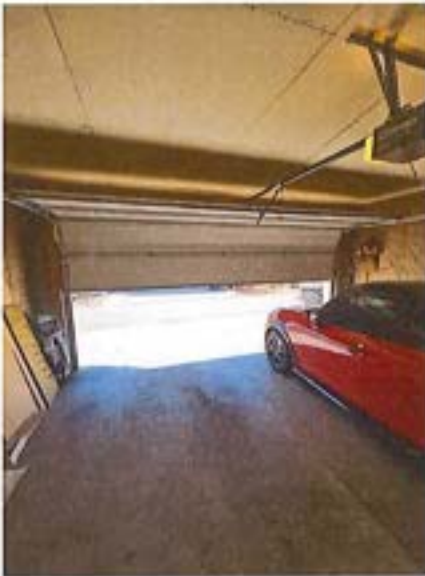
Loud grinding or squealing observed when opening/closing garage door. This can be due to dirt or debris in the track or lack of lubrication. Recommend cleaning the track and lubricating.

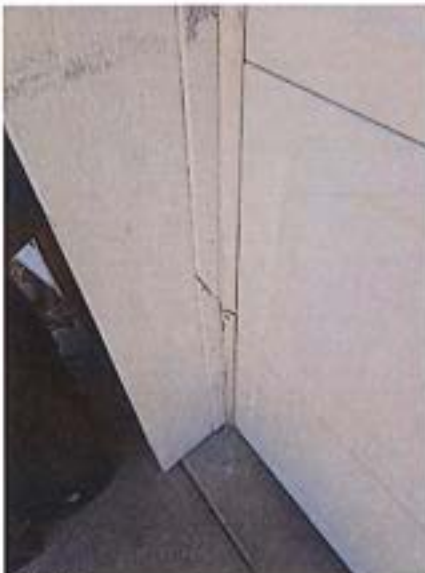
Garage door weather stripping is worn or damaged. Recommend it be replaced by a qualified professional.

Contact a qualified professional.

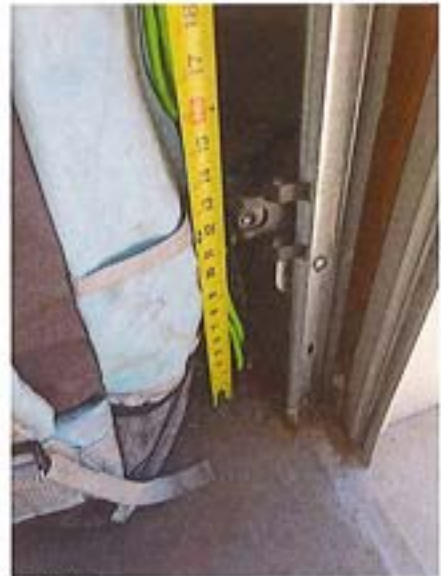
Garage

In one or more areas the garage door safety sensor were installed to high. The sensor should be within 6" of the ground. Recommend a qualified professional repair.

Contact a qualified professional.

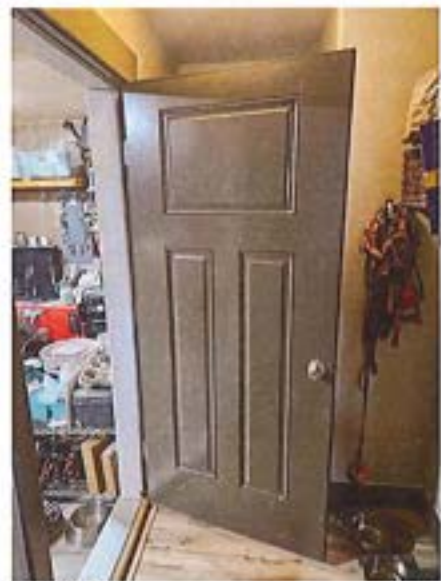
Garage

Door from garage to home should have self-closing hinges to help prevent spread of a fire to living space. Recommend a qualified contractor install self-closing hinges.
