WOOD DESTROYING PESTS INSPECTION REPORT

Firm (PCO) Carson Valley Ext. License No. 5599 Inspection Date 9/15/2003
 Address P.O. Box 230 Gardnerville NV 89410 Inspection Time 9:00
 Address of Property Inspected 2747 Stewart Minden 89403
 City Zip Code
 Inspection Ordered by Thomas Vander Laan - Gardnerville FHA/VA/Escrow or Mortgage No
 Inspection Report Sent to George
 Owner's Name and Address Rodgers

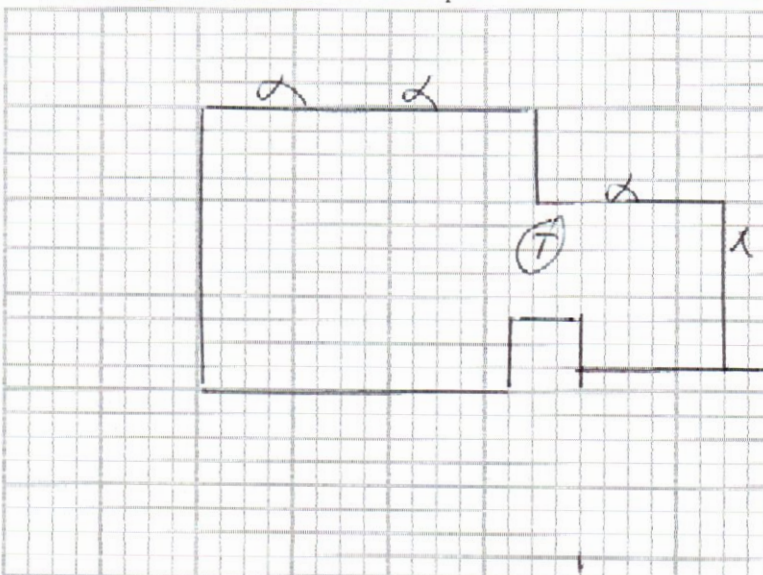
INFESTATION: (See diagram and explanation below)

- ① Inactive termite evidence
 on cement of pier post no
 damage
 * Earth Wood contacts on
 siding outside
