HOLLOWTOP INSPECTION REPORT

25 Sunlight Cir
Billings, MT 59101

Janae Ruiz
07/03/2025

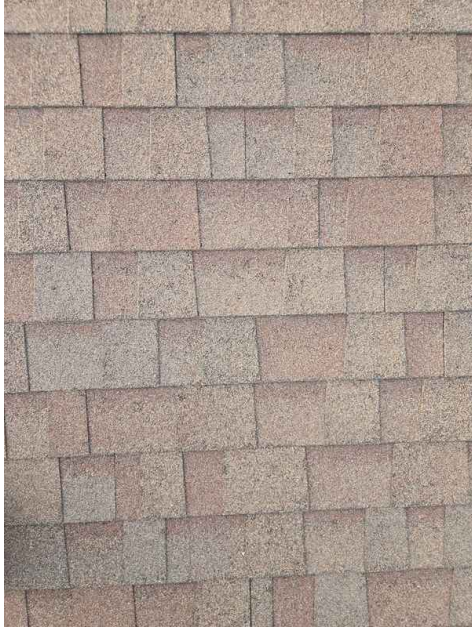
North

HAIL DAMAGE

There was evidence of hail damage on the roof recommend roofing professional check for severity and functional damage.

Contact a qualified roofing professional.

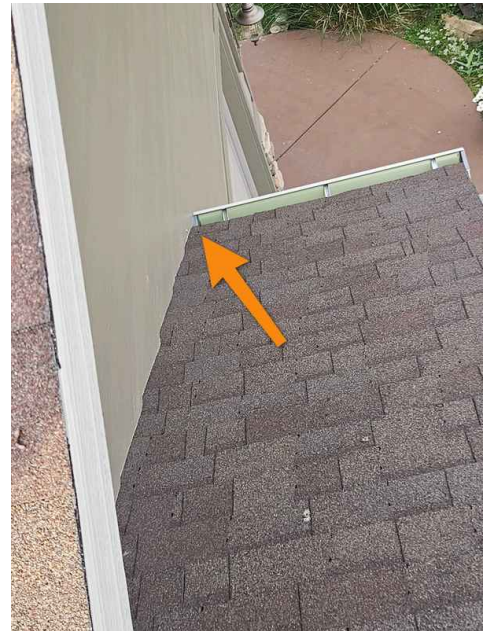
Garage North

Defect Or Recommendation**NO KICKOUT FLASHING**

In one or more areas kickout flashing is missing. This can lead to water intrusion and damage. Recommend a qualified roofing contractor evaluate.

Contact a qualified roofing professional.

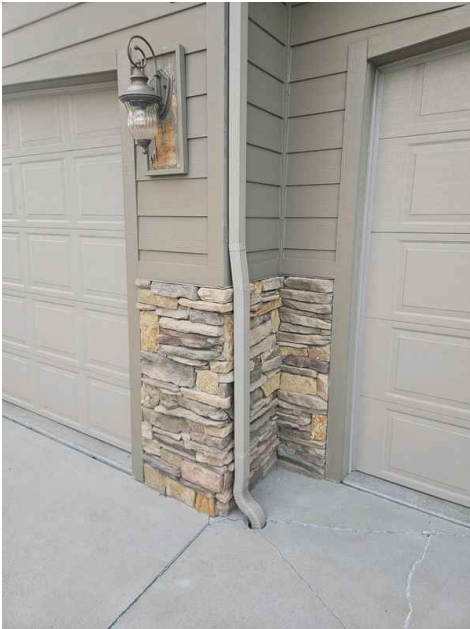
Garage

Defect Or Recommendation**HAIL DAMAGE**

In one or more areas the gutters or downspouts have visible hail damage. Recommend inquiring with sellers on any hail claims made and a roofing professional evaluate for any further damage.

Contact a qualified roofing professional.

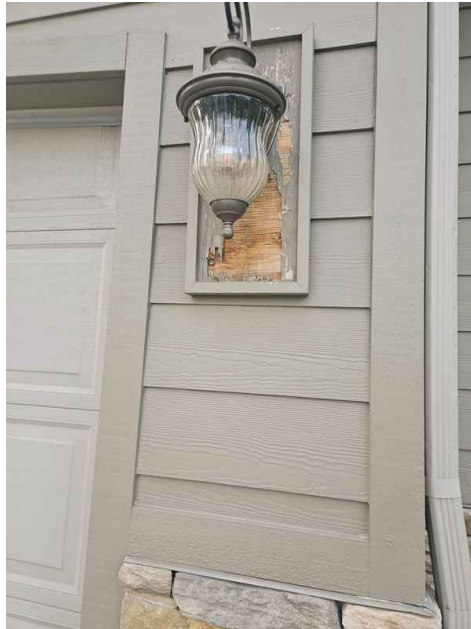
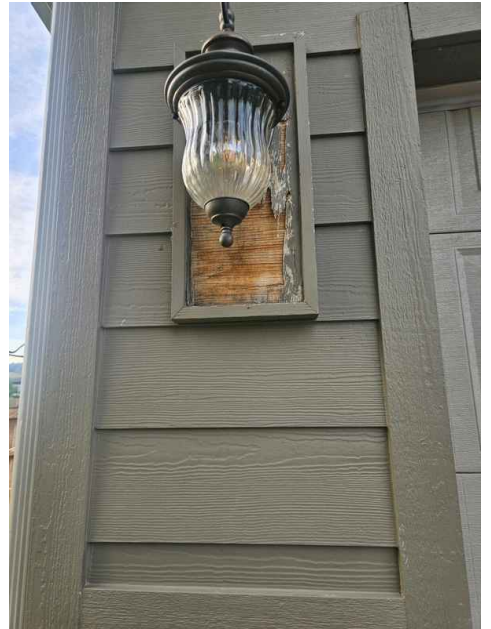
Garage

3.1.2 Siding, Flashing & Trim

CAULKING CRACKING OR MISSING

At one or more areas of the exterior there was visible caulking cracking or missing. Recommend a qualified professional evaluate and reapply.

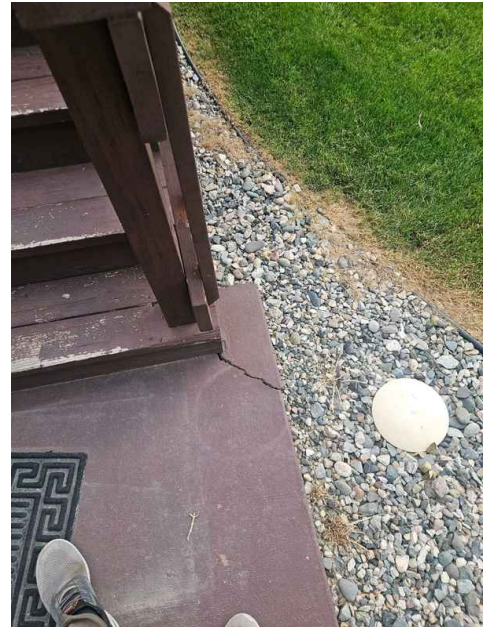
South

Defect Or Recommendation
WALKWAY CRACKING

Cracks observed on the walkway. Recommend concrete contractor evaluate and patch and seal as needed.

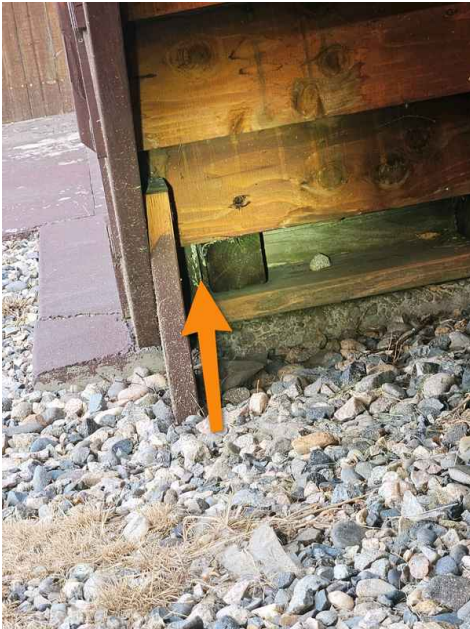
South

Defect Or Recommendation
WOOD ROT OR DECAY

One or more areas of the homes deck had visible wood rot or decay. Recommend a qualified professional evaluate and repair.

Contact a qualified professional.

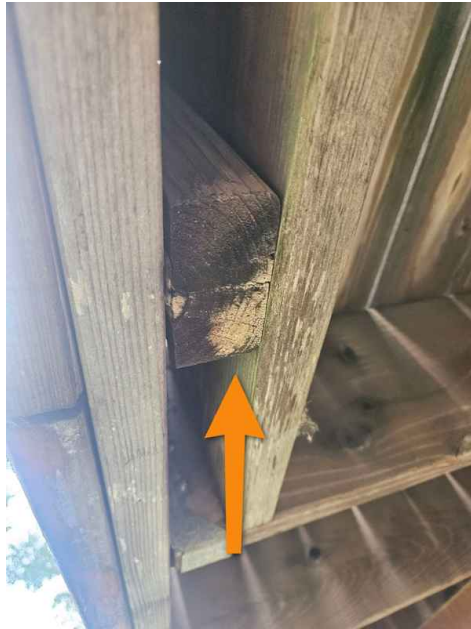
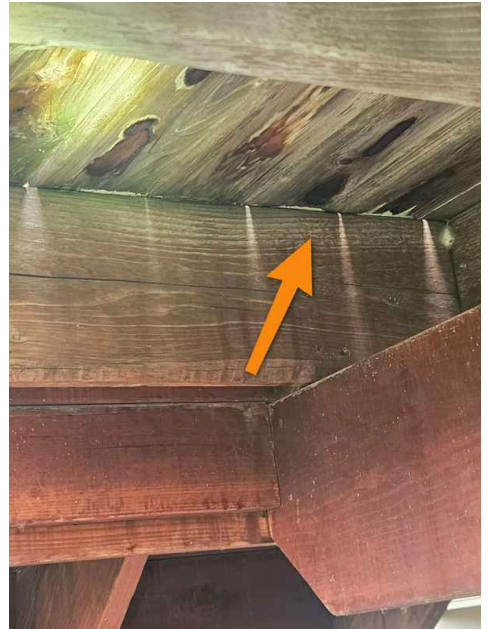
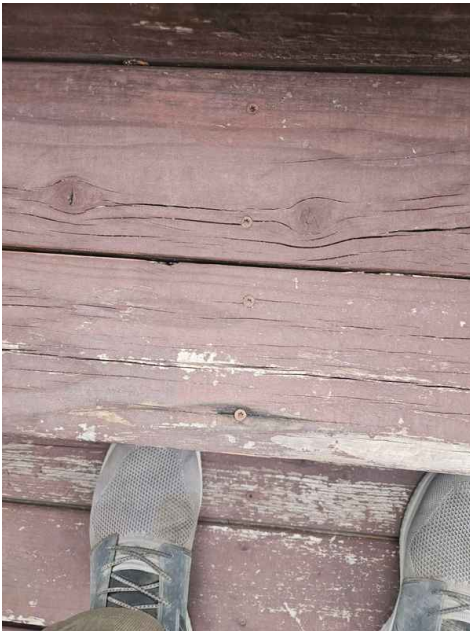
South

3.5.2 Decks, Balconies, Porches & Steps

IMPROPER FASTENERS

One or more of the deck joist hangers or brackets was installed with improper fasteners. These fasteners should be shear rated hanger nails or screws. Recommend a qualified professional evaluate and correct.

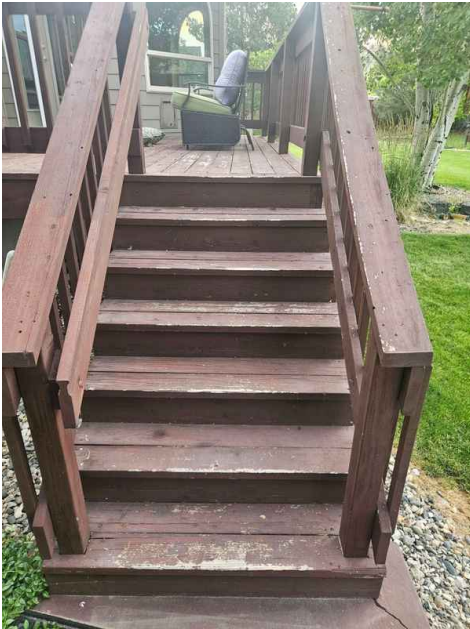
South

Deck is showing signs of weathering and/or water damage. Recommend water sealant/weatherproofing be applied.

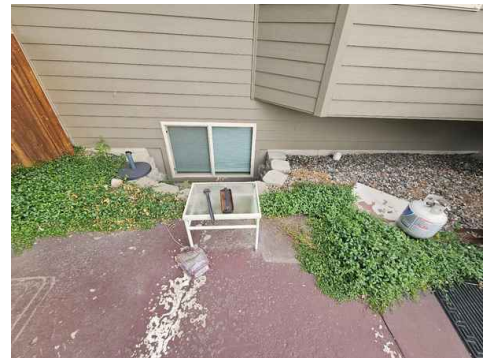
Southwest

3.6.2 Vegetation, Grading, Drainage & Retaining Walls

Vines or other vegetation has grown into the structure, although this may look nice it is very bad for the home. This can cause water intrusion, siding and roof damage, and also general decay of materials.

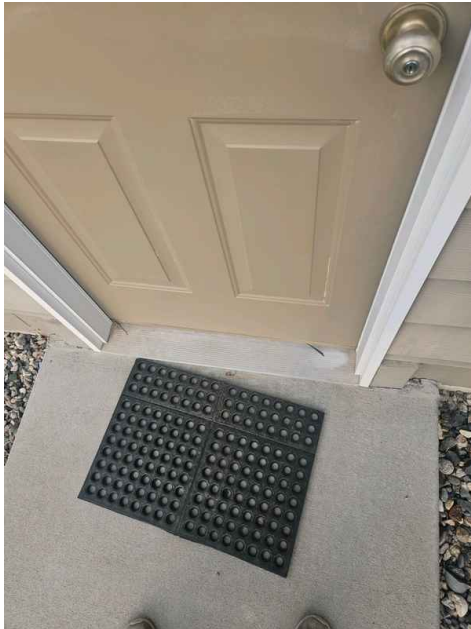
Garage East

Defect Or Recommendation
WEATHER STRIPING

Weather striping shows wear, damage, or is in need of reinstallation. Could lead to drafts and lose of energy efficiency. Recommend a qualified professional evaluate.

Contact a qualified door repair/installation contractor.

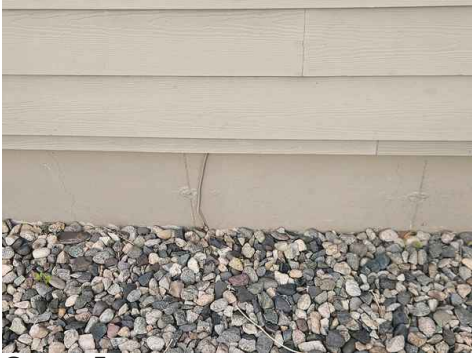
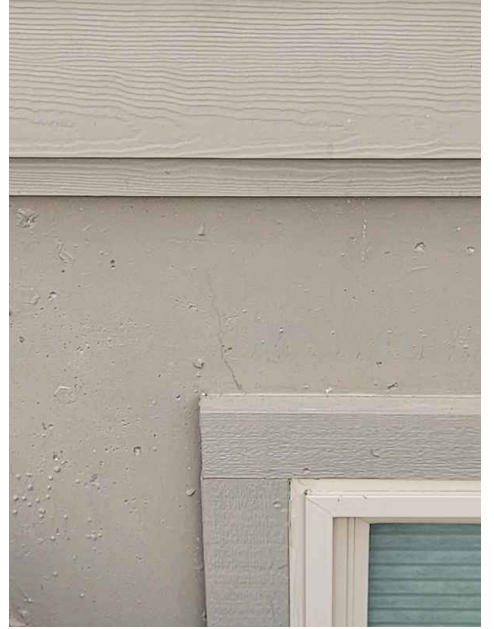
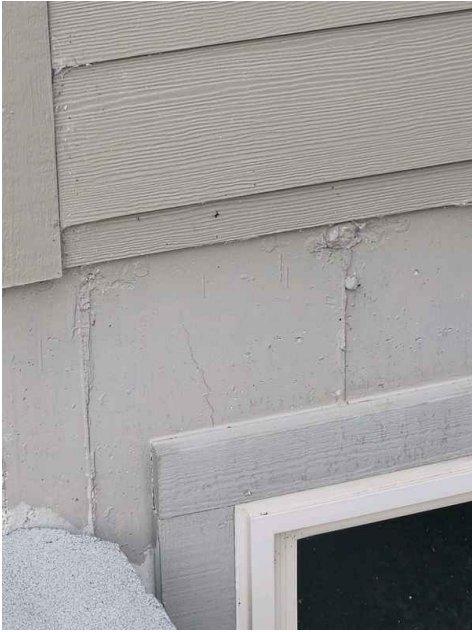
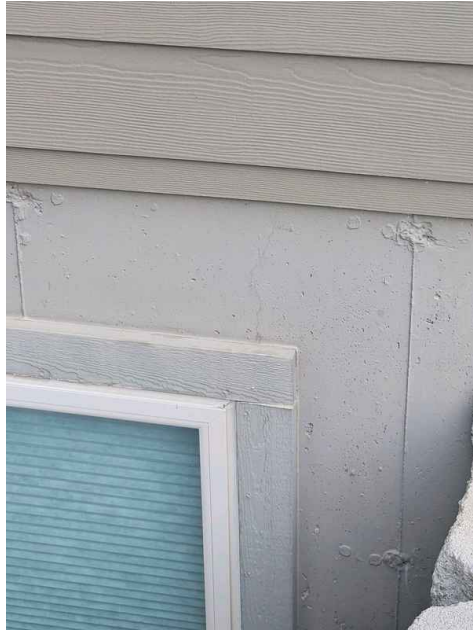
4.1.1 Foundation

FOUNDATION CRACKS

Cracking was noted at the foundation. Some cracking is common as concrete ages and shrinks. Recommend the cracks be evlouted and properly sealed by a foundation contractor.

Contact a foundation contractor.

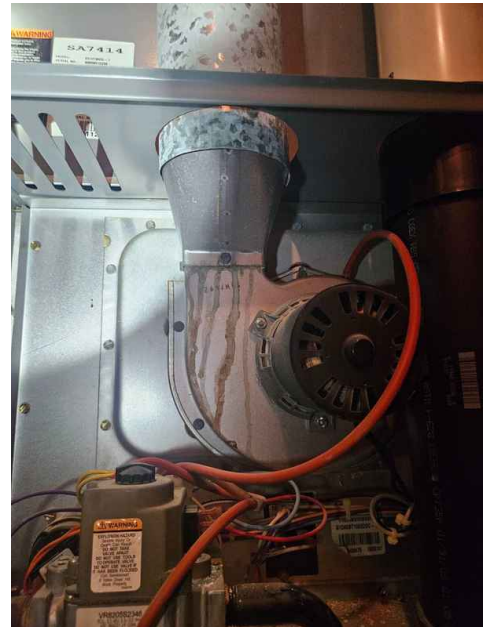
Basement Utilityroom

CORROSION

Furnace was corroded in one or more areas. This could be the result of improper venting, which the source would need to be identified. Recommend a HVAC contractor evaluate and repair.

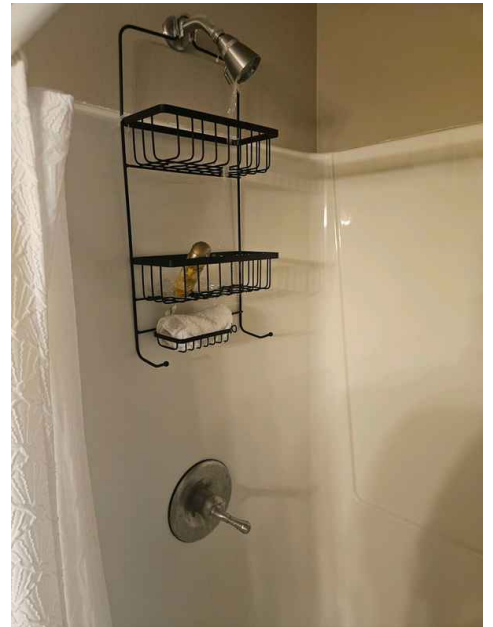
Master Bathroom

INADEQUATE WATER FLOW AT FIXTURE

I observed indications of a defect in the water supply by viewing the functional flow in two fixtures operated simultaneously. The flow was not as strong as expected.

Contact a qualified plumbing contractor.

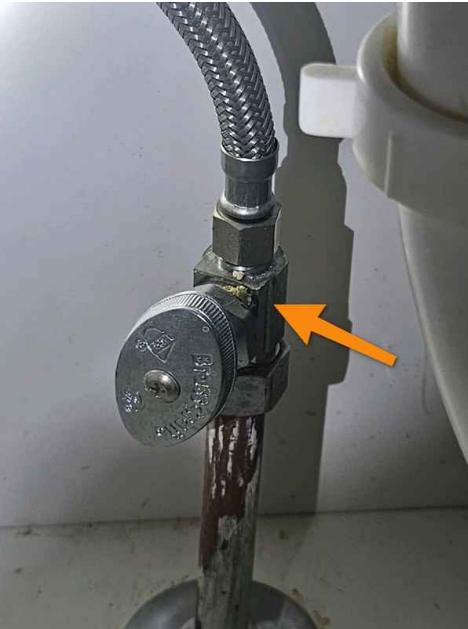
Master Bathroom

CORROSION SHUT OFF VALVE

There was visible corrosion at one or more of the homes shut off valves. Recommend a qualified professional evaluate.

Contact a qualified plumbing contractor.

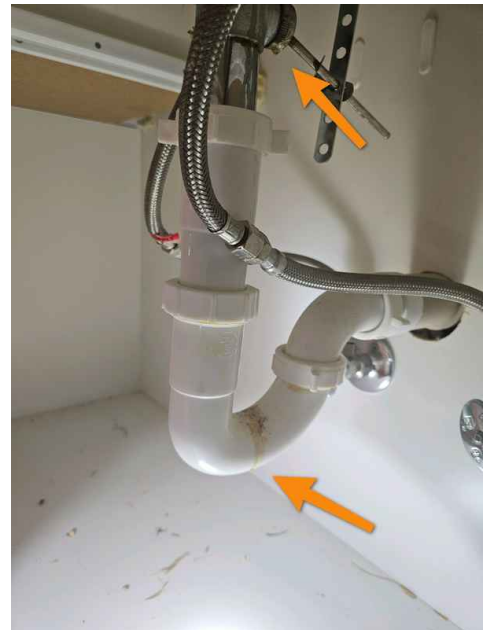
Hallway Bathroom

Defect Or Recommendation
LEAKING PIPE

A drain, waste and/or vent pipe showed signs of a leak. Recommend a qualified plumber evaluate and repair.

Contact a qualified plumbing contractor.

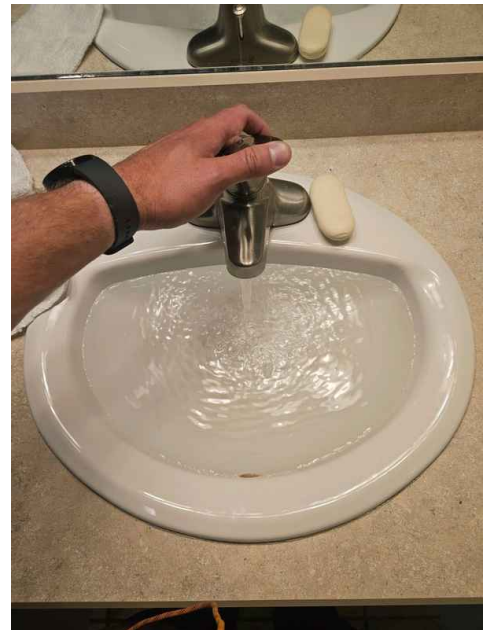
Master Bathroom

One or more of the homes sink over flows were clogged at the time of the inspection. Recommend a qualified professional evaluate.

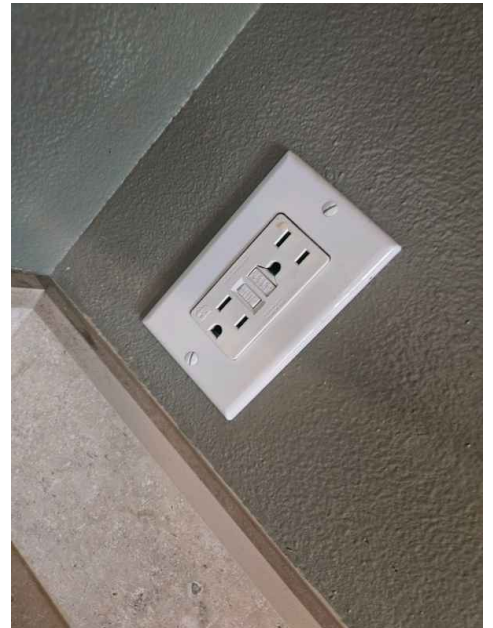
Kitchen

COVER PLATES DAMAGED

One or more receptacles have a damaged cover plate. Recommend replacement.

Contact a qualified electrical contractor.

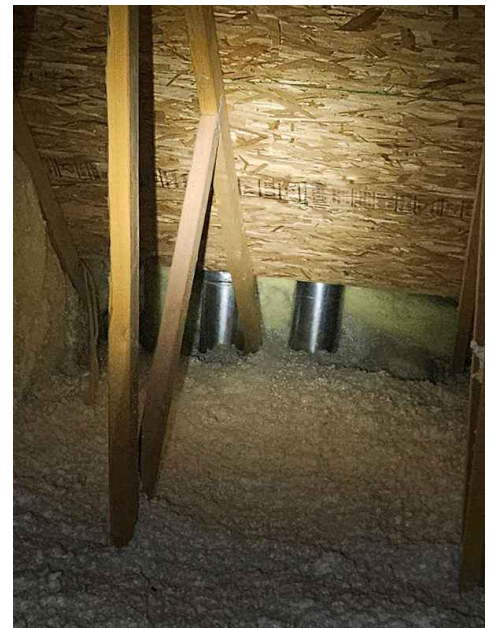
Attic North

The gas flue in the attic did not have sufficient clearance from the insulation. Recommend a qualified professional evaluate and correct

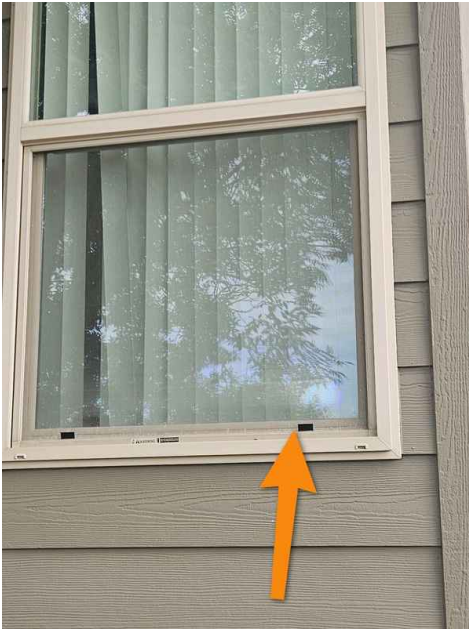
Southwest

FAILED SEAL

Observed condensation or fogginess between the window panes, which could indicate a failed seal. Recommend qualified window contractor evaluate & replace.

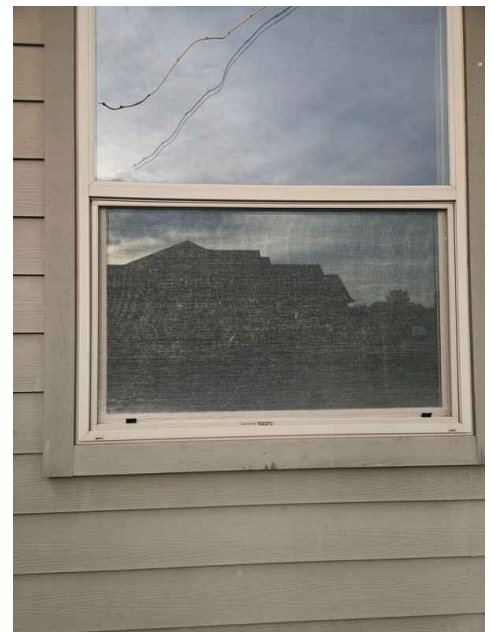
Garage

DAMAGED SCREEN

Window screen is torn or ripped, recommend it be repaired or replaced.

Contact a handyman or DIY project

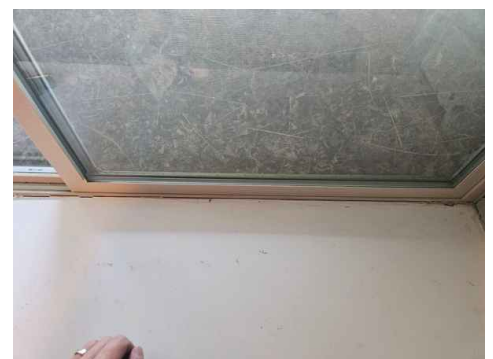
Windows Throughout

CAULKING DETERIORATING

One or more of the homes windows had caulking cracking or deterioration at the sill. Recommend reapplying caulking.

Contact a qualified professional.

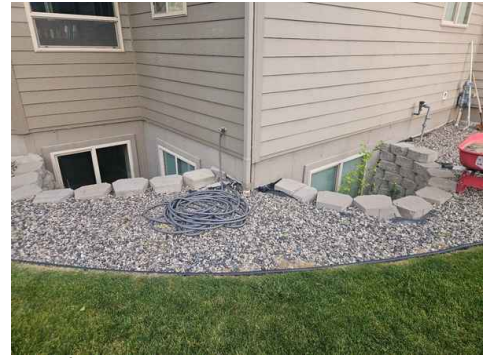
Southeast

Defect Or Recommendation
NO EGRESS WINDOW COVER

At the time of the inspection there was no egress window covers. Although not required they are recommended as an added safety device for window wells.

Contact a qualified professional.

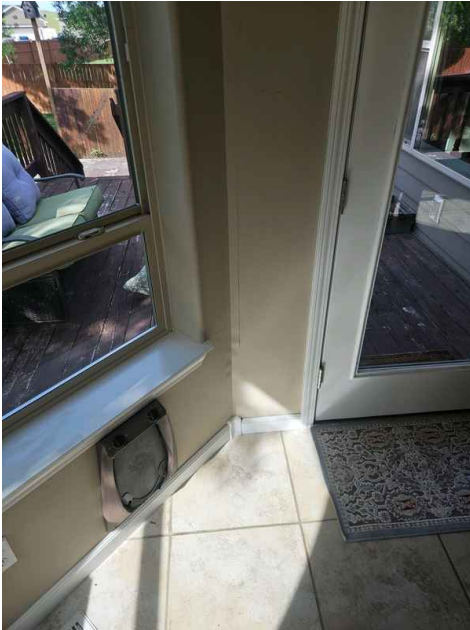
Dining Room

CORNER CRACKS

Cracks at the corners of doors and windows in walls. Appeared to be the result of long-term settling. Recommend a qualified professional evaluate.

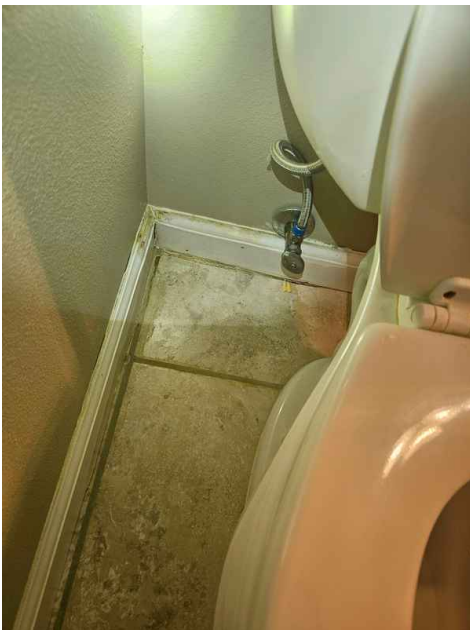
Basement Bathroom

MOISTURE DAMAGE

Stains on the walls visible at the time of the inspection appeared to be the result of moisture damage. Recommend a qualified professional evaluate and repair as needed.

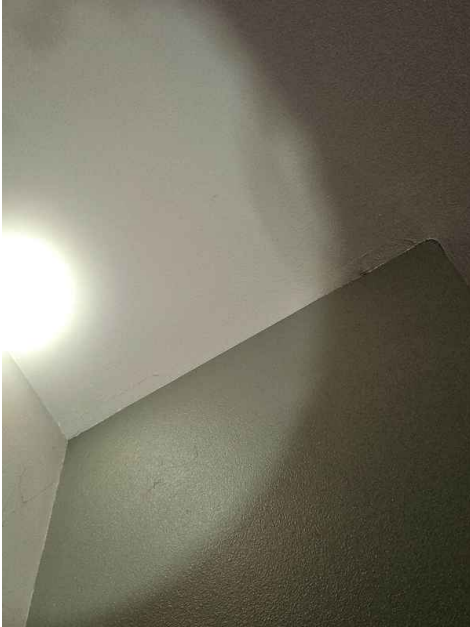
North Living Room

CRACKING

Cracking was visible on the ceiling structure. This could be due to home settlement over time. Recommend a qualified professional examine.

Contact a qualified professional.

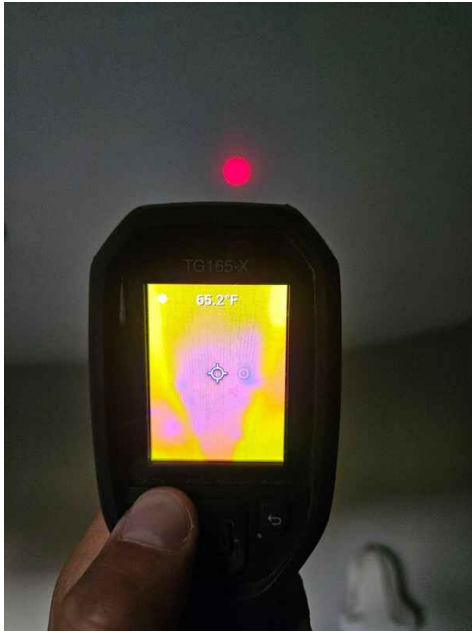
Basement South Bedroom

An infrared (IR) scan revealed a thermal anomaly on the ceiling, which may indicate missing or insufficient insulation, moisture intrusion, or air leakage. The exact cause could not be determined during the inspection. It is recommended to have the area further evaluated by a qualified contractor or insulation specialist to identify the source of the anomaly and perform any necessary repairs or improvements.

Contact a qualified professional.

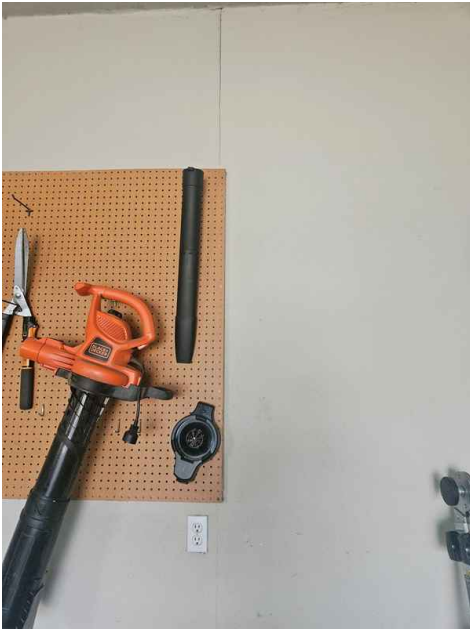
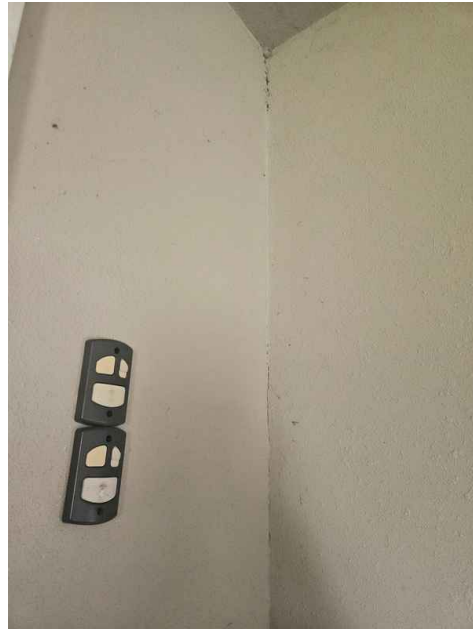
12.4.1 Walls & Firewalls

CRACKING

Cracks were observed in the drywall on one or more garage walls. This may be due to normal settling, thermal expansion, or minor structural movement. While typically cosmetic, cracks should be monitored for progression. If widening or additional movement is noted, further evaluation by a qualified contractor may be warranted to rule out underlying structural concerns. Repair and sealing of the cracks is recommended for improved appearance and to prevent further deterioration.

Contact a qualified professional.

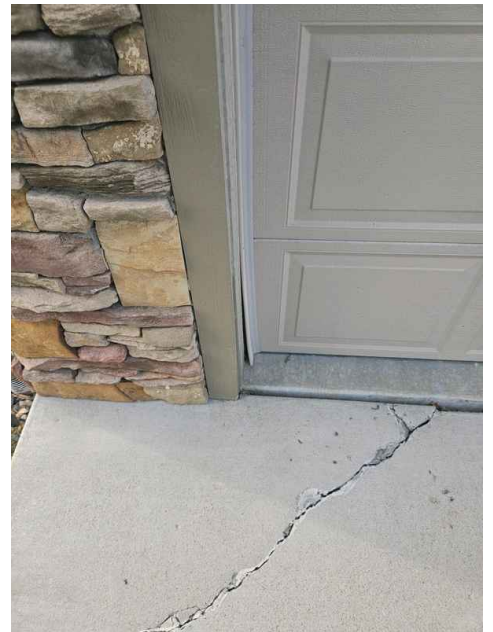
Garage Northeast

WEATHER STRIPPING DAMAGE

Garage door weather stripping is worn or damaged. Recommend it be replaced by a qualified professional.

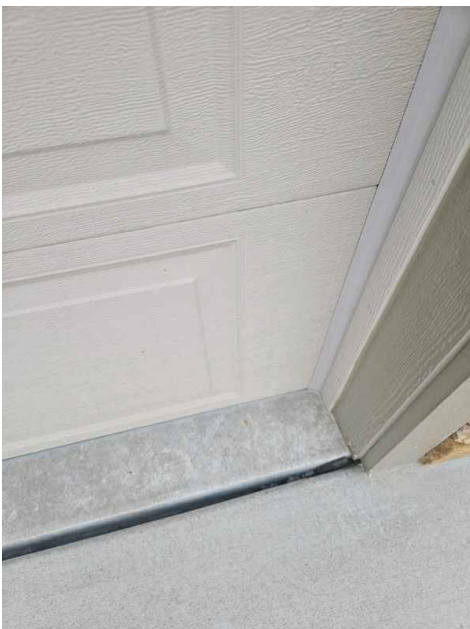
Garage

There were visible hail hits to the garage door. The door was still operational. Recommend inquiring with sellers on any hail claims made.

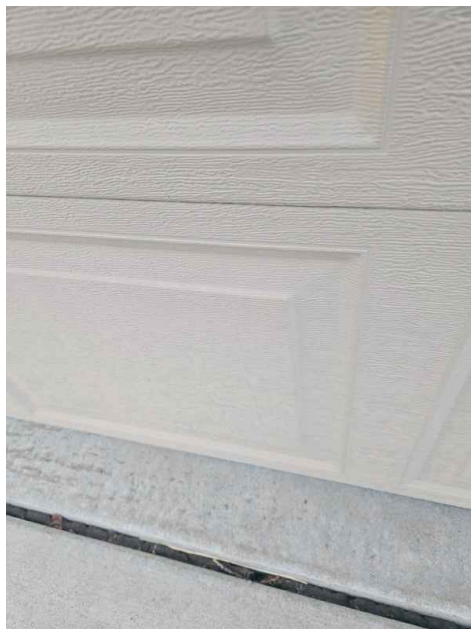
12.5.3 Garage Door
