Inspection Report

Property Address:
744 B Tina Ct.
Stateline NV 89449

Date: 6/14/2023	Time: 09:00 AM	Report ID: SUT744
Property: 744 B Tina Ct. Stateline NV 89449	Customer:	Real Estate Professional: Thomas Vander Laan Coldwell Banker

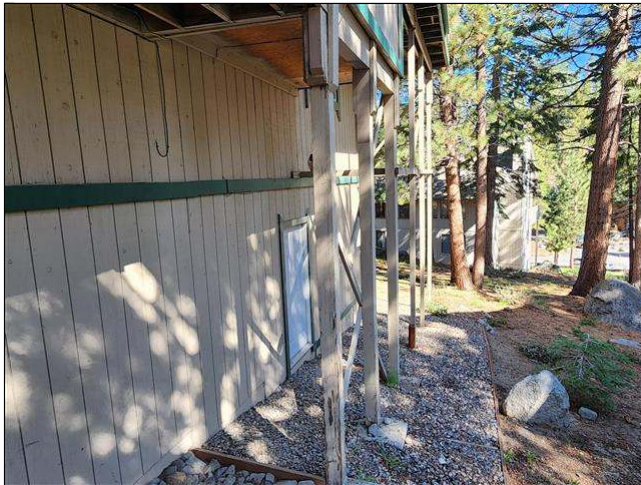
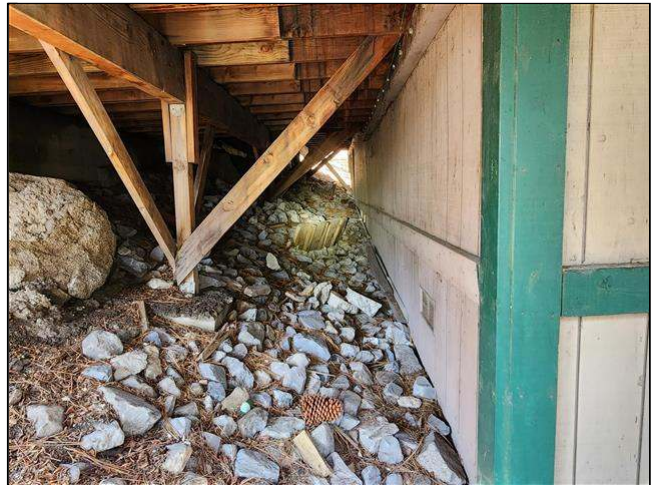
Exterior, as seen at time of inspection.

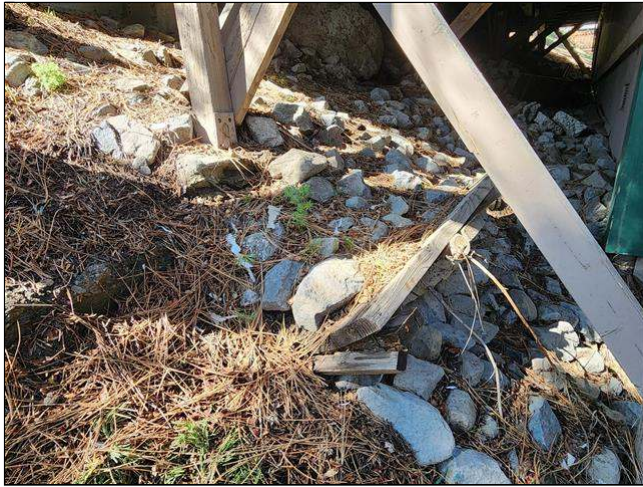
1.8 Item 1(Picture) failing retaining wall

NOTE: Smaller retaining wall at East corner of building appears to be installed to hold the grade from collapsing right below the deck/parking structure post footing. This retaining wall may need straightened and reinforcing to continue to support the concrete footing.

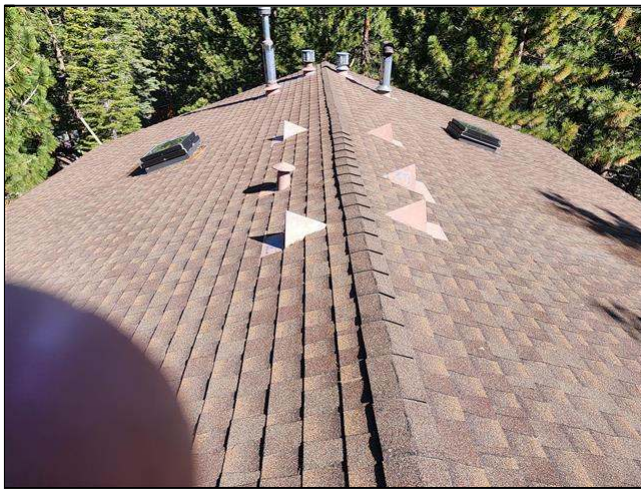
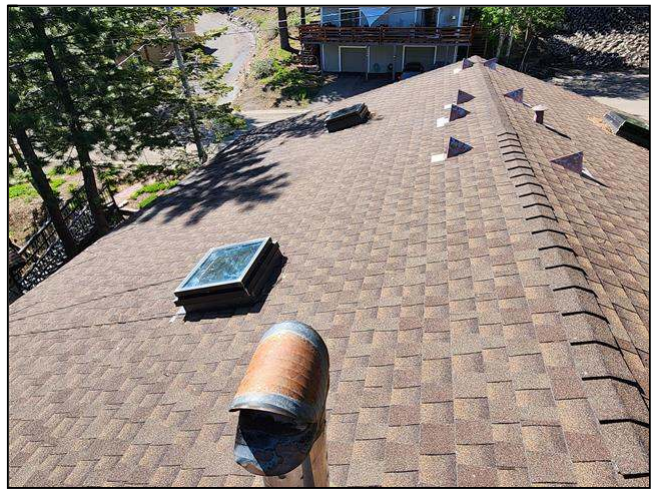
The roof, as seen at time of inspection. Inspected by walking the roof.

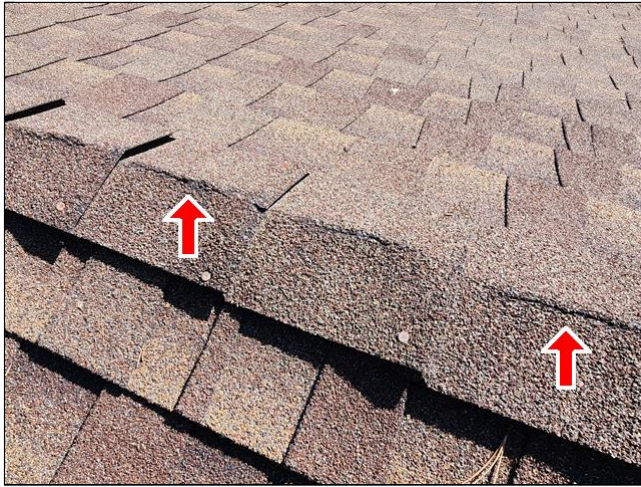
2.1 Item 1(Picture) seal ridge cap shingles

(2) NOTE: There are a few ridge cap shingles that are torn and should be sealed with approved roofing sealant to prevent possible moisture intrusion.

RE: 2.1(2)—Please see *Exhibit: Seller Repair Itemization*

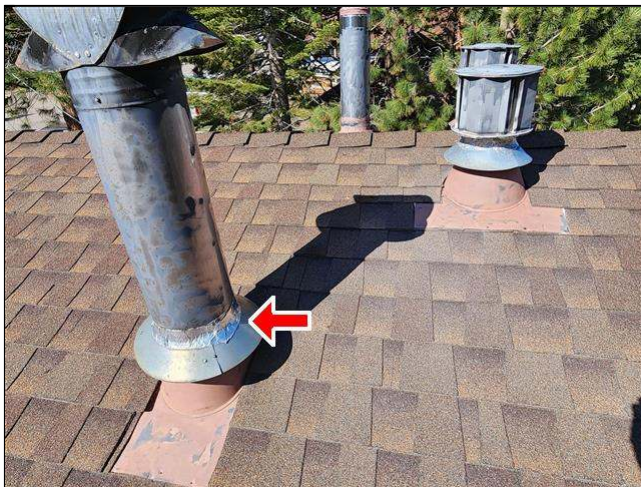
2.3 Item 1(Picture) flue pipes sealed well

Plumbing and furnace vent pipes are sealed well against flashings to prevent moisture intrusion into attic framing areas.

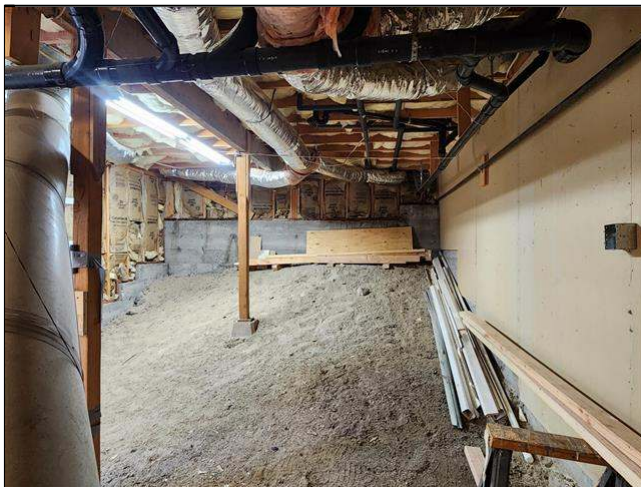
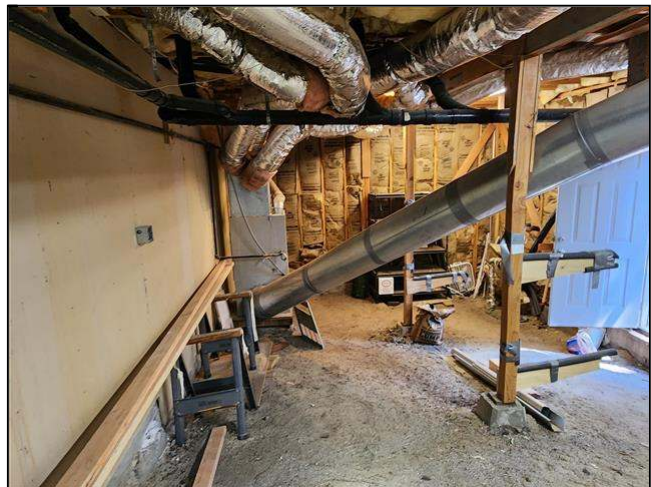
Crawlspace, as seen at time of inspection.

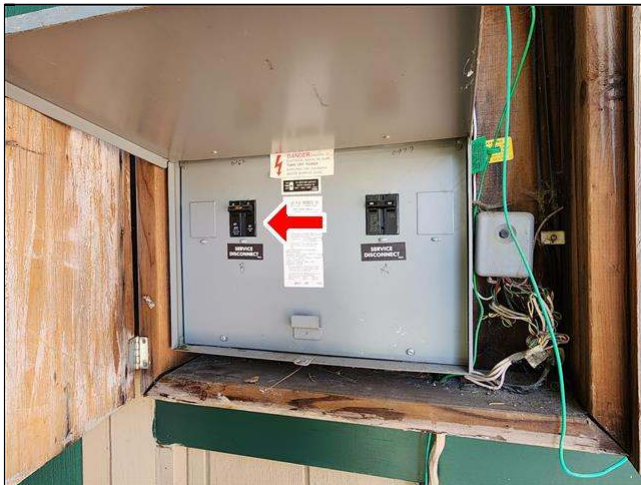
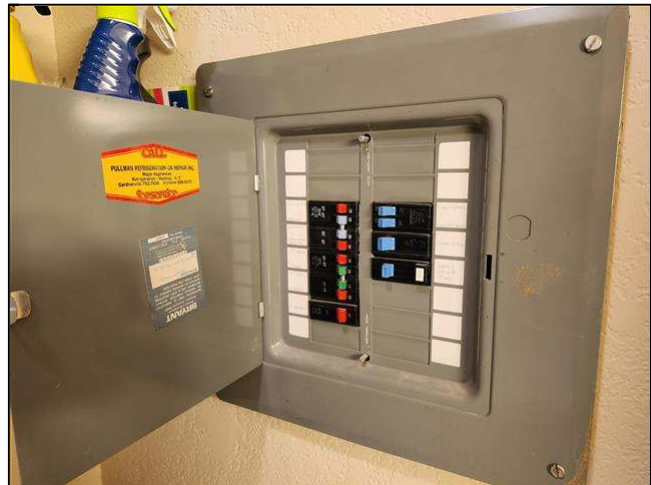
The Main and Distribution Panels are well labeled for circuit identification. "Dead front" cover appears serviceable. No problems noted.

Main Panel and Disconnect is located at the Southwest side of the building exterior, The Distribution Panel is located in the Laundry room.

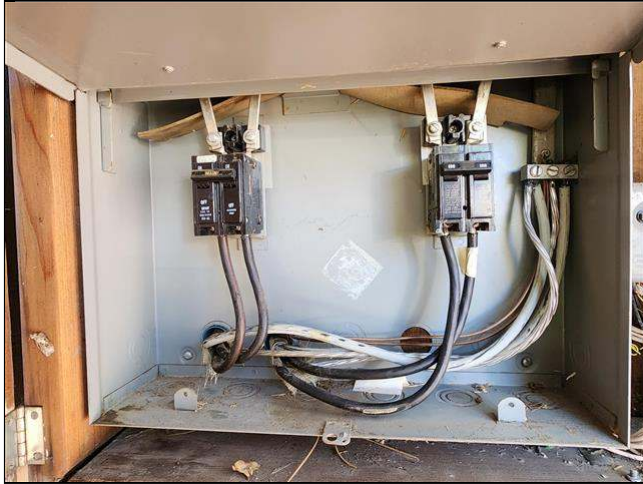
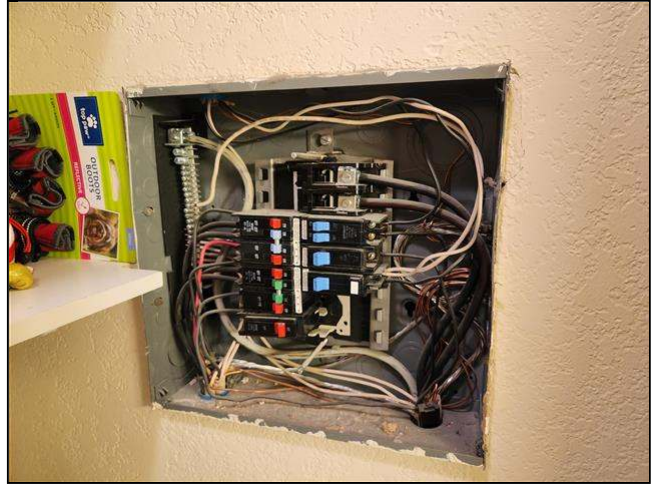
The circuit conductors appear in good condition, and are properly sized for their prospective overcurrent devices. No "double tap" circuit breakers or burned connections noted.

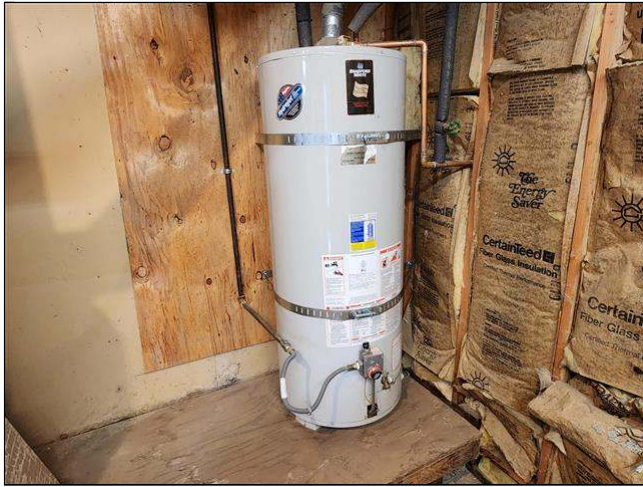
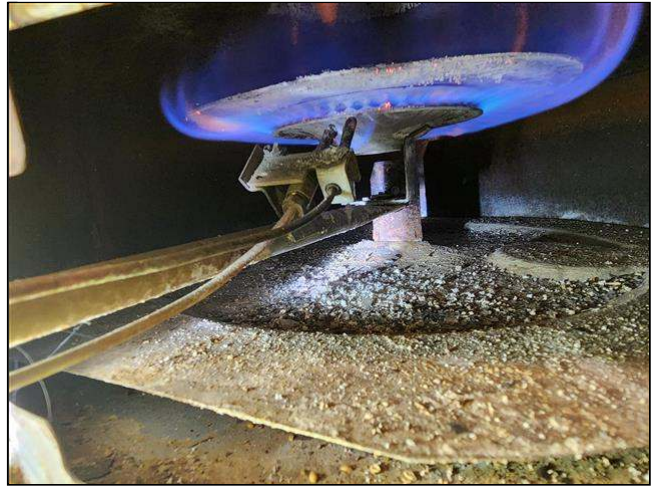
(1) Water heater is located in the basement/crawlspace area, and is strapped to current local codes. Temperature and Pressure Relief Valve is piped to the exterior of the home, (for safety reasons). Water and fuel shut-off valves are present. Water heater operated as intended with no abnormal noises or leaks noted. Manufactured in 1998 by Bradford-White.

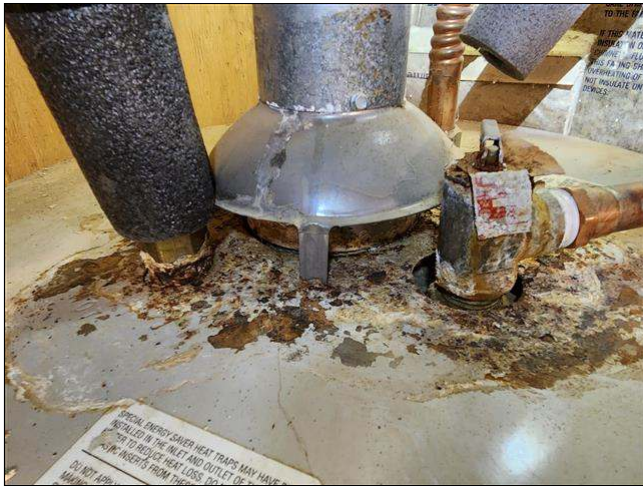
5.4 Item 3(Picture) past moisture leak at water heater

(2) NOTE: Signs of past moisture leaking was noted at the water heater TPR valve test/operation valve stem/handle. I am unable to determine the TPR valve operates as intended. **No leaks were noted at time of inspection.**

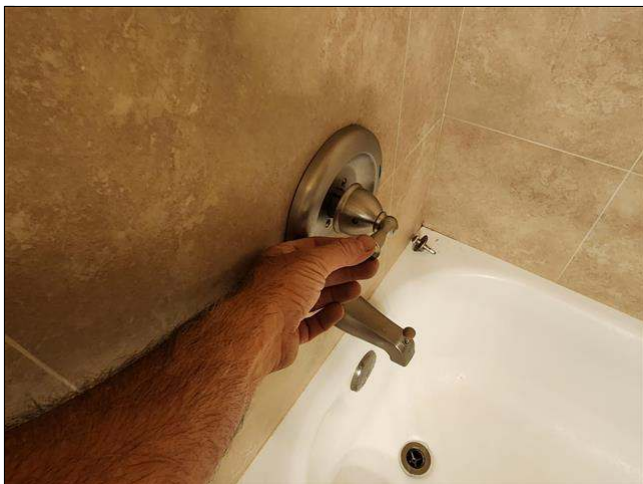
5.5 Item 1(Picture) downstairs shower control valves

NOTE: Both downstairs shower control valves are stiff to operate, and may draw attention to the need for maintenance/greasing the valves to operate smoother.

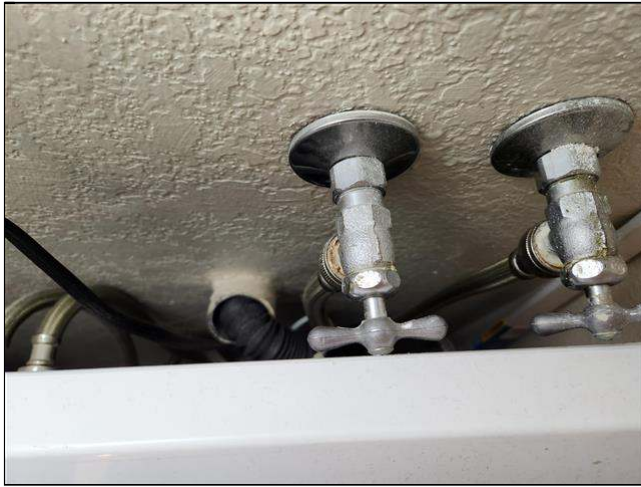
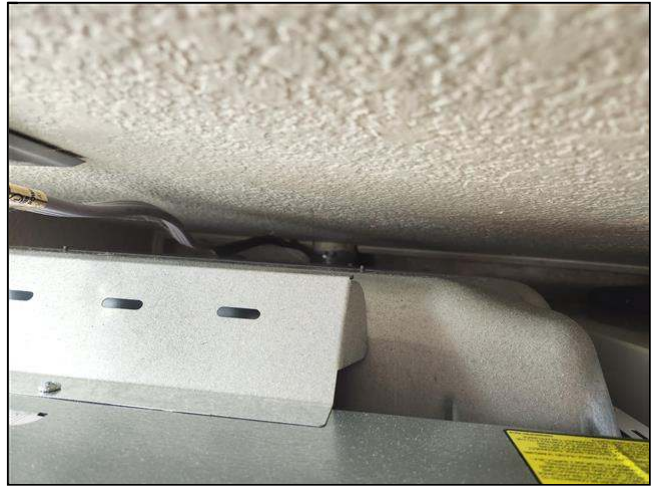
Washer and dryer hook-ups were inspected, with no problems noted. Dryer is electric powered with rigid metal venting installed through the wall. Washer drain is 2" diameter, Hot and Cold hook-ups with no problems noted.

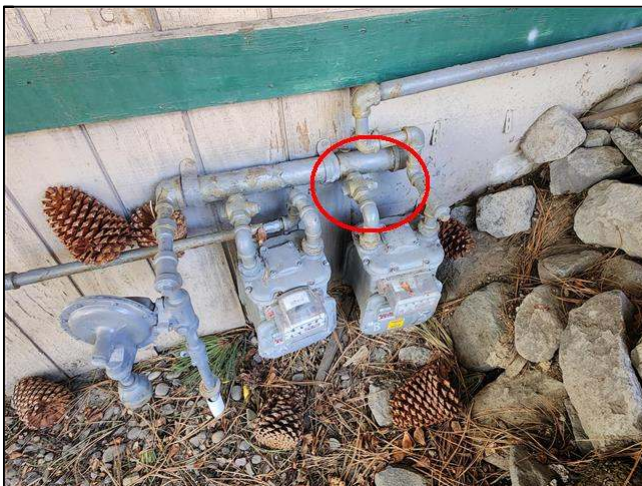
5.11 Item 1(Picture) main fuel shut-off valve

Located at the Southwest side of the building with the gas meters. No problems noted.

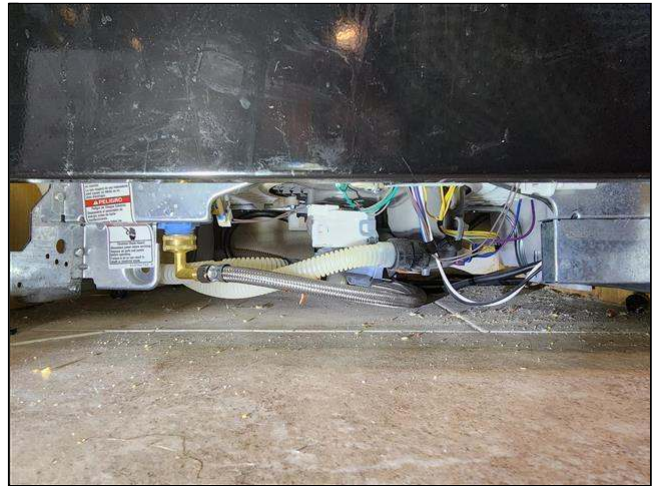
6.0 Item 2(Picture) dishwasher hook-ups

The Dishwasher was run through a complete cycle, with no leaks or abnormal noises noted. Inspection cover was removed to view the Dishwasher electric/plumbing hook-ups, Door seals and dish racks appear in serviceable condition. Mounted securely to under countertop. Drain hose is routed to a high loop prior to connecting to drain, as required to prevent backflow/siphon of waste into dishwasher.

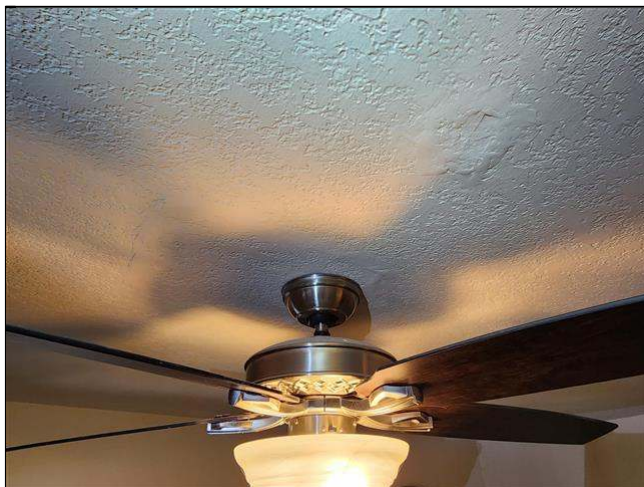
7.1 Item 1(Picture) master bedroom ceiling

NOTE: Downstairs master bedroom shows signs of past drywall repairs. This area was checked using a Thermal Imaging Camera to verify absence of moisture, with no problems noted.

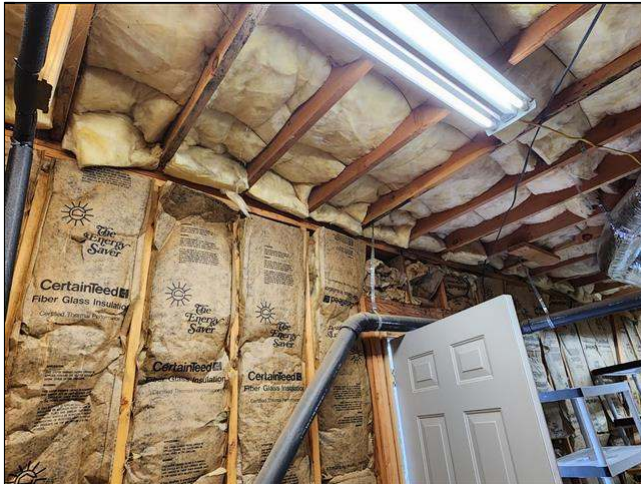
8.1 Item 1(Picture) view of subfloor insulation

The subfloor area is insulated between the floor joists using R19 fiberglass Batts, no problems noted. The exterior "pony walls"bare also insulated with R19 fiberglass bats, with no problems noted.

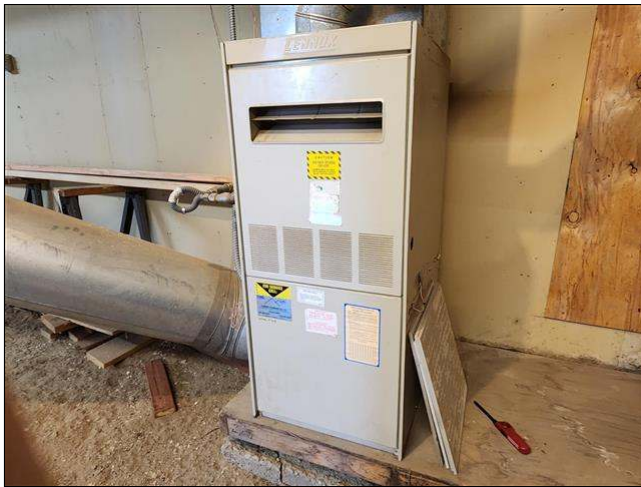
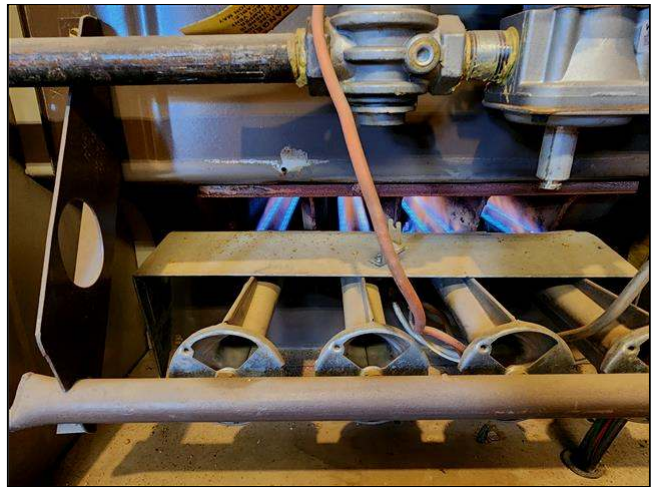
The heating equipment is original (43 years). The furnace is a vertical Upflow natural gas fired forced air unit, Rated at 110,000btu's, that operated as intended with normal operating controls. The burners have an even blue flame. Manufactured in 1980 by LENNOX Heating.

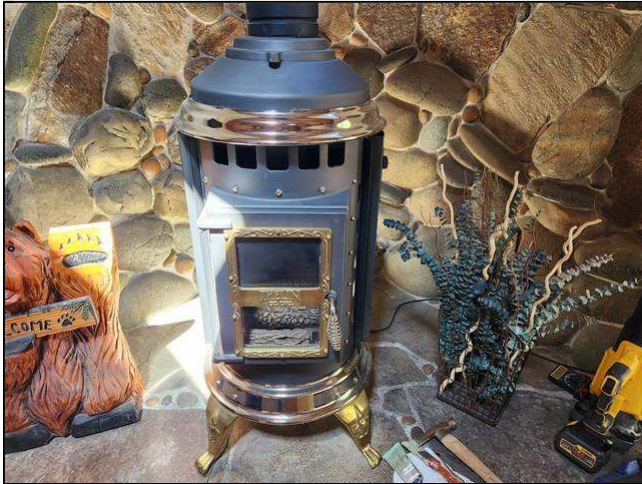
10.0 Item 1(Picture) living room gaslog stove

NOTE: Freestanding gaslog fireplace in living room did not respond to normal operating controls, with gas valves in the ON position. Recommend verify proper operation of this item.

RE: 10.0—Please see *Exhibit: Seller Repair Itemization*
