WOOD DESTROYING PESTS INSPECTION REPORT

Firm (PCO) Raptor Pest Control LLC License No. NV6980 Inspection Date 04/23/2024
 Address 2222 Park PL Unit 2E Minden, Nevada 89444 FHA/VA/Escrow or Mortgage No.
 Address of Property Inspected 3924 GRANITE WY WELLINGTON, NV 89444
 Inspection Ordered by Coldwell Banker Select Real Estate Todd Vander Laan City _____ Zip Code _____
 Inspection Report Sent to Coldwell Banker Select Real Estate Todd Vander Laan
 Owner's Name and Address ROTHAUSER, FRANKLIN 3924 GRANITE WY WELLINGTON, NV 89444

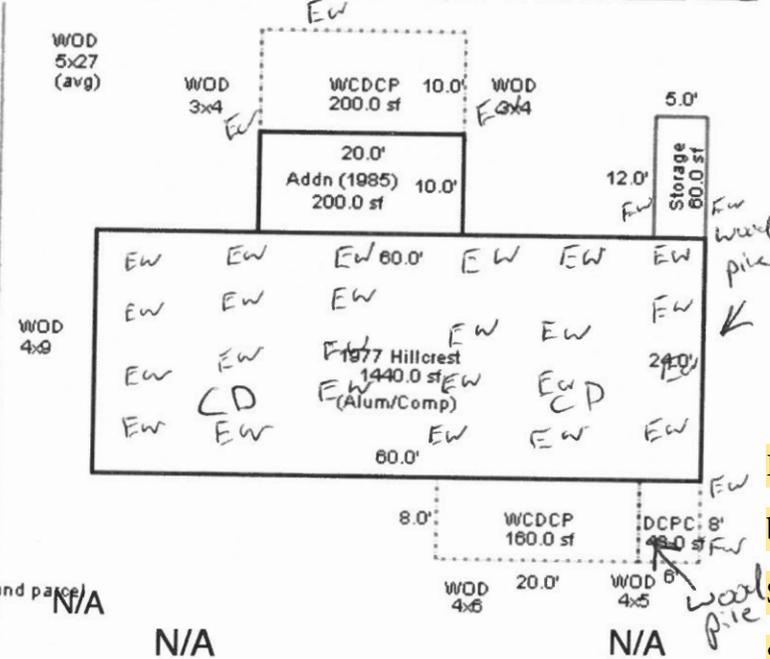
GRAPH EXPLANATIONS:

EW - Earth to Wood Contact - *Supports in crawlspace*
 CD - Cellulose Debris Cardboard in crawlspace
 Wood Pile on side of home and porch area needs to be moved.
