# Inspection Report

1373 Bryan Ln.  
Gardnerville NV

<b>Date:</b> 9/14/2021	<b>Time:</b> 10:30 AM	<b>Report ID:</b> 0001979
<b>Property:</b> 1373 Bryan Ln. Gardnerville NV	<b>Customer:</b>	<b>Real Estate Professional:</b> Thomas Vander Laan Coldwell Banker

**Type of building:**  
Single Family (1 story)

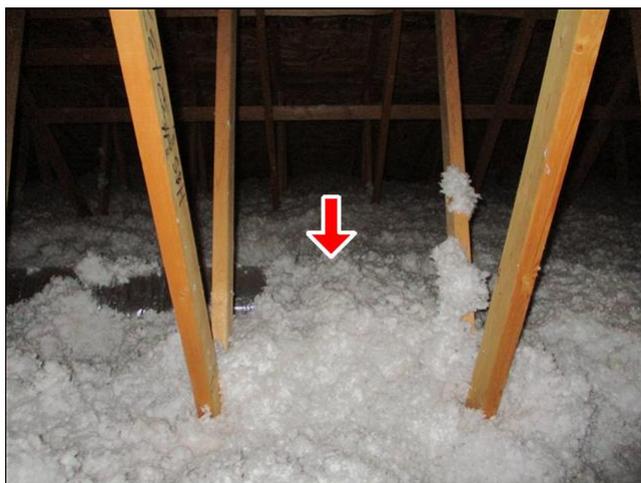
1.14 Item 1(Picture)

Comments: YES

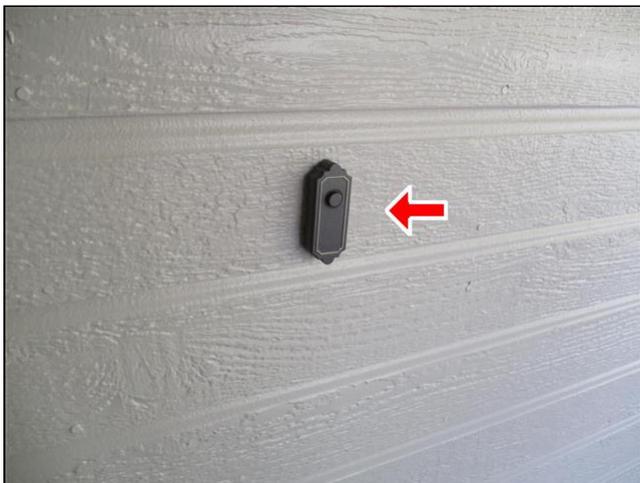
2.3 Item 1(Picture)

The doorbell was not functional at the time of my inspection.(see photo)

Batteries were since replaced and doorbell is operational

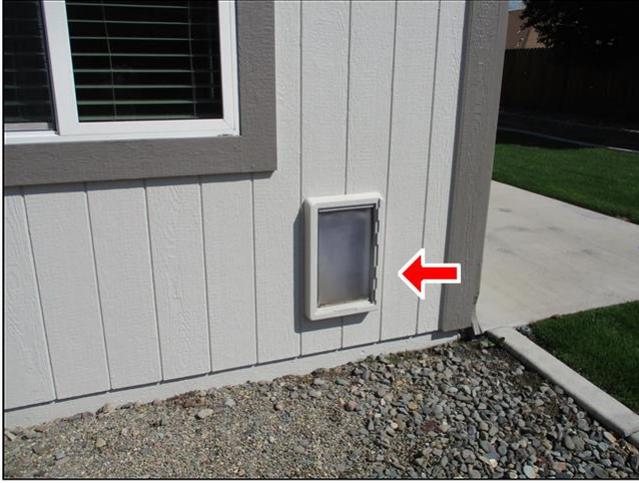
2.9 Item 1(Picture)

It should be noted that there looks to be a functional pet access on the back south wall. This area was covered with furniture on the interior at the time of my inspection.

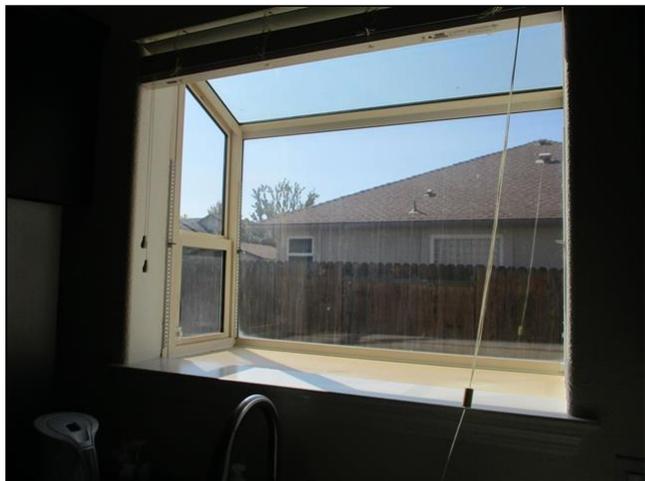
5.5 Item 1(Picture)

Although most all of the moisture stains look to be on the outside of the glass I suggest that the kitchen window be thoroughly cleaned inside and out to be 100% certain that there are no moisture stains between the panes of glass.(see photo)

Windows were professionally washed on 9/16/2021

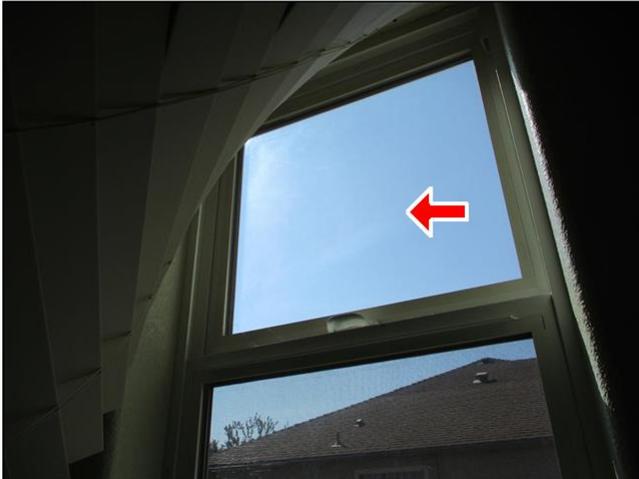
6.3 Item 1(Picture)

Although most of the moisture stains look to be on the outside of the glass I suggest that the laundry room upper window be thoroughly cleaned inside and out to be 100% certain that there are no moisture stains between the panes of glass.

Windows were professionally washed on 9/16/2021

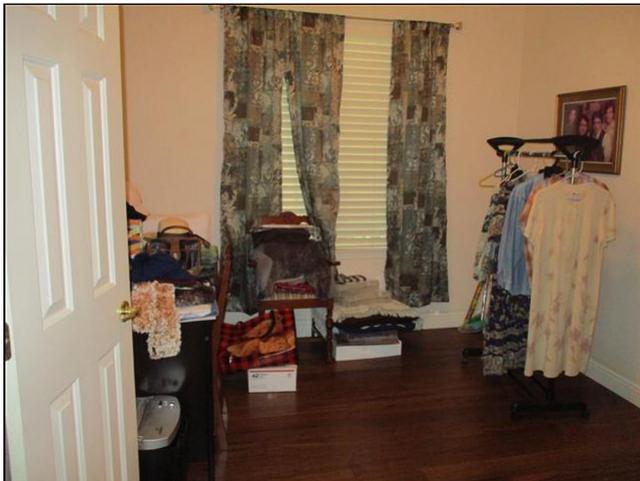
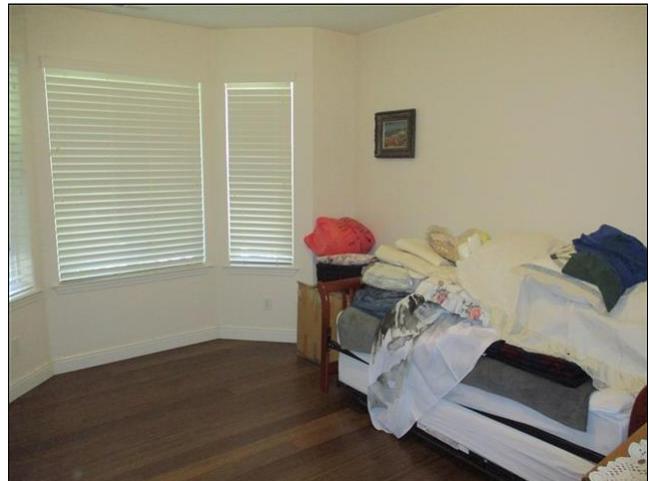
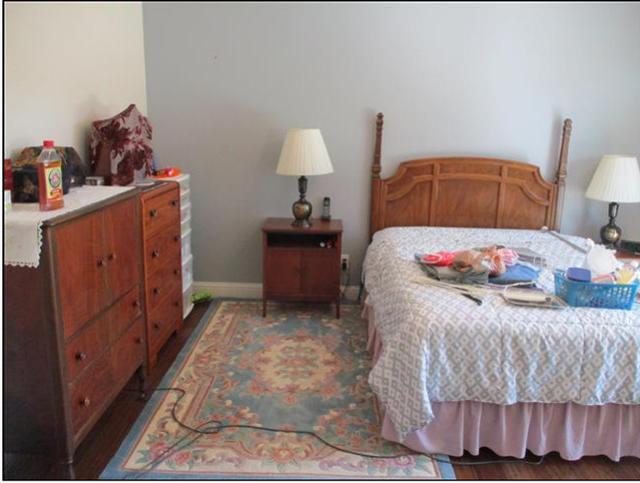
8.5 Item 1(Picture)

100% of the outlets were not accessible due to furniture or personal items. All of the accessible outlets were tested and functioned properly.

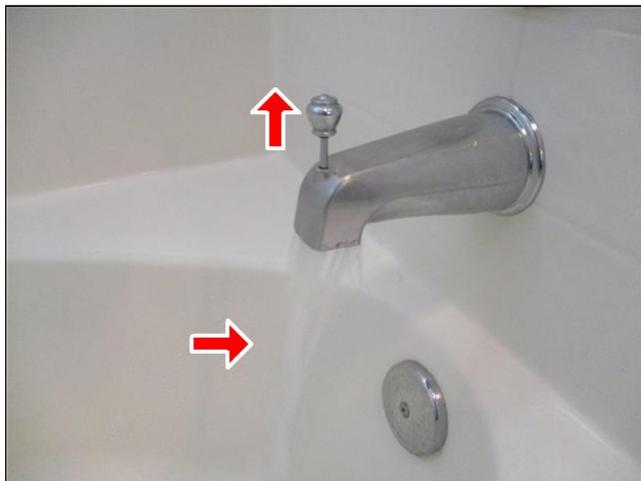
9.14 Item 1(Picture)

The master bathroom changeover valve on the tip of the tub spout to engage the shower head does not seal properly allowing less pressure to the shower head. I suggest that a licensed plumber evaluate and address this issue.(see photo)

This issue has been addressed. Please see receipt for replacement part installed in AD.

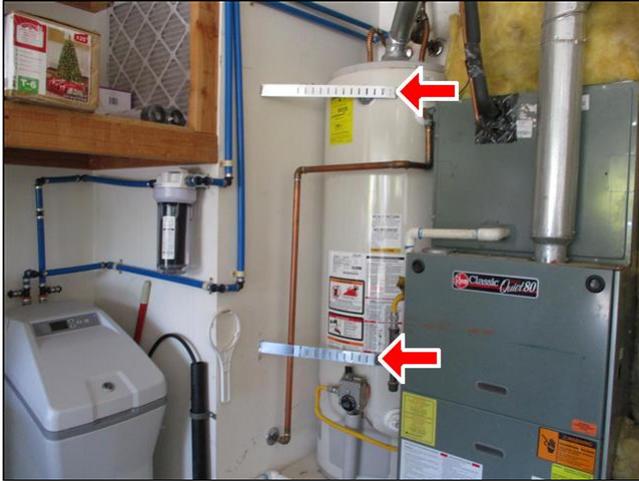
11.9 Item 1(Picture)

- 11.0 Interior Plumbing Water Supply, Distribution System and Fixtures
Refer to question 9.14.
11.1 Interior Plumbing Drain, Waste and Vent Systems
Comments: Functional
11.2 Hot Water Systems, Controls, Chimneys, Flues and Vents
Comments: Functional
11.3 Water Heater Or Hot Water System
Comments: Functional
11.4 Expansion Tank
Comments: YES
11.5 TP Valve Plumbed to Within 6" of the Garage floor or to the Exterior of the Home
Comments: YES
11.6 Water Heater Platfoam & Walls
Comments: Functional
11.7 Condition Of Vent Pipe
Comments: Functional
11.8 Combustion Venting
Comments: Functional
11.9 Seismic Straps For Water Heater
Comments: YES

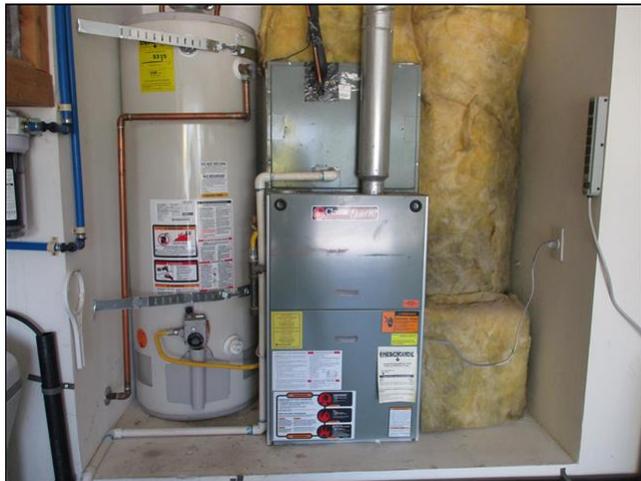
13.0 Item 1(Picture)

Although functional, I suggest that the heating unit be cleaned serviced and evaluated by licensed HVAC technician, or if the seller can provide an invoice of service within the past one year. This is general maintenance that should be done from year-to-year depending on usage.

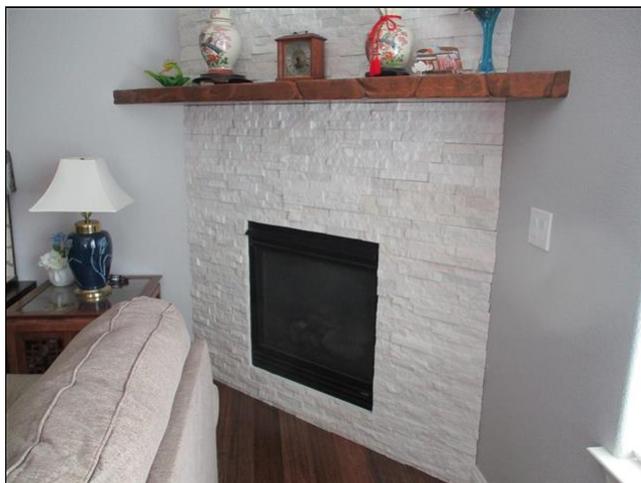
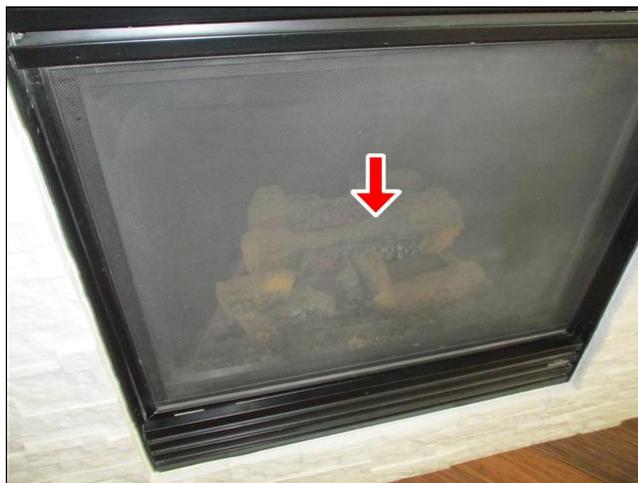
13.4 Item 1(Picture)

The gas fireplace would light and then slowly the flame would extinguish. I suggest that the unit be serviced and evaluated by licensed professional.

An inspection of the fireplace is scheduled for 9/24/2021

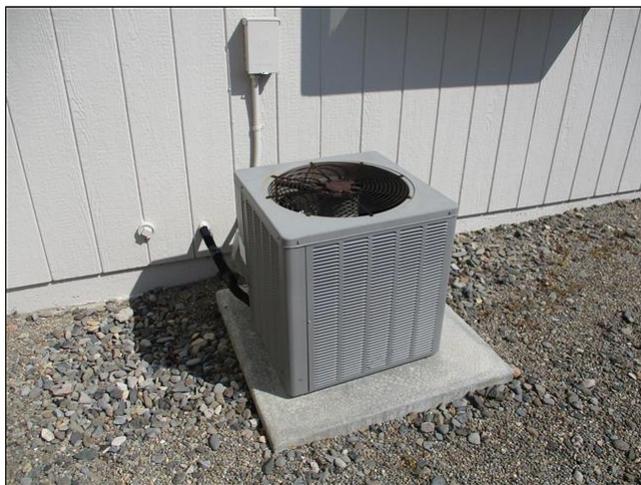
13.6 Item 1(Picture)

I suggest that the AC unit be cleaned serviced and evaluated by licensed HVAC technician, or if the seller can provide an invoice of service within the past one year. This is general maintenance that should be done from year-to-year depending on usage.
