Inspection Report

Property Address:
307-A East Peak Loop
Stateline NV 89449

Clear Choice Home Inspection Services

Date: 7/7/2022	Time: 09:00 AM	Report ID: GOU307
Property: 307-A East Peak Loop Stateline NV 89449	Customer: Bart Gout	Real Estate Professional: Thomas Vander Laan Coldwell Banker

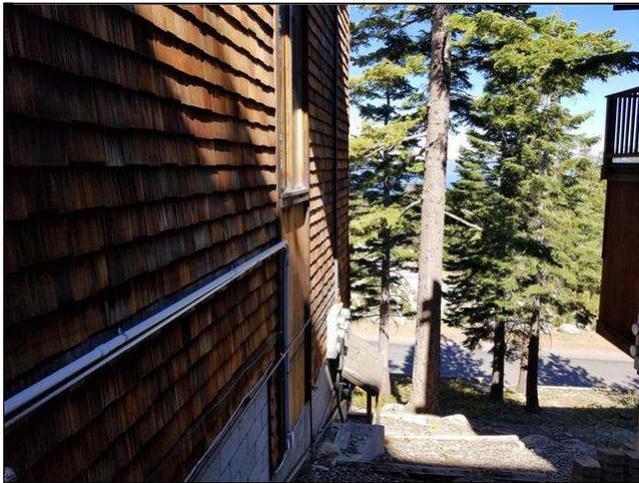
1.0 Item 1(Picture) view of exterior

Comments: Inspected - Appears Functional
Exterior, as seen at time of inspection.

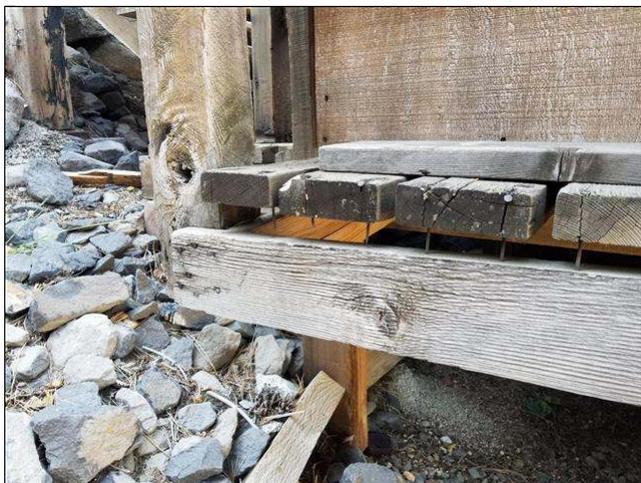
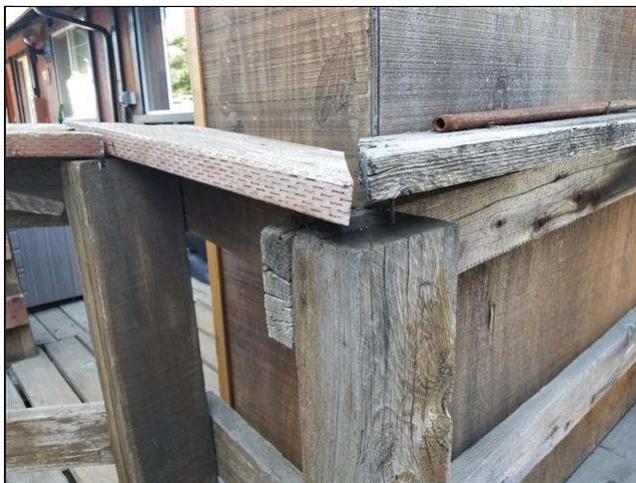
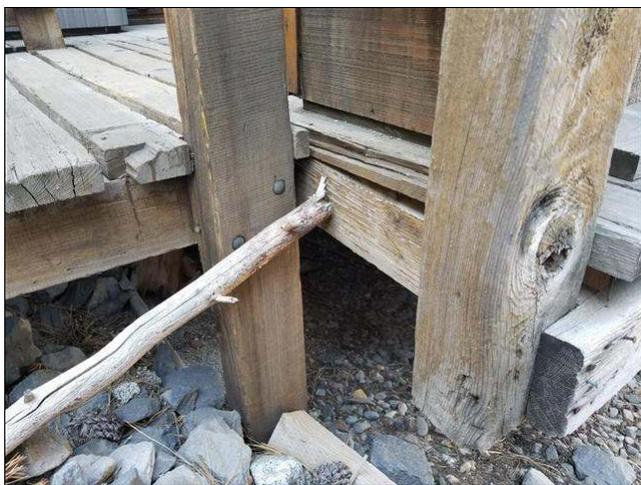
- 🏠 (1) North end framing at front deck is failing, not properly supporting the deck. Recommend further evaluation and repair by a qualified person.

1.6 Item 1(Picture) north end deck framing

1.6 Item 2(Picture) north end deck framing

1.6 Item 3(Picture) north end deck framing

(1) North end framing at front deck is failing, not properly supporting the deck. Recommend further evaluation and repair by a qualified person.
-

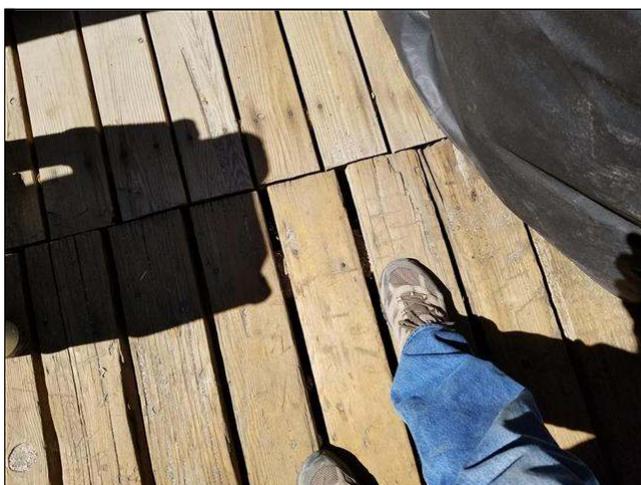
- 🏠 (2) There are a few loosened deck boards, and railing cap boards, the should be secured.

1.6 Item 4(Picture) loosened decking boards

(2) There are a few loosened deck boards, and railing cap boards, the should be secured.

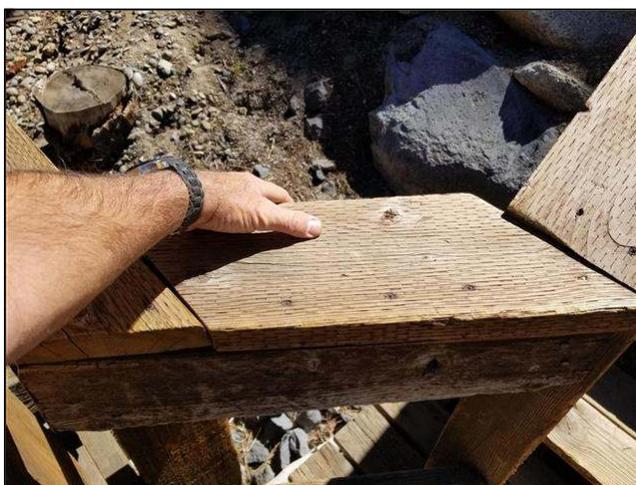
1.6 Item 5(Picture) loose railing caps

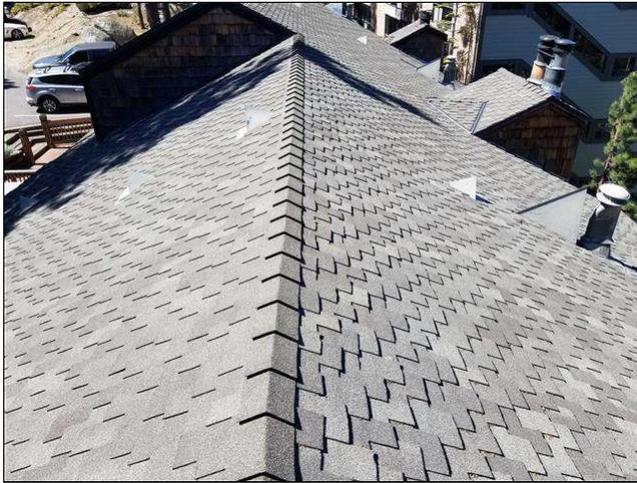
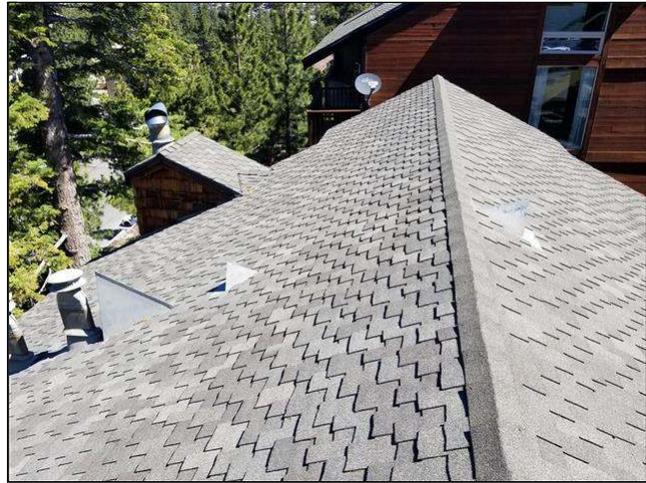
The roof, as seen at time of inspection. Inspected by walking the roof.

The roof covering does not appear to be original, and is a 50 year Presidential Architectural, Asphalt/Fiberglass Composition shingle with much of it's life remaining. Typical loss of granules noted from shingles. No problems noted at time of inspection.

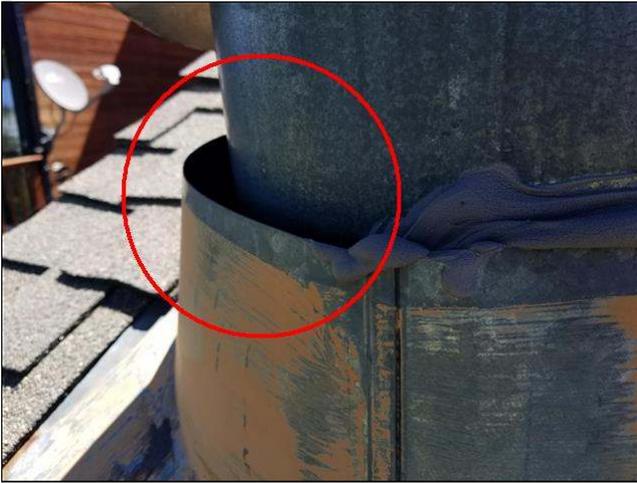
(2) NOTE: Fireplace flue pipe needs to be sealed against flashing to prevent moisture intrusion into chimney structure and behind the fireplace.

2.3 Item 1(Picture) fireplace chimney flue pipe

(2) NOTE: Fireplace flue pipe needs to be sealed against flashing to prevent moisture intrusion into chimney structure and behind the fireplace.

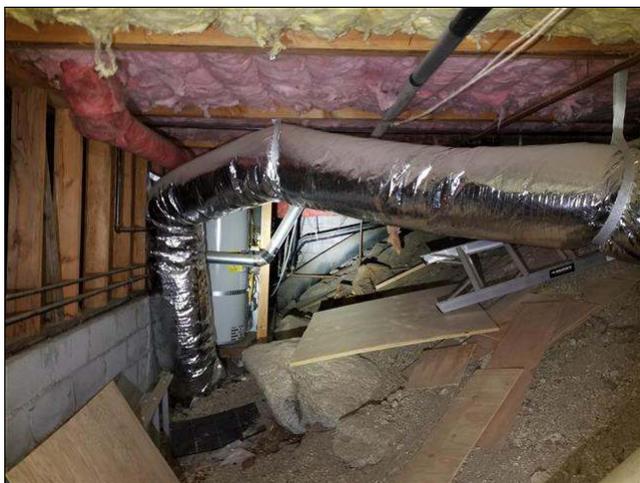
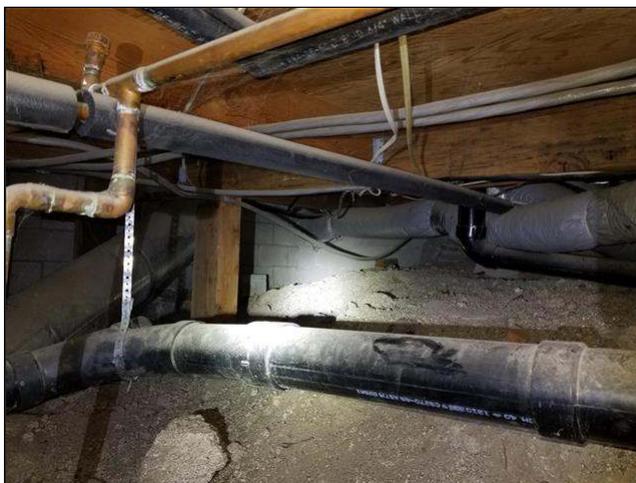
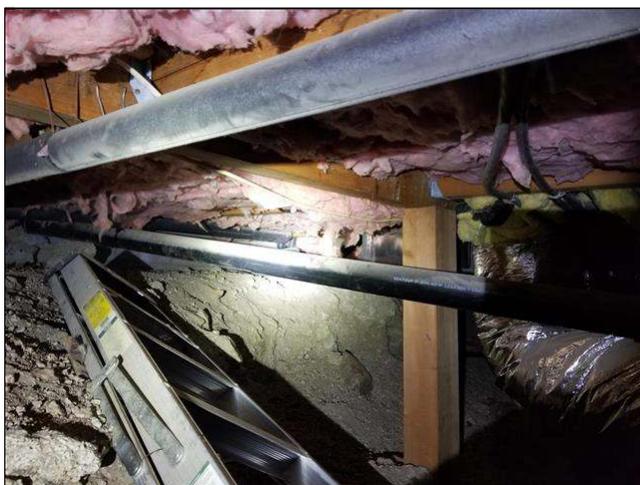
Comments: Inspected
Crawlspace, as seen at time of inspection.

3.0 Item 1(Picture) view of crawlspace

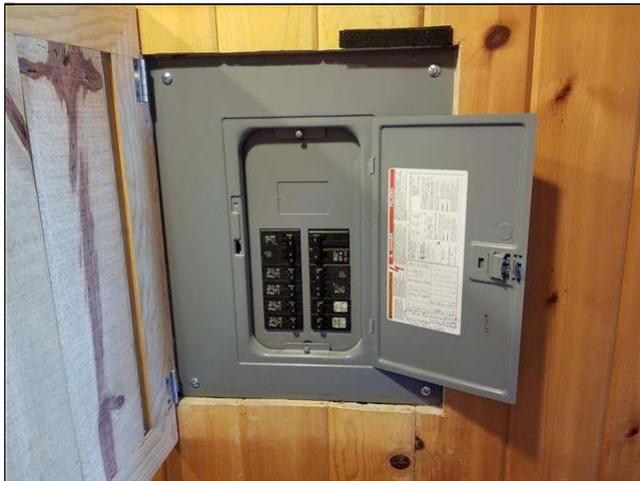
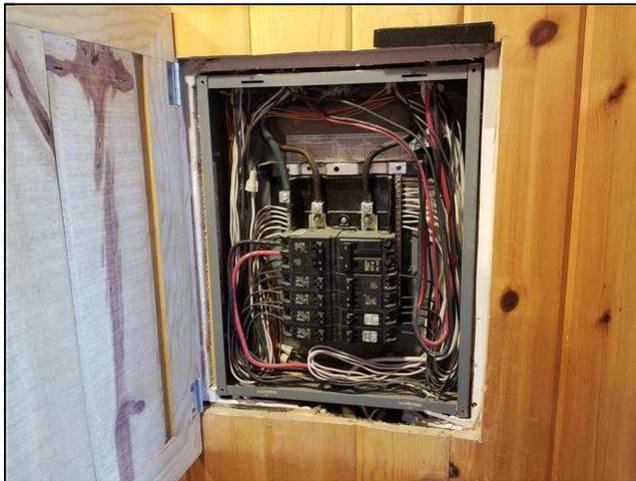
The Main and Distribution Panels are well labeled for circuit identification. "Dead front" cover appears serviceable. No problems noted.

4.1 Item 1(Picture) hallway distribution panel

4.1 Item 2(Picture) distribution panel conductors

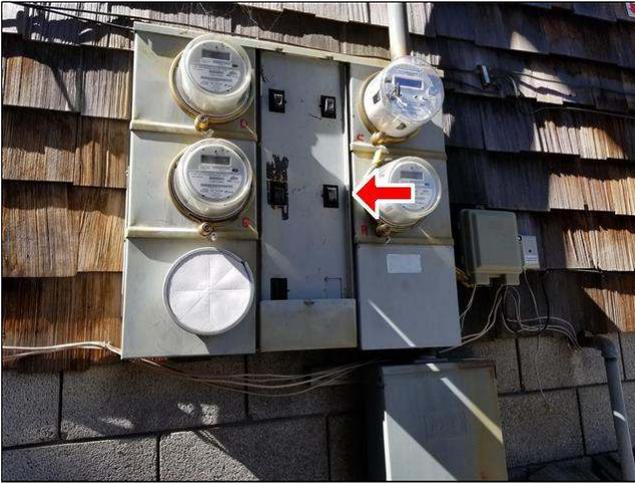
Main Panel and Disconnect are located at the North side of the building exterior, The Distribution Panel is located in the downstairs hallway.

4.2 Item 1(Picture) location of main disconnect

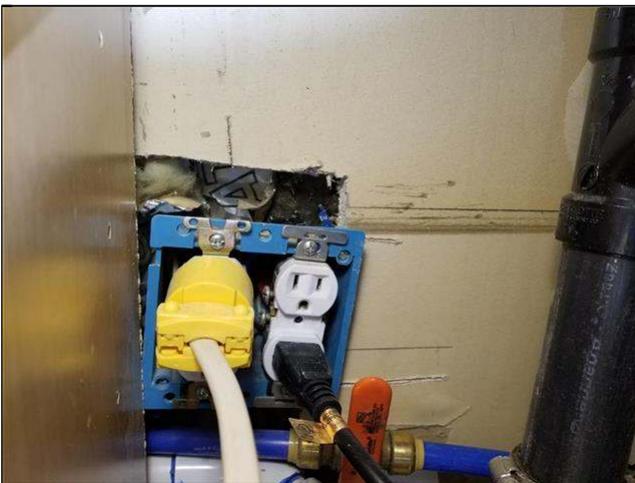
- 🏠 (1) Loose outlets and box under the kitchen sink, and needs to be properly secured to wall framing, and cover plate installed.

4.5 Item 1(Picture) loose box under kitchen sink

(1) Loose outlets and box under the kitchen sink, and needs to be properly secured to wall framing, and cover plate installed.
-

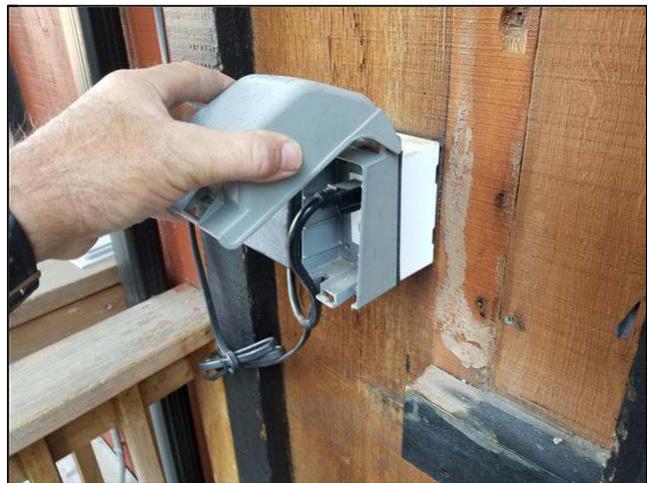
4.5 Item 2(Picture) outlet box at front deck

- 🏠 (2) Recommend securing loose outlet and box at front deck and spa area.
- 🏠 (3) Open grounded receptacle noted at the kitchen island West side outlet, which does not afford electrical circuit ground protection. Recommend further evaluation/repair by a licensed Electrician.
- 🏠 (4) There appears to be an obstruction in the master bedroom entry outlet, preventing use. Recommend repair by a qualified person.

(2) Recommend securing loose outlet and box at front deck and spa area.
-

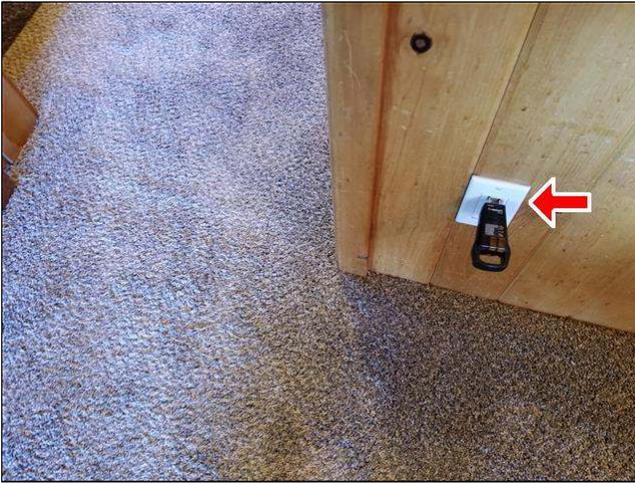
4.5 Item 3(Picture) obstruction in outlet

(4) There appears to be an obstruction in the master bedroom entry outlet, preventing use. Recommend repair by a qualified person.

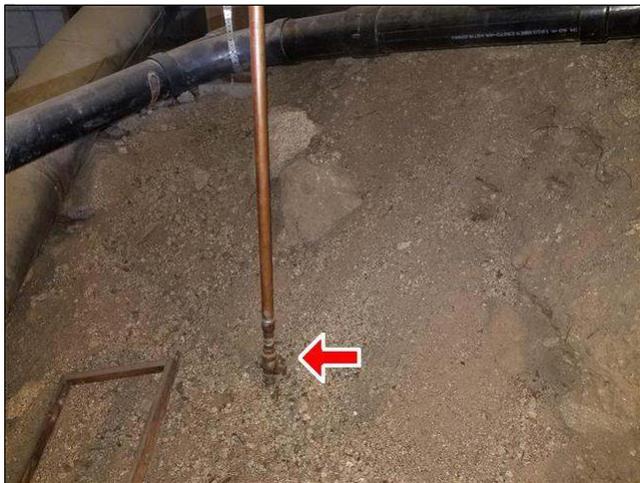
Located in the crawlspace area, no problems noted.

5.0 Item 1(Picture) main water shut-off valve in crawlspace

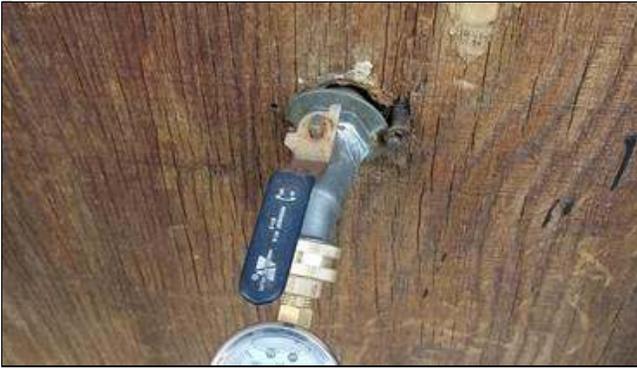
Front exterior hose bib does not function properly, and should be repaired to shut-off water without finding the "sweet spot"

5.1 Item 1(Picture) front hose bib

Front exterior hose bib does not function properly, and should be repaired to shut-off water without finding the "sweet spot"

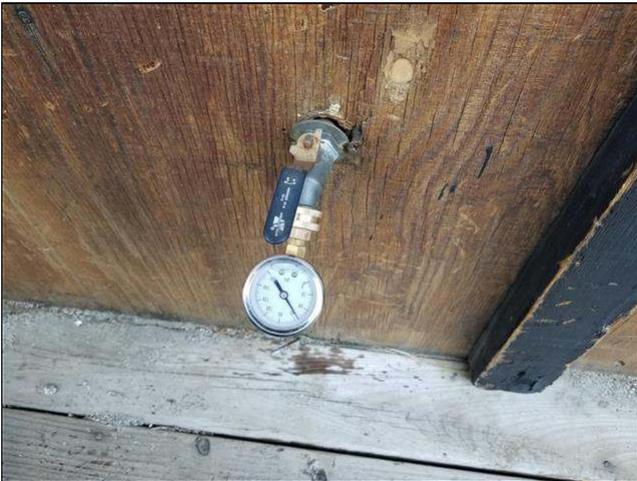
The water pressure was tested at the front hose bib, pressure was 60 psi at time of inspection.

5.2 Item 1(Picture) water pressure at front hose bib

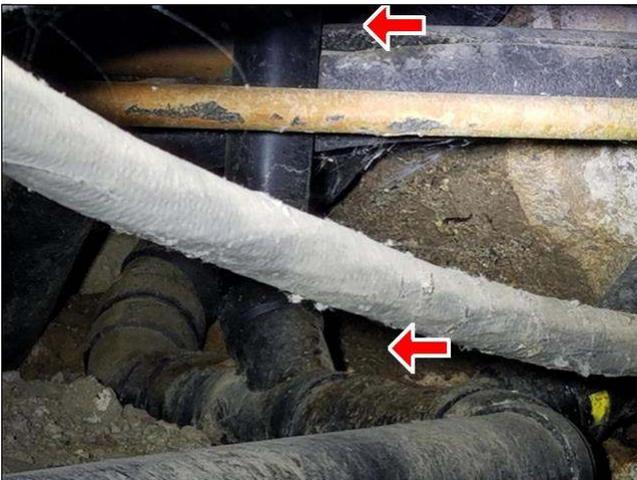
The bathroom sink drain leaks in the crawlspace area under the guest bathroom. Water leaking under home can cause problems such as mold, erosion or deterioration. A qualified licensed plumber should repair or correct as needed.

5.3 Item 1(Picture) leak and moisture under guest bathroom

The bathroom sink drain leaks in the crawlspace area under the guest bathroom. Water leaking under home can cause problems such as mold, erosion or deterioration. A qualified licensed plumber should repair or correct as needed.

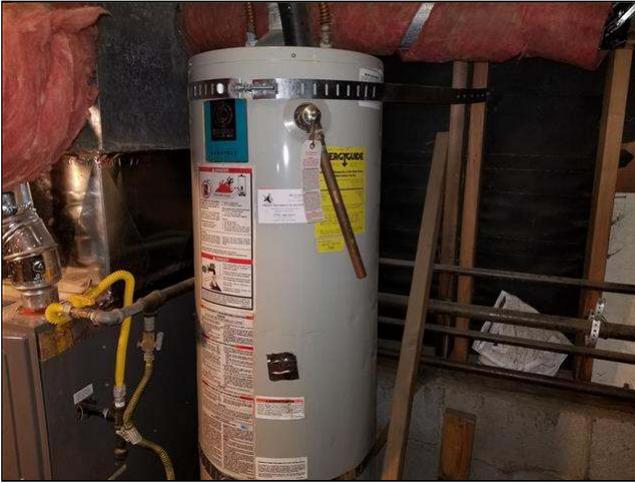
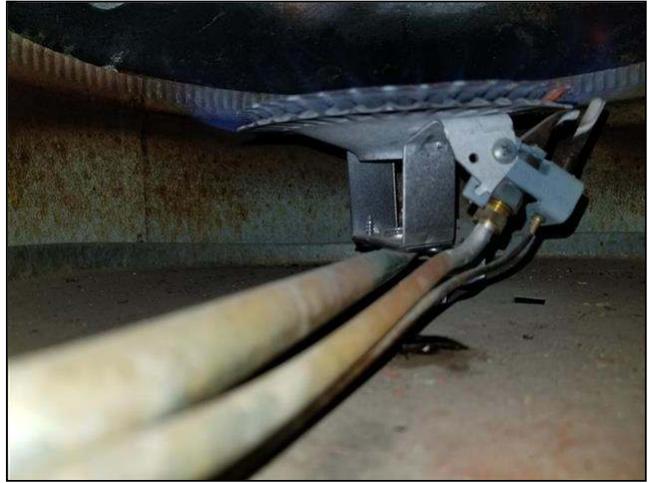
(1) Water heater is located in the crawlspace area, and is strapped to current local codes. Temperature and Pressure Relief Valve is NOT piped to the exterior of the home, or within 6 inches of the floor (for safety reasons). Drip leg has been installed in the gas supply piping, water and fuel shut-off valves are present. Water heater operated as intended with no abnormal noises or leaks noted. Manufactured in 1995 by State Industries.

5.4 Item 1(Picture) water heater

5.4 Item 2(Picture) water heater burner compartment

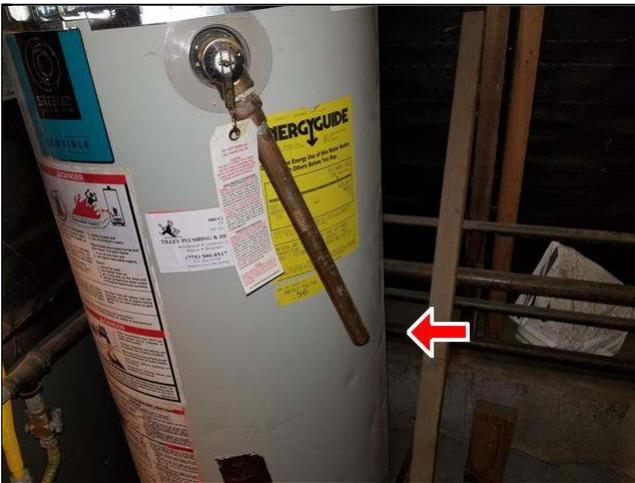
(2) Temperature and Pressure Relief valve discharges into the crawlspace, and can cause elevated moisture levels due to being un-noticed, unhealthy for building components and air quality. Recommend extending TPR valve drain to the exterior of the home.

5.4 Item 3(Picture) tpr valve drain pipe

(2) Temperature and Pressure Relief valve discharges into the crawlspace, and can cause elevated moisture levels due to being un-noticed, unhealthy for building components and air quality. Recommend extending TPR valve drain to the exterior of the home.

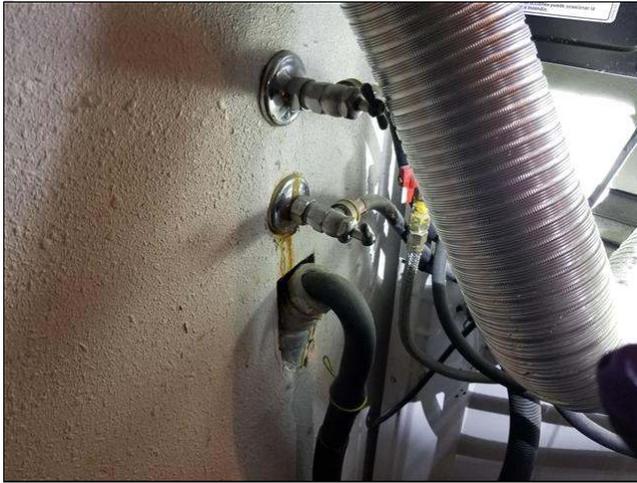
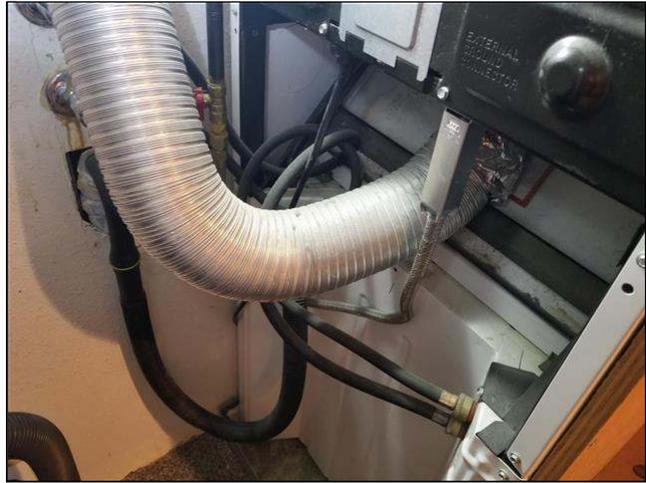
Washer and dryer hook-ups were inspected, with no problems noted. Dryer is gas powered with rigid metal venting installed. Washer drain is 2" diameter, Hot and Cold hook-ups with no problems noted.

5.6 Item 1(Picture) laundry hook-ups

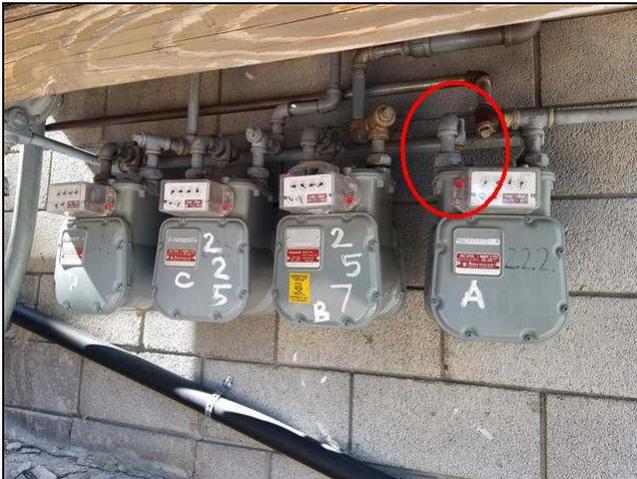
Located at the North side of the building with the gas meters. No problems noted.

5.11 Item 1(Picture) main fuel shut-off valve

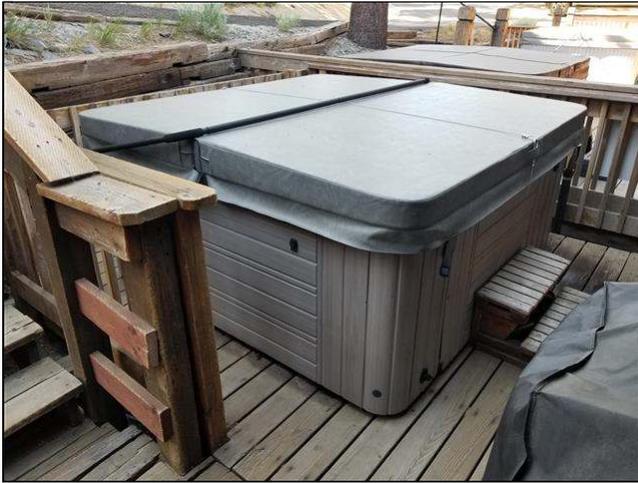
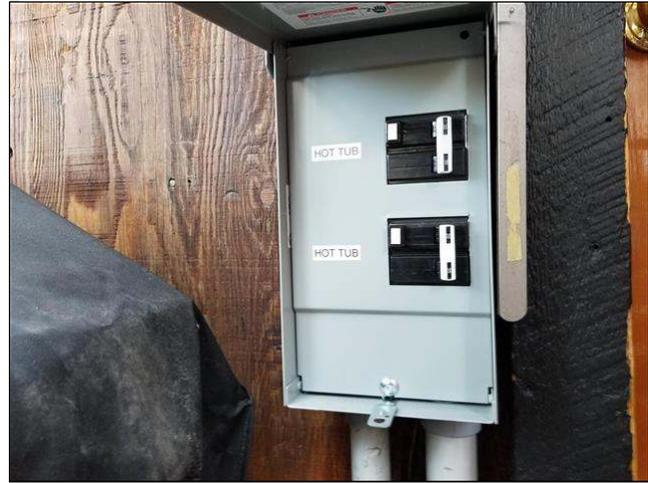
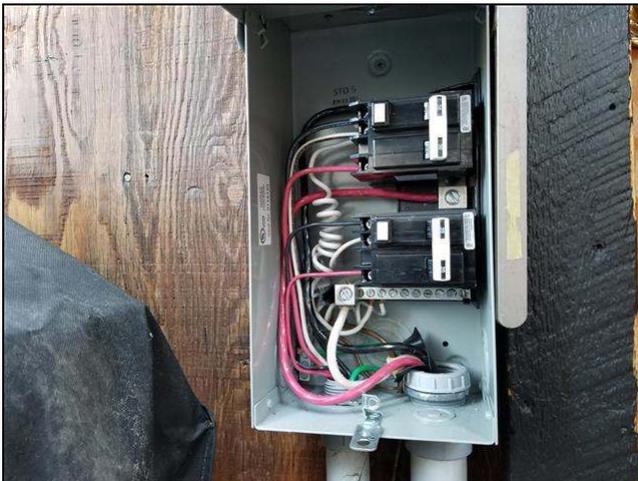
(1) Clear Choice Home Inspection Services does not inspect Pools, Hot Tubs or any related equipment. Recommend a licensed Pool Contractor further evaluate and service as needed. NOTE: electrical panel for Spa was inspected, with no problems noted.

5.13 Item 1(Picture) spa not inspected

5.13 Item 2(Picture) spa electrical panel

5.13 Item 3(Picture) spa electrical breakers

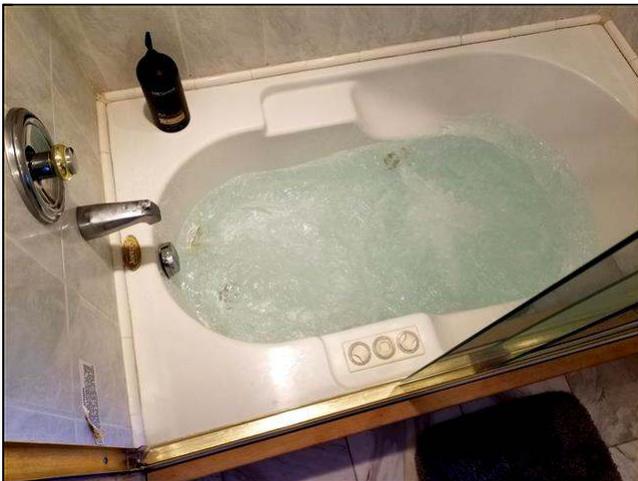
(2) Master Bathroom jetted tub was filled, and jets were checked for proper operation. No problems noted with jets operation.

5.13 Item 4(Picture) master jetted tub

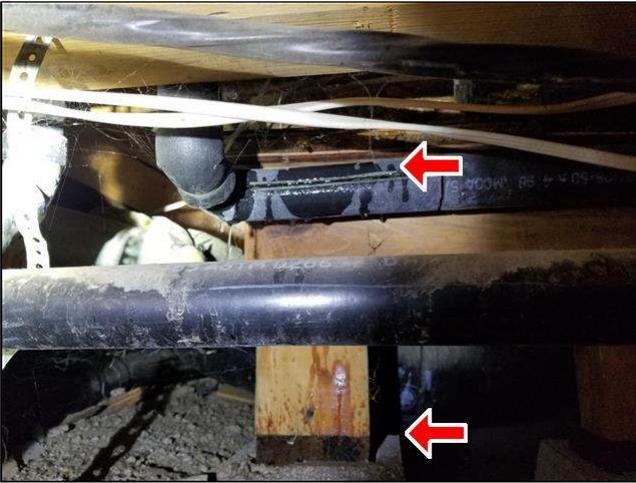
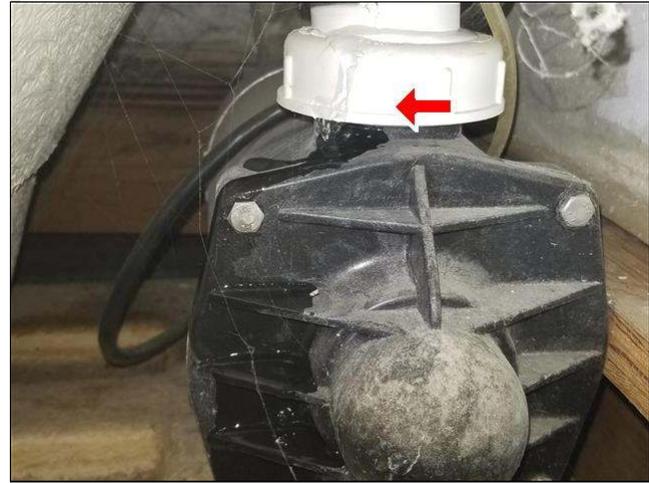
(3) NOTE: plumbing drain pipe leaks at the connection to the jetted tub pump, and was noted in the crawlspace area. Recommend repair by a qualified person.

5.13 Item 5(Picture) moisture in crawlspace

5.13 Item 6(Picture) leak under jetted tub

(3) NOTE: plumbing drain pipe leaks at the connection to the jetted tub pump, and was noted in the crawlspace area. Recommend repair by a qualified person.

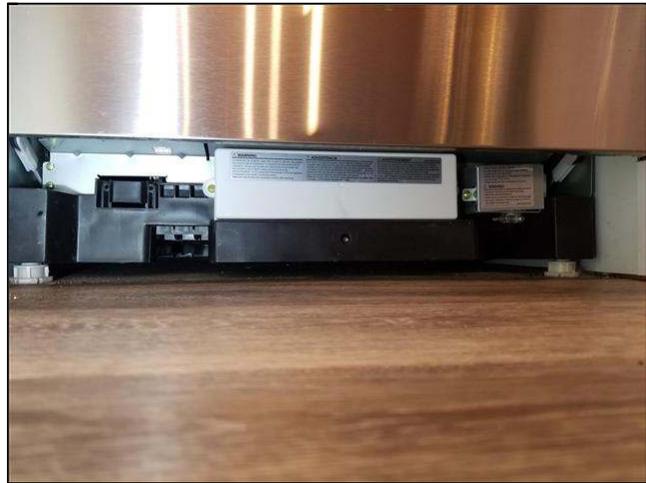
6.0 Item 2(Picture) dishwasher hook-ups

The Dishwasher was run through a complete cycle, with no leaks or abnormal noises noted. Inspection cover was removed to view the Dishwasher electric/plumbing hook-ups, Door seals and dish racks appear in serviceable condition. Mounted securely to under countertop. Drain hose is routed to a high loop prior to connecting to drain, as required to prevent backflow/siphon of waste into dishwasher.

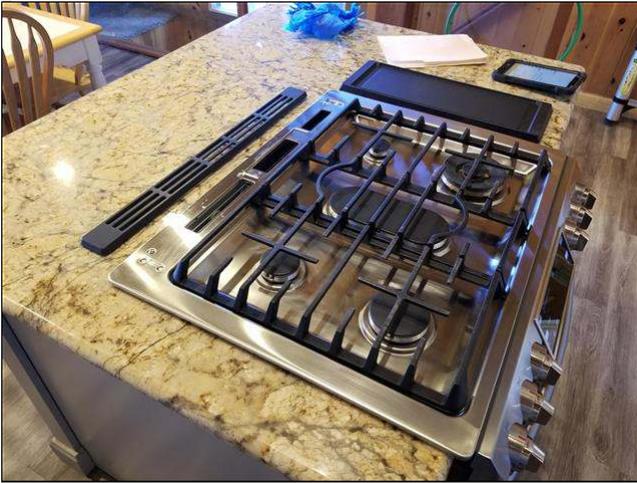
There is NO range vent installed in the kitchen for the gas range.

6.3 Item 1(Picture) no range hood in kitchen

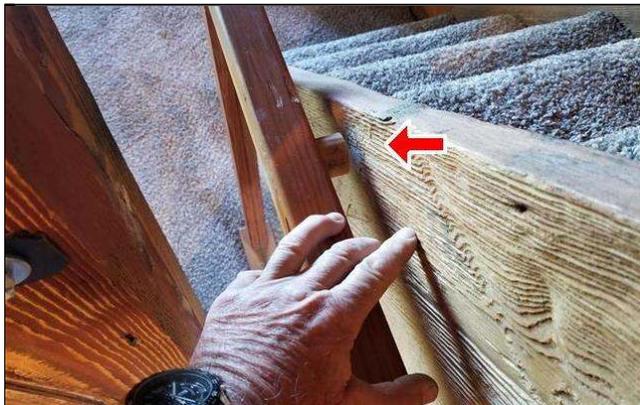
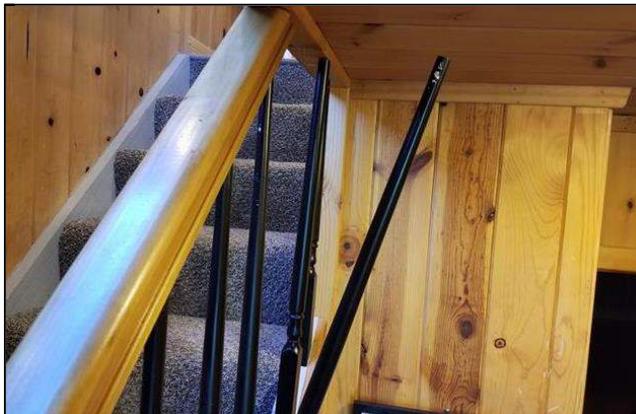
Recommend securing glass railing frame to upper staircase to prevent excessive movement and possible breakage... Recommend repair lower staircase railing as needed.

7.6 Item 1(Picture) recommend secure glass railing

7.6 Item 2(Picture) lower staircase railing

Recommend securing glass railing frame to upper staircase to prevent excessive movement and possible breakage... Recommend repair lower staircase railing as needed.

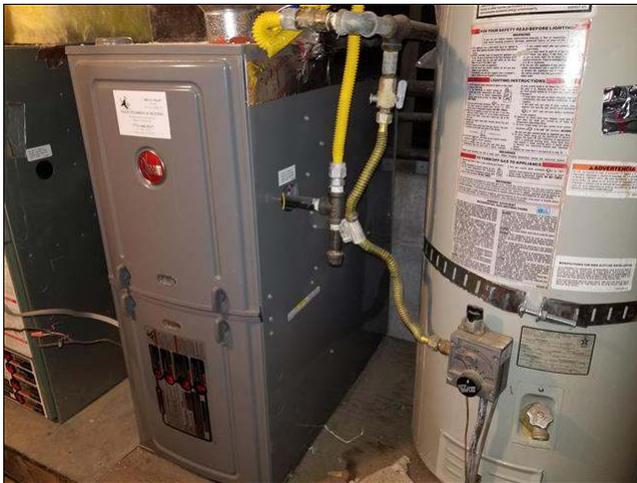
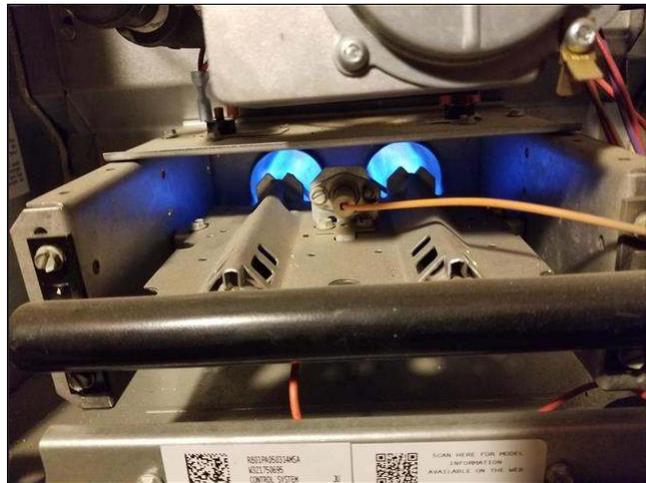
The heating equipment is NOT original (5 years). The furnace is a vertical Upflow natural gas fired forced air unit, Rated at 50,000btu's, that operated as intended with normal operating controls. The burners have an even blue flame. Manufactured in August 2017 by Rheem Heating.

9.0 Item 1(Picture) forced air furnace

9.0 Item 2(Picture) furnace burners

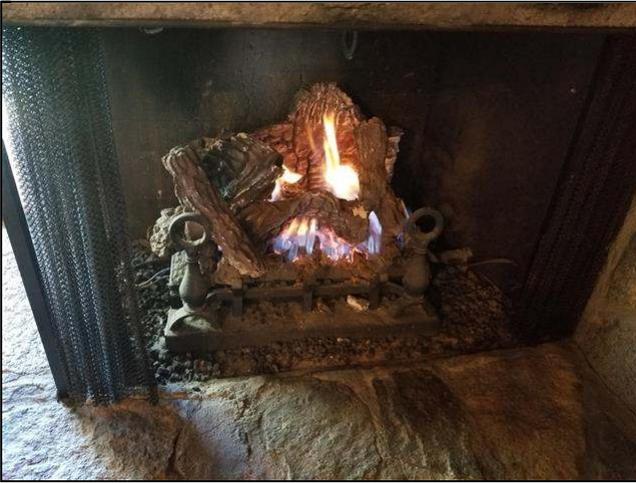
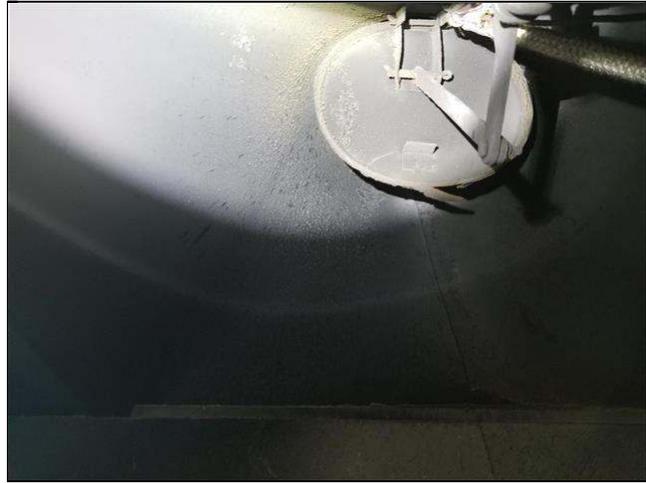
Living room fireplace's pilot light was turned "on" and operational upon arrival for inspection. Firelog burner ignited, using the control switches located at the fireplace mantle. No problems noted at time of inspection.

10.0 Item 1(Picture) living room gaslog fireplace

10.0 Item 2(Picture) fireplace damper
