Inspection Report

Property Address:
1019 Arbor Rd.
Carson City NV 89701

Clear Choice Home Inspection Services

Date: 8/30/2022	Time: 09:00 AM	Report ID: HAT101
Property: 1019 Arbor Rd. Carson City NV 89701	Customer: Tyler & Michelle Hatchett	Real Estate Professional: Thomas Vander Laan Coldwell Banker

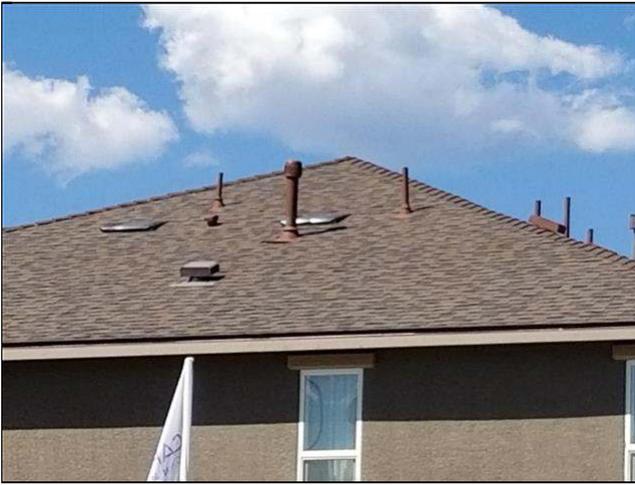
2.0 Item 1(Picture) view of roof

The roof covering is a 30/40 year architectural, asphalt/fiberglass shingle with much/most of it's life remaining. No problems noted at time of inspection. Viewed from the ground with binoculars. Responsibility of the HOA.

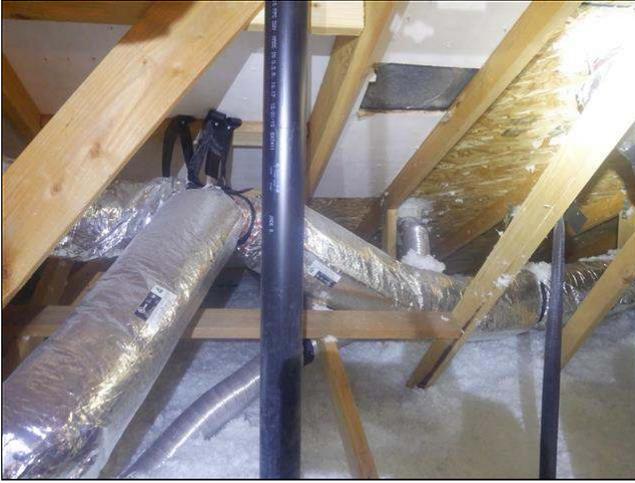
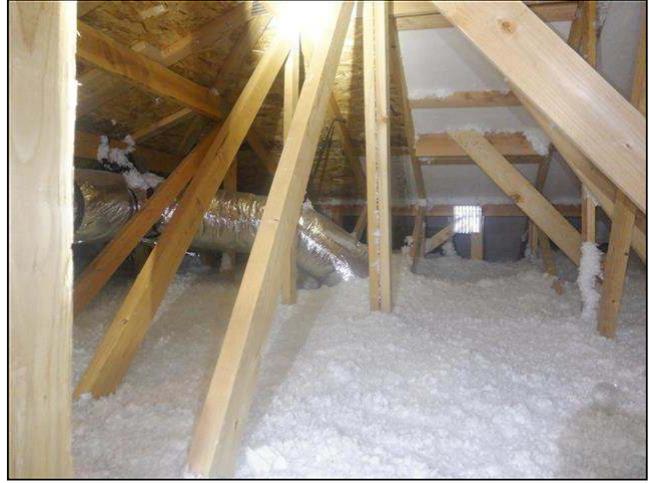
The Attic, as seen at time of Inspection.

3.4 Item 1(Picture) view of attic

3.4 Item 2(Picture) view of attic

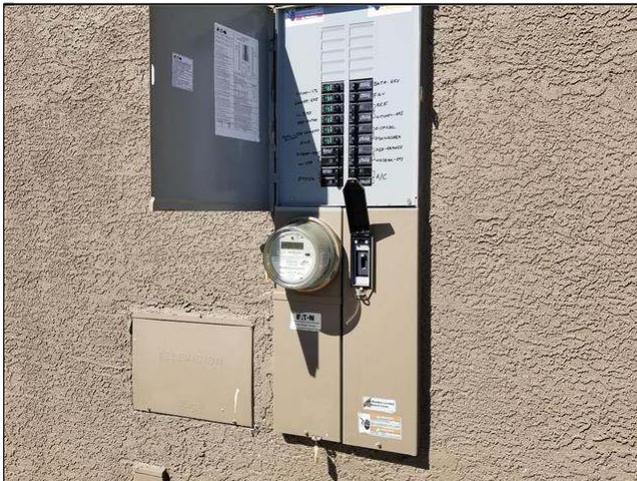
4.1 Item 1(Picture) main electrical panel

The Main and Distribution Panels are well labeled for circuit identification. "Dead front" cover appears serviceable. No problems noted.

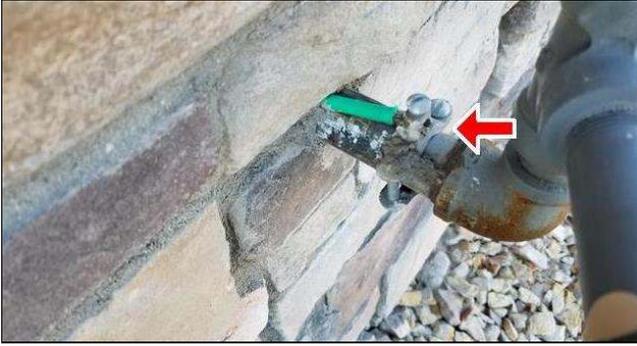
4.3 Item 1(Picture) bond to plumbing

The Grounding system for the Main Service Panel is not visible due to construction materials. However, there is a Grounding wire present in the Panel, and there is a Bonding wire present at the cold water pipe, which are important for proper grounding (safety) of the home.

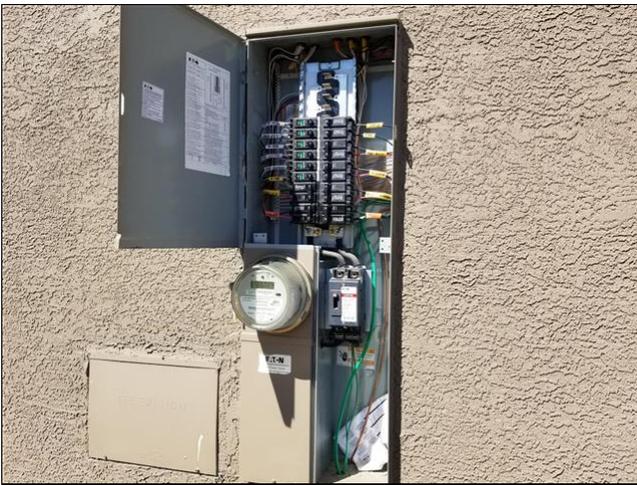
4.4 Item 1(Picture) main panel conductors

(1) The circuit conductors appear in good condition, and are properly sized for their prospective overcurrent devices. No "double tap" circuit breakers or burned connections noted.

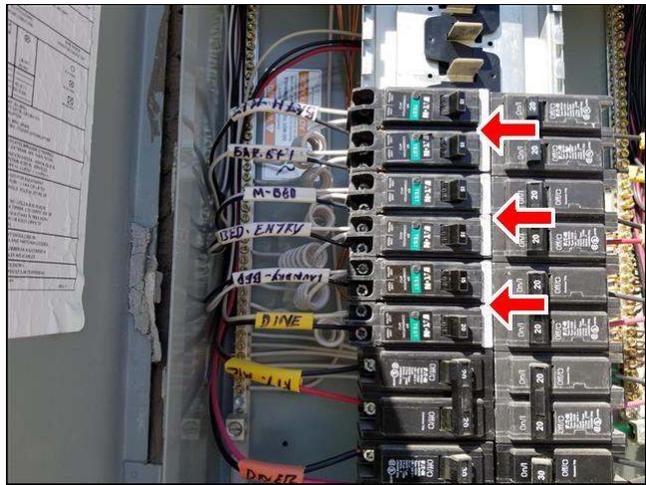
4.4 Item 2(Picture) arc fault circuit breakers

(2) The presence of Arc Fault circuit breakers noted in the Main Panel for Master and Guest bedroom receptacles. Arc Fault Breakers are designed to "trip" the circuit breaker in the event of an arc (poor connection) in the circuit wiring. Tripped and reset as intended.

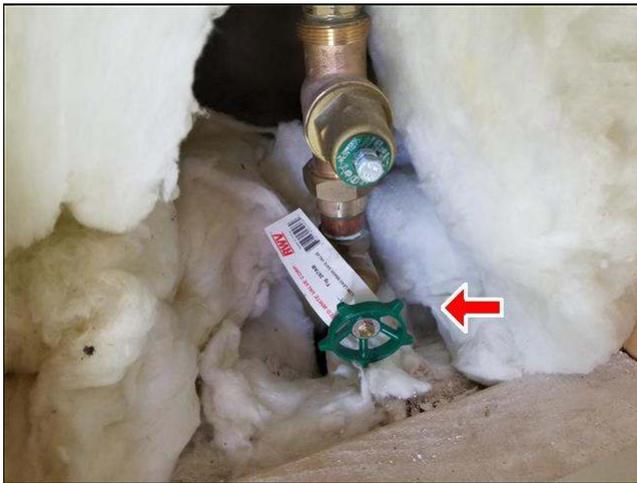
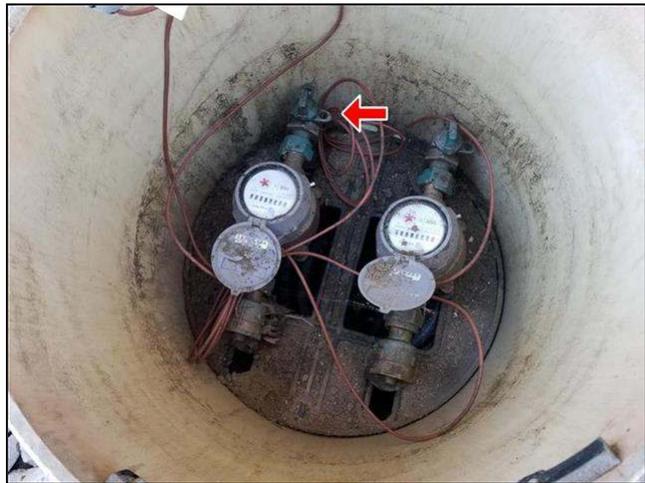
There are a couple main water shut-off locations. With the water meter at North side of building (for emergencies), and in the garage under the water heater pedestal. No problems noted.

5.0 Item 1(Picture) main water shut-off valve

5.0 Item 2(Picture) main water shut-off valve at street

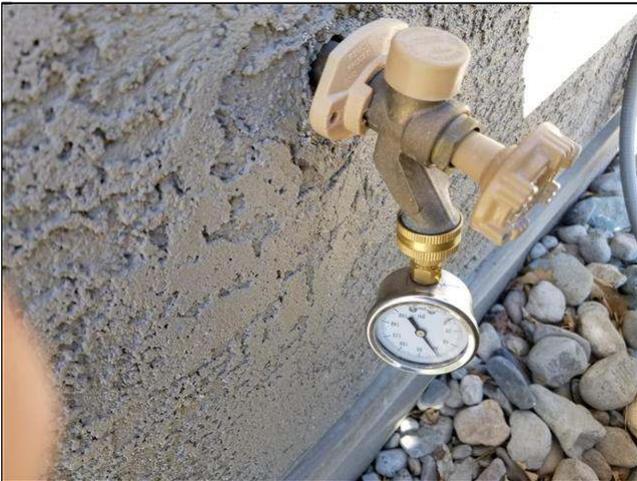
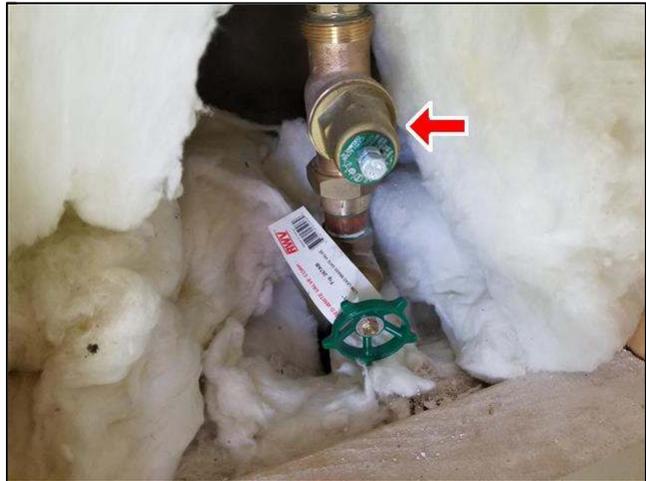
The water pressure was tested at the East hose bib, pressure was 62 psi at time of inspection. Pressure regulator noted at the Main water shut-off valve location, for future water pressure adjustments, if necessary.

5.2 Item 1(Picture) water pressure at east hose bib

5.2 Item 2(Picture) water pressure regulator

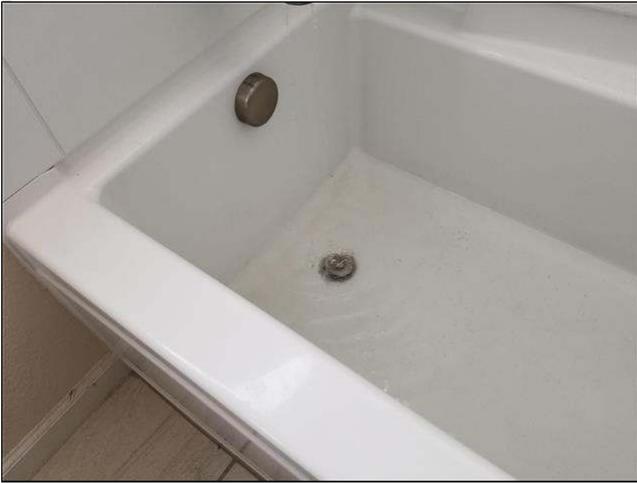
5.3 Item 1(Picture) downstairs tub does not drain

The tub/shower does not drain (plugged) at the Downstairs bath. A qualified licensed plumber should repair or correct as needed.

The tub/shower does not drain (plugged) at the Downstairs bath. A qualified licensed plumber should repair or correct as needed.

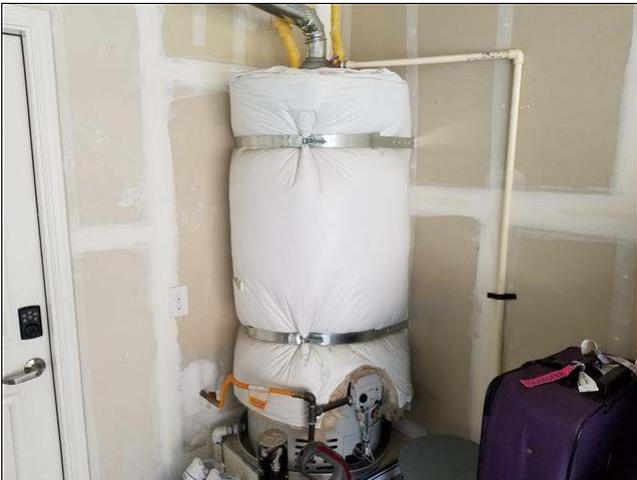
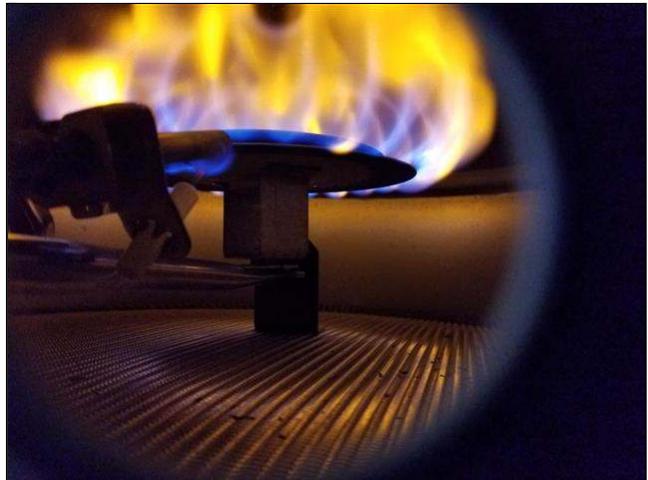
(1) Temperature and Pressure Relief valve is piped to the exterior of the house, or within 6 inches of the floor (for safety). Water Heater is strapped with approved strapping material, and is setting on a pedestal minimum of 18" above the garage floor. Drip leg is installed in the gas line, water and fuel shut-off valves are present. Water heater operated as intended with no abnormal noises or leaks noted. No problems noted at time of inspection... Manufactured in 2019 by Bradford-White.

5.4 Item 1(Picture) water heater

5.4 Item 2(Picture) water heater burner compartment

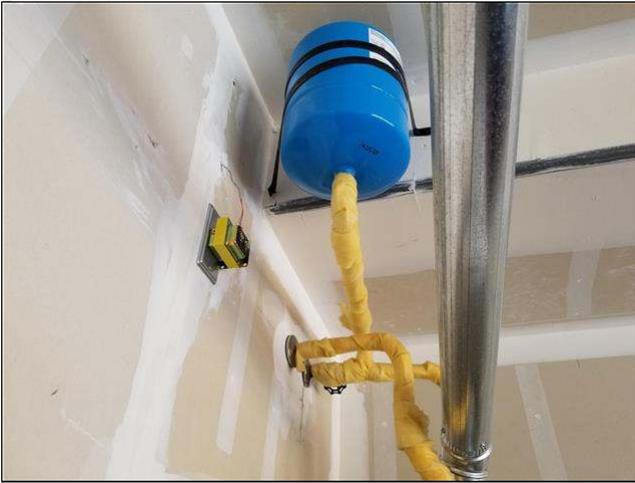
5.4 Item 3(Picture) thermal expansion tank

(2) Your water heater does have a "Thermal Expansion tank" installed to prevent a possible leak at the Temperature and Pressure relief valve, or "pop-off" valve, by absorbing the excessive pressure built-up in the water heater.

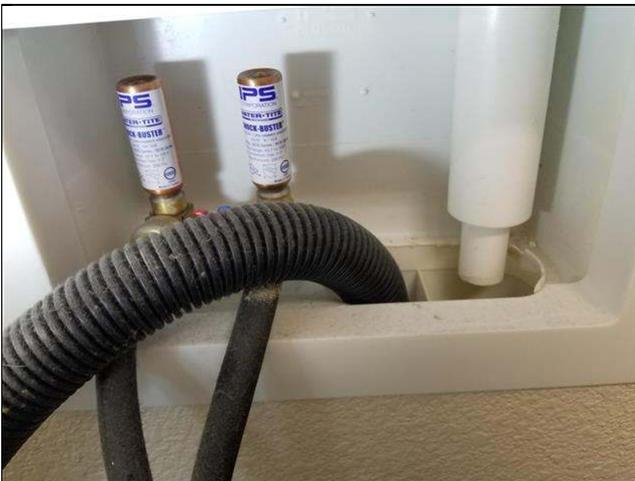
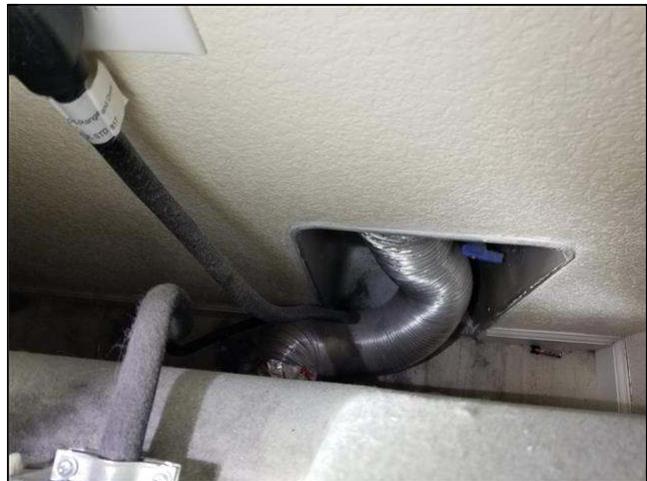
Washer and dryer hook-ups were inspected, with no problems noted. Dryer is electric or gas powered with rigid metal venting installed through the wall. Washer drain is 2" diameter, Hot and Cold hook-ups with no problems noted.

5.6 Item 1(Picture) laundry hook-ups

5.6 Item 2(Picture) laundry hook-ups

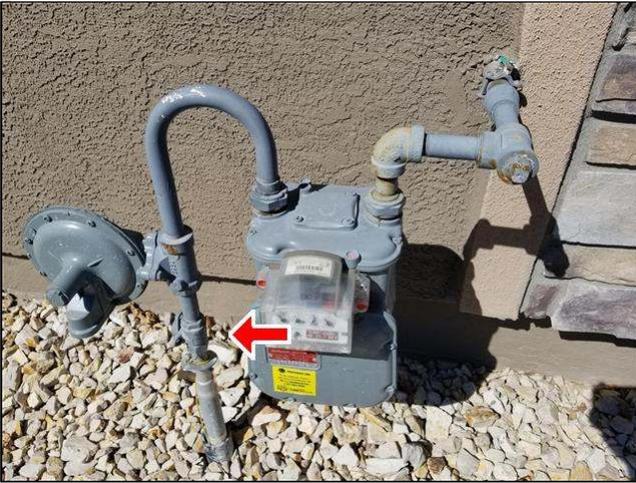
5.11 Item 1(Picture) main fuel shut-off valve

Located at the East side of the building with the gas meter. No problems noted.

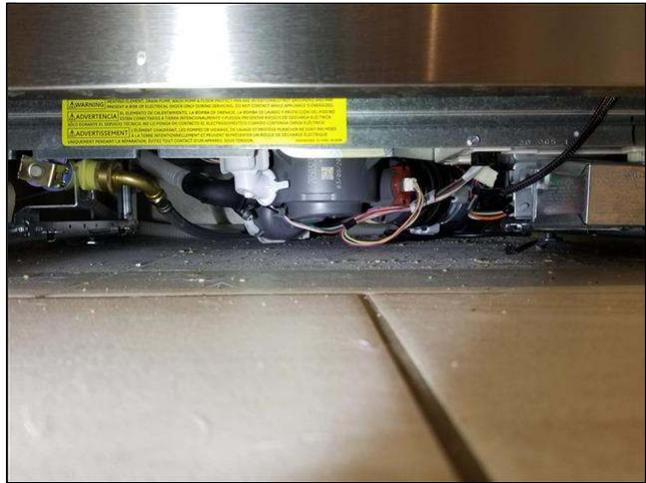
6.0 Item 2(Picture) dishwasher hook-ups

The Dishwasher was run through a complete cycle, with no leaks or abnormal noises noted. Inspection cover was removed to view the Dishwasher electric/plumbing hook-ups, Door seals and dish racks appear in serviceable condition. Mounted securely to under countertop. Drain hose is routed to a high loop prior to connecting to drain, as required to prevent backflow/siphon of waste into dishwasher.

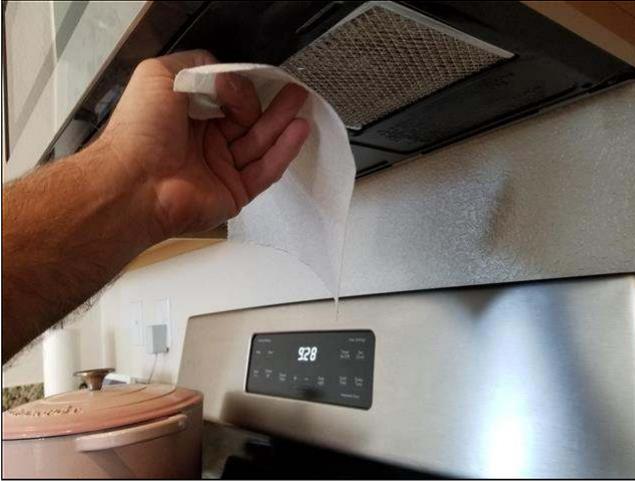
6.3 Item 1(Picture) no draw through vent screens

The range hood is a three speed, vented type with light. DID NOT operate as intended. Range hood and built-in microwave are one unit. There is NO draw through the ventilation screen filters. Recommend further evaluation by a qualified person.

The range hood is a three speed, vented type with light. DID NOT operate as intended. Range hood and built-in microwave are one unit. There is NO draw through the ventilation screen filters. Recommend further evaluation by a qualified person.

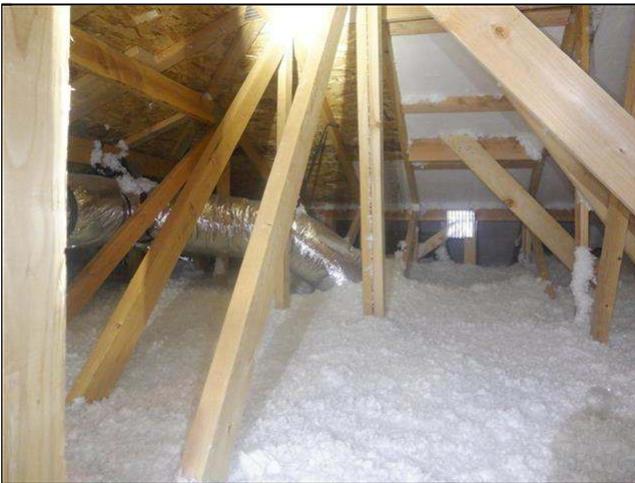
9.0 Item 1(Picture) view of attic insulation

The attic insulation is loose-fill, and is approximately 14 to 16 inches deep. (R-38) No problems noted.

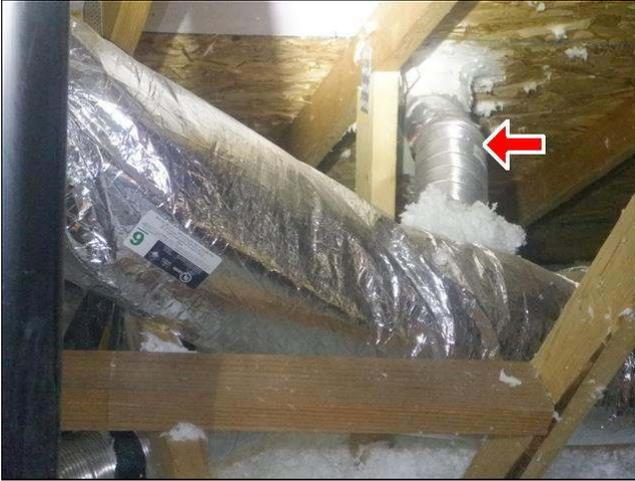
9.4 Item 1(Picture) properly ducted to exterior

Bathrooms, Kitchen and Laundry vents are properly ducted to the exterior of the home.

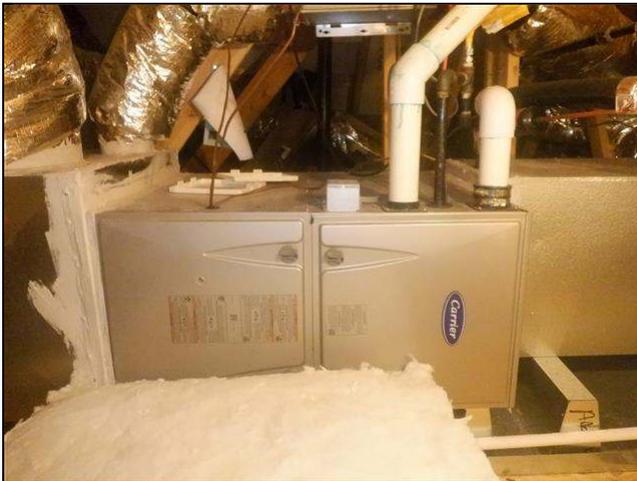
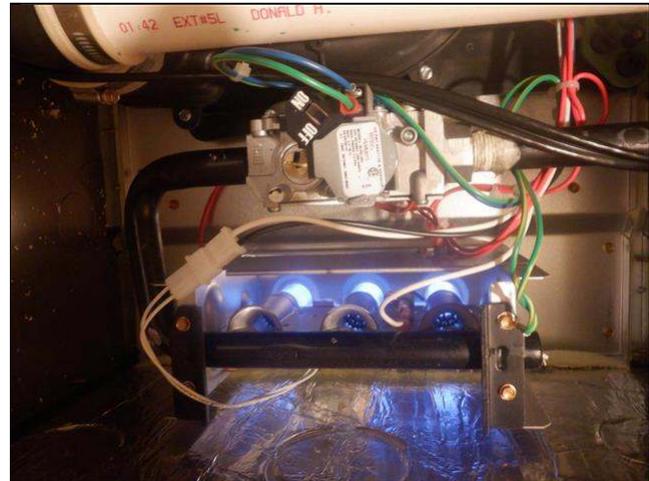
The heating equipment is original (3 years). The furnace is a Horizontal downdraft natural gas fired forced air unit, Rated at 60,000btu's, that operated as intended with normal operating controls. The burners have an even blue flame. Manufactured in November 2019 by Carrier Heating.

10.0 Item 1(Picture) forced air furnace

10.0 Item 2(Picture) furnace burners

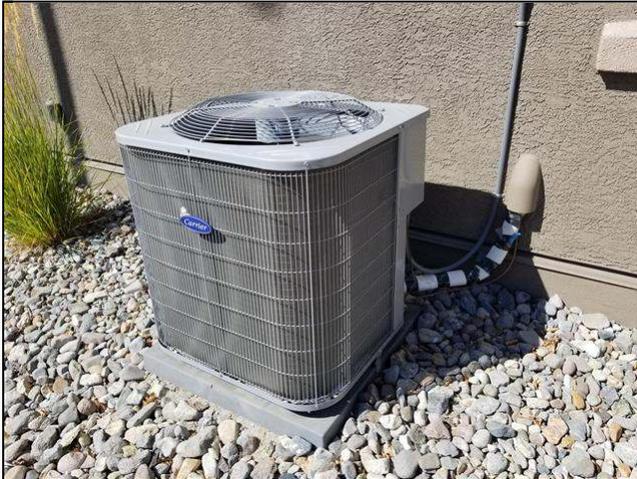
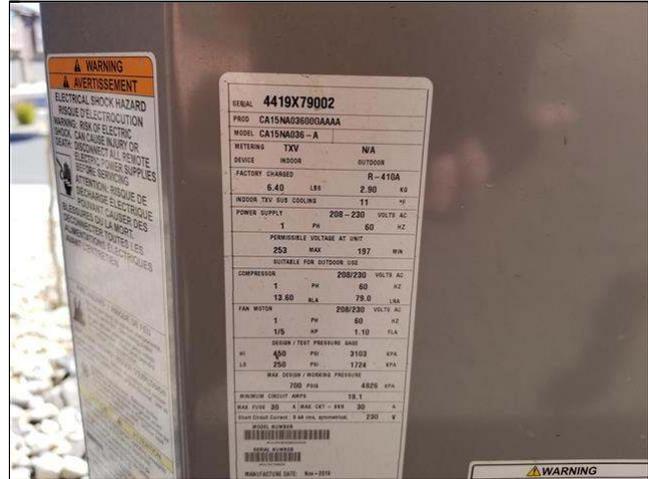
The ambient air test was performed by using thermometers on the air handler of Air conditioner to determine if the difference in temperatures of the supply and return air are between 14 degrees and 22 degrees which indicates that the unit is cooling as intended. The supply air temperature on your system read 56 degrees, and the return air temperature was 71 degrees (a/c cabinet temperature measured 82 degrees). This indicates the range in temperature drop is normal. Condensing unit operated as intended with normal operating controls, and no abnormal noises noted. Unit was manufactured in 2019 by Carrier.

10.5 Item 1(Picture) condensing unit

10.5 Item 2(Picture) manufacturer's label
