## Inspection Report

121 Keetly Dr.  
Dayton NV 89403

### Clear Choice Home Inspection Services

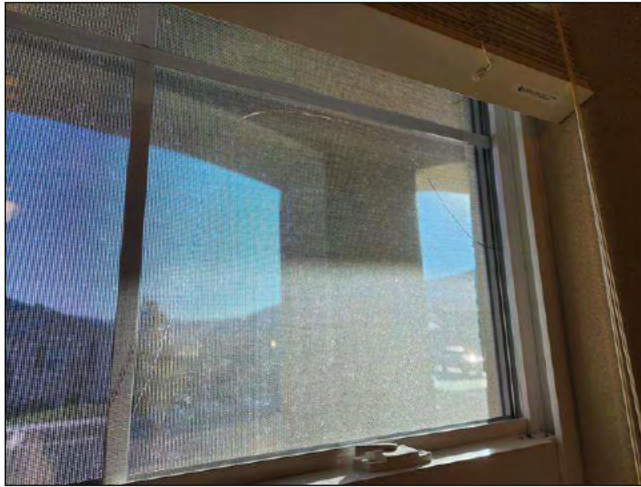
1.4 Item 1(Picture) cracked window at office

(2) Window is cracked at the East facing wall in Office, and should be replaced by a qualified person.

(2) Window is cracked at the East facing wall in Office, and should be replaced by a qualified person.

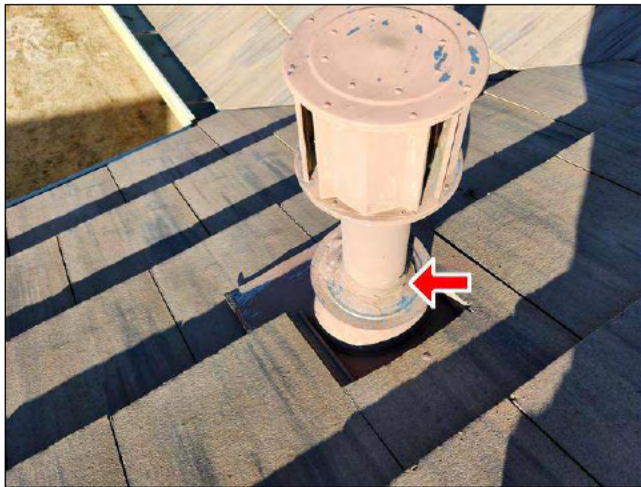
2.3 Item 1(Picture) flue pipes sealed well

Plumbing and furnace vent pipes are sealed well against flashings to prevent moisture intrusion into attic framing areas.

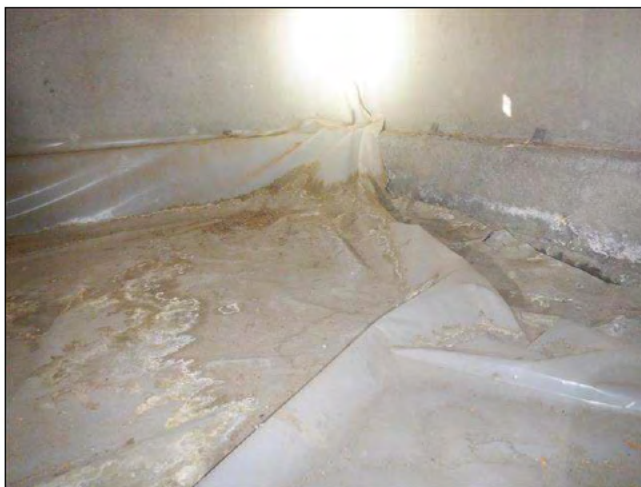
3.2 Item 1(Picture) under master bedroom area

(2) NOTE: There are signs of past pooled moisture noted in the SW crawlspace area under the master bedroom (all areas were dry at time of inspection). This appears was caused from excessive watering at the Southwest corner planter area in the past. Exterior foundation grading appears adequate.

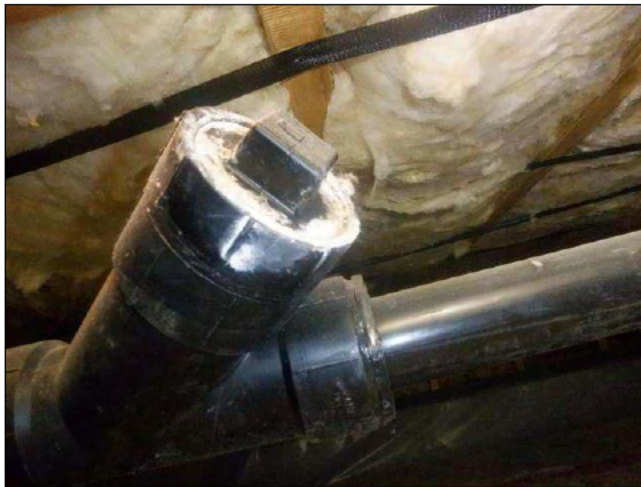
3.2 Item 3(Picture) past clean-out maintenance

(3) The crawlspace area was dry at time of inspection, with no signs of past moisture intrusion through/under the foundation and stemwall noted. Small moisture stained areas were noted on top of the vapor barrier in plumbing clean-out areas, however are believed to have been caused by past plumbing drain maintenance. No problems noted.

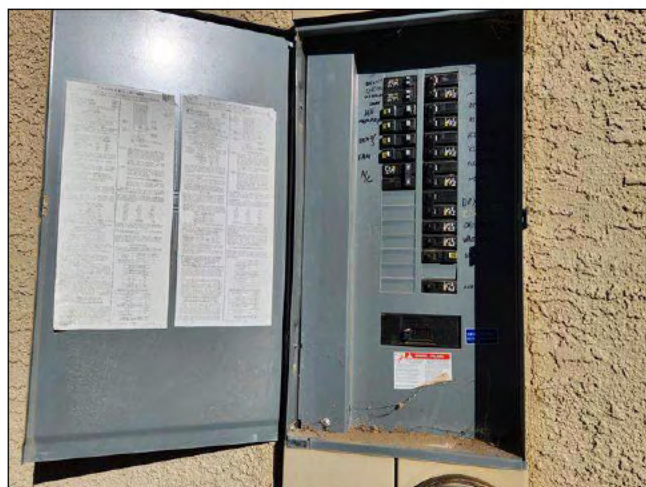
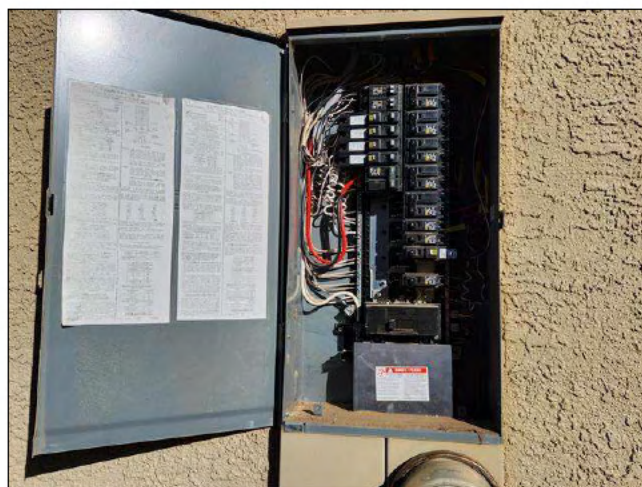
4.1 Item 1(Picture) main electrical panel

The Main and Distribution Panels are well labeled for circuit identification. "Dead front" cover appears serviceable. No problems noted.

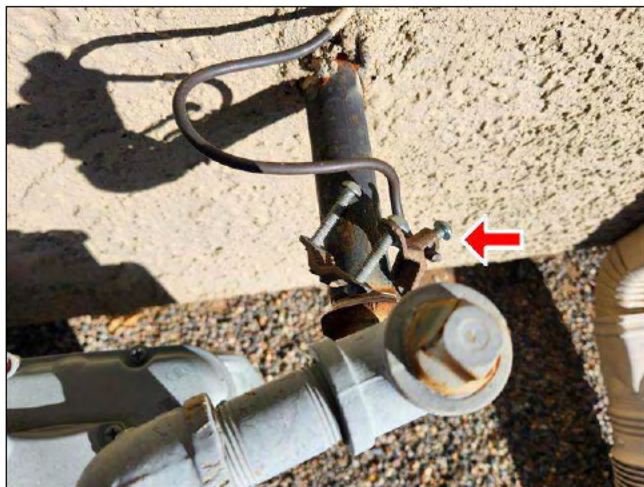
4.3 Item 1(Picture) UFER bond wire/clamp

UFER bond wire clamp is disconnected at the main gas meter/entrance to home. Recommend securing bond wire clamp for proper grounding.

UFER bond wire clamp is disconnected at the main gas meter/entrance to home. Recommend securing bond wire clamp for proper grounding.

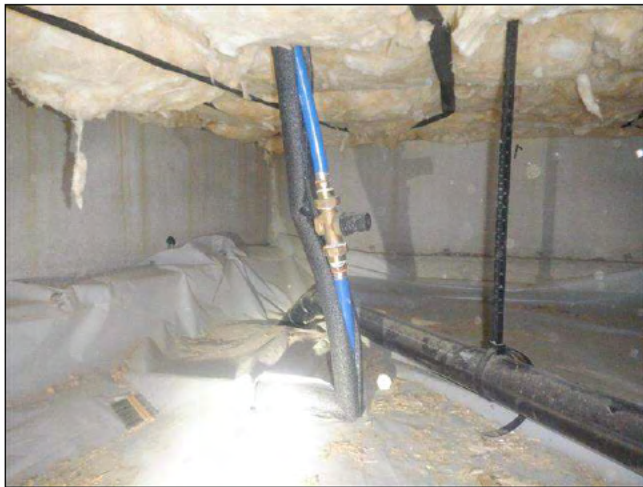
5.2 Item 1(Picture) main plumbing entrance to home

Recommend securing pipe insulation around plumbing supply pipe entrance to home (in crawlspace area), for proper protection against freezing temperatures.

Recommend securing pipe insulation around plumbing supply pipe entrance to home (in crawlspace area), for proper protection against freezing temperatures.

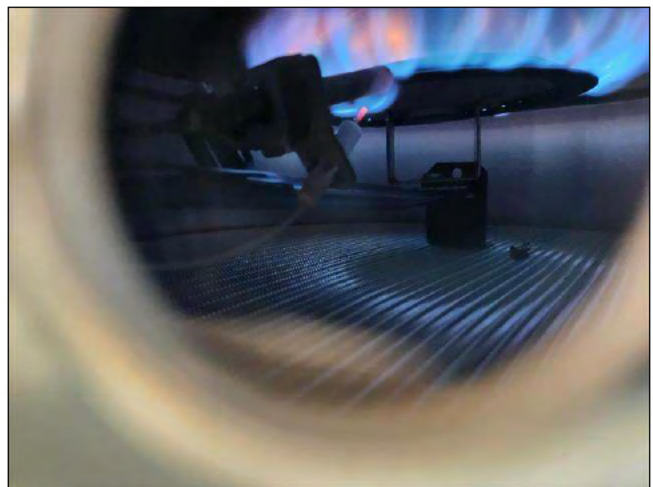
5.4 Item 1(Picture) water heater

(1) Temperature and Pressure Relief valve is piped to the exterior of the house, or within 6 inches of the floor (for safety). Water Heater is strapped with approved strapping material, and is setting on a pedestal minimum of 18" above the garage floor. Drip leg is installed in the gas line, water and fuel shut-off valves are present. Water heater operated as intended with no abnormal noises or leaks noted. No problems noted at time of inspection... Manufactured in 2016 by Bradford-White.

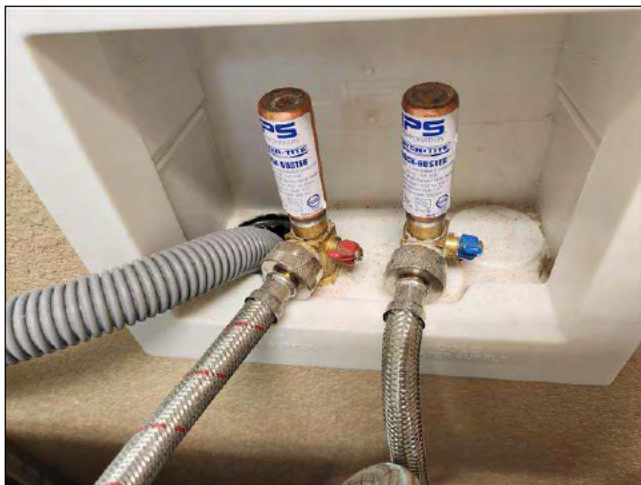
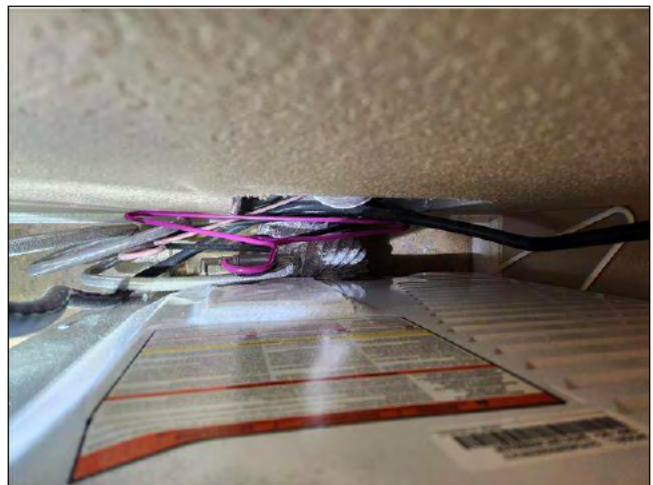
5.6 Item 1(Picture) laundry hook-ups

Washer and dryer hook-ups were inspected, with no problems noted. Dryer is electric powered with rigid metal venting installed through the wall. Washer drain is 2" diameter, Hot and Cold hook-ups with no problems noted.

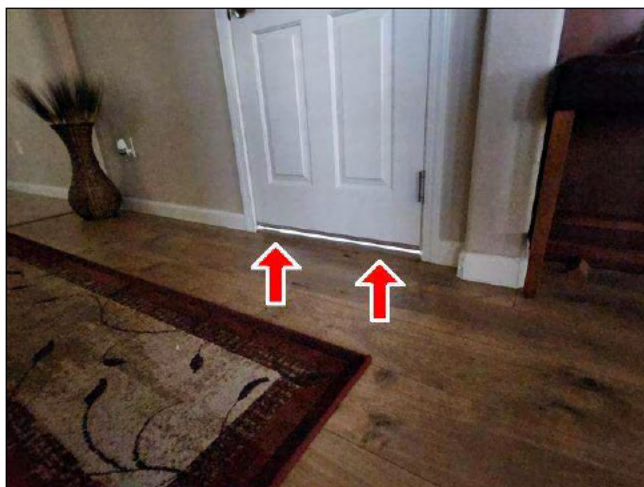
8.7 Item 1(Picture) lower seal at garage occupant door

(2) NOTE: Large gap is noted under the garage occupant door, which could allow Carbon Monoxide to enter the home. Recommend repair or replace lower door seal as needed.

(2) NOTE: Large gap is noted under the garage occupant door, which could allow Carbon Monoxide to enter the home. Recommend repair or replace lower door seal as needed.

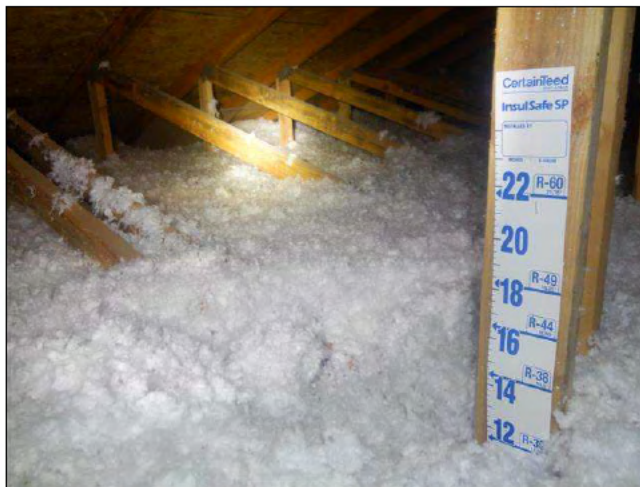
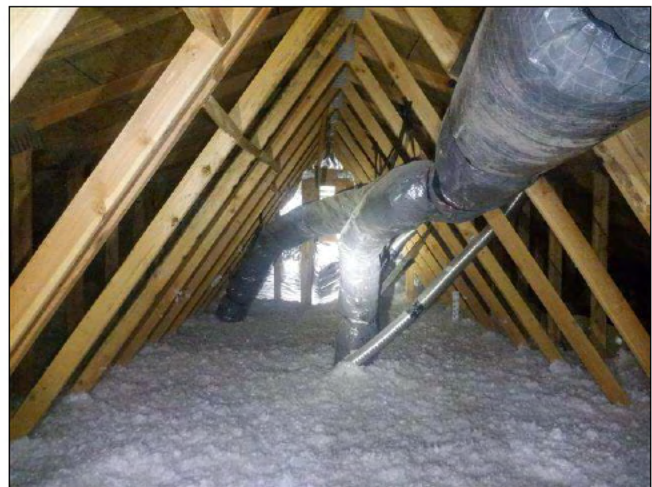
9.0 Item 1(Picture) view of attic insulation

The attic insulation is loose-fill, and is approximately 14 to 16 inches deep. (R-38) No problems noted.

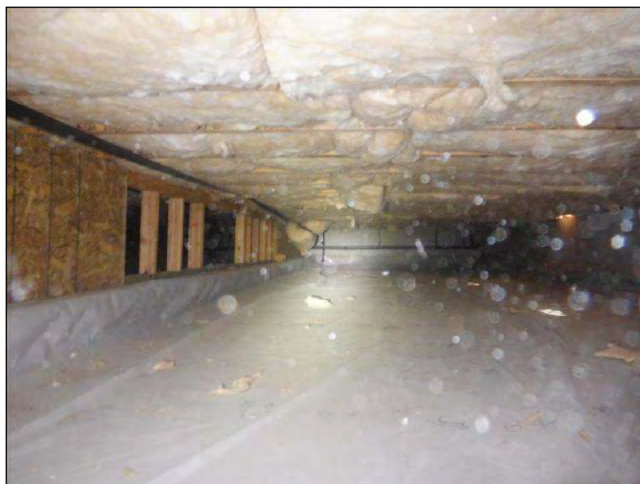
9.1 Item 1(Picture) view of subfloor insulation

The subfloor area is insulated between the floor joists using R30 fiberglass Batts, no problems noted.

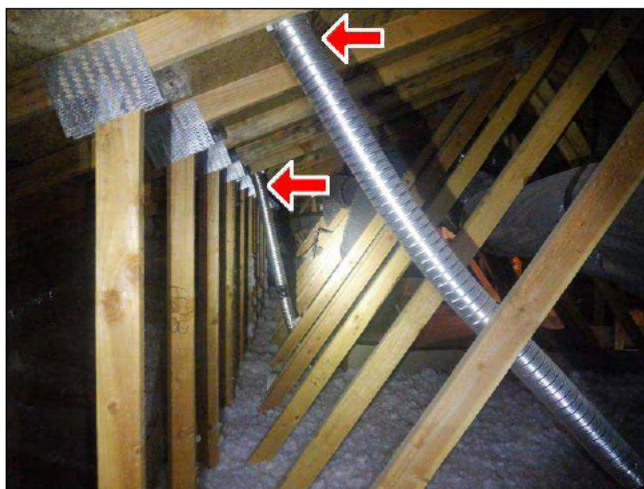
9.4 Item 1(Picture) vented properly to exterior

Bathrooms, Kitchen and Laundry vents are properly ducted to the exterior of the home.

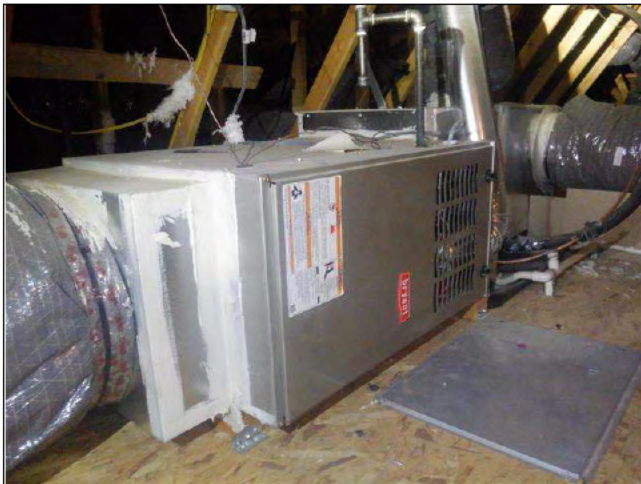
10.0 Item 1(Picture) forced air furnace

The heating equipment is original (6 years). The furnace is a Horizontal downdraft natural gas fired forced air unit, Rated at 66,000btu's, that operated as intended with normal operating controls. The burners have an even blue flame. Manufactured in 2016 by Bryant Heating.

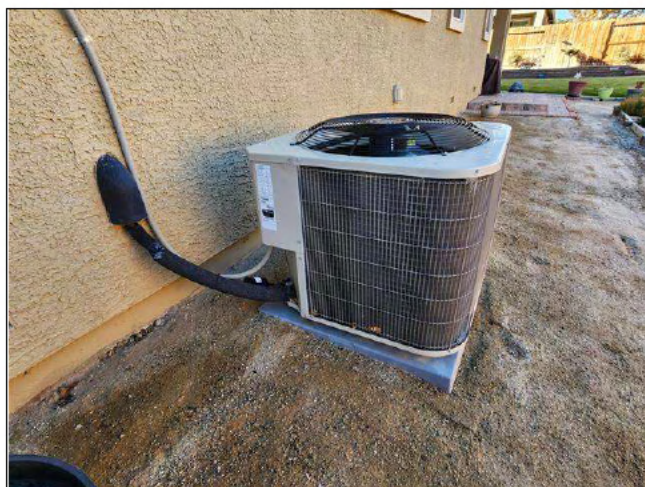
10.5 Item 1(Picture) condensing unit

Performed a visual only inspection. The A/C was not tested for proper operation due to the outside air temperature being 42 degrees or less, and possibility of cooling equipment failure could occur. 60 degree minimum ambient temperature must be achieved for safe compressor operation. NOTE: Licensed HVAC Contractors possess the required knowledge and equipment to check operation of cooling system in cold weather. Recommend consulting an HVAC Contractor for further evaluation of cooling system as desired. We did not inspect this unit(s). Manufactured in 2016 by Bryant.
