## Home Inspection Report

PROPERTY INSPECTED:  
6227 Western Bluffs Boulevard  
Billings, MT 59106

Date of Inspection: 07/17/2024

Inspection No. 45957-1-1090

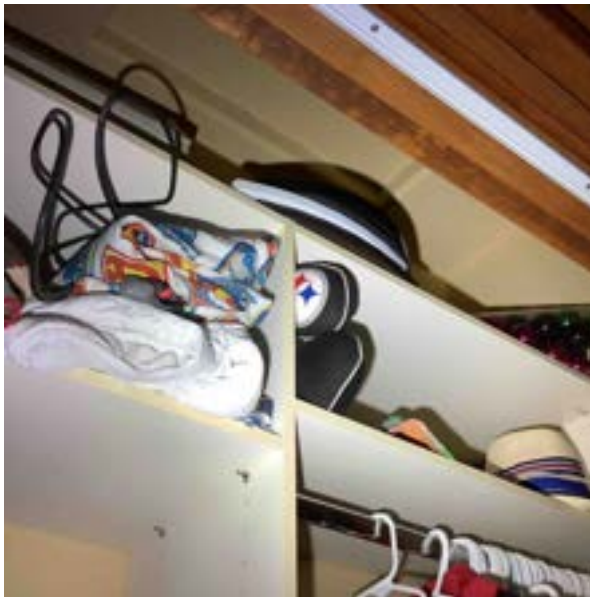
5.1.1 Further investigate attic when access is available. Fixed shelving/belongings obstructing attic access.  
**(2nd Floor West Bedroom)**

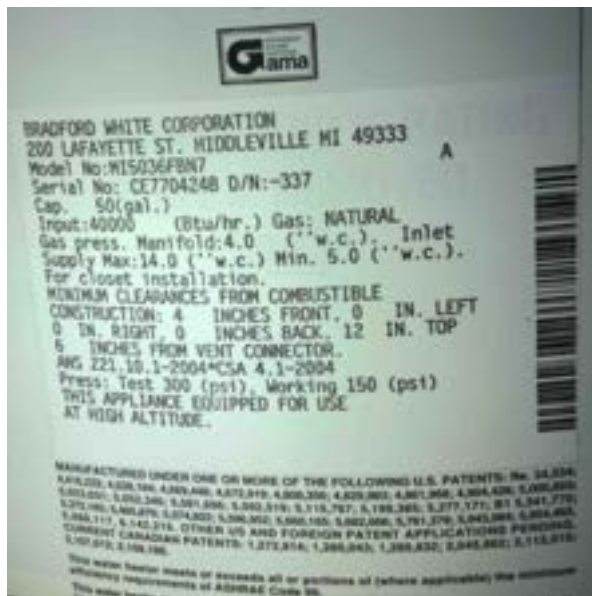
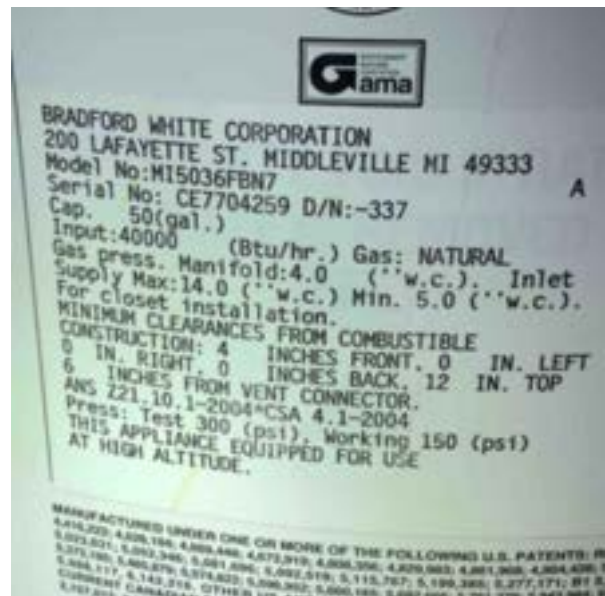
Data Plate: (Utility Area)

10.4.2 Exceeded typical life expectancy. Budget to replace.
