Inspection Report

3924 Granite Way
Wellington NV 89444

Clear Choice Home Inspection Services

Date: 4/22/2024	Time: 09:00 AM	Report ID: QUI392
Property: 3924 Granite Way Wellington NV 89444	Customer: Doris Quijada	Real Estate Professional: Thomas Vander Laan Coldwell Banker

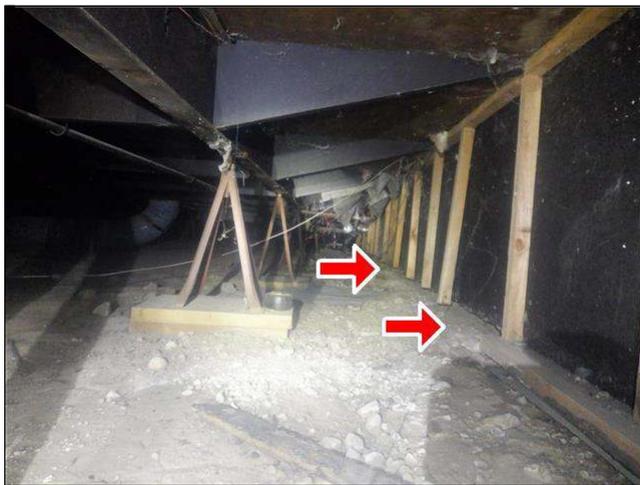
1.1 Item 1(Picture) under kitchen area

(2) NOTE: Siding/Skirting areas under the front and back deck/porch have the "sole plate" removed from the skirting wall framing. This appears was completed to eliminate earth-to-wood contact in the past, however has removed a small framing section that could possibly provide some support to the exterior wall "sagging" condition.

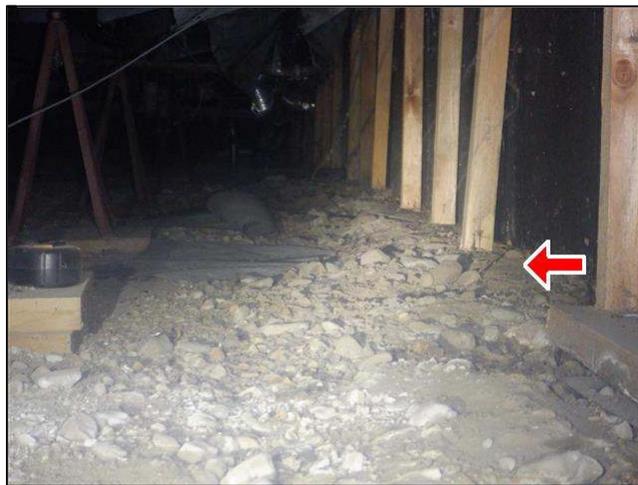
1.1 Item 2(Picture) framing sole plate removed

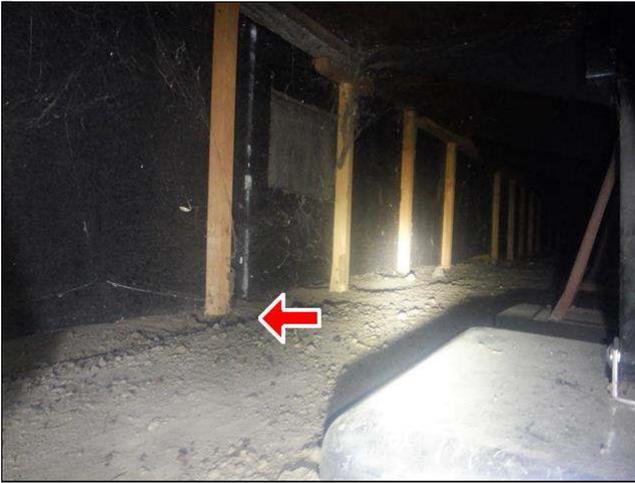
1.1 Item 3(Picture) no sole plate under front entry

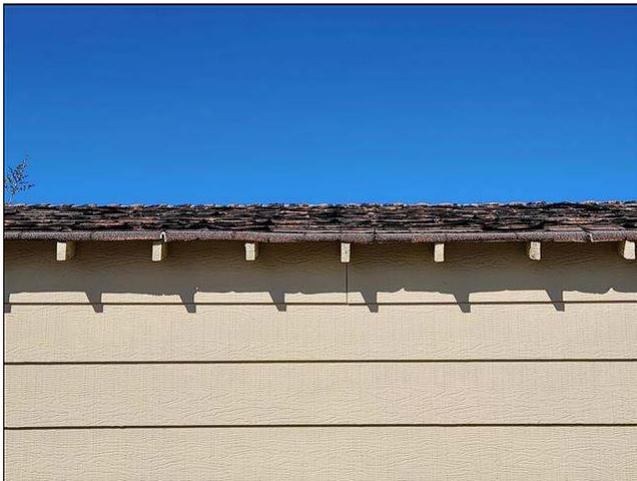
NOTE: Exterior wood entry door is damaged from moisture absorption at the storage shed... Roof covering has expired at the storage sheds.

1.9 Item 3(Picture) roof covering at sheds

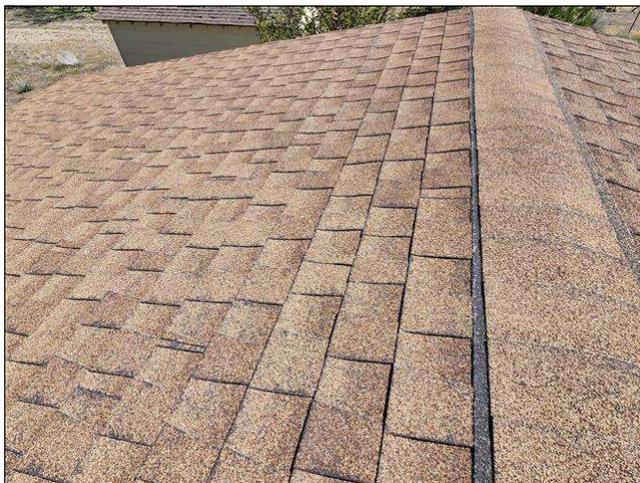
(1) Main House Roof... The roof covering does not appear to be original, and is a 30 year architectural, asphalt/fiberglass Composition shingle that has an appearance of over 20 years old. Typical loss of granules noted from shingles, however is more advanced at the South slope of roof. No major problems noted at time of inspection. Recommend further evaluation of roof covering materials by a licensed Roofing Contractor for estimated remaining life of roof, as desired.

2.1 Item 1(Picture) north slope shingles

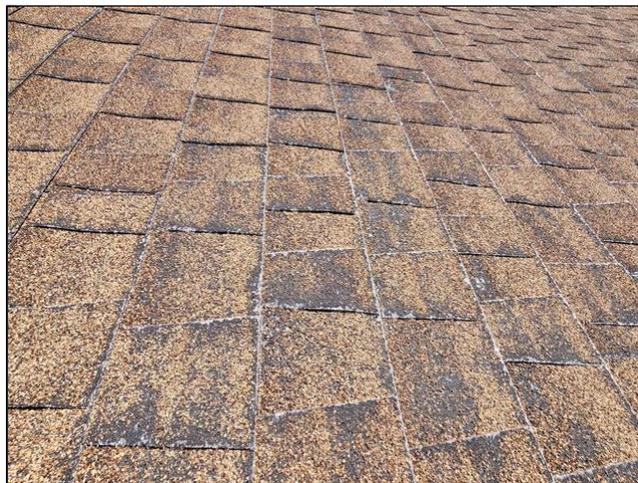
2.1 Item 2(Picture) south slope shingles

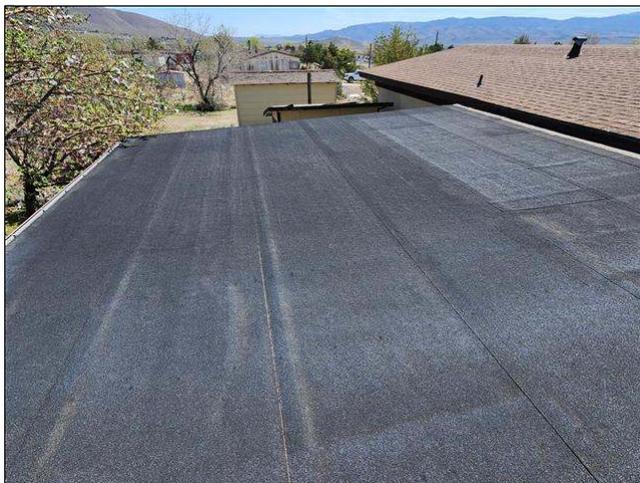
(3) Rear Porch Roof... Uses "rolled asphalt" roofing, and appears to be in good overall condition, with seams and edges sealed well.

2.1 Item 7(Picture) rear porch roof cover

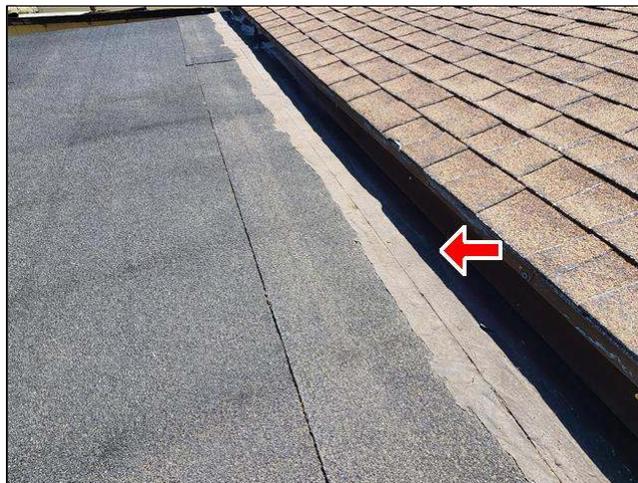
2.1 Item 8(Picture) proper flashings at connection to house

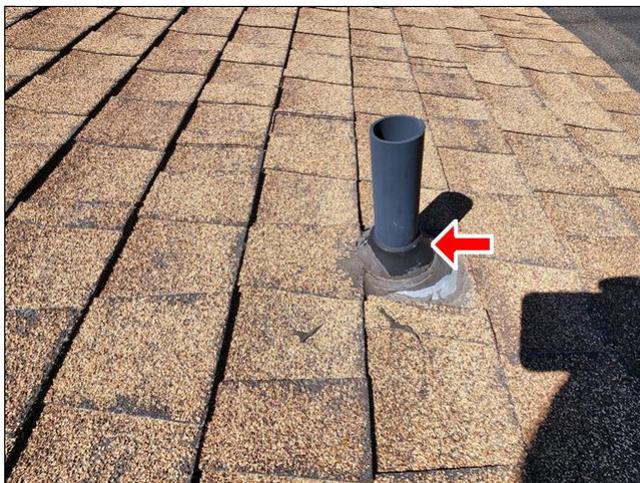
Plumbing and furnace vent pipes are sealed well against flashings to prevent moisture intrusion into attic framing areas.

2.3 Item 1(Picture) plumbing vent pipes sealed well

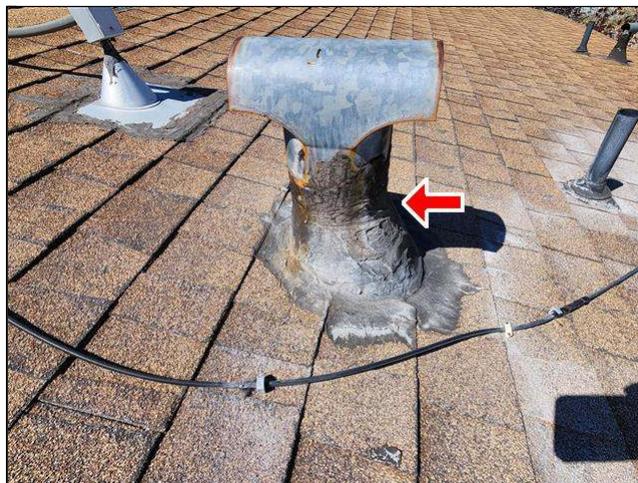
2.3 Item 2(Picture) flue pipes sealed well

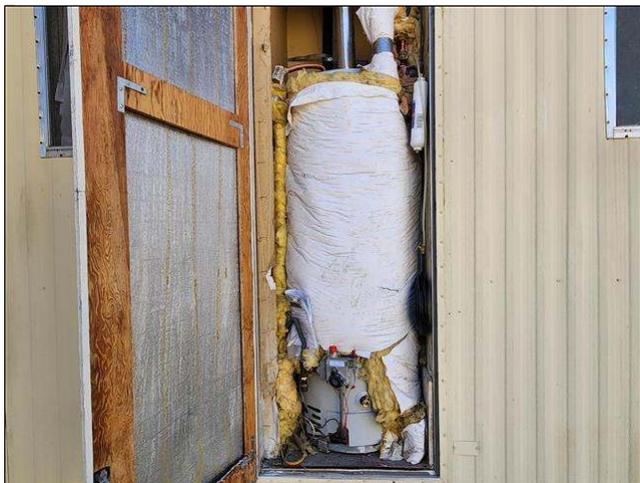
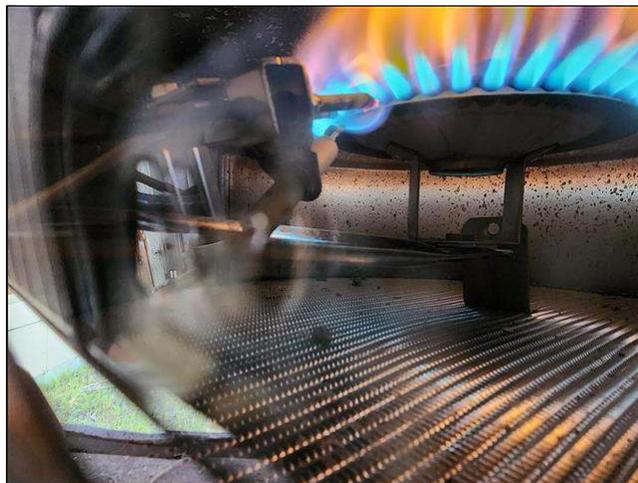
Water heater is located in the West exterior closet of home, and is strapped to current local codes. Temperature and Pressure Relief Valve is piped to the exterior of the home, or within 6 inches of the floor (for safety reasons). Water and fuel shut-off valves are present. Water heater operated as intended with no abnormal noises or leaks noted. NOTE: I was unable to verify Manufacturer or capacity of water heater due to being wrapped with an insulation blanket. No obvious problems noted, water heater appears newer.

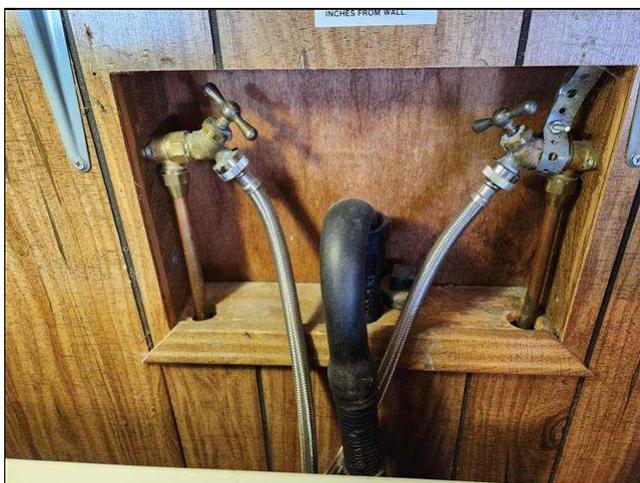
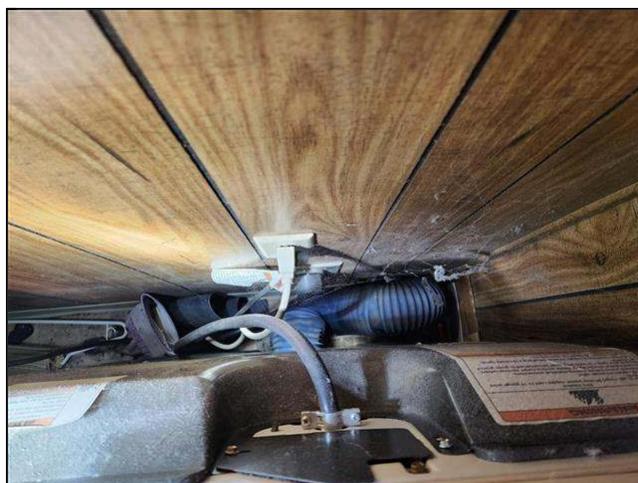
Washer and dryer hook-ups were inspected, with no problems noted. Dryer is electric or gas powered with flexible vinyl venting installed. Washer drain is 1 1/2" diameter, Hot and Cold hook-ups with no problems noted.

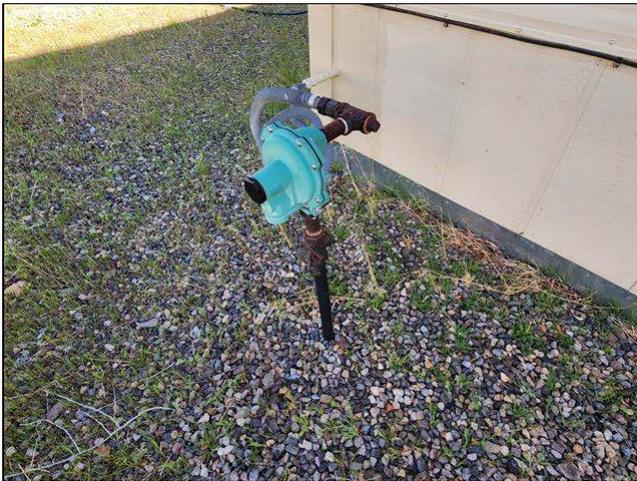
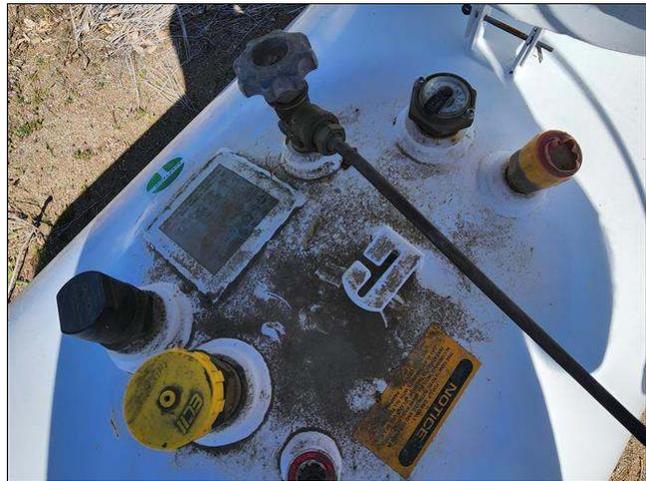
Main tank shut-off for fuel is located on top of the fuel storage tank, at the West side of the house. Main fuel shut-off valve for house is located at the fuel regulator, at the West side of the house.

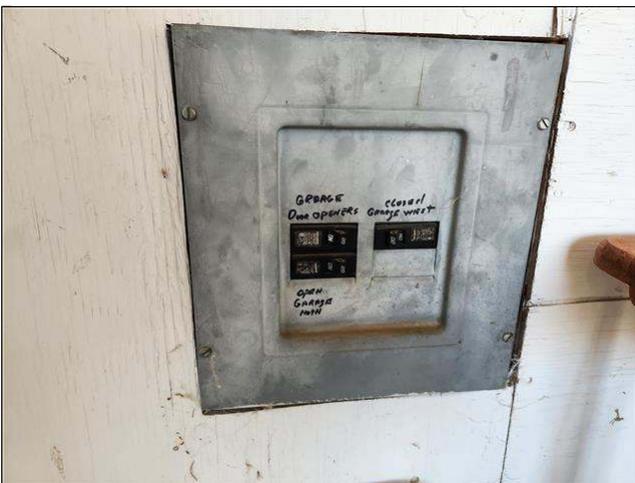
Comments: Inspected
Garage panel is well labeled for circuit identification, The circuit conductors appear in good condition, and are properly sized for their prospective overcurrent devices. No "double tap" circuit breakers or burned connections noted.

8.1 Item 1(Picture) main garage panel

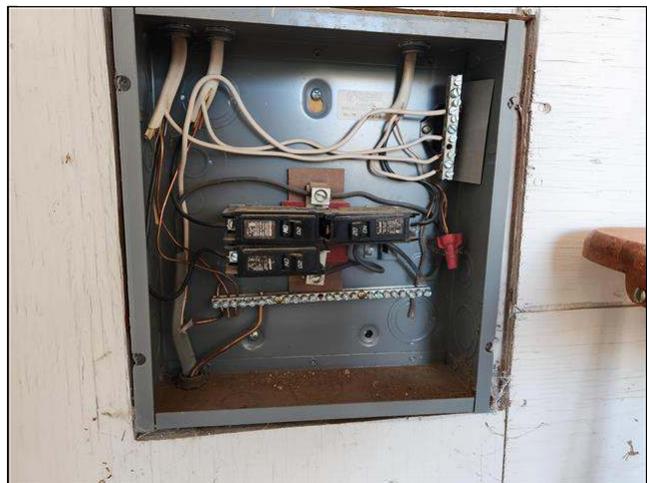
8.1 Item 2(Picture) garage panel conductors

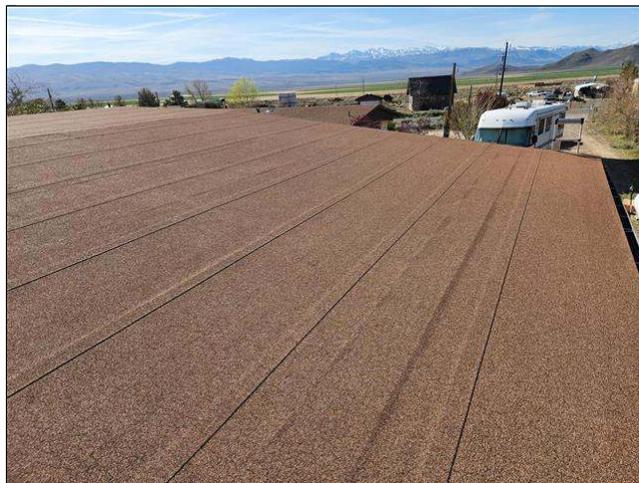
(1) The Garage roof covering does not appear to be original to the building, and is "rolled asphalt" roofing that appears to be near the end of it's useful life. Cracking/checking was noted throughout the roof area, however no signs of moisture intrusion noted. Recommend further evaluation of roof covering materials by a licensed Roofing Contractor for estimated remaining life of roof, as desired. NOTE: signs of past moisture intrusion noted at the interior roof sheathing plywood, however appear to be caused from past roof covering issues that no longer exist.

8.10 Item 2(Picture) view of roof

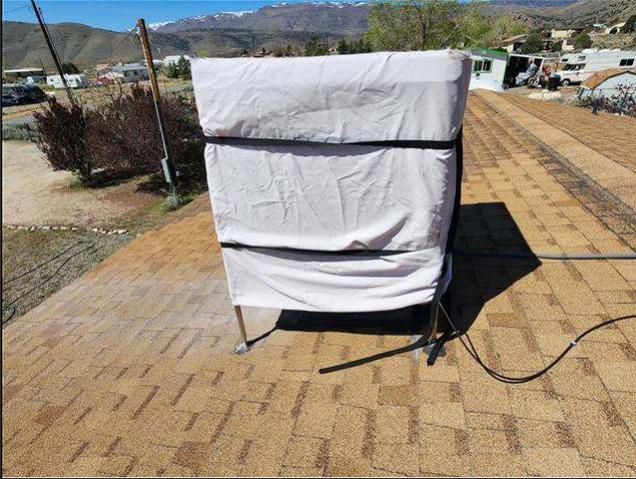
The home uses an Evaporative Cooler located on the roof. Cooler has been winterized, and could not be checked for proper operation. Water pan appeared serviceable (viewed from underneath), pads and drive belt may need replacing, as regular annual maintenance. Could not determine if water pump functions properly.

10.5 Item 1(Picture) winterized cooler

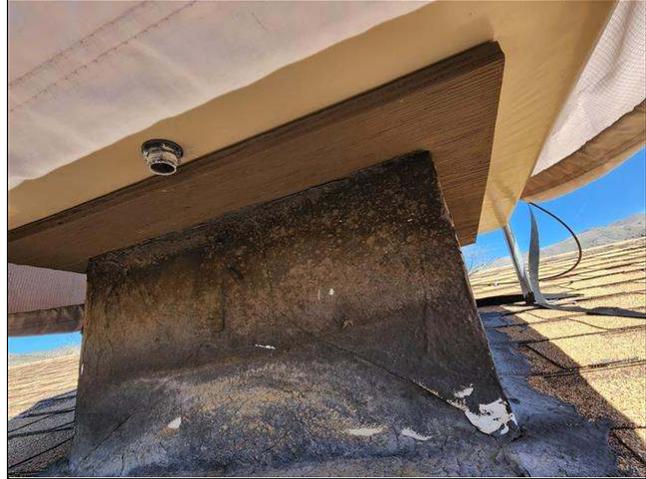
10.5 Item 2(Picture) water pan appears in good condition

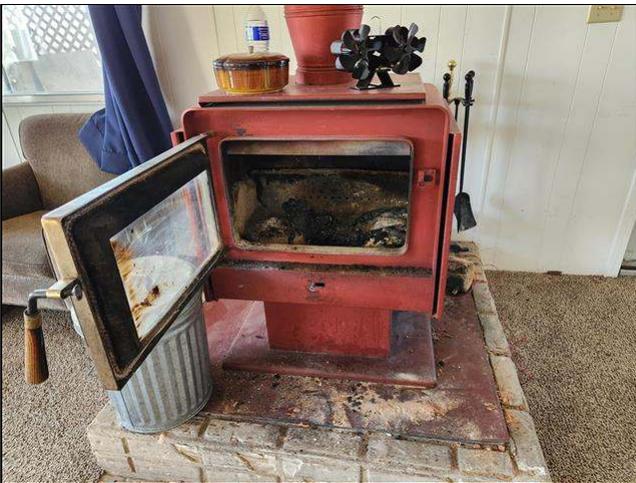
Woodstove appears operational, with stovepipe fastened securely. Clearances to combustibles appears acceptable. Door seals and damper controls appear serviceable. Note: Recommend consulting a licensed fireplace contractor for a more thorough examination of the woodstove, pipe systems and code compliance, as needed. Combustion air is noted to be drawn from the crawlspace area for the stove, as required by current local codes.

11.3 Item 1(Picture) living room woodstove

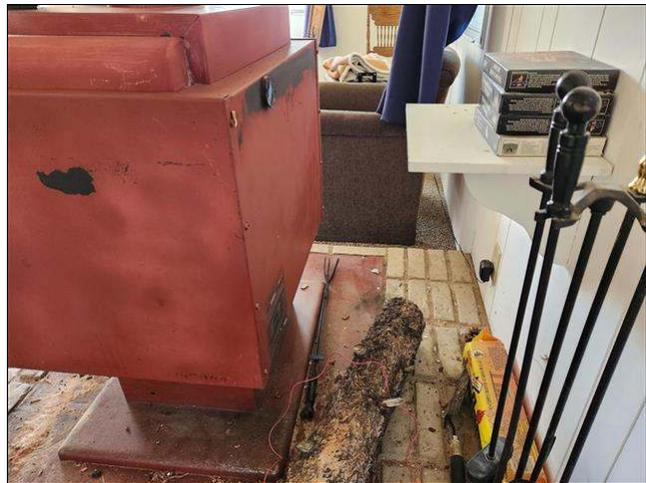
11.3 Item 2(Picture) clearance behind stove

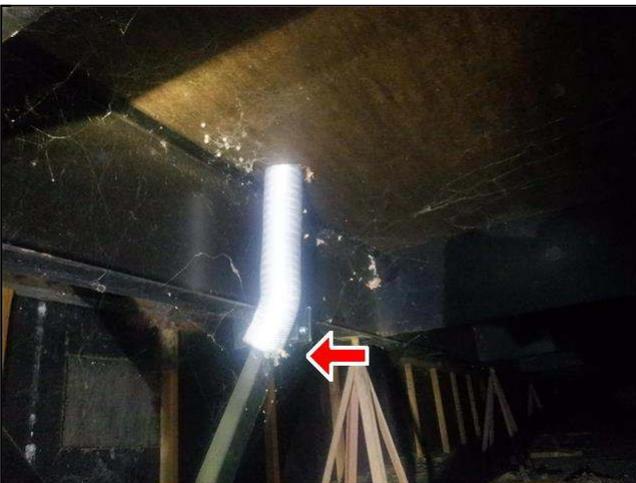
11.3 Item 3(Picture) combustion air duct
