Inspection Report

Property Address:
1370 Chichester Dr.
Gardnerville NV 88410

Clear Choice Home Inspection Services

Date: 7/17/2023	Time: 08:00 AM	Report ID: WAL137
Property: 1370 Chichester Dr. Gardnerville NV 88410	Customer:	Real Estate Professional: Thomas Vander Laan Coldwell Banker

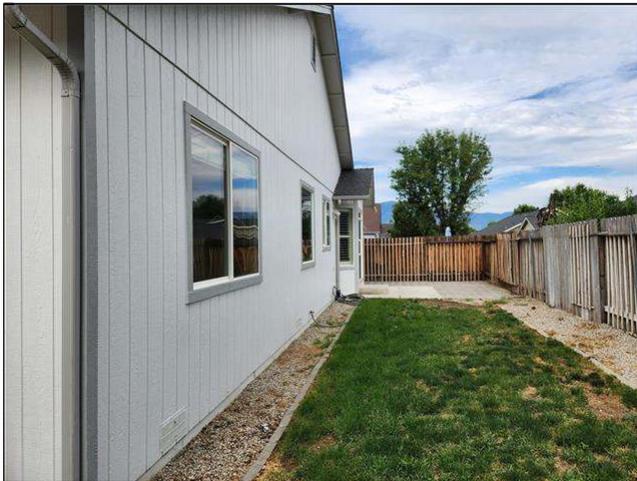
1.0 Item 1(Picture) view of exterior

Exterior, as seen at time of inspection.

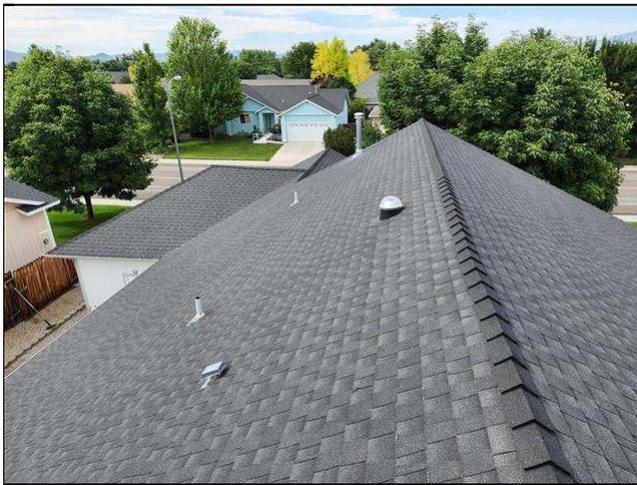
2.0 Item 1(Picture) view of roof

The roof, as seen at time of inspection. Inspected by walking the roof.

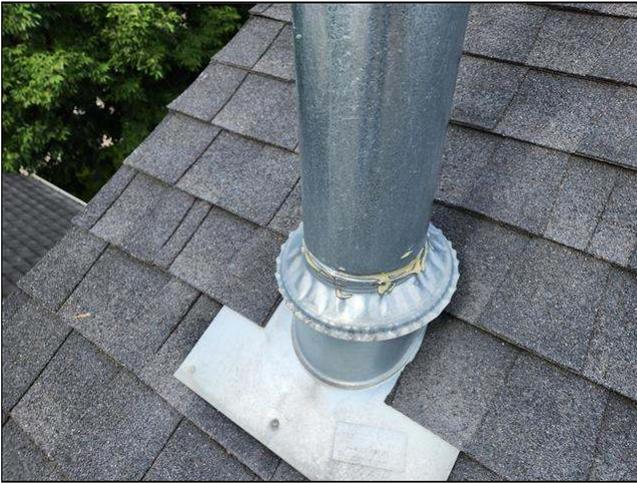
Plumbing and furnace vent pipes are sealed well against flashings to prevent moisture intrusion into attic framing areas.

2.3 Item 1(Picture) furnace flue pipe well sealed

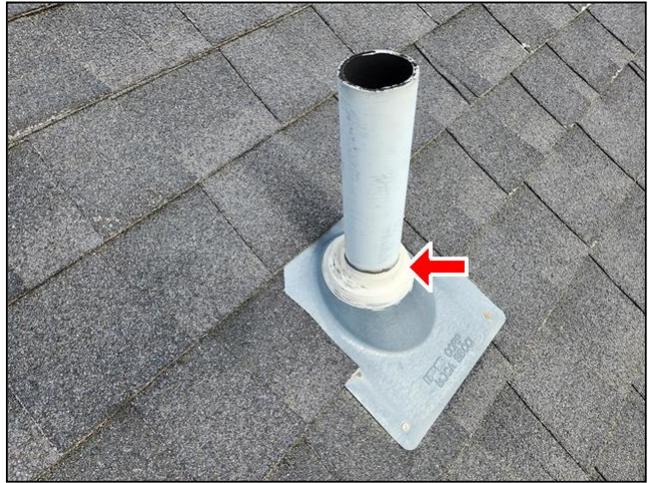
2.3 Item 2(Picture) plumbing vent pipes well sealed

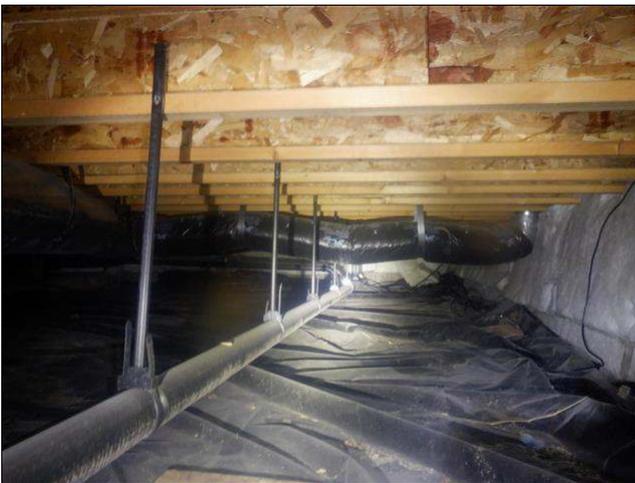
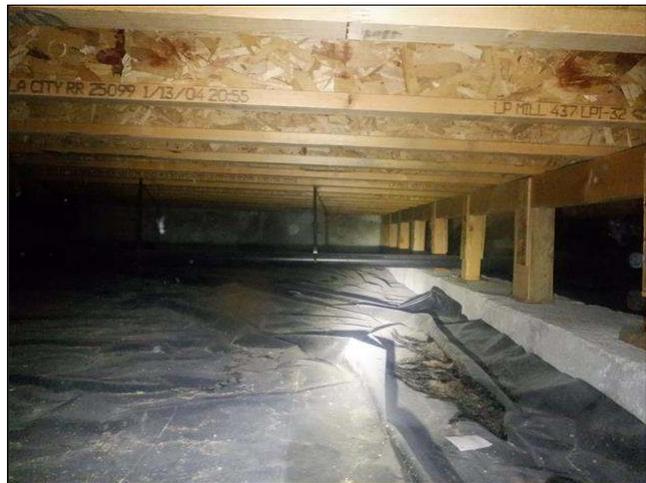
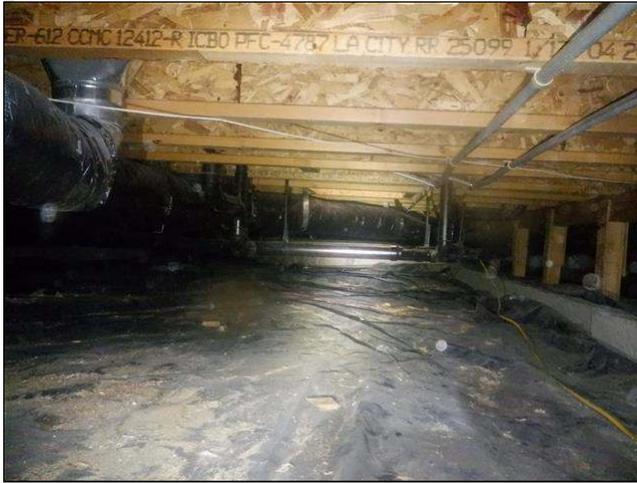
Comments: Inspected
Crawlspace, as seen at time of inspection.

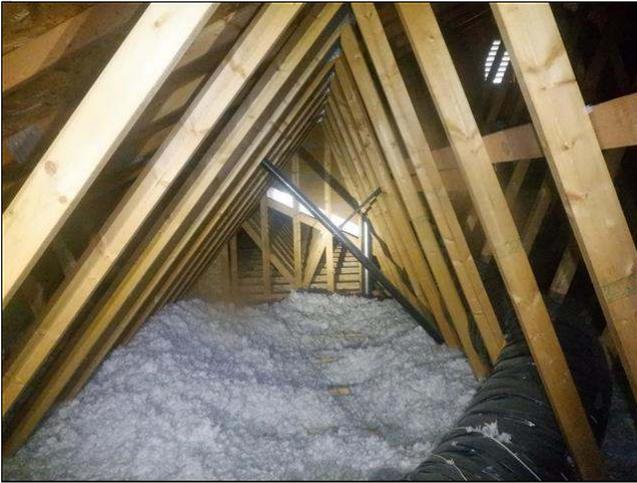
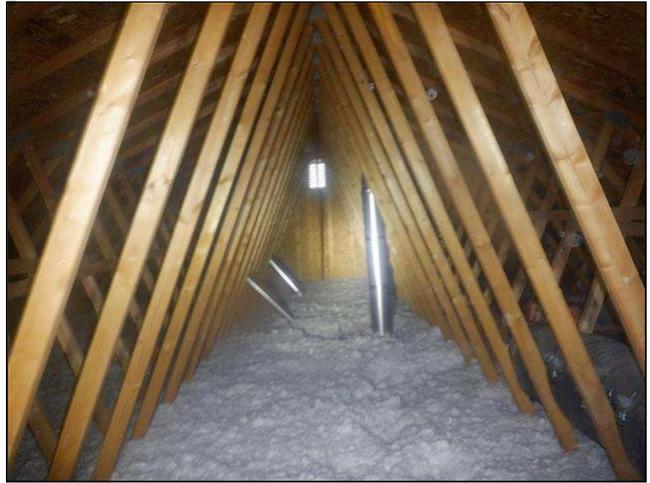
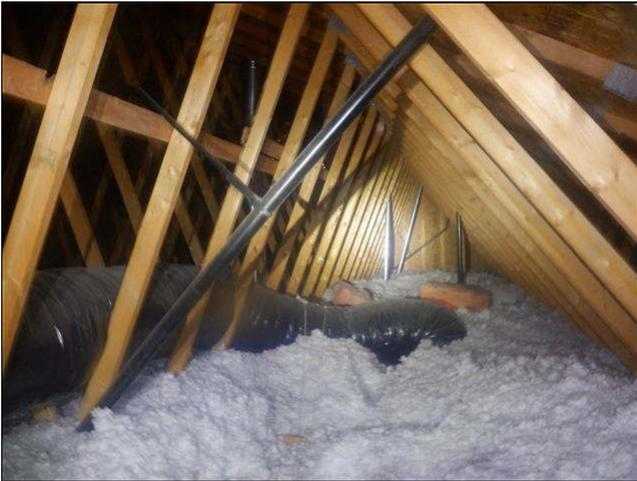
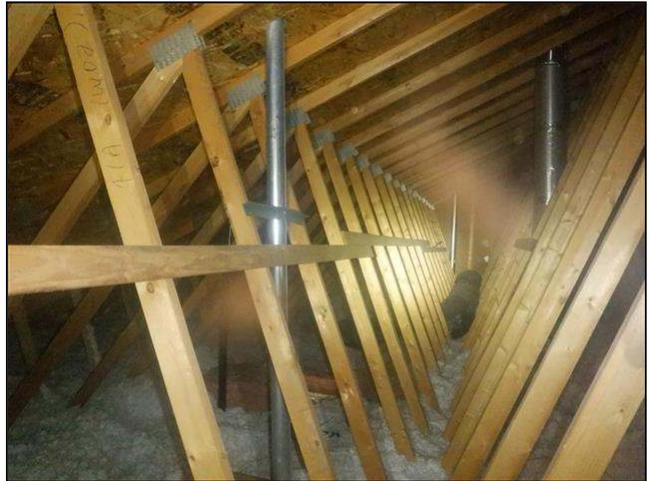
The Attic, as seen at time of Inspection.

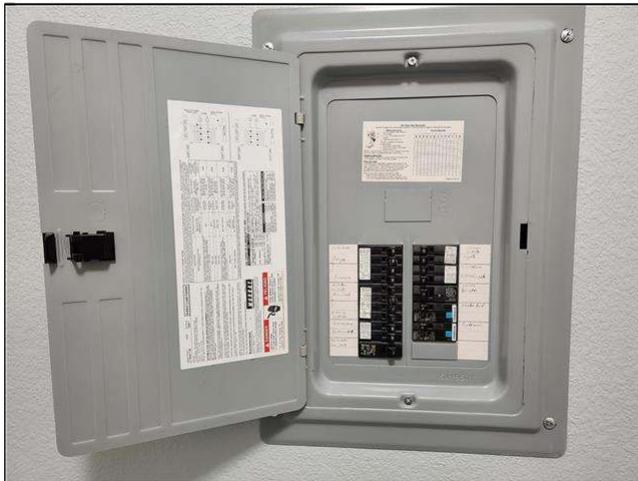
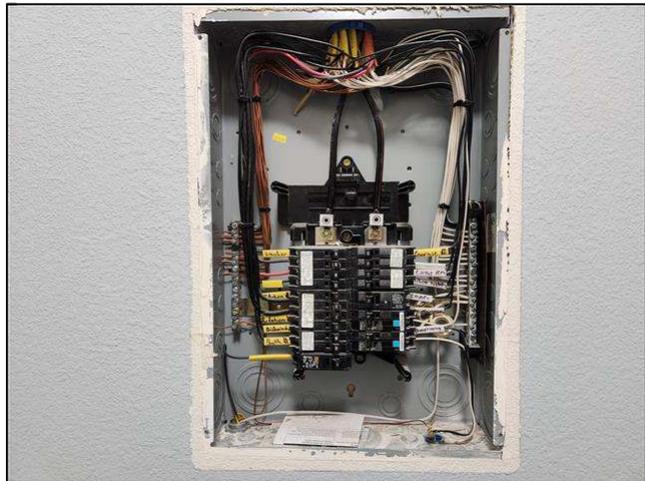
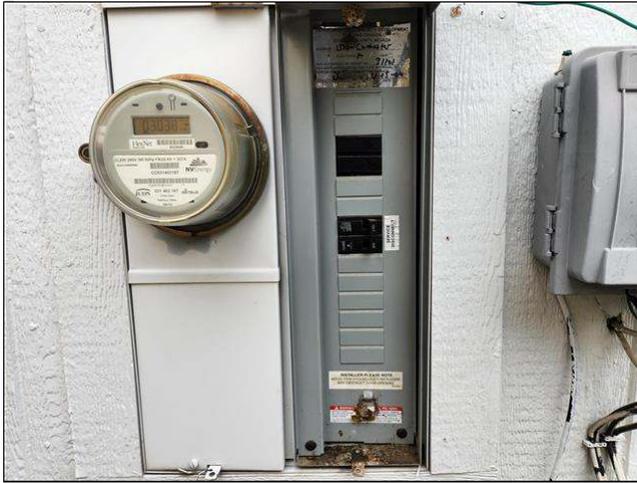
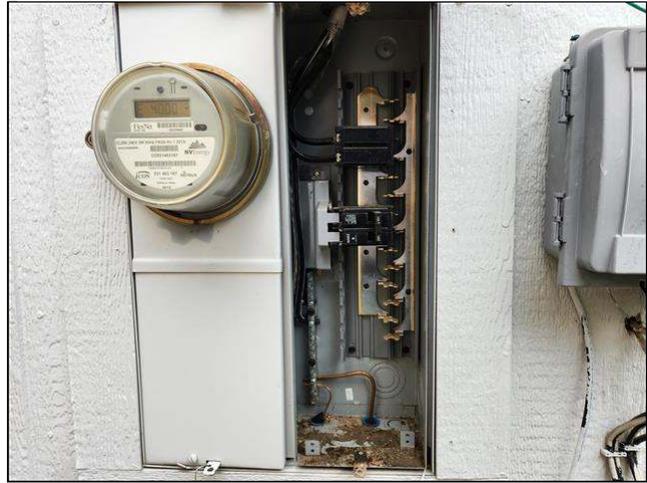
The Main and Distribution Panels are well labeled for circuit identification. "Dead front" cover appears serviceable. No problems noted.

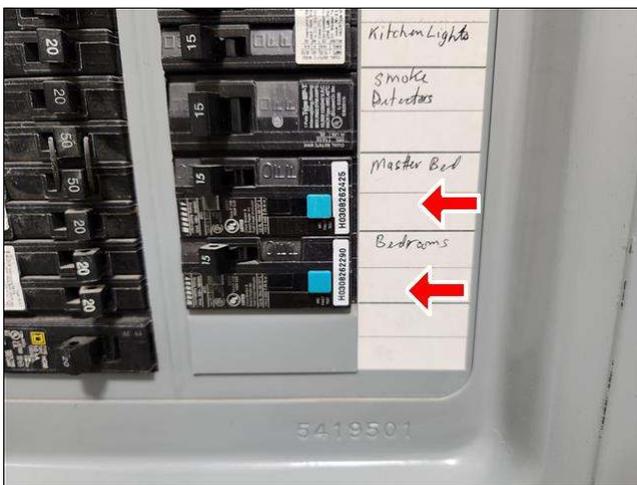
(2) The presence of Arc Fault circuit breakers noted in the Main Panel for Master and Guest bedroom receptacles. Arc Fault Breakers are designed to "trip" the circuit breaker in the event of an arc (poor connection) in the circuit wiring. Tripped and reset as intended.

4.4 Item 1(Picture) arc fault circuit breakers

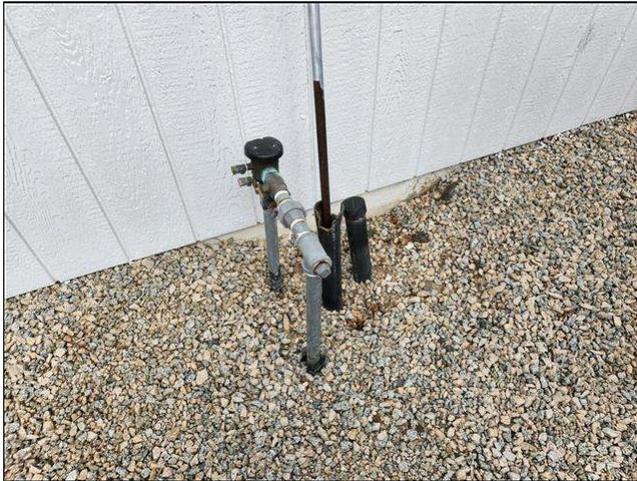
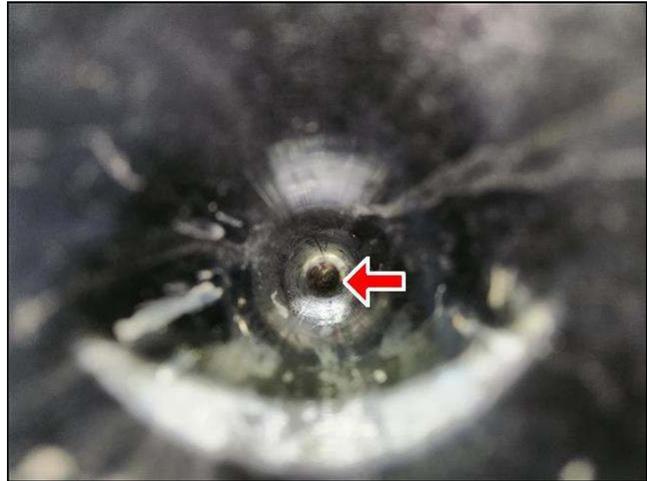
There are a couple main water shut-off locations. With the water meter at front of property (for emergencies), and at side yard to right of house. Note: Both of these locations will require a water key tool to operate. No obvious problems noted.

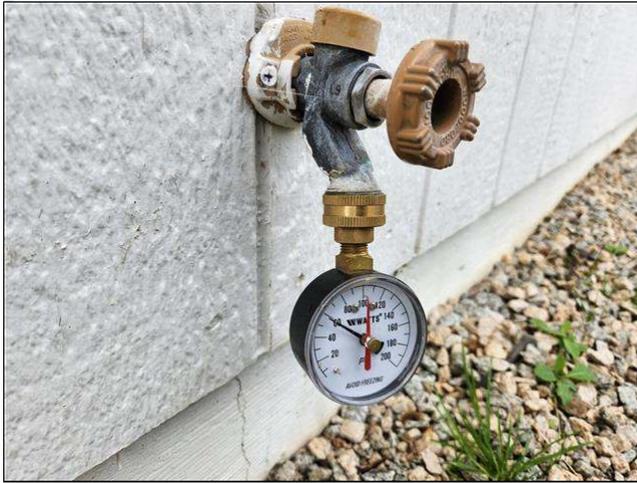
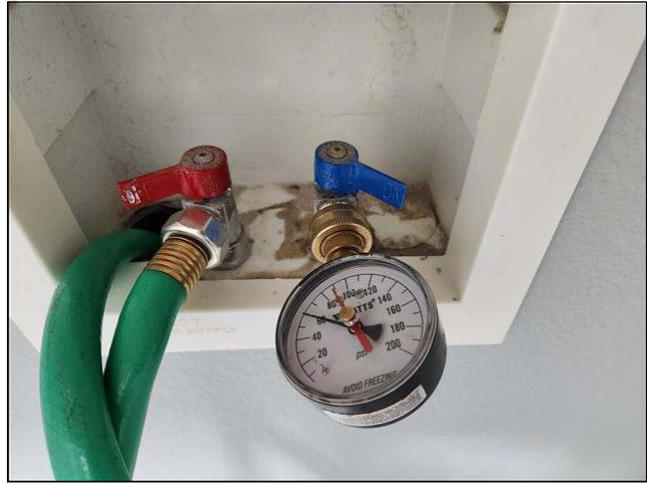
The water pressure was tested at the rear hose bib (and verified at the laundry hookups), pressure was 60 psi at time of inspection.

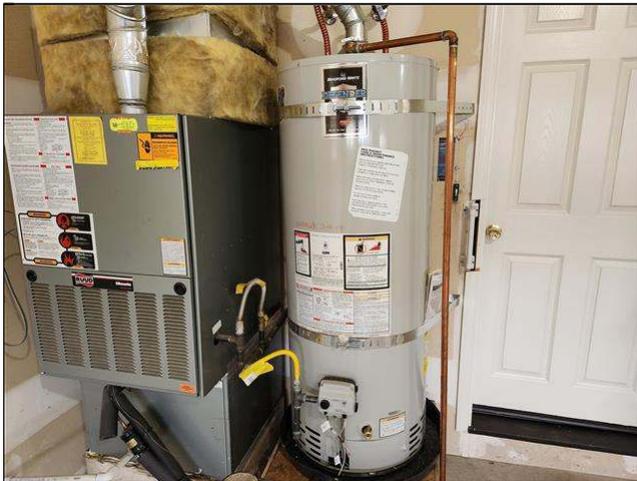
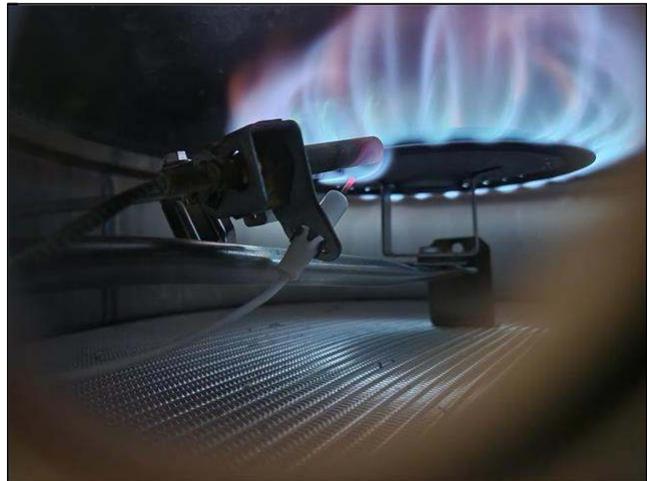
(1) Temperature and Pressure Relief valve is piped to the exterior of the house, or within 6 inches of the floor (for safety). Water Heater is strapped with approved strapping material, and is setting on a pedestal minimum of 18" above the garage floor. Drip leg is installed in the gas line, water and fuel shut-off valves are present. Water heater operated as intended with no abnormal noises or leaks noted. No problems noted at time of inspection... Manufactured in 2019 by Bradford-White.

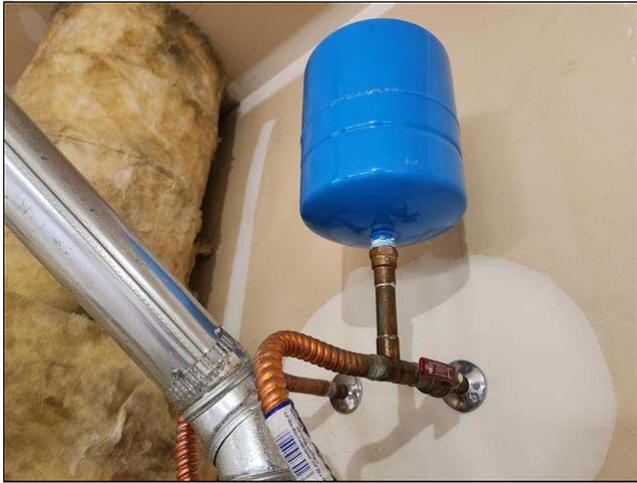
(2) Your water heater does have a "Thermal Expansion tank" installed to prevent a possible leak at the Temperature and Pressure relief valve, or "pop-off" valve, by absorbing the excessive pressure built-up in the water heater.

5.4 Item 3(Picture) thermal expansion tank

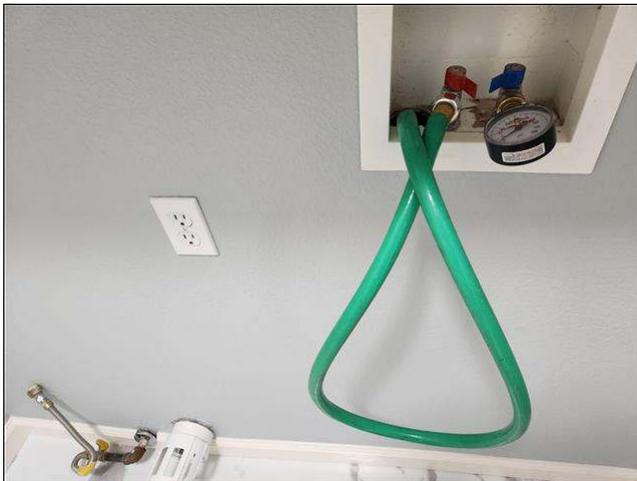
Washer and dryer hook-ups were inspected, with no problems noted. Dryer is electric or gas powered with rigid metal venting installed in the crawlspace. Washer drain is 2" diameter, Hot and Cold hook-ups with no problems noted.

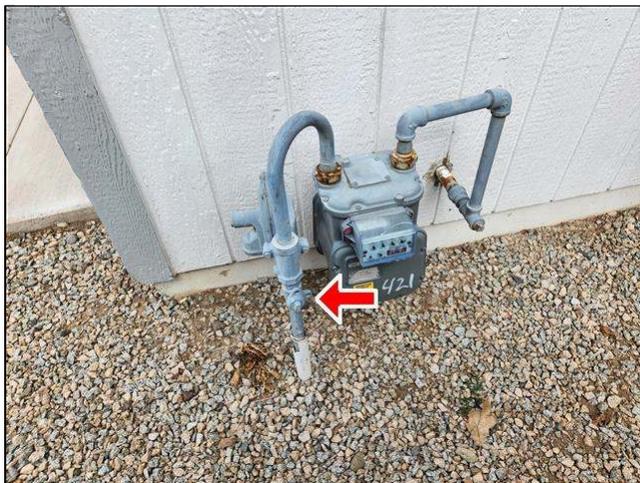
Located at the East side of the house with the gas meter. No problems noted.

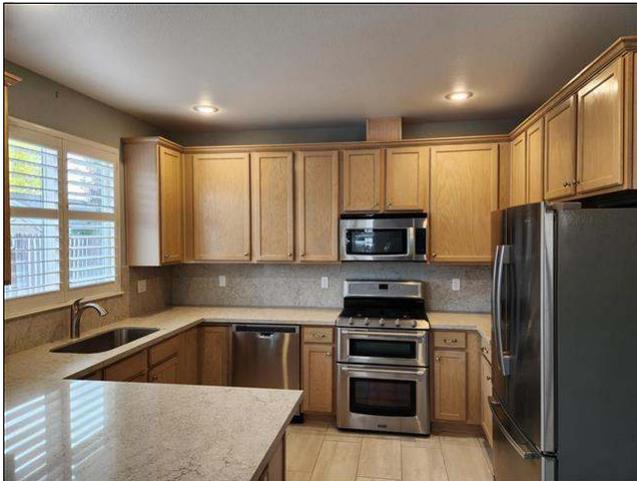
6.0 Item 1(Picture) view of kitchen

Kitchen, as seen at time of inspection.

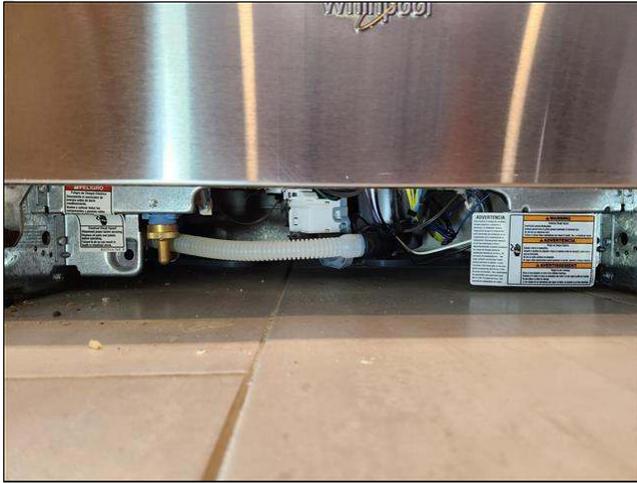
(1) The Dishwasher was run through a complete cycle, with no leaks or abnormal noises noted. Inspection cover was removed to view the Dishwasher electric/plumbing hook-ups, Door seals and dish racks appear in serviceable condition. NOT mounted securely to under countertop. Drain hose is routed to a high loop prior to connecting to drain, as required to prevent backflow/siphon of waste into dishwasher.

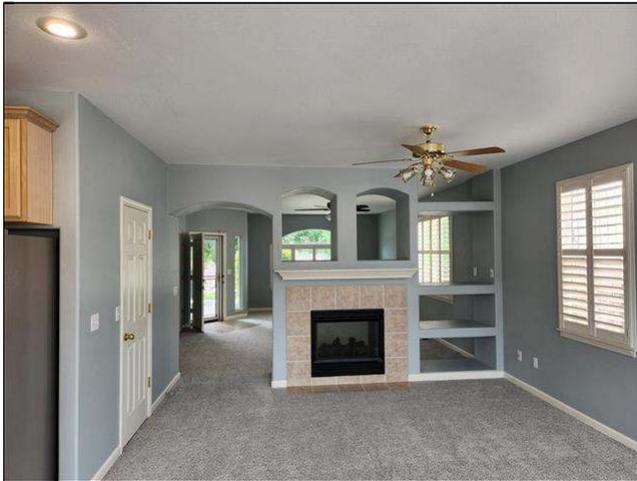
7.0 Item 1(Picture) view of interior

Interior, as seen at time of inspection.

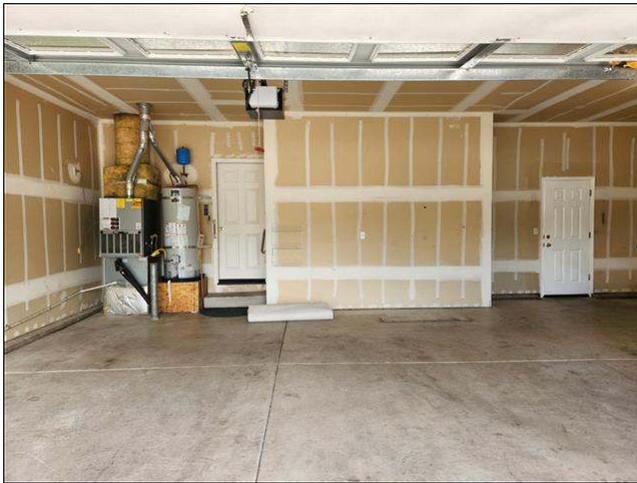
8.0 Item 1(Picture) view of garage

Garage, as seen at time of inspection.

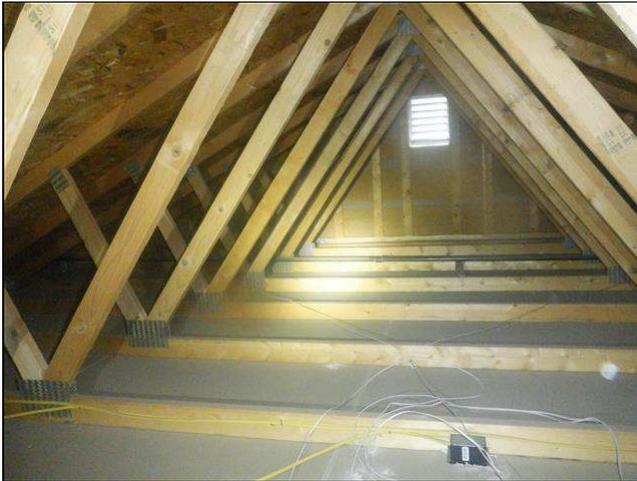
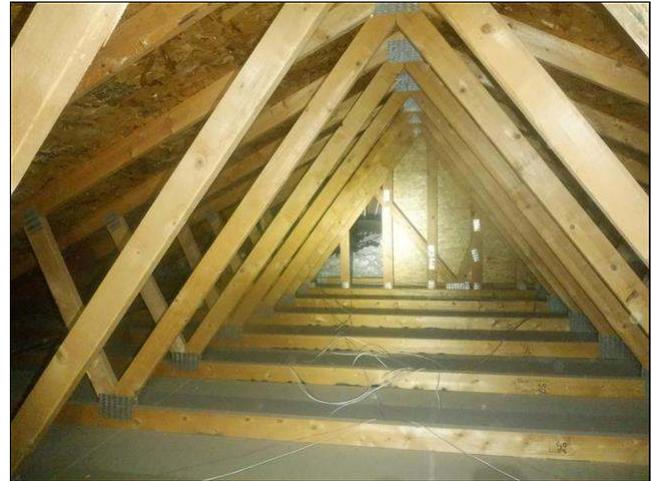
Garage attic area as seen at time of inspection.

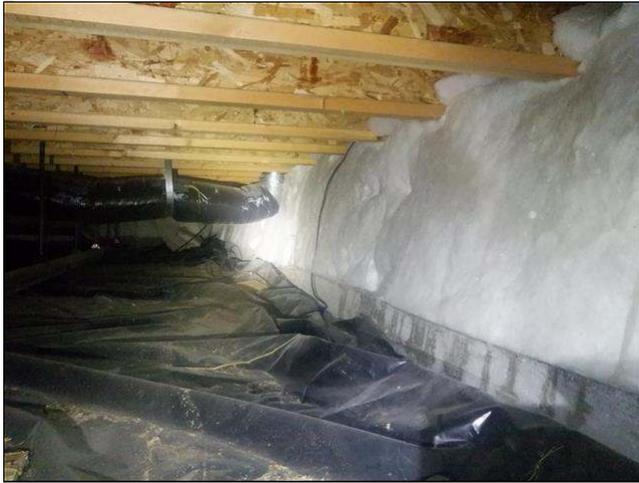
The crawlspace area is insulated on the inner wall of perimeter of the foundation using R13 fiberglass Batts, with a couple areas of loosened/fallen insulation, no problems noted.

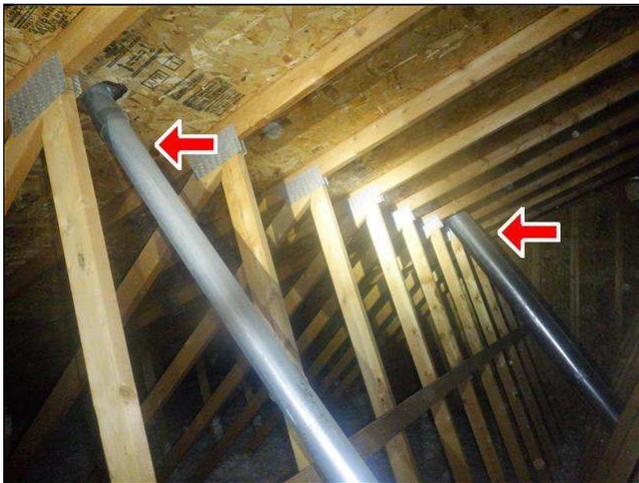
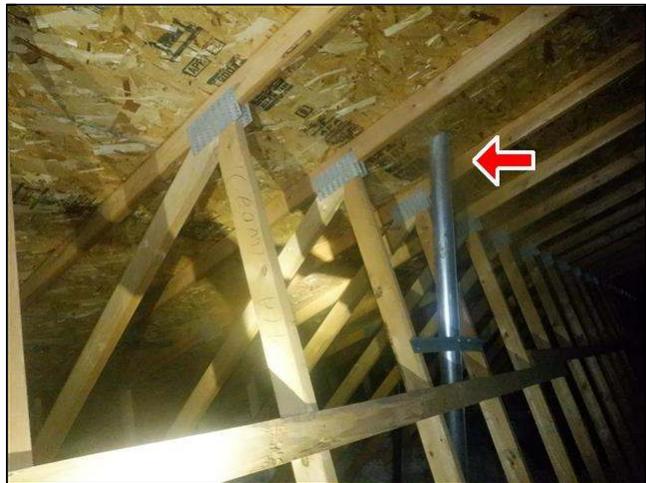
(1) Bathrooms, Kitchen and Laundry vents are properly ducted to the exterior of the home.

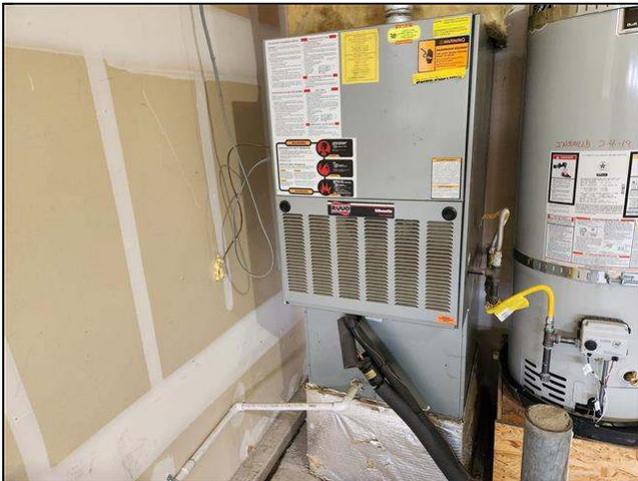
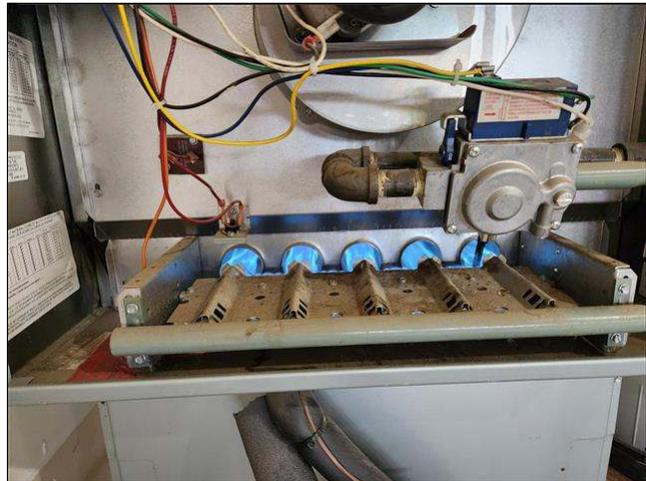
(1) The heating equipment is original (20 years). The furnace is a vertical downdraft natural gas fired forced air unit, Rated at 125,000btu's, that operated as intended with normal operating controls. The burners have an even blue flame. Manufactured in 2002 by RUUD heating.

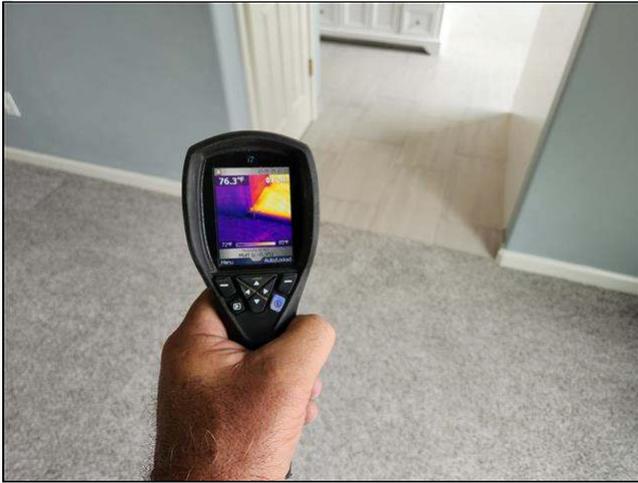
(2) Additional electric heating is installed at the master bathroom floor, which operated as intended using normal operating controls. Floor heat was checked for proper operation and distribution using a Thermal Imaging Camera, with no problems noted.

10.0 Item 3(Picture) checking floor heat at master bathroom

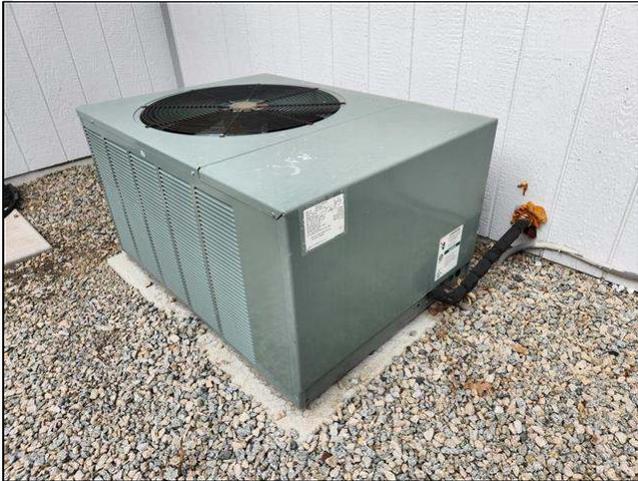
The ambient air test was performed by using thermometers on the air handler of Air conditioner to determine if the difference in temperatures of the supply and return air are between 14 degrees and 22 degrees which indicates that the unit is cooling as intended. The supply air temperature on your system read 55 degrees, and the return air temperature was 71 degrees (a/c cabinet temperature measured 82 degrees). This indicates the range in temperature drop is normal. Condensing unit operated as intended with normal operating controls, and no abnormal noises noted. Unit was manufactured in 2004 by RUUD.

10.5 Item 1(Picture) condensing unit

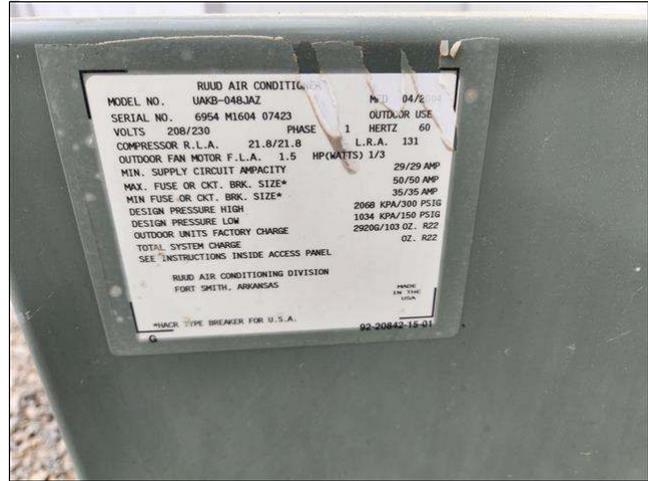
10.5 Item 2(Picture) manufacturer's label

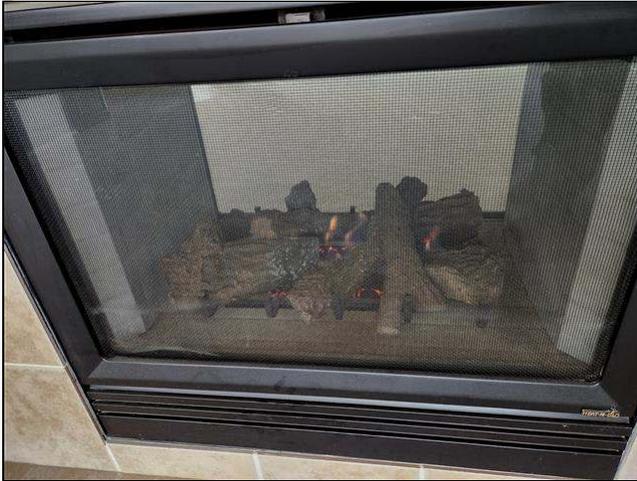
(1) Family room fireplace's pilot light was turned "on" and operational upon arrival for inspection. Firelog burner ignited, using the control switches located at base of fireplace unit, and at right side of unit. No problems noted at time of inspection.

11.0 Item 1(Picture) family room fireplace
