Inspection Report

Property Address:
994 Mica Dr.
Carson City NV 89705

Clear Choice Home Inspection Services

Date: 9/8/2023	Time: 08:30 AM	Report ID: HAY994
Property: 994 Mica Dr. Carson City NV 89705	Customer: Debra Hays-Vaughn	Real Estate Professional: Thomas Vander Laan Coldwell Banker

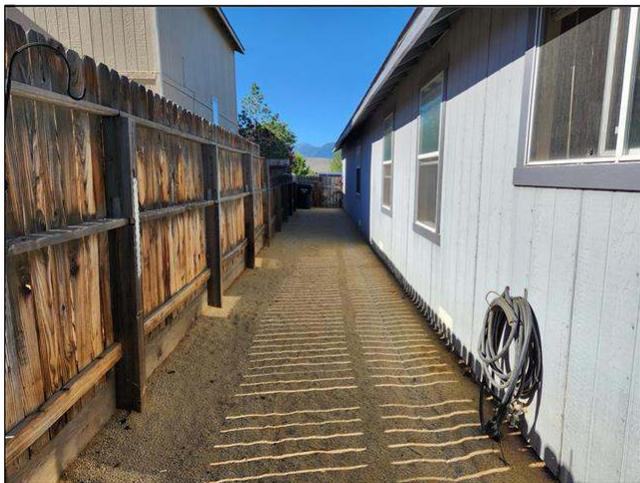
1.0 Item 1(Picture) view of exterior

Exterior, as seen at time of inspection.

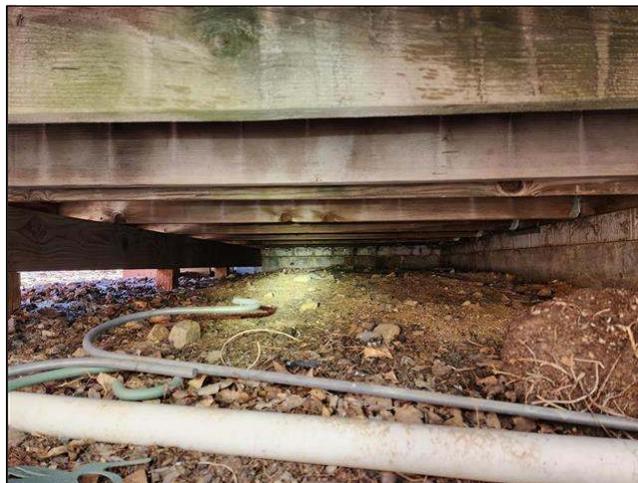
1.6 Item 2(Picture) view under rear deck

Rear deck steps are NOT secure, and should be secured to prevent possible trip hazard.

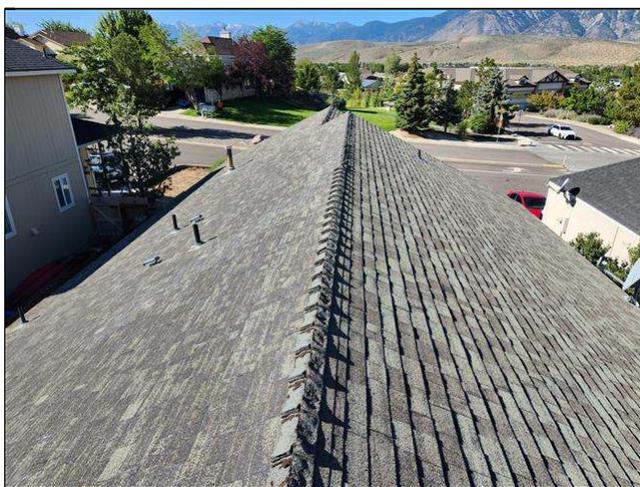
2.0 Item 1(Picture) view of roof

The roof, as seen at time of inspection. Inspected by walking the roof.

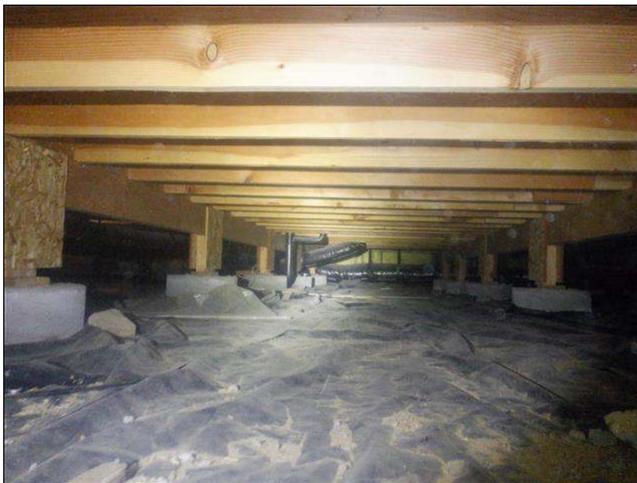
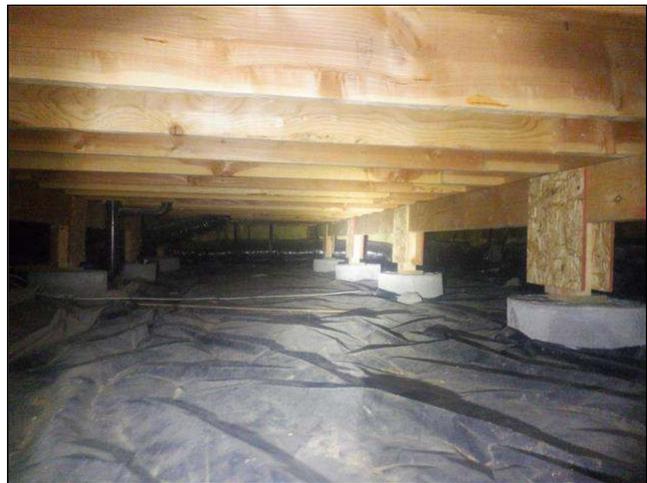
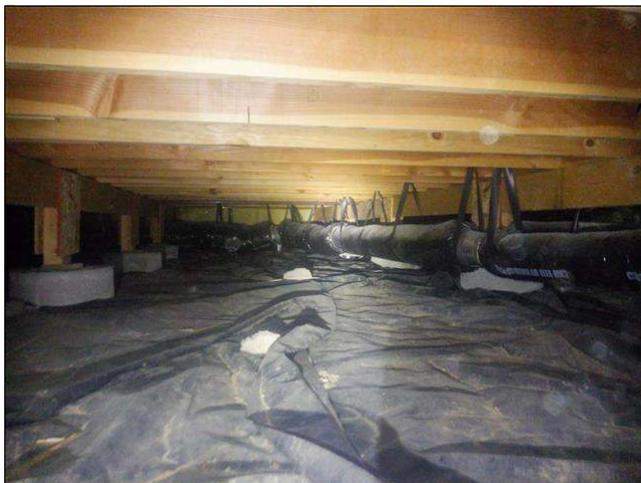
Comments: Inspected
 Crawlspace, as seen at time of inspection.

3.0 Item 1(Picture) view of crawlspace

3.0 Item 2(Picture) view of crawlspace

3.0 Item 3(Picture) view of crawlspace

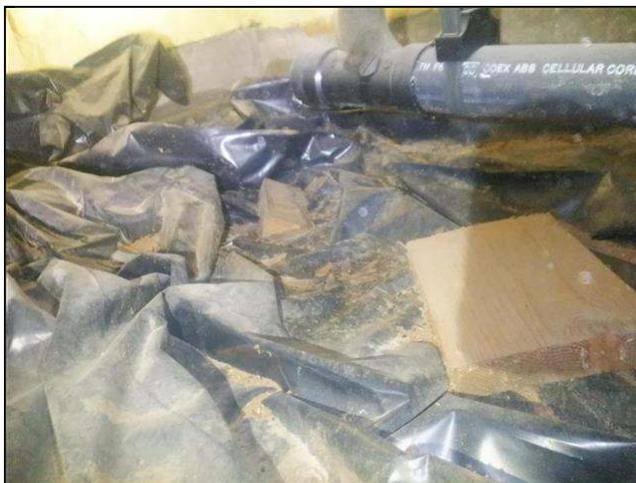
(3) Small areas of Construction debris (and/or trash) should be removed from the crawlspace area. Trash/Debris noted at various locations.

3.2 Item 2(Picture) construction debris

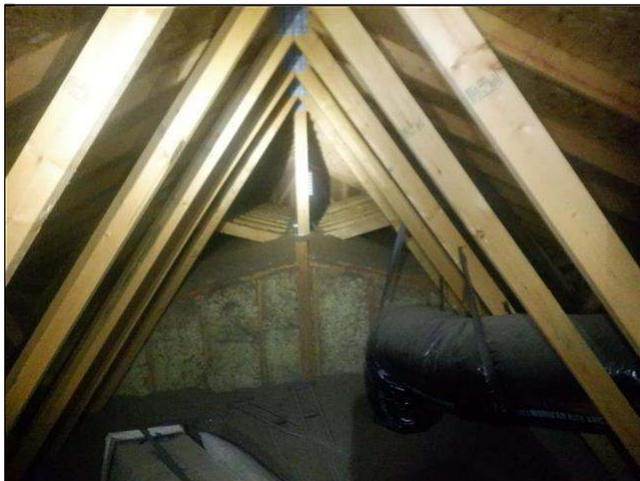
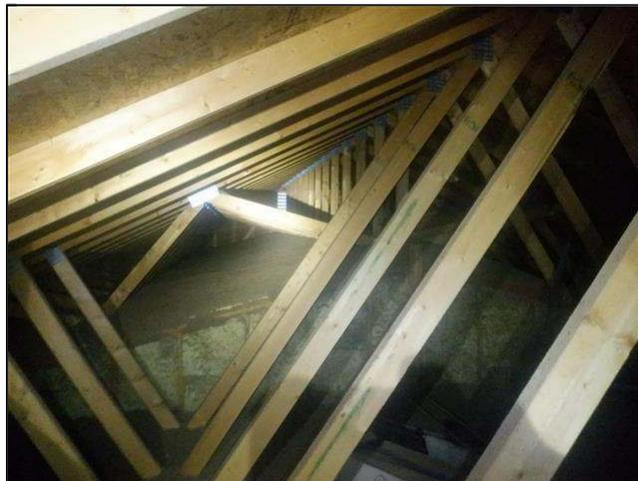
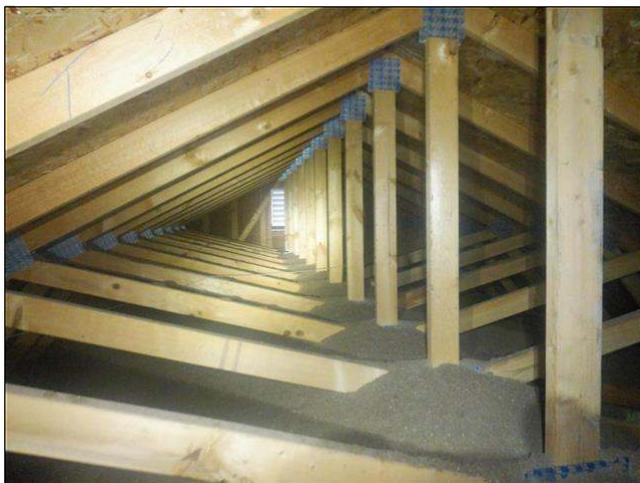
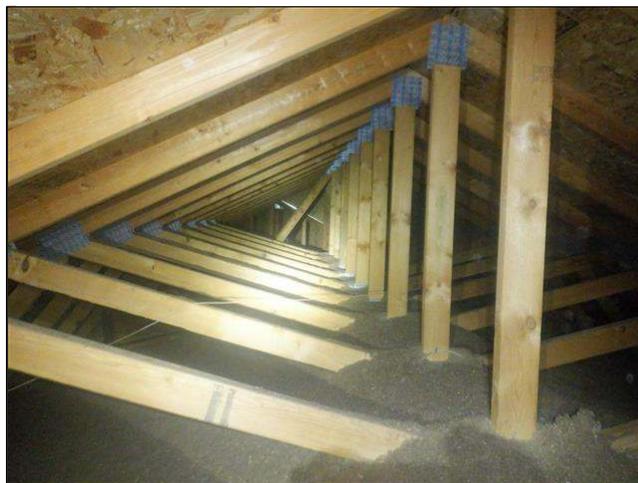
The Attic, as seen at time of Inspection.

3.8 Item 1(Picture) view of attic

3.8 Item 2(Picture) view of attic

3.8 Item 3(Picture) view of attic

3.8 Item 4(Picture) view of attic

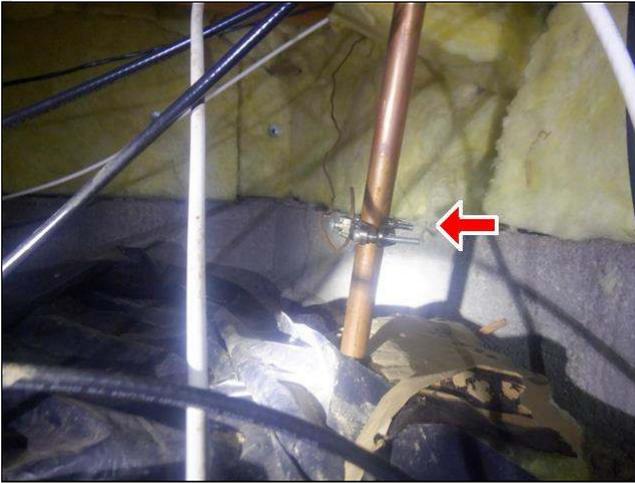
The Grounding system for the Main Service Panel is not visible due to construction materials. However, there is a Grounding wire present in the Panel, and there is a Bonding wire present at the cold water pipe, which are important for proper grounding (safety) of the home.

4.3 Item 1(Picture) bond to plumbing

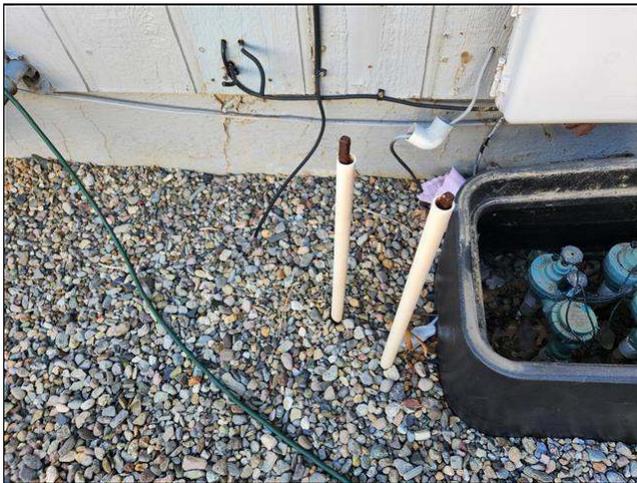
There are a couple main water shut-off locations. With the water meter at front of property (for emergencies), and at side yard to left of house. Both appear in serviceable condition.

5.0 Item 1(Picture) main water shut-off valve location

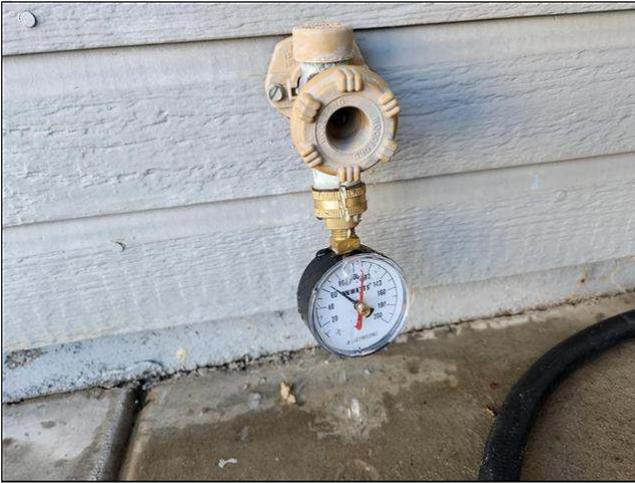
The water pressure was tested at the front hose bib, pressure was 68 psi at time of inspection.

5.2 Item 1(Picture) water pressure at front hose bib

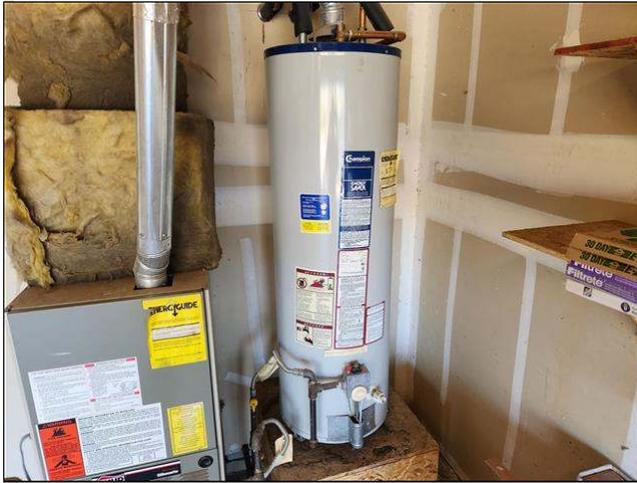
(1) Temperature and Pressure Relief valve is piped to the exterior of the house, or within 6 inches of the floor (for safety). Water Heater is NOT properly strapped with approved strapping material, and is setting on a pedestal minimum of 18" above the garage floor. Drip leg is installed in the gas line, water and fuel shut-off valves are present. Water heater operated as intended with no abnormal noises or leaks noted. No problems noted at time of inspection... Manufactured in 1993 by Bradford-White (30 years old). **NOTE: Signs of slow leaking noted at the water heater drain valve, and should be repaired.**

5.4 Item 1(Picture) water heater

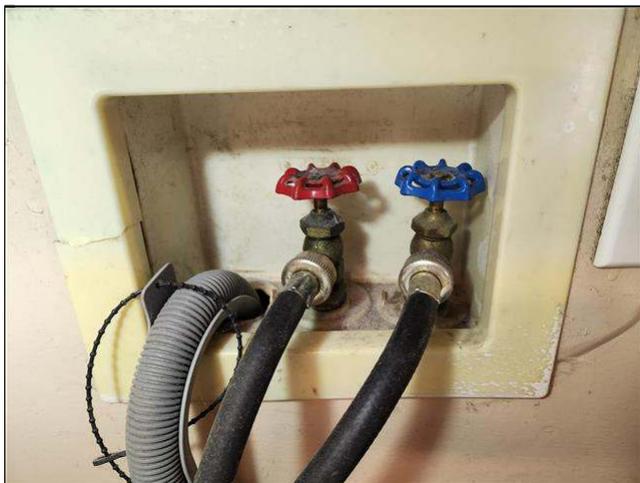
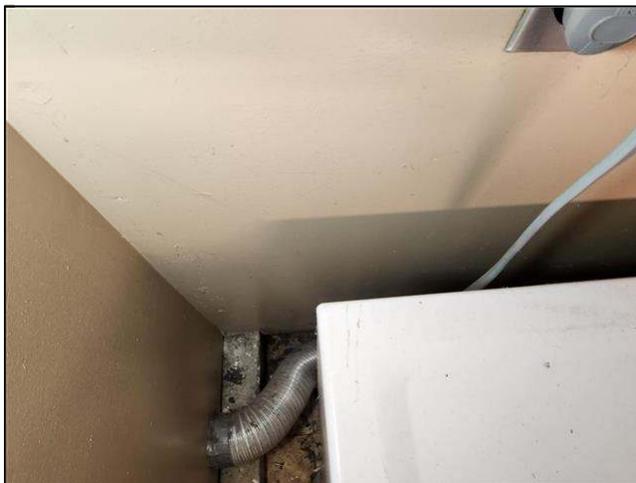
Washer and dryer hook-ups were inspected, with no problems noted. Dryer is electric powered with rigid metal venting installed through the wall. Washer drain is 2" diameter, Hot and Cold hook-ups with no problems noted.

5.6 Item 1(Picture) laundry hook-ups

5.6 Item 2(Picture) laundry hook-ups

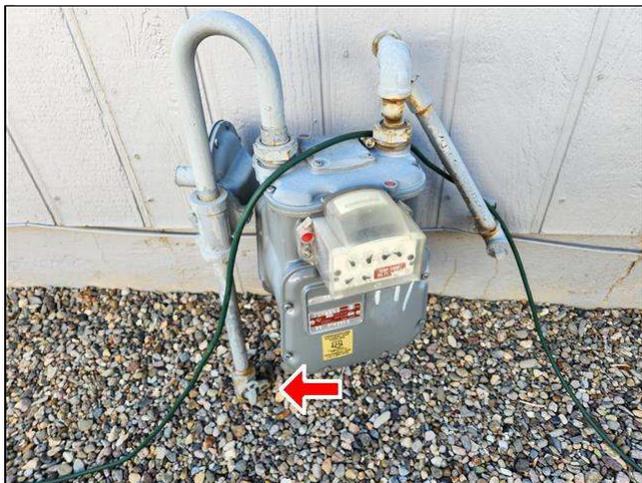
Located at the West side of the house with the gas meter. No problems noted.

5.11 Item 1(Picture) main fuel shut-off valve

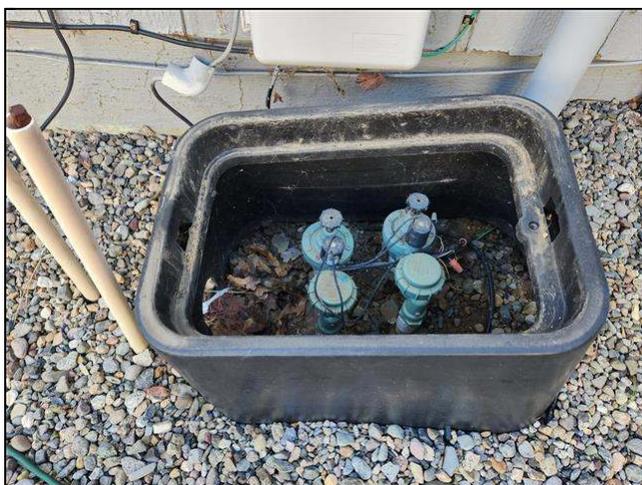
Sprinkler system inspection is beyond the scope of this Home Inspection. Irrigation boxes were opened and inspected for damage and/or major water leaks. No obvious problems noted at time of inspection.

5.13 Item 1(Picture) irrigation box/valves

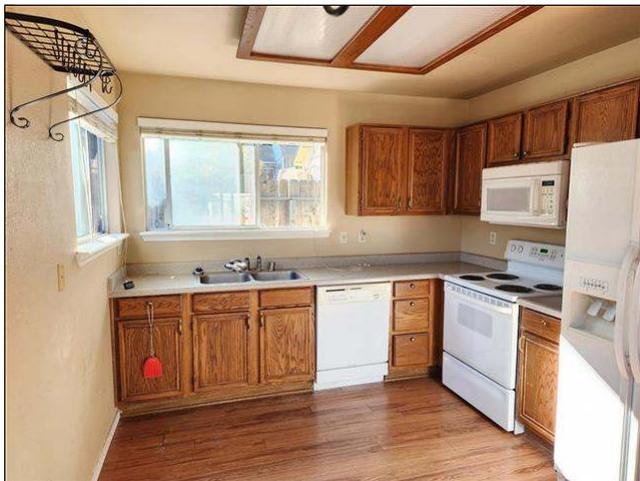
6.0 Item 1(Picture) view of kitchen

Kitchen, as seen at time of inspection.

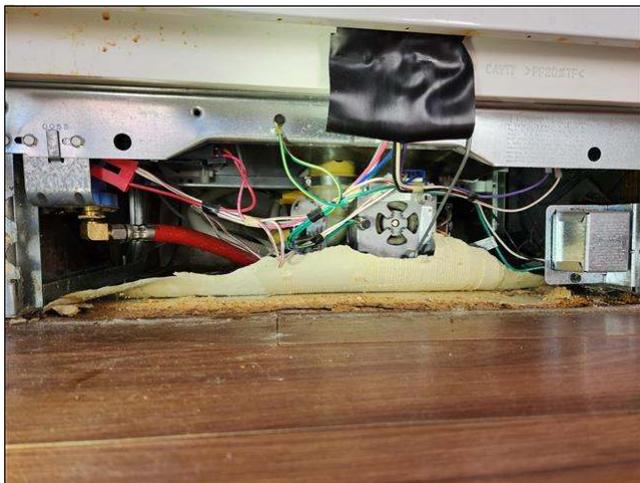
(1) The Dishwasher was run through a complete cycle, with no abnormal noises noted. Inspection cover was removed to view the Dishwasher electric/plumbing hook-ups, Door seals and dish racks appear in serviceable condition. Mounted securely to under countertop. Drain hose is routed to a high loop prior to connecting to drain, as required to prevent backflow/siphon of waste into dishwasher.

6.1 Item 1(Picture) dishwasher hook-ups

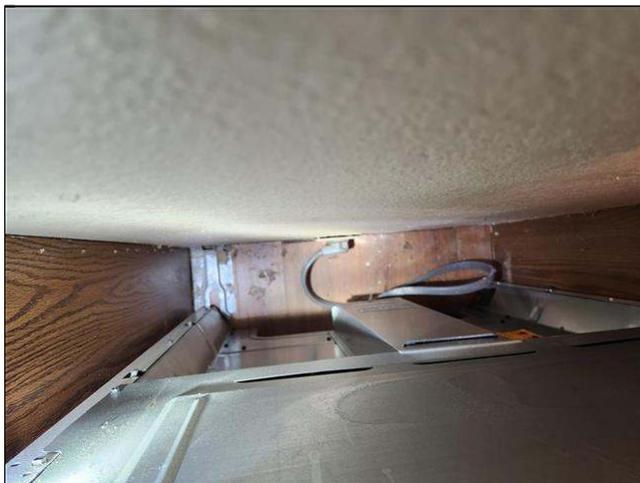
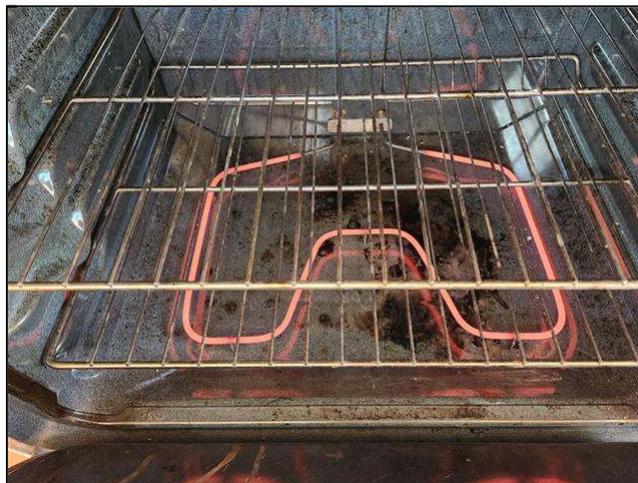
The Electric Range and Oven was inspected at all heating elements and settings. No problems noted at time of inspection.

This appliance **has** an anti-tip bracket installed. This is recommended by the MFG to prevent accidental tipping of the appliance, in the event of a child standing on the oven door.

6.2 Item 1(Picture) behind range

6.2 Item 2(Picture) oven heating operation

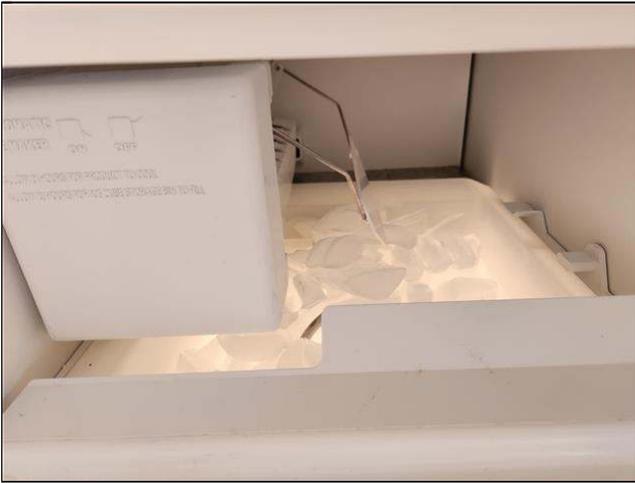
Refrigerator was operating at time of inspection. Door seals and ice maker appear to be in good condition. The Fridge and Freezer temperatures were 44 and 16 degrees respectively at time of inspection.

6.6 Item 1(Picture) ice maker inside freezer

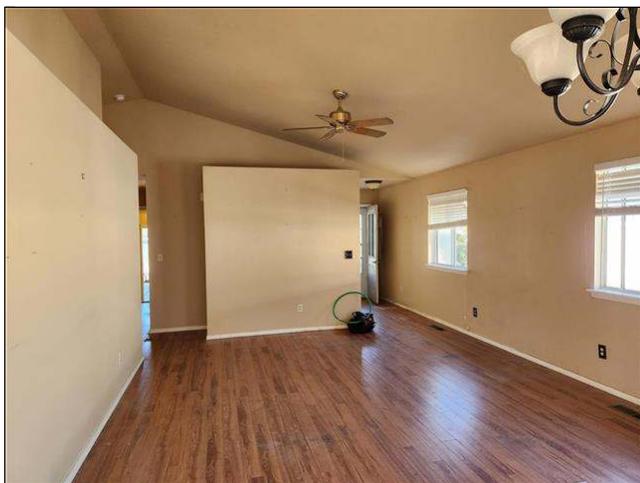
7.0 Item 1(Picture) view of interior

Interior, as seen at time of inspection.

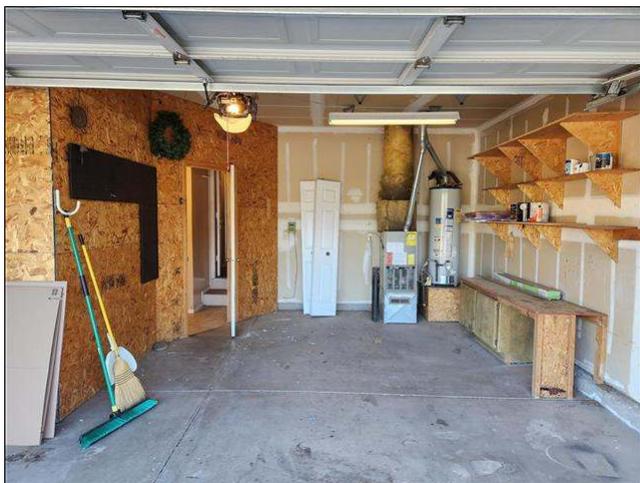
8.0 Item 1(Picture) view of garage

Garage, as seen at time of inspection.

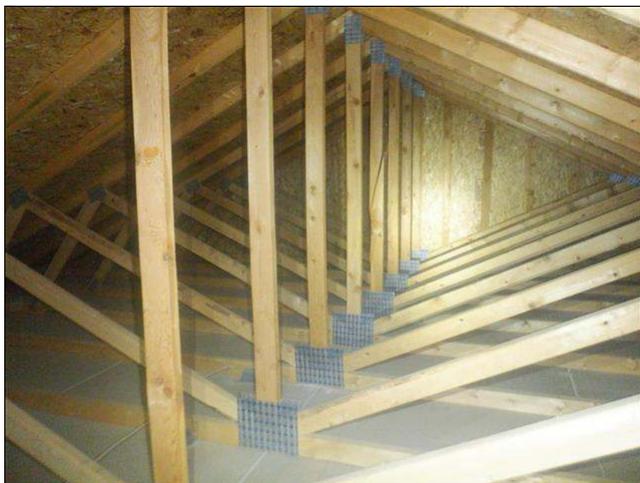
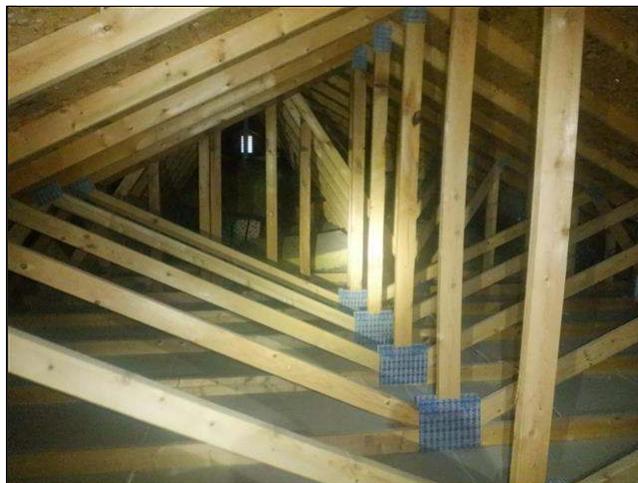
(1) Garage attic area as seen at time of inspection. NOTE: Garage ceiling is NOT insulated.

8.9 Item 1(Picture) view of garage roof structure

8.9 Item 2(Picture) view of garage roof structure

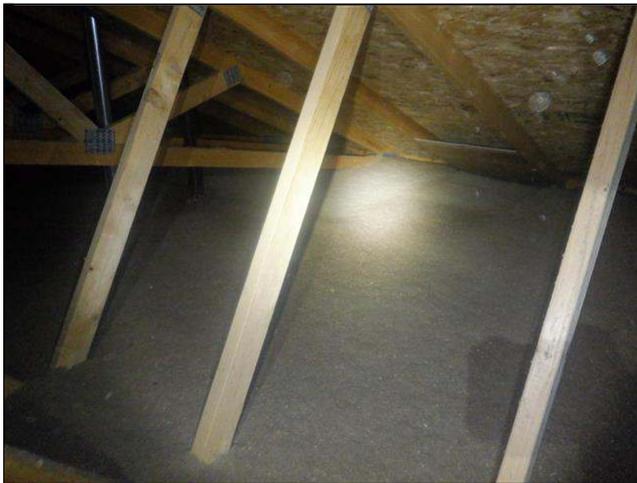
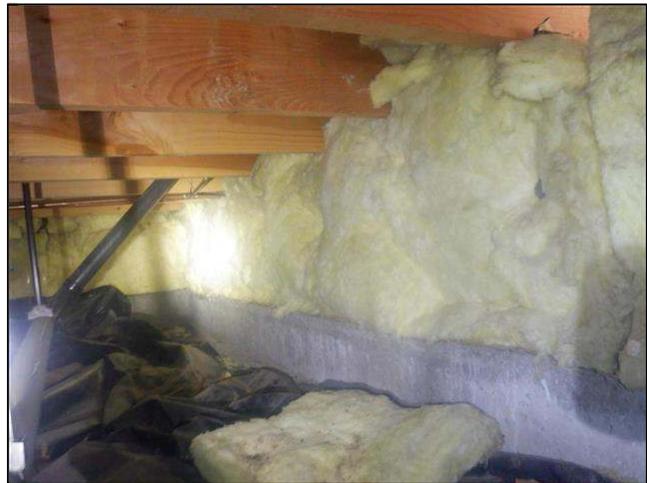
Cellulose insulation (recycled newspaper) is about six to eight inches thick or just under 22 R Value. (3.5 per inch)

9.0 Item 1(Picture) view of attic insulation

9.0 Item 2(Picture) view of crawlspace insulation

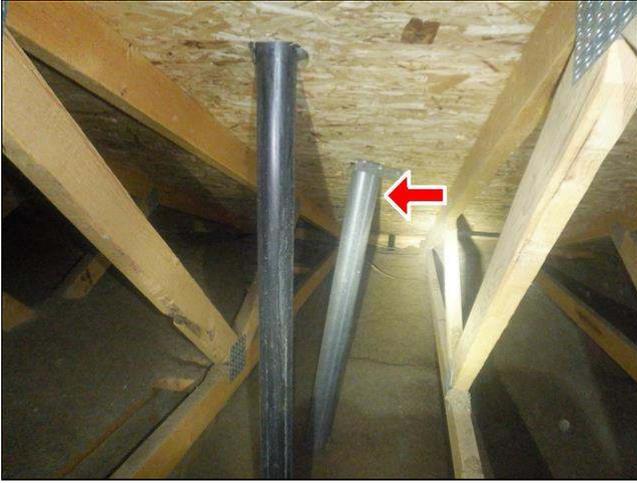
Bathroom vents are properly ducted to the exterior of the home.

9.4 Item 1(Picture) properly vented to exterior

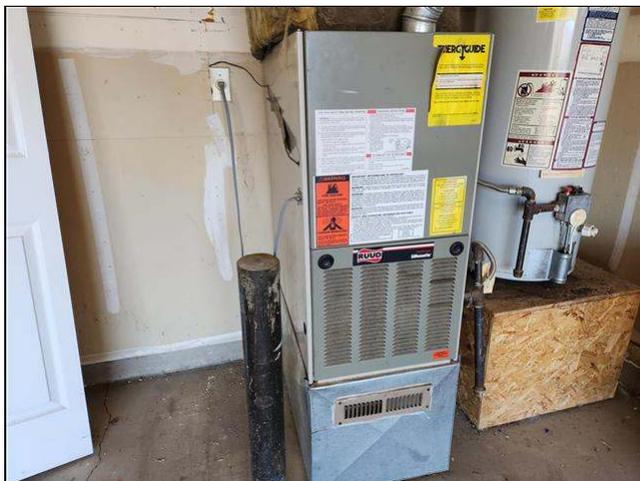
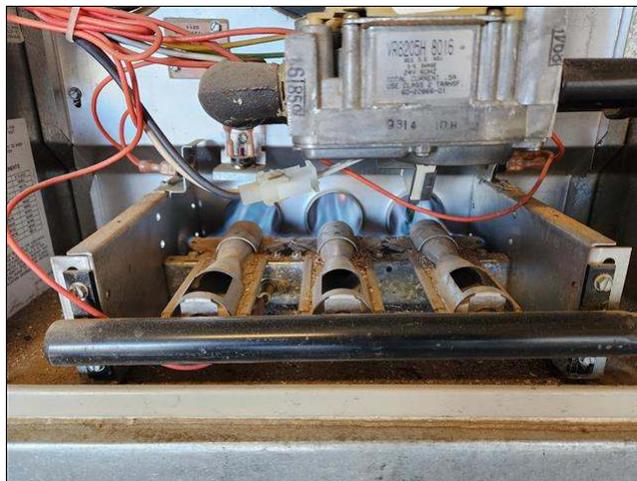
The heating equipment is original (30 years). The furnace is a vertical downdraft natural gas fired forced air unit, Rated at 75,000btu's, that operated as intended with normal operating controls. The burners have an even blue flame. Manufactured in 1993 by RUUD heating.

10.0 Item 1(Picture) forced air furnace

10.0 Item 2(Picture) furnace burners
